[Docket No. FAA-2006-25105; Directorate Identifier 2006-CE-33-AD; Amendment 39-15016; AD 2007-06-01 R1]

#### Airworthiness Directives; Raytheon Aircraft Company Beech Models 45 (YT-34), A45 (T-34A, B-45), and D45 (T-34B) Airplanes

**2007-06-01 R1 Raytheon Aircraft Company:** Amendment 39-15016; Docket No. FAA-2006-25105; Directorate Identifier 2006-CE-33-AD.

**Appendix to AD 2007-06-01 R1—Surface Eddy Current Inspection Procedure**

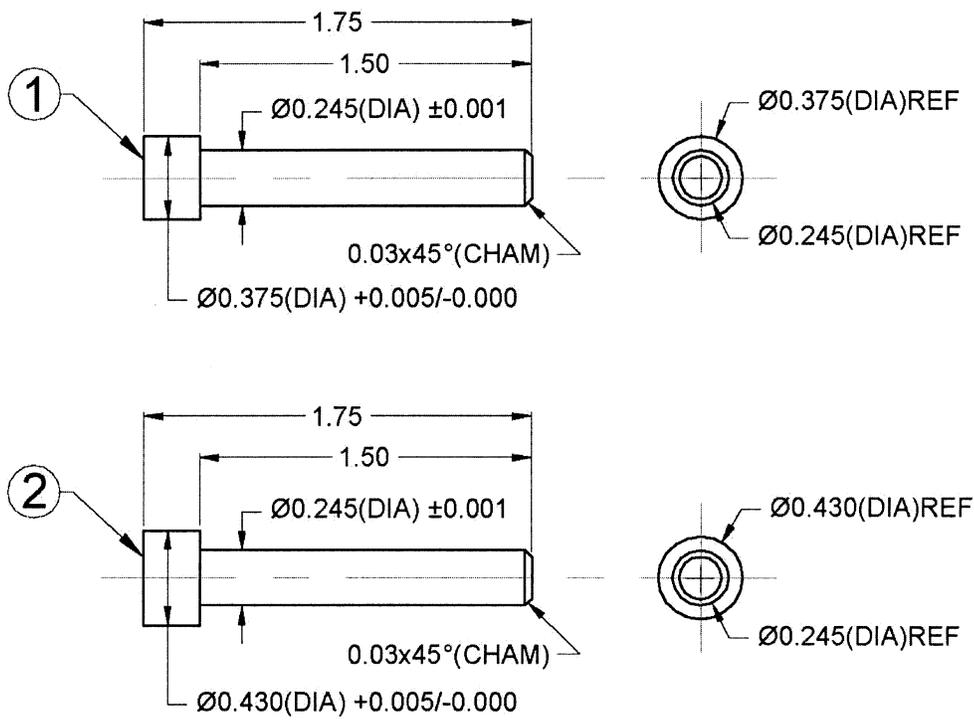
Figure 1

Typical Set-up Parameters:  
 Frequency – 350 KHz, Gain Vertical – 75 dB, Horizontal – 69 dB, Drive-Mid, Filters-Lo Pass-30, Hi Pass-0, Lift off-Horizontal to the left, adjust as required. The most reliable indication (minimum of 1/2 to 2 graticules) of the smallest observable flaw in the coupon (see the attached Figures) occurs from the notch extending 0.025" past the edge of the nominal fastener head (total notch length of 0.100" from the edge of the nominal hole). Install appropriate aluminum guide pin into bushing such that the edge of the guide pin

is flush with the edge of the bushing. Using the pin (see the attached Figures) as a guide, circle the area surrounding the steel bushing with the probe and adjacent area (approximately 1/4") to inspect for cracks. Inspect forward and aft surfaces surrounding bushings of each spar.
