[Docket No. FAA-2007-28828; Directorate Identifier 2007-NM-010-AD; Amendment 39-15258; AD 2007-23-12]

**Airworthiness Directives; Boeing Model 707 Airplanes and Model 720 and 720B Series Airplanes**

## Appendix 1. 707 SFAR 88 Survey Areas

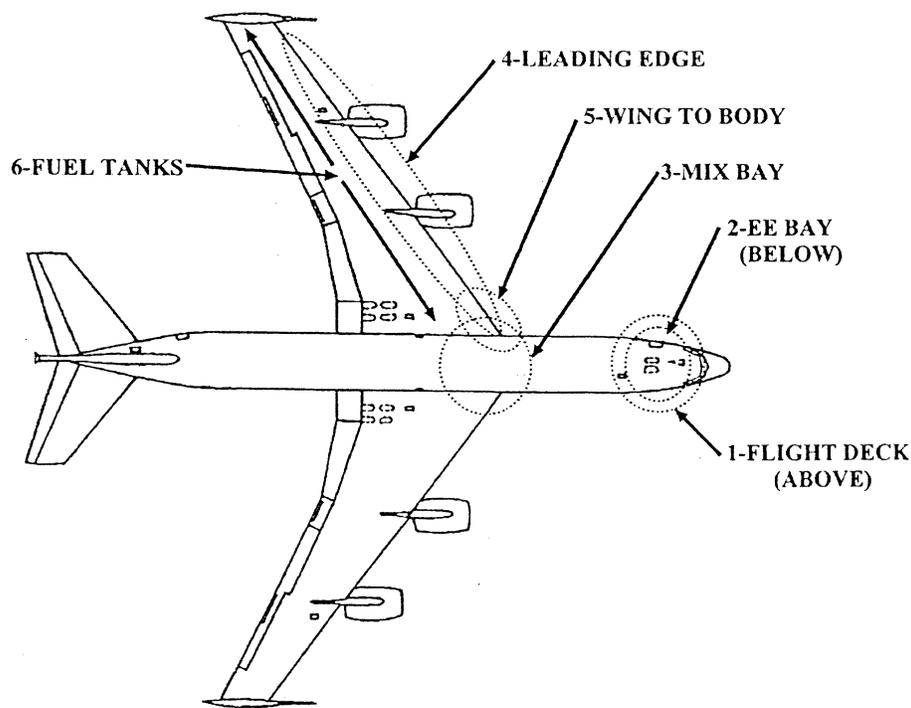
**707 SFAR 88 SURVEY  
AREAS****1) Flight Deck**

New circuit breakers will be installed on the P1, P2, P3, P4 and/or P5 panels. Two new indication lights are installed in the lower P11 panel. Provide photographs of these panels.

Provide photos of the Flight Deck area above and below the Engineer's panel and on the opposite side showing the existing wire bundle routing with the ceiling and side panels removed. This will be used to route additional wire bundles separated from the existing power wires that will be routed to the EE Bay.

Verify the part number(s) of the FQIS indicators installed in the P11 panel. Verify if a remote trimmer is installed for this indicator.
