**[Docket No. FAA-2007-28688; Directorate Identifier 2005-SW-21-AD; Amendment 39-15312; AD 2007-26-10]**

#### **Airworthiness Directives; Bell Helicopter Textron Canada Model 430 Helicopters**

#### 2007-26-10 Bell Helicopter Textron

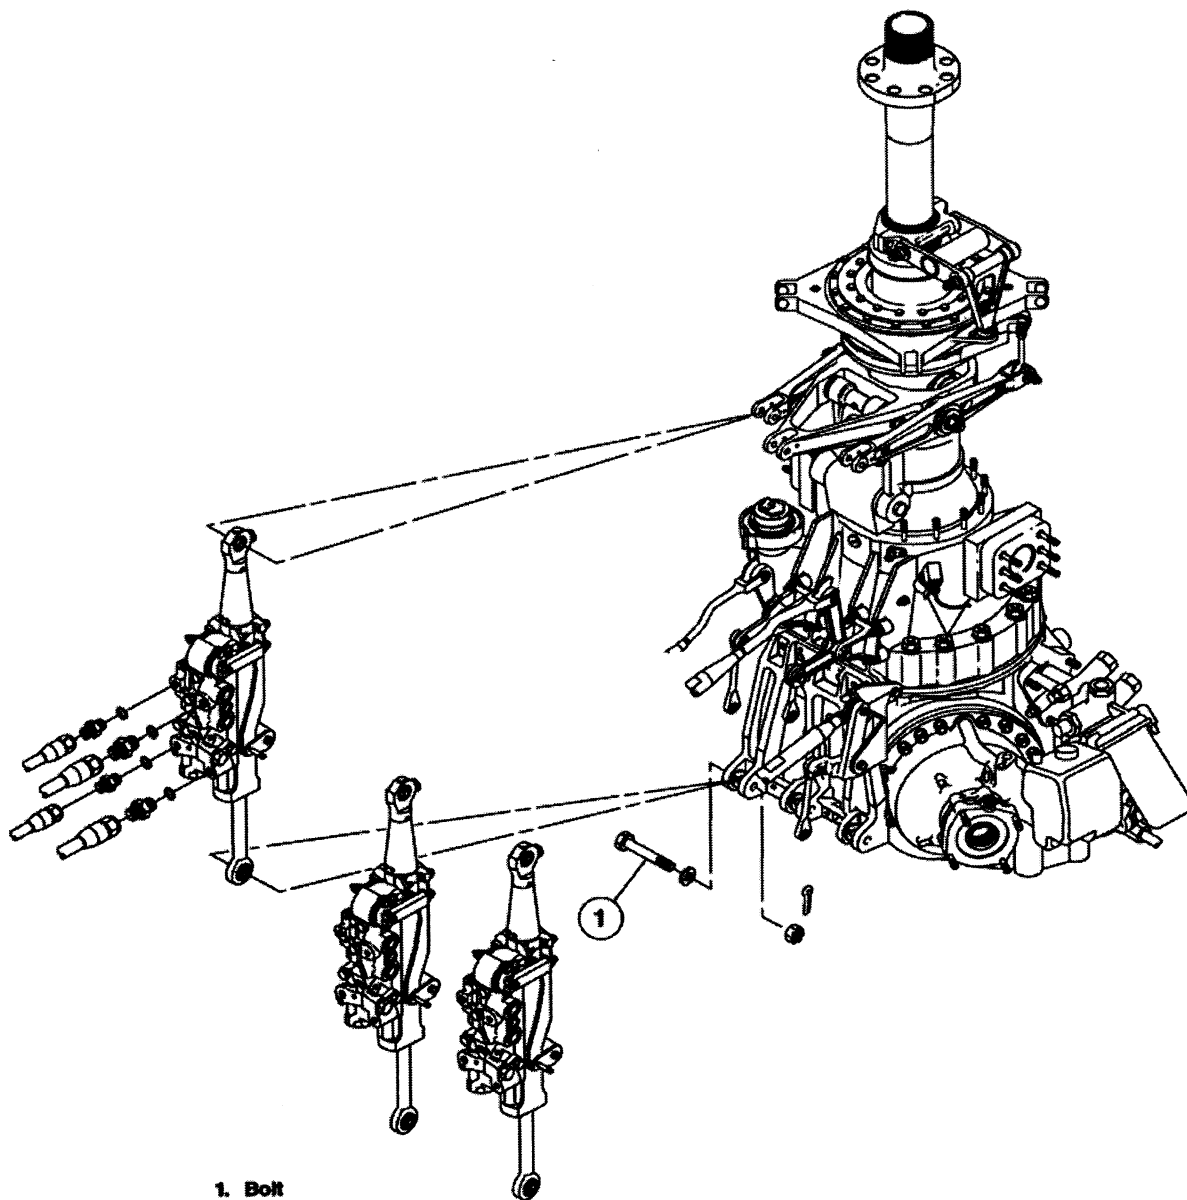
**Note 1:** Only the right servo lower attach bolt (1) is shown. The collective and left cyclic servo lower attach bolts are also to be replaced. (This AD does not apply to the same part-numbered bolts at the upper end of each servo.)

- (a) Within 150 hours time-in-service (TIS), replace all three affected bolts, as depicted for one of these bolts in Figure 1 of this AD, with airworthy, zero-time bolts, P/N 50-047C8-31.
