[Docket No. FAA-2007-28688; Directorate Identifier 2005-SW-21-AD; Amendment 39-15312; AD 2007-26-10]

Airworthiness Directives; Bell Helicopter Textron Canada Model 430 Helicopters

SUMMARY: This amendment adopts a new airworthiness directive (AD) for Bell Helicopter Textron Canada (BHTC) Model 430 helicopters that requires replacing a certain servo actuator-to-actuator support attachment bolt (bolt) with an airworthy bolt. This action also requires establishing a retirement life for certain bolts and recording the retirement life on a component history card or equivalent record. This amendment is prompted by further evaluation of certain fatigue-critical parts, resulting in establishing a life limit of 5,000 hours for the affected bolts. The actions specified by this AD are intended to prevent fatigue failure of the bolt and subsequent loss of control of the helicopter.

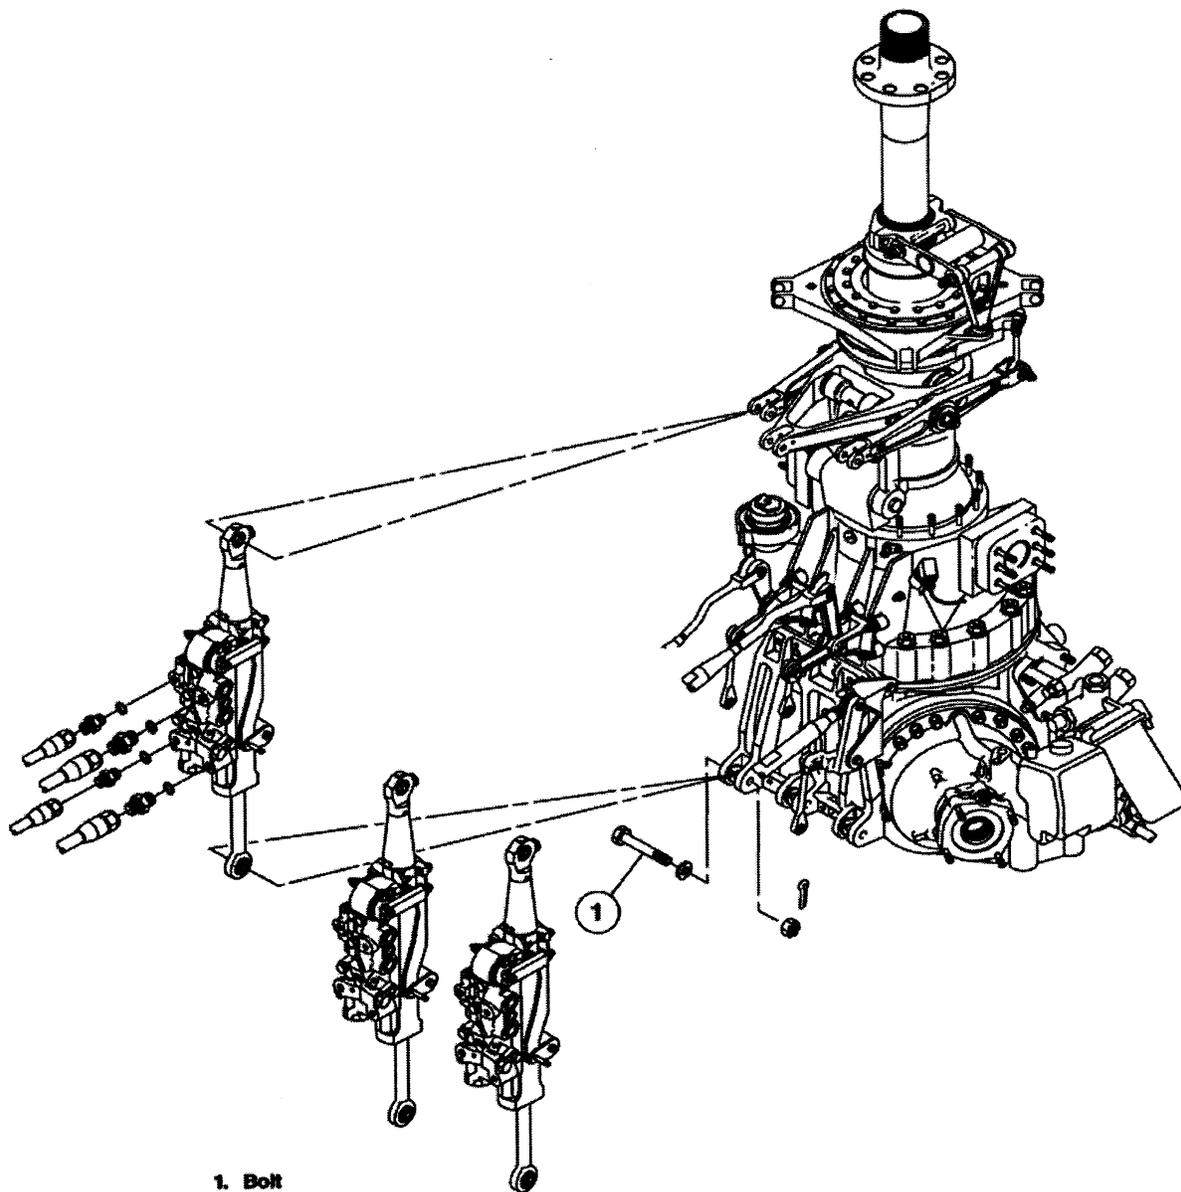
To prevent fatigue failure of the bolt and subsequent loss of control of the helicopter, do the following:

Note 1: Only the right servo lower attach bolt (1) is shown. The collective and left cyclic servo lower attach bolts are also to be replaced. (This AD does not apply to the same part-numbered bolts at the upper end of each servo.)

- (a) Within 150 hours time-in-service (TIS), replace all three affected bolts, as depicted for one of these bolts in Figure 1 of this AD, with airworthy, zero-time bolts, P/N 50-047C8-31.
