[Docket No. NM399; Special Conditions No. 25-387-SC]

Special Conditions: Boeing Model 747-8/-8F Airplanes; Additional Airframe Structural Design Requirements Related to Sudden Engine Stoppage Due to Fan Blade Failures

[Docket No. FAA-2009-0464; Directorate Identifier 2008-NM-189-AD; Amendment 39-15992; AD 2008-16-09 R1]

Airworthiness Directives; Short Brothers Model SD3-60 Airplanes

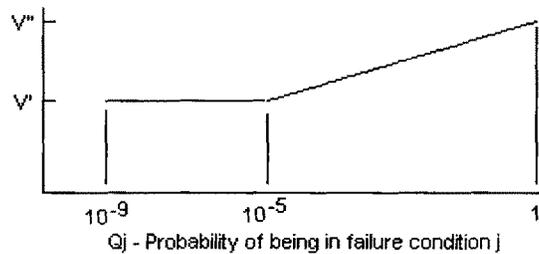
Clearance speed

V' = Clearance speed as defined by § 25.629(b)(2).

V'' = Clearance speed as defined by § 25.629(b)(1).

Note: If P_j is greater than 10^{-3} per flight hour, then the flutter clearance speed must not be less than V''.

(6) Freedom from aeroelastic instability must also be shown up to V' in Figure 3 above, for any probable system failure condition combined with any damage required or selected for investigation by § 25.571(b).
