[Docket No. FAA-2013-0574; Directorate Identifier 2008-SW-22-AD]

Airworthiness Directives; Bell Helicopter Textron Canada (Bell) Helicopters

ACTION: Notice of proposed rulemaking (NPRM).

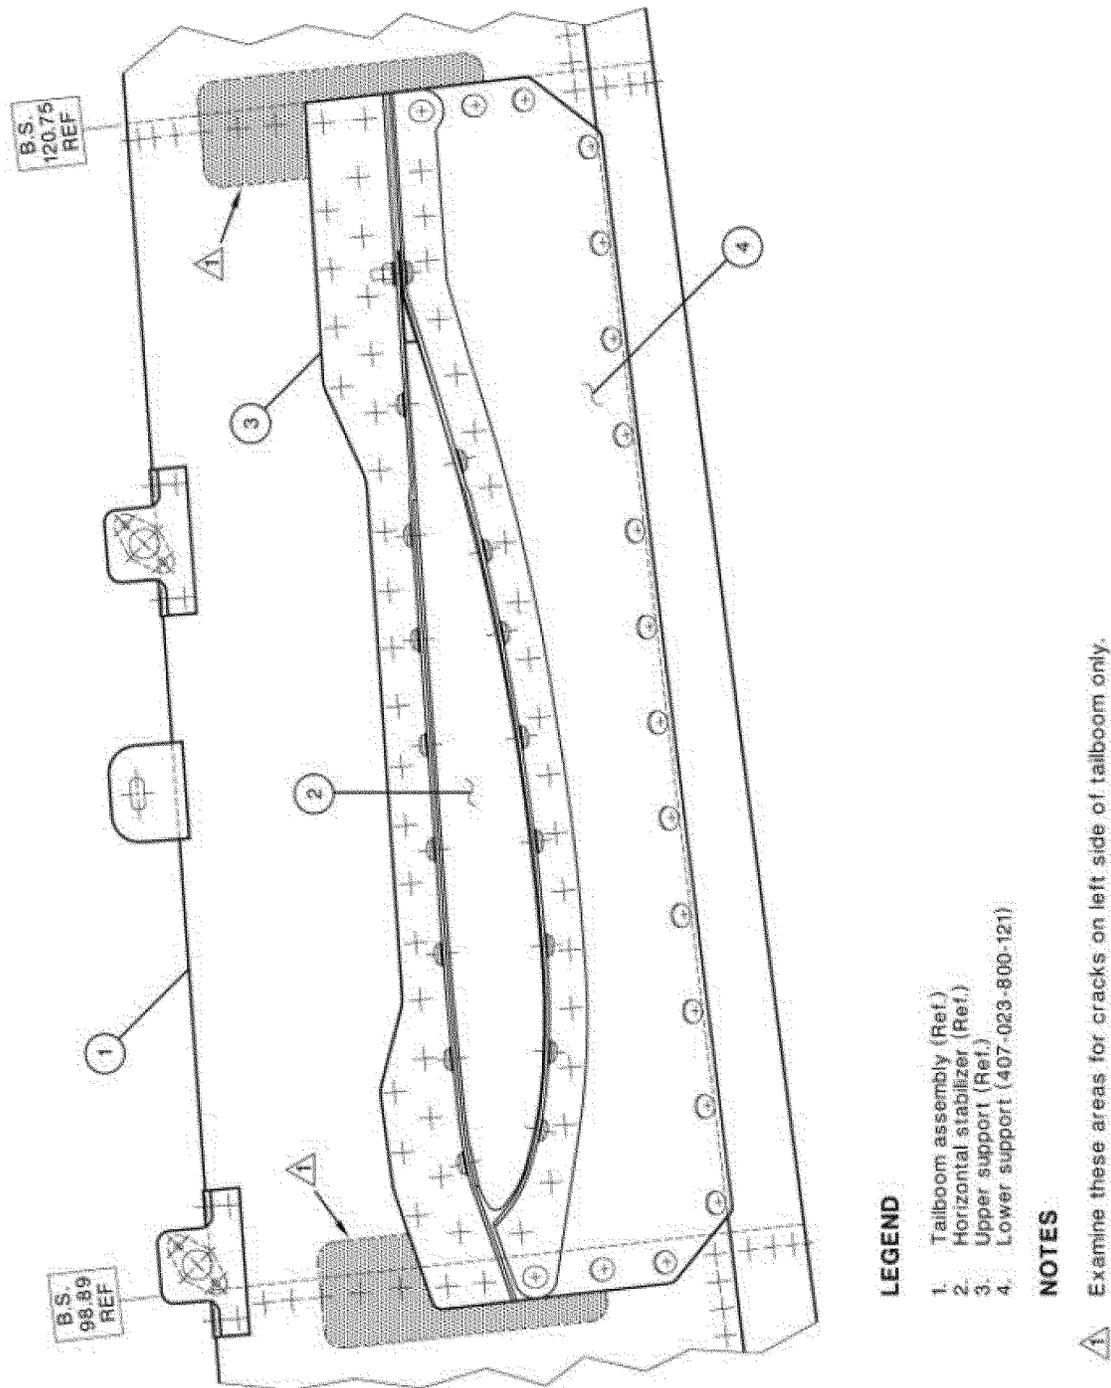
Figure 1 to Paragraph (f)(1)(i)(A)

(A) Before the first flight of each day, visually check the tailboom for a crack, as depicted in Figure 1 to paragraph (f)(1)(i)(A) of this AD.

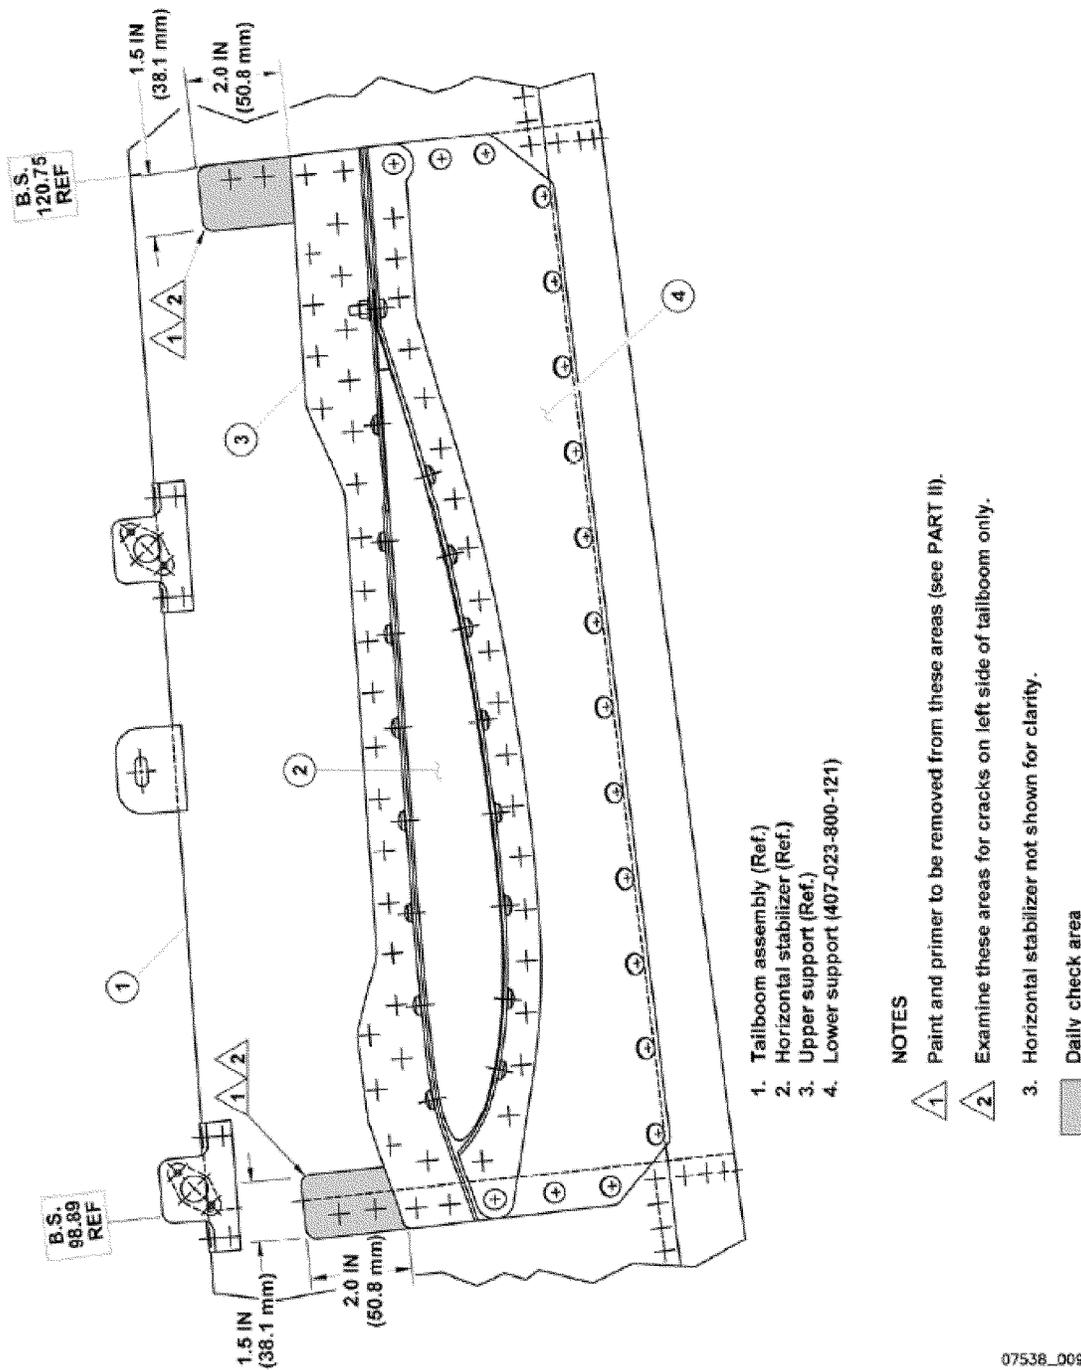
(iii) Thereafter, before the first flight of each day, clean the area on the tailboom

where paint has been removed and visually check the tailboom for a crack as depicted in Figure 2 to Paragraph (f)(2)(iii) of this AD.

(3) If there is a crack, before further flight, replace the tailboom.

(4) If there is no crack, make sure both of the inspection area surfaces are dry and protect each reworked area with a thin coat of clear coating.
