**National Highway Traffic Safety
Administration**

Denial of Motor Vehicle Defect Petition

Appendix—Petition Analysis—DP15–005

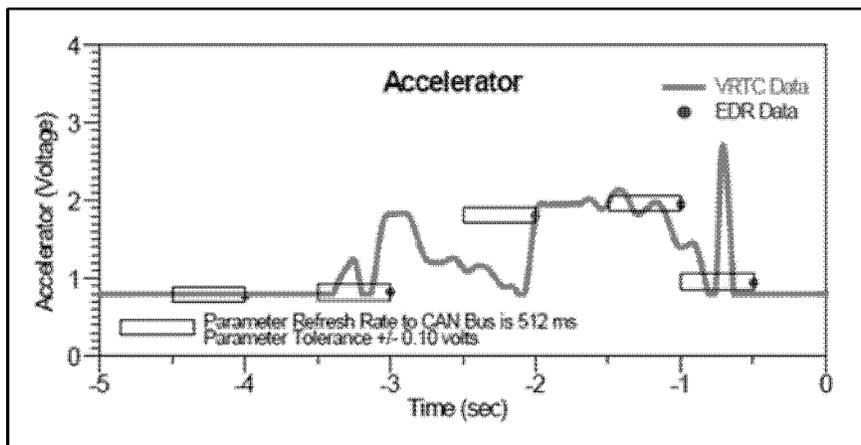
accelerator pedal sensor voltage data from one test performed by VRTC in the validation testing.⁵ As the figure shows, the EDR does not necessarily capture all accelerator pedal applications during an event and the accelerator pedal voltage recorded at each EDR time interval may not be the actual accelerator pedal voltage at that interval.

Figure 1. VRTC validation testing of EDR accelerator pedal sensor voltage from simulated collisions in a 2007 Toyota Camry.
