[Docket No. FAA-2018-0454; Product Identifier 2017-NM-056-AD]

Airworthiness Directives; Airbus Airplanes

ACTION: Notice of proposed rulemaking (NPRM).

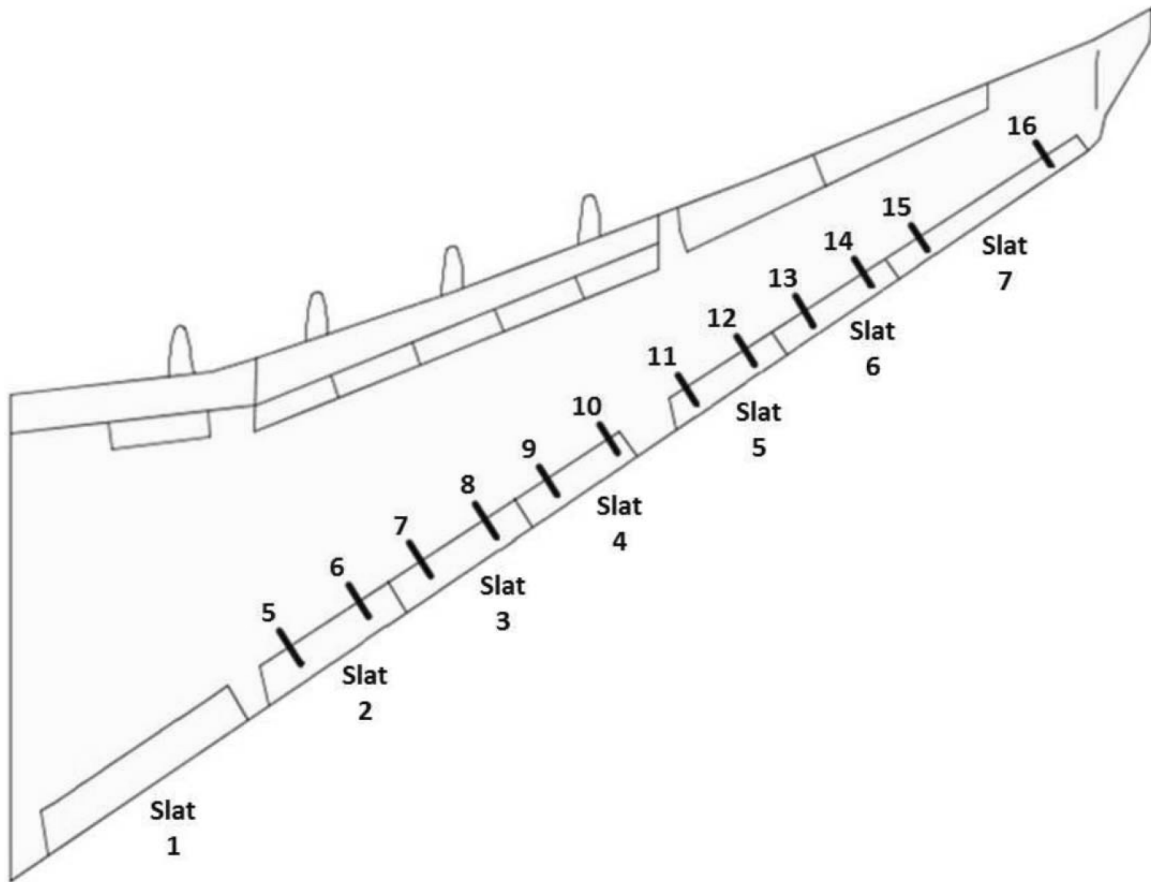
Figure 1 to paragraph (g) of this AD – Positions of Affected Slat Tracks

(1) For the purpose of this AD, “affected slat track” is defined as a pre-modification 45967 slat track, located at the wing positions as indicated in figure 1 to paragraph (g) of this AD, and having a part number specified in figure 2 to paragraph (g) of this AD. In case the part number identification (ID) plate is missing or cannot be read, the slat track can be identified by the ink marking.
