DEPARTMENT OF TRANSPORTATION

Federal Aviation Administration

[Docket No. FAA-2018-0454; Product Identifier 2017-NM-056-AD; Amendment 39-19387; AD 2018-18-08]

Airworthiness Directives; Airbus SAS Airplanes

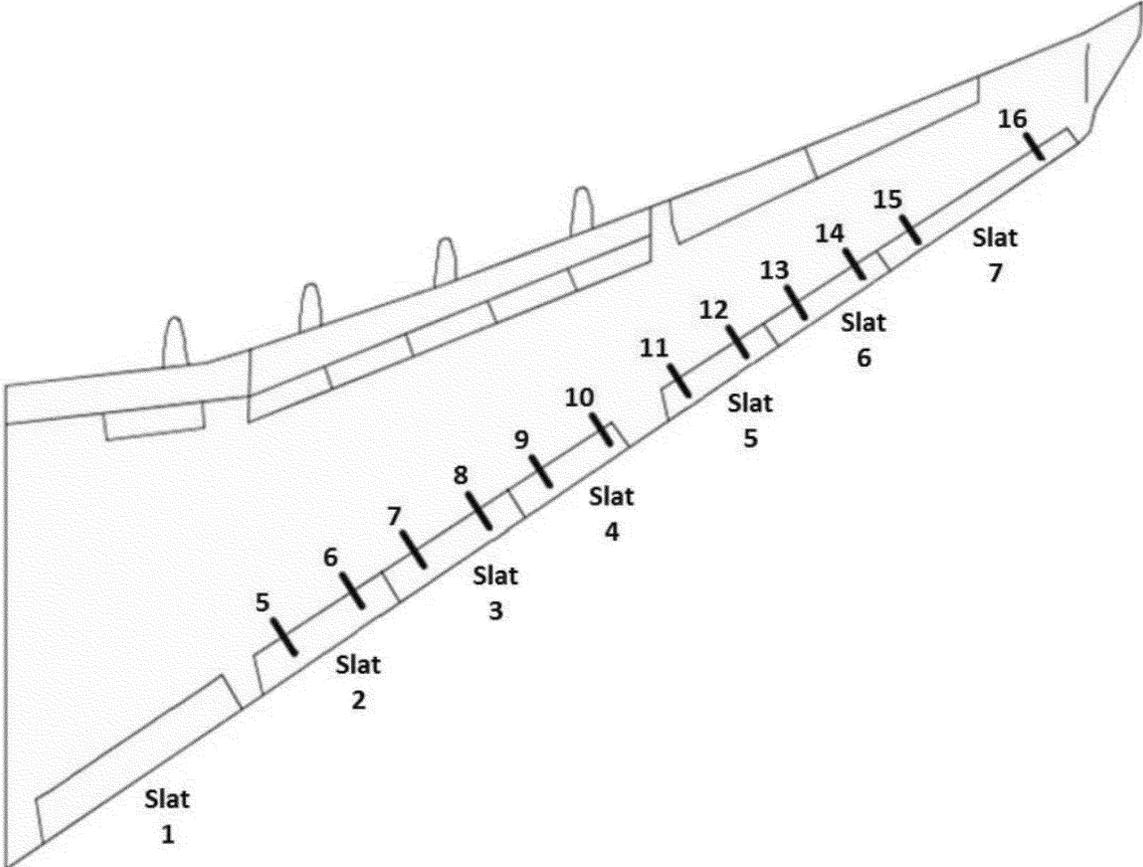
Figure 1 to paragraph (g) of this AD – Positions of Affected Slat Tracks

(1) For the purpose of this AD, "affected slat track" is defined as a pre-modification 45967 slat track, located at the wing positions as indicated in figure 1 to paragraph (g) of this AD, and having a part number specified in figure 2 to paragraph (g) of this AD. In case the part number identification (ID) plate is missing or cannot be read, the slat track can be identified by the ink marking. If the operator cannot determine the part number, then that airplane is in Group 1.
