DEPARTMENT OF TRANSPORTATION

National Highway Traffic Safety Administration

[Docket No. NHTSA–2018–0020]

Denial of Motor Vehicle Defect Petition, DP13–001

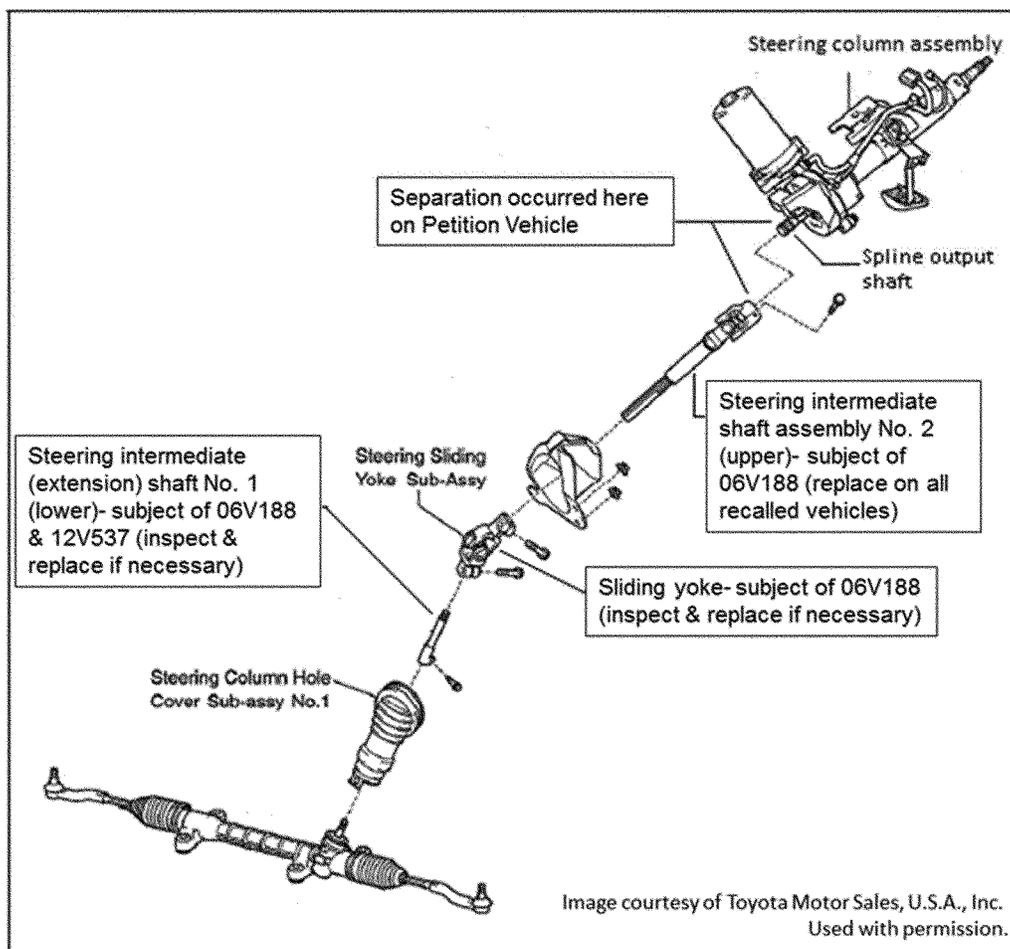
The subject power steering system is assisted by an electric motor linked to the steering column assembly. Steering torque is transmitted to a manual steering rack via a pair of intermediate shafts and a sliding yoke assembly. Image 1 below illustrates the Toyota Prius steering system and the components subjected to the two recalls.
