[Docket No. FAA-2020-0883; Project Identifier 2019-CE-034-AD]

Airworthiness Directives; Rockwell Collins, Inc. Flight Display System Application

ACTION: Notice of proposed rulemaking (NPRM).

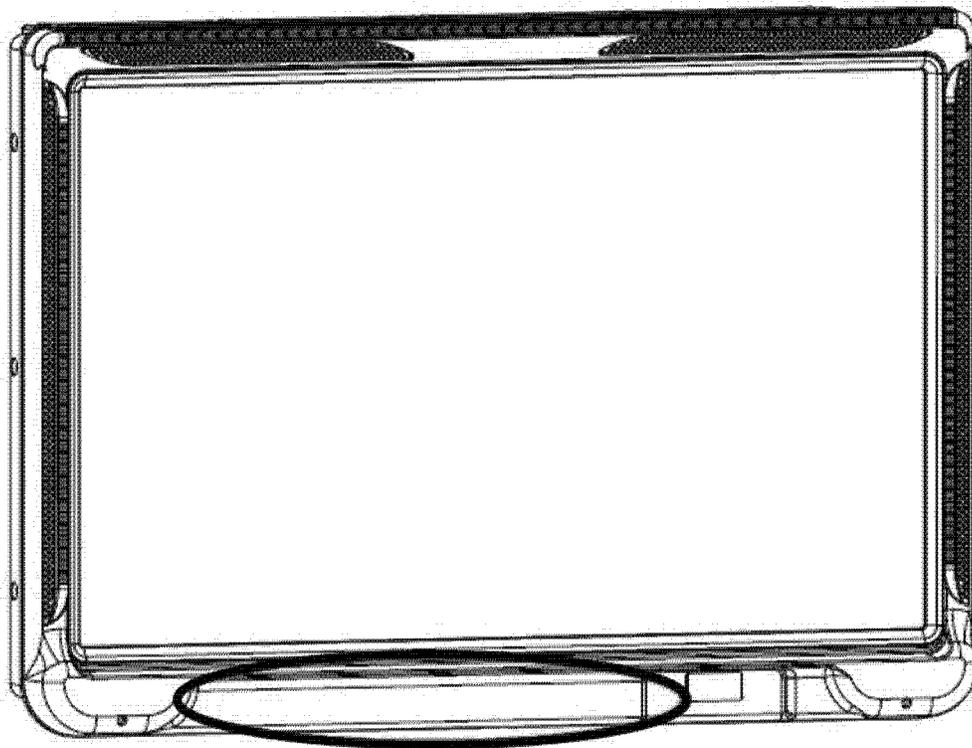
Figure 1 to paragraph (g)(1)(iii); placard location on bezel

This AD was prompted by a conflict between the traffic collision avoidance system (TCAS) primary display indications and aural alerts during a resolution advisory (RA) scenario. The FAA is issuing this AD to prevent conflicting TCAS information, which could result in the pilot under-correcting or over-correcting and may lead to inadequate aircraft separation and a mid-air collision.

(ii) Fabricate a placard for each aircraft primary flight display, using at least 1/8 inch letters, with the following text: TCAS Flight Ops—TA Only mode (TA/RA mode prohibited).

(iii) Install the placard on the bottom of each aircraft primary flight display bezel in the area depicted in figure 1 to paragraph (g)(1)(iii) of this AD.
