**NIST Technical Note 2203**

# **Fire Resilience of a Steel-Concrete Composite Floor System: Full-Scale Experimental Evaluation for Influence of Slab Reinforcement (Test #2)**

The National Institute of Standards and Technology is conducting a series of large compartment fire tests to investigate the behavior and fire-induced failure mechanisms of full-scale composite floor assemblies with a two-story steel gravity frame, two bays by three bays in plan. This report presents the experimental design and results from the second composite floor fire experiment (Test #2).

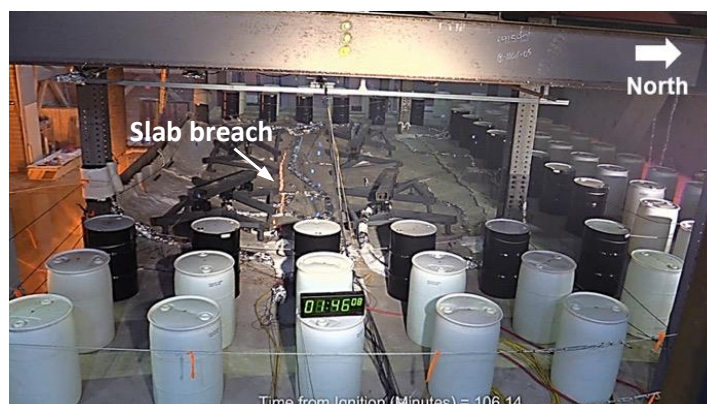
Whereas temperatures of the protected steel beams were acceptable compared to the ASTM E119 [13] limiting temperatures, significant integrity failure (concrete cracks) occurred in the heated composite floor before attaining the specified fire rating period. Large concrete cracks appeared around the hogging moment region (next to the test-bay column gridline) less than 30 min into heating, and the mid-panel concrete cracks began to occur at 70 min, exposing the hot glowing steel deck beneath along the longitudinal centerline (Fig. 2).

The limited ductility of the heated composite slab was the primary cause of the integrity failure which might initiate fire spread above the compartment of fire origin and eventually lead to local collapse mechanisms during longer (uncontrolled) fires. The steel wire reinforcement (60 mm<sup>2</sup>/m) embedded in the test floor slab ruptured in tension at critical locations as the thermally degraded composite floor sagged but before reaching the ASTM E119 displacement limit. The minimum steel reinforcement (60 mm<sup>2</sup>/m) prescribed for concrete crack control in normal conditions and permitted in standard furnace testing may not be sufficient to maintain the integrity of a full-scale composite floor undergoing the 2-hour standard fire exposure.

**Fig. 2.** Still image showing top of the Test #1 composite floor developing slab breach at 106 min after burner ignition.

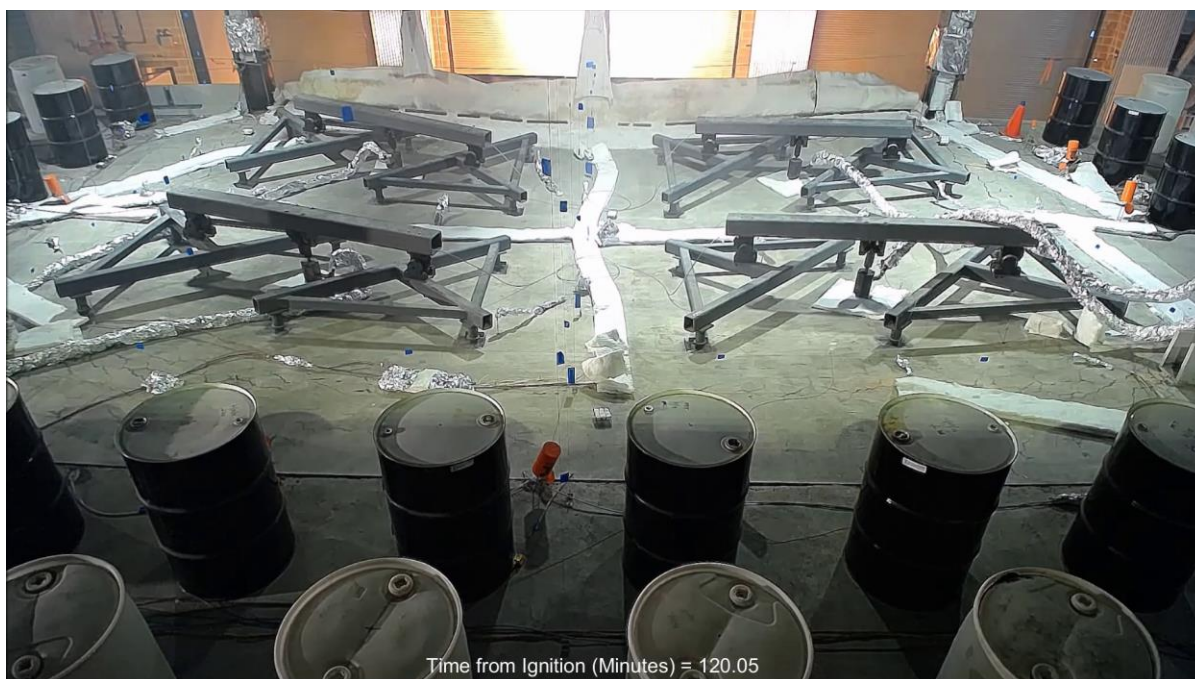
**Fig. 29. Video image showing top of the test floor at 120 min after fire ignition.**

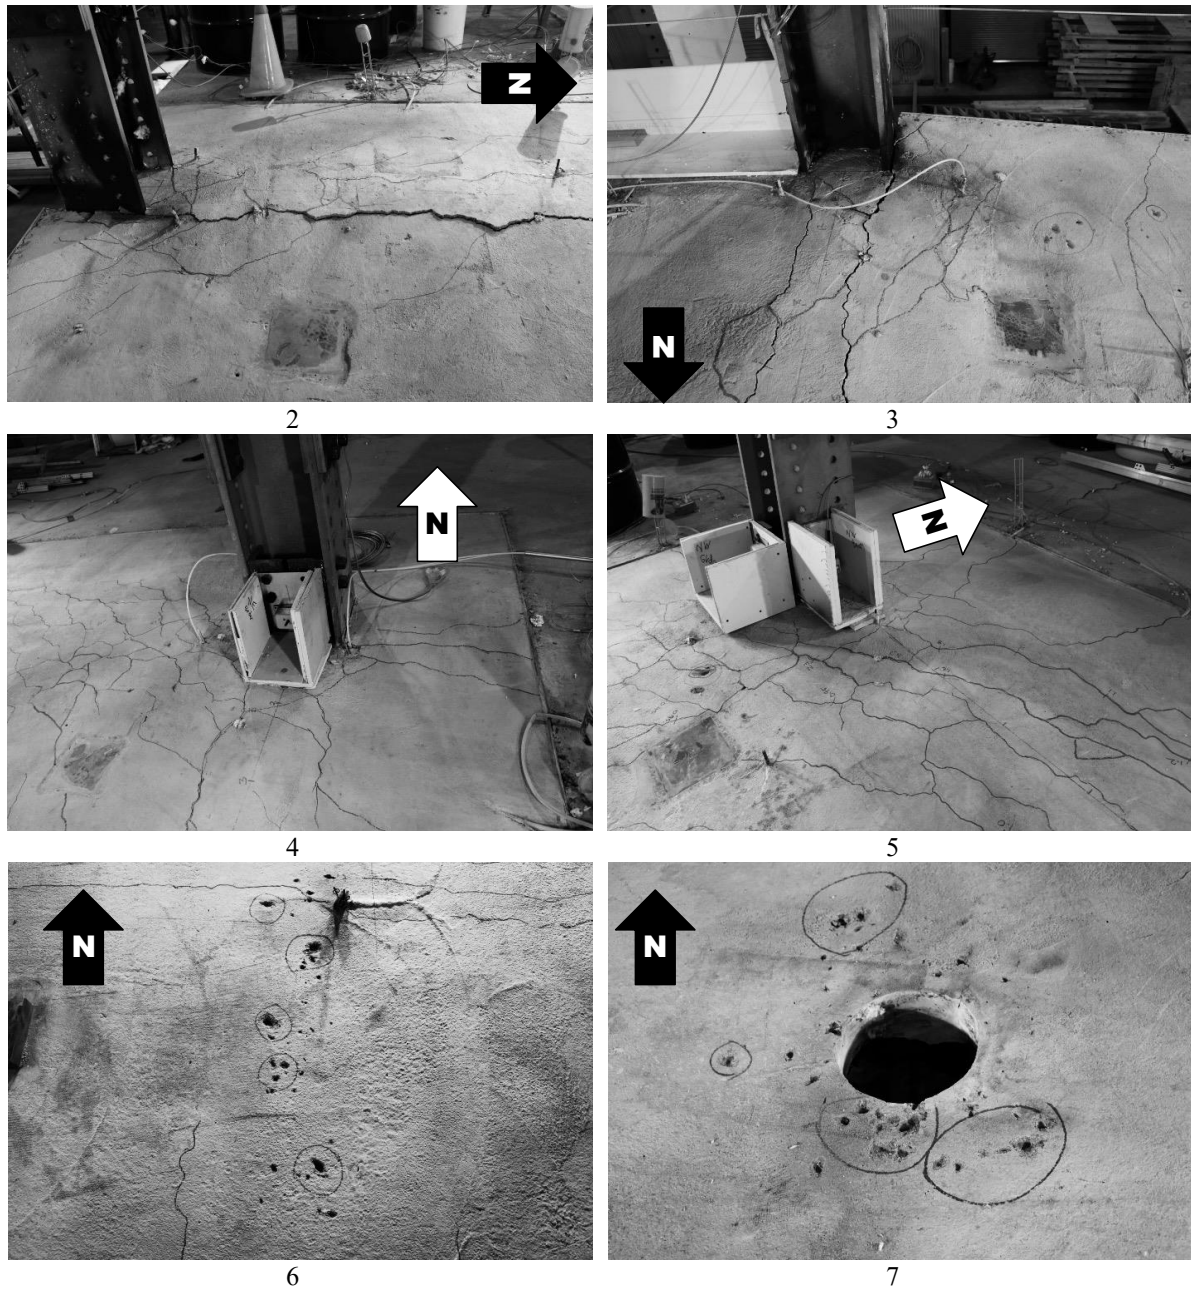
**Fig. 35. Post-test photographs of the test floor slab, including closeups of concrete damage at locations 2 through 7.**

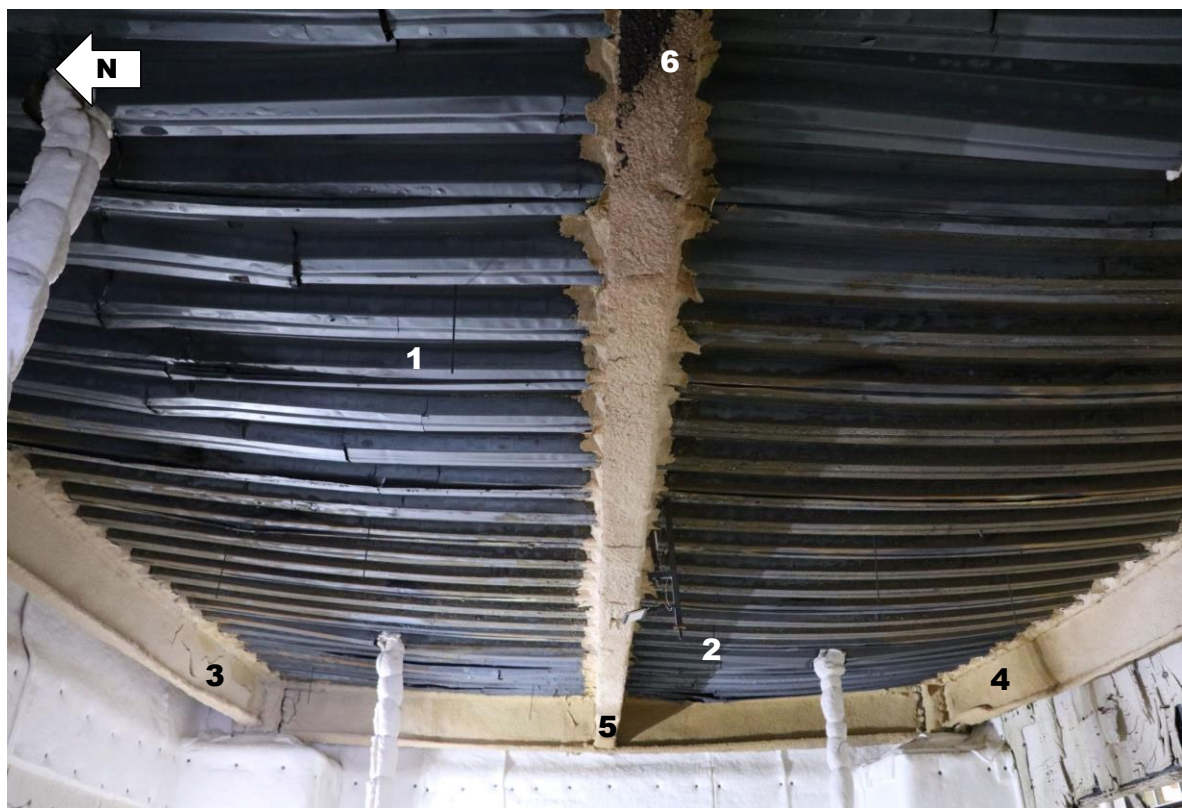
Fig. 36. Post-test photograph of the floor specimen soffit.

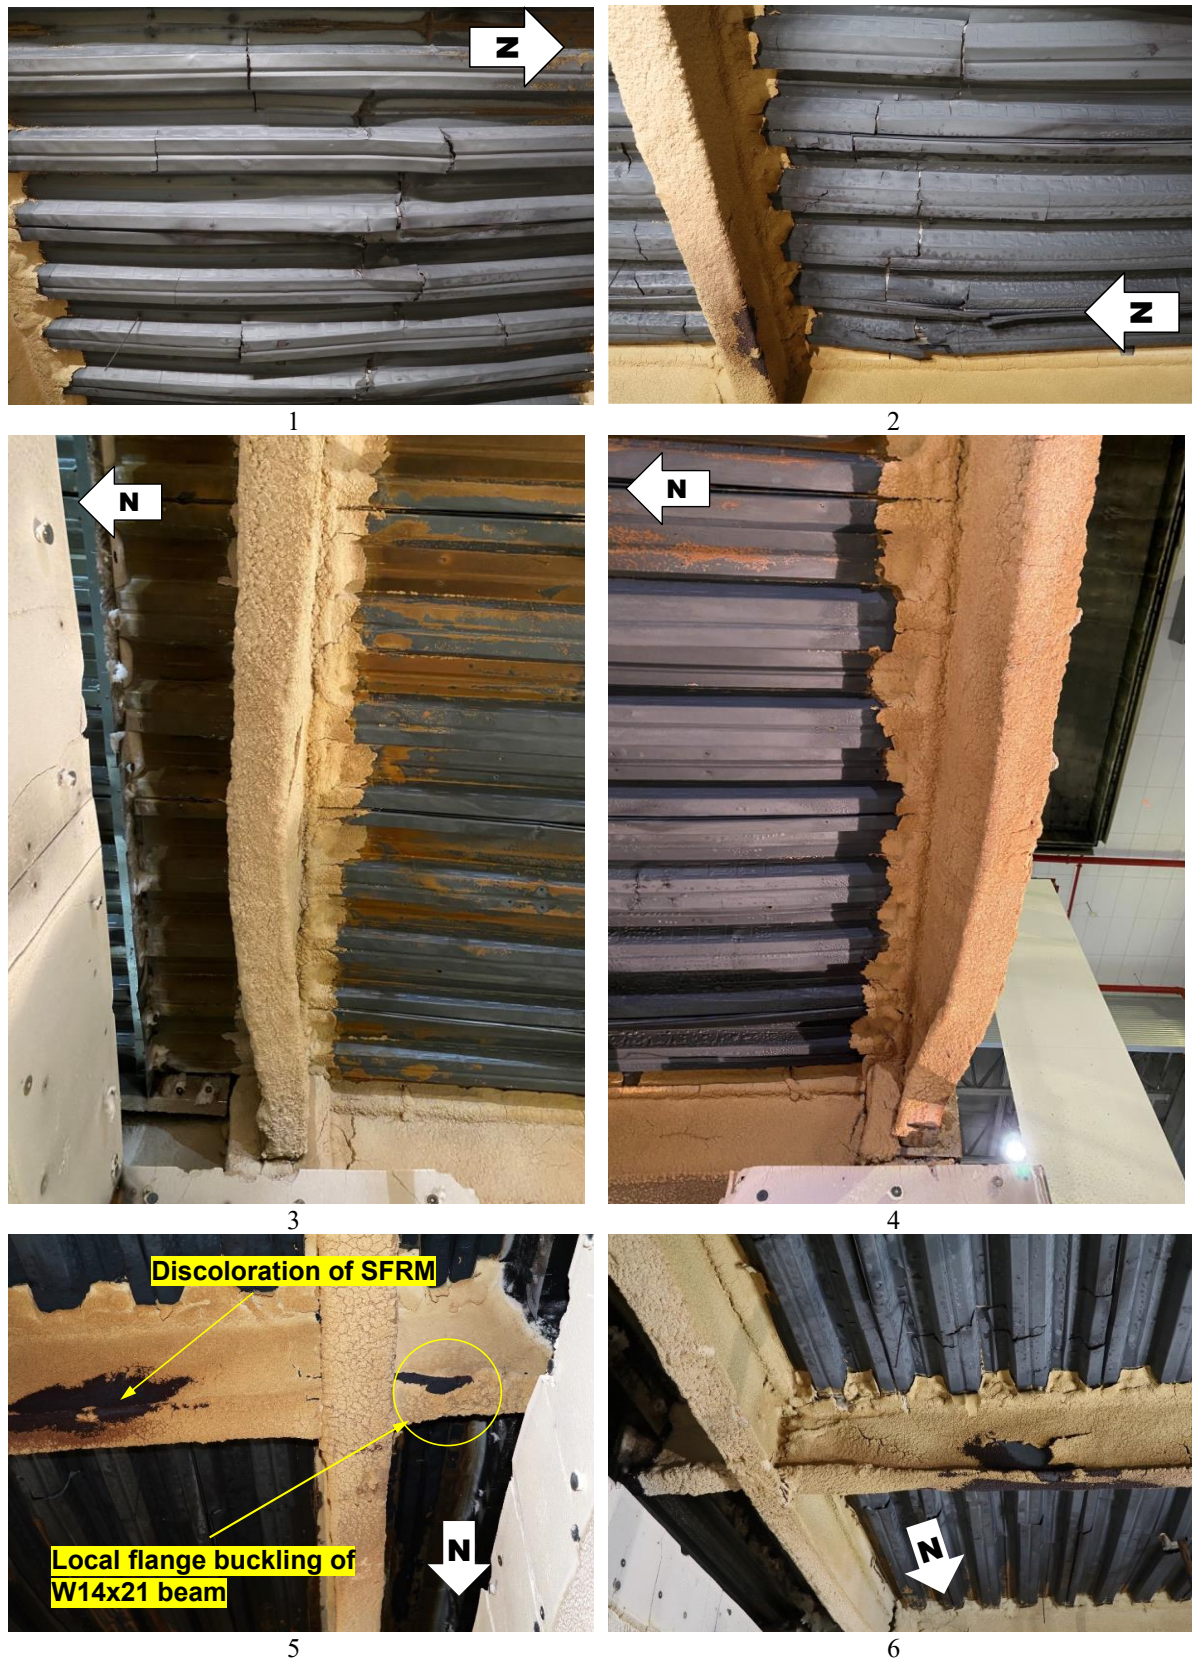
Fig. 37. Closeup photographs of steel damage at locations 1 through 6 shown in Fig. 36.

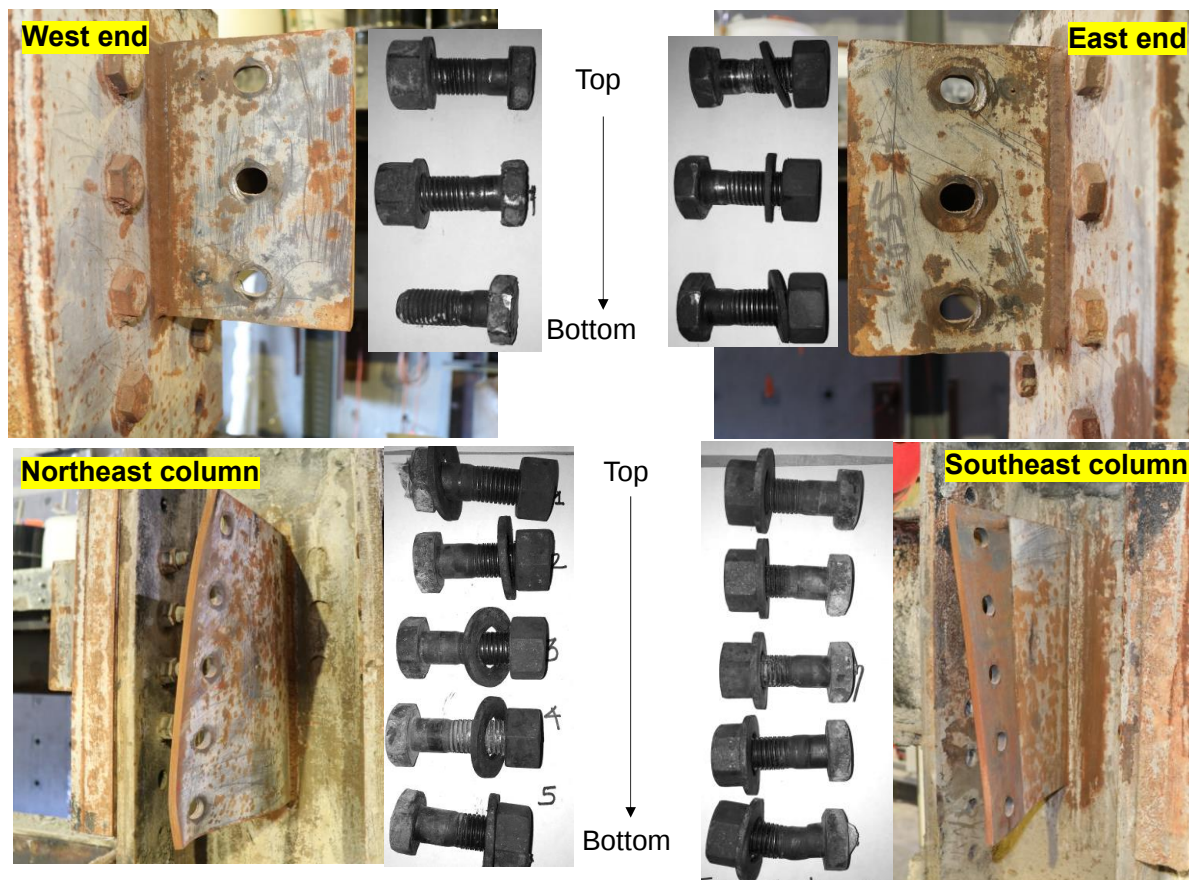
**Fig. 38.** Post-test photographs of the standard shear tab connections of the north edge beam (top) and the extended shear tab connections of the east girder (bottom).

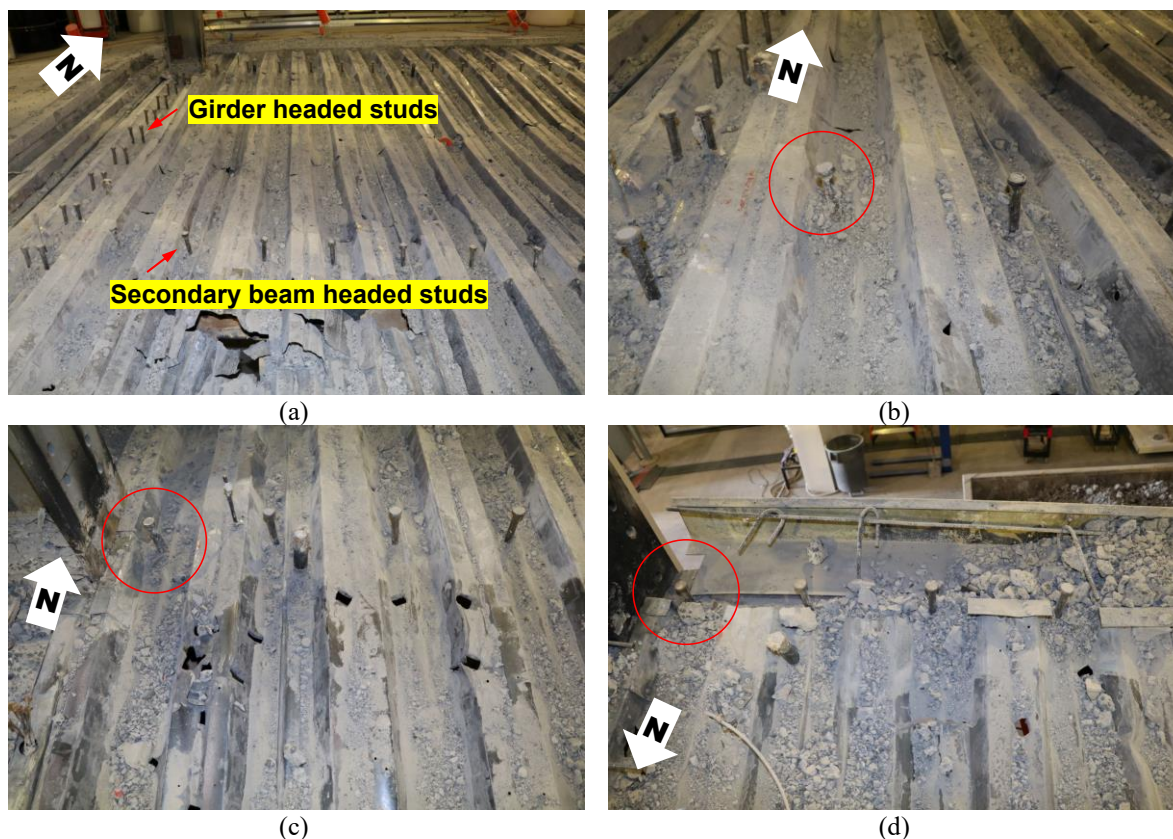
**Fig. 70. Post-test photographs of headed studs after concrete removal: (a) Northwest steel decking; (b) Secondary beam; (c) North edge beam; (d) South edge beam. The beam-end stud is in a red color ring.**

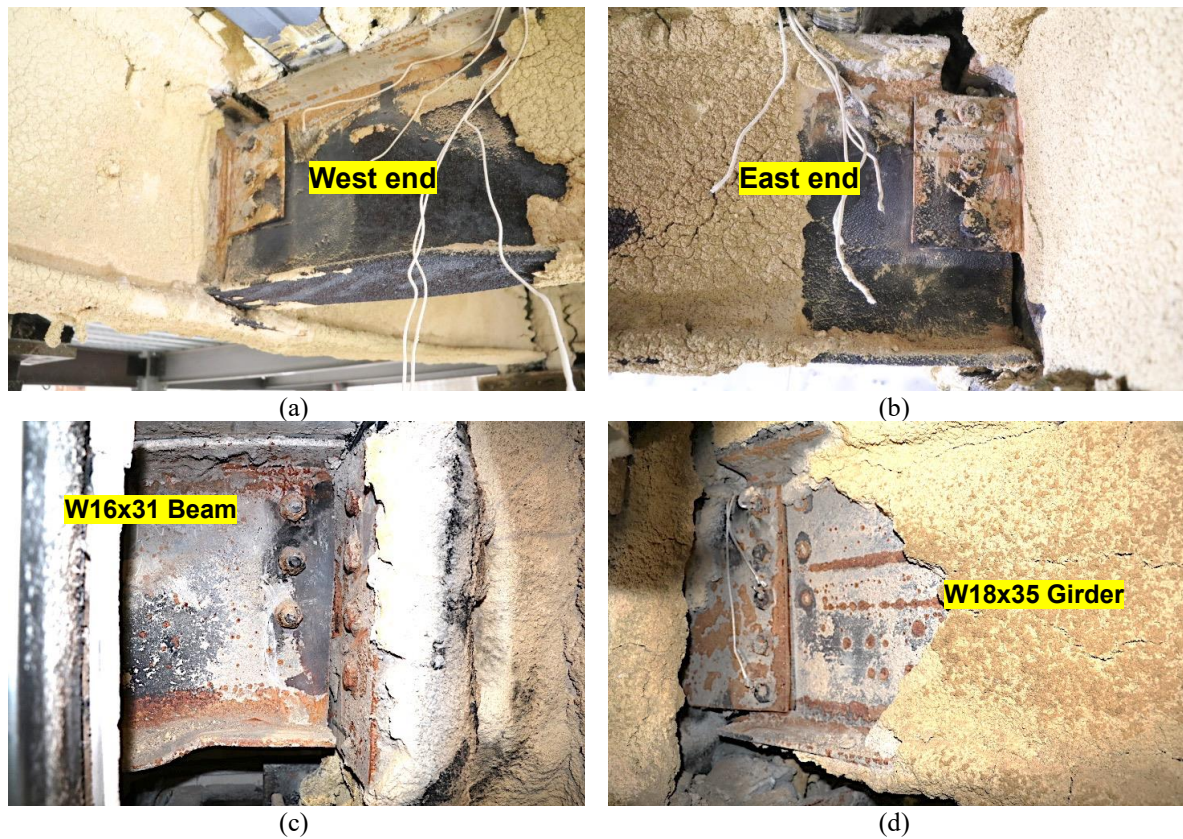
**Fig. 71. Post-test photographs of shear tab connections: (a-b) secondary beam, (c) north beam, and (d) east girder. Fireproofing was removed manually.**

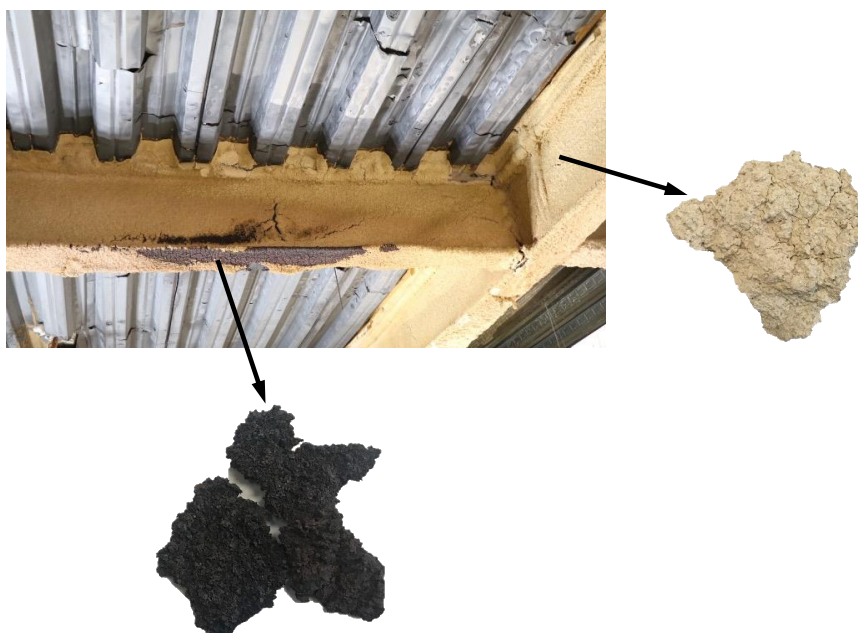
**Fig. 77. Samples of fire exposed SFRM applied on the support steel beam framing.**
