Fire Resistance of Structural Clay Tile Partitions

Building Materials and Structures Report BMS113

United States Department of Commerce
National Bureau of Standards

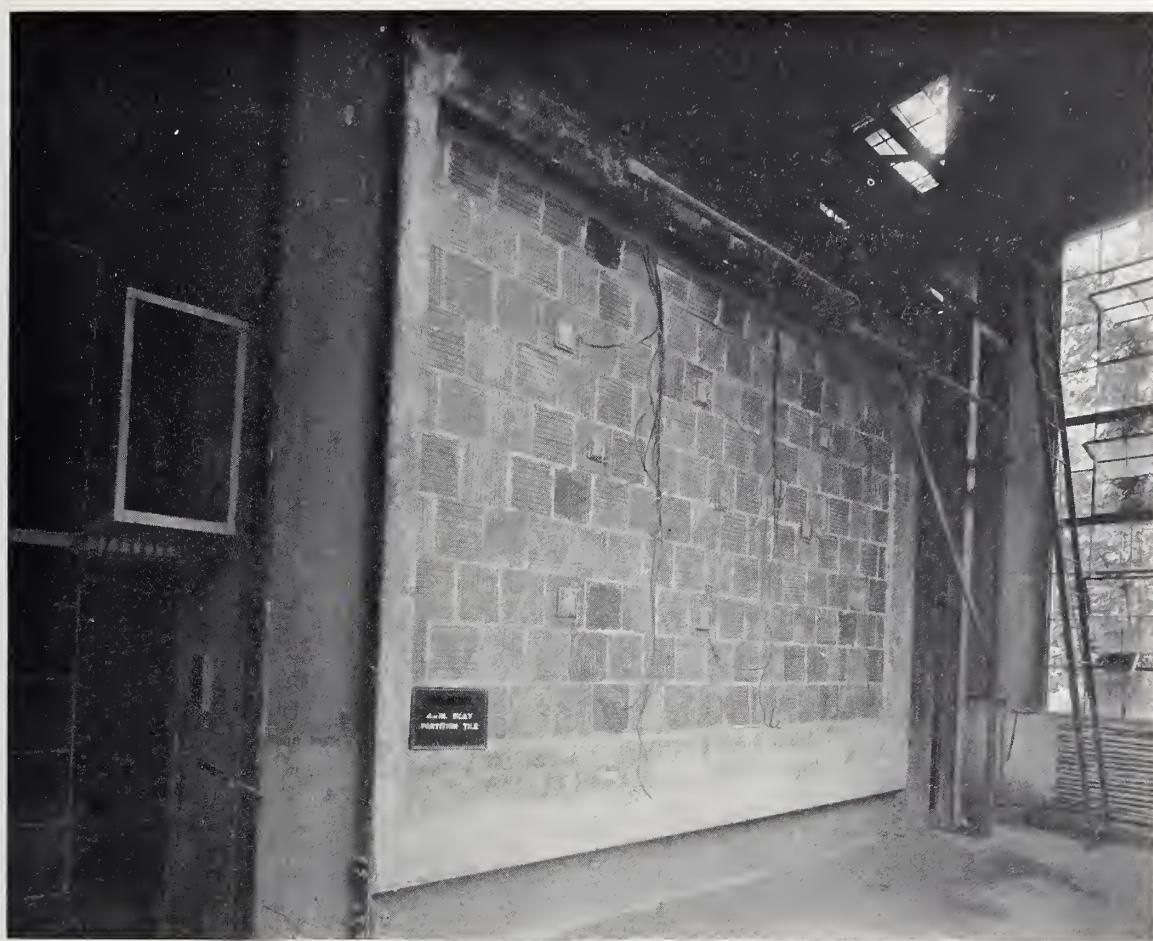
FIGURE 3. Partition 4 in furnace after a fire exposure of 12½ min, on the opposite side.

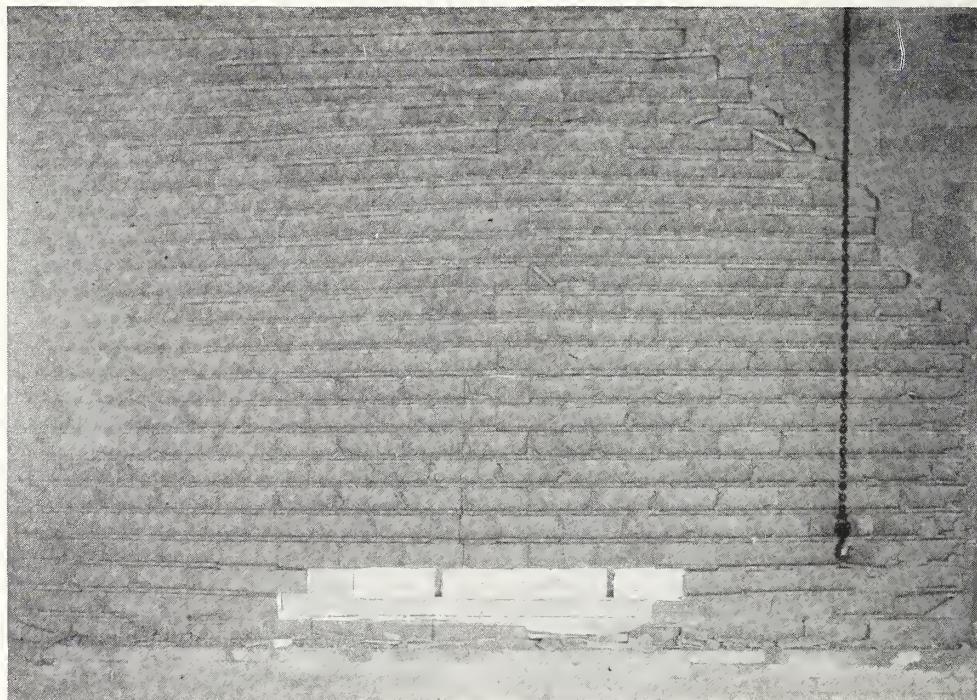
Test 9.—Four-inch partition plastered on the unexposed side, one cell in thickness, Ohio fire clay unglazed double-shell face tile, and side construction. At 2½ min, popping noises were heard and a thin horizontal craek formed across the full width of the partition at midheight. At 3½ min, the popping sounds increased in frequency and intensity. At 6 min, the craeking sounds diminished and the horizontal craek noted at 2½ min was closed. At 8 min, diagonal craeks appeared across the lower corners. At 14½ min, rapidly recurring sounds indicated that the cross webs in many of the tiles were fractured. At 16¾ min, exposed shells fell from the lower courses. At 19¼ min and at 22½ min, additional exposed shells fell. At 24 to 25 min, horizontal craeks appeared on the unexposed surface 10 and 18 in. from the top, near the center. At 31½ min, a hole formed in the lower part of the partition, figure 5. At 32 min, the gas was turned off.

average temperature rise of 250 deg F (139 deg C) on the unexposed surface to 1 hr 1 min. The 2-cell partitions retained considerable stability even after some of the exposed face shells had fallen. Some of the tiles in the lower portion of partition 9, constructed of fire-clay tile and plastered only on the unexposed side, fell out at 31 min. Although the units had double shells, they were severely damaged by fire and by the end of the test almost all of the exposed shells, figure 5, had fallen.

FIGURE 5. Exposed side of partition 9 showing the hole that limited the fire resistance of the partition.

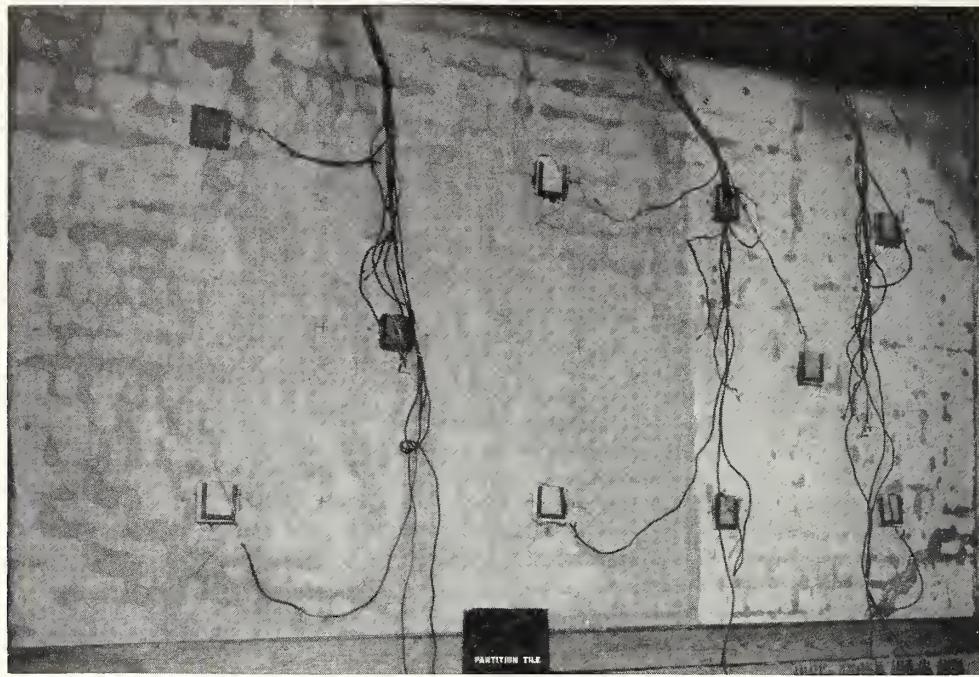
heard and slight cracks appeared in the surface of the plaster. During this time numerous wet spots showed on the unexposed surface. At 44½ min, the bulging of the exposed surface indicated that about 80 percent of the shells fell from an area of about 2½ sq yd; other shells fell at intervals, leaving 25 percent of the surface intact. At 2 hr, the wet spots began to dry, figure 6. At 2 hr 17½ min, the gas was turned off.

FIGURE 6. *Unexposed side of partition 11 after a fire exposure of 2 hr on the opposite side.*
The dark plaster was 1:3 sanded gypsum and the light plaster was neat gypsum.

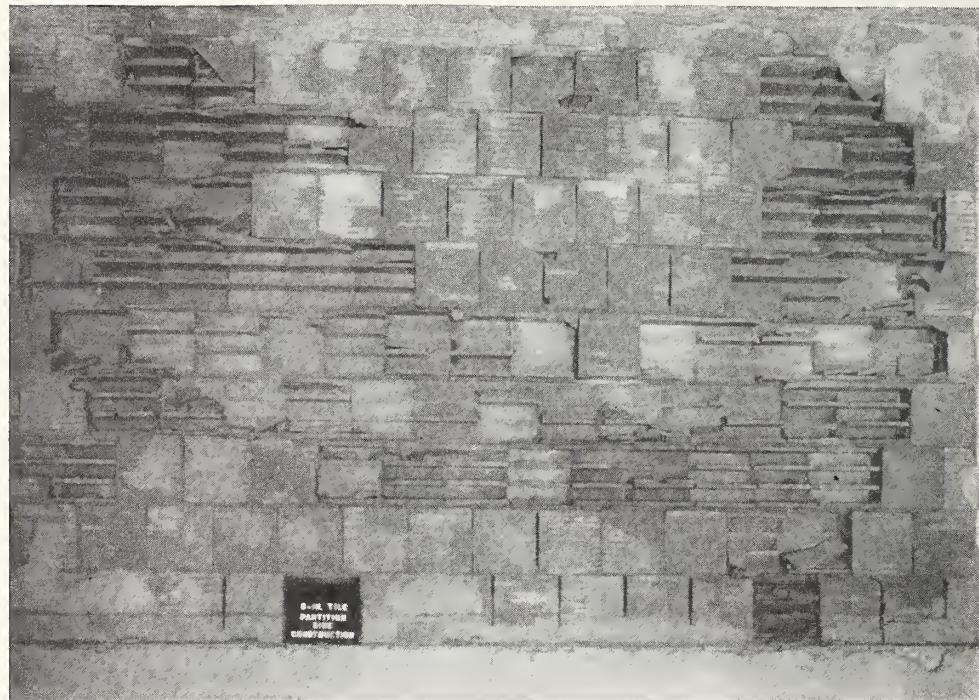
Test 14.—Six-inch partition plastered on both sides, one cell in thickness, Illinois surface clay tile, side construction. At 13 min, cracking sounds were heard, which continued with varying intensity for 15 min. At 47½ min, a dull thud indicated the fracture of webs holding the shells in the middle portion of the partition, although no cracks were visible. At 1 hr 8 min, a horizontal crack was observed in the exposed plaster 4 ft above the lower edge of the partition. At 1 hr 11 min, a similar horizontal crack formed 1 ft above the lower edge. At 1 hr 21 min, horizontal cracks appeared in the unexposed plaster. At 2 hr, the gas was turned off.

FIGURE 7. *Exposed side of partition 14 showing exposed side shells of tiles washed off by hose-stream.*

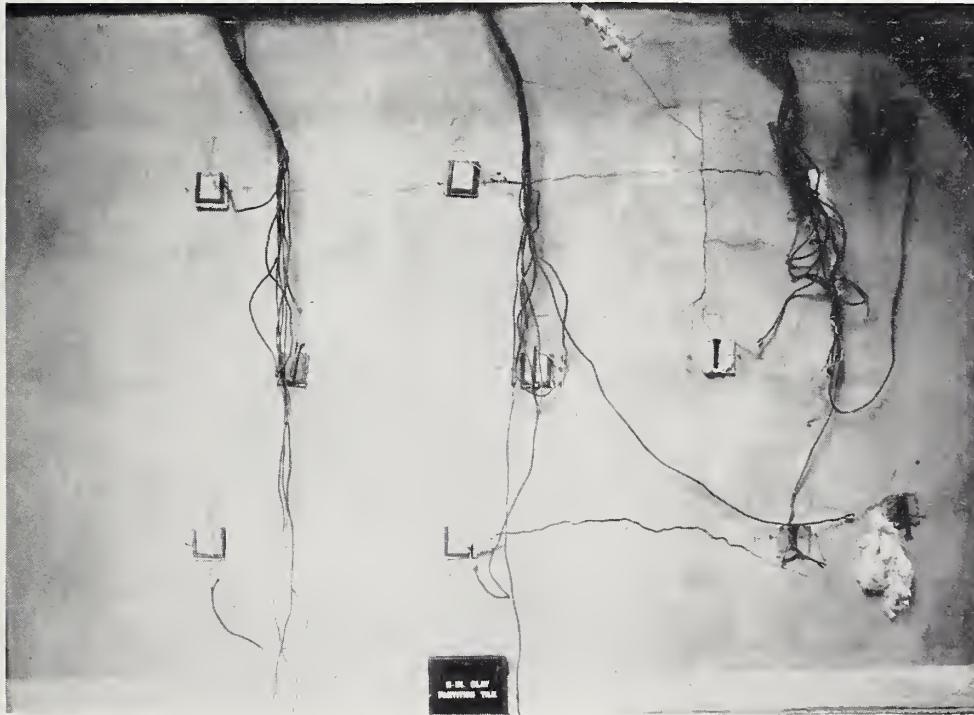
Test 19.—Six-inch partition plastered on both sides, two cells in thickness, Illinois surface clay tile, and alternate construction. Up to 15 min, no fire effects were observed except the burning of the baseboard. At 16 min, popping sounds were heard. At 31 min, wet spots appeared along the top border. A 10-ft vertical crack appeared on the exposed side 2 ft from one end with the adjacent plaster protruding about 2 in. At 40 min, horizontal cracks appeared at midlength of the unexposed surface 2 ft from the lower edge and 1 ft from the top. At 45 min, a similar crack appeared 3 ft from the lower edge. At 46½ min, the plaster fell from one side of the vertical crack which was observed at 31 min. At 58 min, additional thermocouples were placed on the unexposed surface opposite areas from which the plaster had spalled. At 1 hr 6 min, vertical cracks in the unexposed plaster appeared 2 and 3 ft from the center of the partition. At 1 hr 14 min, a diagonal crack in the unexposed plaster appeared across one corner. At 1 hr 35 min, cotton waste was placed on the unexposed surface, figure 9. At 1 hr 50 min, the cotton waste in one upper corner began to smoke and soon burst into flame. At 2 hr 32 min, the gas was turned off.

FIGURE 9. Unexposed side of partition 19 showing cotton waste which ignited at 1 hr 50 min.

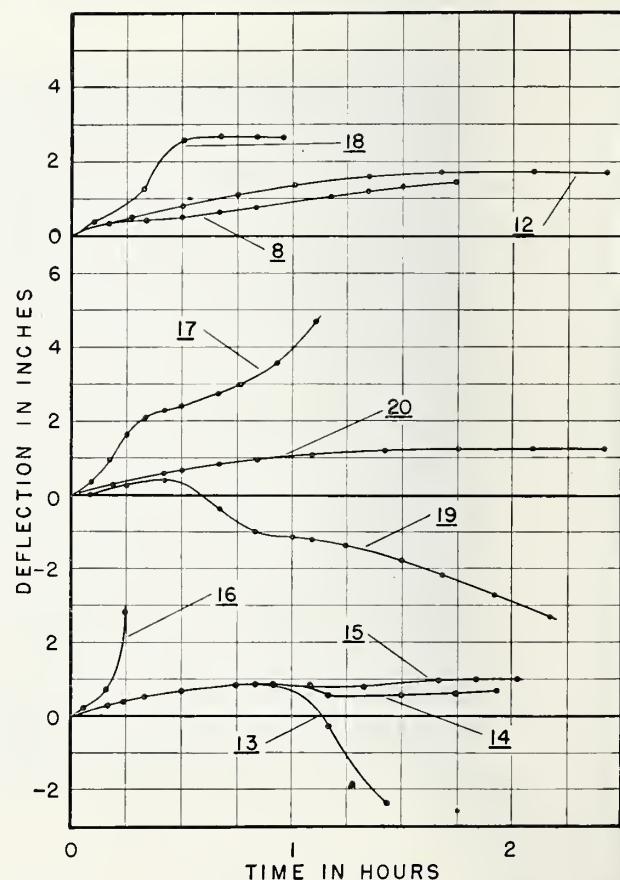
The partitions deflected inward or toward the fire during the first part of the tests. This caused high stresses in the tiles near the borders of the partition and in some cases resulted in the crushing of the tiles or the falling of the exposed shells. After the stresses were relieved by the loosening of the shells, the amount of the deflection decreased and for several partitions its direction was reversed, figure 12.

FIGURE 12. Deflections at center of 4- and 6-in. tile partitions during fire-resistance tests.
