# Fire Resistance of Shutters for Moving-Stairway Openings

United States Department of Commerce  
National Bureau of Standards  
Building Materials and Structures Report 129

Building Materials and Structures Report 129

Issued March 1, 1952

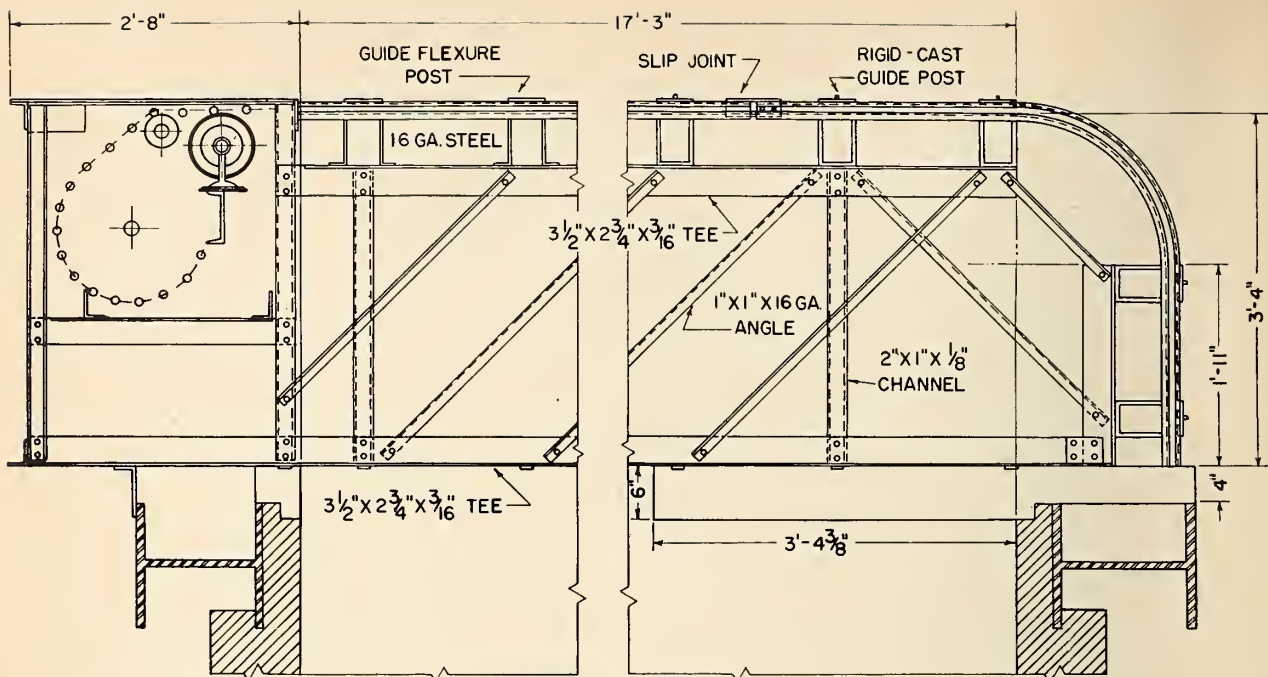
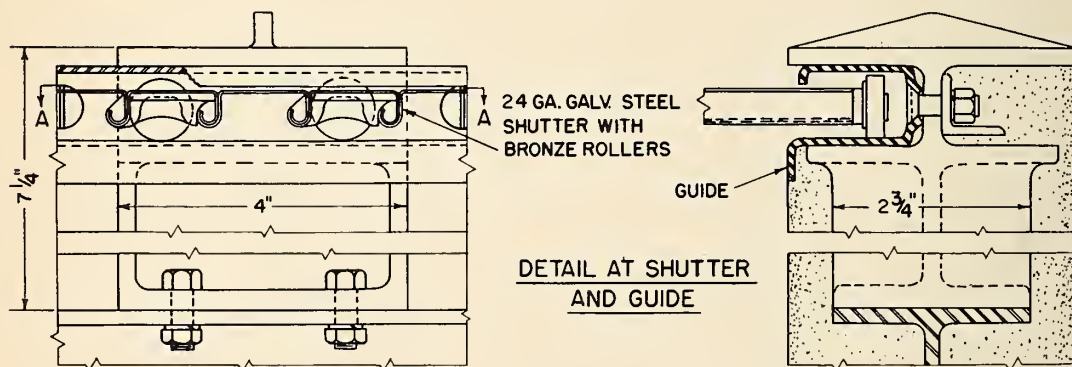
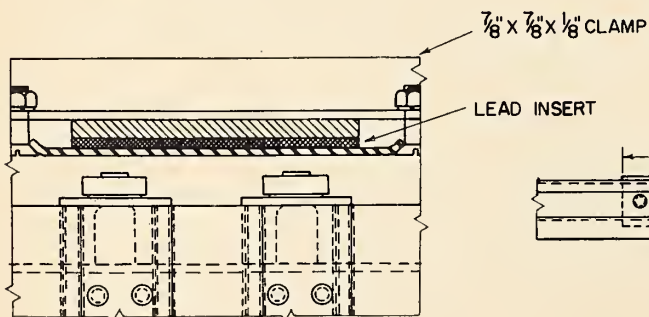
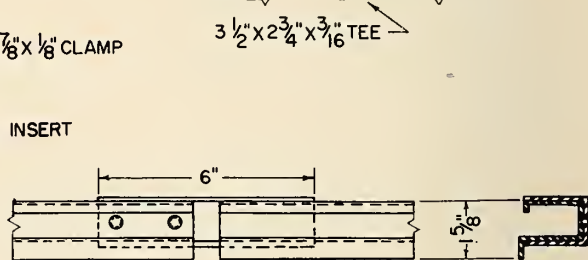
FIGURE 3. Construction details for test B.

Placing the top chord of the balustrade truss 7 in. below the guide rail in test B made its protection from the fire by plaster possible and imparted some flexibility to the structure. The expansion joint in the shutter guide rail appeared to be not quite long enough. For the temperature obtained in the test, the expansion of a guide rail of the length required would be about  $2\frac{3}{4}$  in. The number of saw cuts in the inner edge of each top chord should be increased to not less than one every 5 ft.

shutters for moving stairways and to establish goals to be achieved in the development of satisfactory designs. Although the design of the specimen for test B (fig. 3) was satisfactory, it is not to be implied that the manner in which this was achieved was the only satisfactory one. Any design must make adequate provision for thermal expansion equal or unequal, avoid undue distortions, and must retain the necessary structural stability of the device if it is to be deemed satisfactory from a fire-protection standpoint.

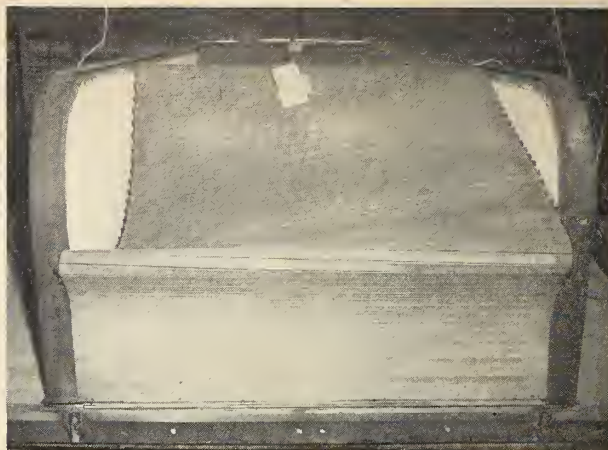
FIGURE 7. Shutter after test A.

The lubricants in the shutter started burning and smoke was observed at 5 min. At 7 min the shutter guide rails were observed to be spreading apart at the curved portion. At 20 min the curved portion of the rails had spread so much that the shutter rollers had come out of the guide slots. At 1 hr the shutter was out of the slot 1 in. on one side and  $\frac{1}{2}$  in. on the other. It had pulled clear of the slot for a length of 6 ft on one edge and 3 ft on the other and had sagged, causing the shutter to bow out beyond the front end about 6 in. The bottom chords of the balustrades had expanded over  $\frac{3}{8}$  in. longitudinally, notwithstanding the restraint of the floor slab. The test was ended at 3 hr 1 min, at which time a portion of the shutter had sagged 3 to  $3\frac{1}{2}$  in. at its center line, although the rollers were still held in the side-rail slots. The condition of the specimen after the test is shown in figure 7.

Following the cooling of the furnace and test specimen, the shutter surface was found to be badly oxidized under the surface thermocouple pads (fig. 9). The shutter was out of the guide rail slot for a length of 3 or 4 ft on one edge and 12 or 14 ft on the other (fig. 10). The electric equipment was damaged in the test to the extent that it could no longer function. The shutter could not be retracted with the hand crank. Hence it was removed by use of a cutting torch.

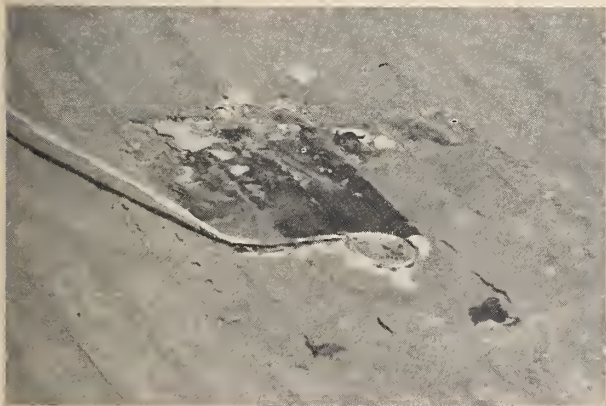
FIGURE 9. Surface of shutter under pad after test B.

The following day, after cooling, the shutter still sagged 4 in., but the ends of the slats were back in the guide slots (fig. 11). The unexposed surface of the shutter was coated with zinc oxide, except under the thermocouple pads where the

oxide had blistered and flaked off. However, the steel of the shutter was in good condition. The plaster was cracked extensively but remained in place. The guide rail was deformed to the extent that four men were needed to open the shutter.

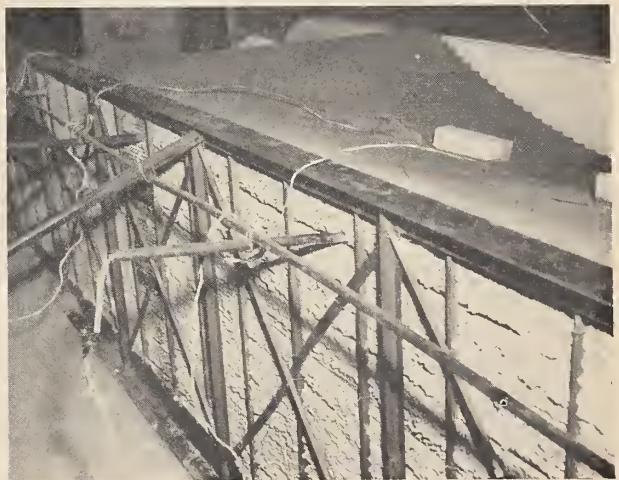
FIGURE 10. Specimen after test A.

The primary source of trouble in test A was the spreading of the side rails, or balustrades. The shutter guide rail was rigidly attached as a part of the top chord of the truss, the inner portions being directly exposed to the furnace fire, whereas the outer portions were cooled by the air outside the furnace, a condition which resulted in a considerable difference in the thermal expansions along the inner and outer edges. This difference in expansion caused bowing of the chord members and consequent spreading of the guide rail, thus allowing the shutter rollers to drop out of the guide slots. The transverse members of the housing for the operating mechanism fixed the rear ends of the guides, and outside braces set at  $2\frac{1}{2}$  ft from the beginning point of curvature of the rail resulted in the spreading of the relatively free curved portion of the guides. In test B this effect was partly obviated by providing an expansion joint in the guide rail and placing the top chord of the balustrade framework below the guide rail, where it was somewhat protected from the fire by plaster. Another means of neutralizing unequal expansion was introduced by making saw cuts in the inner edges of the top chord and the guide rail. In spite of these provisions, some spreading of the guide rails was observed. This should be overcome by increased allowance for expansion. Any provisions that make adequate allowances for expansion effects might be substituted for those employed in test B.

The shutters for both tests A and B were of the same design. The failure of the structure in test A could therefore be laid to the warping of the balustrade framework rather than to any deficiency of the shutter itself. It is doubtful whether the use of the bolted rather than a welded balustrade assembly in test B made any difference in the fire resistance. Either method should provide an acceptable structure.
