FIRE ENDURANCE AND HEAT TRANSFER
TESTS OF PREFABRICATED PANELS

NBS REPORT

May 4, 1960

6837

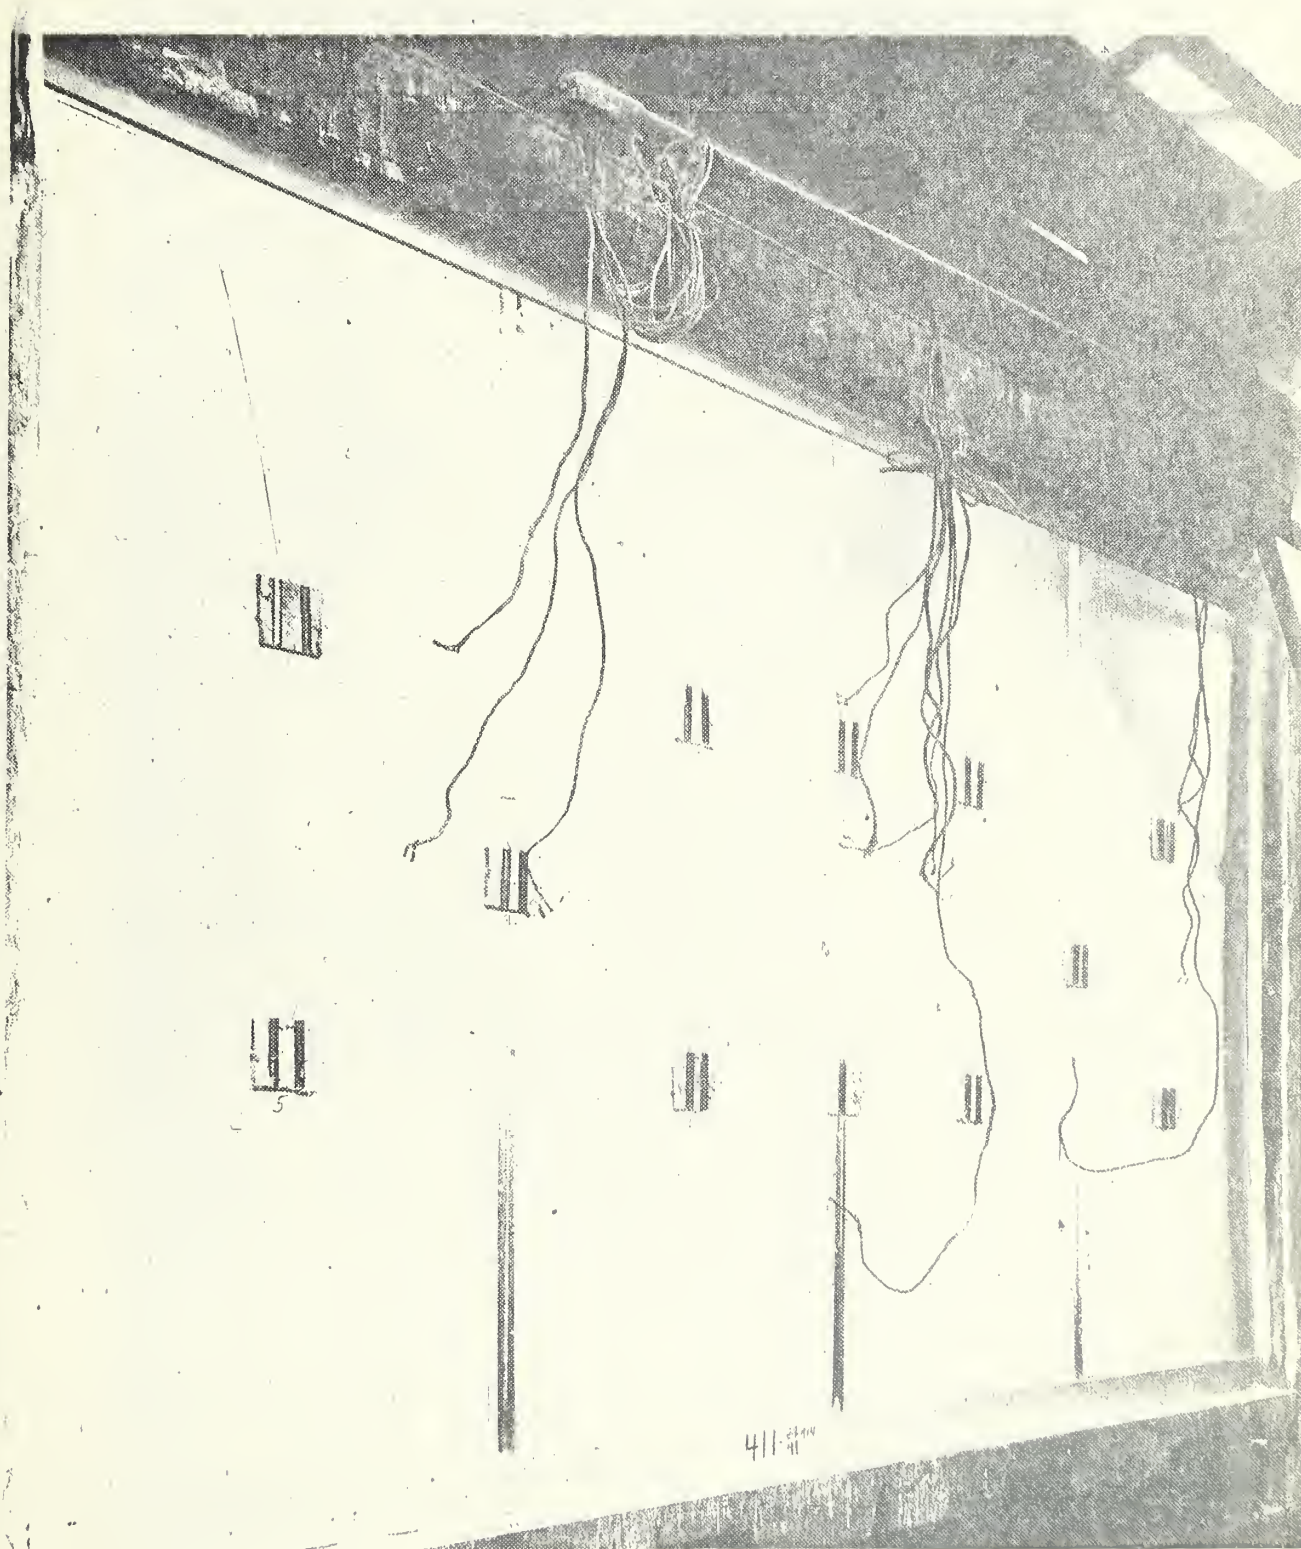
There was no observable lateral deflection as a result of the application of load just before the start of the test. There were intermittent flames on the exposed surface in the first 6 min. The unexposed surface of the south-center panel was wrinkled at 13 min. At 17 min, about 1/2 sq ft of gypsum board fell from the south-center panel; the extra metal liner on the exposed surface of the south panel was warped and bulging. By 28 min, there were flames from the exposed surface along all the joints plus several cracks in the gypsum board. At 31-1/2 min, about 8 sq ft of gypsum board fell from the north-center panel. By 35 min, this had increased until about half the gypsum board was down from the north-center panel plus about 8 sq ft from the south-center panel with an equal area leaning on a furnace thermocouple pipe. By 40 min, about 2/3 of the gypsum board had fallen from the north-center and south-center panels and the exposed metal was buckled. The condition of the unexposed surface at 41 min is shown in Figure 3. At 51 min, smoke was coming through the center joint and about half the gypsum board had fallen from the north panel. At 58 min, the unexposed surface of the south-center panel was discolored. At 1 hr, there appeared to be an offset of about 1/2 in. along the joints on each edge of the north-center panel. Flames came through the center joint at 1 hr 3 min and the north joint at 1 hr 3-1/2 min; see Figure 4. The test was stopped at 1 hr 5 min. The interior of the specimen continued to burn. The frame and specimen were removed from the furnace and the flames extinguished. Temperature and deflection data are summarized in Figure 1. Figure 5 shows the exposed surface at removal from the furnace.

Figure 3. Unexposed surface of perlite-filled wall at 41 min.

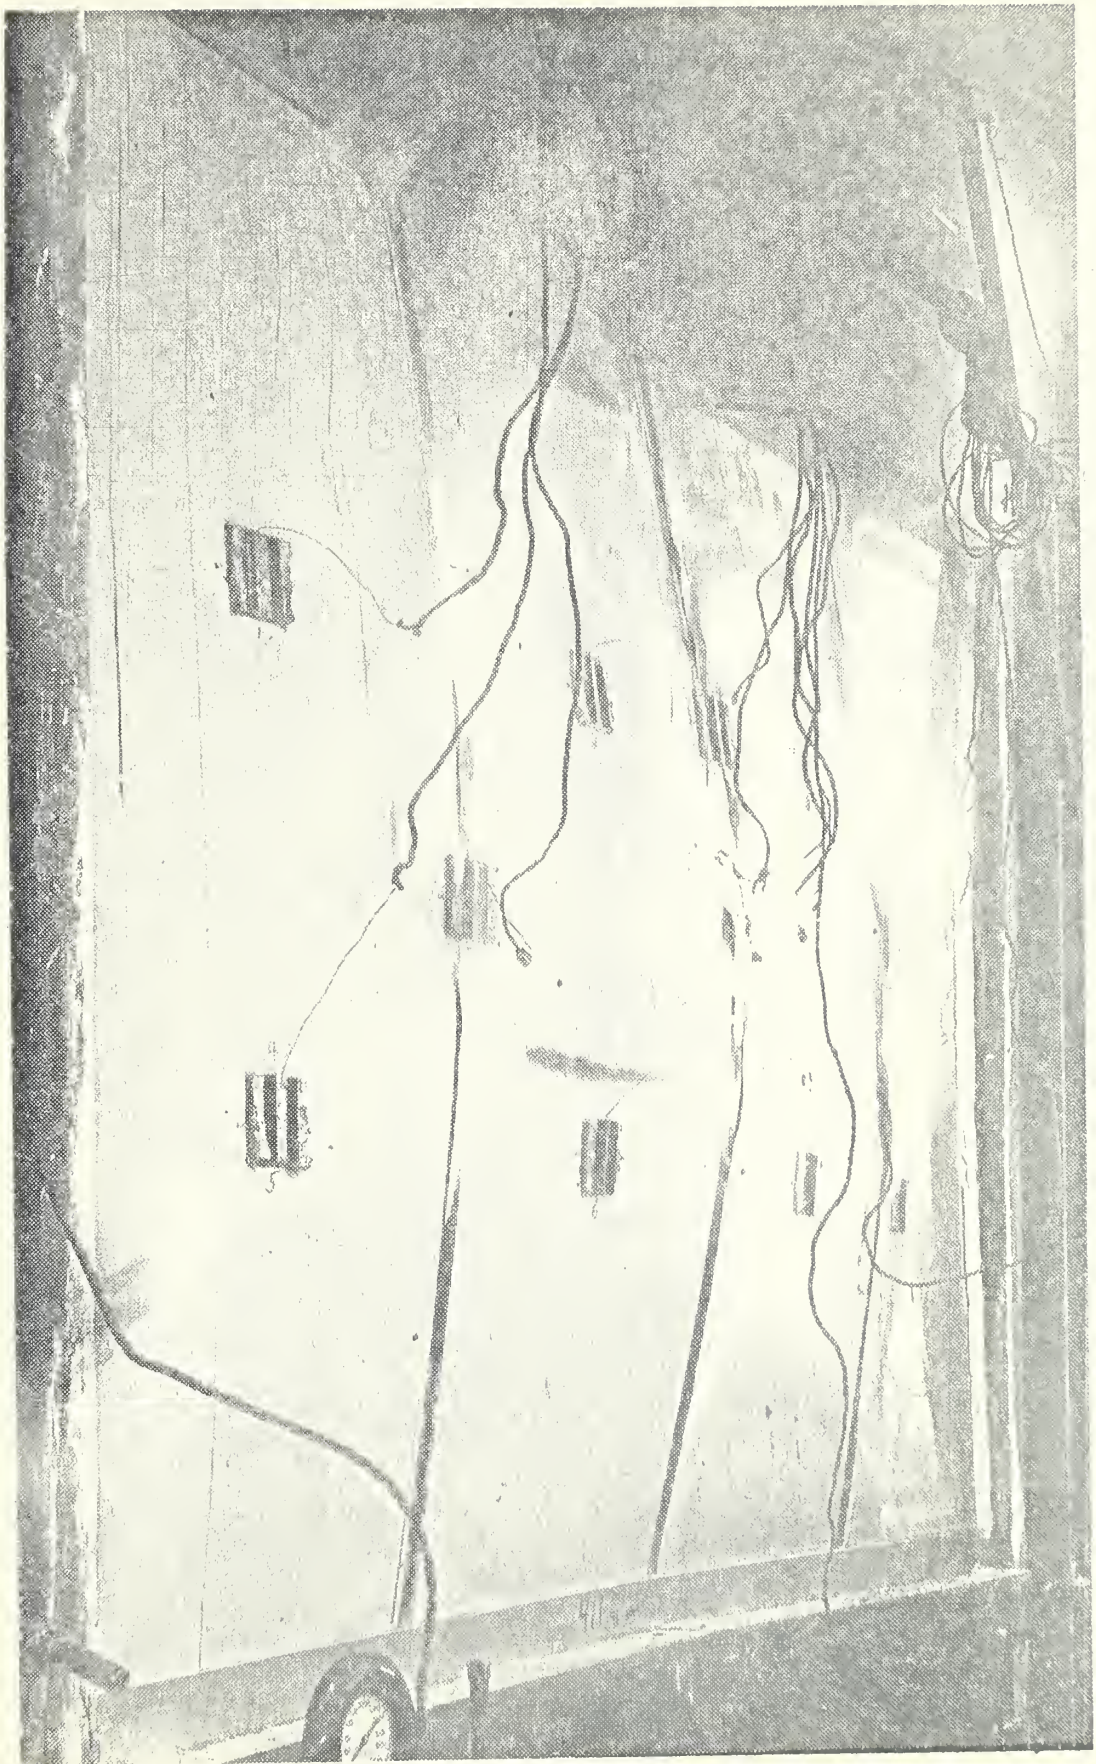
The fire endurance of the specimen was limited by 325°F rise above initial temperature at each of two thermocouples on the unexposed surface at 1 hr 2 min. The correction for actual furnace temperatures reduced this to 1 hr 1 min. The specimen continued to support the applied load until it was removed after the first breakthrough of flames at 1 hr 3 min.

Figure 4. Unexposed surface of perlite-filled wall as flames broke through north joint, 1 hr 3½ min.

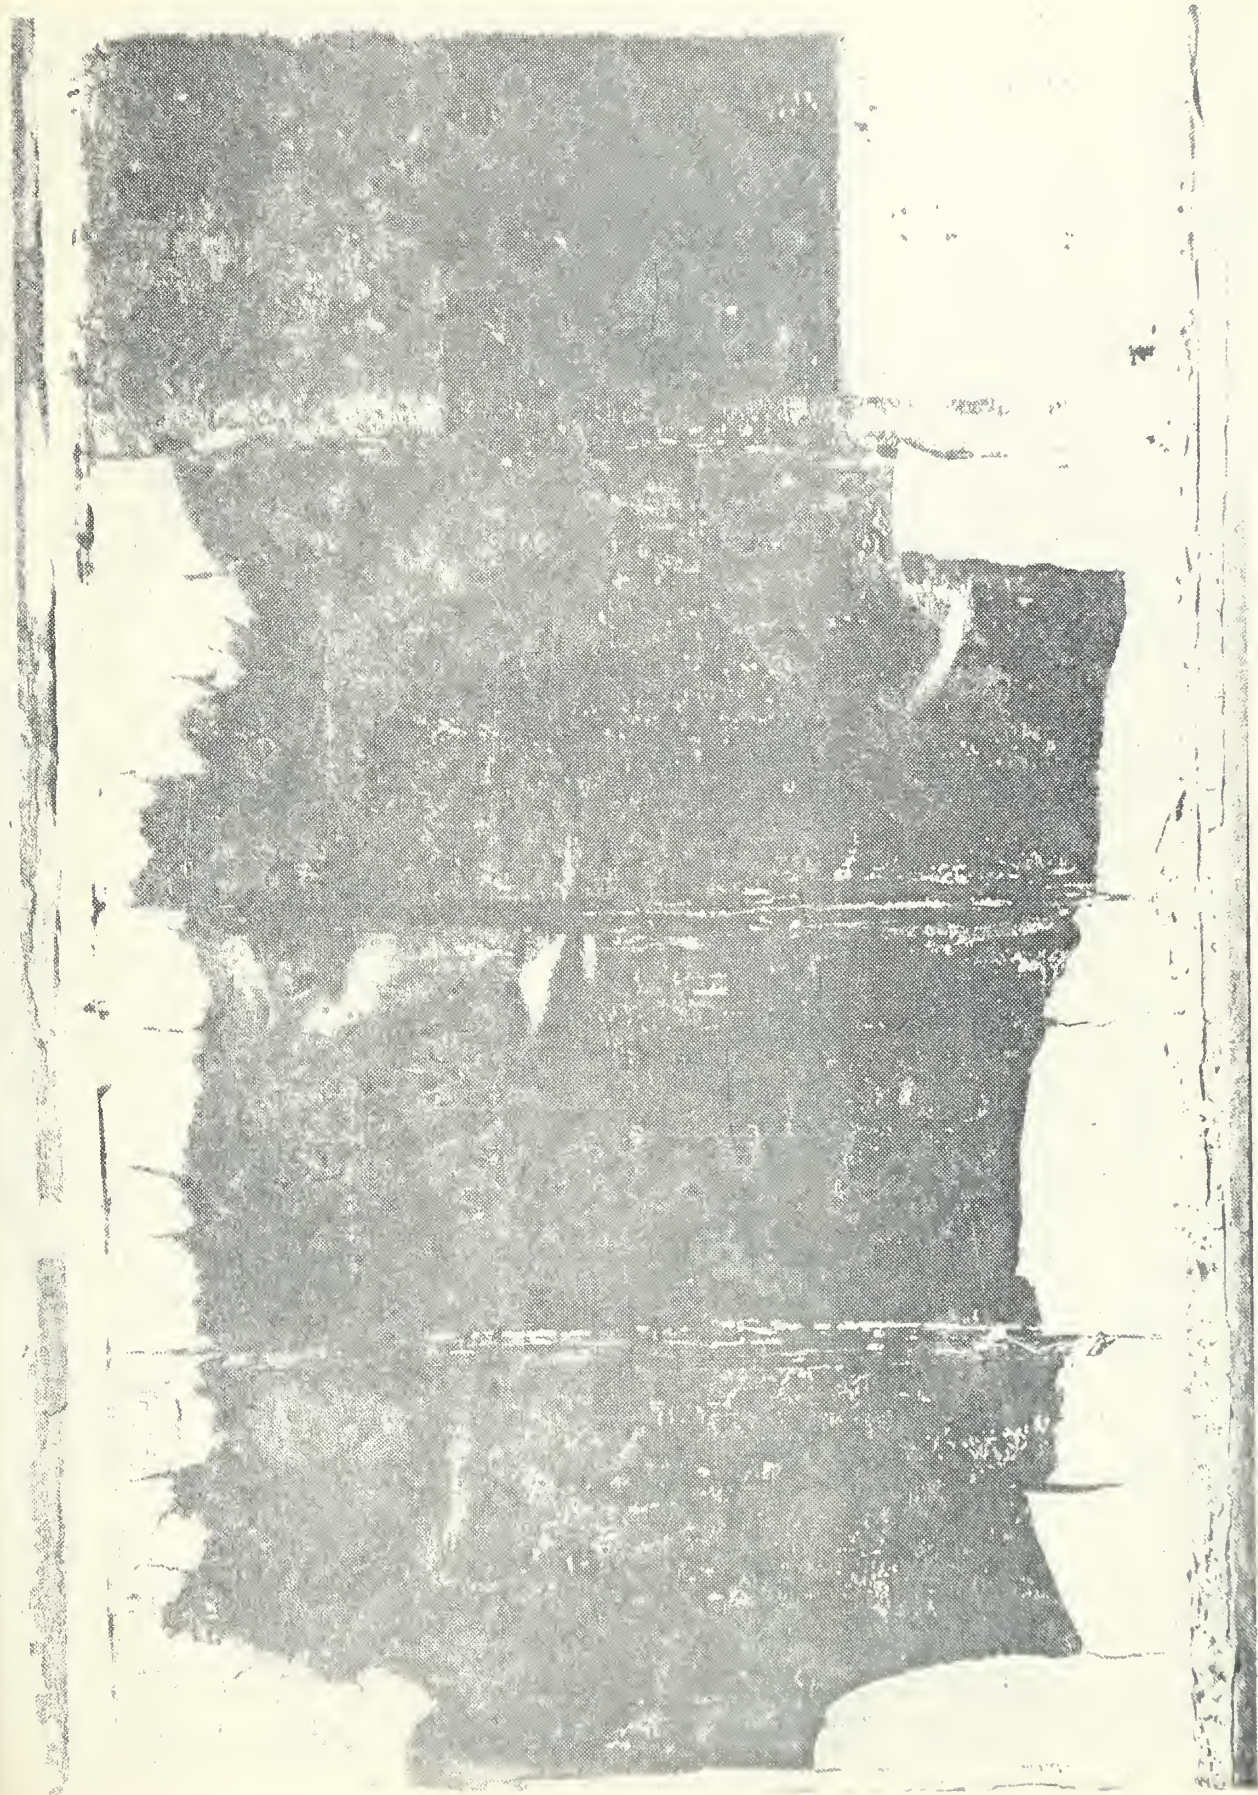
Examination of the specimen after test showed that the glue joint between the honeycomb and the exposed surface metal skin was broken in all panels; but the joint between the honeycomb and the unexposed surface metal skin was intact. Most of the perlite was still in the honeycomb cells and the paper of the honeycomb was charred to about 1-1/2 in., or half its depth, on the average. The wood framing members were charred to about 2/3 of their depth.

Figure 5. Exposed surface of perlite-filled wall after test;
extra metal liner on right panel only.

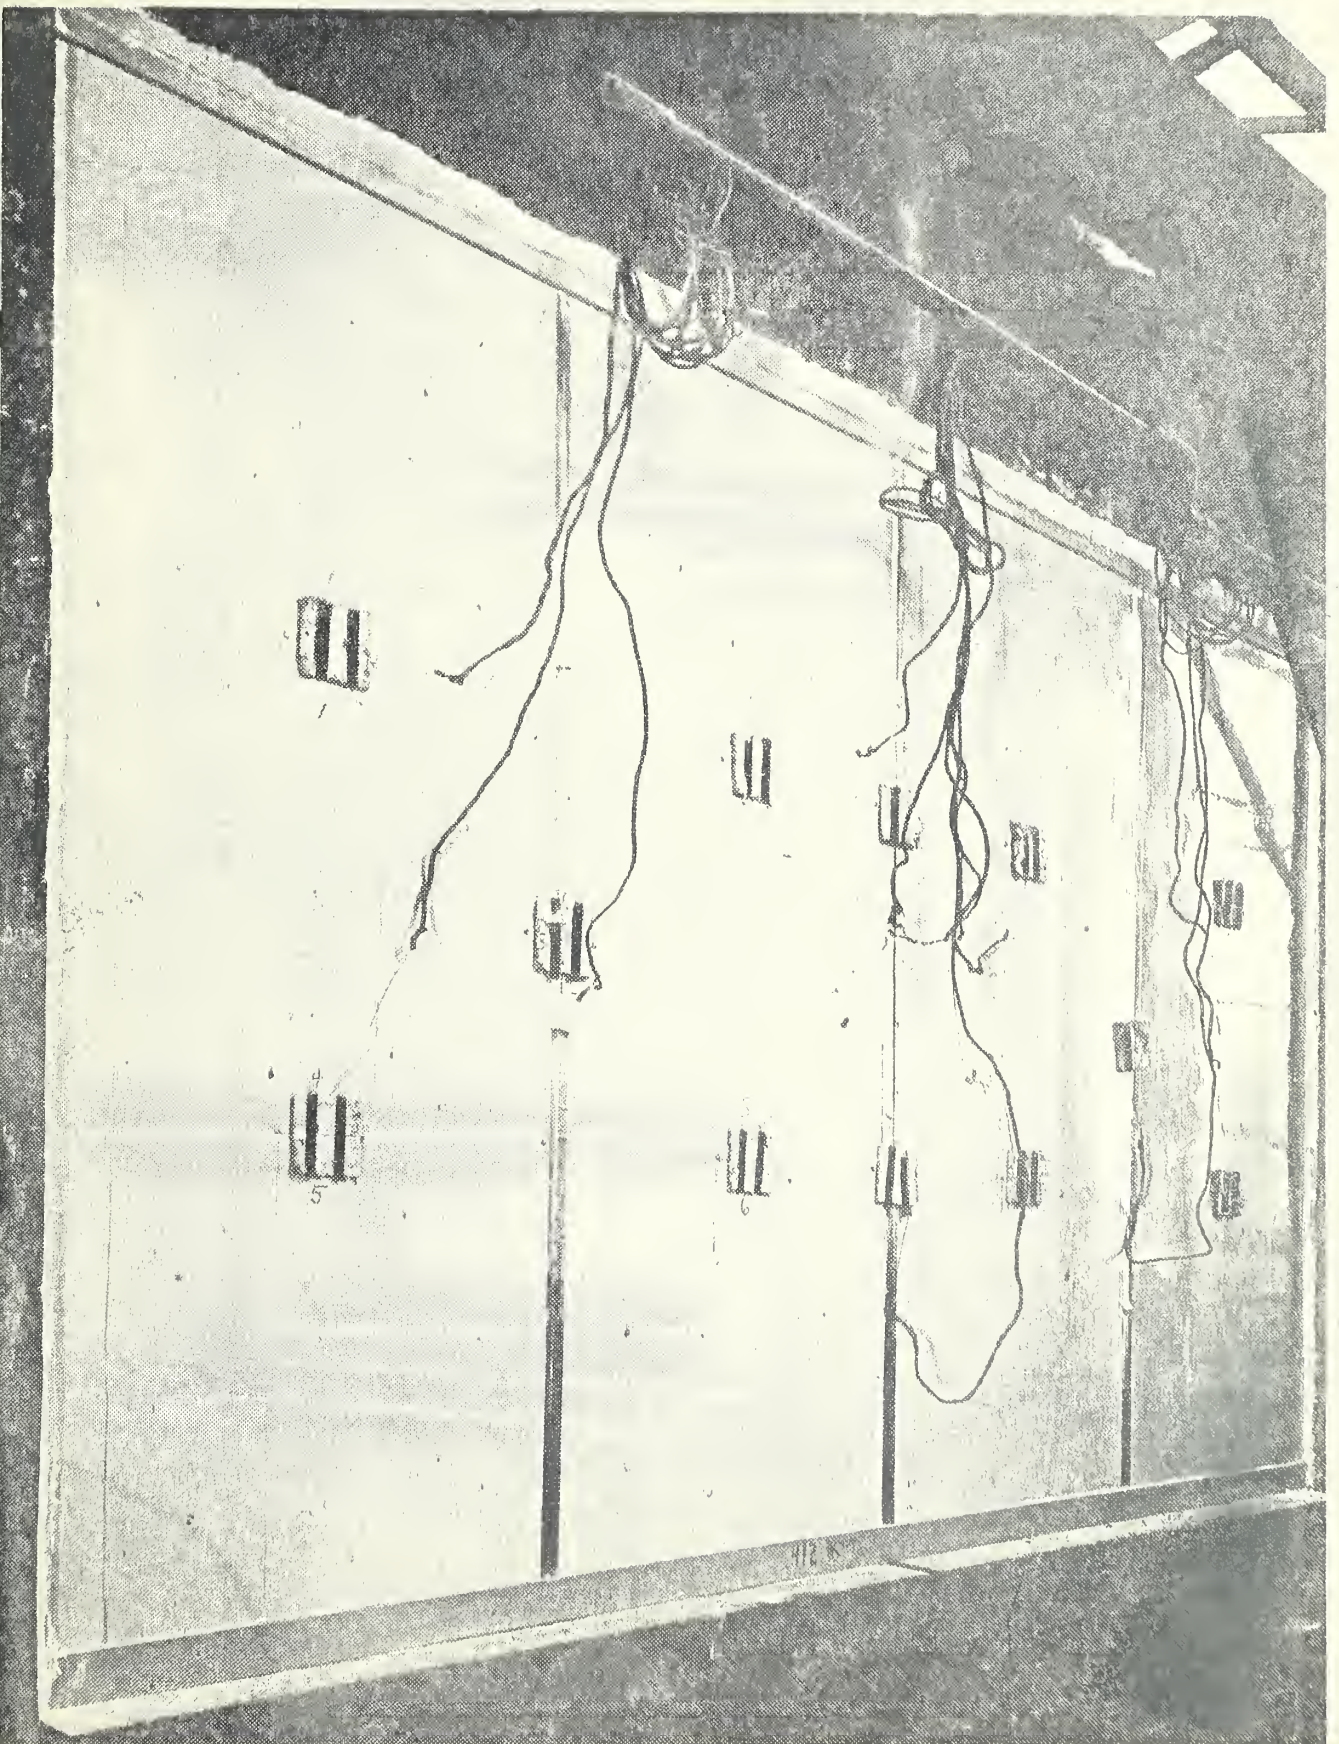
Figure 6. Unexposed surface of wall without perlite fill at 40 min.

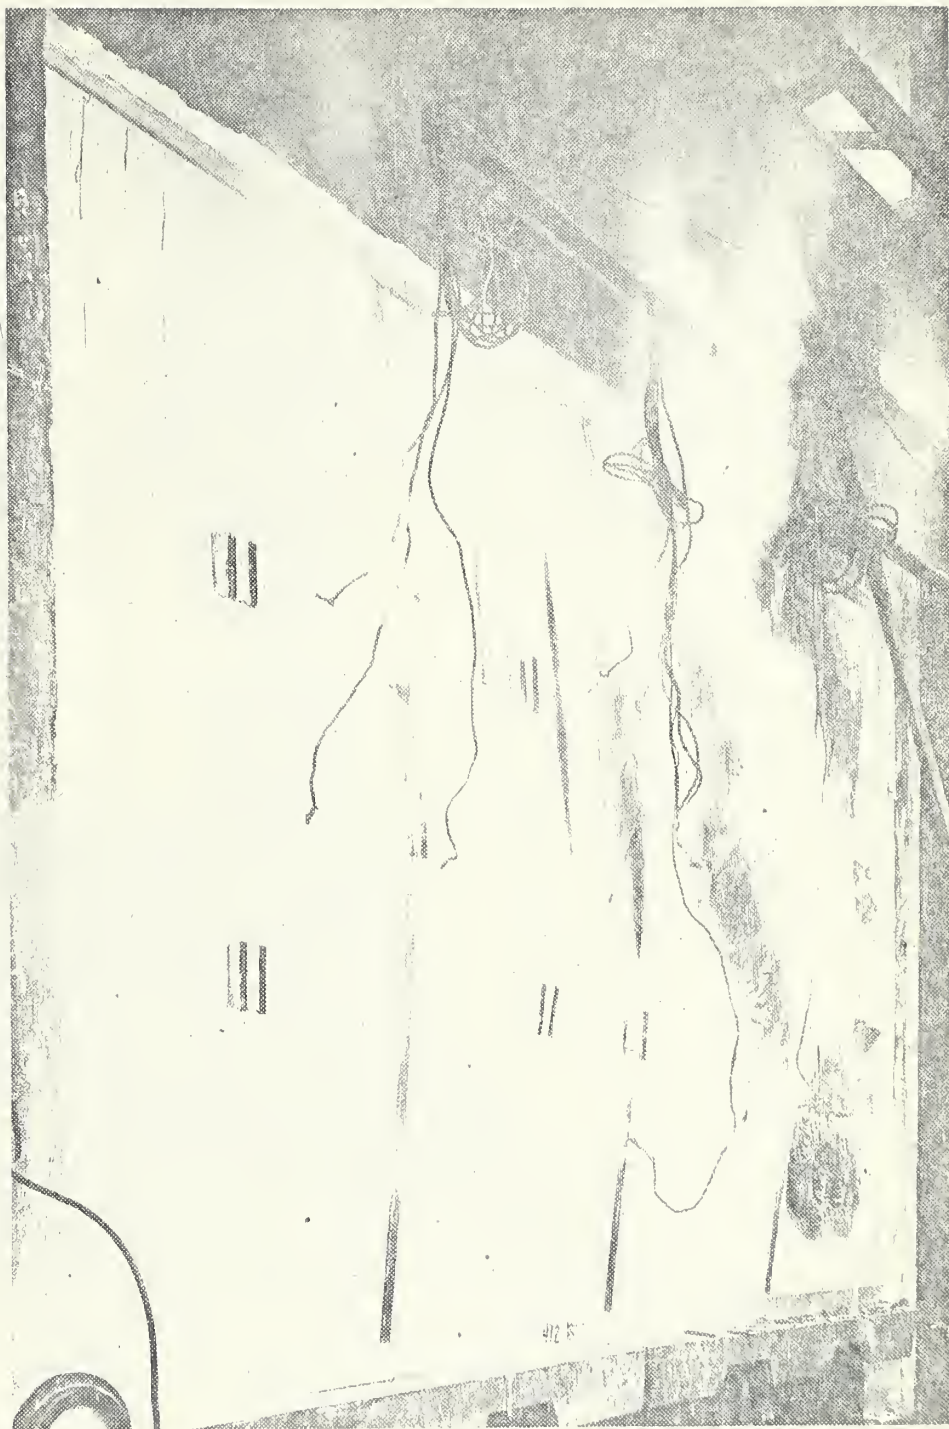
There was no observable lateral deflection of three of the panels as a result of the application of load just before the start of the test. The fourth panel deflected about .05 in. By 3 min, there were flames over the entire exposed surface, but these were reduced to a few intermittent flames by 6 min. The extra metal liner on the exposed surface of the south panel was warped by 11 min. At 21-1/2 min, there were small flames from the exposed side of the center joint and from a crack in the north panel. By 28 min, there were flames from the exposed side of all joints plus smoke from a seam in the unexposed surface of the north-center panel. By 32 min, the flaming from the joints was heavy. At 38 min, the south edge of the north panel was open on the exposed side and heavy flames were issuing from within the panel. The condition of the unexposed surface at 40 min is shown in Figure 6. At 41 min, smoke was issuing from under the thermocouple pad on the north joint. At 45 min, the unexposed surface of the north panel was turning black. At 47-1/2 min, most of the gypsum board on the north panel fell. At 50 min, about half the unexposed surface of the north panel was blackened and the paint on the upper half of the north-center panel hung in a single large blister. The paint on the north panel burst into heavy flaming about 51-1/2 min. At 54 min, about half the gypsum board on the north center panel fell. The test was stopped at 55 min. Figure 7 shows the unexposed surface at 55 min, just after flames broke through the north joint.

Figure 7. Unexposed surface of wall without perlite fill at 55 min.

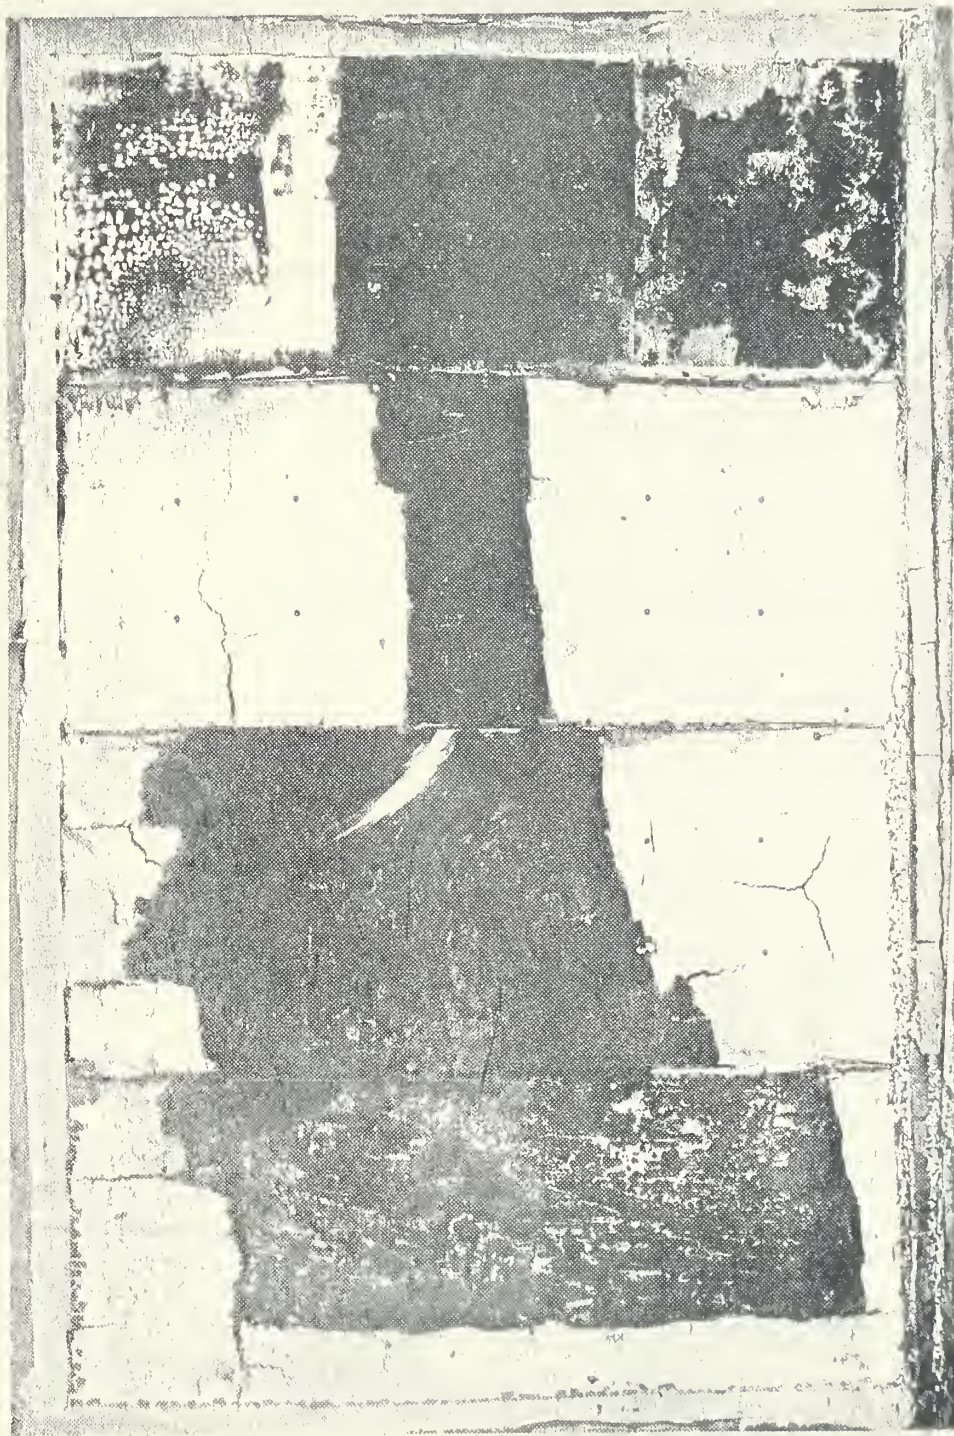
The fire endurance of the specimen was limited by 325°F rise above initial temperature at one thermocouple on the unexposed surface of the north panel at 44 min. The correction for actual furnace temperatures increased this to 45 min. The specimen continued to support the applied load throughout the test. The gypsum board on the north-center and south-center panels, supported by the addition of sheet metal screws and washers as described in 2.1.1, remained in place for all but the last minute of test. About half of it remained in place through the vibration incident to removal of the frame from the furnace. See Figure 8.

Examination after test showed that the glue joint between honeycomb and exposed surface metal skin was broken in all panels; but the joint between honeycomb and unexposed surface metal was intact. The honeycomb was charred full depth throughout and an appreciable amount washed away under the stream of water (from a garden hose) used to quench the interior flames. The wood framing of the panels had been completely charred and most of it had been dislodged.

Figure 8. Exposed surface of wall without perlite fill immediately after test. Extra screws and washers in two center panels only; extra metal liner on right panel only.

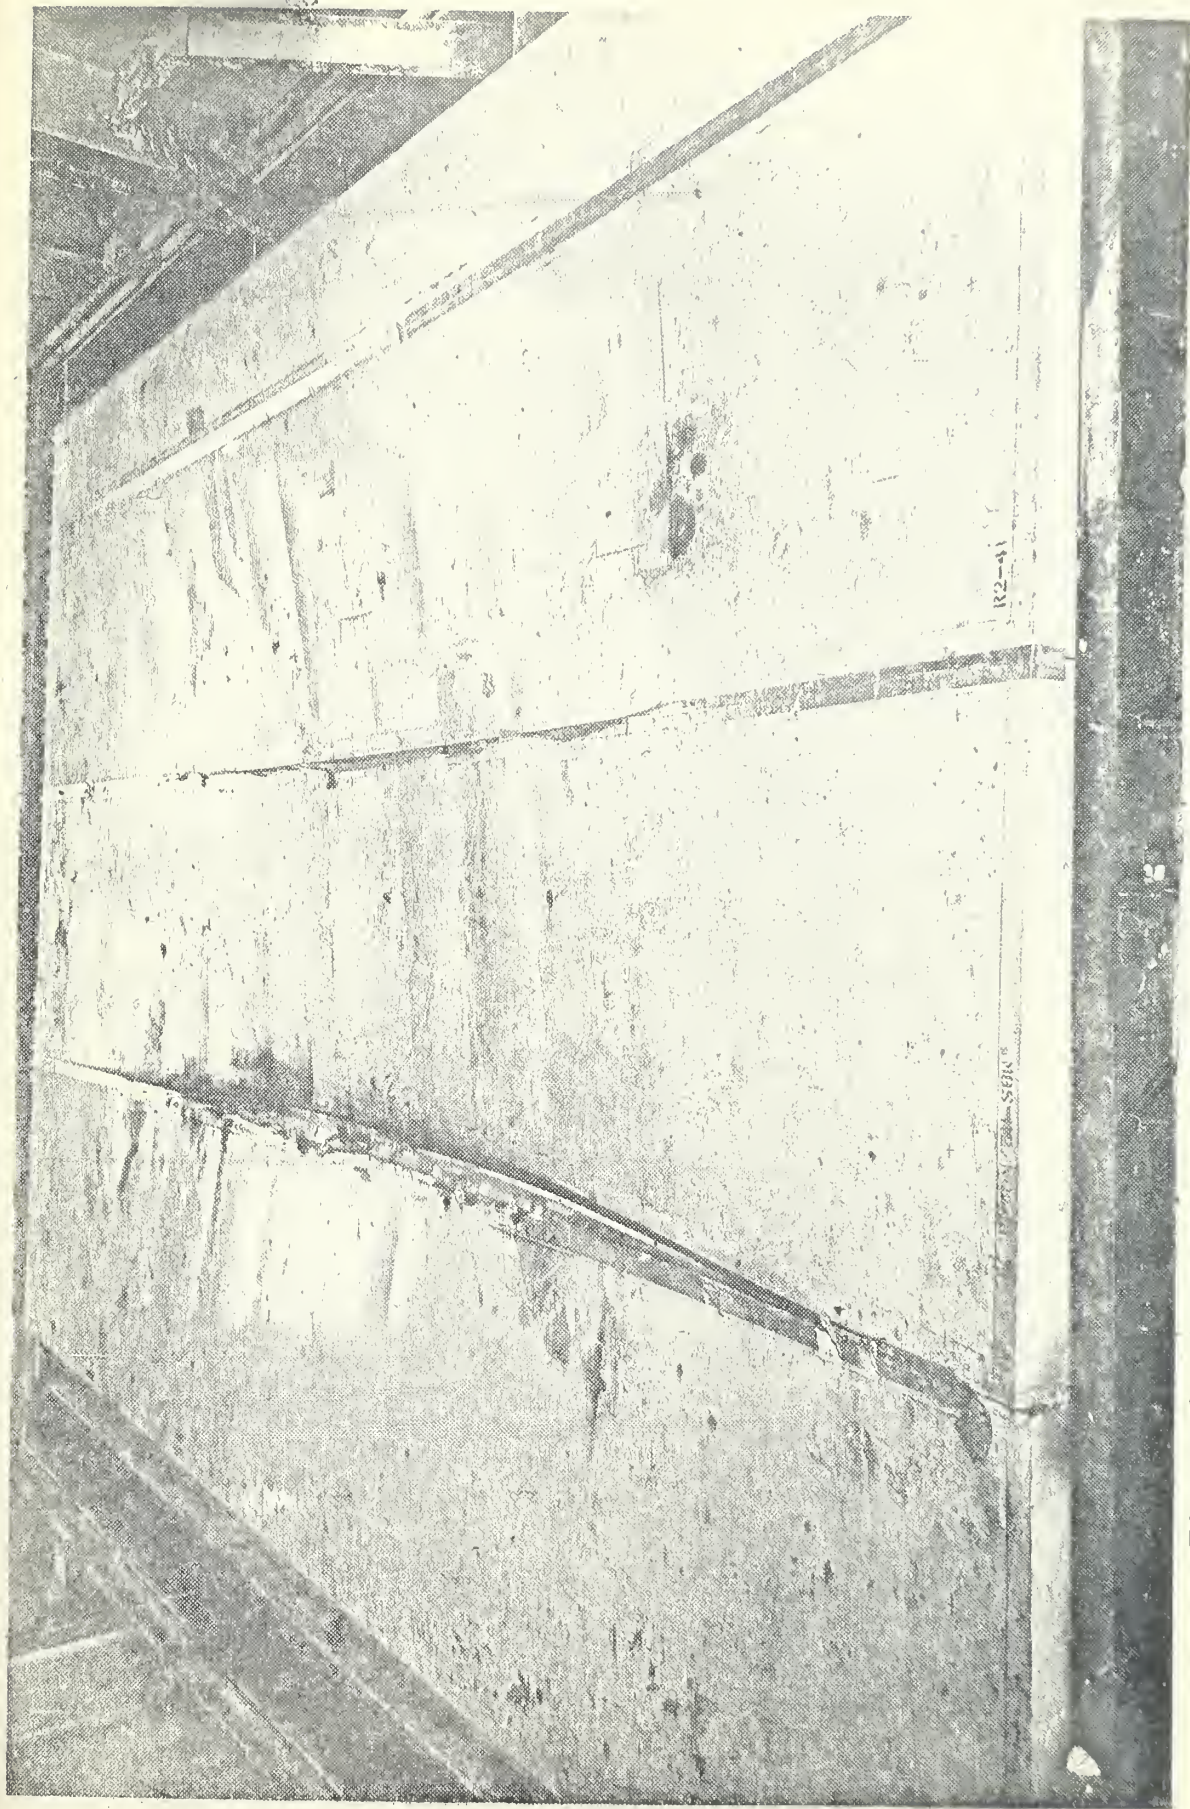
The fire endurance of the specimen was limited by 325°F rise above initial temperature at one thermocouple over the west joint, and by flaming through the west joint, both at 28 min. The applicable correction for furnace temperatures increased this to 29 min. The specimen supported the load until after the temperature rise and flame penetration limits had been reached. However, the magnitude of deflections and the rate at which they were increasing made it obvious that load failure would have occurred within the next 1-1/2 minutes. Even with the load removed, the specimen had sagged until it was resting on furnace thermocouple pipes at the end of the test. Figures 9 and 10 show the unexposed and exposed surfaces, respectively, after test and removal of the loading apparatus and instrumentation.

Figure 9. Unexposed surface of roof specimen after test and removal of loading equipment.

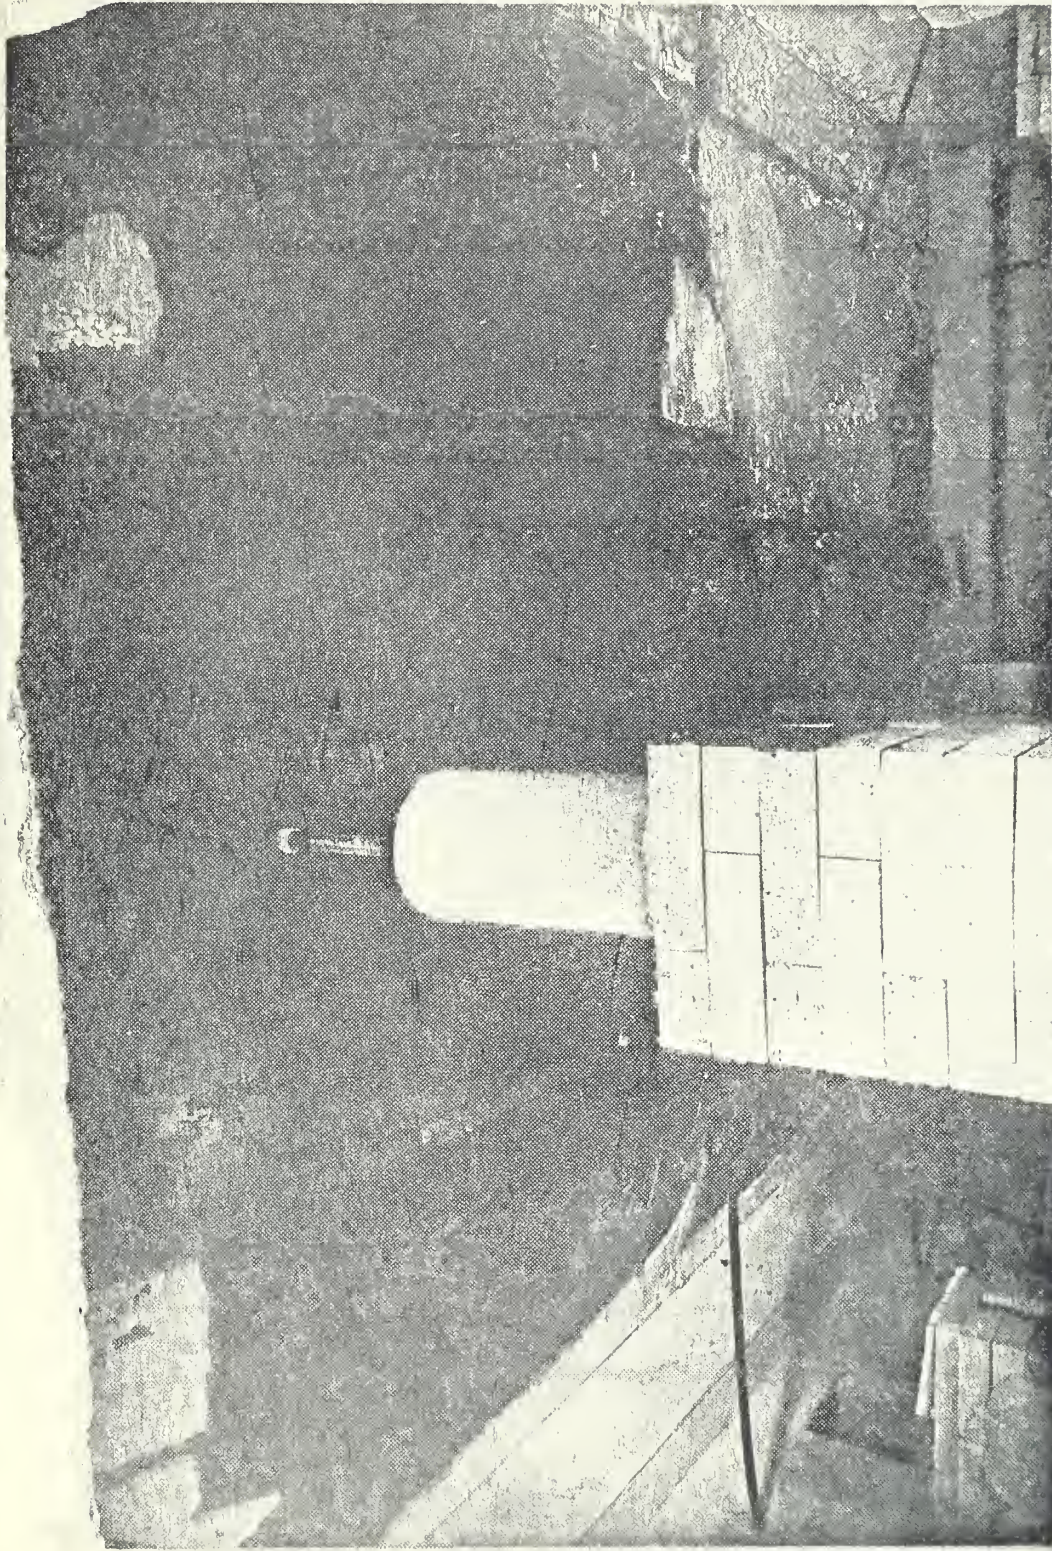
Examination after test showed that the glue joint between the honeycomb and exposed surface metal skin was broken in all panels; but that the joint between honeycomb and unexposed surface metal skin was intact. The perlite had fallen from the honeycomb cells. The honeycomb was charred to its full depth along the edges of the individual panels. The wood framing was charred to full depth where the edges of the panels had opened during the test. The gypsum board given additional support by cap head sheet metal screws fell shortly after the end of the test, but that given additional support by the same screws plus 3/4 in. o.d. washers remained in place.

Figure 10. Exposed surface of roof specimen after test. Extra screws in near end of right panel; screws and washers in far end of same panel.
