# Riparian Condition Assessments for the Pecos River and Lower Glorieta Creek

*Pecos National Historical Park, New Mexico*

Natural Resource Report NPS/NRSS/WRD/NRR—2011/422

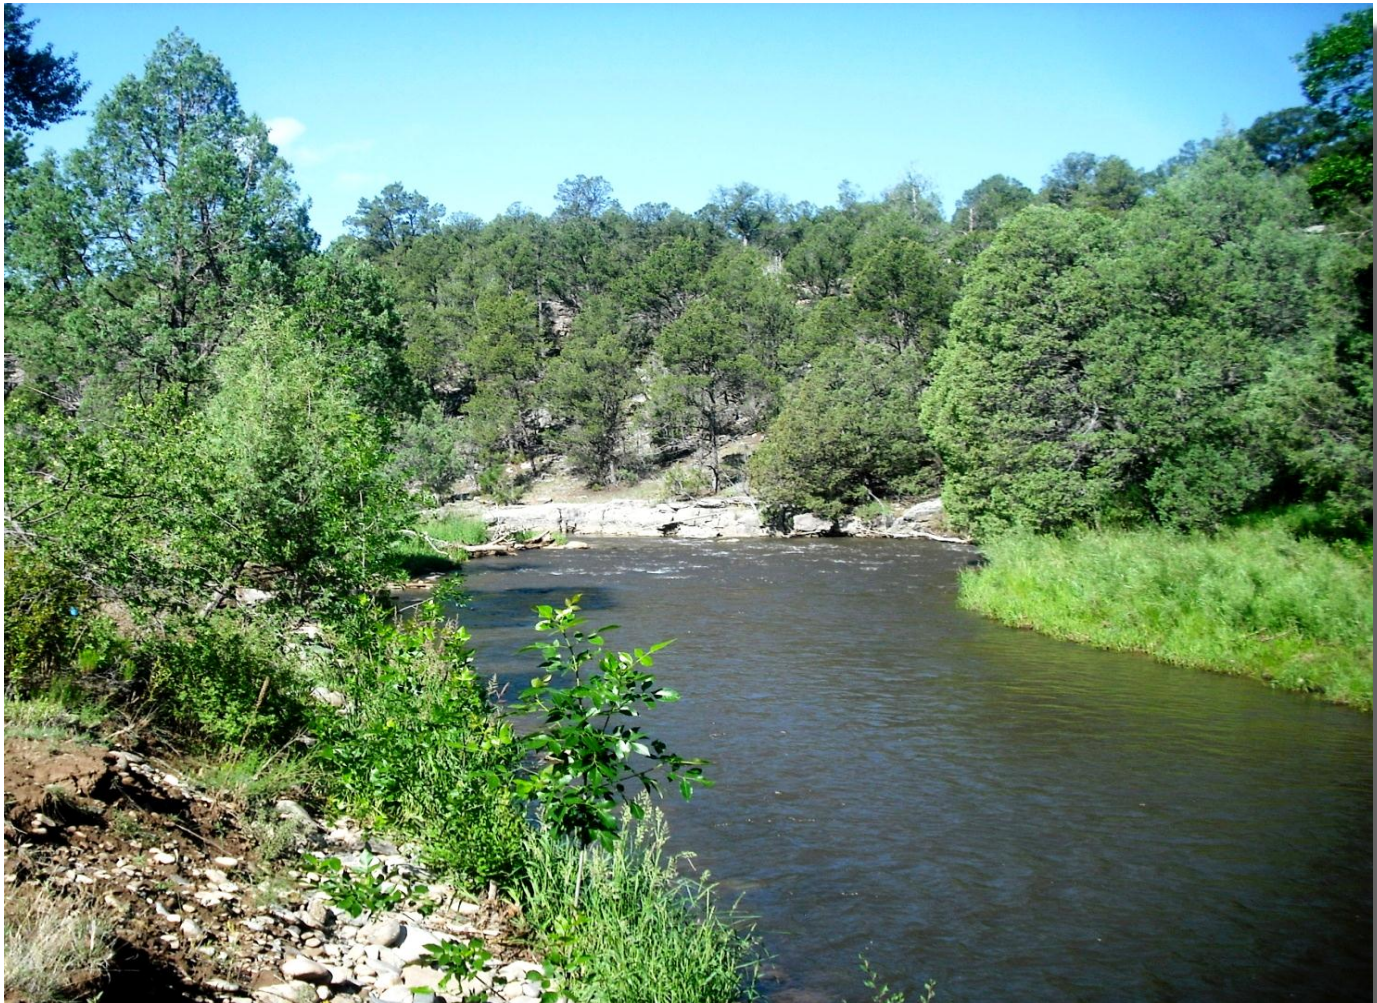
Pecos River Assessment Reach #1, Pecos National Historical Park.

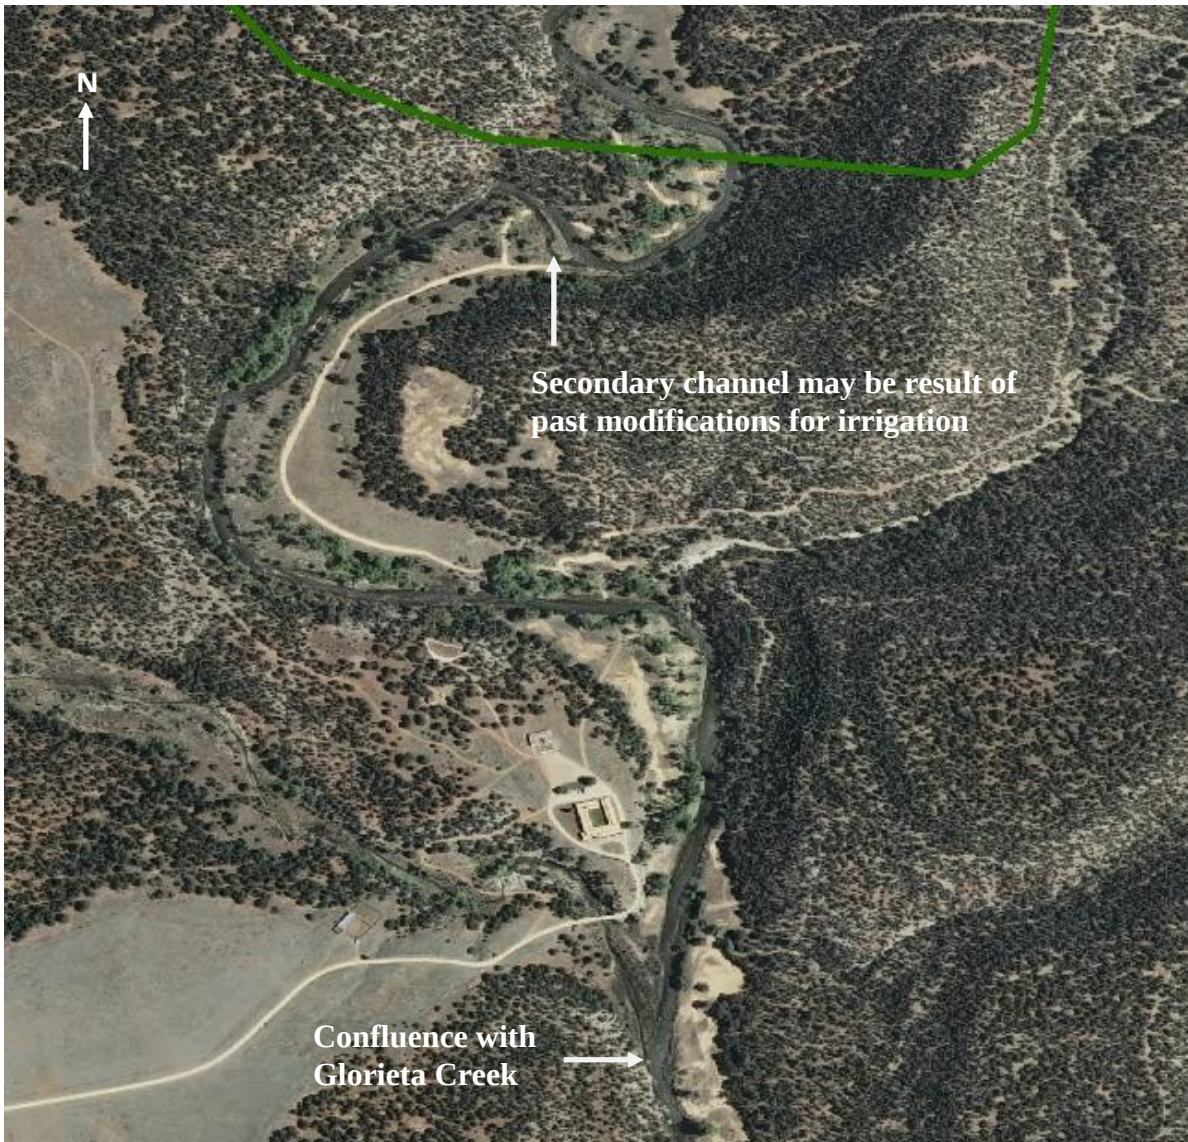
Figure 3 is an aerial photograph of this river reach, with some key features identified. Channel sinuosity, width/depth ratio, and gradient in this reach are in balance with the landscape setting. The channel and floodplain are able to pass the water and sediment being delivered by the watershed without excessive erosion or deposition (watershed is not contributing to riparian-wetland degradation). The northernmost meander has a secondary channel that may be the result of past channel modifications to provide irrigation water for the apple orchard on the adjacent terrace. Regardless of origin, this feature does not threaten the stability of this riparian reach.

**Figure 3.** Pecos River Assessment Reach #1 -- northern park boundary (green line) to confluence with Glorieta Creek. (Photo source: NAIP 2009)

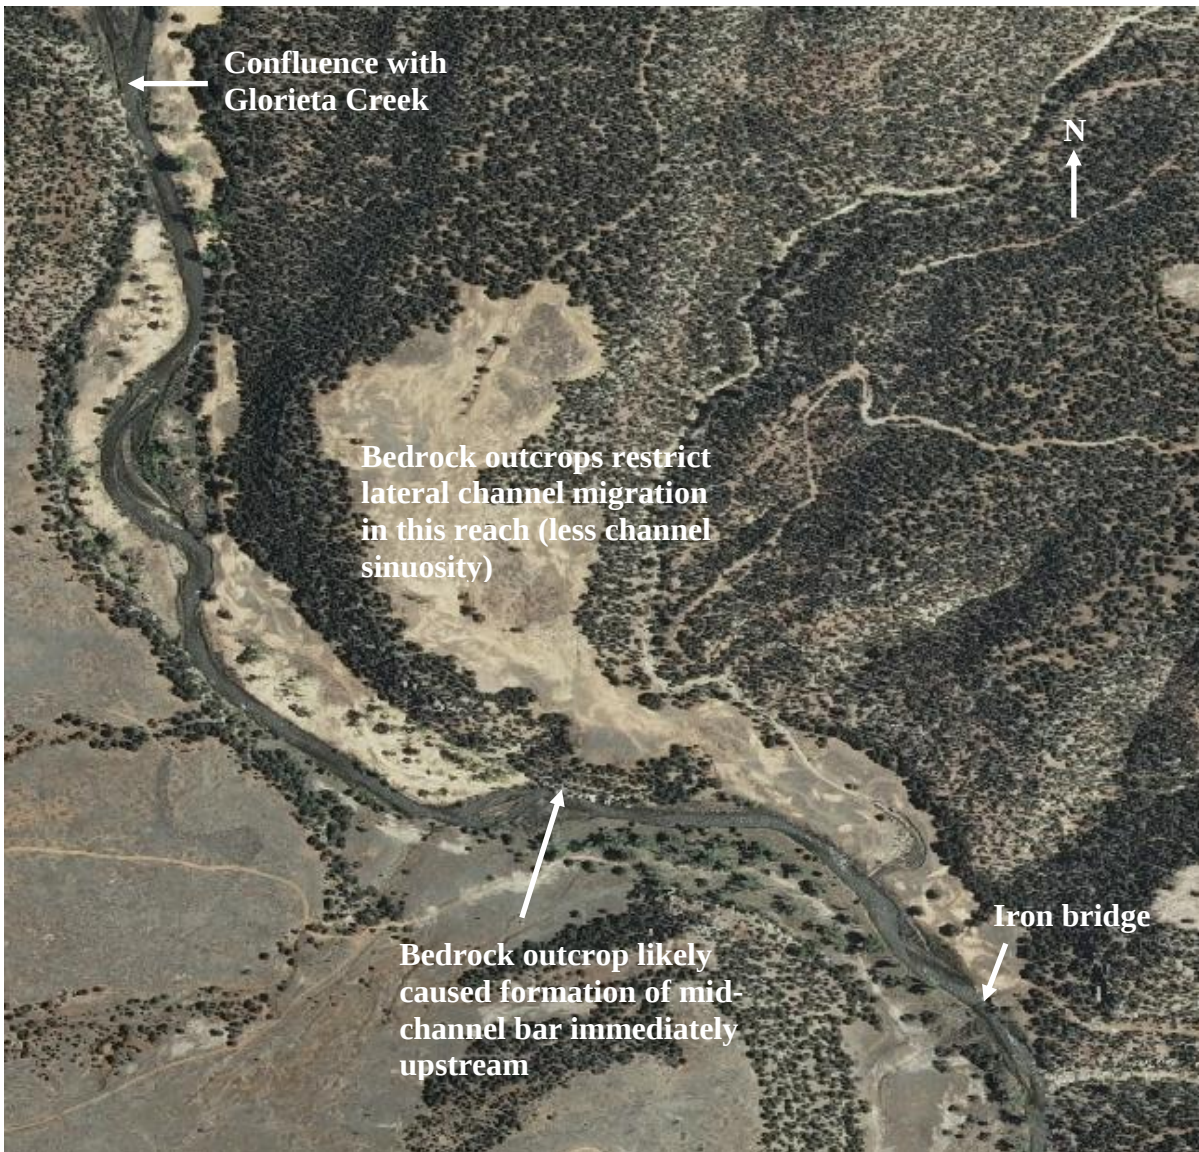
Figure 4 is an aerial photograph of this river reach, with some key features identified. The overall morphology of this reach (e.g., sinuosity, gradient, channel form) is controlled by shallow bedrock (base level control) and bedrock outcrops that limit lateral migration in some segments. Within that context, channel sinuosity, width/depth ratio, and gradient are in balance with this landscape setting. The channel and floodplain are able to pass the water and sediment being delivered by the watershed without excessive erosion or deposition (watershed is not contributing to riparian-wetland degradation).

**Figure 4.** Pecos River Assessment Reach #2 -- confluence with Glorieta Creek south to abandoned iron bridge. (Photo source: NAIP 2009)

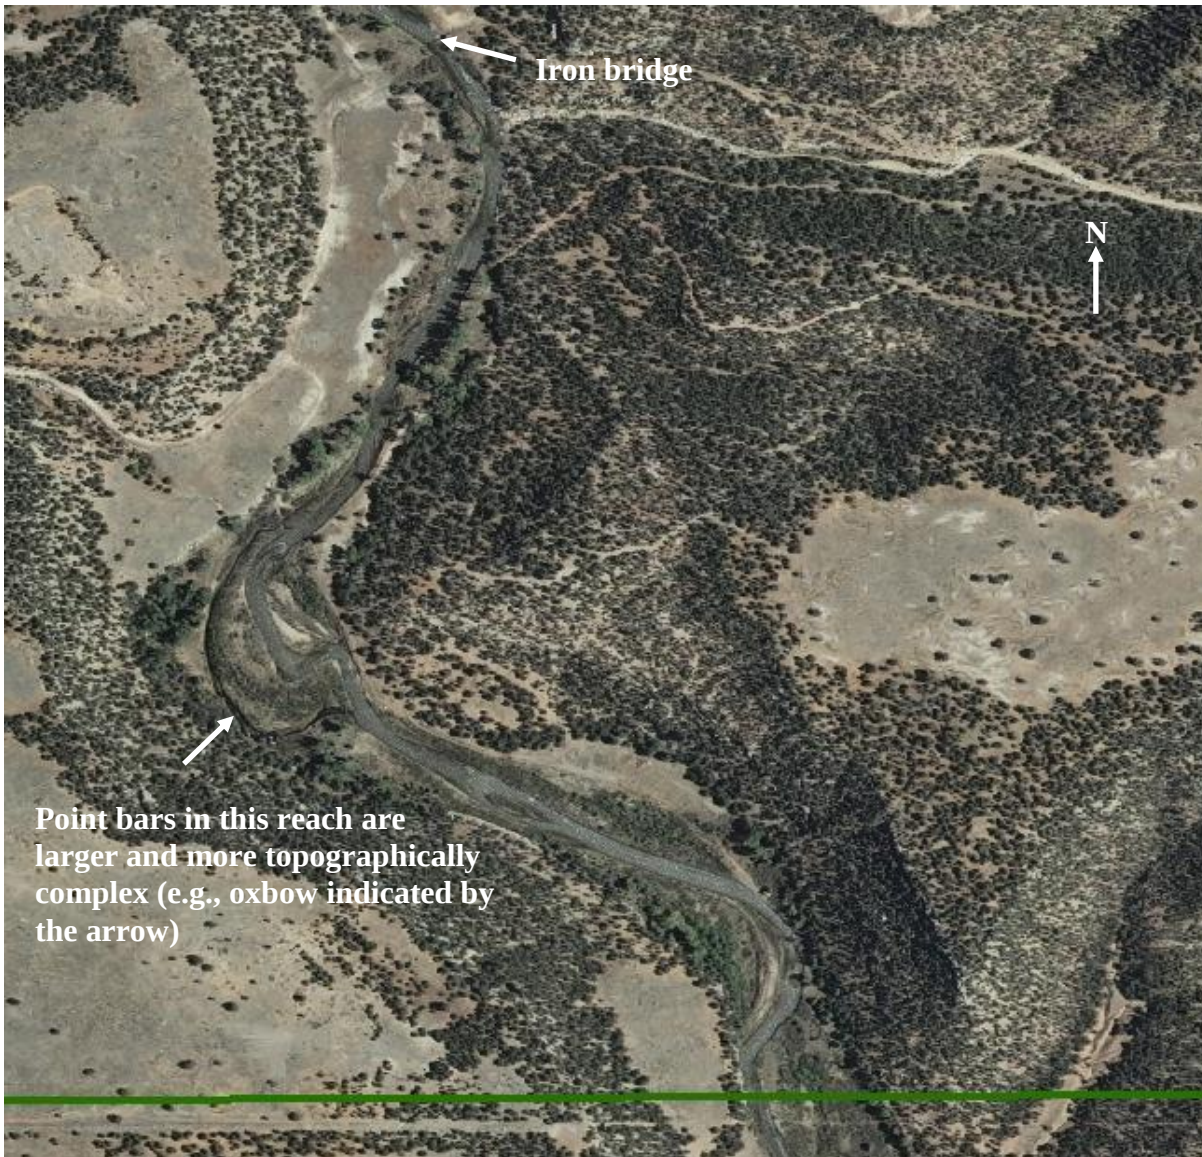
Figure 5 is an aerial photograph of this river reach, with some key features identified. The overall morphology of this reach (e.g., sinuosity, gradient, channel form) is controlled by substantial shallow bedrock (base level control) and bedrock outcrops that limit lateral migration in some segments. However, point bars are better developed here (Figure 6) than on reaches 1 and 2, being larger in width and area and having more diverse topographic structure (including oxbows and overflow channels). This topographic complexity contributes to the more diverse wetland-riparian vegetation communities discussed below. Within that context, channel sinuosity, width/depth ratio, and gradient are in balance with this landscape setting. The channel and floodplain are able to pass the water and sediment being delivered by the watershed without excessive erosion or deposition (watershed is not contributing to riparian-wetland degradation).

**Figure 5.** Pecos River Assessment Reach #3 -- abandoned iron bridge to southern park boundary (green line). (Photo source: NAIP 2009)

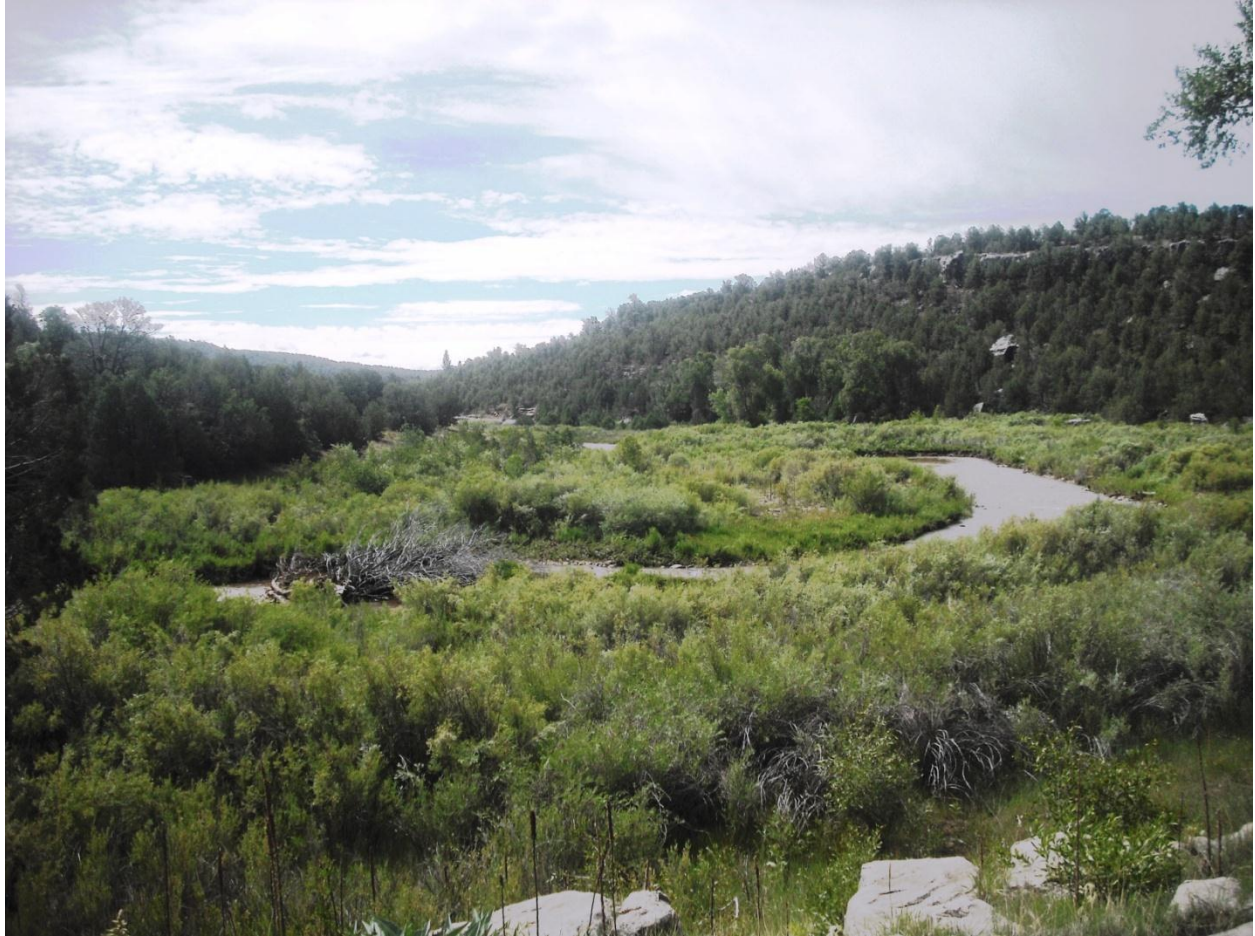
**Figure 6.** Riparian areas on Pecos River Assessment Reach 3 are larger and have more topographic complexity than on reaches 1 and 2, creating more diverse wetland-riparian vegetation communities. (Photo by Michael Martin, NPS-NRSS, Water Resources Division, 2010.)

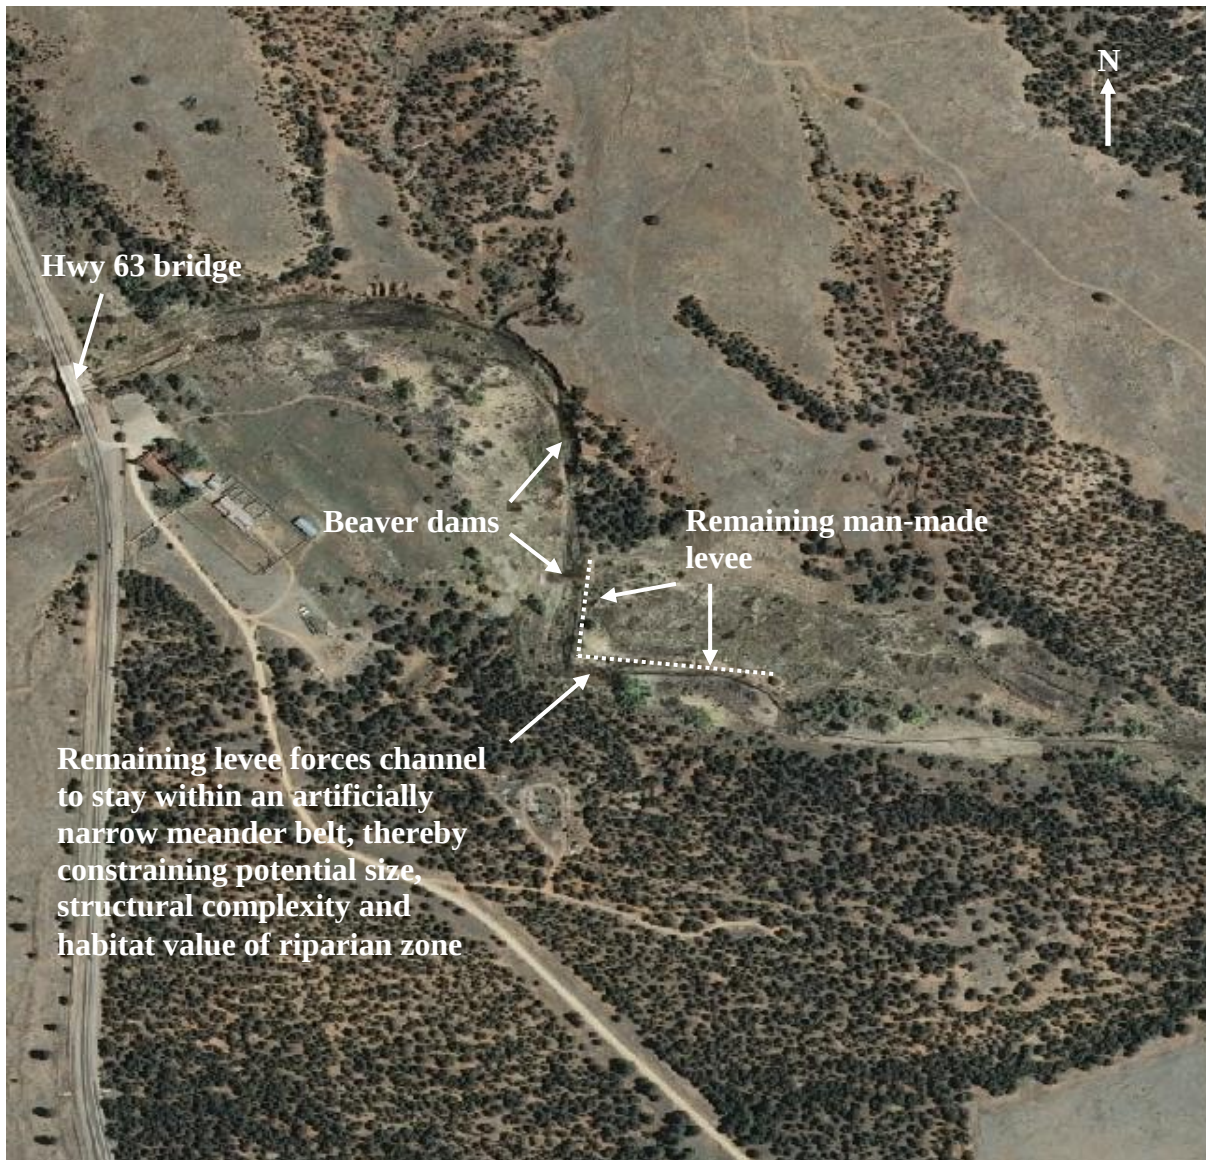
Figure 7 is an aerial photograph of this stream reach, with some key features identified. In the upper two-thirds of this assessment reach, channel sinuosity, width/depth ratio, and gradient are in balance with the landscape setting. However, the lower third of the reach has a substantial artificial levee located very near the left bank of the channel. The levee is a remaining section of the former “upper reservoir” that was built by former land owners in mid 1980s and was left in place as a temporary erosion protection measure during the 1999-2000 lower Glorieta Creek restoration project. In this lower segment, the channel is forced to stay within an artificially narrow meander belt between the levee and the high terrace to the south. As a result, the stream gradient steepens due to reduced sinuosity. Nevertheless, our observations indicated that the channel and floodplain are able to pass the water and sediment being delivered by the watershed throughout the entire assessment reach without excessive erosion or deposition.

Two beaver dams and associated ponds were observed in sequence at approximately 0.27 and 0.35 stream miles below the Highway 63 bridge (Figure 7). Both are well-stabilized by riparian shrubs, and both are being actively maintained (we observed an adult beaver in the upper pond). These dams play an important role in maintaining high riparian-wetland water tables in their vicinities during the drier parts of the summer and fall.

However, there is an ongoing risk that a large flood could cause the creek to erode a new channel through the upper part of the levee (e.g., at the lower beaver dam location shown in Figure 7) and down through the recently restored wetland-riparian area (Figure 9). The result could be excessive deposition of eroded levee material into the recently restored wetlands and back into the Glorieta Creek channel immediately downstream. We therefore assigned the rating “Functional – At Risk” to this stream reach. The trend is “downward” because the levee will continue to degrade over time, increasing the chance for failure. We strongly recommend removal of the remaining levee to complete the lower Glorieta Creek restoration (i.e., connect the restored wetland area to the stream corridor), allow the riparian system to reach its full potential for habitat size, diversity, and quality, and eliminate the threat of excessive sediment deposition in the restored wetlands or downstream riparian system from this source.

**Figure 7.** Glorieta Creek Assessment Reach -- Highway 63 bridge downstream to lower end of remaining artificial levee (0.5 stream miles below bridge). (Photo source: NAIP 2009)

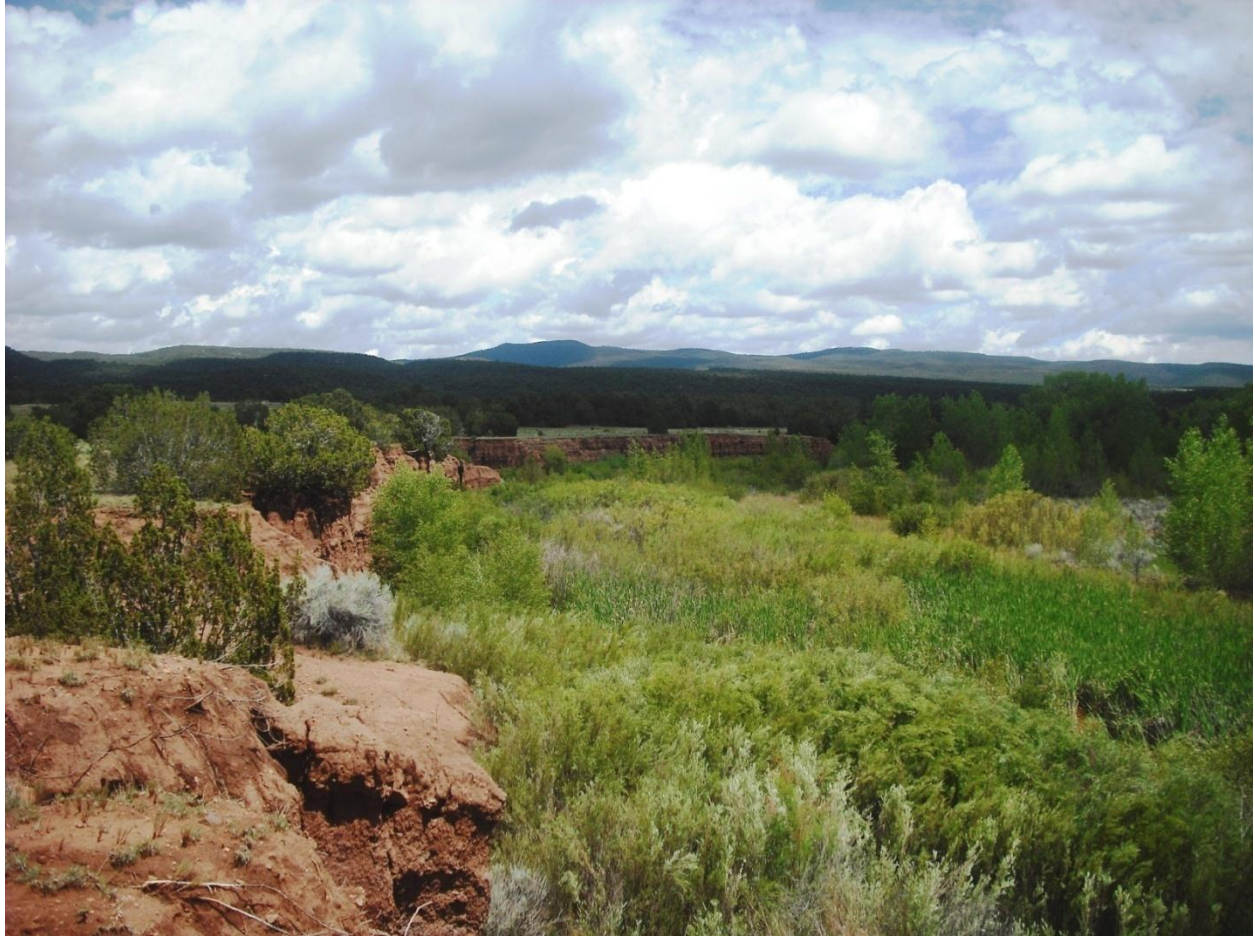
**Figure 8.** Diverse woody and herbaceous plant communities along the Glorieta Creek reach below the Highway 53 bridge provide adequate root mass and above-ground biomass to protect streambanks from excessive erosion, dissipate flood energy and perform other beneficial riparian-wetland functions. (Photo by Michael Martin, NPS-NRSS, Water Resources Division, 2010.)

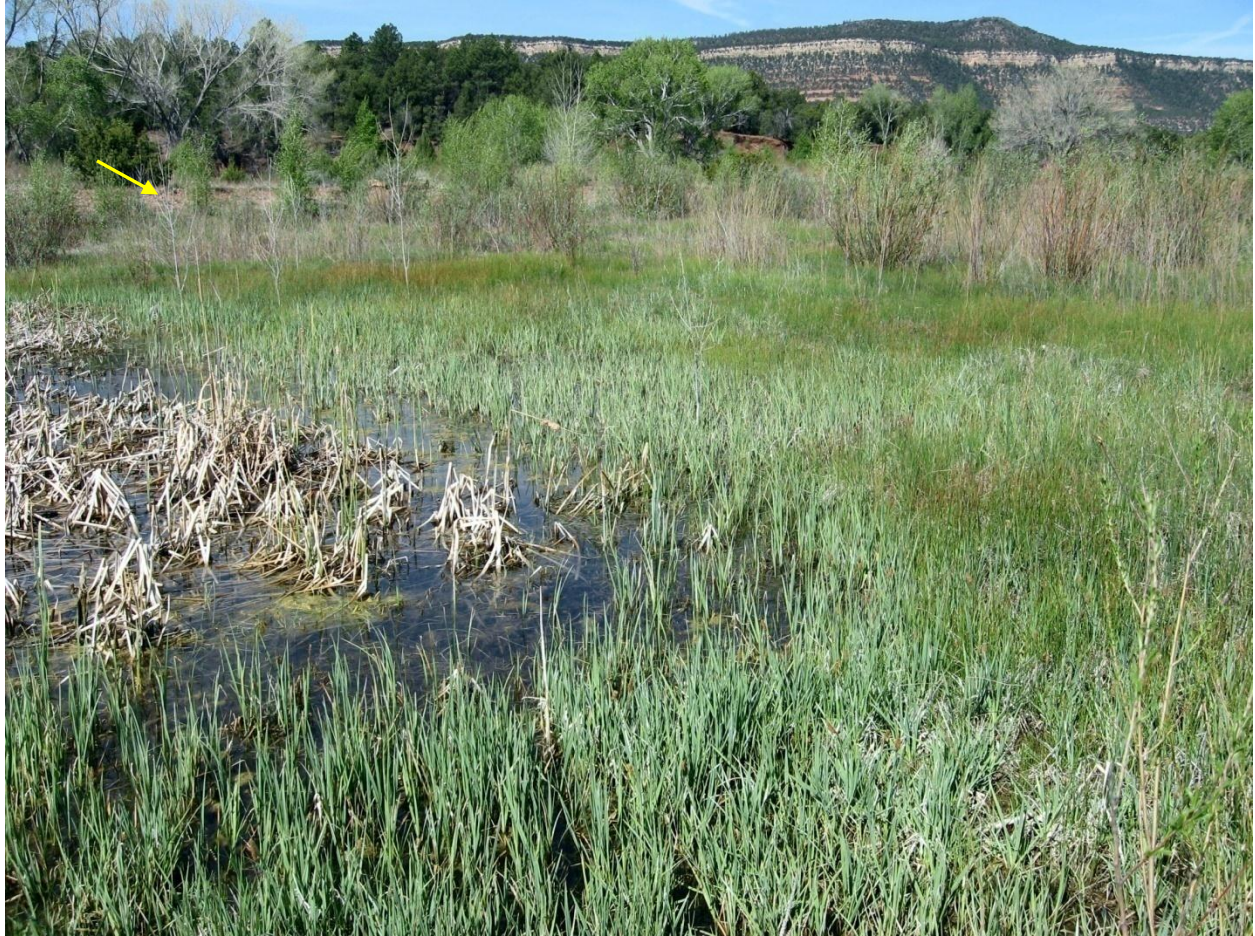
**Figure 9.** Diverse wetland-riparian plant communities are developing within the former reservoirs along lower Glorieta Creek, which were largely restored in 2000. The remaining levee segment (yellow arrow) separating the creek from this portion of the floodplain limits riparian system function and could cause excessive sediment deposition in downstream aquatic habitats. (Photo by Joel Wagner, NPS-NRSS, Water Resources Division, 2007.)
