# FLOOD PLAIN INFORMATION

## ONTONAGON RIVER ONTONAGON, MICHIGAN

## LAKE SUPERIOR SHORELINE ONTONAGON COUNTY, MICHIGAN

PREPARED IN COOPERATION  
with  
WATER RESOURCES COMMISSION  
MICHIGAN DEPARTMENT OF NATURAL RESOURCES  
THE VILLAGE OF ONTONAGON  
and  
ONTONAGON COUNTY  
by  
DEPARTMENT OF THE ARMY  
ST. PAUL DISTRICT CORPS OF ENGINEERS  
ST. PAUL, MINNESOTA  
SEPTEMBER 1970

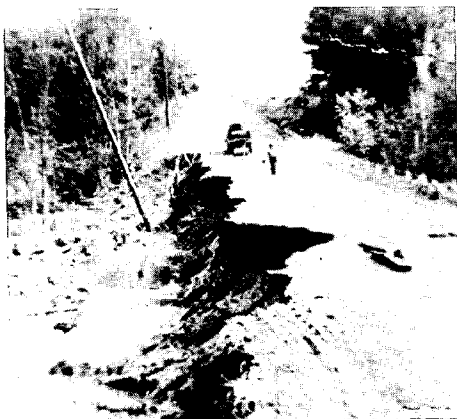
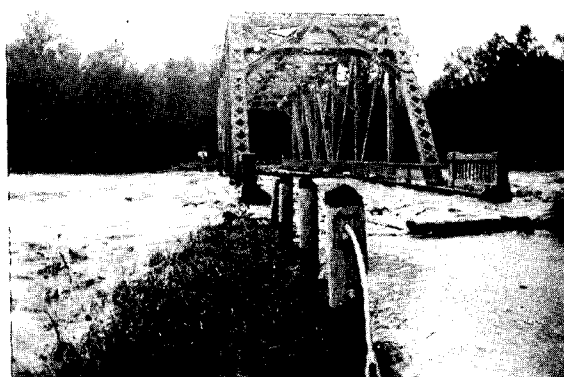
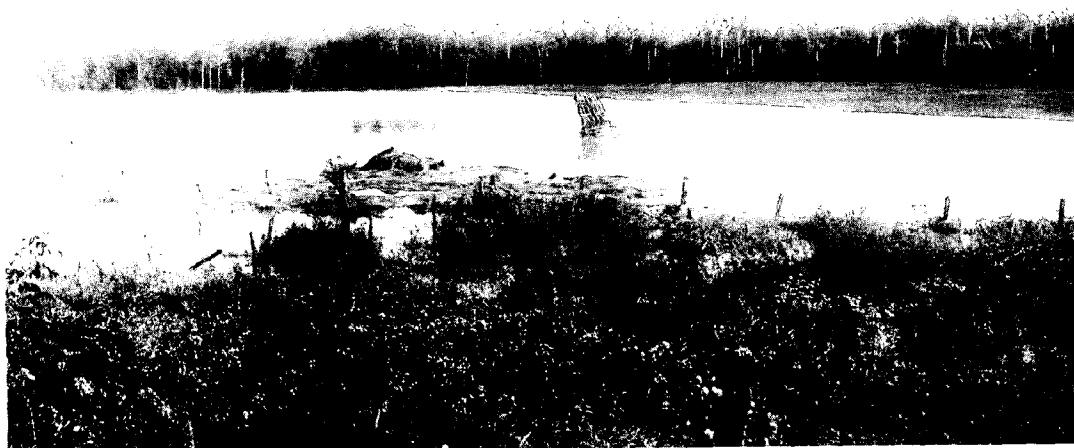
Figure 7. -- FLOOD SCENES IN ONTONAGON - AUGUST 1942

Upper left view shows damaged U. S. Highway 45 1.5 miles north of Bruce Crossing, Michigan. The stream is the Mile and One-half Creek, a tributary of the Ontonagon River. Upper right view shows flood conditions at the Military Bridge (U. S. Highway 45) over the Ontonagon River two miles south of Rockland, Michigan. Lower view is looking southwest from Stubb's Museum in Ontonagon.

The largest recorded flood resulting from rainfall occurred in August 1942. High water elevations from this flood rank second only to the April 1963 flood of record. Some photographs taken during the 1942 flood are included as Figure 7.

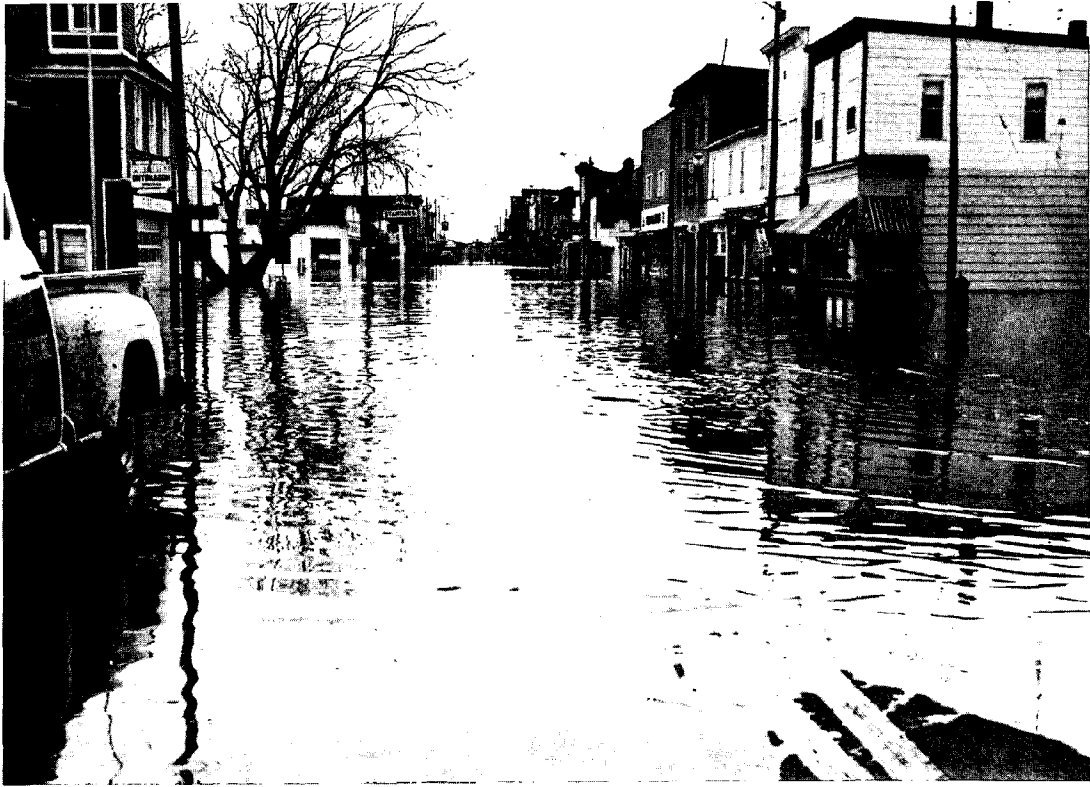
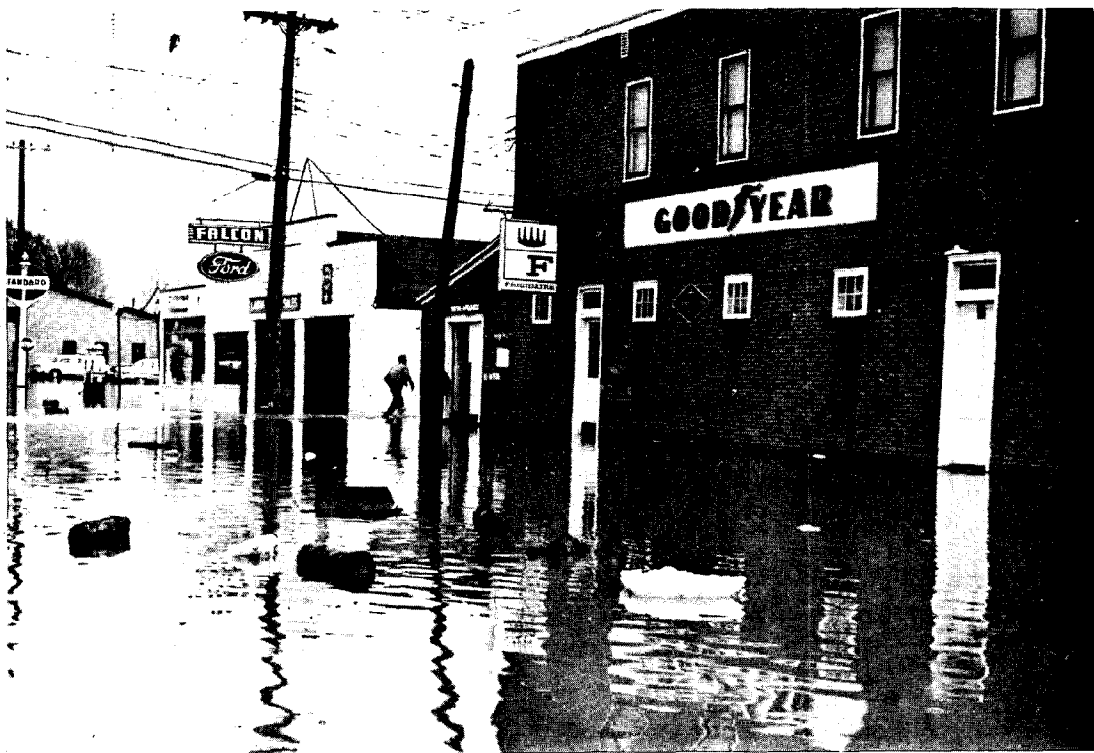
Figure 14. -- FLOOD SCENES IN ONTONAGON - APRIL 1963

Top view is looking northwest along the flooded River Street in Ontonagon. Lower view also shown flooded condition in the commercial area of Ontonagon.

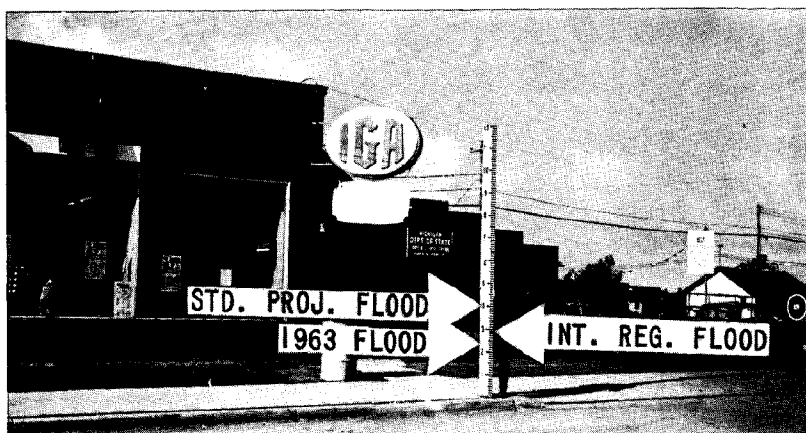
Figure 20. -- FLOOD HEIGHTS AT IGA FOODLINER

Merchandise in the store was extensively damaged when flood waters reached the level shown by the 1963 arrow. Even greater flooding would occur during an Intermediate Regional or Standard Project Flood.

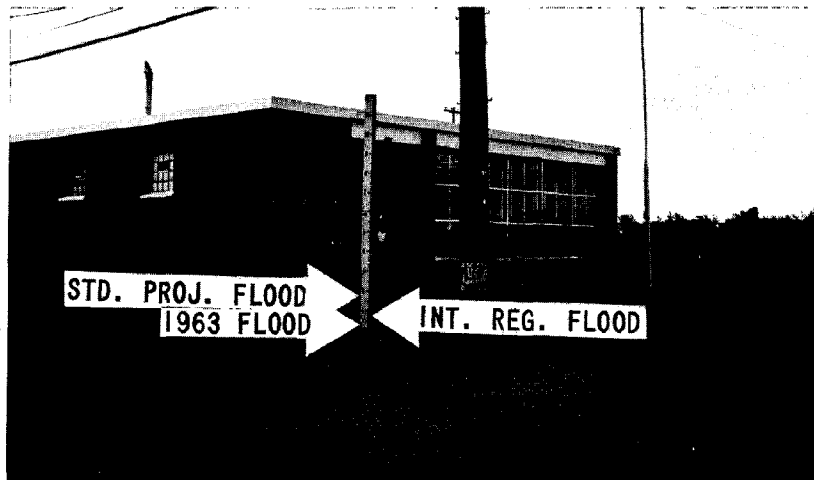
Figure 25. -- FLOOD HEIGHTS AT U. S. POST OFFICE

Although this building was not damaged by the 1963 flood it is vulnerable to the design floods of the future as shown on this photograph.

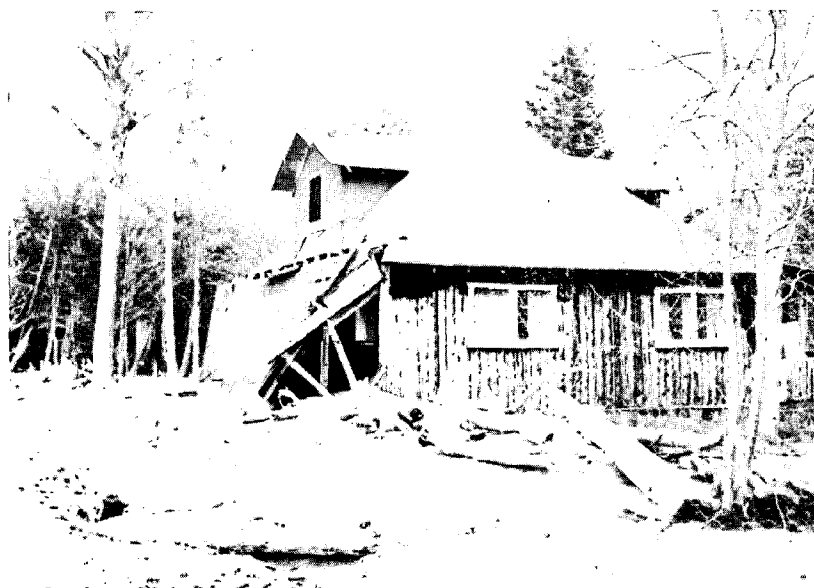
Figure 31. -- PROPERTY DAMAGE - REACH NO. 4

Reach No. 4. This reach extends from the rocky point on the east bank of the Little Iron River to another rocky point 1,800 feet east. Shoreline recession is active here. Several houses are threatened; at least two may be destroyed in the near future. The extent of erosion is depicted by the accompanying photograph (Figure 31) which was taken along Reach No. 4.

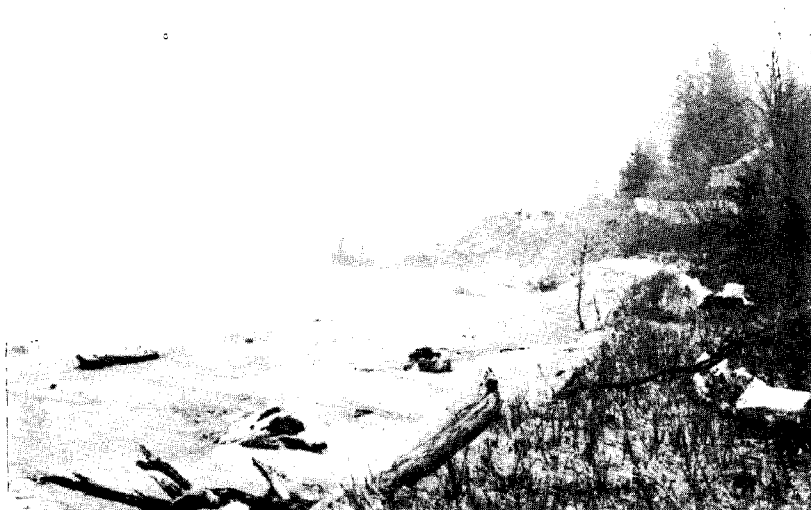
Figure 46. -- LOCAL SHORELINE PROTECTION - EASTERN REACH NO. 16

The remains of an old pier lie 1,000 feet west of Township Park. Between this pier and the park, a house has been protected by a short seawall constructed of broken concrete, brick, stone, and concrete filled tires with two short 10-foot groins constructed of old tires and piles (see Figure 46). The shoreline has receded 15 feet on the west side and 20 feet on the east side of the seawall. While the seawall is holding fairly well, extensions will be required along the sides in addition to periodic maintenance.

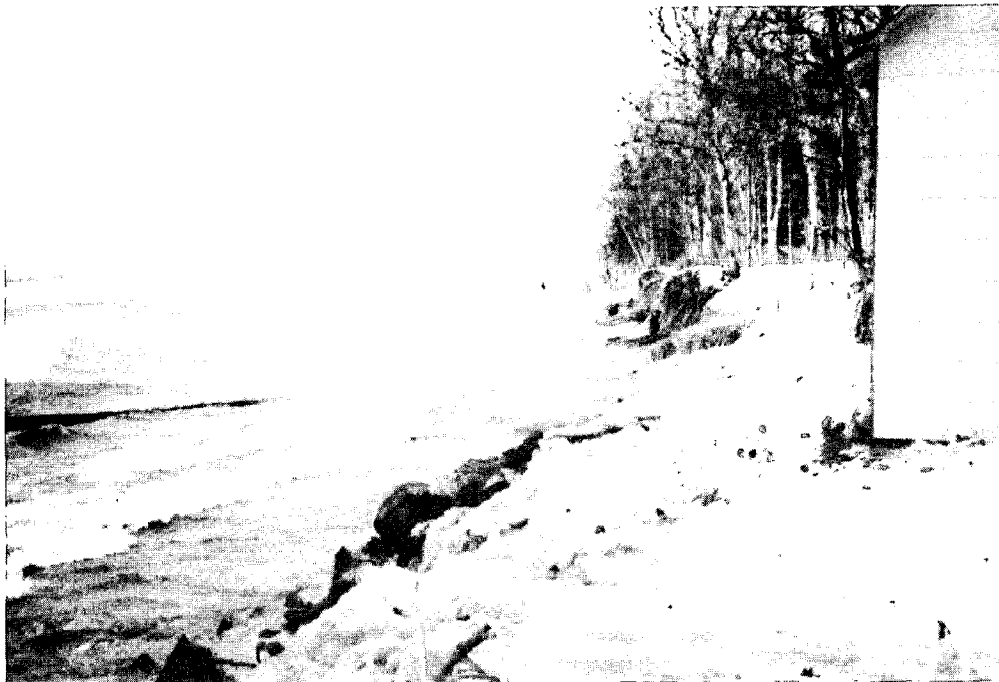
Figure 66. -- SHORE EROSION SCENES IN ONTONAGON COUNTY - DECEMBER 1968

Top photograph was taken at the Kirouac property at Green. Lake Superior has gouged deeply into this property and has undermined several cottages as well as destroyed trees. Lower view shows Lake Superior shoreline threatening a building approximately four miles west of Ontonagon.
