# Monitoring Bluff Erosion Along Pennsylvania's Portion of the Lake Erie Shoreline

Prepared by  
Paul D. Knuth  
Richard Lindenberg, Ph.D.  
Edinboro University of Pennsylvania  
Institute for Research and Community Service

October 30, 1995

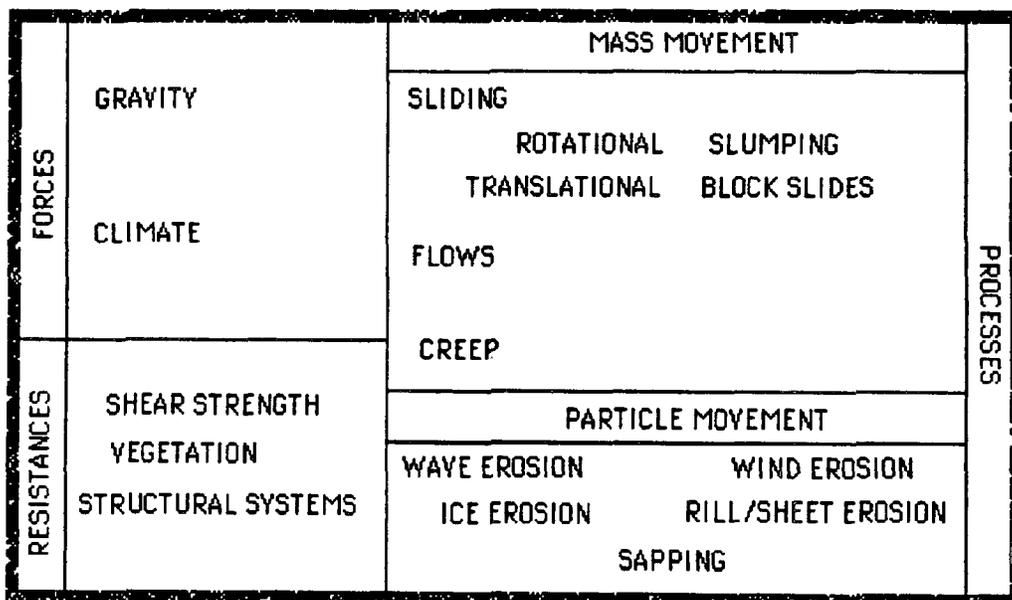
The following diagram illustrates the relationship of terms used in discussing mass wasting as a concept.

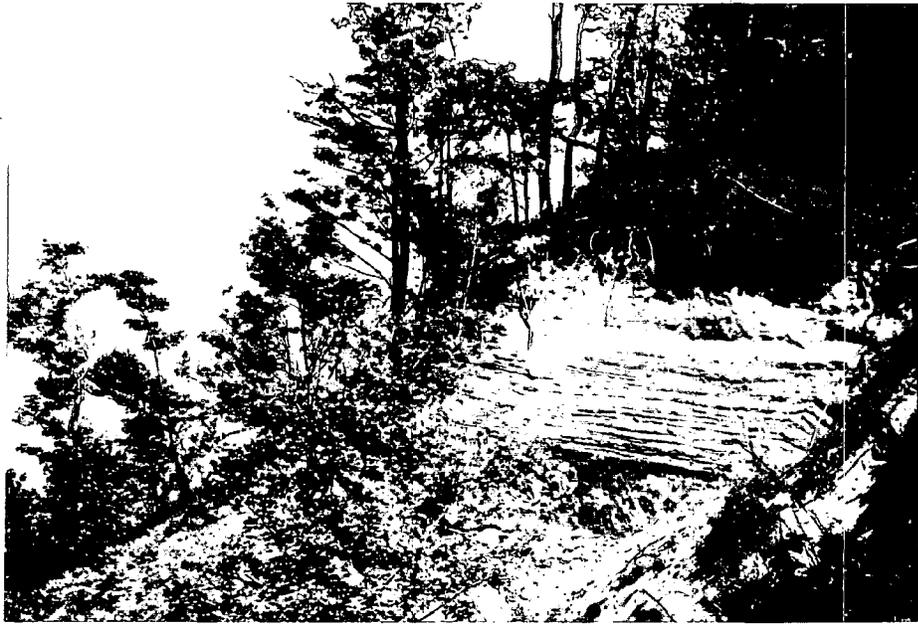
### Photo # 3

This is a steeply sloping bluff viewed from just offshore of control point number 7.0. The bluff face is linear because the till layers are retreating along a parallel plane. If the lower layer were less resistant to erosion the bluff would be far steeper. If the upper layer were more erodible, the slope angle would be steeper in the upper slope, less steep in the lower slope producing a compound slope angle. The large rocks are eroding out of the lower till layers.

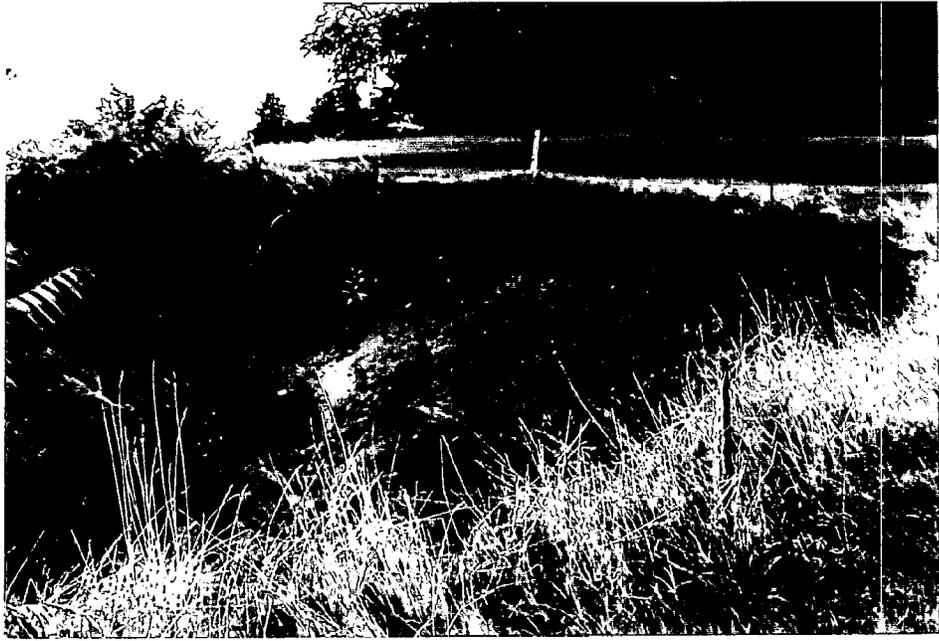
**Photo # 4**

A view east from control point number 13.0. This is a complex, high bluff prone to rapid recession. Most of the recession in this reach extending from Elk Creek to Crooked Creek is in the form of large slump blocks. The sandy layer on top of the till loses shear strength as the tills are eroded by sheet and flow wasting. Thirty feet of recession has been measured in these bluffs over a recent four year time span. These sands are reminders of post glacial lake levels.

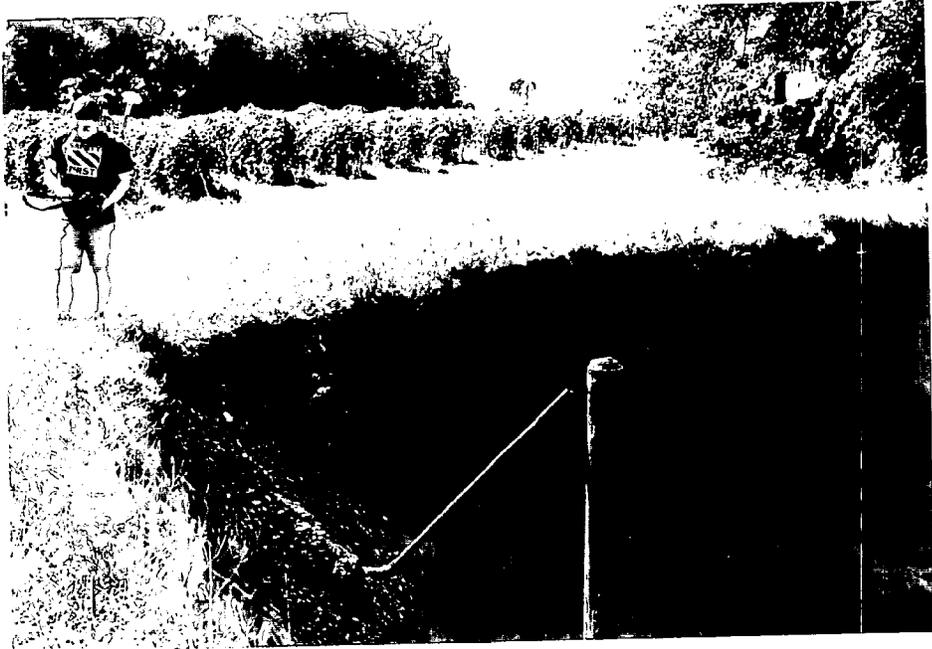
**Photo # 6**

This is a view from just offshore of control point number 4.0. Rapid recession in these till/lacustrine bluffs is evident by the steepness of the slope angle, the linear face of the bluff, and the absence of vegetation.

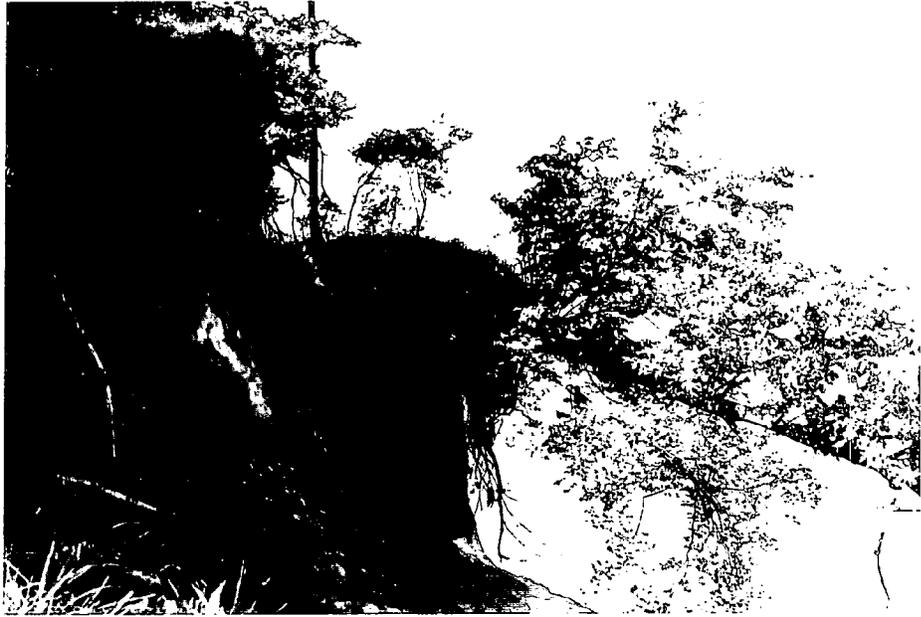
**Photo # 7**

These arcuate forms are produced in otherwise linear bluffs usually in the presence of a highly localized causal factor. These forms are found where drain pipes from home construction are laid to the bluff edge. They can also be produced by groundwater piping at the base of the layer. Large amounts of material are associated with these events which can be sudden and dramatic. After the initial event these forms tend to stabilize for long periods of time.

An excellent example of the above. This is a view of the control point at site 59.0. A gas well and associated pipelines has caused the loss of a considerable amount of bluff in a highly localized event.

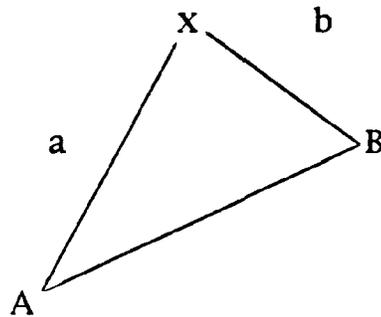
If the marker is located on a developed property it is found by trilateration using easily located landmarks. For example, Control Point Number 25 is found by:

- A= the westernmost corner of the structure
- B= the easternmost corner of the structure
- a= distance A to the control point
- b= distance B to the control point

For trilateration methodology to work, only two measurements are needed. Trilateration works best when the angle produced between the two coordinate bearings is close to ninety degrees. Three people are required. Hold the "0" end of the tape against each respective landmark, and pull the tapes each to the appropriate

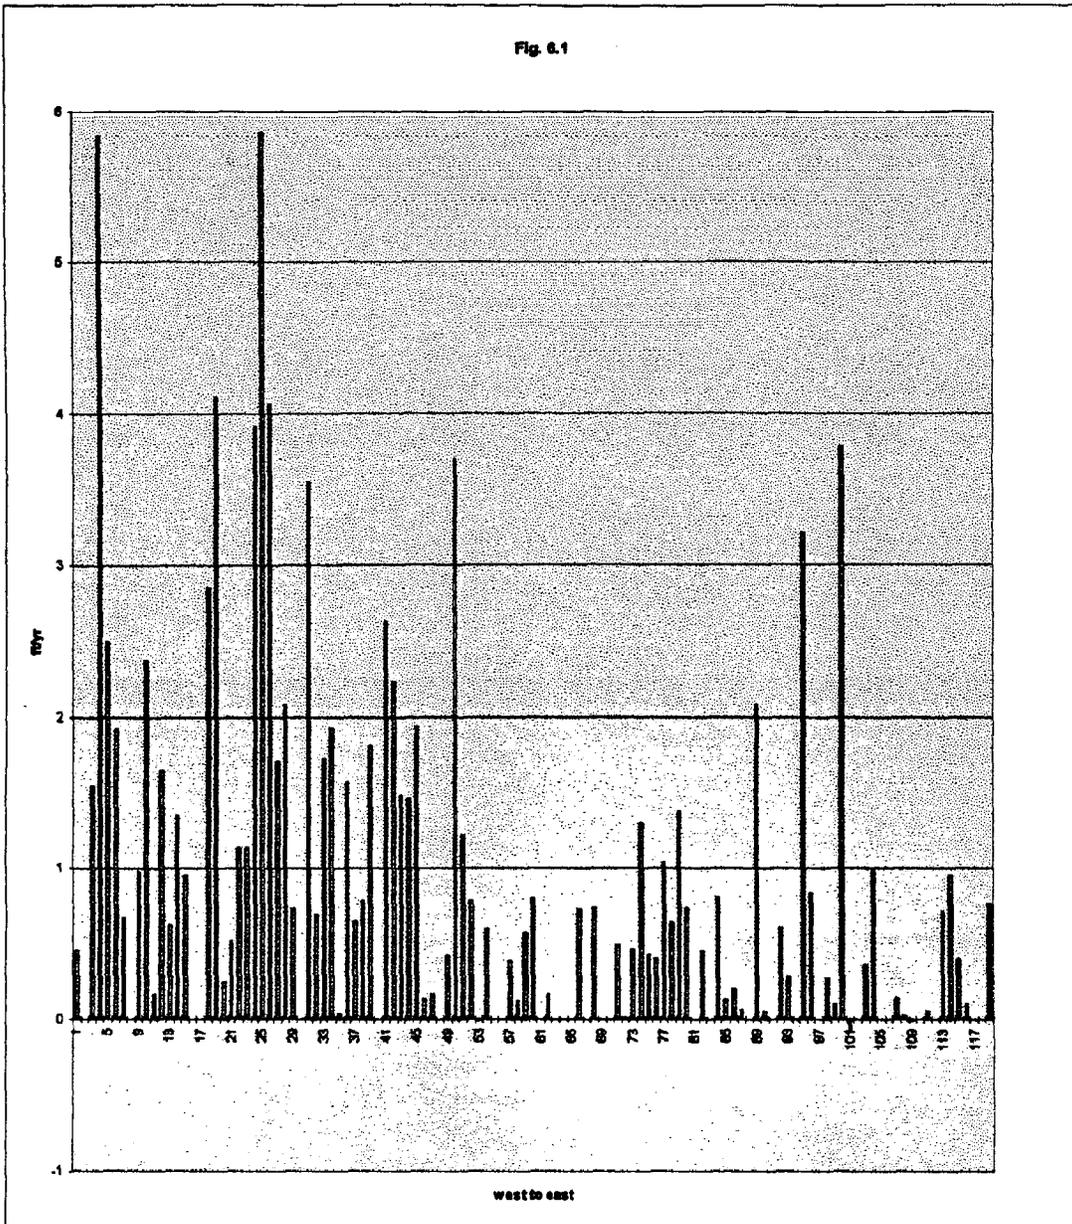
Fig. 6.1

Recession Rates in Ft/Yr

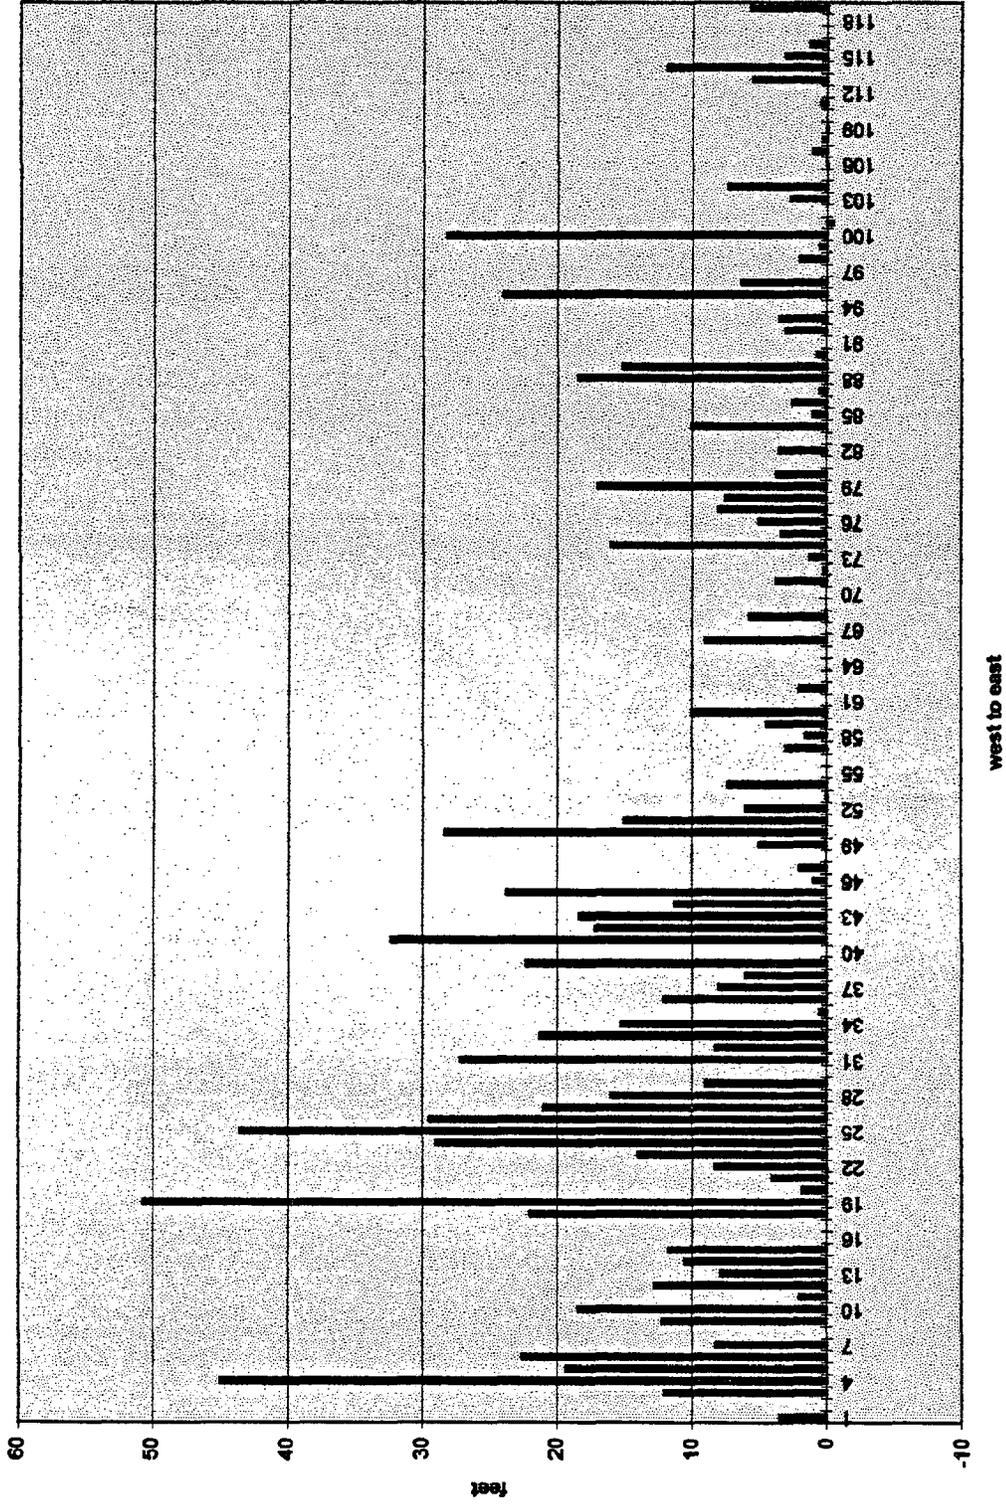
Fig. 6.3 Recession

Recession in Actual Amount of Loss in Feet
