PREPARED FOR THE ALABAMA DEVELOPMENT OFFICE  
AND THE ALABAMA COASTAL AREA BOARD  
BY THE GEOLOGICAL SURVEY OF ALABAMA

# Shoreline and Bathymetric Changes —In the Coastal Area of Alabama

A Remote-Sensing Approach

Geological Survey of Alabama  
University, Alabama  
June 1975

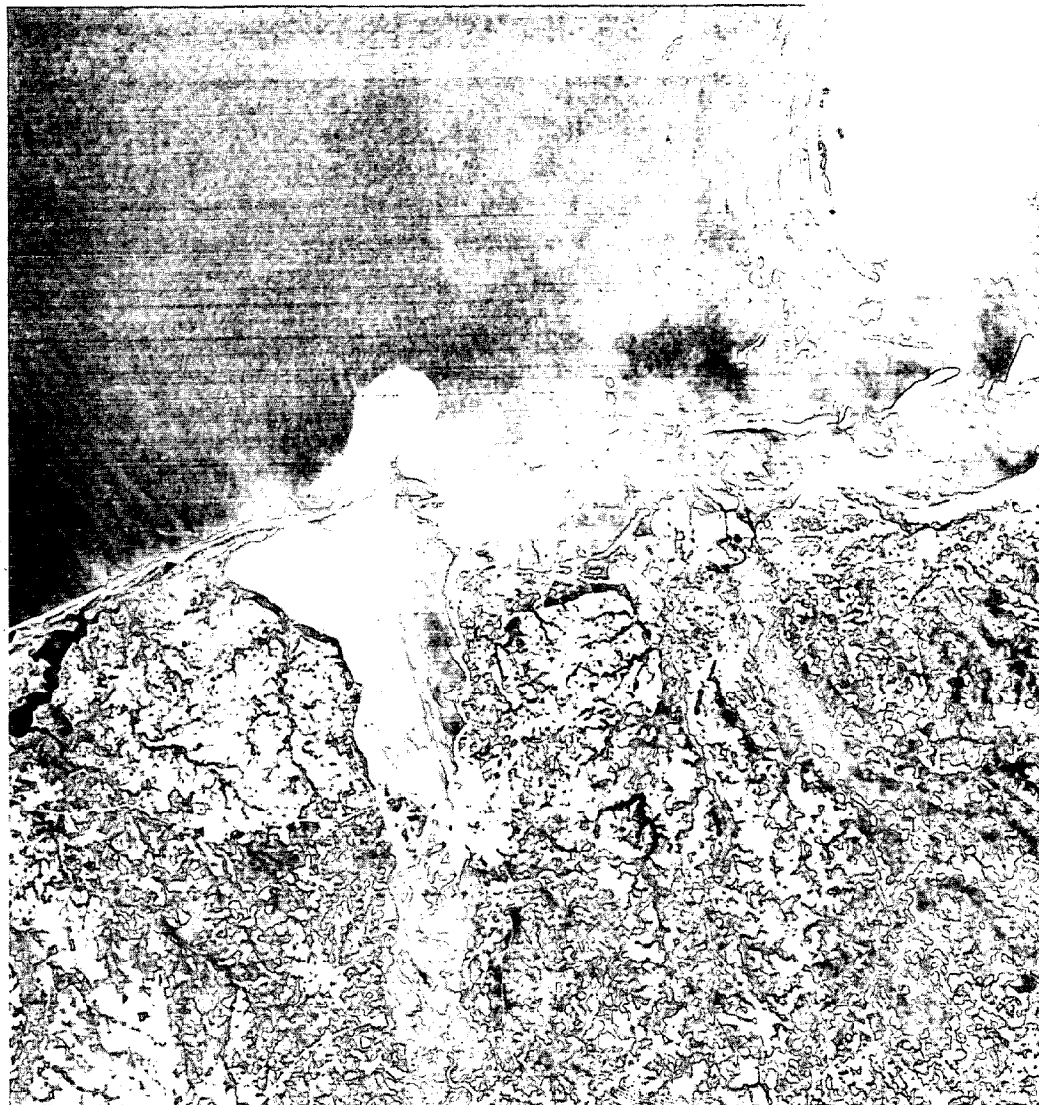
Figure 8. --Landsat-1 band 5 scene taken on November 12, 1974, over Mobile Bay. Unusual sediment patterns appear higher on the eastern side of the bay instead of the western part. High amounts of sediment transported by the Mississippi River appear off the west side of Chandeleur Island. Also well outlined is the concentration of suspended sediment on the northern side of the Mississippi Sound Islands, which supports Austin's results on the circulation pattern.

Suspended sediment transported by streams and rivers is quite visible on Landsat imagery and can be easily traced in the sea. For example, the Landsat-1 band 5 image of November 12, 1974 (fig. 8), illustrates very nicely the sediment plume extending approximately 20 km (12 mi.) into the Gulf of Mexico. This image is of particular interest because the ship channel forms a boundary between the heavily sedimented eastern part of the bay and the less sedimented western part of the bay. Such a pattern is contrary to the findings of previous studies on circulation patterns within the bay; however, it probably resulted from unusual conditions because patterns on most other Landsat-1 images seem to follow the earlier findings. Noted also on this November 12 image is a large amount of sediment off the Mississippi

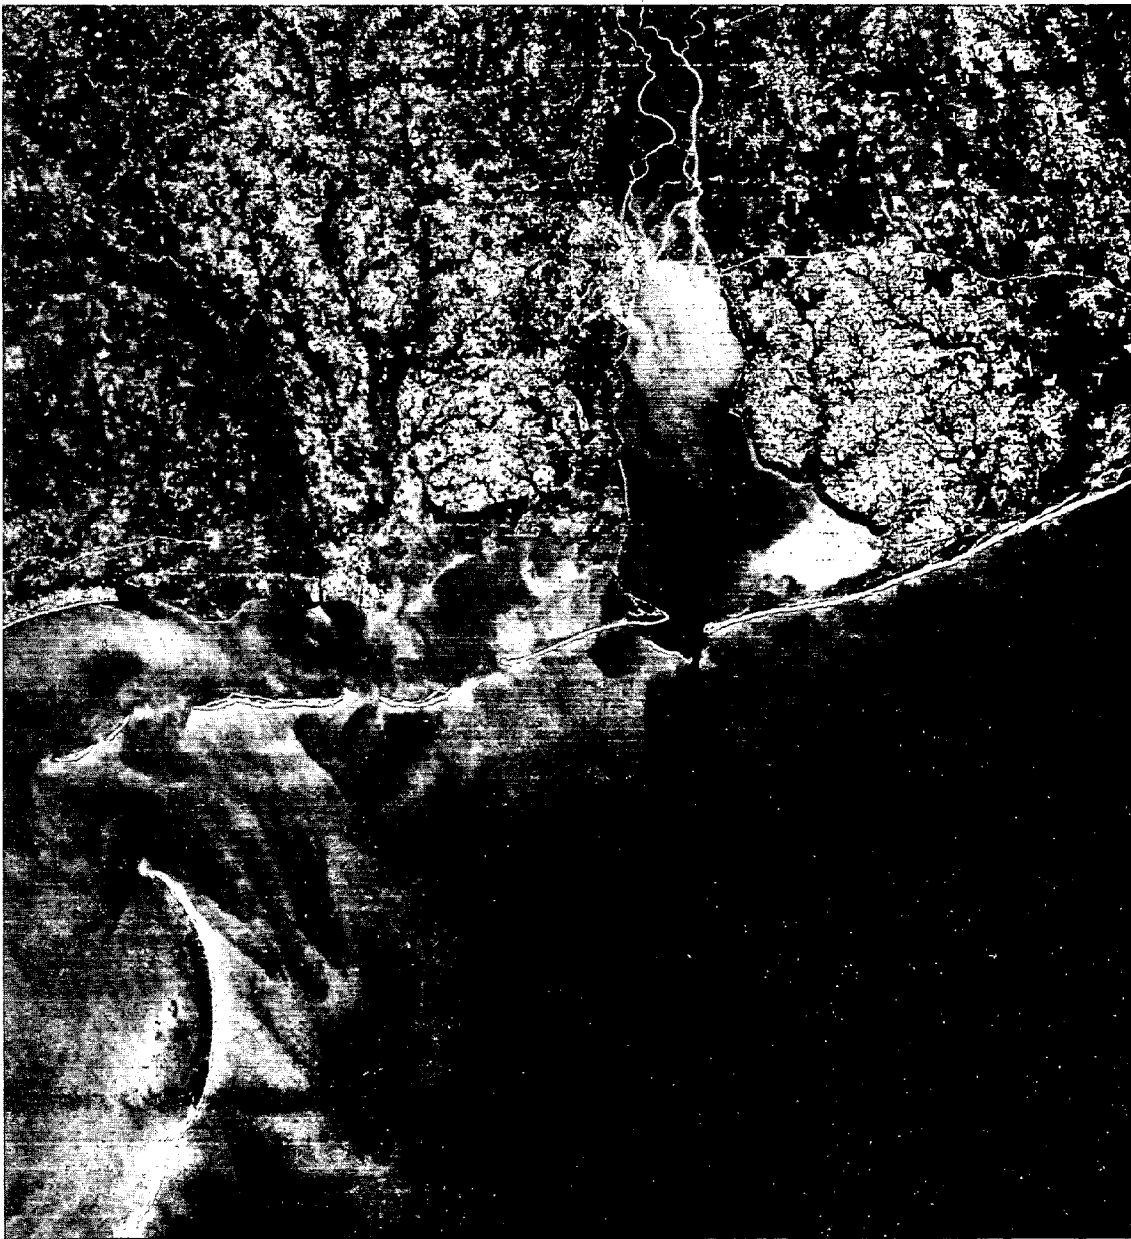
Figure 9.--Landsat-1 band 5 scene taken on December 5, 1973. The image displays large amount of suspended sediment detectable as far as 100 km (60 mi.) southeast of the Mississippi River delta.

From the Skylab and Landsat-1 scenes, several observations concerning suspended sediment can be made: 1) suspended sediment is clearly visible on the imagery; 2) the amount of sediment is usually associated with the discharge characteristics of the Alabama - Tombigbee Rivers; 3) the boundaries between sedimented and less-sedimented waters can be drawn as far as 100 km (64 mi.) out into the Gulf of Mexico; 4) there is a definite sedimentation concentration on the

northern side of the Mississippi Sound Islands. This represents not only discharge of sediment by other streams, but also confirms Austin's study stating that about 15 percent of the sediment from Mobile Bay flows through the Mississippi Sound outlets; 5) general patterns in the current directions can be inferred; 6) the long-shore westward current is detectable on most of the imagery. For sediment studies, band 5 (red) Landsat-1 imagery is found to be the best for the detection of sediment distribution patterns.

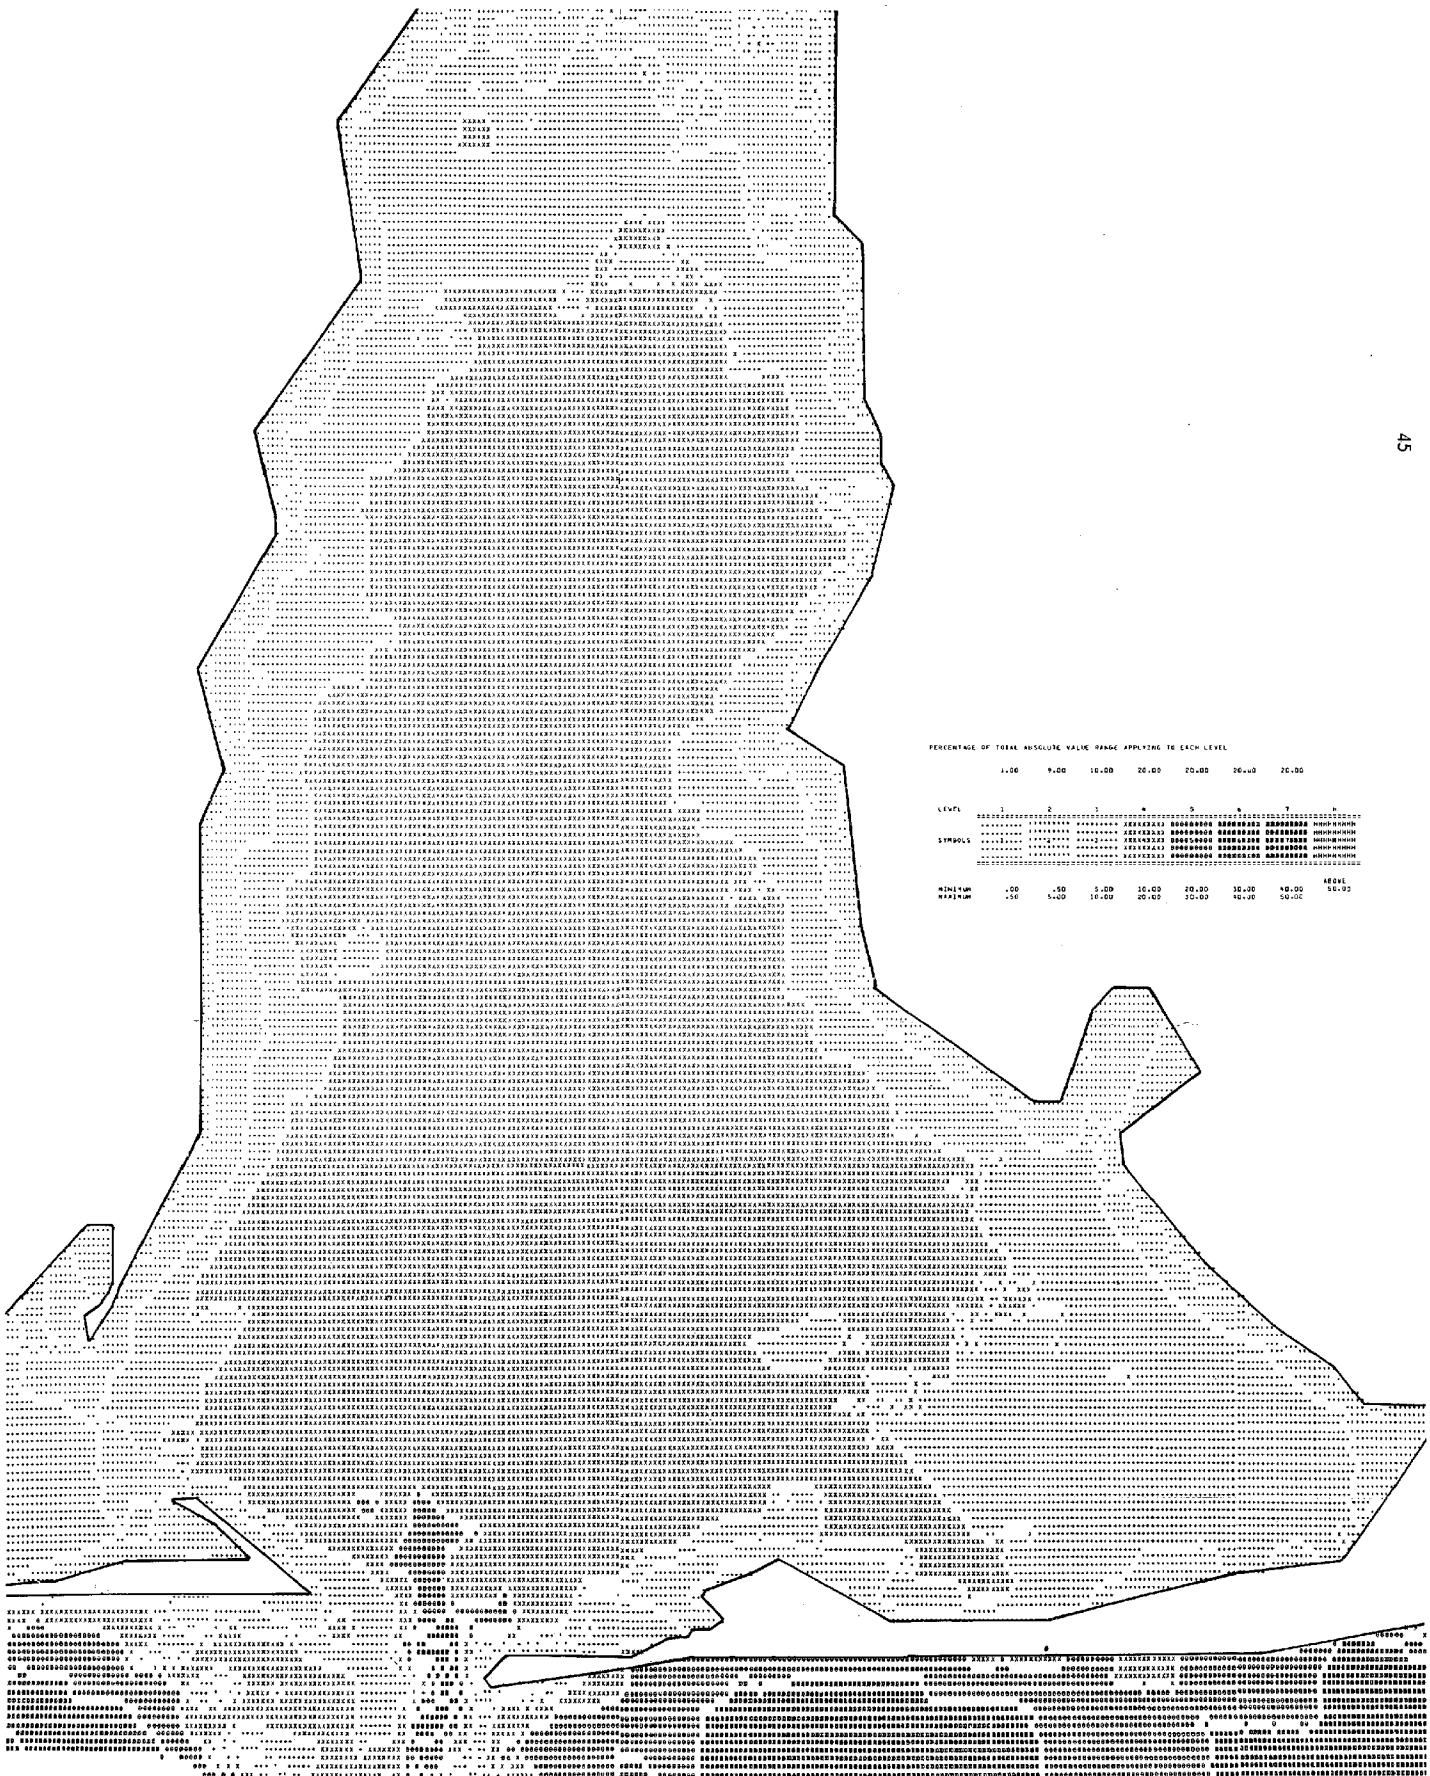
Figure 12. Mobile Bay bathymetry 1852
