PHASE I REPORT:

[TOPOGRAPHICAL SURVEY AND
HYDROLOGICAL ANALYSIS

WALLIS SANDS AND
PHILBRICK BROOK MARSHES

THE TOWN OF RYE, NEW HAMPSHIRE

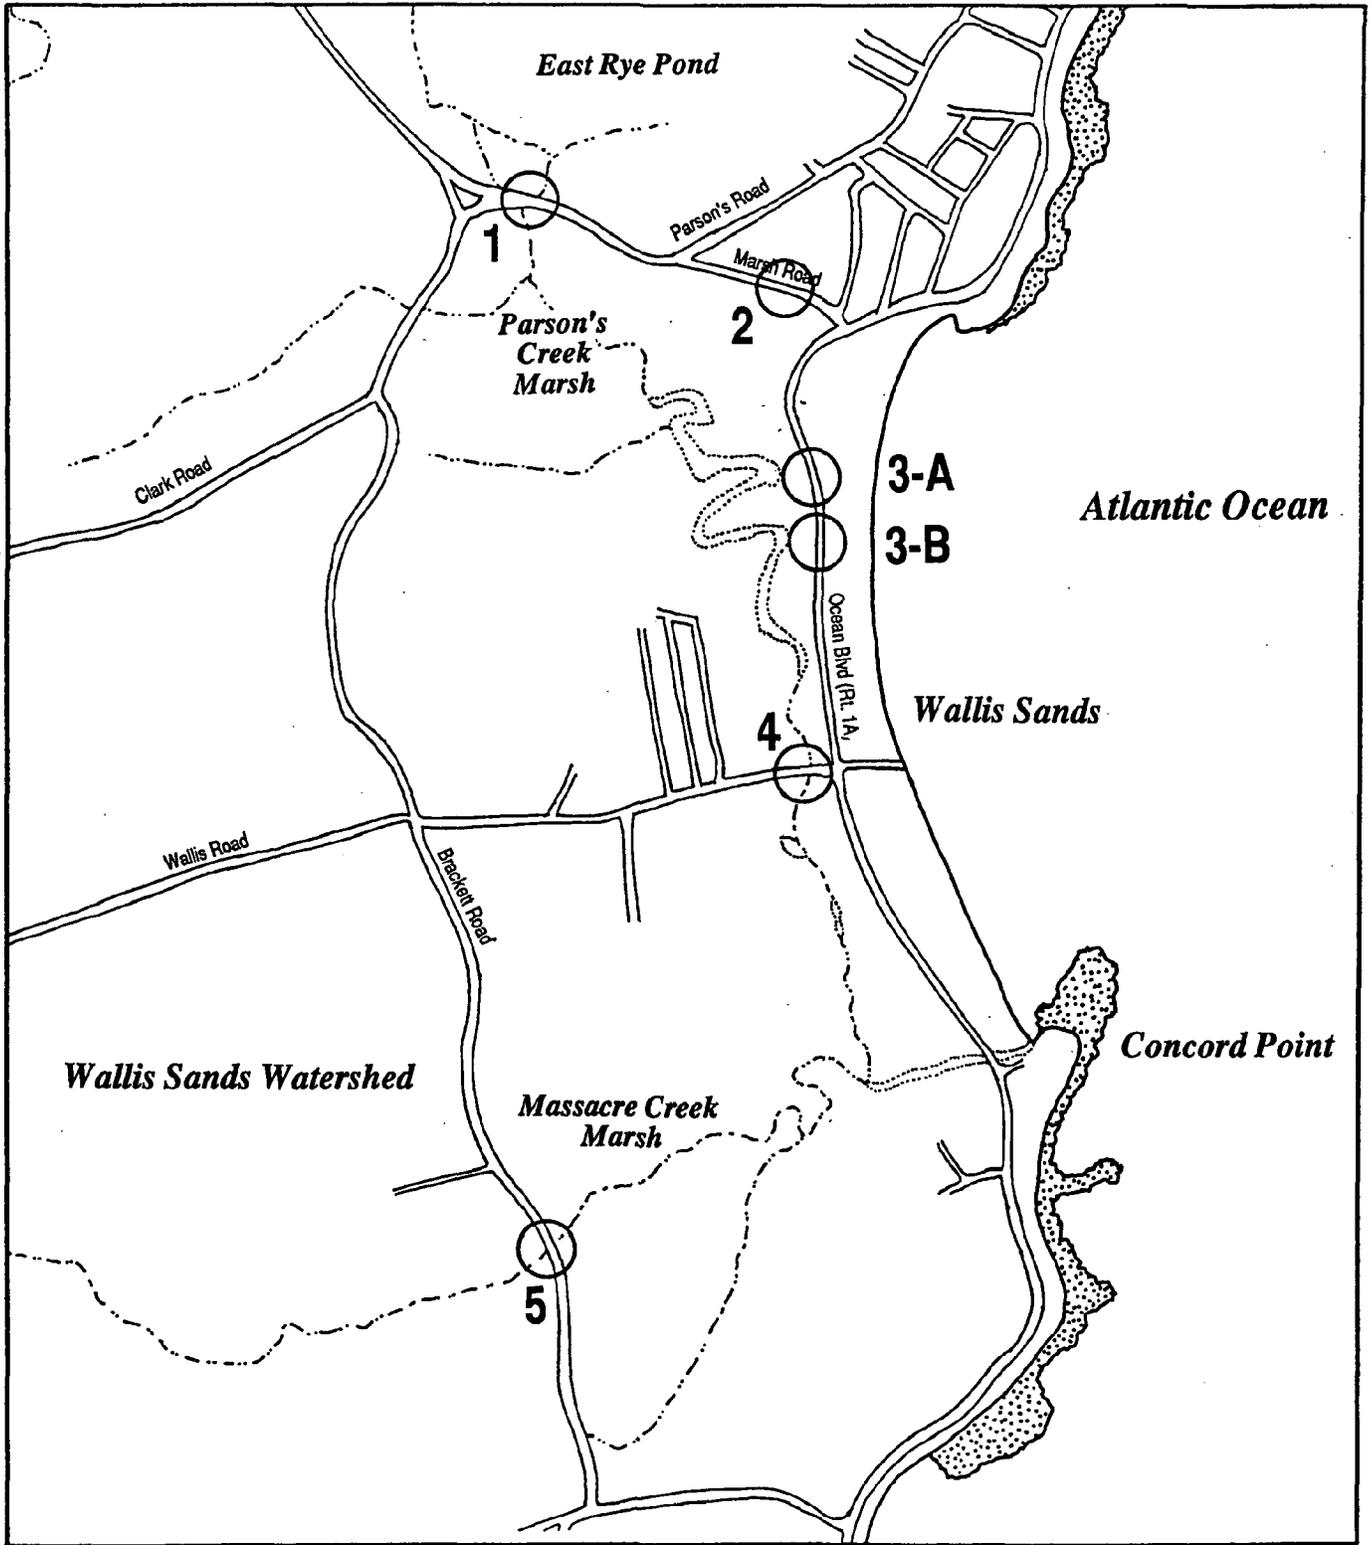
Map 1. Wallis Sands Study Area. Points examined for tidal restrictions are circled and numbered.

Existing drainage features of the Wallis Sands marshes include the Concord Point outlet, the tidal portions of Parson's and Massacre Creeks, and a network of deteriorated mosquito ditches (Map 1). Points of suspected tidal restriction that were examined for this study are described below.

Concord Point Outlet - This channel provides regular exchange of tidal water for the entire Wallis Sands marsh system. At the Concord Point Bridge the channel measures 39 ft. wide with a bottom profile ranging between 0.96 and 2.91 ft. N.G.V.D. No restriction of tidal flow was observed at the bridge abutment. Minimum water levels in the channel are controlled by bedrock outcrops seaward of the bridge at approximately 2.4 ft. N.G.V.D., or 6.5 ft. above local mean low water (MLW). Previous reports (Simpson 1986, NAI 1986a, NAI 1986b) have indicated that the seaward channel is artificially high due to portions of a sunken barge blocking the natural drainage pathway. The significance of the channel's present configuration to marsh hydrology will be discussed in Section 3.3, Hydrological Analysis.

Recommended drainage improvements to increase tidal circulation in the Wallis Sands marsh focus on the removal of obstructions along the main channel of Parson's Creek in the vicinity of Wallis Road. Second in priority is improvement of the tidal channel at Concord Point, although this may not be an option for reasons discussed in Simpson (1986). Improvements to culverts and ditches that connect Parson's Creek to small marshes isolated by road crossings are also recommended. Though less critical to the overall restoration process, improved drainage of the small peripheral marshes will increase stormwater runoff capacity during flood events.

Parson's Creek - Removal of obstructions and channel enlargement are recommended from the Old Wallis Road roadbed north to the vicinity of the Horse Paddock. Highest priority should be given to the Old Wallis Road roadbed, which should be removed from the creek, with the channel improved to conform with surrounding dimensions. Shallows in the vicinity of Wallis Road are also recommended for dredging to an elevation of approximately 2.5 ft. N.G.V.D. (1.0 ft. below existing grade). Reconfiguration of the channel at the sharp bend south of the Horse Paddock, known as trash corner, is recommended to increase flow and alleviate channel erosion problems. Channel reconfiguration alternatives may include widening the existing channel and stabilizing the creekbank, or straightening the channel by relocating it further west. The exact extent of recommended channel modifications in the vicinity of Wallis Road will be determined during Phase II of the study, in consultation with Town officials.

Concord Point Outlet - Restoration of the Concord Point outlet channel to pre-barge dimensions is recommended for improving tidal flushing of the marsh. The political and biological aspects of this action are discussed at length in Simpson (1986). Detailed review of the engineering of the dredging project is beyond the scope of this study.

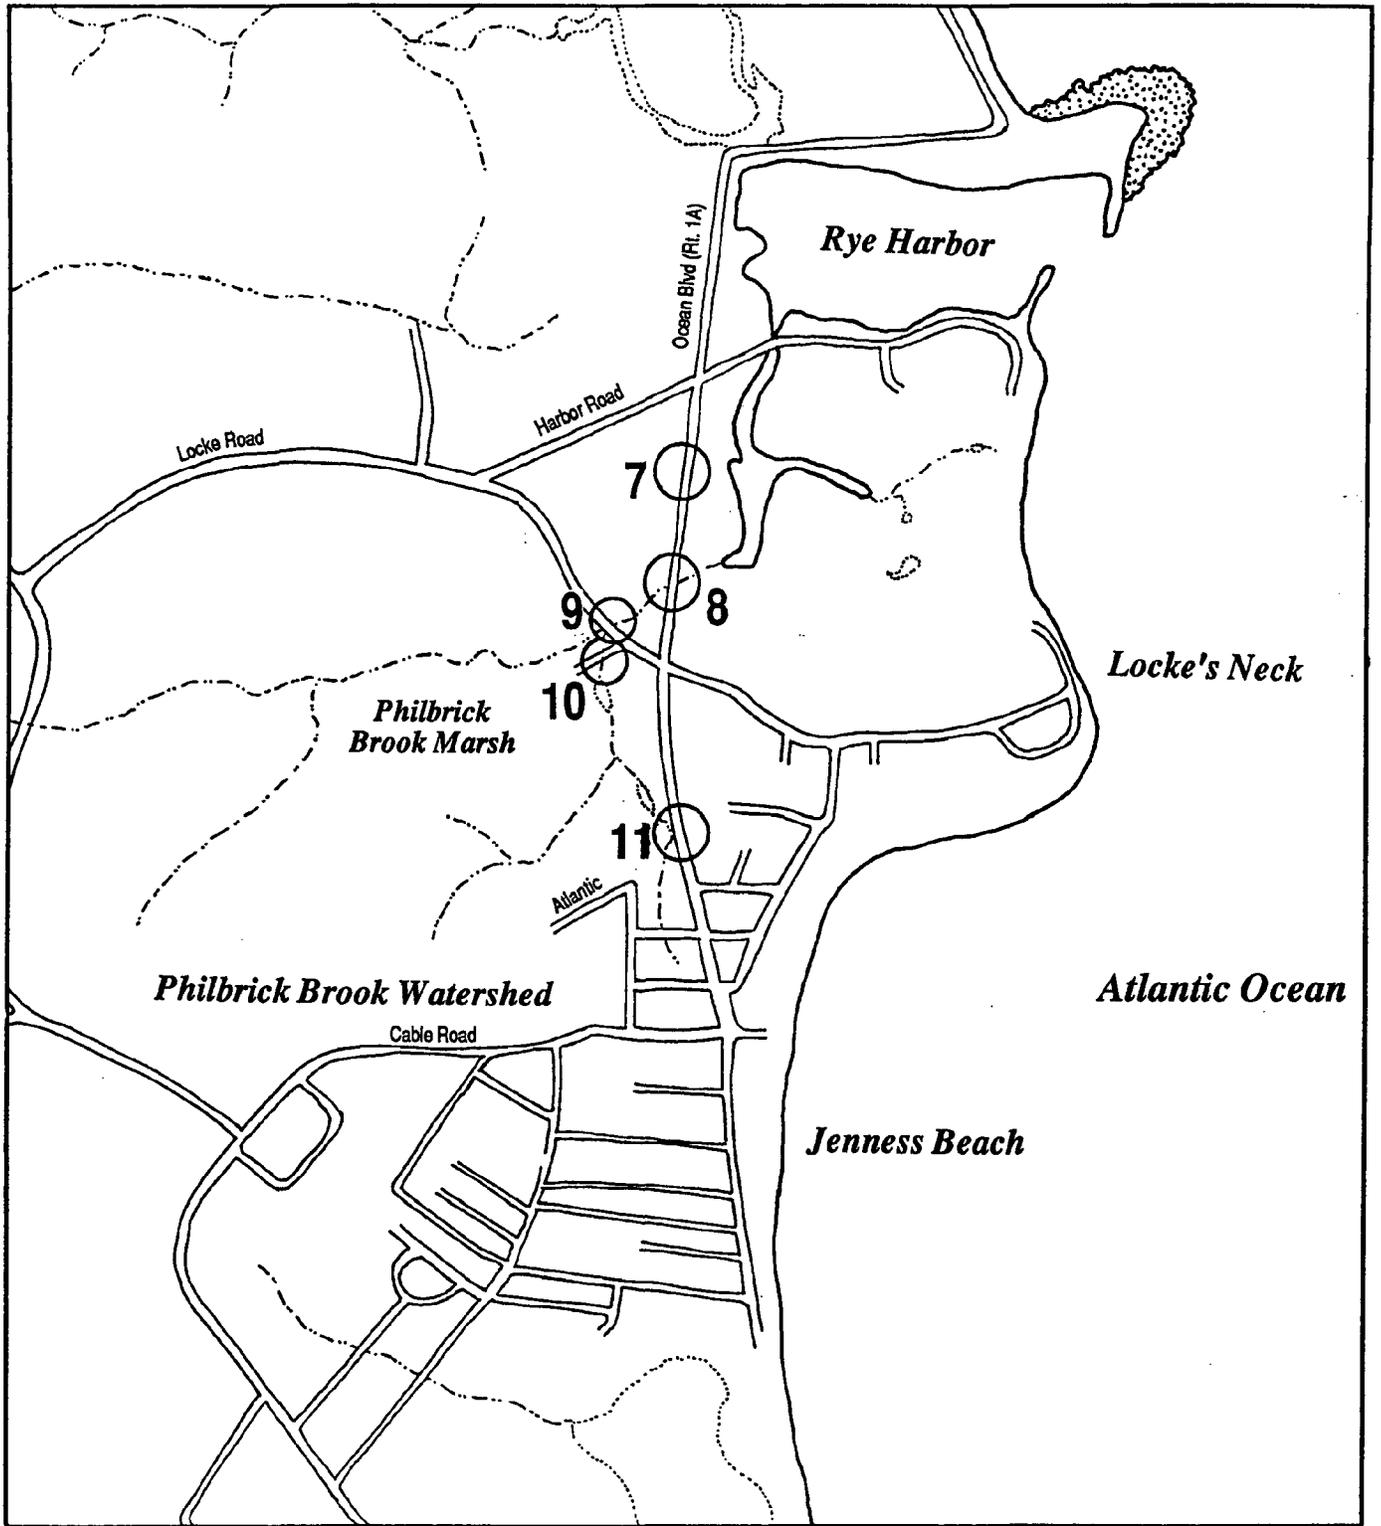
Map 2. Philbrick Brook Study Area. Points examined for tidal restrictions are circled and numbered.

Rye Harbor Outlet - This channel provides tidal exchange for the entire Philbrick Brook marsh system. At the Harbor Road Bridge, the channel measures 19 ft. wide with a rocky, irregular bottom. Measurements of bottom elevations ranged between -2.40 ft. and -0.60 ft. Minor restriction of flow was observed at the bridge abutment, which appears to be in very good condition. Minimum water levels in the channel are controlled by stony-gravelly shoals seaward of the bridge at approximately -1.5 ft., or 2.6 ft. above MLW.

Culvert #7 - This culvert connects the main portion of the tidal marsh with a semi-isolated marsh west of Route 1A just south of the Harbor Road junction. The pipe is 24-inch diameter CMP in good condition, set at invert elevations of -0.44 ft. (east) and -0.57 ft. (west). The network of ditches west of this pipe is showing signs of slumping and deterioration, as described in NAI (1986b).

Culvert #8 - This drainage structure is a sluiceway constructed of granite blocks that passes under Route 1A approximately 850 ft. south of culvert #7. The granite sides of the sluiceway appear to be in good condition, however, the overlying concrete slab is severely deteriorated particularly at the east end. The channel measures approximately 40 inches wide, with a rocky, irregular bottom at about 2.37 ft. The bottom is elevated at this point relative to the Rye Harbor outlet

Culvert 9 - This 36-inch CMP hydraulically connects salt marshes on either side of Locke Road, and is situated upstream of culvert #8 in the primary Philbrick Brook drainage. The pipe, though set too high, appears to be in very good condition with invert elevations of 2.39 ft. (north) and 2.87 ft. (south). The pipe is set in a granite stone abutment.

Culvert #10 - This 30-inch CMP passes under a private drive just south of culvert #9 along the main Philbrick Brook channel. Invert elevations are 2.98 ft. (north) and 2.97 ft. (south). The pipe appears to be in very good condition.

Culvert #11 - This culvert is located south of the junction of Locke Road and Route 1A, and north of the junction of Atlantic Avenue and Route 1A. This culvert connects the main branch of Philbrick Brook salt marsh to a small, isolated brackish marsh (ca. 4.2 acres) east of Route 1A. The culvert is 18-inch diameter CMP that is corroded, partially collapsed, and partially clogged with sediment. Invert elevations are 4.37 ft. (west) and 4.22 ft. (east). The west invert is set well above the tidal channel, thus limiting tidal flooding. The

Rye Harbor Outlet - Maintain channel in present configuration or larger. In marsh areas that have been cut-off by old stone walls, extend ditches from tidal creeks into panne areas to restore natural drainage and encourage revegetation.

Culvert #8 - Repair deteriorating sluiceway, especially at east end where collapse is imminent and potentially hazardous. Breach old stone walls on both sides of the creek upstream of culvert #8. Extend ditches through breached walls to restore natural drainage and encourage revegetation.

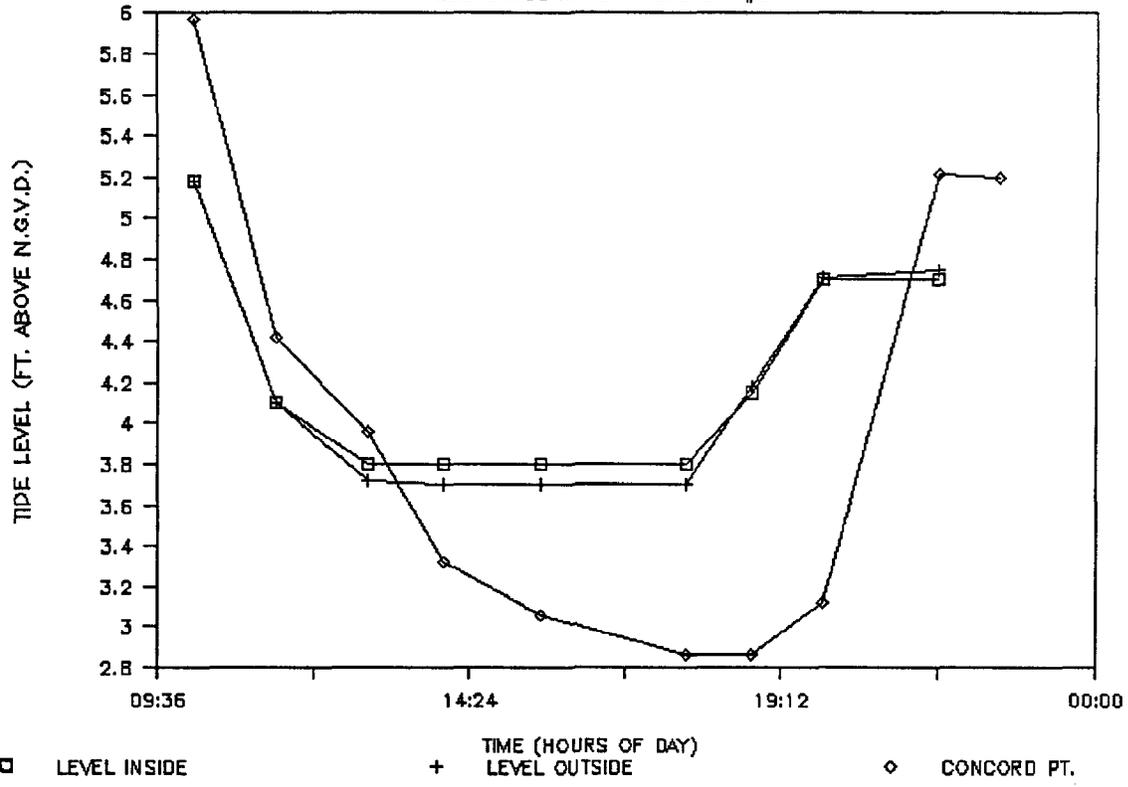
FIGURE 1

good tidal flushing, as evidenced by the relatively lush and even growth of high marsh grasses. Culvert #5 is 30-inch diameter corrugated metal pipe (CMP), approximately 30 ft. long, set at an invert elevation of 3.5 ft. (pipe is level). The culvert appears to be in very good condition and, though set a little high, very functional.

WALLIS SANDS MARSH: CULVERT #5

Culvert #5 - There is no immediate need to replace this culvert for tidal restoration purposes. In the normal course of maintenance, it is recommended that a replacement structure of similar size be set approximately 0.5 ft. below the invert of the existing culvert.

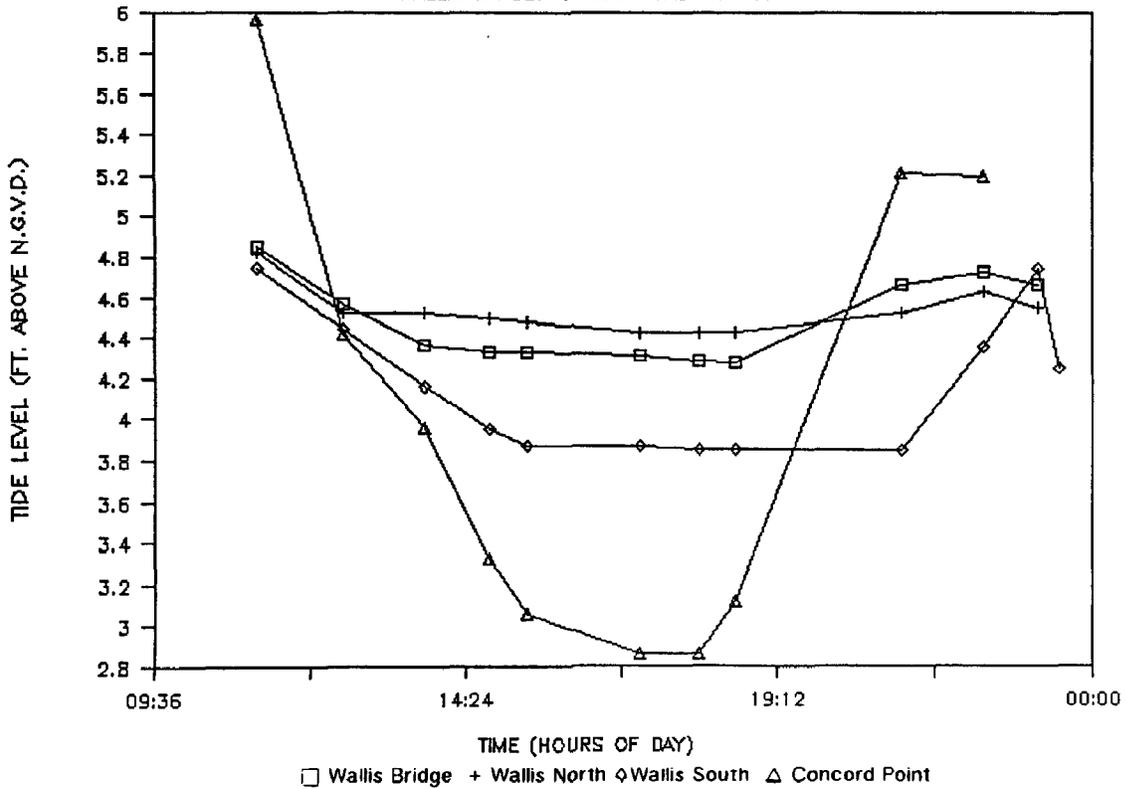
FIGURE 2

Wallis Road Vicinity - Water levels were monitored in the vicinity of Wallis Road at three stations: 1) Wallis South, located in a wide portion of the channel roughly 400 ft. south of Wallis Road; 2) Wallis Road at the bridge over the creek; and 3) Wallis North, located near the Horse Paddock roughly 350 ft. north of Wallis Road. Water level data indicate continuous restriction of flow along this channel due to inadequate channel dimensions (Figure 2). Debris clogging the channel further restricts flow. Tidal amplitudes for the three stations are as follows:

WALLIS SANDS: WALLIS ROAD VICINITY

The inadequacy of the tidal creek in this vicinity is compounded by the remnants of the Old Wallis Road roadbed about 300 ft. south of the Wallis South staff. Large stones blocking the creek channel at this point effectively form a dam, the overflow elevation of which is approximately 3.8 ft. Outflow is severely restricted at this point, with water levels below the dam having several times the amplitude observed above the dam. Though no water level staff was placed directly below the dam, the low tide water level was observed to drop approximately 1.5 ft. below dam level, or to approximately 2.3 ft. N.G.V.D., on 16 March. The Old Wallis Road roadbed is the single most restricting feature along Parson's Creek.

Further restriction of flow occurs north of Wallis Road in the vicinity of the Horse Paddock and "trash corner" (Simpson 1986), where a sharp bend in the channel is eroding fill along the bank of an abutter's property. Bank stabilization attempts are evident in the form of boards, cable, and other debris, but are apparently only partially effective. Trash corner is located on the outside curve of a sharp bend and strong currents, especially during outflow, undermine stabilization attempts.

Finally, shallows in the immediate vicinity of Wallis Road cause flow restriction. Bottom elevations at stations north and south of Wallis Road are 0.5 to 1.0 ft below the invert elevation of 3.6 ft N.G.V.D. at the Wallis Road bridge. These depth changes slow both inflow and outflow.

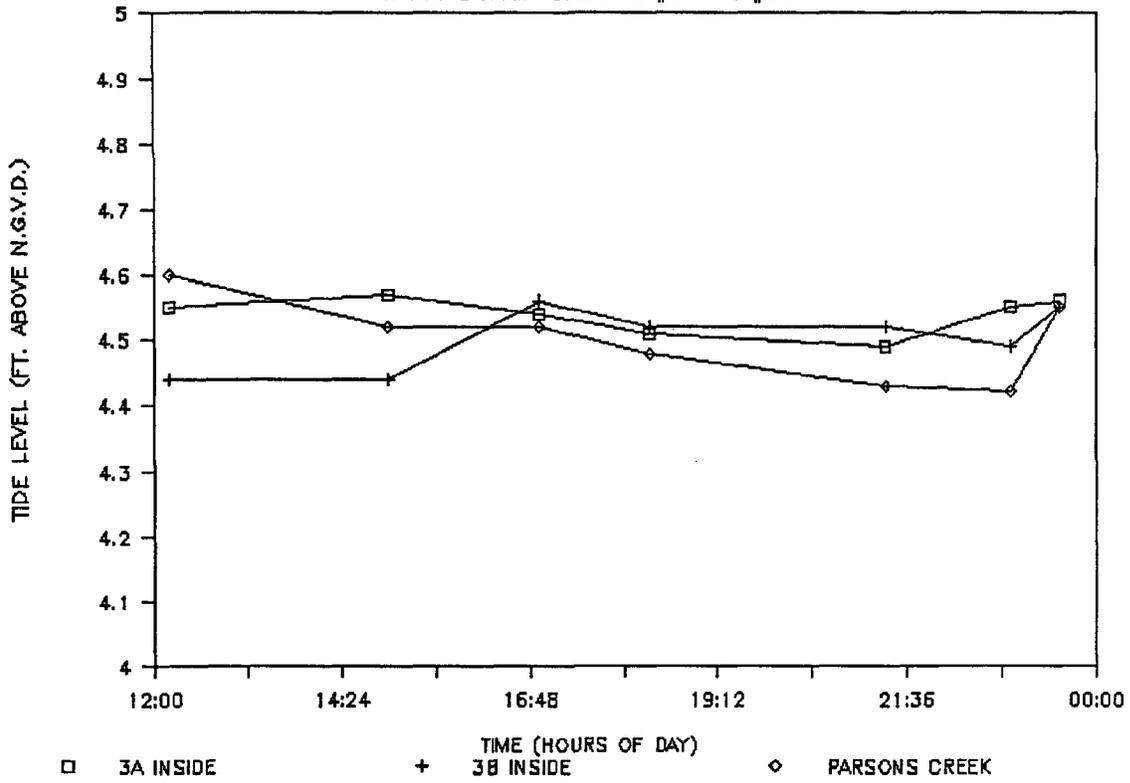
FIGURE 3

Culverts #3A and #3B - These two culverts connect Parson's Creek with a remnant salt/brackish marsh east of Route 1A about 2.6 acres in size. Both culverts are reinforced concrete pipe (RCP) with an internal diameter of 18 inches. The northern pipe, #3A, is approximately 60 feet in length, with invert elevations of 3.28 ft. (west) and 3.52 ft. (east). Pipe #3B, to the south, is approximately 70 ft. long with invert elevations of 3.85 ft. (west) and 3.92 ft. (east). Both culverts appear to be in good condition. Culvert #3A feeds directly into Parson's Creek and thus has good placement for carrying tidal water from the creek to the remnant marsh. On the east side of the road, culvert #3A feeds into an open channel and pond system which facilitate free exchange of water through the pipe. In contrast, culvert #3B has indirect and only semi-functional connection to Parson's Creek, with limited potential for transmitting tidal water.

WALLIS SANDS: CULVERTS #3A AND #3B

Culverts #3A and #3B - Replacement of culvert #3A with a drainage structure of roughly twice the capacity, and improvement of drainage ditches at both ends of culvert #3B are recommended. Self-regulating tide gates are recommended to reduce the hazard of storm surge flooding. These structures are designed to allow free passage of tidal waters during normal tidal cycles. During extreme flood tides, a one-way valve closes over the culvert mouth, thus preventing inflow beyond flood levels. At low tide the valve allows free outflow to drain flood waters, and can be reset manually to allow free-flow (T. Steinke, Town of Fairfield, CT, Conservation Commission, personal communication).

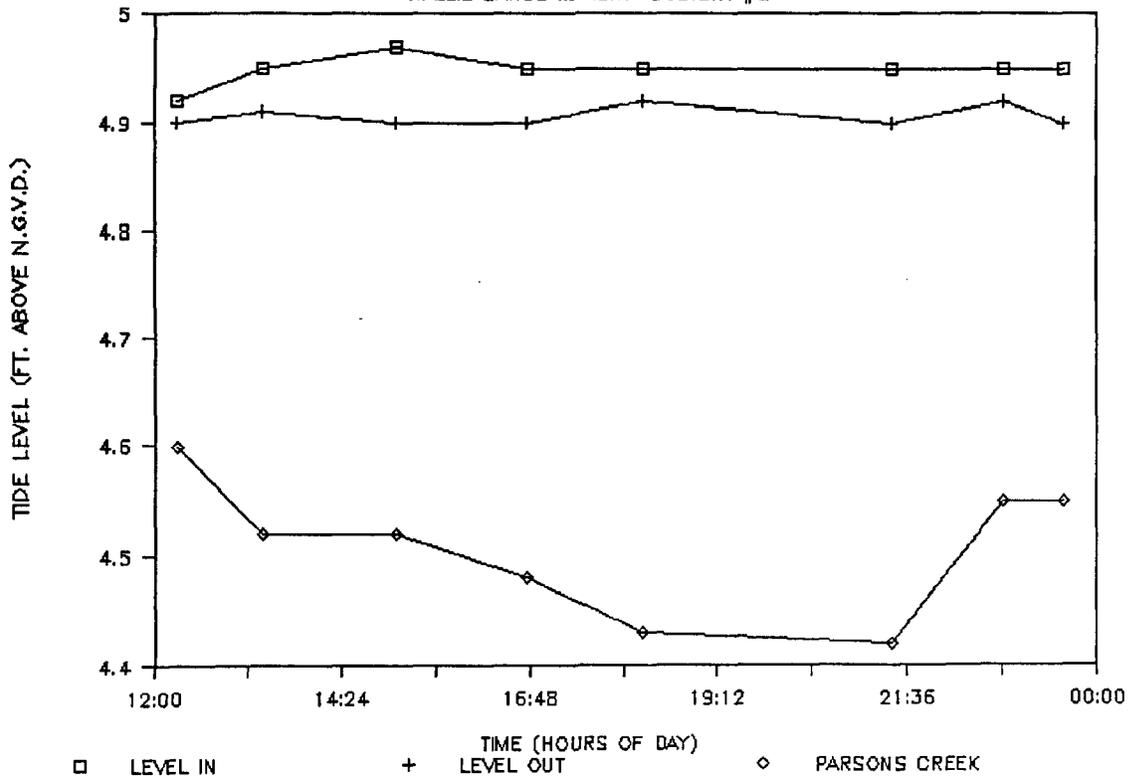
FIGURE 4

Culvert #2 - This culvert connects the northeast section of Parson's Creek marsh to a small brackish marsh (about 6.5 acres) that lies north of Marsh Road. The culvert is 18-inch diameter RCP approximately 40 ft. long. Invert elevations are 3.32 ft. at the culvert's south end and 2.72 ft. at its north end. While the culvert is in good condition, the channels it serves are poorly maintained.

Culvert #2 - Although this culvert is in good condition and functional, very little flow was observed during the survey period. Water levels on either end of the culvert remained nearly constant, and essentially equal (Figure 4). Tidal flow in and out of the small brackish marsh north of Marsh Road is restricted mainly by the lack of a functional channel between culvert #2 and Parson's Creek. Flow between the creek and the culvert must pass through dense vegetation and shallow ditches, and thus shows little response to tide levels. The culvert itself readily equalizes changes in water level, which are due mainly to freshwater streamflow and runoff from the north. Water levels in this vicinity were 0.3-0.5 ft. above levels in Parson's Creek due to flow restriction between the culvert and the creek.

WALLIS SANDS MARSH: CULVERT #2

Culvert #2 - Improvement of drainage ditches and channels south of culvert #2 is recommended. A self-regulating tide gate, to protect against flooding due to tidal storm surge, is recommended for installation at the south end of the pipe.

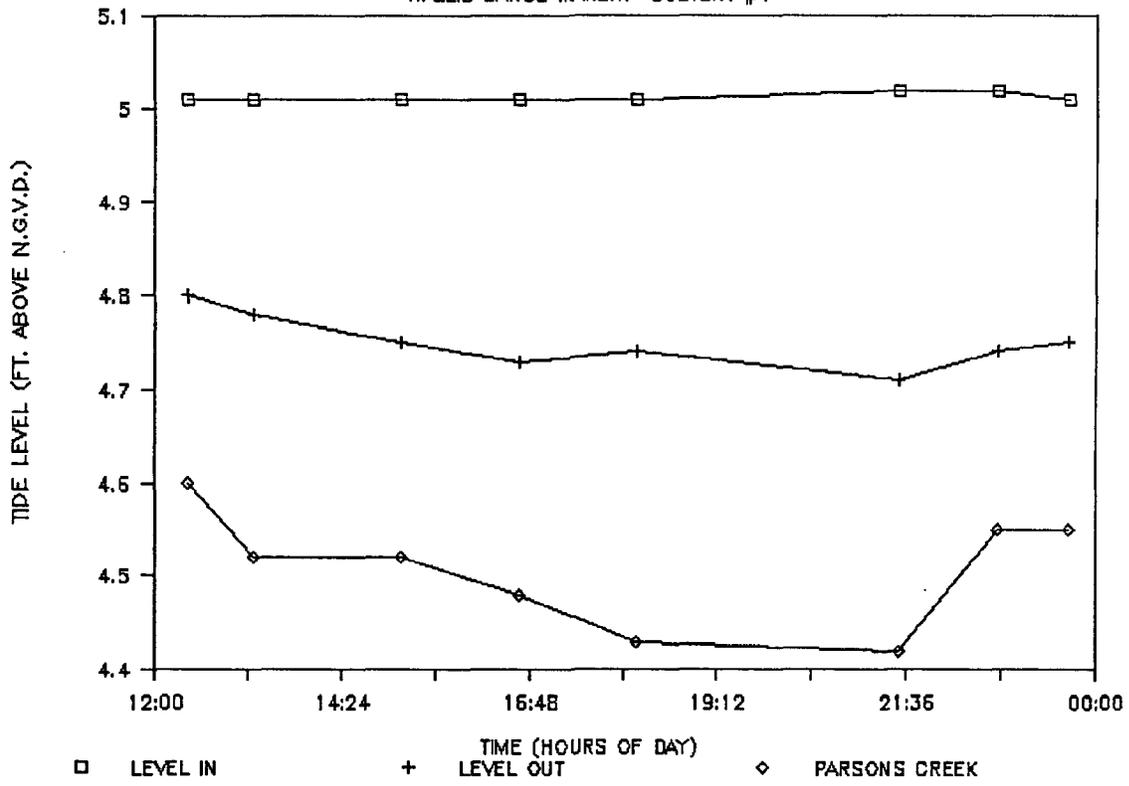
FIGURE 5

Culvert #1 - This culvert connects the northwest section of Parson's Creek marsh to East Rye Pond which lies north of Marsh Road. The culvert is 18-inch diameter CMP, approximately 40 ft. long, and is functional but showing signs of deterioration at both ends. Invert elevations are 3.95 ft. at the culvert's south end and 4.11 ft. at its north end. Flow in this pipe is non-tidal (unidirectional outflow draining East Rye Pond) except during extreme spring or storm tides.

WALLIS SANDS MARSH: CULVERT #1

Culvert #1 - Previous reports have noted that the East Rye Pond area was formerly a high salt marsh community (Simpson 1986, NAI 1986b), that has gradually been converted to a brackish pond by freshwater retention and tidal restriction. Although the present ecological community is artificial in this respect, locally it is relatively rare compared with salt marsh. East Rye Pond provides open water habitat for waterfowl, as well as providing additional habitat diversity for wetland-dependent wildlife. In addition, the pond adds aesthetic value to the area. Complete tidal restoration of East Rye Pond would result in loss of the brackish pond community and its associated values. Therefore, we recommend that East Rye Pond be maintained as a brackish pond, with drainage improvements made to reduce flooding due to stormwater runoff.

Replacement of the existing culvert with larger capacity drainage structures is recommended to improve stormwater runoff. Replacement structures can be set at the approximate elevation of the existing culvert to maintain open water in East Rye Pond, while allowing for rapid passage of overflow during storm events. The low elevation of Marsh Road in this vicinity limits drainage and flood control options, and will be a consideration in designing specific recommendations in Phase II.

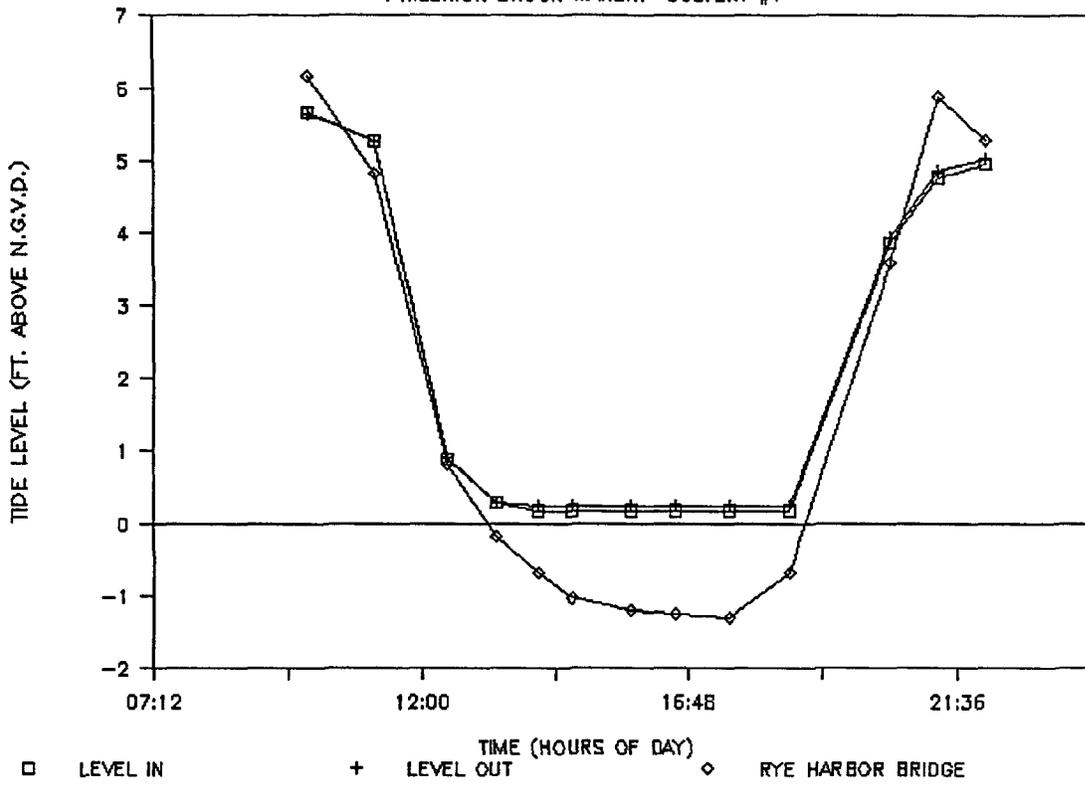
FIGURE 6

Culvert #7 - Water levels measured at culvert #7 are shown in Figure 6. Close tracking of water levels on both sides of the pipe indicate that there is no restriction of flow through the existing channel. The marsh area west of Culvert #7 suffers from the effects of old stone walls and poor infiltration as described above. Unvegetated pannes have formed behind old walls, and peat slumping and erosion are prevalent.

PHILBRICK BROOK MARSH: CULVERT #7

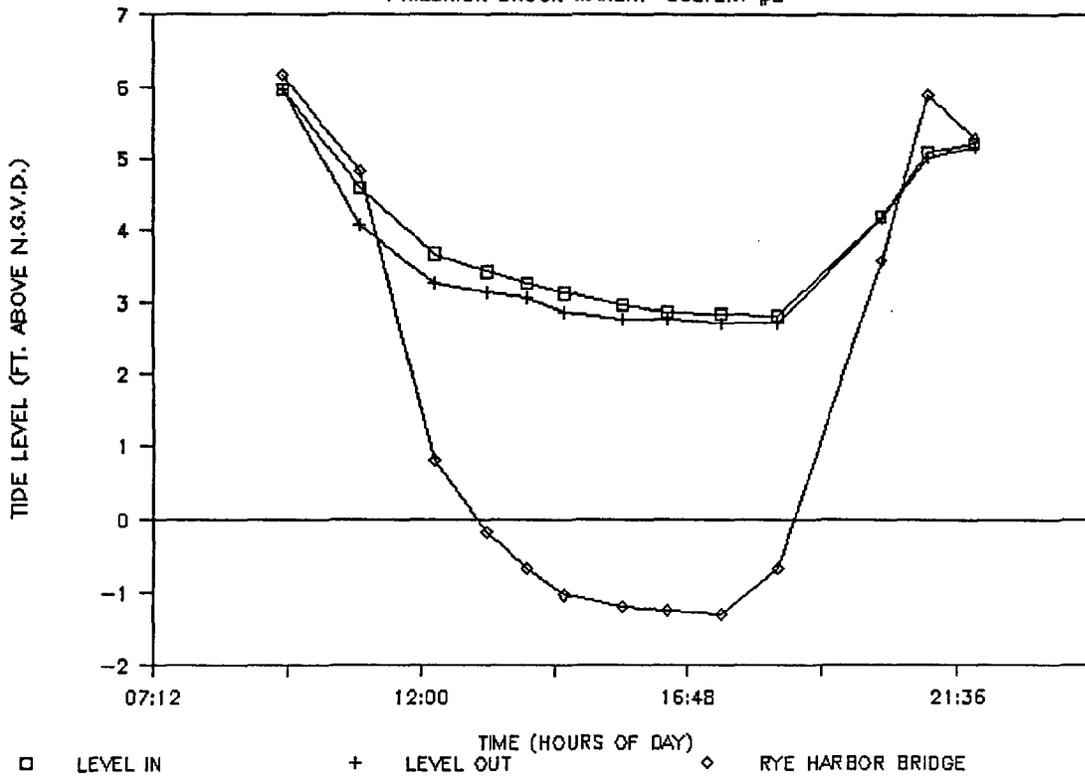
FIGURE 7

Culvert #8 - Water levels from 16 March indicate good tidal flooding through the granite sluiceway. Minor restriction of outflow, shown in Figure 7, is caused by a higher bottom elevation at the sluiceway's landward end. Figure 7 also shows water levels at the Rye Harbor outlet, which drop several feet below culvert #8 at low tide. This is the result of the increasing elevation of the channel east of culvert #8. Whether this shoaling is of natural origin or the result of fill is not known at this time. Nonetheless, channel elevations are sufficiently low to permit adequate drainage during outflow.

PHILBRICK BROOK MARSH: CULVERT #8

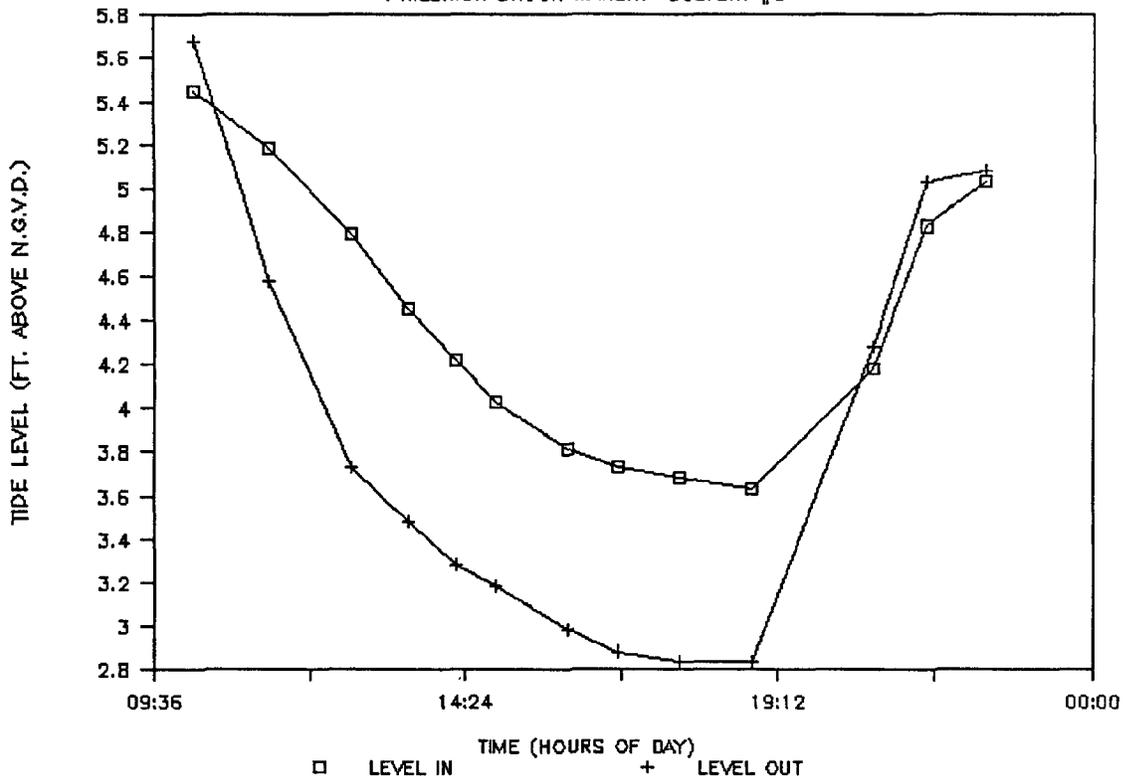
FIGURE 8

Culvert #9 - This culvert was found to restrict outflow due to improper placement. Figure 8 shows water levels on both sides of the pipe during sampling on 16 March. The pipe's size is sufficient to allow flood tides to enter the marsh, but does not allow adequate drainage because it is set above the grade of the creek bed. Low tide water levels on the upstream side of the pipe remained approximately 1.0 ft. higher than the downstream side. Elevated water levels prevent peat

PHILBRICK BROOK MARSH: CULVERT #9

Culvert #9 - Replace existing culvert with drainage structure of similar capacity set approximately 1.0 ft. below the present invert elevation to improve outflow and maintain inflow capability.

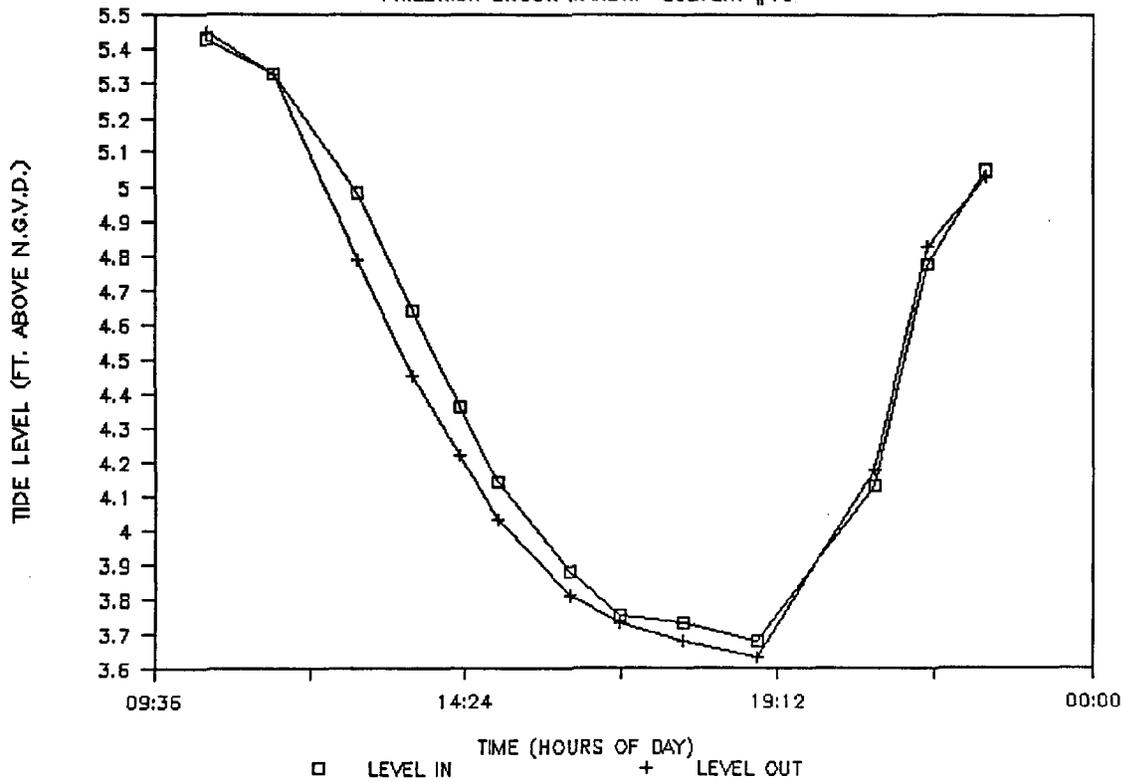
FIGURE 9

PHILBRICK BROOK MARSH: CULVERT #10

drainage, resulting in water-logging and vegetation die-off. The effects of outflow restriction can best be seen in the marsh area upstream of culvert #10, where the peat surface is deteriorating and pannes are forming.

Culvert #10 - Figure 9 illustrates relatively free exchange of tidal flow through culvert #10. This culvert is slightly undersized for the channel it serves, and minor restriction of outflow was observed during the sample period. Outflow water levels were elevated approximately 0.1 ft. upstream of the pipe compared with downstream levels.

Culvert #10 - Replace existing structure with slightly larger structure set at present elevation.

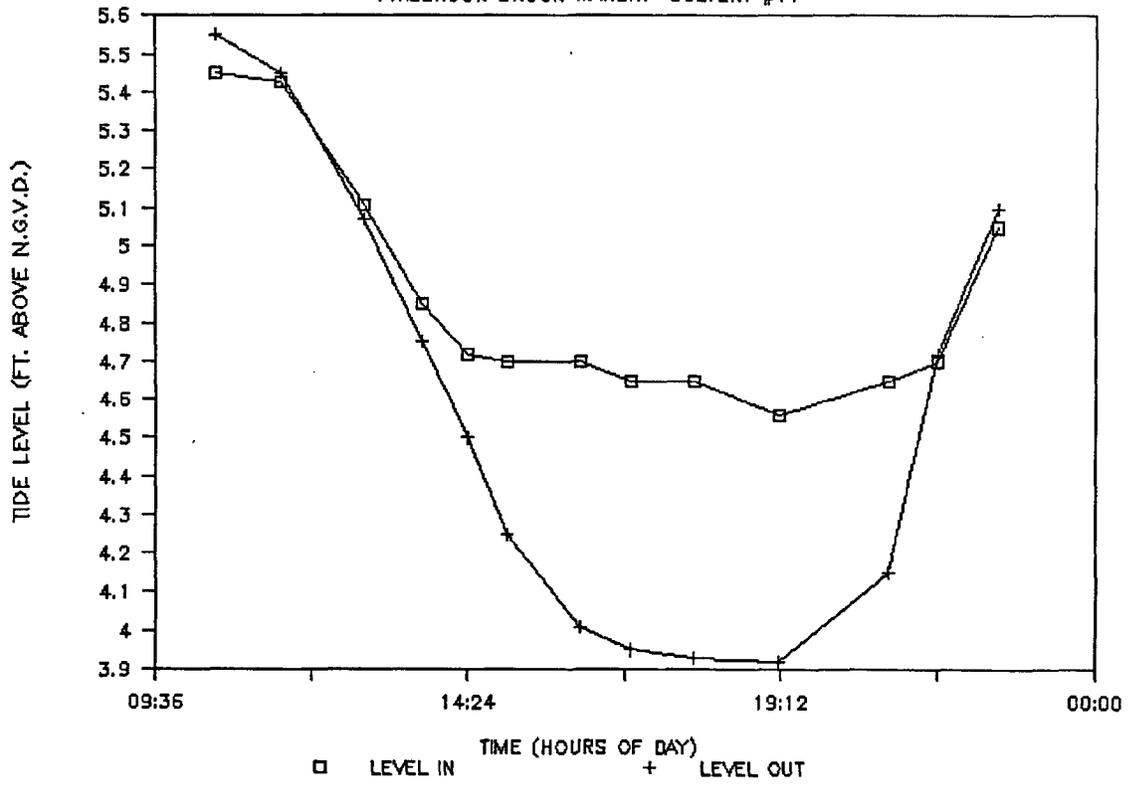
FIGURE 10

Culvert #11 - This culvert severely restricts tidal exchange between the brackish marsh east of Route 1A and Philbrick Brook. Water levels on both sides of the culvert are shown in Figure 10. At the end of the flood tide period, water levels in Philbrick Brook measured 0.1 ft. higher than in the isolated marsh, indicating moderately restricted flow. Severe restriction of outflow is caused by the pipe's high setting and deteriorated condition, and resulted in water levels in the brackish marsh being elevated by approximately 0.7 ft. during low tide.

PHILBROOK BROOK MARSH: CULVERT #11

Culvert #11 - Replace existing culvert with larger capacity pipe set approximately 1.5 ft. below the present invert elevation to improve outflow and inflow capacity. Install a self-regulating tide gate on the pipe's western end to protect against flooding due to tidal storm surge.
