**Restoration and Enhancement of Aquatic Habitats in Alaska:
Case Study Reports, Policy Guidance, and Recommendations**

By
Betsy L. Parry and Glenn A. Seaman

Technical Report No. 94-3

July 1994

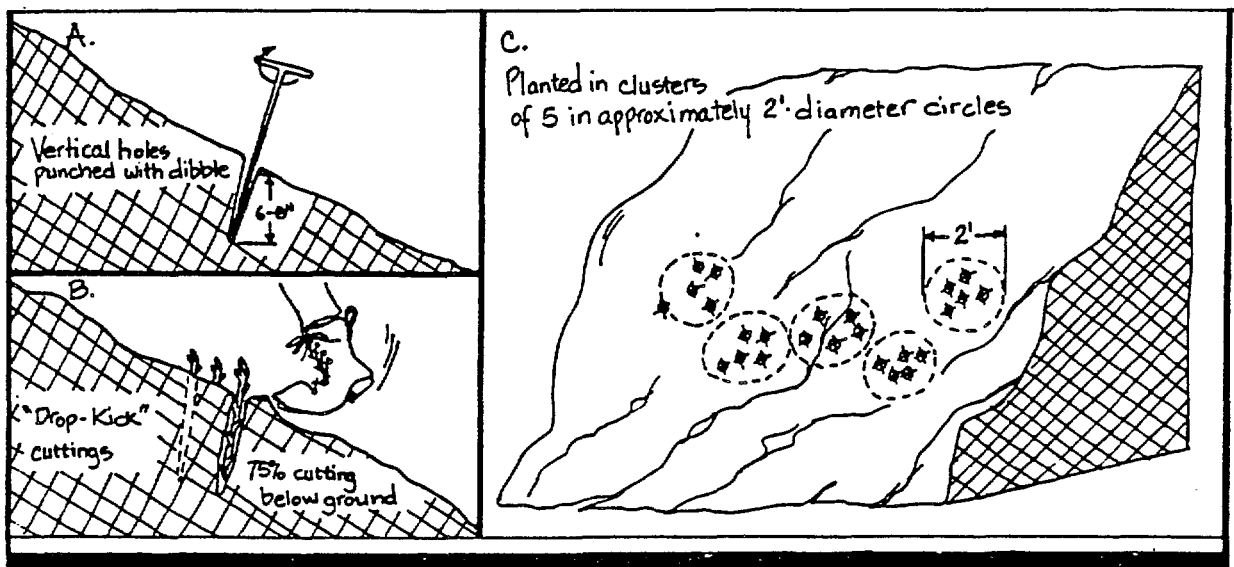
Figure 2. Planting method for dormant willow cuttings, Independence Creek project, 1989.
Source: Barbara Masinton, BLM.

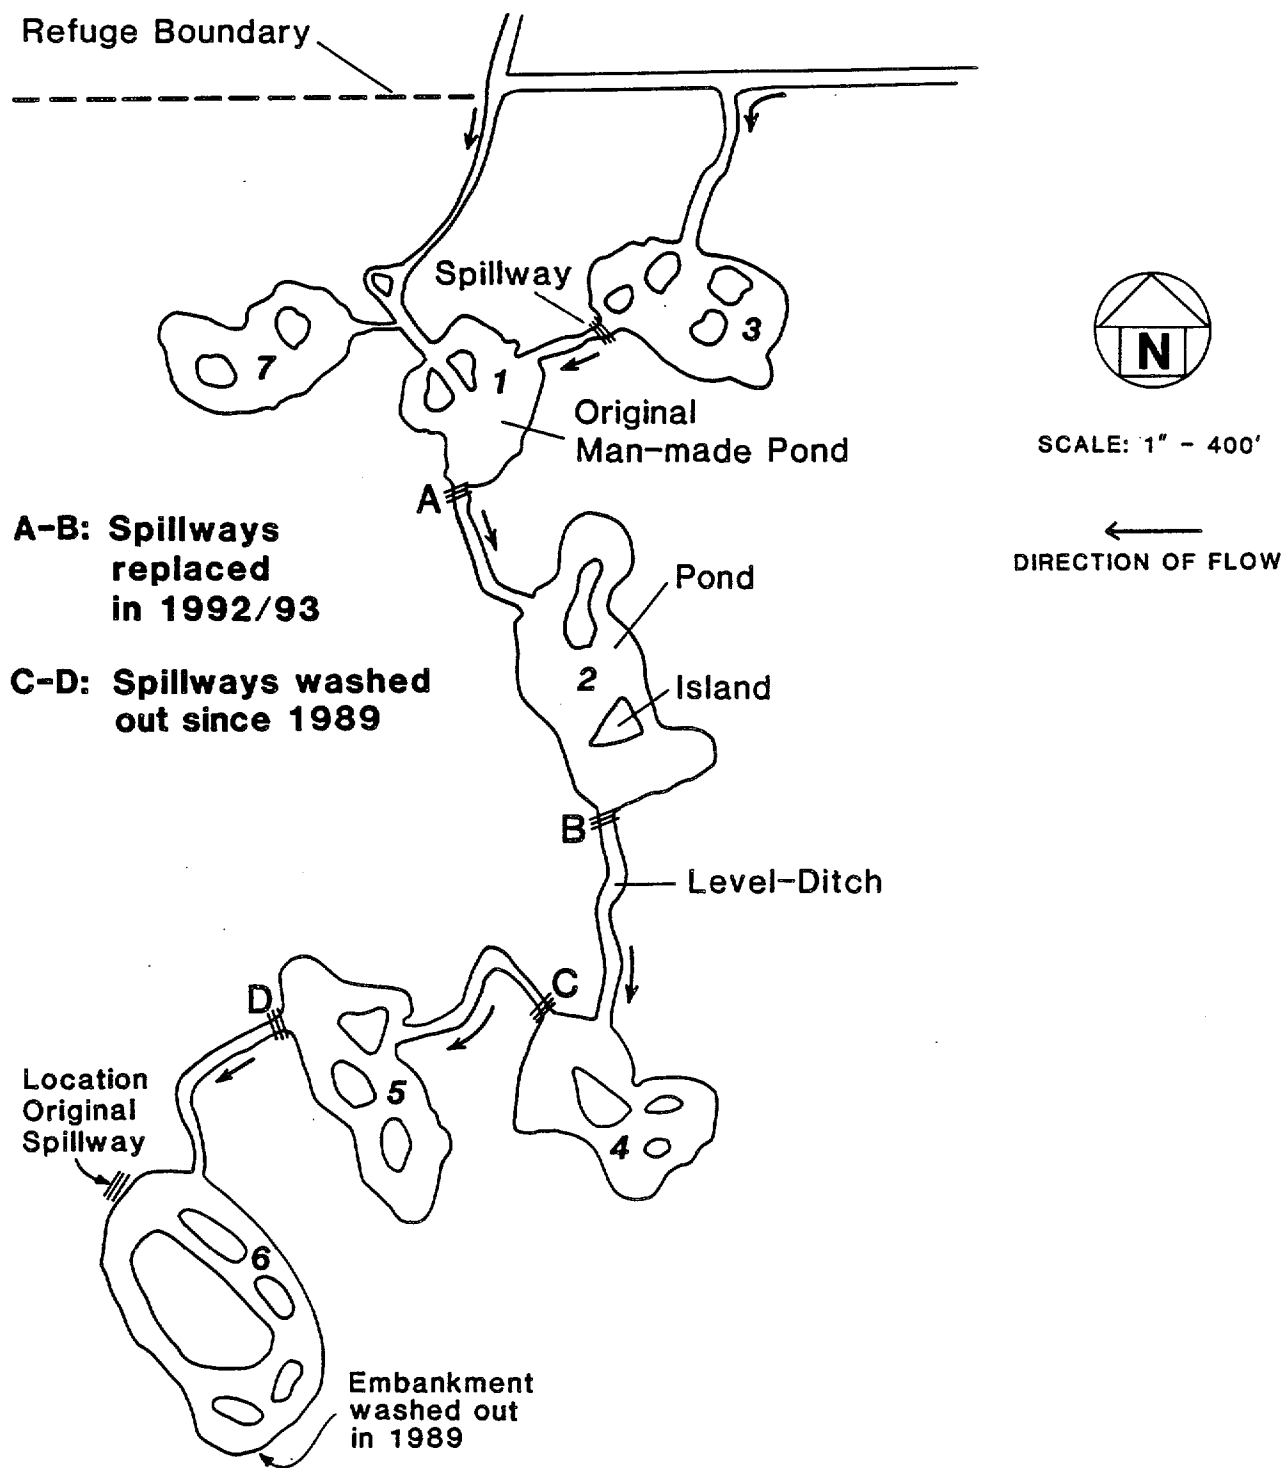
Figure 3. Creamer's Field waterfowl enhancement project showing ponds, islands, level-ditches, and spillways as of 1993. Source: Dan Rosenberg, ADF&G.

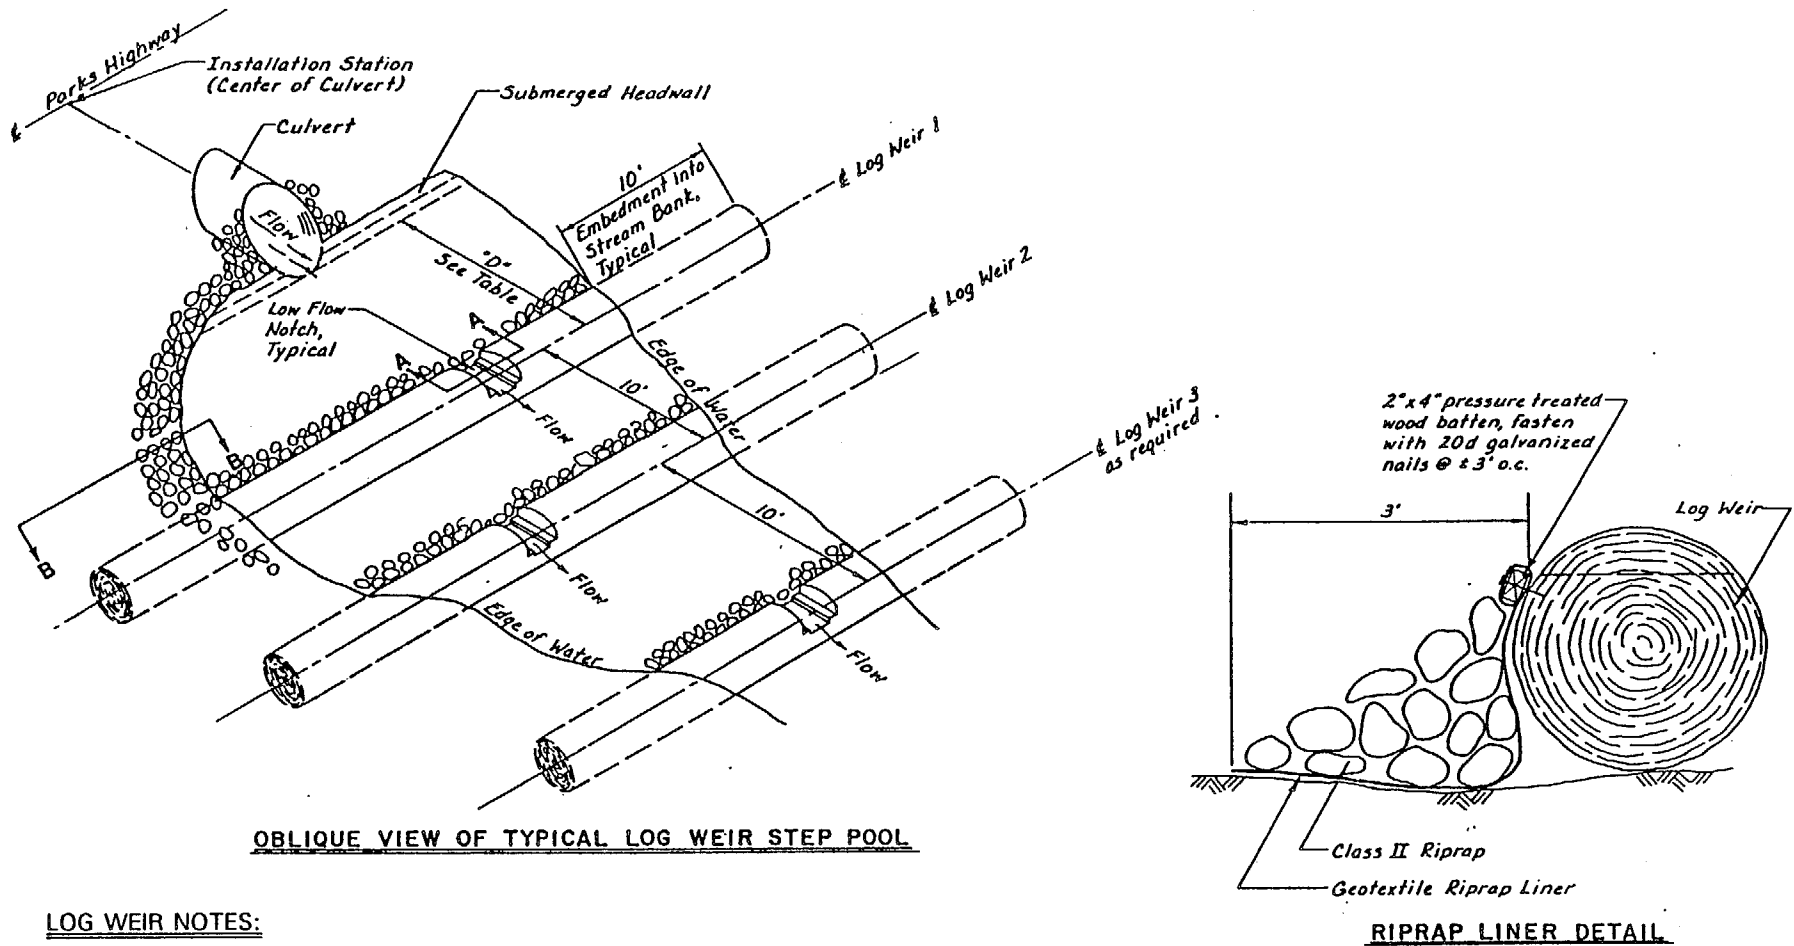
Figure 4. Construction diagrams of the log weir step pool structures installed by ADOT/PF on three unnamed creeks between Mile 118 and Mile 122 of the Parks Highway. Source: ADOT/PF

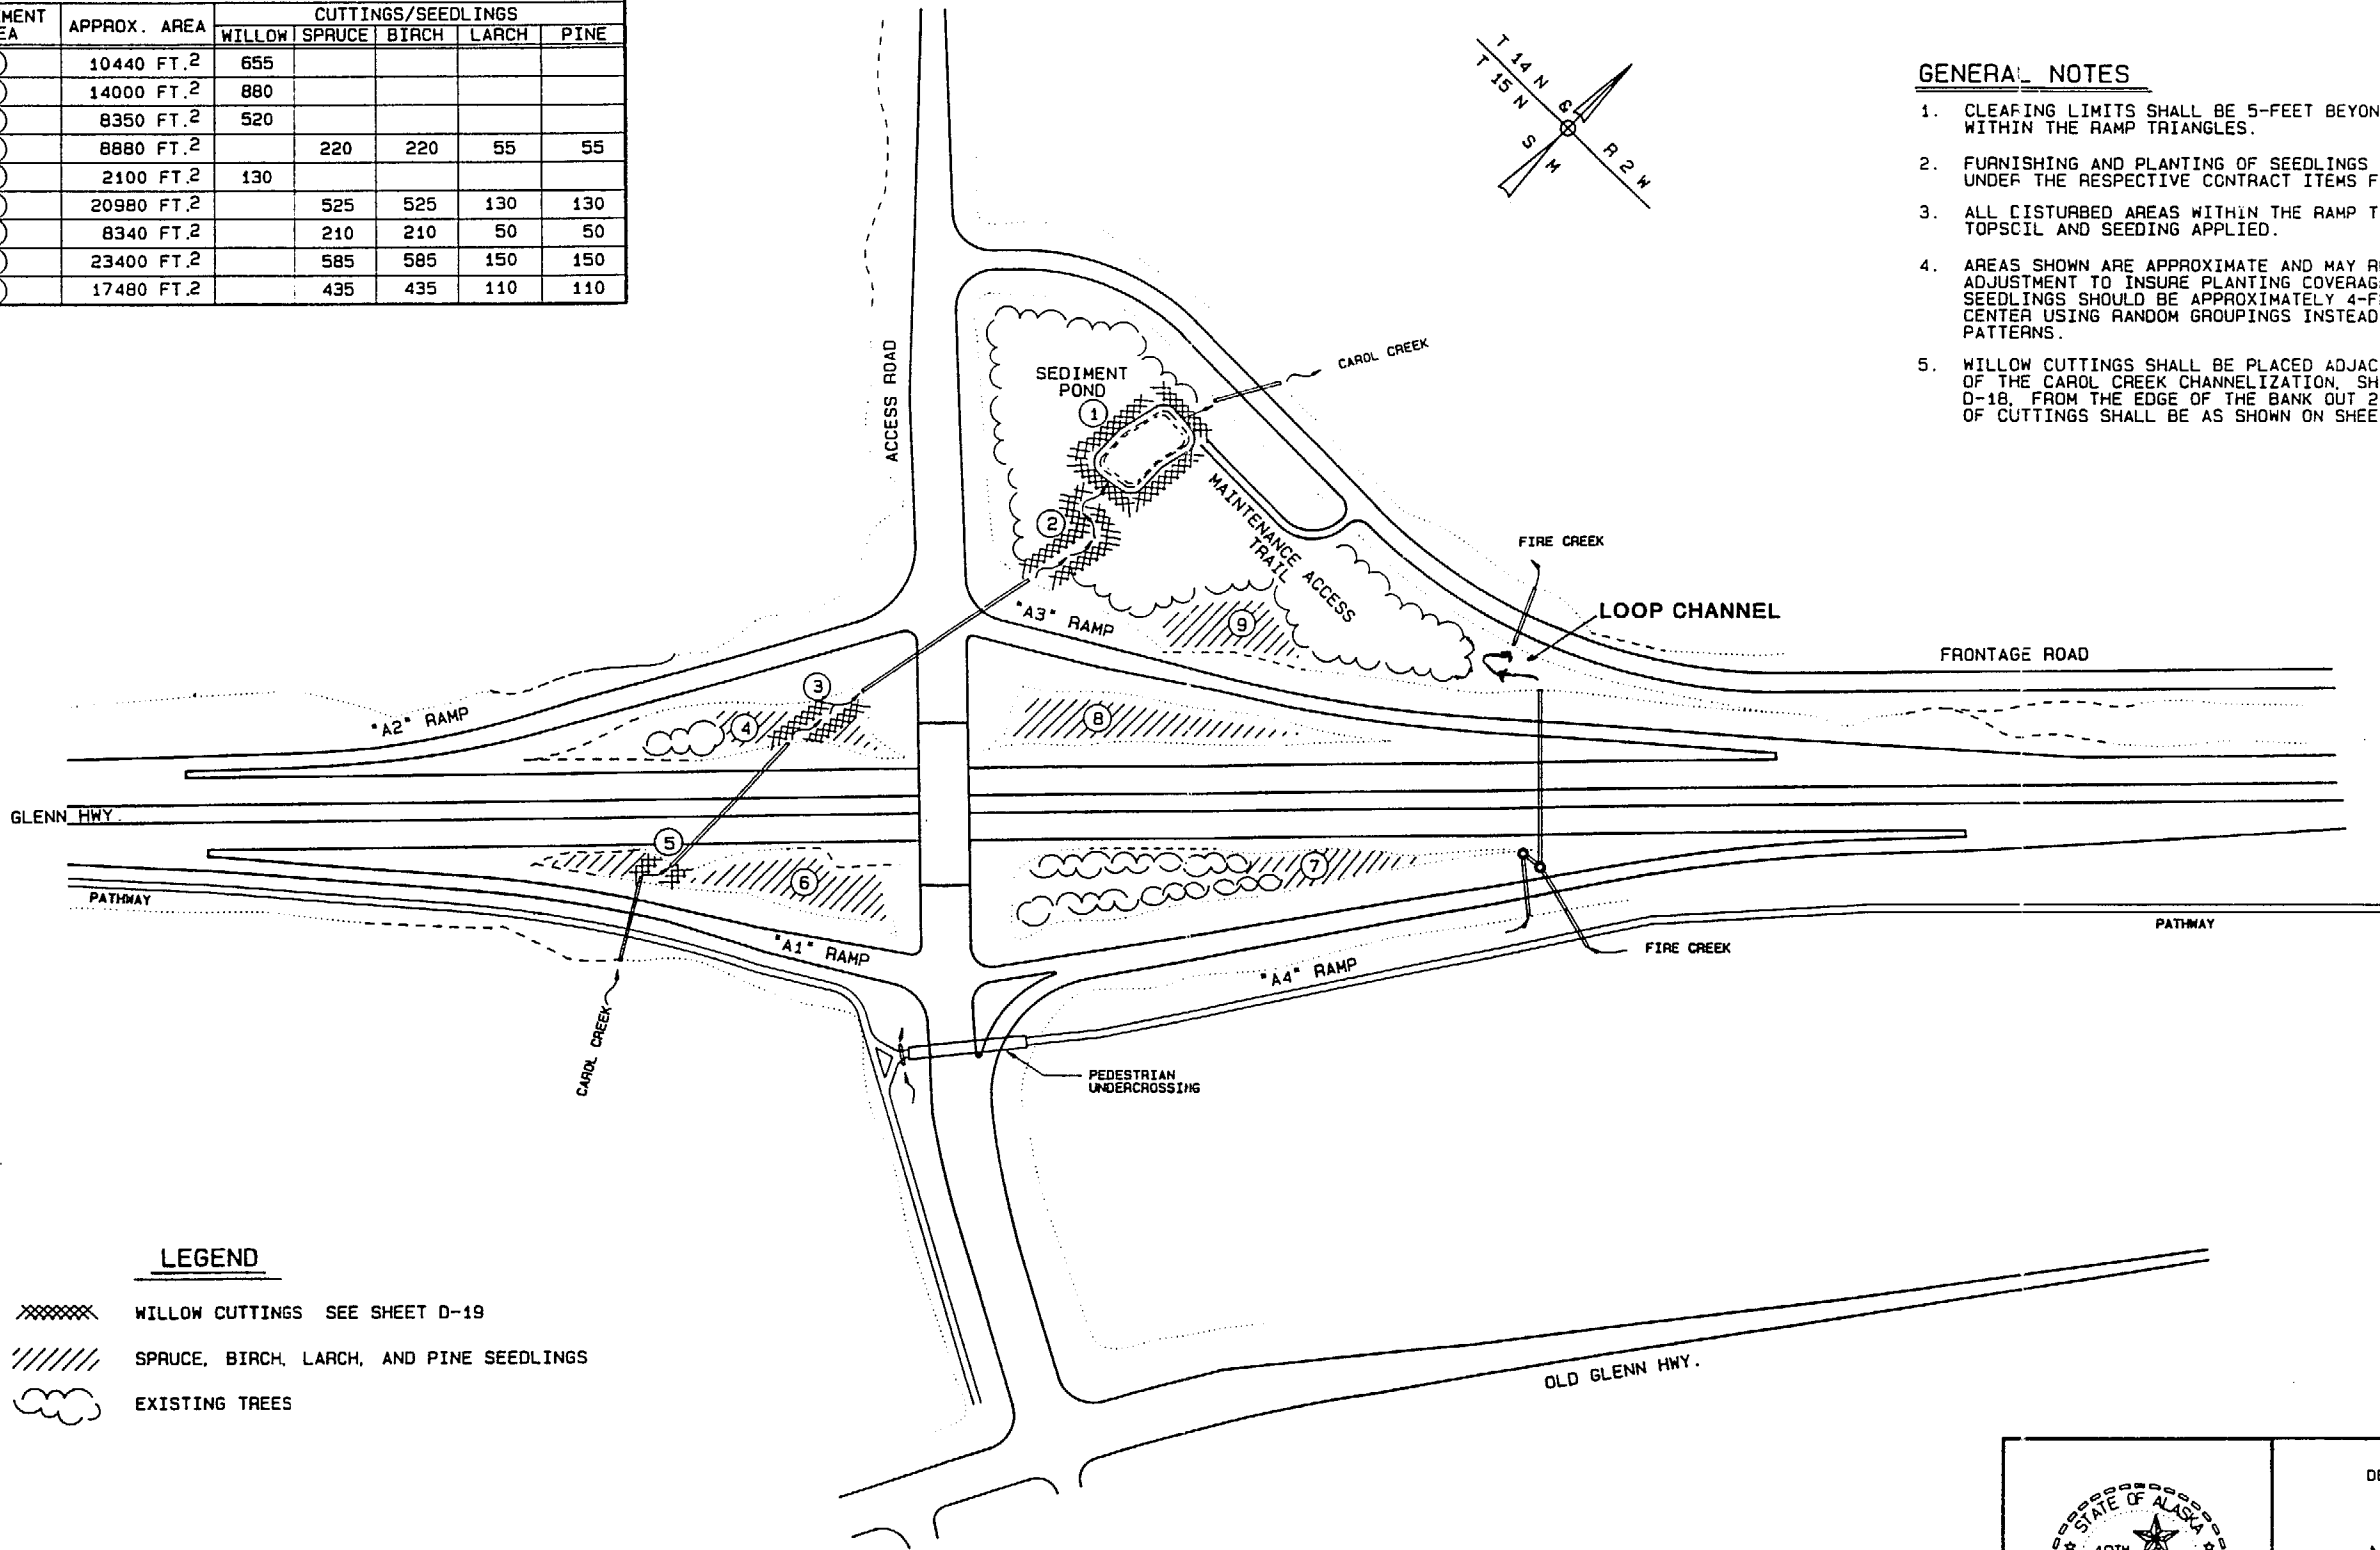
REVISIONS			STATE	PROJECT DESIGNATION	YEAR	SHEET NO.	TOTAL SHEETS
NO.	DATE	DESCRIPTION	ALASKA	I-F-0A1-6 (4)	1990	D-25	129

SUMMARY						
PLACEMENT AREA	APPROX. AREA	CUTTINGS/SEEDLINGS				
		WILLOW	SPRUCE	BIRCH	LARCH	PINE
1	10440 FT. ²	655				
2	14000 FT. ²	880				
3	8350 FT. ²	520				
4	8880 FT. ²		220	220	55	55
5	2100 FT. ²	130				
6	20980 FT. ²		525	525	130	130
7	8340 FT. ²		210	210	50	50
8	23400 FT. ²		585	585	150	150
9	17480 FT. ²		435	435	110	110

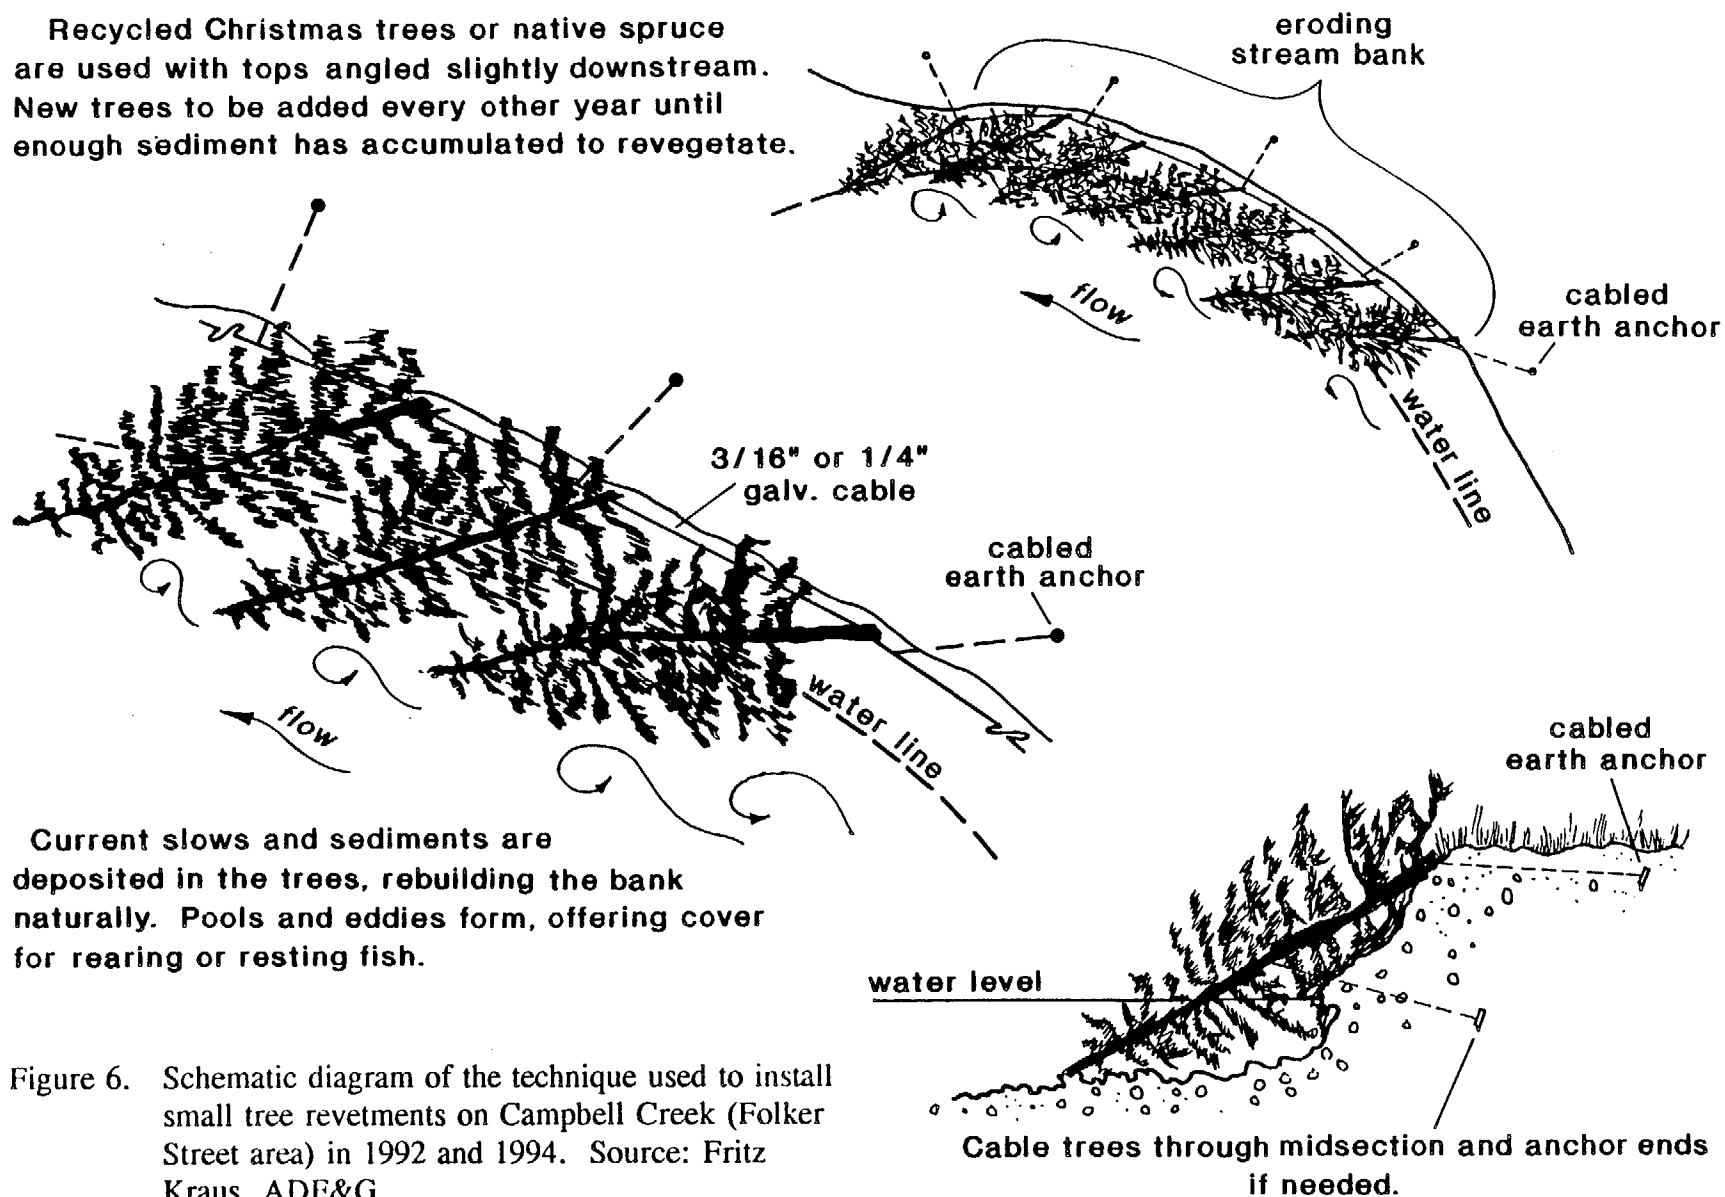
Recycled Christmas trees or native spruce are used with tops angled slightly downstream. New trees to be added every other year until enough sediment has accumulated to revegetate.

Figure 6. Schematic diagram of the technique used to install small tree revetments on Campbell Creek (Folker Street area) in 1992 and 1994. Source: Fritz Kraus, ADF&G.

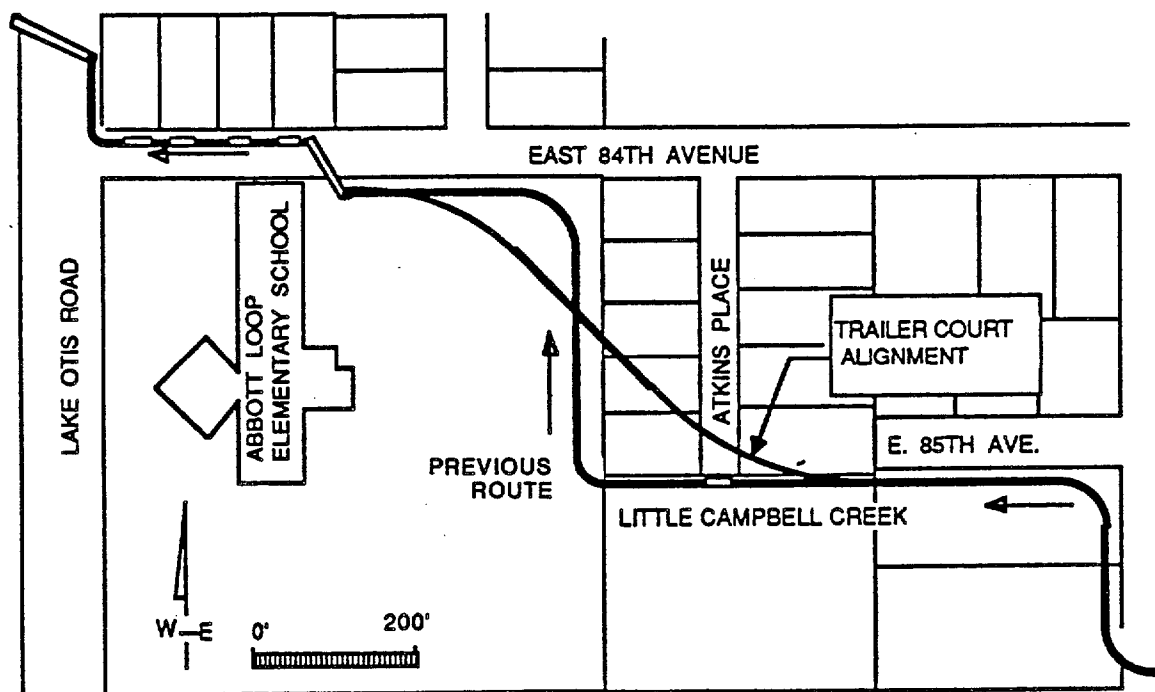
Figure 7. Previous and realigned routes of Little Campbell Creek near Abbott Loop School. Source: Bacon and Sandler, 1987.

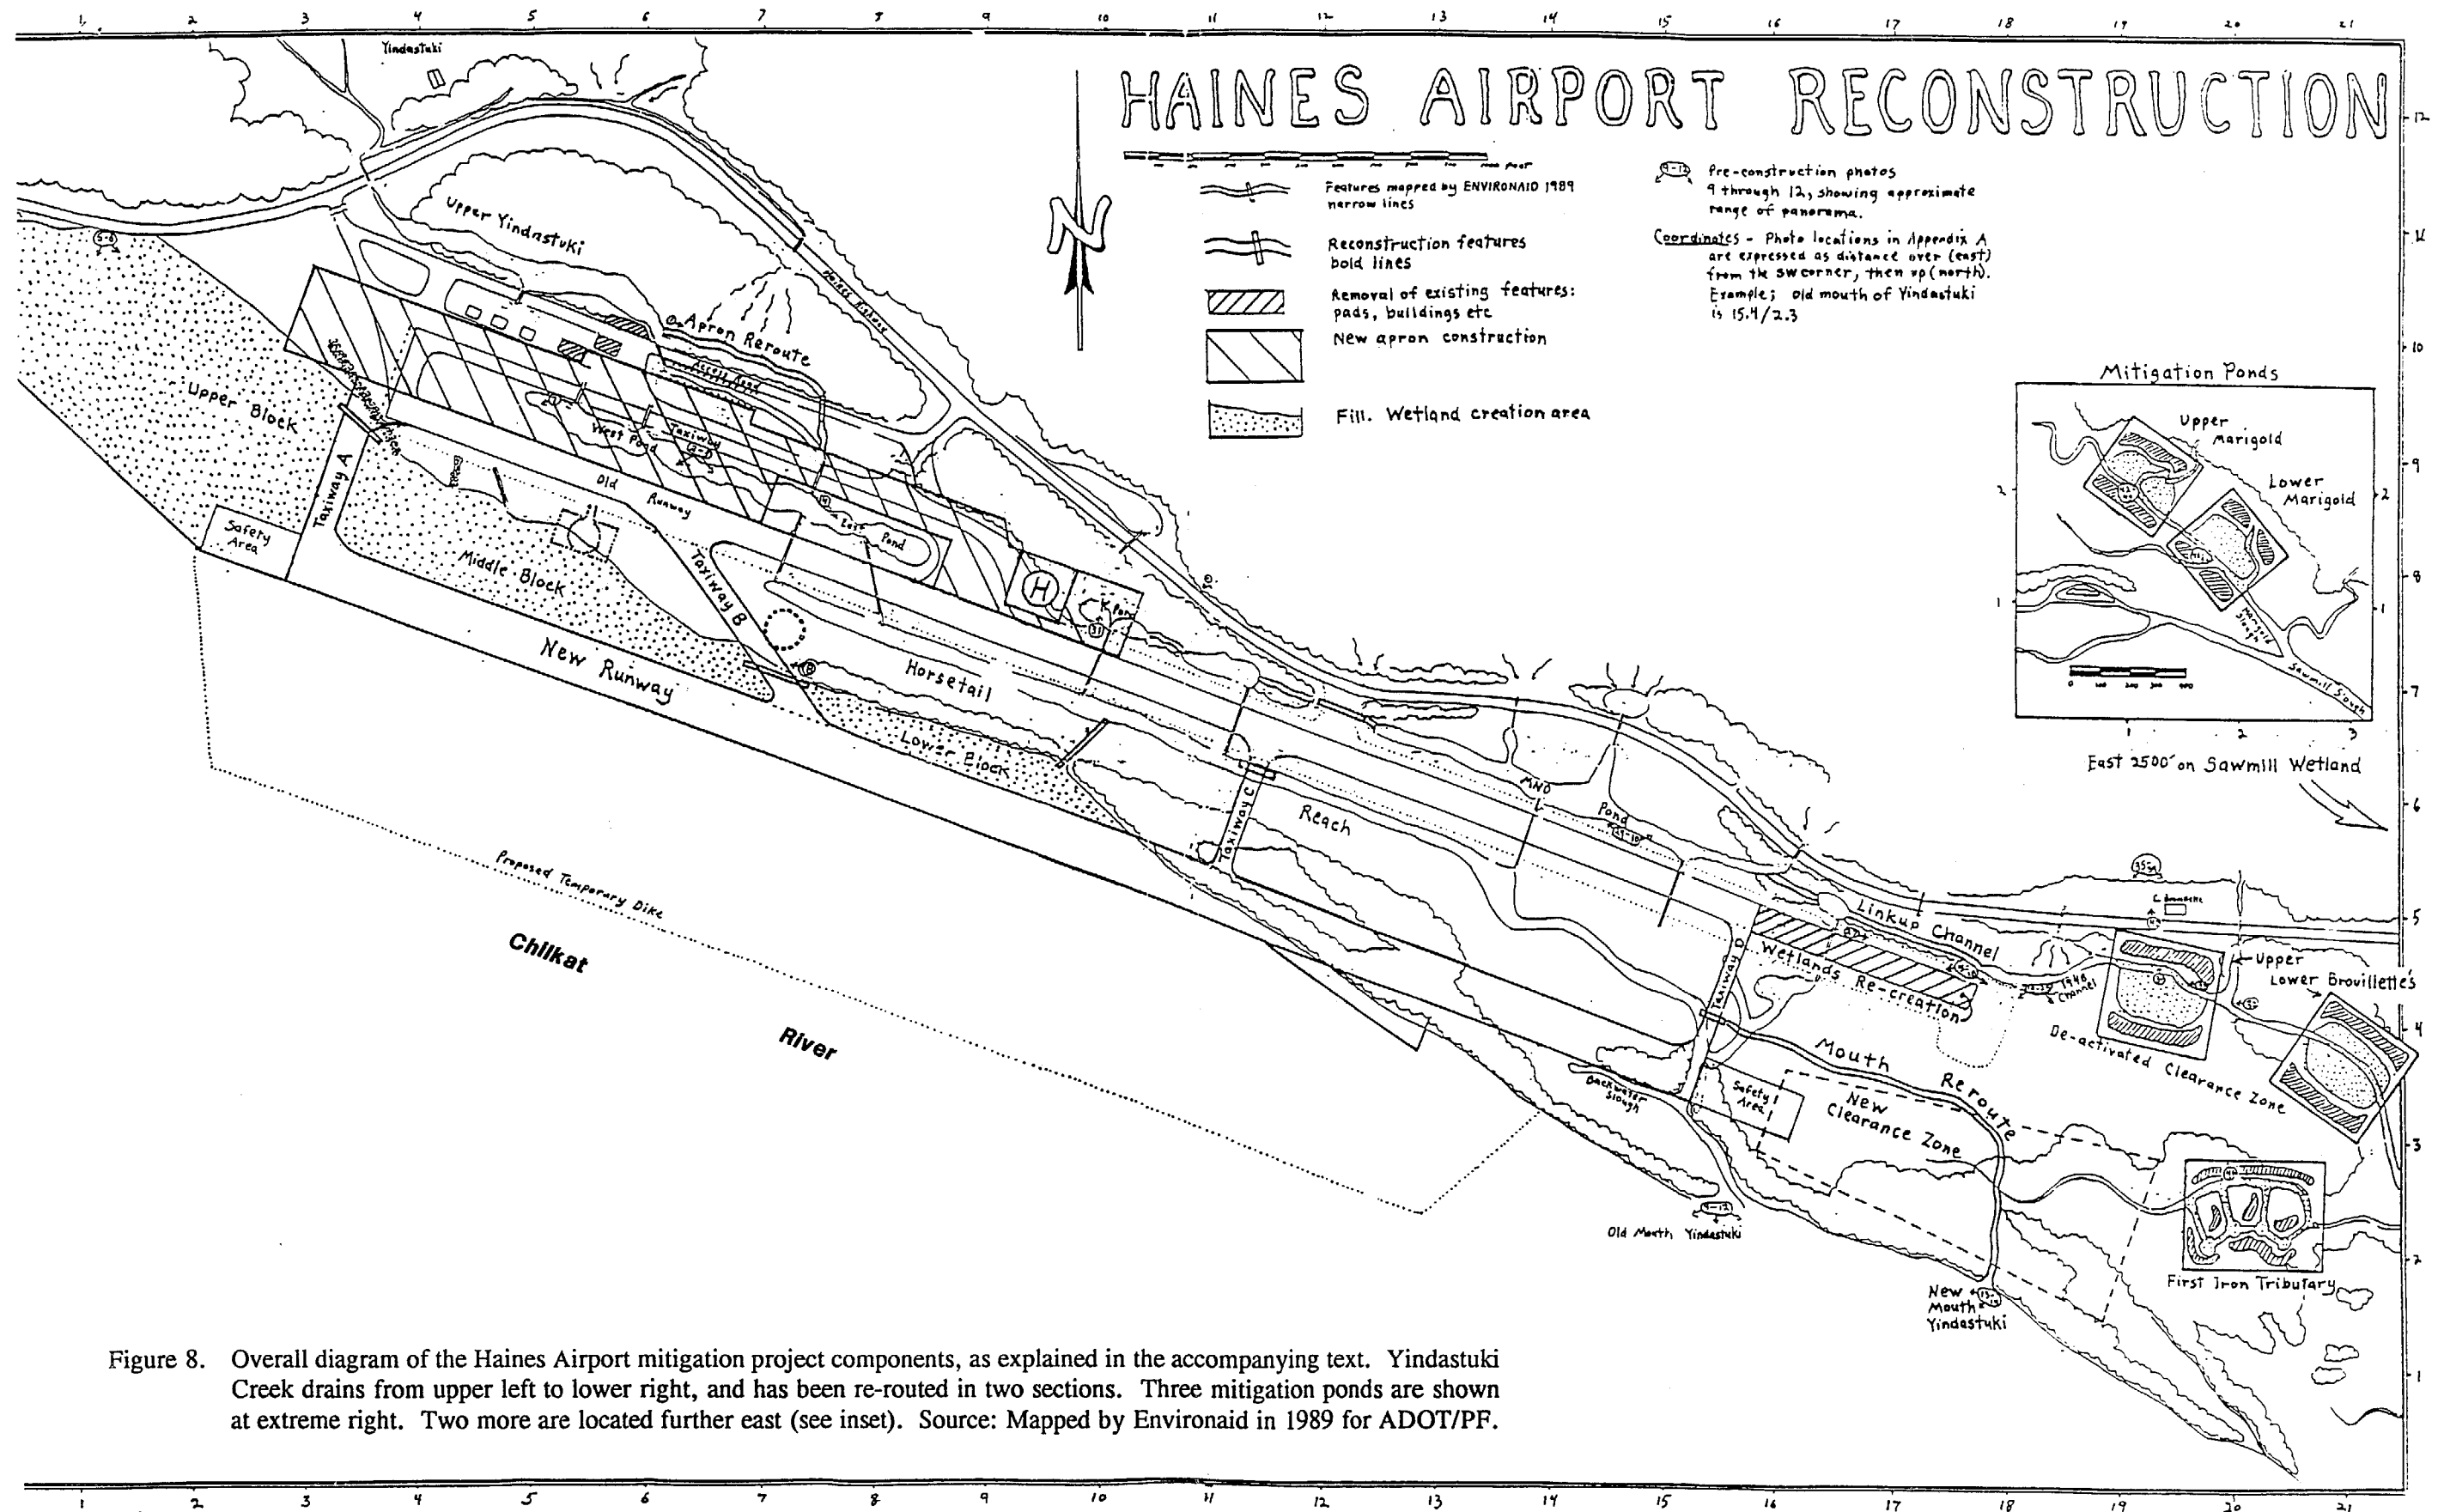
Figure 8. Overall diagram of the Haines Airport mitigation project components, as explained in the accompanying text. Yindastuki Creek drains from upper left to lower right, and has been re-routed in two sections. Three mitigation ponds are shown at extreme right. Two more are located further east (see inset). Source: Mapped by Environaid in 1989 for ADOT/PF.

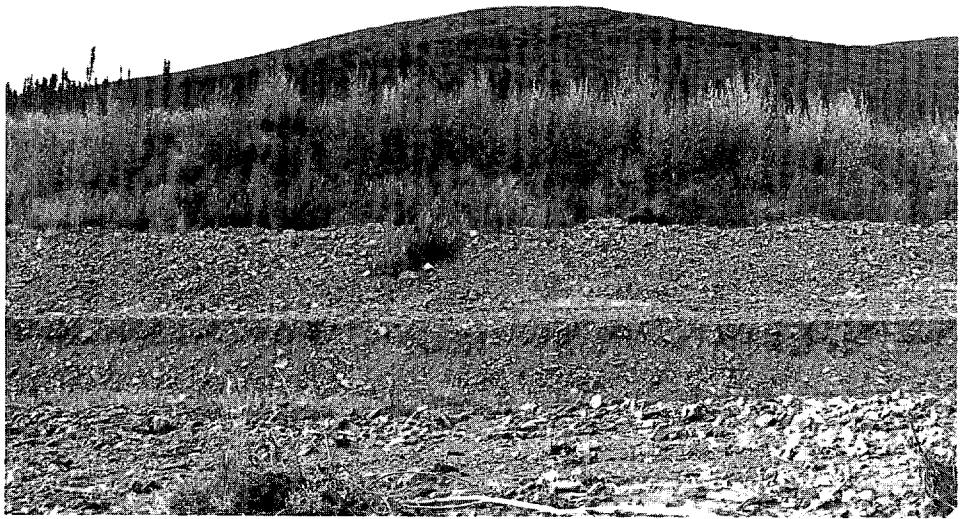
Plate 1. Independence Creek slope stabilization using dormant willows. Uppermost layer of overburden was planted four years earlier. Note high content of fine sediment in overburden stockpiles.

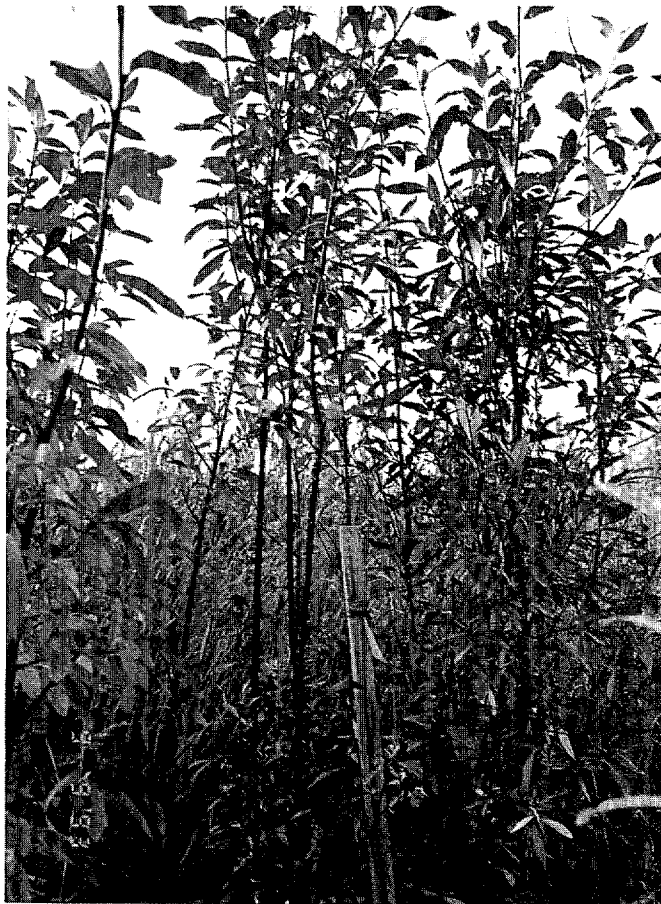
Plate 2. Independence Creek slope stabilization project. Ten-foot growth of planted dormant willow cuttings after 5 growing seasons (1989-93) at one of the marked control points.

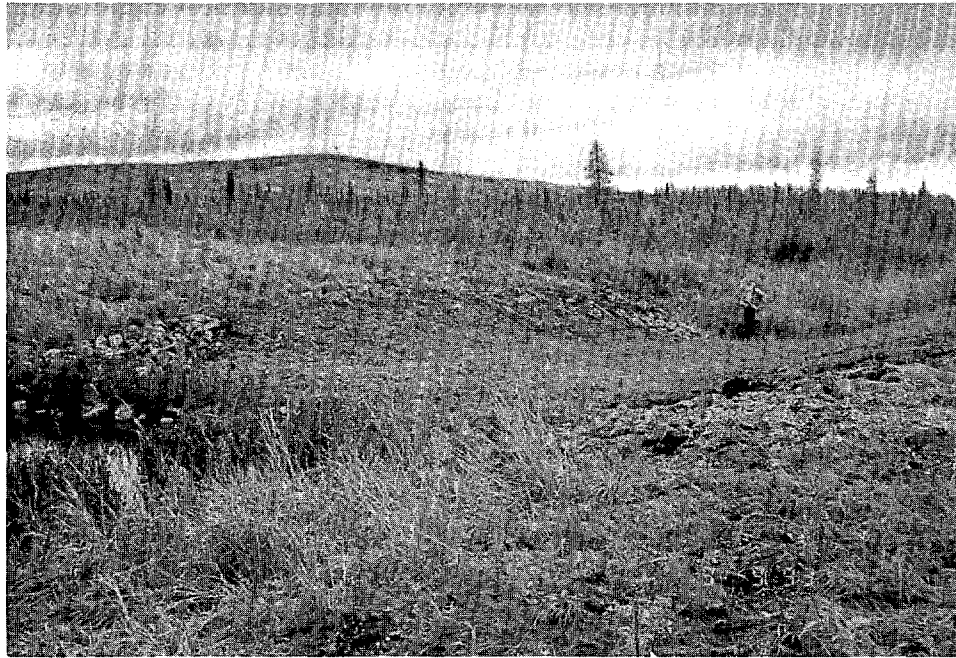
Plate 3. Spillway between upper ponds at the Creamer's Field waterfowl enhancement project. This spillway was reconstructed in winter and spring of 1992/93 using rock riprap recovered with stockpiled topsoil, fertilized, and seeded. Photo from September 1993.

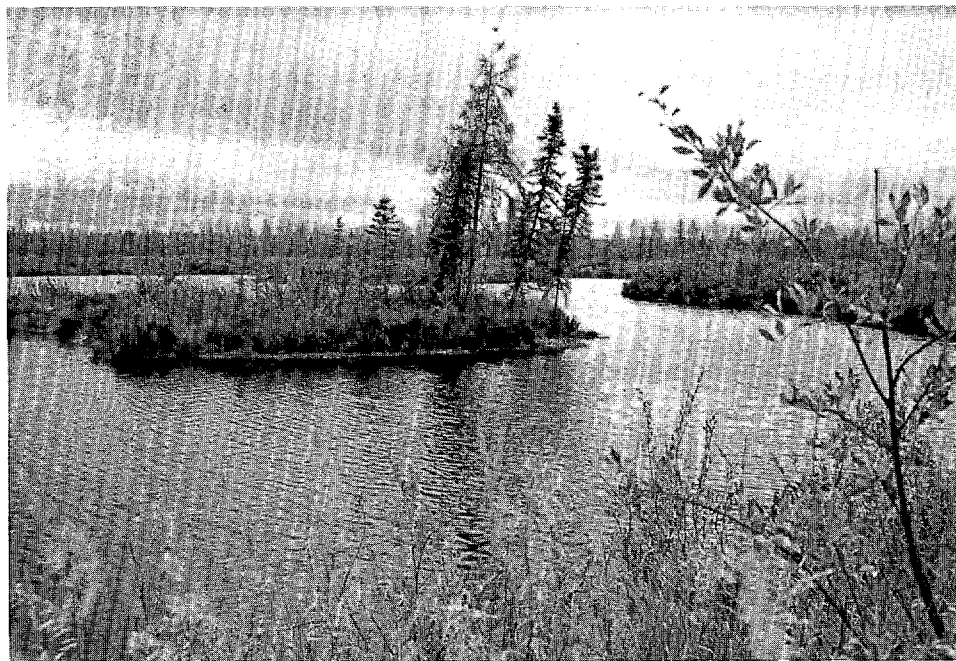
Plate 4. Pond 1 of Creamer's Field waterfowl enhancement project in 1993 after the spillway below was replaced, allowing the pond to refill. Note that existing vegetation was left standing on the "islands" during pond excavation.

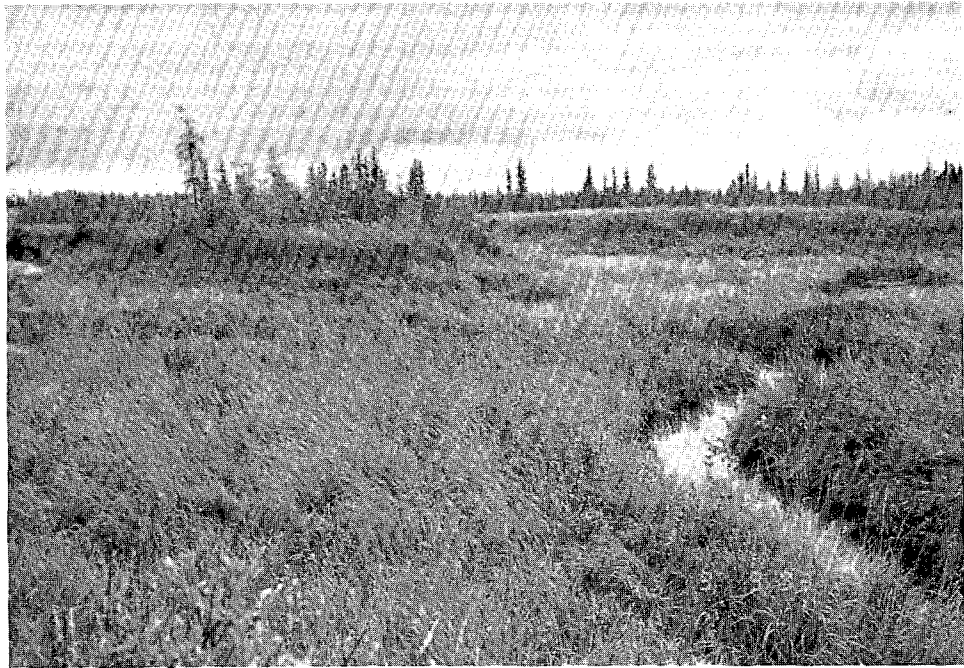
Plate 5.

Pond 4 of Creamer's Field waterfowl enhancement project, dewatered due to spillway washout below it in 1989. The intended island is center left. Only a channel of water currently runs through the excavated area.

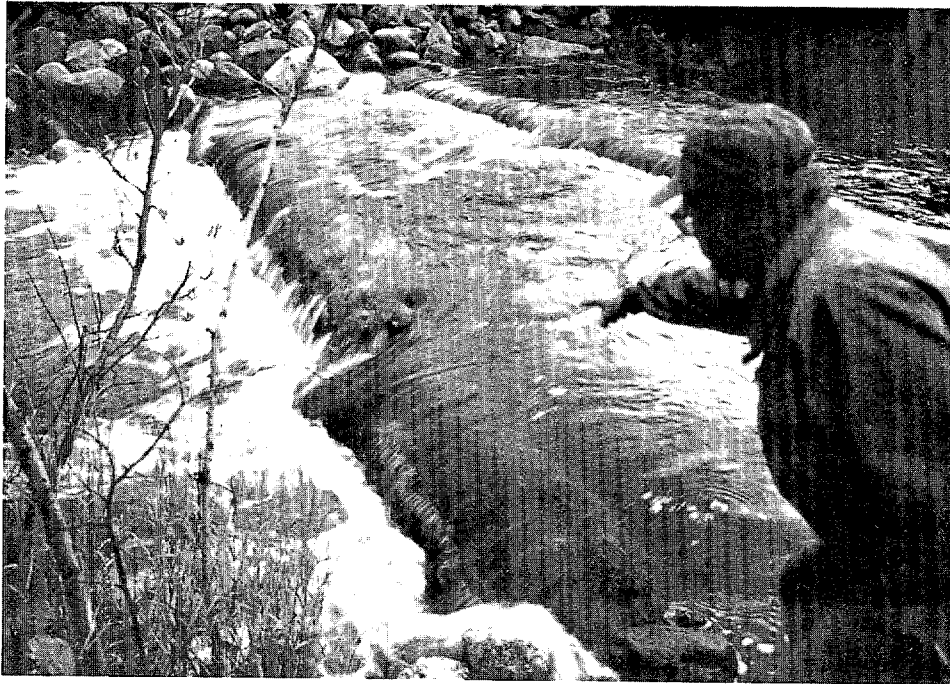
Plate 7. Log step pools near Trapper Creek during high flow. Photo shows staggered notch openings in the weirs. 1991 ADF&G file photo.

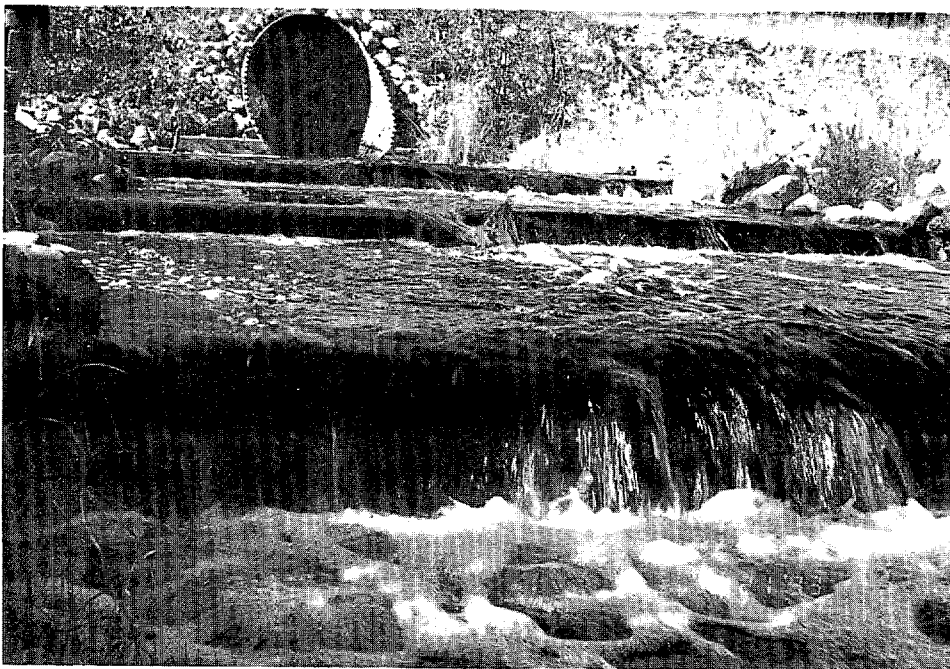
Plate 8. Log step pools at Milepost 120 of the Parks Highway during lower flow (Sept. 1993). The lowest weir was measured to have a 1 ft, 8 in. drop, which easily passes adults but may be excessive to pass juvenile salmon.

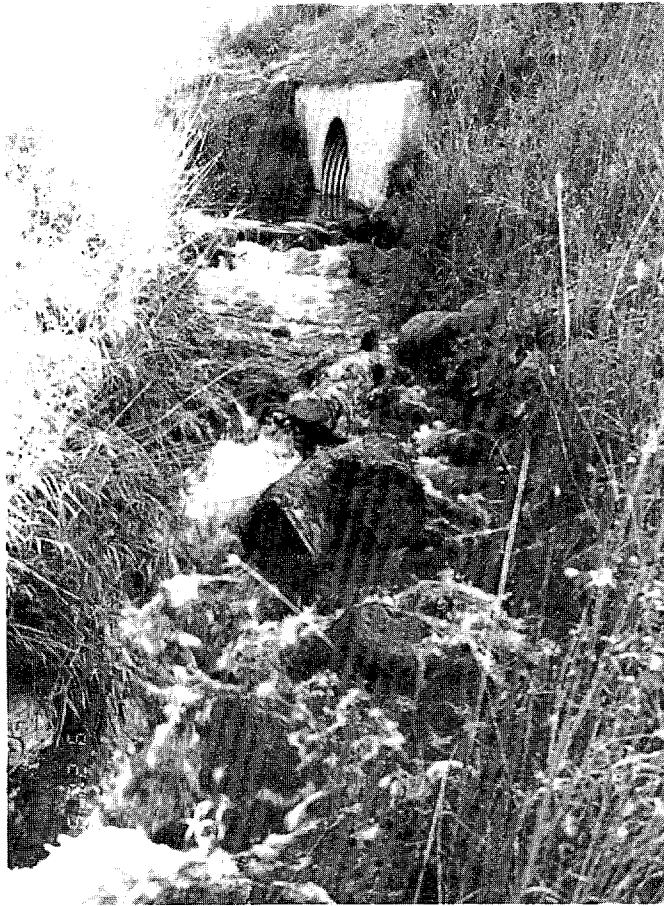
Plate 9. Rapids along the realigned loop section of Fire Creek as it exits the culvert north of the new highway interchange in North Eagle River (see Figure 5). The close succession of drop structures without resting space may be impeding fish passage through this section.

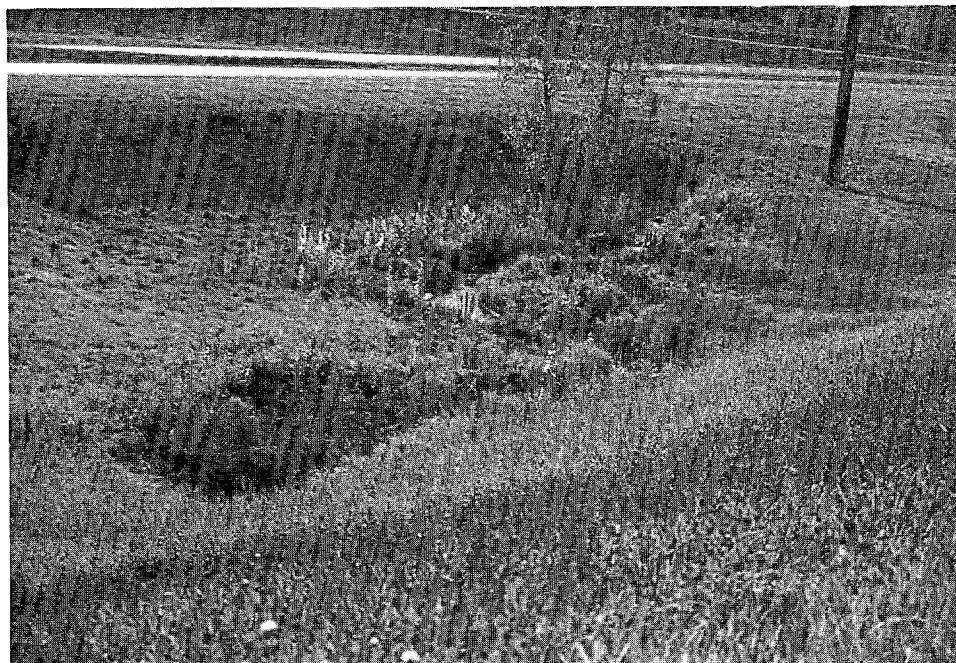
Plate 10. Realigned section of Carrol Creek at the North Eagle River highway interchange (between the "A2" ramp and the highway, see Figure 5). Willow cuttings are persisting in this area more than in the other sections of the project.

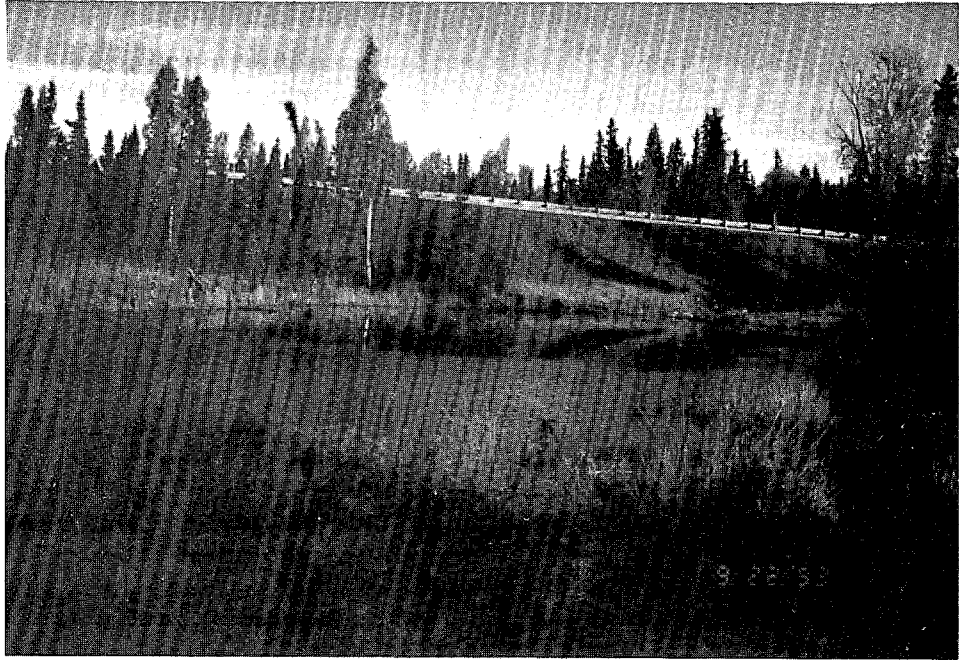
Plate 11. Looking north at the sedimentation/mitigation pond at the North Eagle River highway interchange. Skim of ice visible in shallower areas. Frontage road in rear.

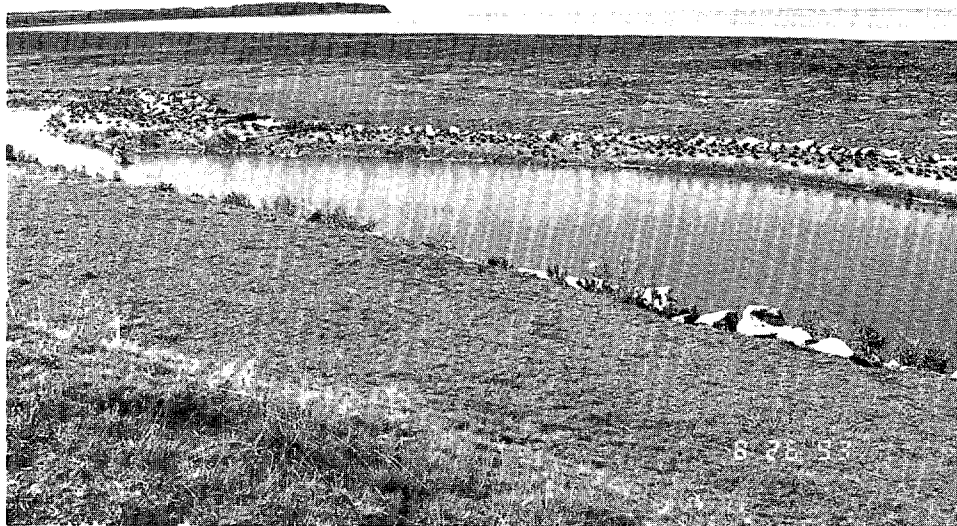
Plate 12. Coastal Trail mitigation project, consisting of an excavated pond and berm on the tidal mud flats in Anchorage. The brackish water pond receives stormwater runoff. Ducks primarily use the site as "loafing habitat," congregating on the bare berm.

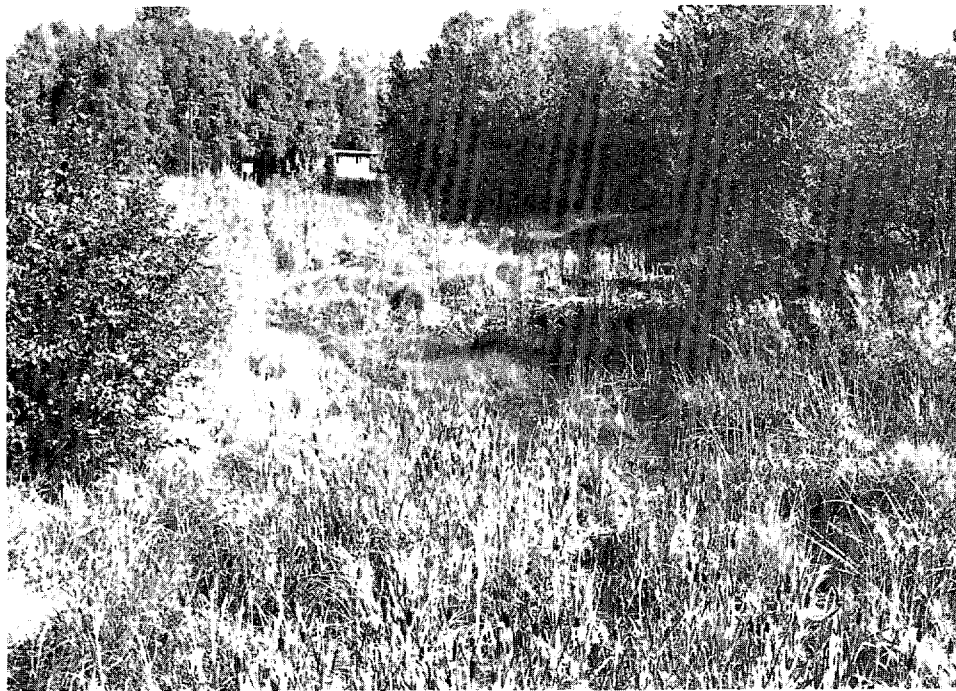
Plate 13. Westchester Lagoon offsite mitigation project. View looking uphill the length of the project; Westchester Lagoon located behind photographer. Cattails in foreground; transplanted willows halfway up site at center left.
