**Restoration and Enhancement of Aquatic Habitats in Alaska:
Case Study Reports, Policy Guidance, and Recommendations**

By
Betsy L. Parry and Glenn A. Seaman

Technical Report No. 94-3

July 1994

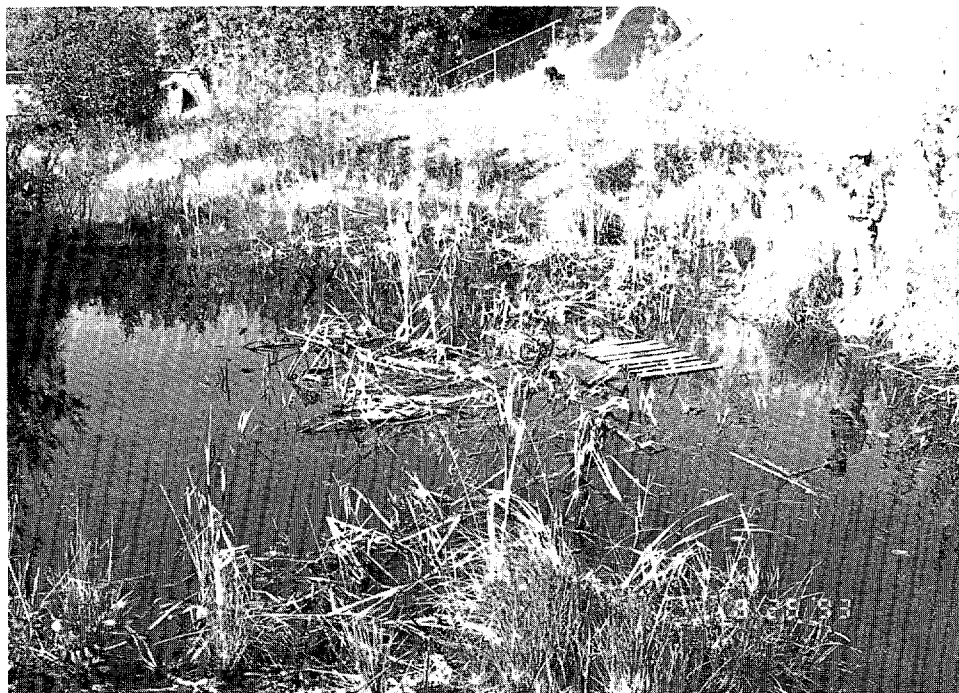
Plate 14. Lower section of Westchester Lagoon offsite mitigation project, showing shallow standing water and coastal trail in rear. Transplanted willows on right bank near person.

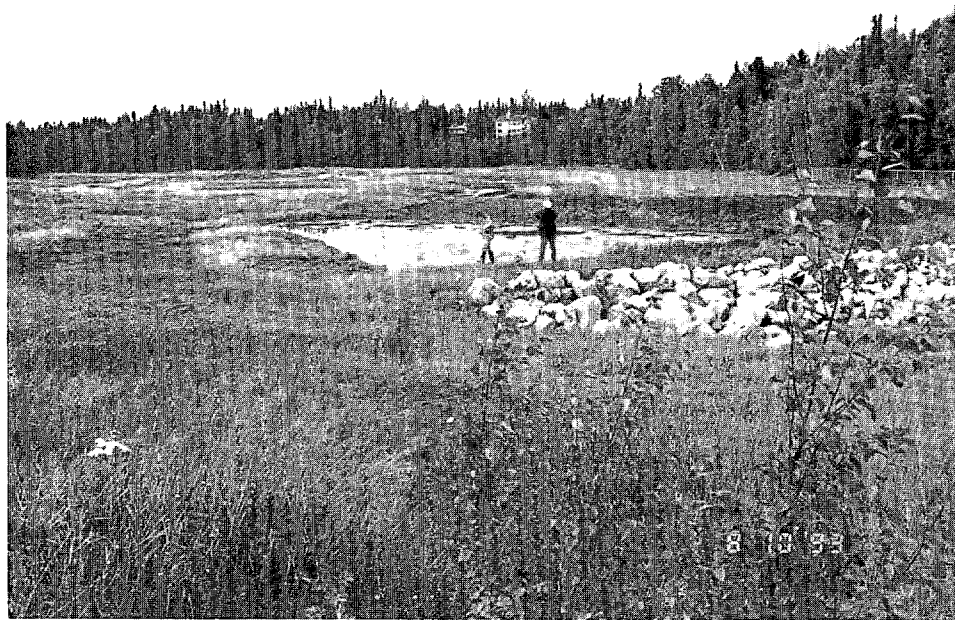
By 1993, the vast majority of the area has adequately revegetated due to the combination of seeding, transplanting from adjacent communities, fertilizing, and natural recolonization (Plate 15). The site is complex in that the soil types and elevations are highly variable.

The ponds originally built for waterfowl (in 1987) have not proven so successful (Plate 15). The ponds are perched higher in elevation than the creek, and lack surface connections to the creek. They differ from natural ponds in their appearance (less cover around edges, fairly distinct sloped boundaries). Only one pond (with the island) appears to receive any duck use, whereas ducks are in abundance in the adjacent free-flowing Fish Creek itself. One pond dike serves as a loafing area; revegetation at this site proved difficult because ducks consumed the seeds and transplants.

Plate 15. Fish Creek estuarine wetland restoration project, showing revegetation on the varied terrain. Behind figures, an intended duck pond holds little water.

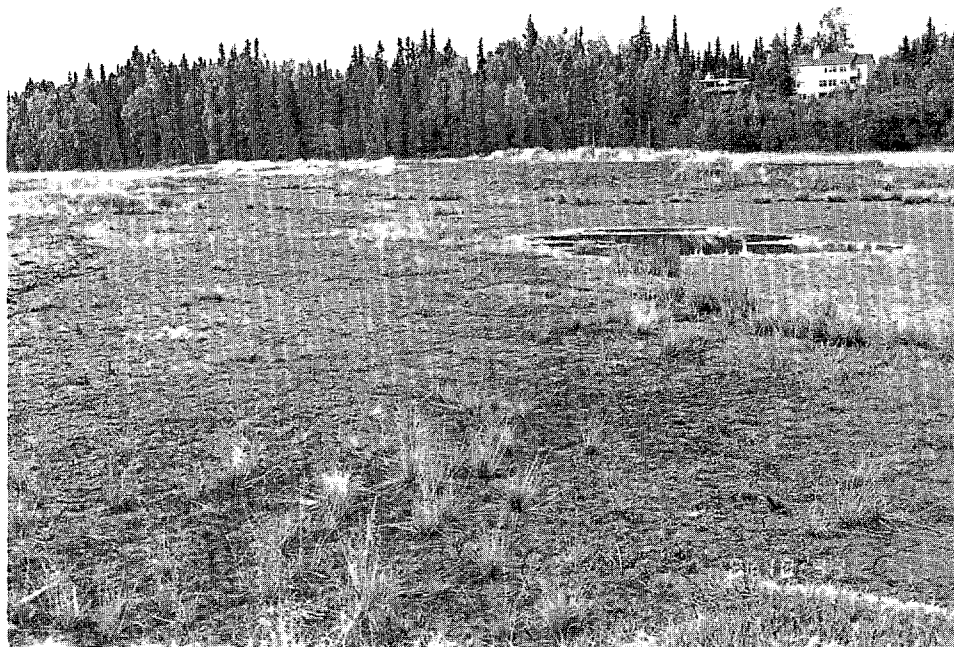
Overall, this project's results are promising because the patches of vegetation that have established reflect the diversity of the site. Originally (1987) the entire area was seeded and fertilized at one uniform rate (by AWWU). But a combination of elevational differences leading to different salt and water conditions, along with fertilization and natural reinvasion, has led to a variegated cover of emergent vegetation across most of the site (Plates 15, 16).

Plate 16. Fish Creek wetlands, showing sedge plugs in foreground (transplanted from edge of project site) and naturally reinvading salt-tolerant species such as pickleweed. Fertilization appears to speed natural regrowth in these salty clay soils.

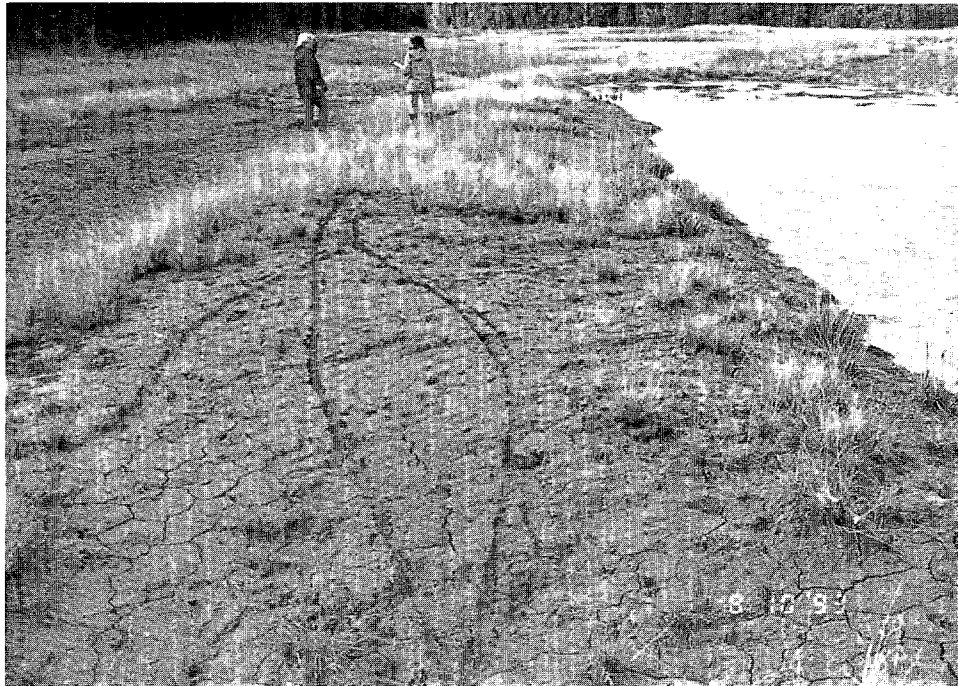
Plate 17. Fish Creek wetlands. Human impact (foot and bike traffic) in this area was much higher than anticipated, hindering plant establishment in the easily compacted clay substrate.

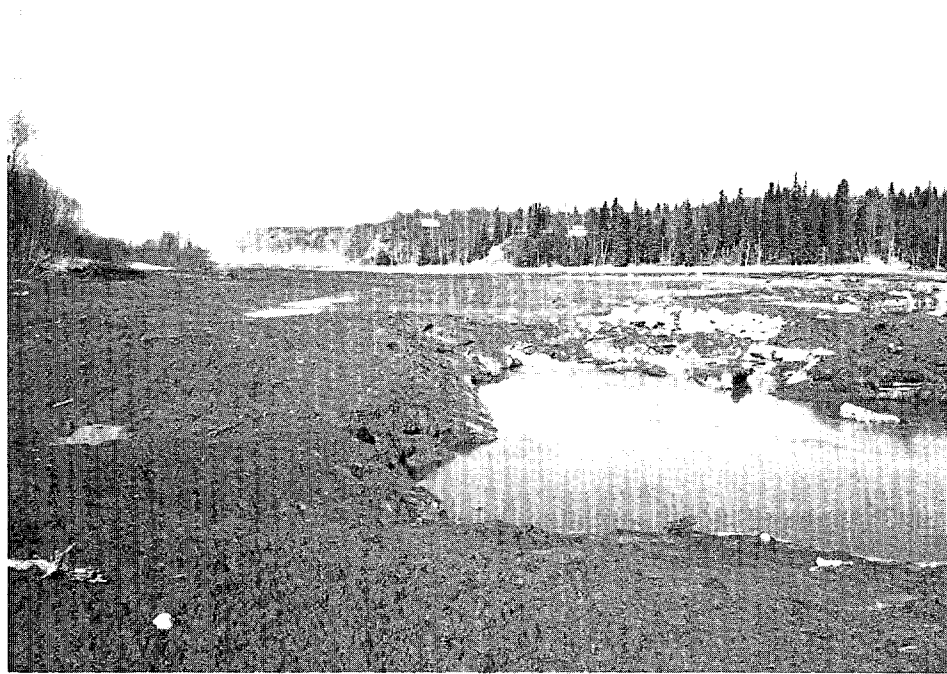
Plate 18. Campbell Creek sedge wetlands in 1989, after sewer line installation and erosion denuded approximately 3 1/2 acres of high intertidal wetlands. ADF&G file photo.

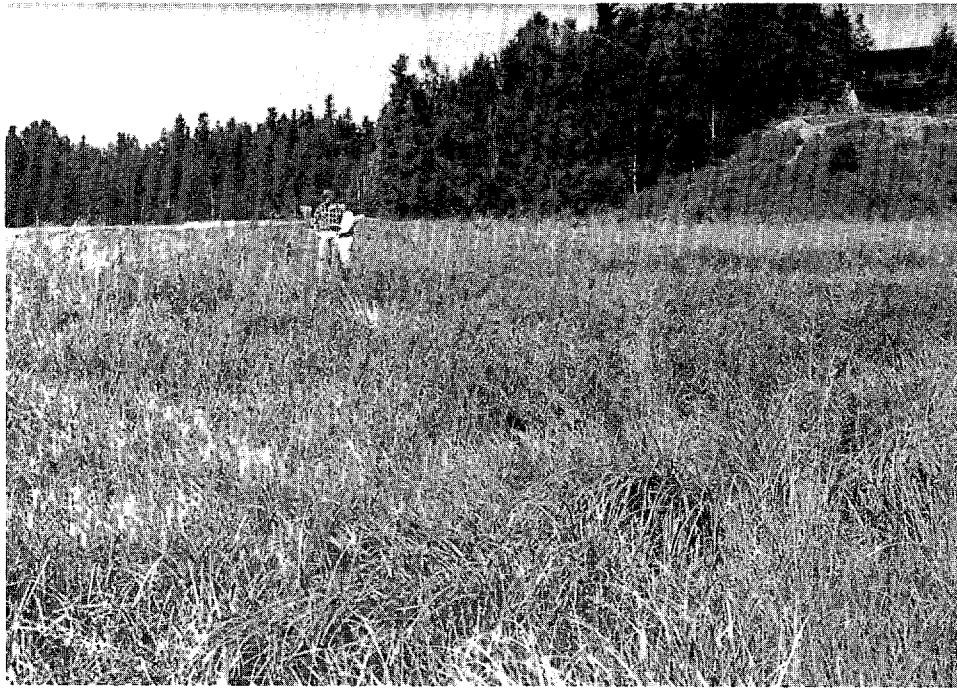
Plate 19. Successful revegetation on east side of Campbell Creek wetlands. Photographed in 1993, four years after sedge plugs were transplanted.

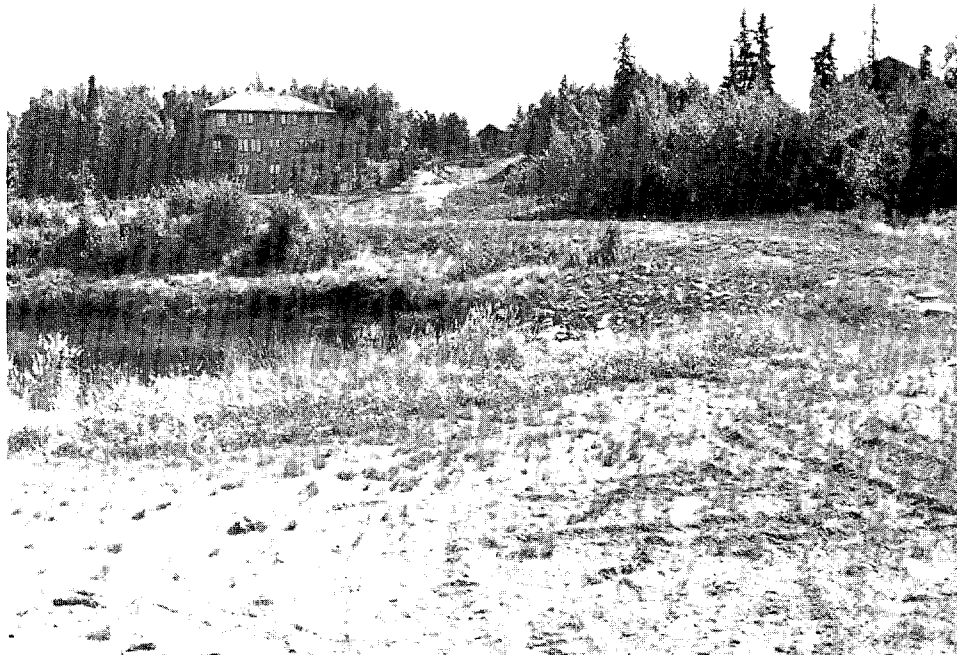
However, on the west side of the creek, revegetation was only partially complete. Approximately 50,000 sq. ft. was plugged with sedges or hydro-seeded. Sedges had re-established in the lower elevation areas (i.e., swales on northeast end, approximately 15% of west side), but the higher areas contained only patchy vegetation (some grasses, clover, *Potentilla* sp., which account for another 15% of the west side of the project). The northern portion contained patchy stands of grasses (20% of west side) on hummocky, uneven ground. The remaining or central portion (50% of west side) was hardpacked and nearly devoid of vegetation (Plate 20). A few sedge plugs (2-5 m spacing) were evident.

Approximately 17,500 sq. ft. of woody vegetation along the south stream bank had been cleared during construction activities. Re-establishment of the tree buffer occurred on only one-third (5000 sq. ft.) of the impacted area (appearing at extreme left in Plate 20). It is not known why trees were not planted along the remaining two-thirds of the impacted tree buffer (which would have continued along creek at least as far as riprapped area in Plate 20). The tree mixture called for in the revegetation plan (spruce, willow, and birch) also was apparently altered during installation. Of the 10 spruce trees indicated in the plan, only 5 trees were found. Other apparent changes included the presence of several mountain ash and aspen trees along with the stated birch and willow. The spacing between trees generally appeared too close (4 foot centers rather than the 6 foot spacing identified in the plan), but overall, the planted section (5000 sq. ft.) of the impacted tree buffer appeared to be functioning. Some natural invasion of willows was beginning on the far west end of the impacted stream bank (end of bank nearest riprap on Plate 20).

Plate 20. Human impact at the Campbell Creek wetlands (demonstrated by foot traffic, vehicle and bike tire tracks) has prevented the establishment of planted vegetation in parts of the western section. In this region, only the lowest (and wettest) areas were successfully vegetated. Below the house on left lies the only section of tree buffer that was replanted. The creek bank at the sewer line crossing was reinforced with riprap after erosion, appearing in center right of photo.

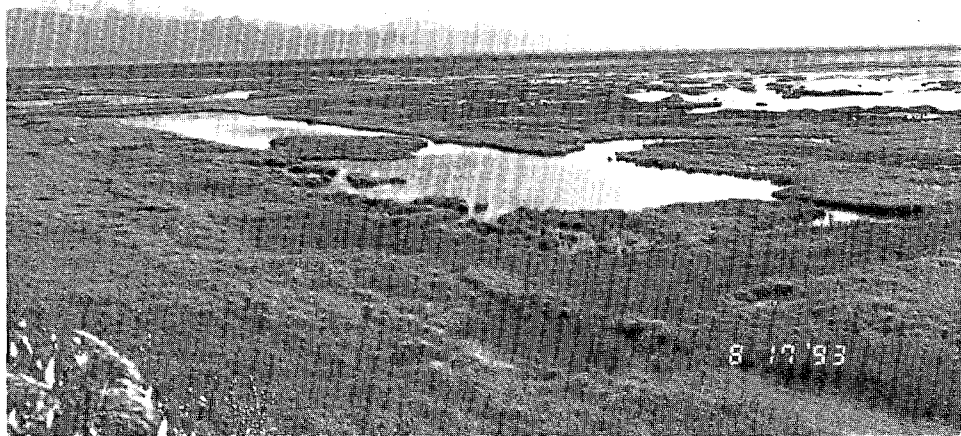
Plate 21.

Two of the rectangular waterfowl nesting ponds, constructed at the base of the Bayshore bluff in Anchorage some twenty years earlier (in 1973).

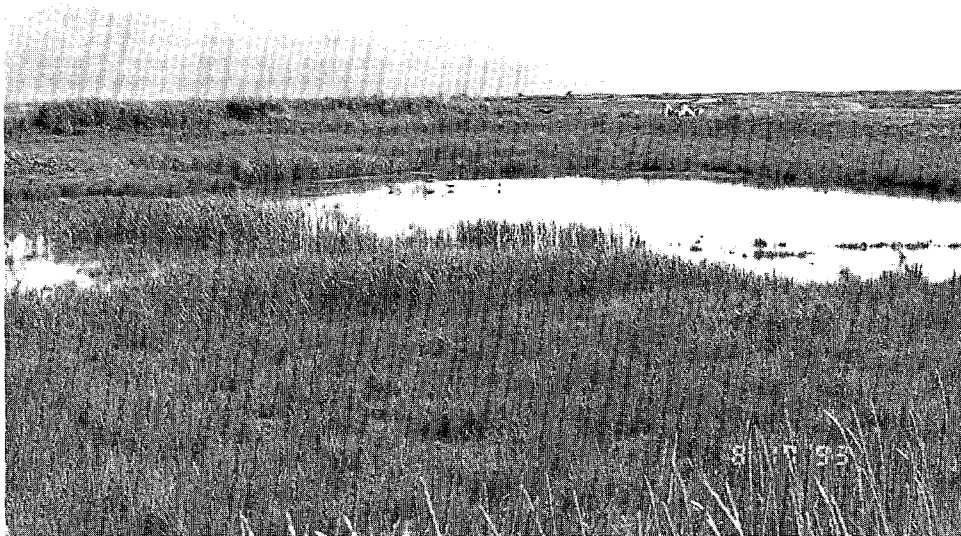
Plate 22.

Bayshore waterfowl ponds. Although perhaps not actively used for nesting, the constructed ponds do receive considerable waterfowl use, such as from these feeding greater yellowlegs.

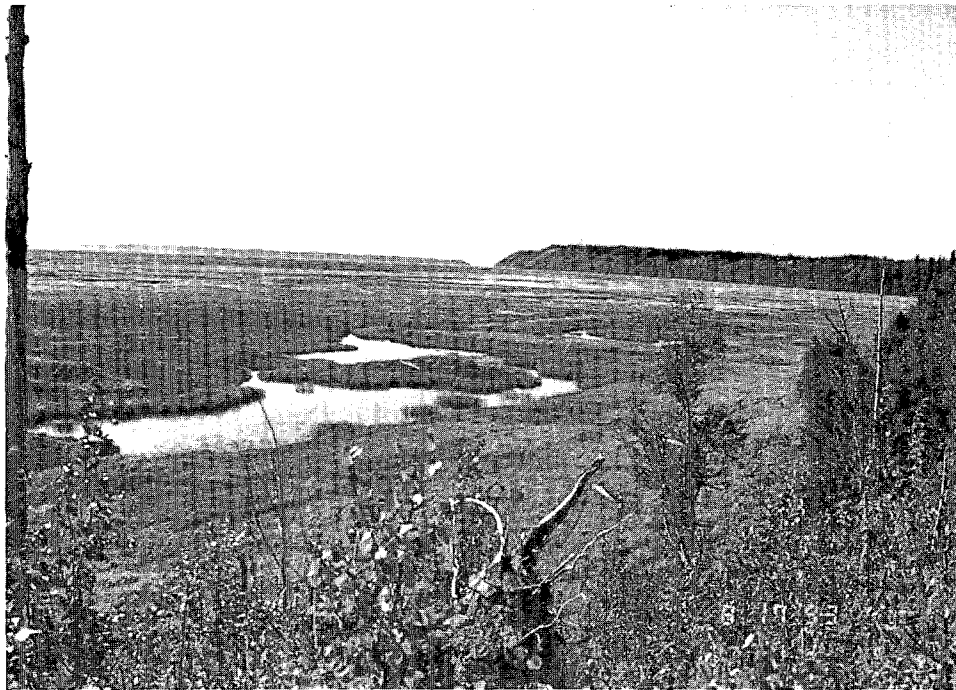
Plate 23. 20 years of weather and tides have altered the waterfowl ponds below Bayshore, changing their original shape and drainage patterns. The nesting island was built too high to revegetate well.

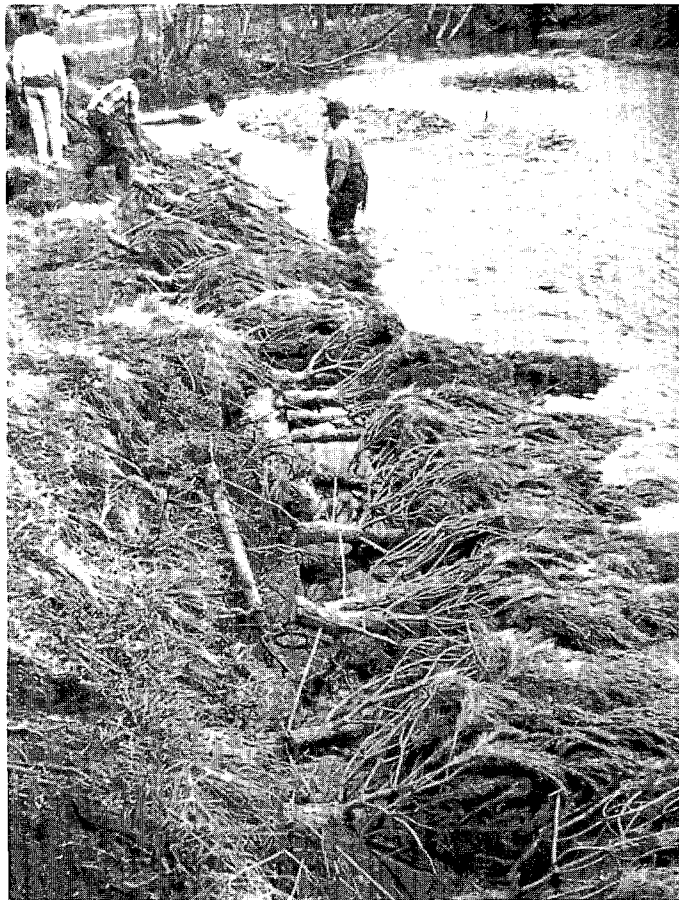
Plate 24. Volunteers installing a layer of donated Christmas trees on the eroding bank of Campbell Creek in 1992. Trees were anchored with a cable strung through the bases. Source: Fritz Kraus, ADF&G.

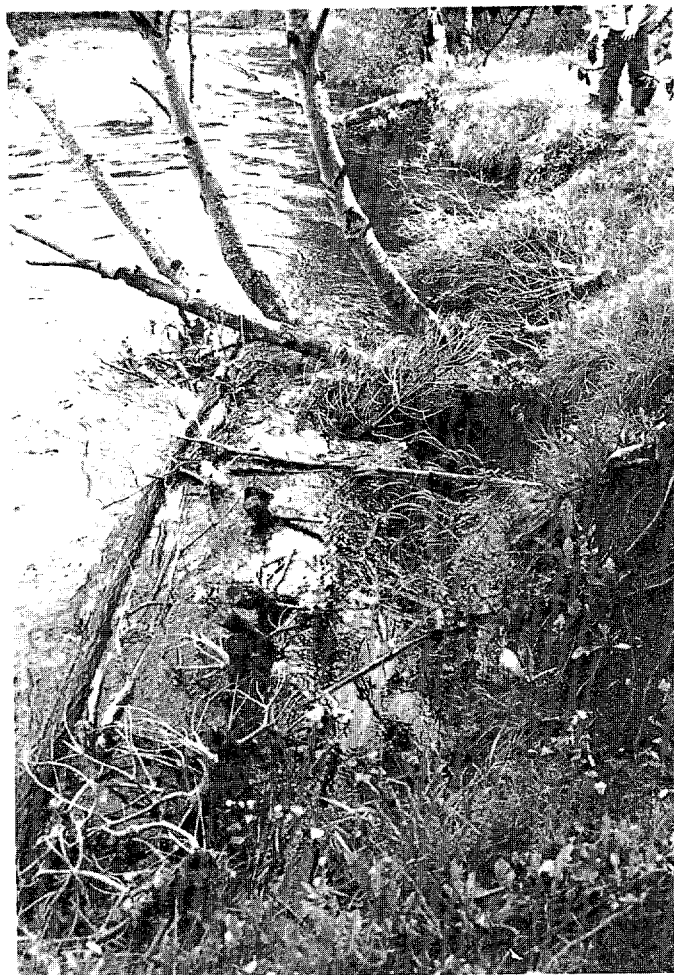
Plate 25.

The tree revetment installed the previous year (Plate 24) is stabilizing the eroding bank along Campbell Creek. In addition to slowing the current, the tree branches provide eddies and cover for juvenile fish.

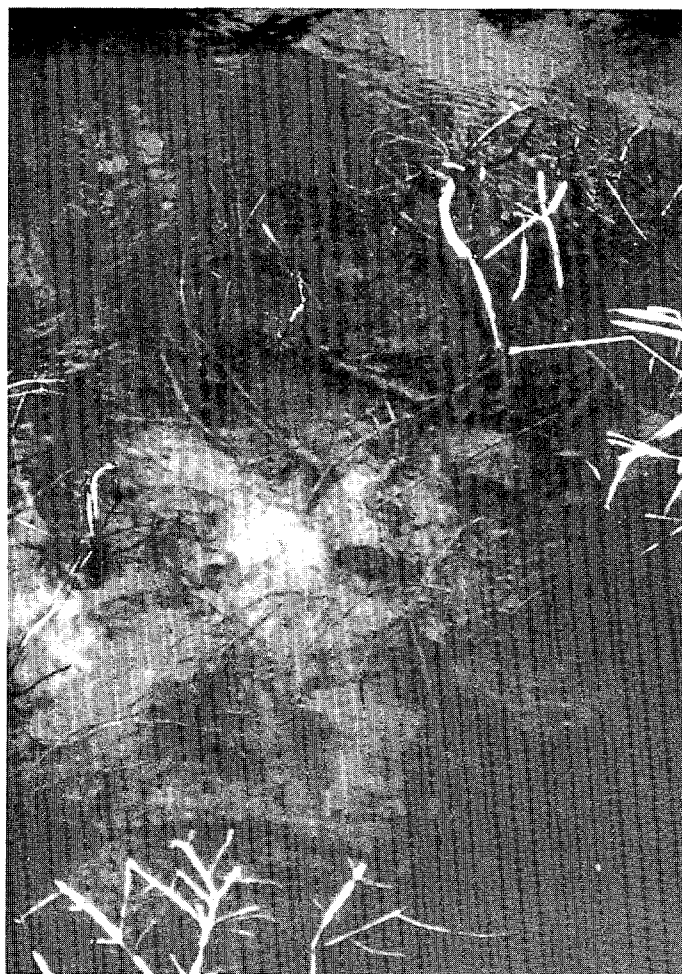
Plate 26.

The branches of the tree revetment cause water to slow and silt to drop out along the creek edge, rebuilding the eroding bank. Eventually, the accumulation of silty bank will be replanted with woody vegetation. Source: Fritz Kraus, ADF&G.

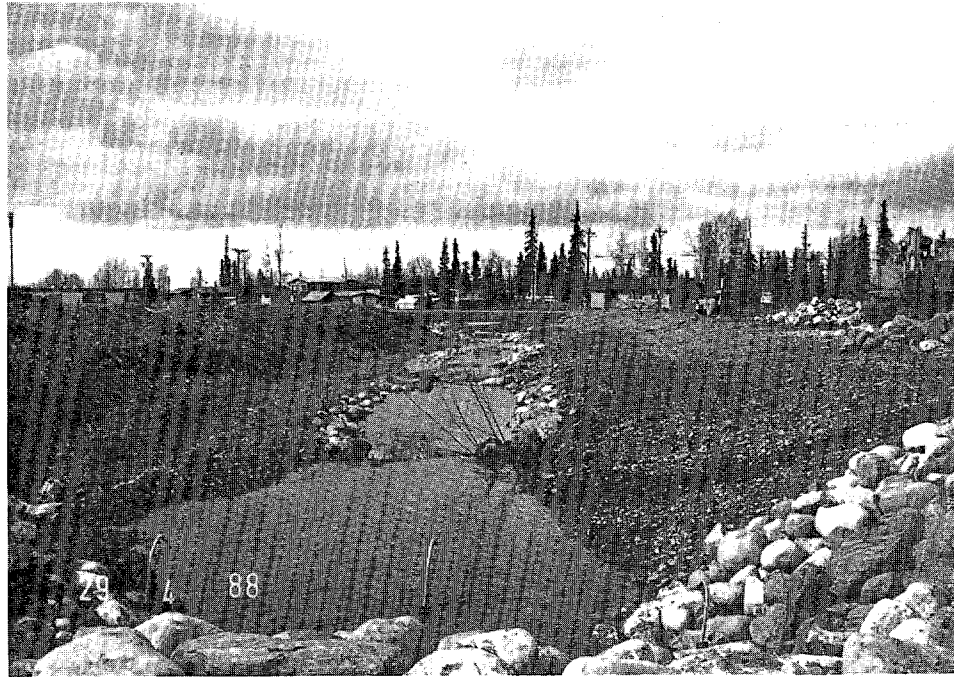
Plate 27. Realignment of Little Campbell Creek at Abbott Loop School. The new channel (700 feet long) included pool and riffle sequences to enhance fish habitat. 1988 ADF&G file photo.

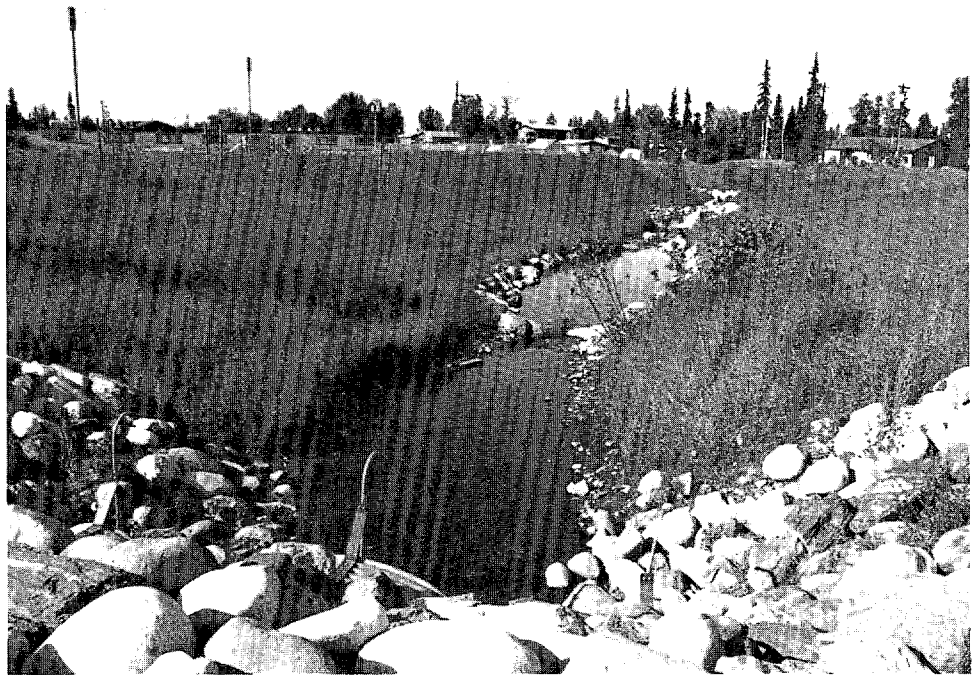
Plate 28. The same view as above, taken the following year after replanting. 1989 ADF&G file photo.

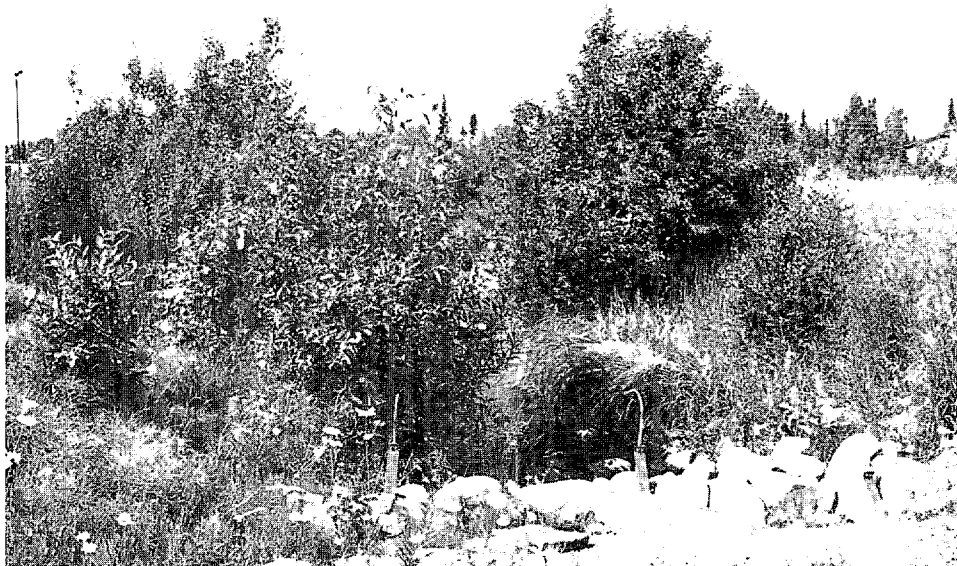
Plate 29.

The same view of the realigned section of creek at Abbott Loop School, five years after planting. The view from the top of the culvert is almost obscured by willow bushes.

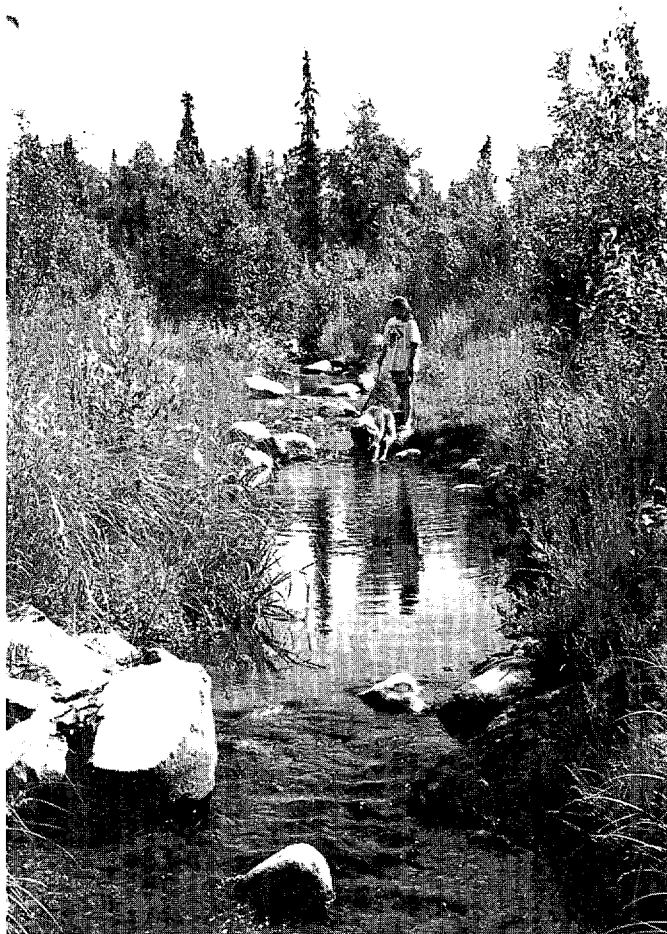
Plate 30.

A realigned section of Little Campbell Creek near Abbott Loop School in 1993. The pool and riffle sequences continue to function as planned. The project area now serves as a neighborhood park.

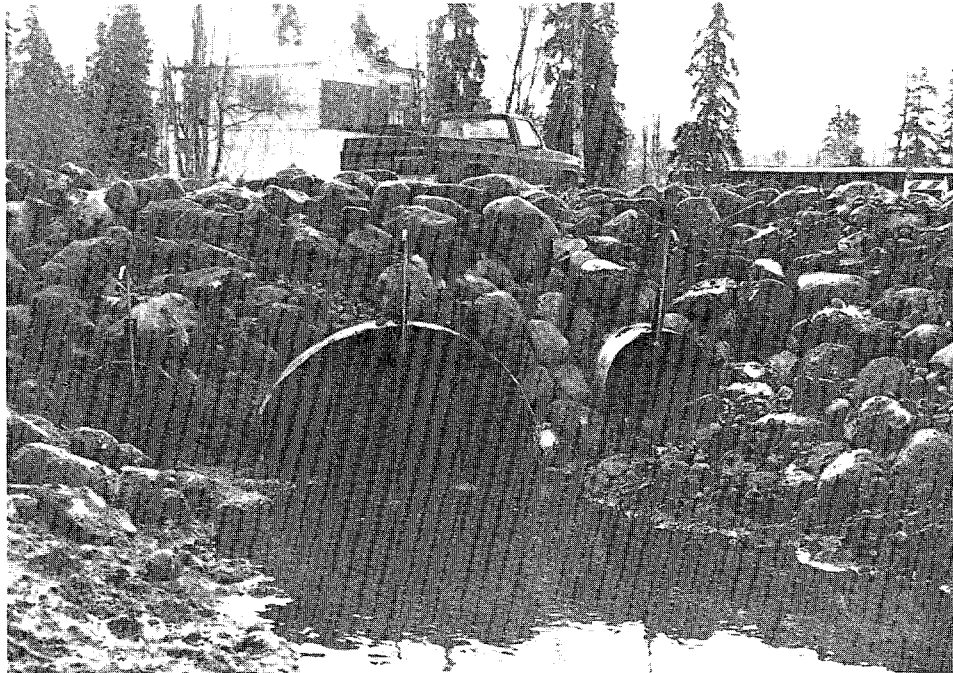
Plate 31.

The culvert under Atkins Place was reinforced with round stones when first installed over the realigned reach of Little Campbell Creek. 1988 ADF&G file photo.

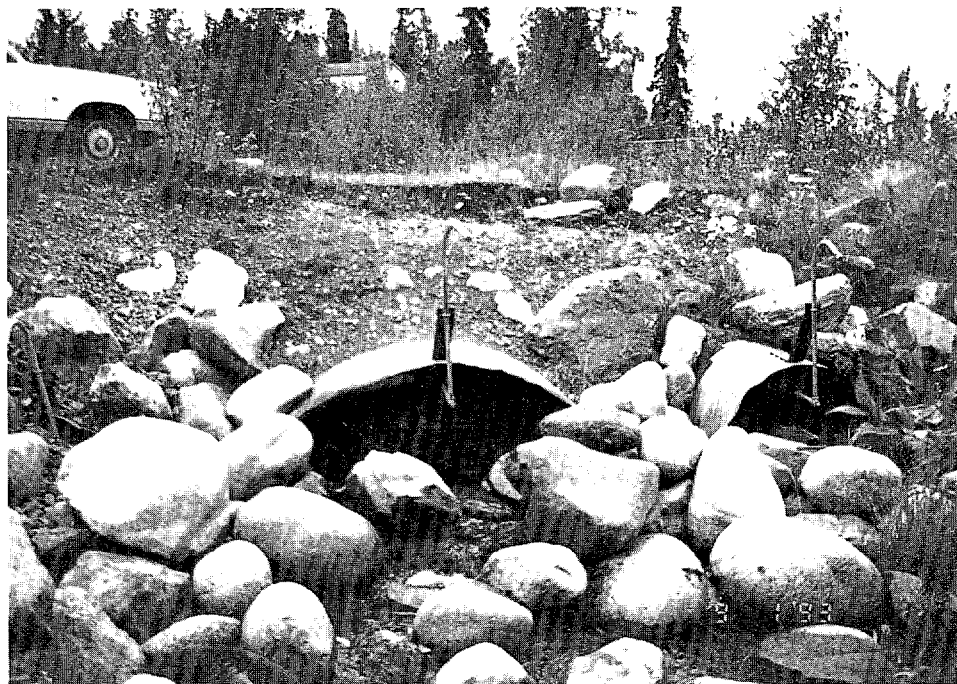
Plate 32.

The same culvert in 1993. The stones proved to be irresistible to neighborhood children. The opening on the left is completely obscured by fill (note wand marker above), and the other two culvert openings are substantially blocked, undermining the objectives of flood conveyance and fish movement through the project area.

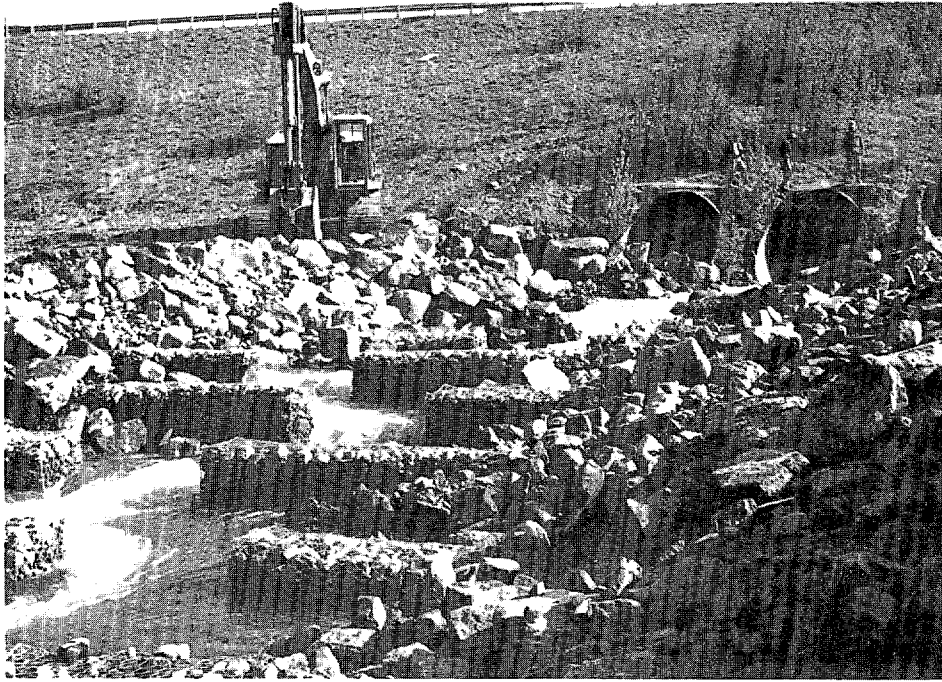
Plate 33. Rabbit Creek fish pass during construction in 1988. The gabion weirs are intended to break the elevation change into smaller gradations, so that fish can negotiate their way upstream and through the culvert. ADF&G file photo.

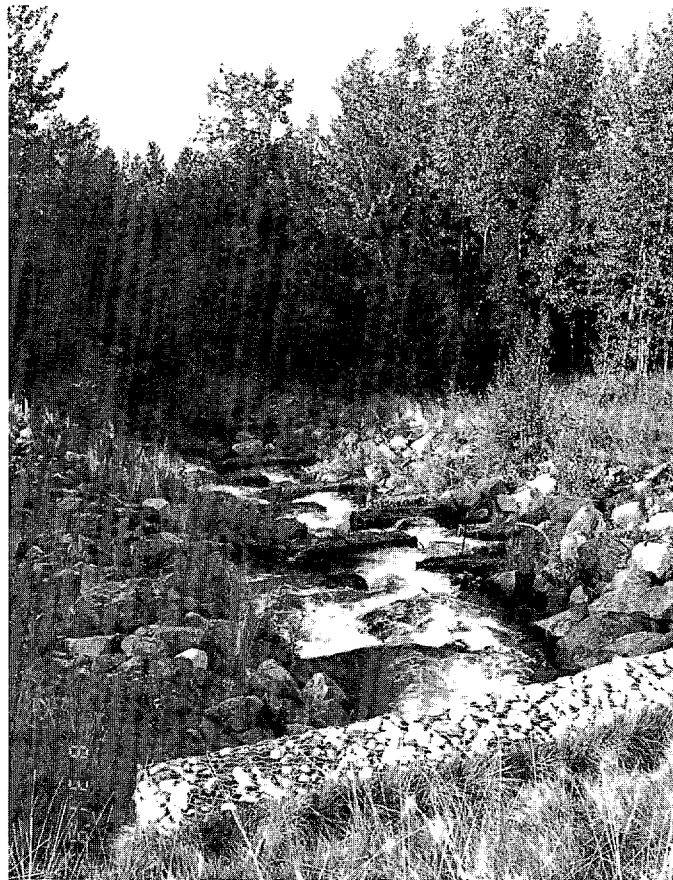
Plate 34. Rabbit Creek fish pass in 1993. The structure continues to function as intended, although no fish were observed there. Other obstacles downstream may be interfering with fish migration through this project area.

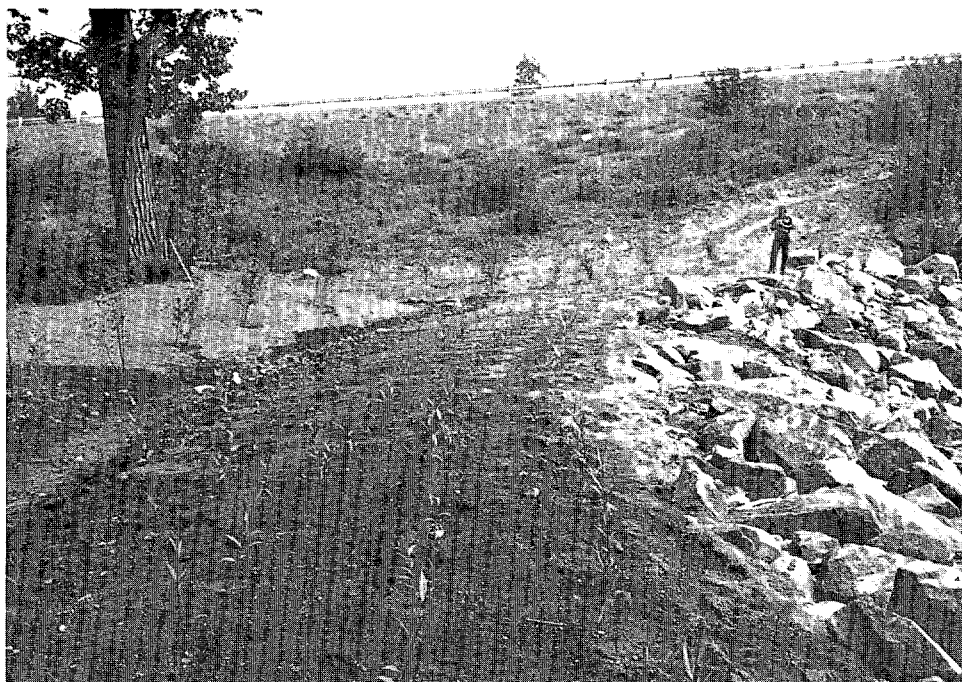
Plate 35. The west bank of Rabbit Creek just after replanting with riparian vegetation. Rooted willow cuttings are in the foreground; 4-6 ft. high transplanted willow trees in rear. 1988 ADF&G file photo.

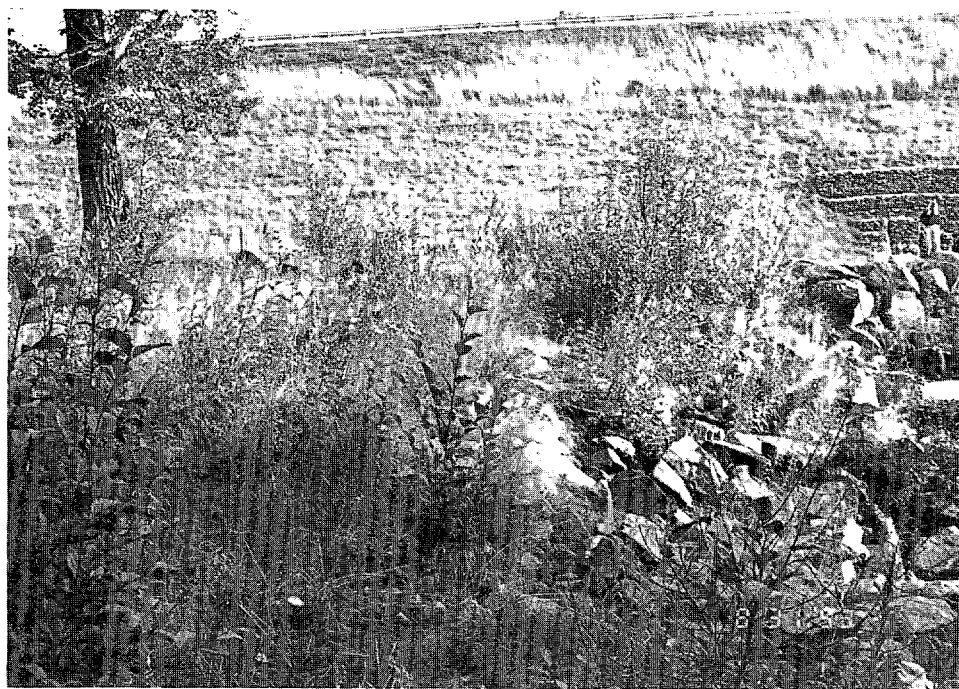
Plate 36. The same view in 1993. Several shrubs in the foreground are new alders that have grown in, not the planted willows. Willow survival has been spotty (cf. Plate 35). Grazing damage the first season from a neighbor's horse could be partly responsible.

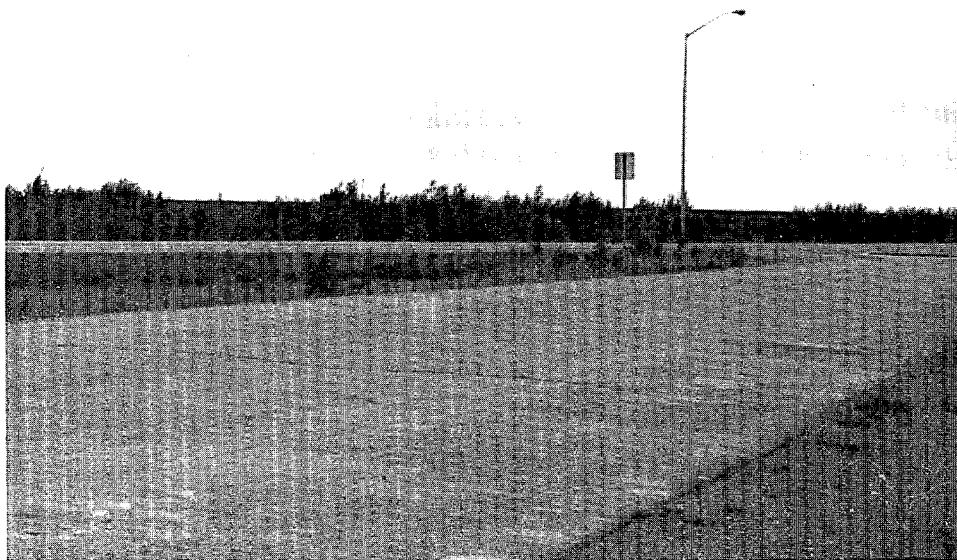
Plate 37. The removal of this access road across the south end of Potter Marsh served as mitigation for another unrelated fill permit. 1984 ADF&G file photo.

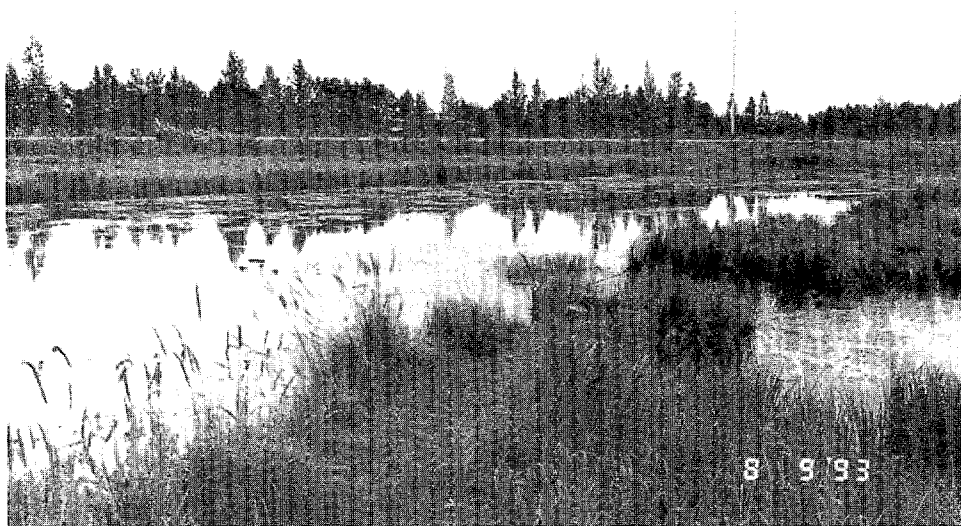
Plate 38. Same view as above in 1993, the new Seward Highway in rear of photo. The outside edges of the former road fill area have revegetated well, though the outline is still clearly visible.

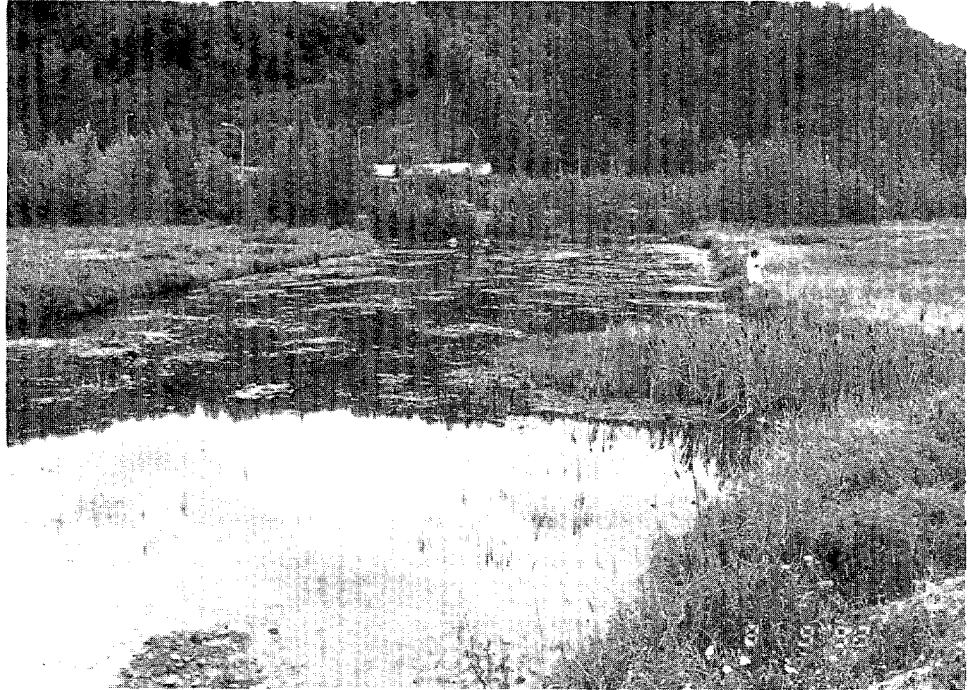
Plate 39.

View from northwest end of the former road fill area at Potter Marsh, as seen from the New Seward Highway. Foreground portion is very shallow (2" deep). Marestalk visible in formerly filled area. Many woody species were planted on embankment at rear.

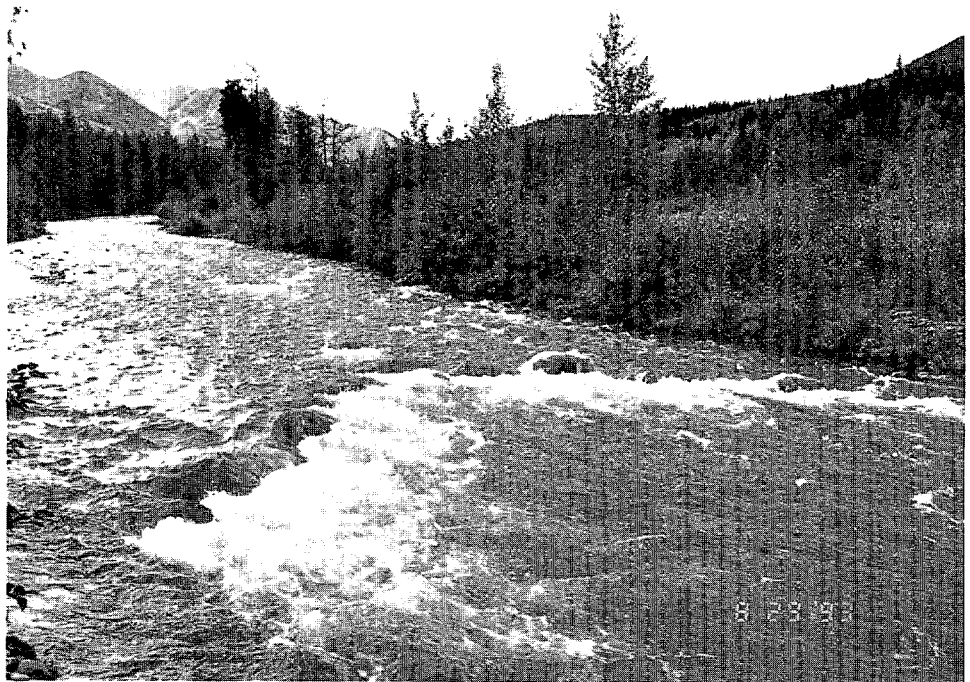
Plate 40.

A vortex rock weir installed in Resurrection Creek in 1992. These structures are intended to produce interconnected pool habitats both upstream and downstream, while also permitting sediment transport through the structure. Some boulders have shifted position.

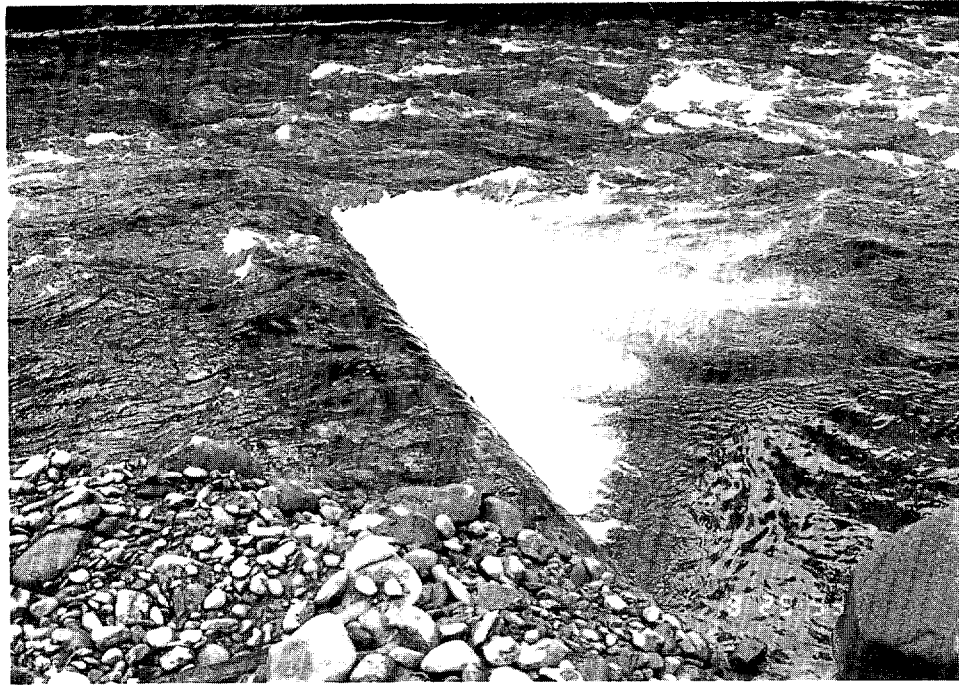
Plate 41. Log barb structure on Resurrection Creek, imbedded into the streambank for half its length. A downstream pool forms at the tip of the log.

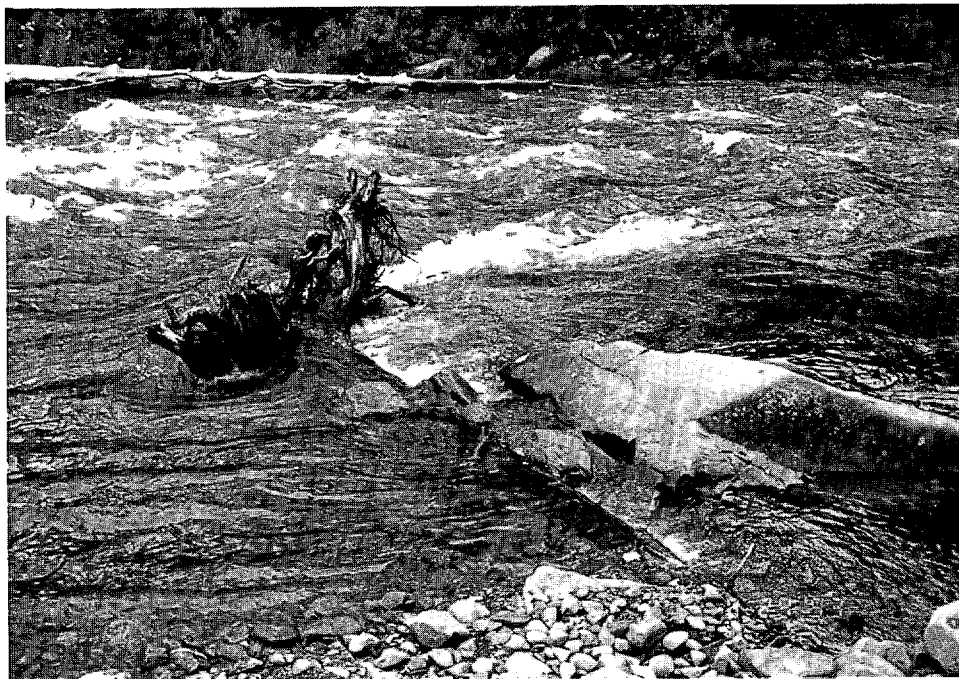
Plate 42. Tree root wad cabled to a boulder in Resurrection Creek. Root wads provide cover for fish, and help to vary the flow rate and channel depth.

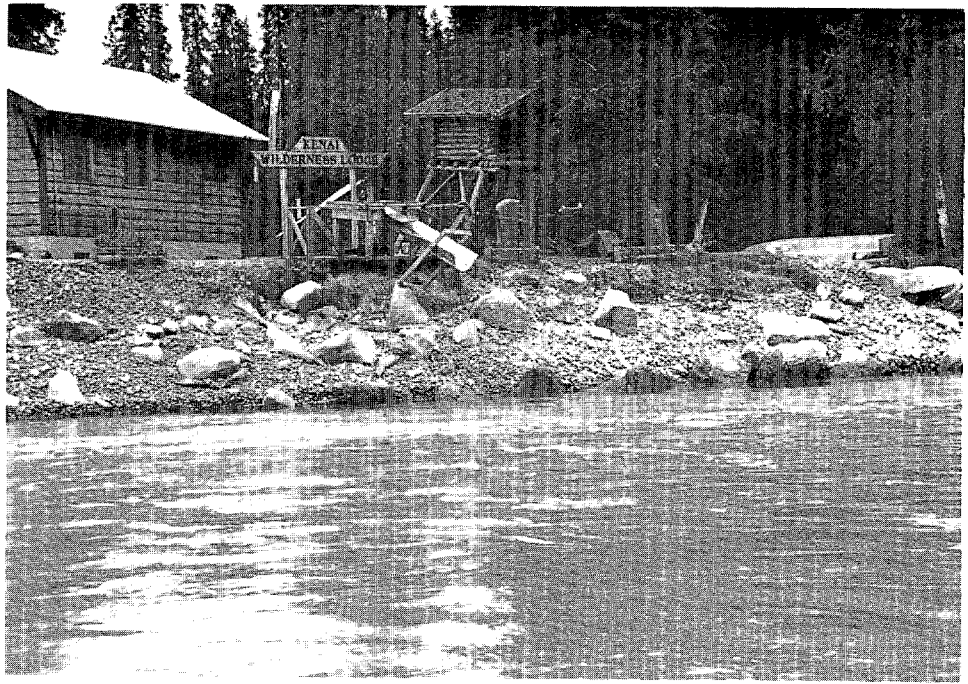
Plate 43. Bank in front of the Kenai Wilderness Lodge in spring 1993, before installation of the bioengineered bank restoration project. ADF&G file photo.

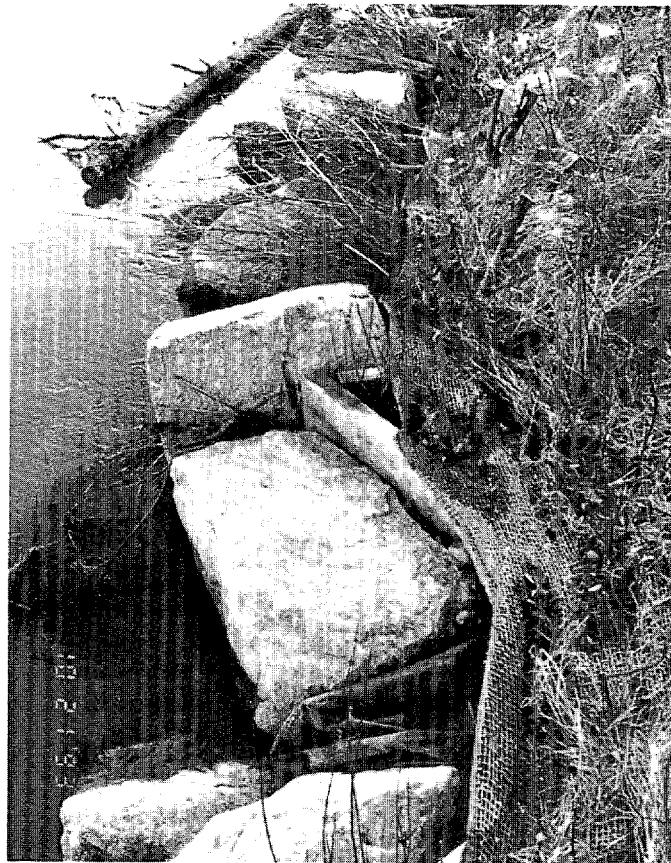
Plate 44. Bioengineered bank at Kenai Wilderness Lodge. A wooden timber was used to facilitate the transition between the rock at the toeline and the planted bank above. Willow fascines (over rocks), live stakes, and willow sprigs are visible on bank.

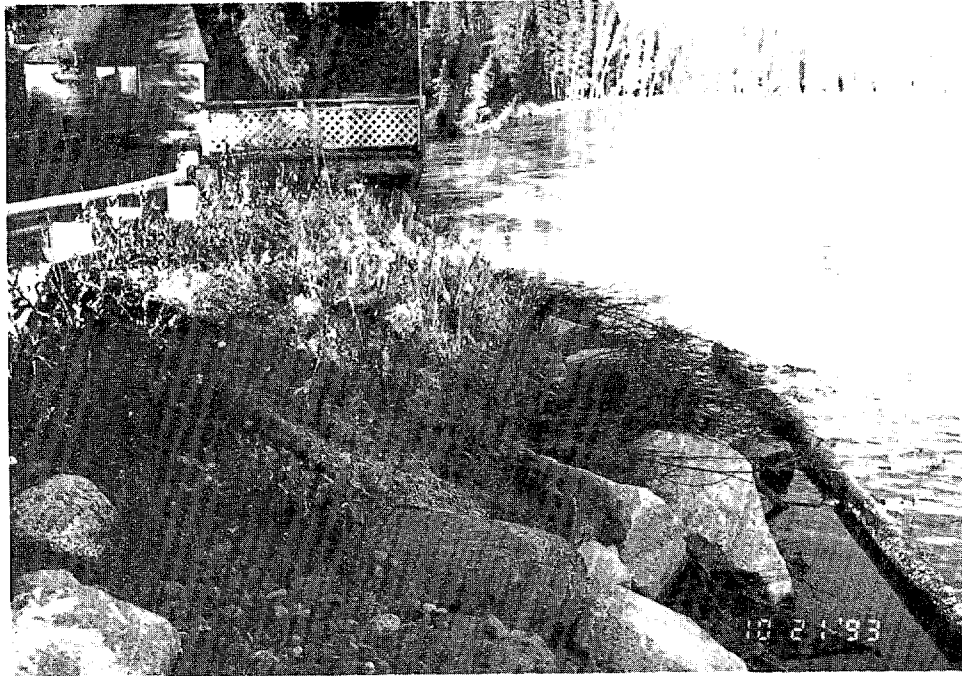
Plate 45. General view of the replanted bank at the Kenai Wilderness Lodge bioengineering project. The horizontally-installed fascines (which did not survive and resemble dead branches) and cabled-in spruce trees are at right.
