**Restoration and Enhancement of Aquatic Habitats in Alaska:
Case Study Reports, Policy Guidance, and Recommendations**

By
Betsy L. Parry and Glenn A. Seaman

Technical Report No. 94-3

July 1994

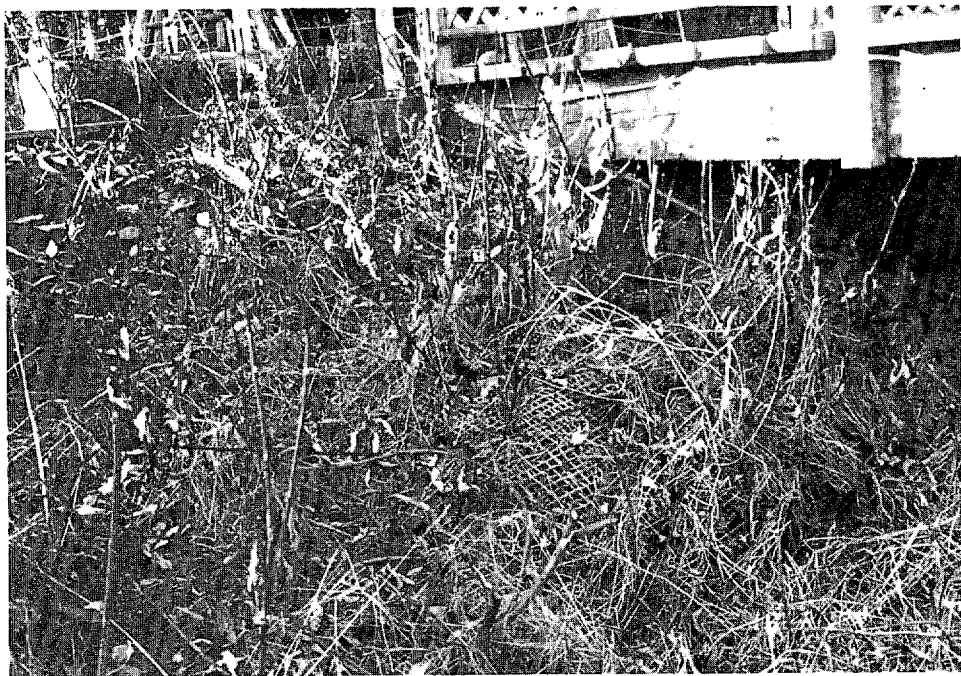
Plate 46. Close-up of the various planted woody materials after high flood waters receded in the fall. Rooted willow cuttings appear to be the most successful after the first season.

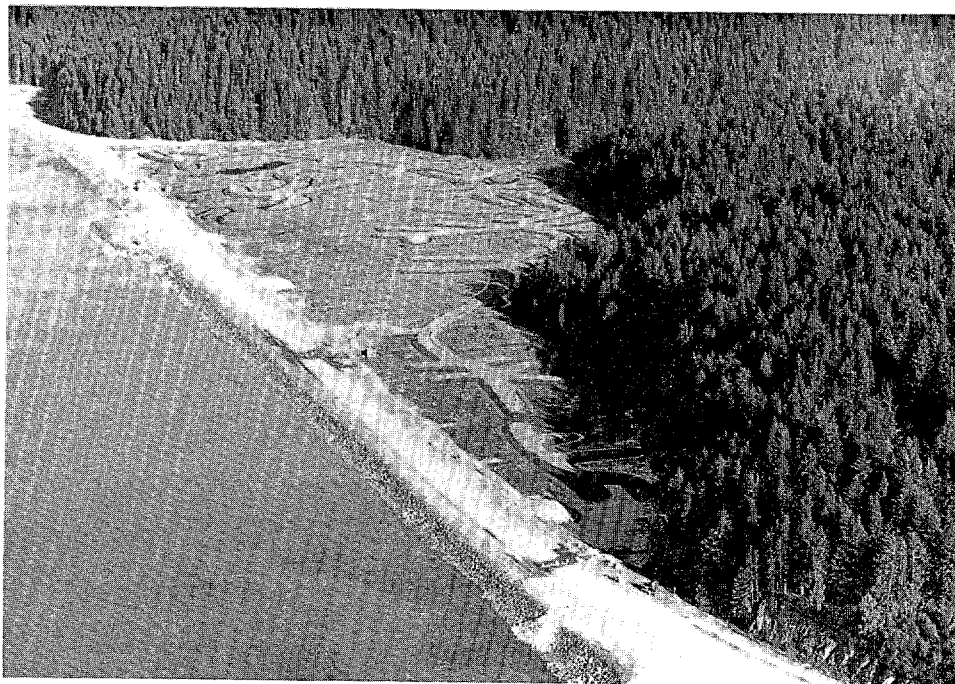
Plate 47. Bradley Lake Hydroelectric Plant waterfowl mitigation area in 1992. The water impounded inside a road dike was designed to become a waterfowl nesting area, with islands laid out in finger-like configurations. Low water levels and slow revegetation has hampered the project. Source: Dan Rosenberg, ADF&G.

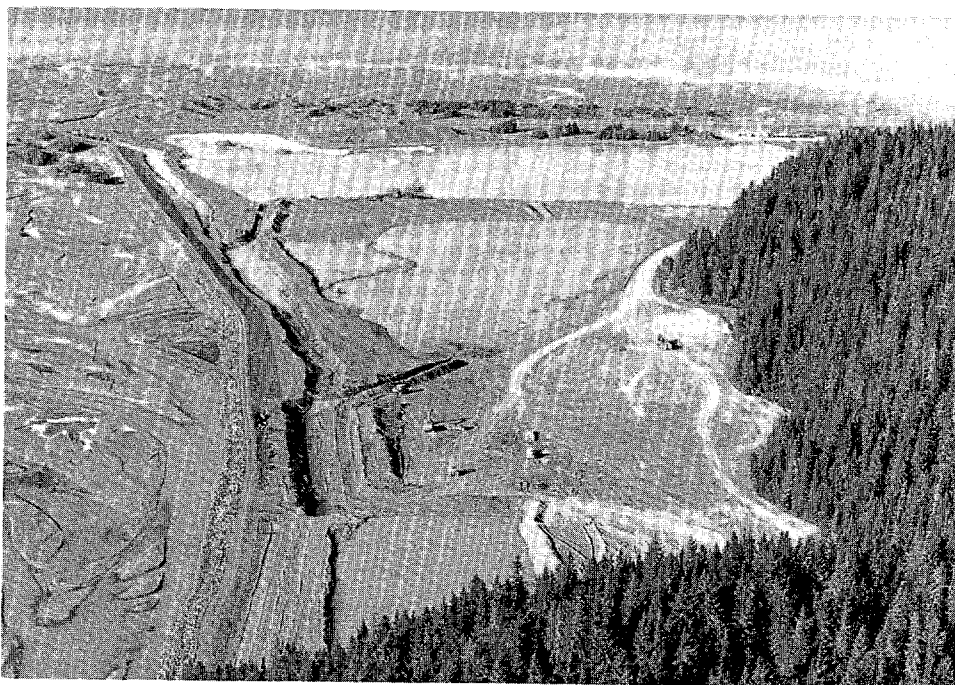
Plate 48. The Martin River delta at the conclusion of gravel mining operations. The armored dike on the left protected the mining operations (and later the fish ponds) from large fluctuations in flow. The spawning channel lies alongside and just to the right of the dike, and connects to each of the rearing ponds. Pit 1 is in the foreground, with Pits 2 and 3 behind, and Kachemak Bay in the distance. Source: Dan Rosenberg, ADF&G.

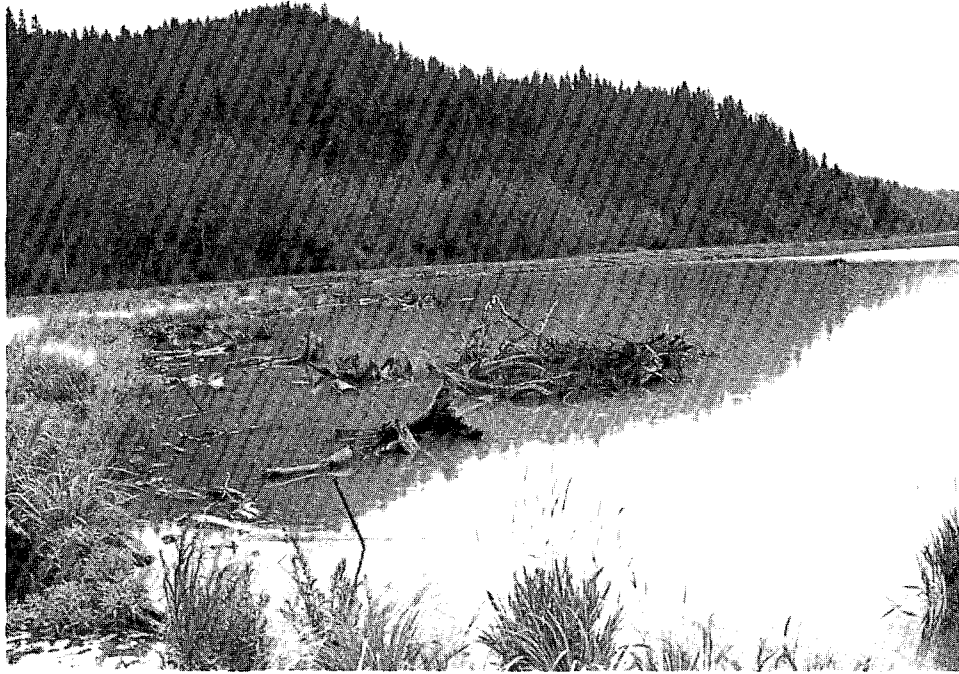
Plate 49. Former gravel pits at the Martin River delta in 1993. Woody debris was added along the margins of the sterile ponds to improve cover and fish habitat features.

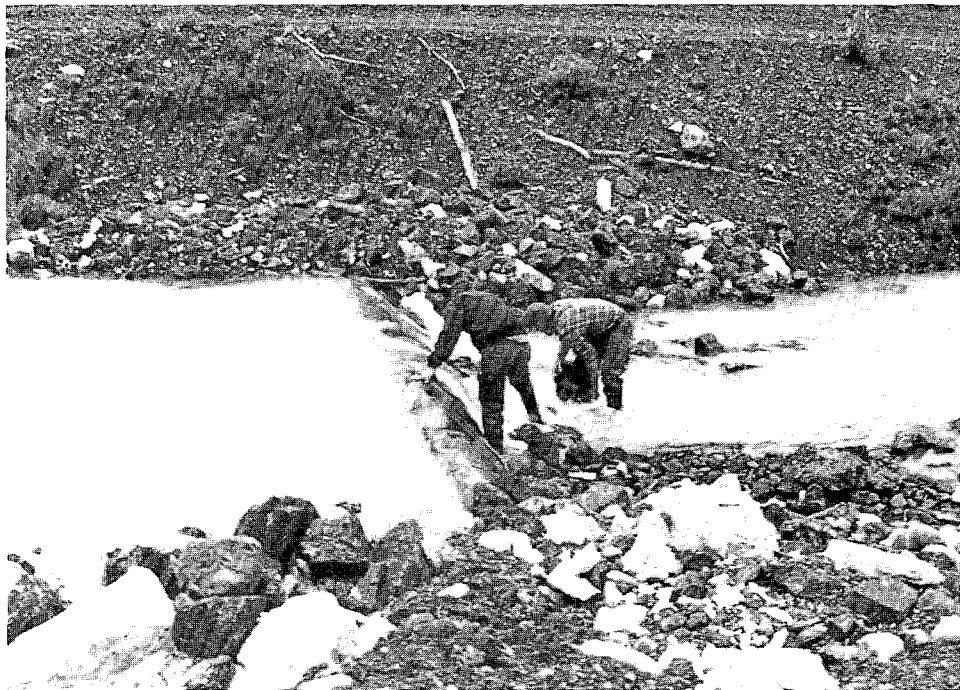
Plate 50. A notched log weir in the constructed spawning channel at the Martin River delta. When visited in 1993, several riprap rocks had washed below the notch, preventing fish from accessing the upper reaches of the spawning channel and other rearing areas. Regular inspection and maintenance is necessary for all instream structures.

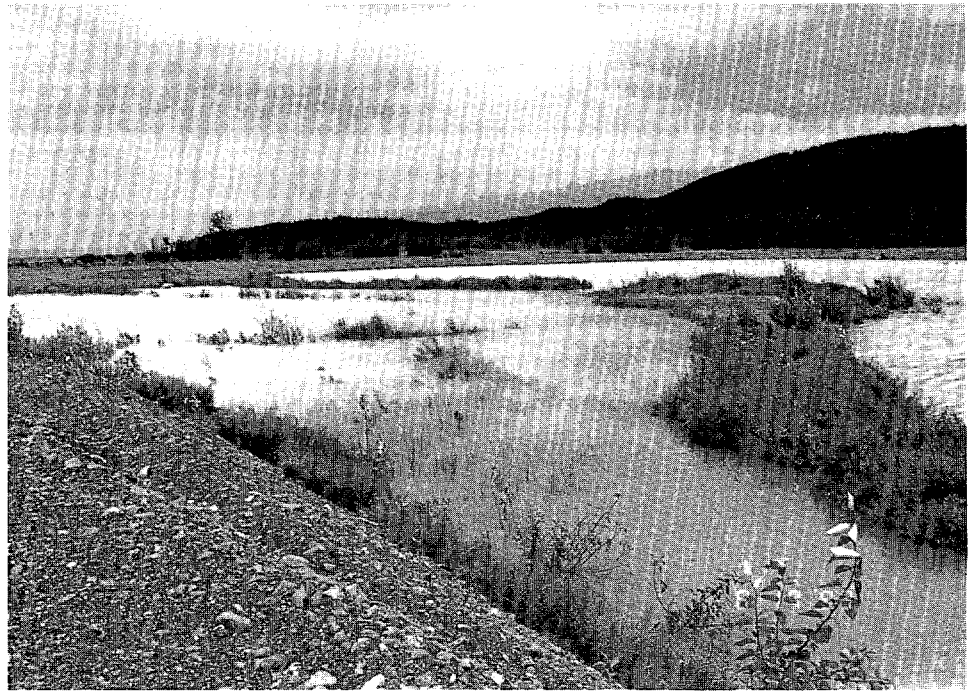
Plate 51. Regrowth at the Martin River fish ponds in 1993. Here, on one side of Pond 2 (cf. Plate 48), a few "islands" and some existing vegetation were left in place. This area contained the most regrowth observed, including some emergent vegetation. A higher amount of fine sediment in the local substrate may also have aided revegetation.

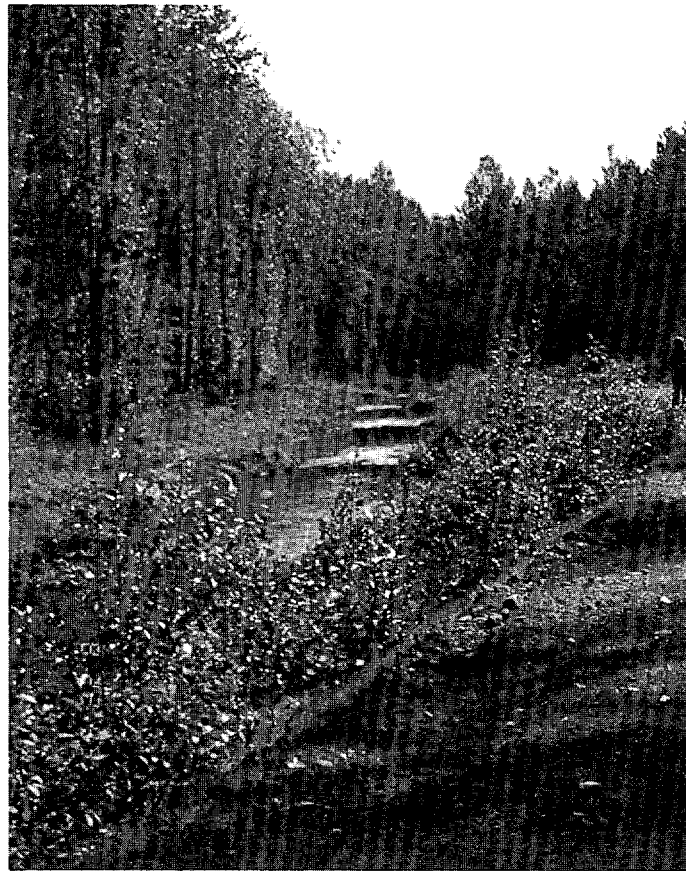
Plate 52. Box Canyon Creek rearing ponds near Seward, built as a series of small ponds separated by shallow riffle areas.

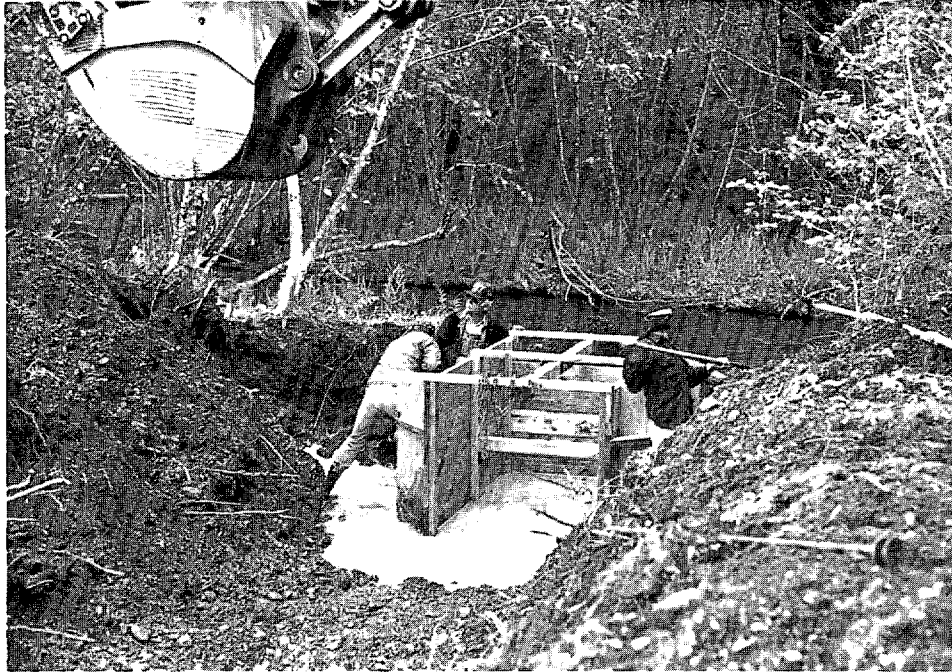
Plate 53. Headgate installed in the short channel between Box Canyon Creek and the existing gravel pond to control the flow through the mitigation area. 1987 ADF&G file photo.

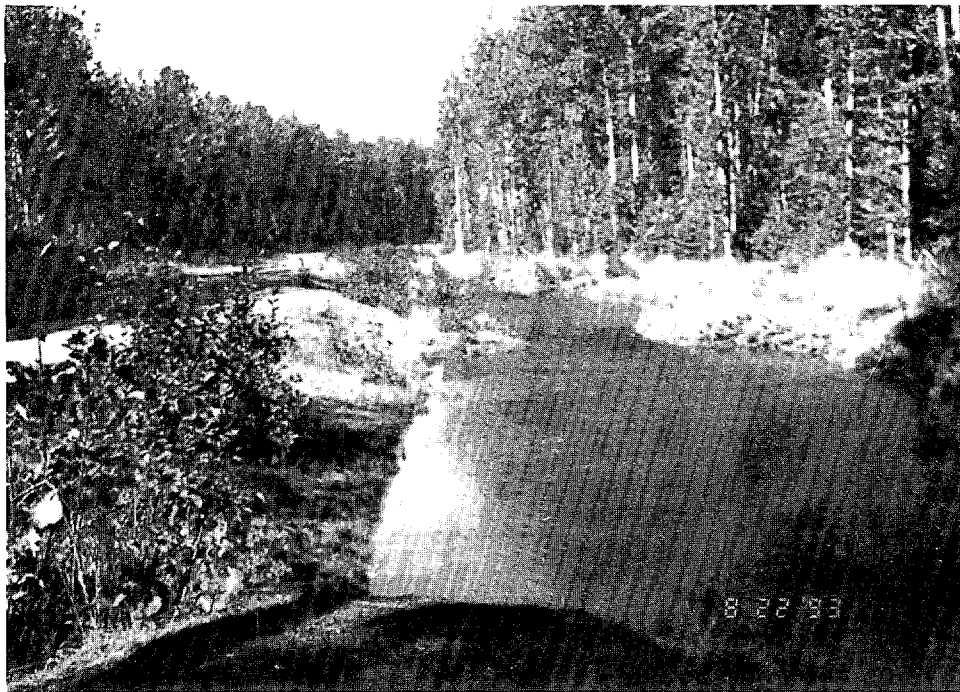
Plate 54. View of Box Canyon Creek rearing ponds from the downstream end, showing a lack of instream and bank cover, and the steeply sloped banks.

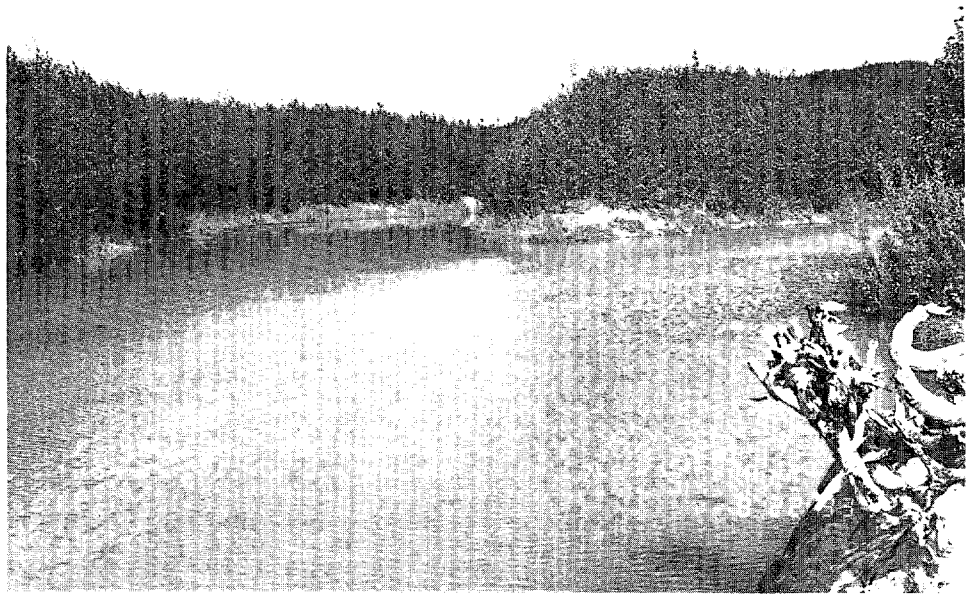
Plate 55. View upstream towards confluence of the two branches of the Fourth of July Creek spawning channel. Outlet to Resurrection Bay lies behind photographer.

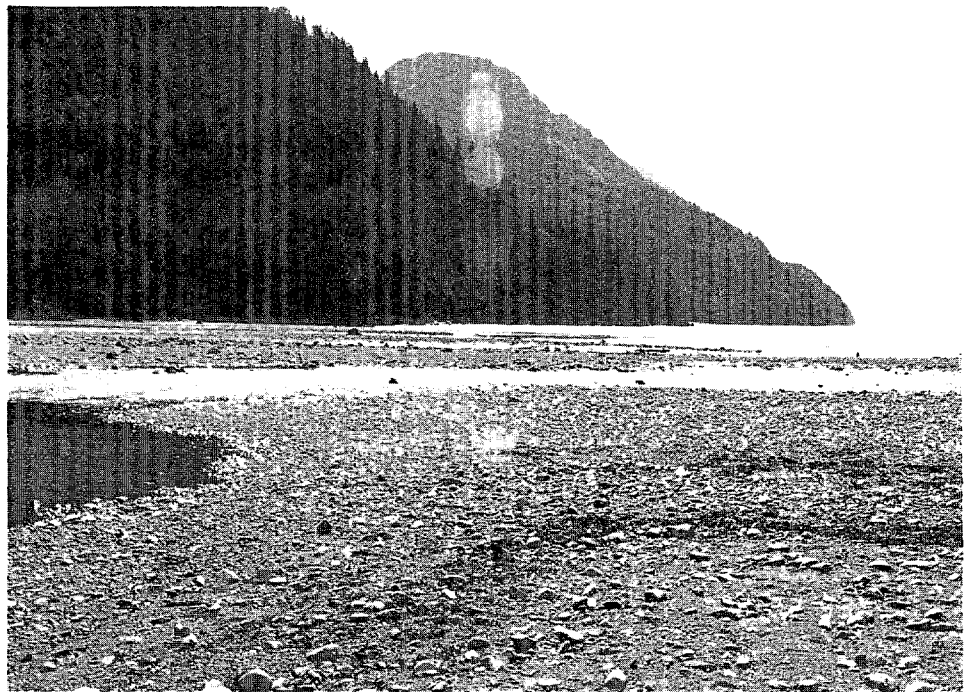
Plate 56. The mouth/entrance to the spawning channel on Resurrection Bay is blocked by beach berms. The material deposited at the mouth of Fourth of July Creek (adjacent to spawning channel, just left of photograph) is formed into berms by wave action.

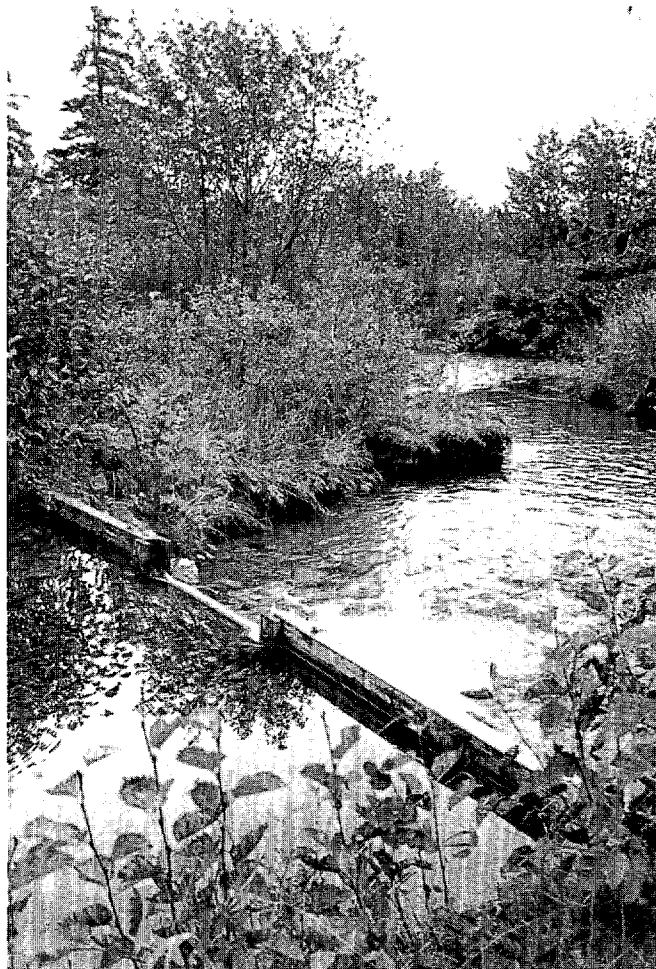
Plate 57. Confluence of forks A and B of the Mile 25 spawning channel, Copper River Delta. Photo shows a wooden drop structure in Channel A, and on the far bank, a grass-covered wooden platform that was intended to provide hiding cover for fish, simulating an undercut bank.

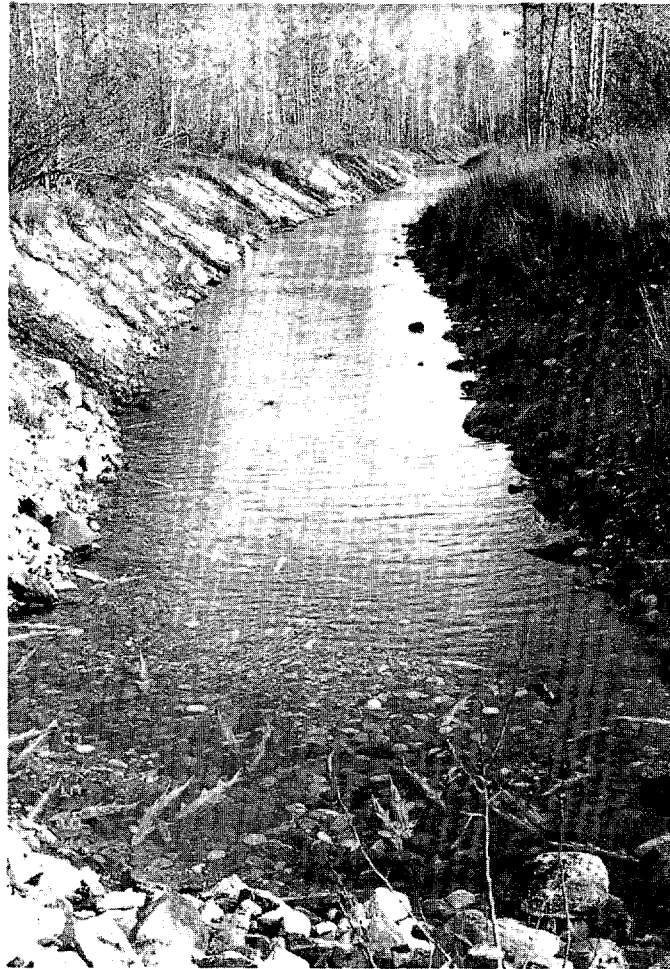
Plate 58. Herman Creek spawning channel at its origin. Groundwater flows from the Klehini River through a gravel road dike and into the constructed channel. Spawned-out salmon in foreground.

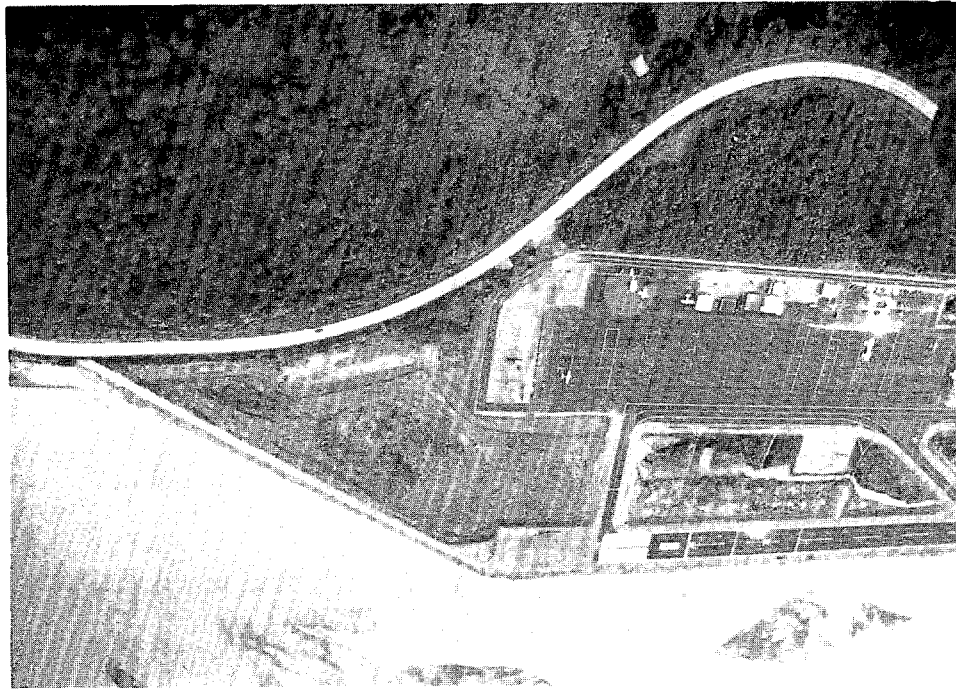
Plate 59. West end of Haines Airport project area in 1992, showing created emergent wetland west of and between the old and new runways. The new runway is along the Chilkat River, at bottom of photograph. The created drainage slough runs from an infiltration galley at far left, across the new wetland area to a taxiway at far right. Source: Ron Josephson, ADF&G.

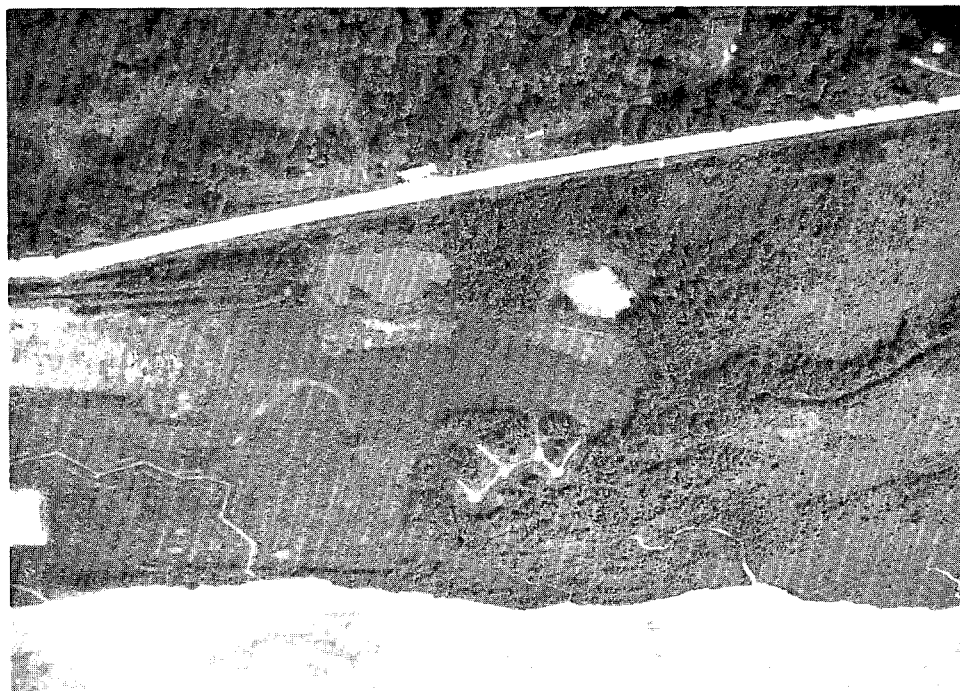
Plate 60. East end of Haines Airport expansion in 1992, showing the area of restored wetland (center left), the re-routing of Yindastuki Creek around the end of the new runway at bottom left (zigzag pattern), two of the created rearing ponds in center, as well as the First Iron Pond (actually several connected finger channels) at lower center (see also Figure 8). Source: Ron Josephson, ADF&G.

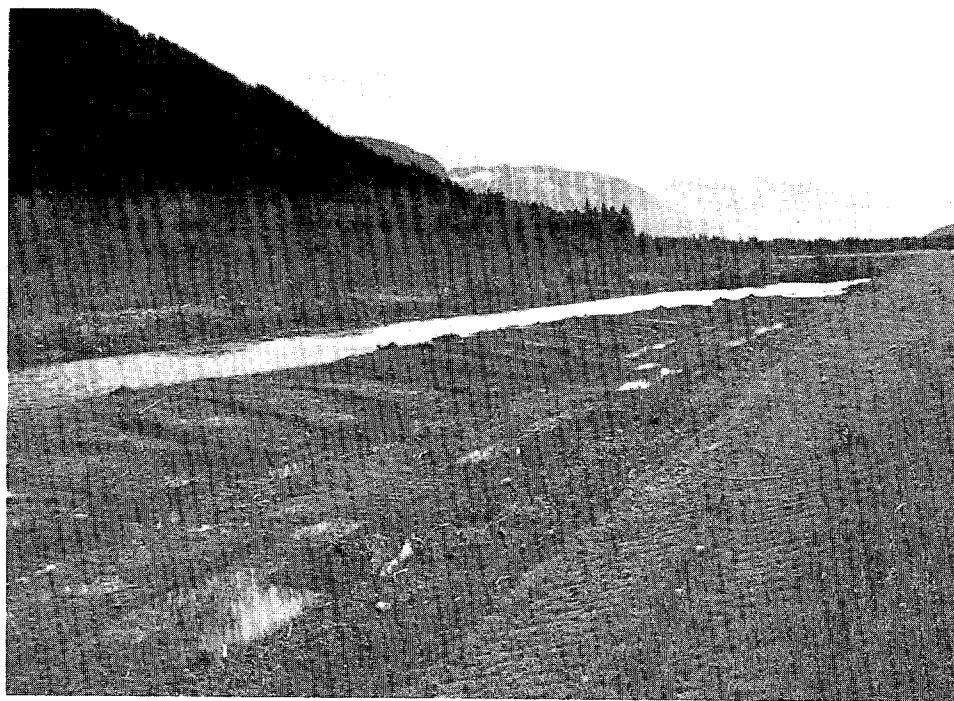
Plate 61. 1992 vegetation monitoring photo of the created emergent wetlands and drainage slough at west end of Haines Airport (cf. aerial shot, Plate 59). Source: Ron Josephson, ADF&G.

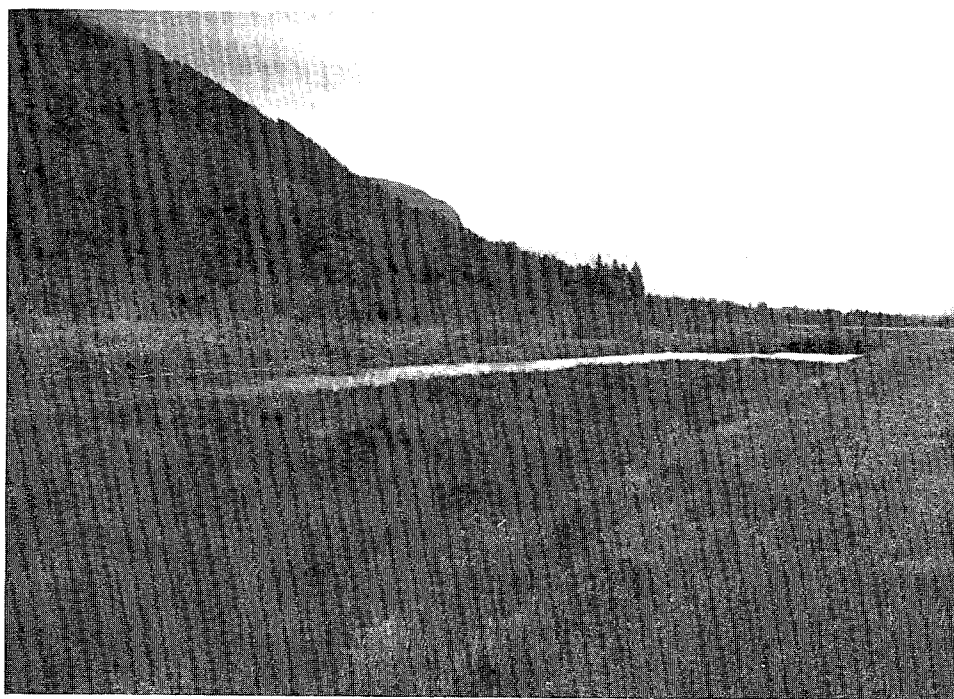
Plate 62. New vegetational cover on same site one year later in August 1993. The drainage slough has become productive coho rearing habitat. Source: Ron Josephson, ADF&G.

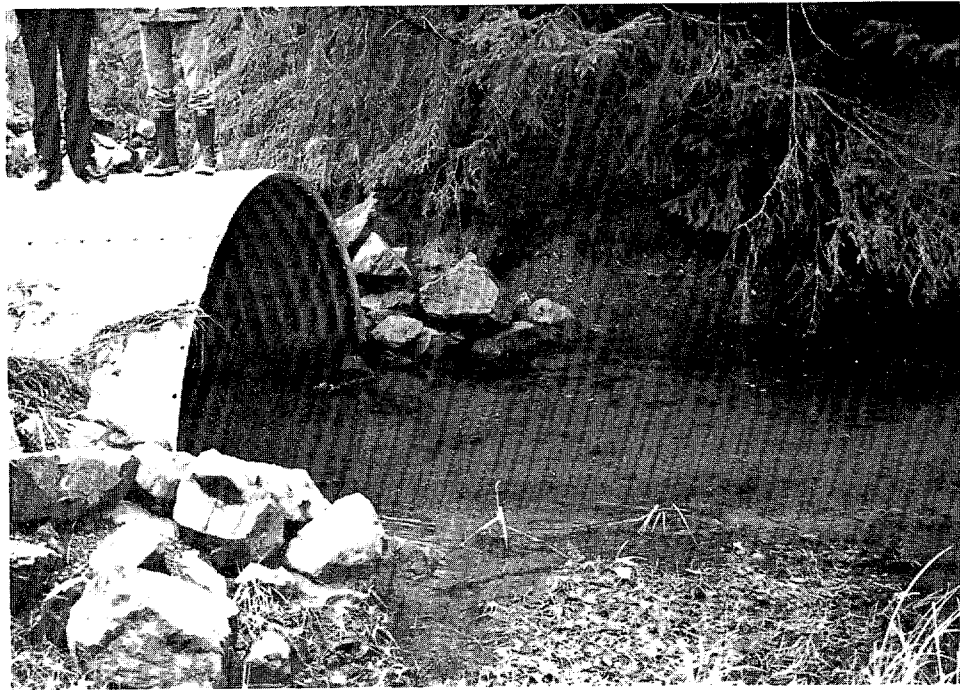
Plate 63. Arched culvert installed to replace perched culvert on Jordan Creek as part of the mitigation package for Juneau Airport expansion project.

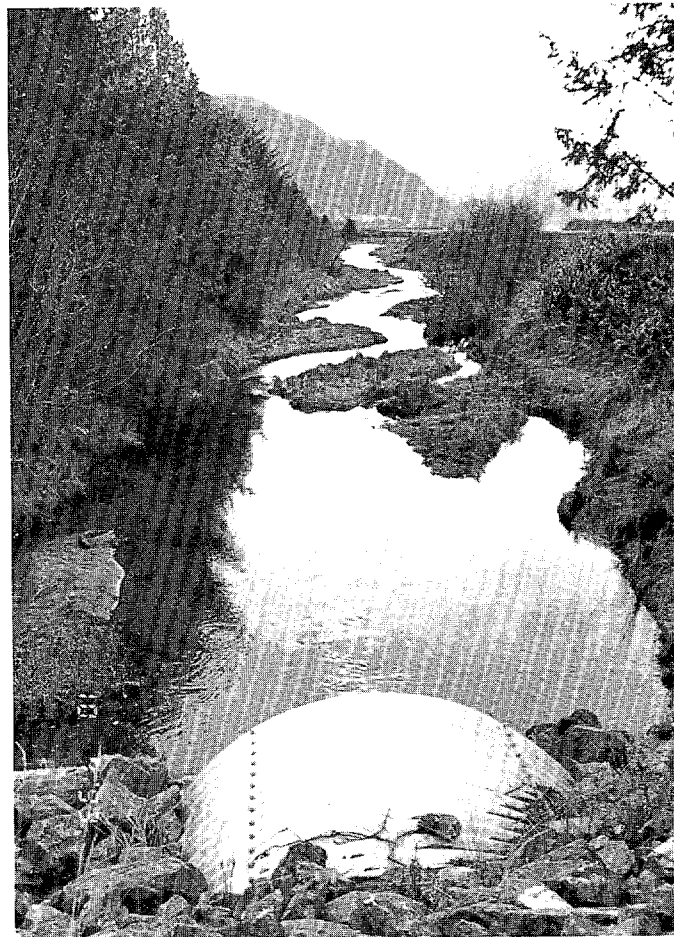
Plate 64. Besides correcting the perch, the arched culvert on Jordan Creek led to a more natural meandering channel downstream, by allowing the creek to cut its own path through the substrate (previously the channel was a straight run).

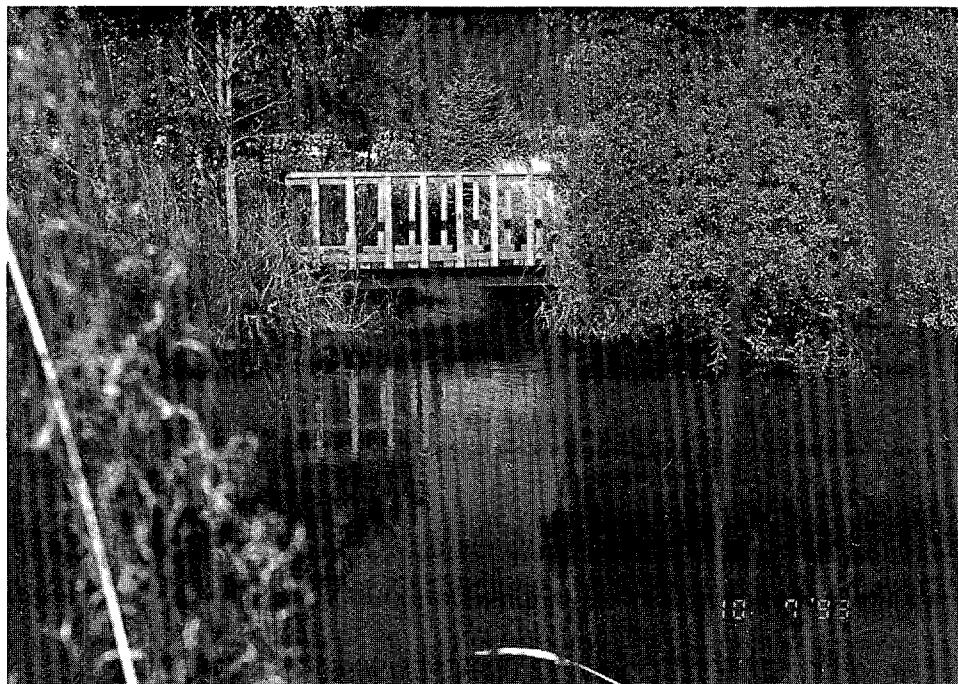
Plate 65.

This wooden bridge over Jordan Creek was built for an interpretive trail, one of the activities funded by the Juneau Airport expansion mitigation fund. In the foreground is a former borrow pit, now rehabilitated as a rearing pond for fish.

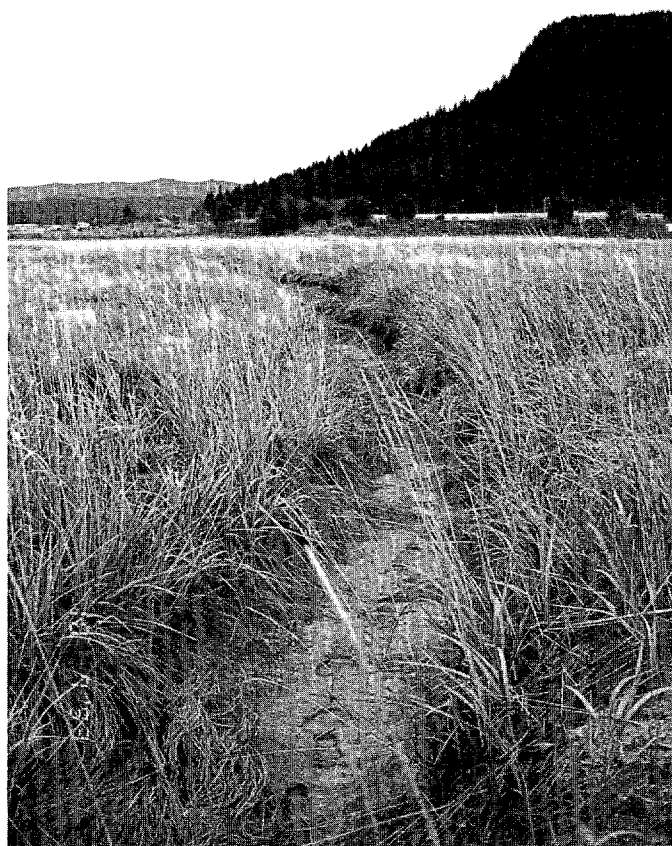
Plate 66.

One of the experimental sandy-bottomed sloughs constructed on high intertidal wetlands to compensate for acres of similar habitat filled during taxiway expansion. The sloughs were also intended to attract sand lance, a prey species for salmon.

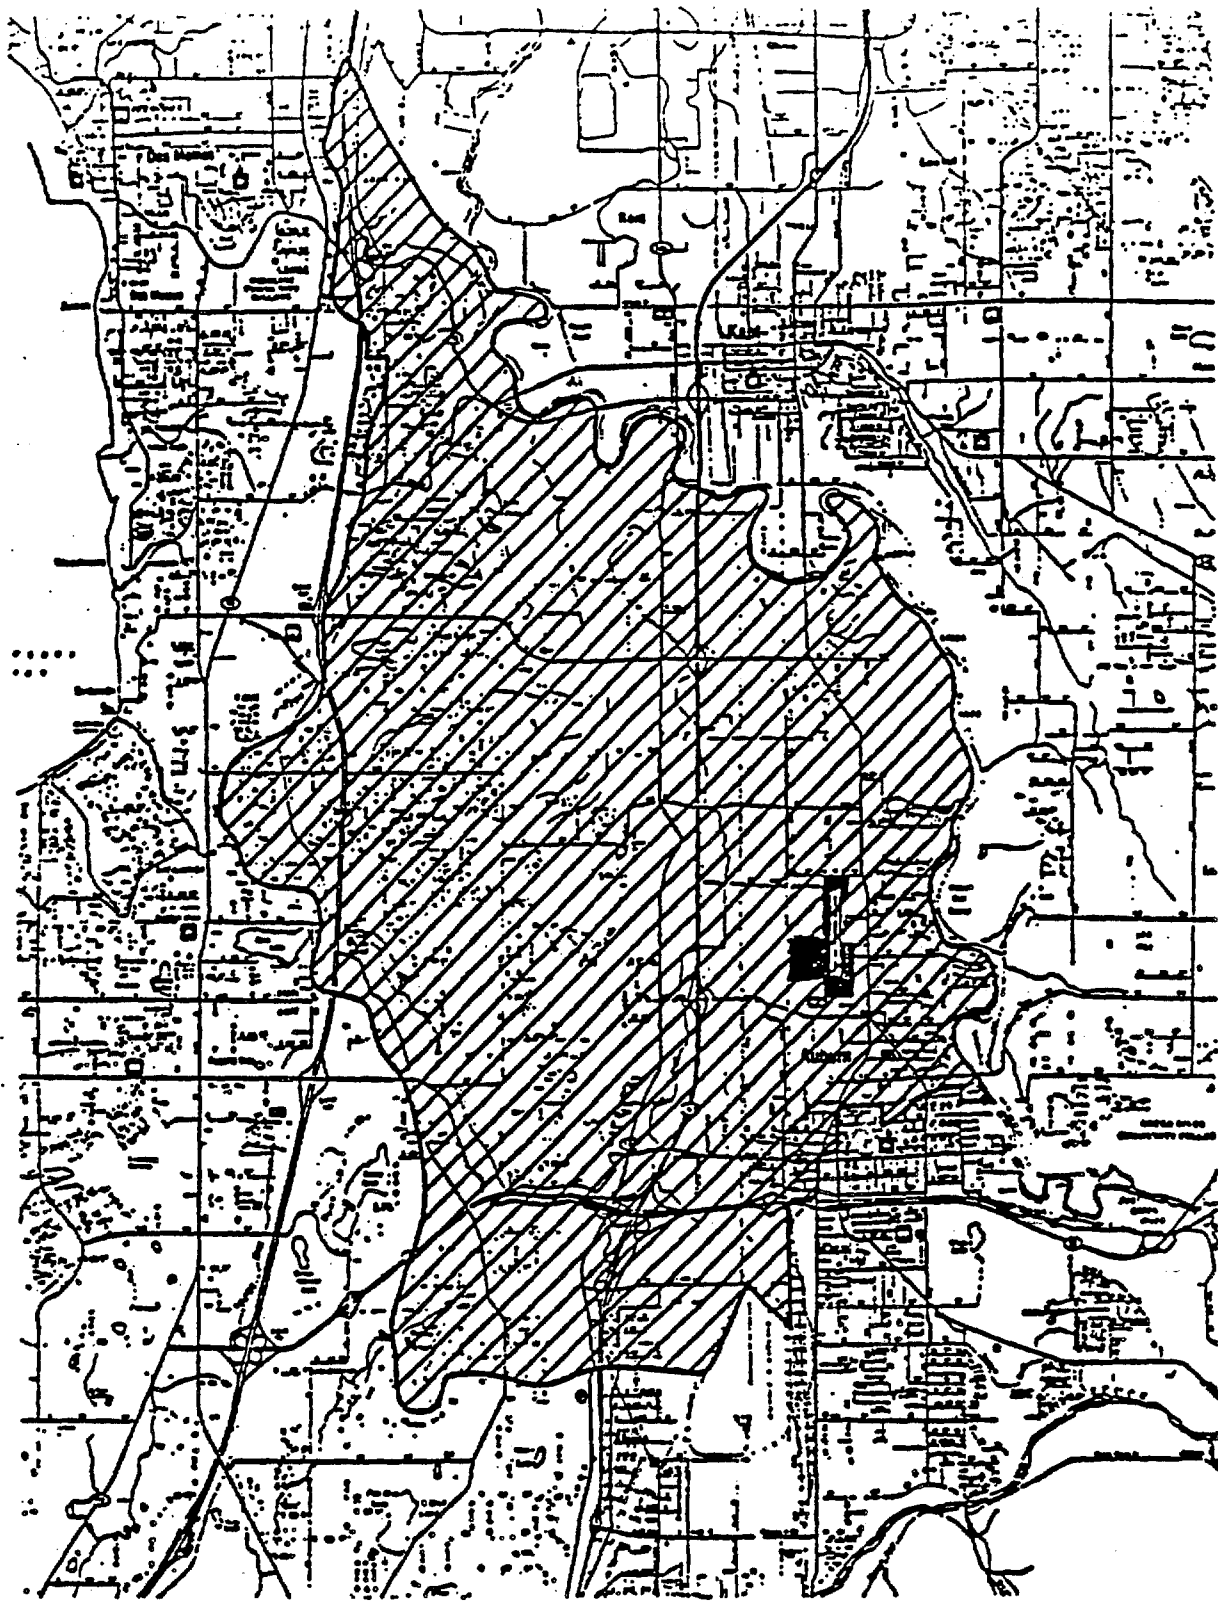
FIGURE 2

MILL CREEK DRAINAGE BASIN AS DEFINED BY THE
SPECIAL AREA MANAGEMENT PLAN

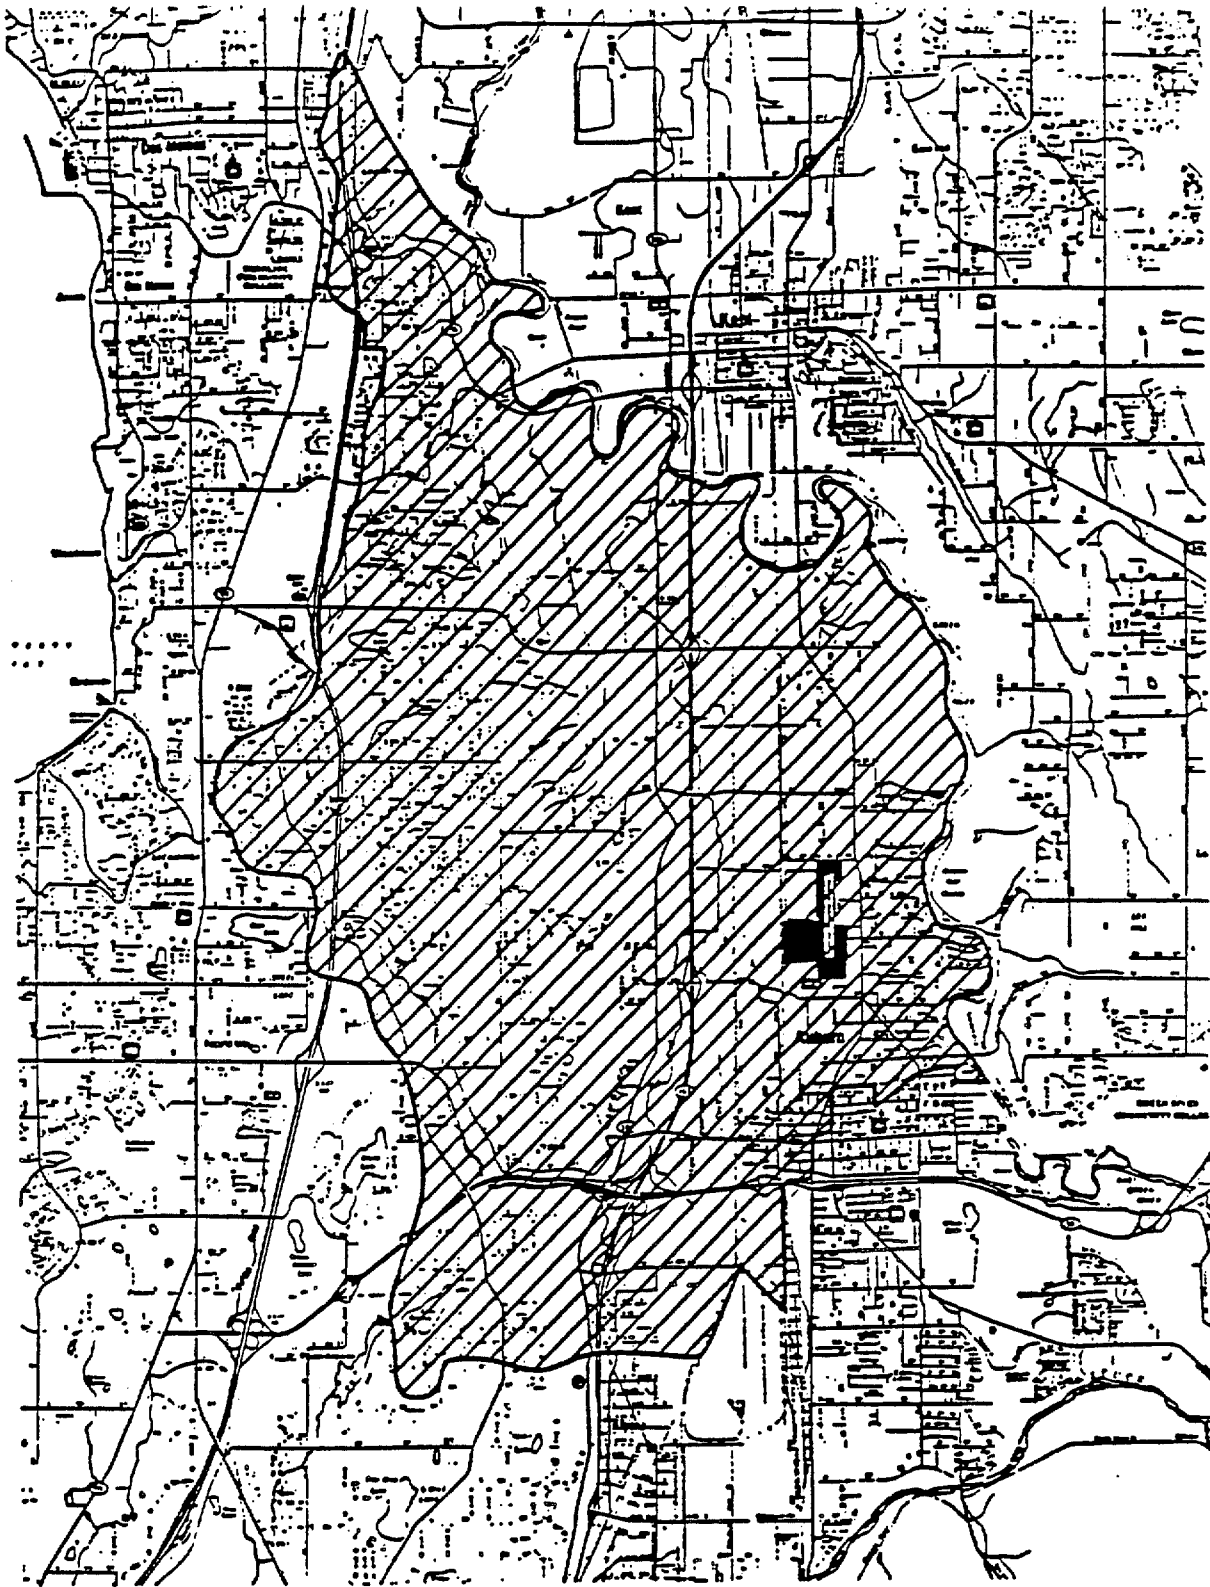
FIGURE 1

MILL CREEK DRAINAGE BASIN AS DEFINED BY THE
SPECIAL AREA MANAGEMENT PLAN

3. Study Area. The Mill Creek Basin SAMP study area includes all areas tributary to the Mill Creek, Mullen Slough, Midway Creek, and Northeast Auburn drainage systems (see Figure 1). Mill Creek is the largest stream within this 22 square mile area, which includes both flat valley bottom and portions of the Federal Way plateau east of Interstate 5. The study area includes portions of unincorporated King County, and portions of the cities of Auburn and Kent.

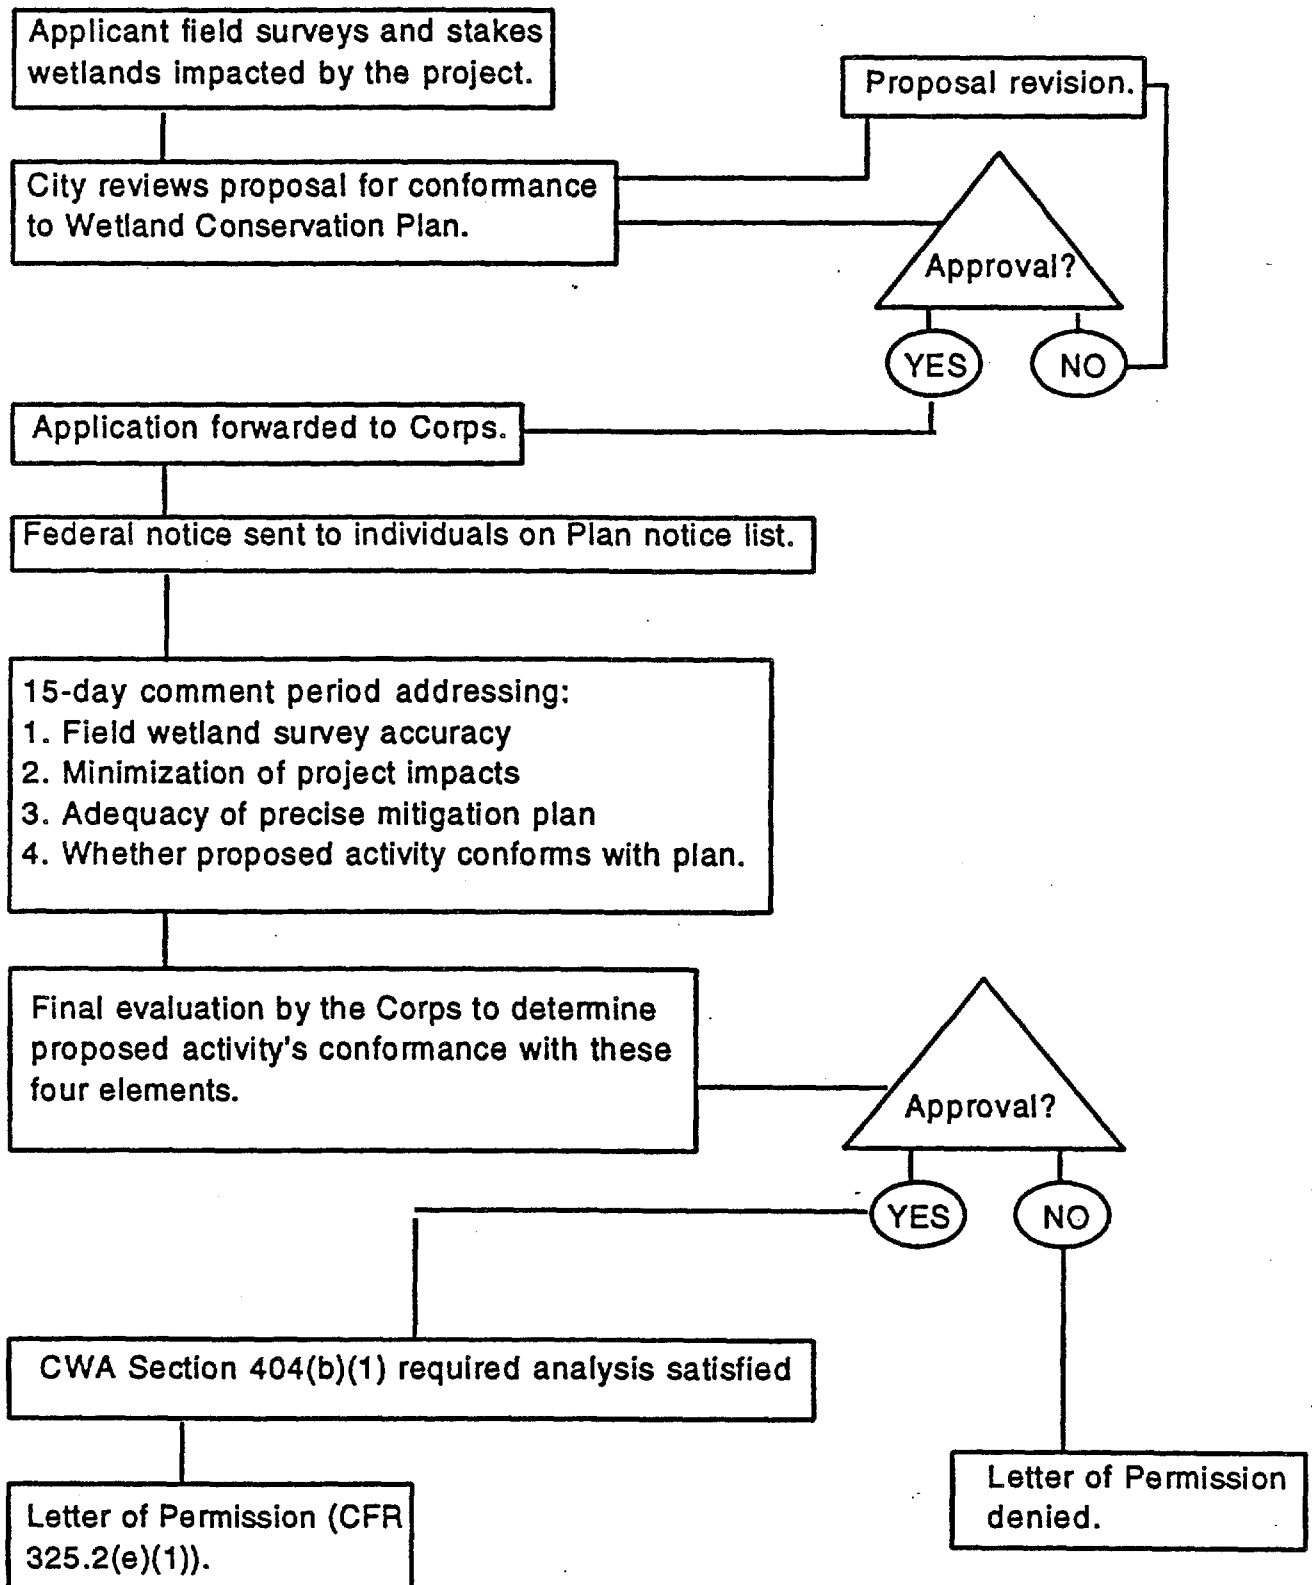
Newton Creek Letter of Permission Process

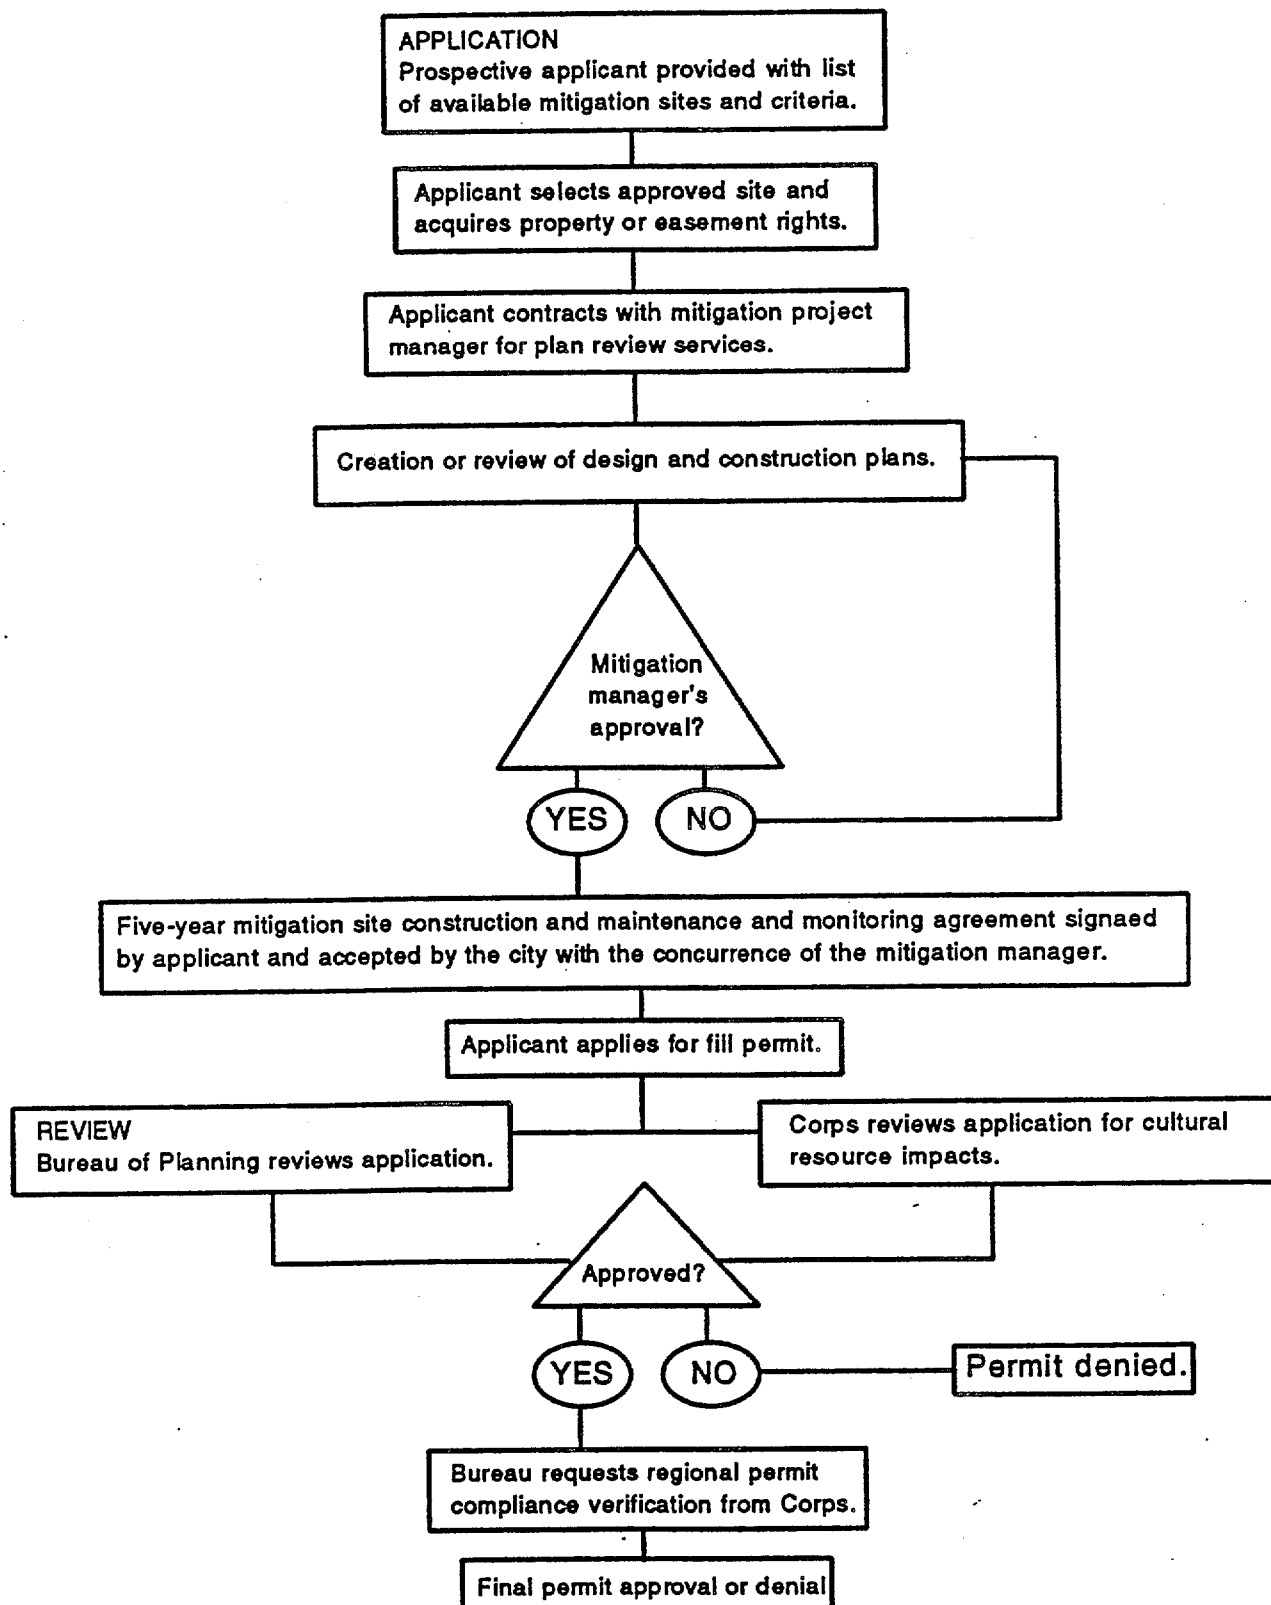
Columbia South Shore Permit Process
