**Restoration and Enhancement of Aquatic Habitats in Alaska:
Case Study Reports, Policy Guidance, and Recommendations**

By
Betsy L. Parry and Glenn A. Seaman

Technical Report No. 94-3

July 1994

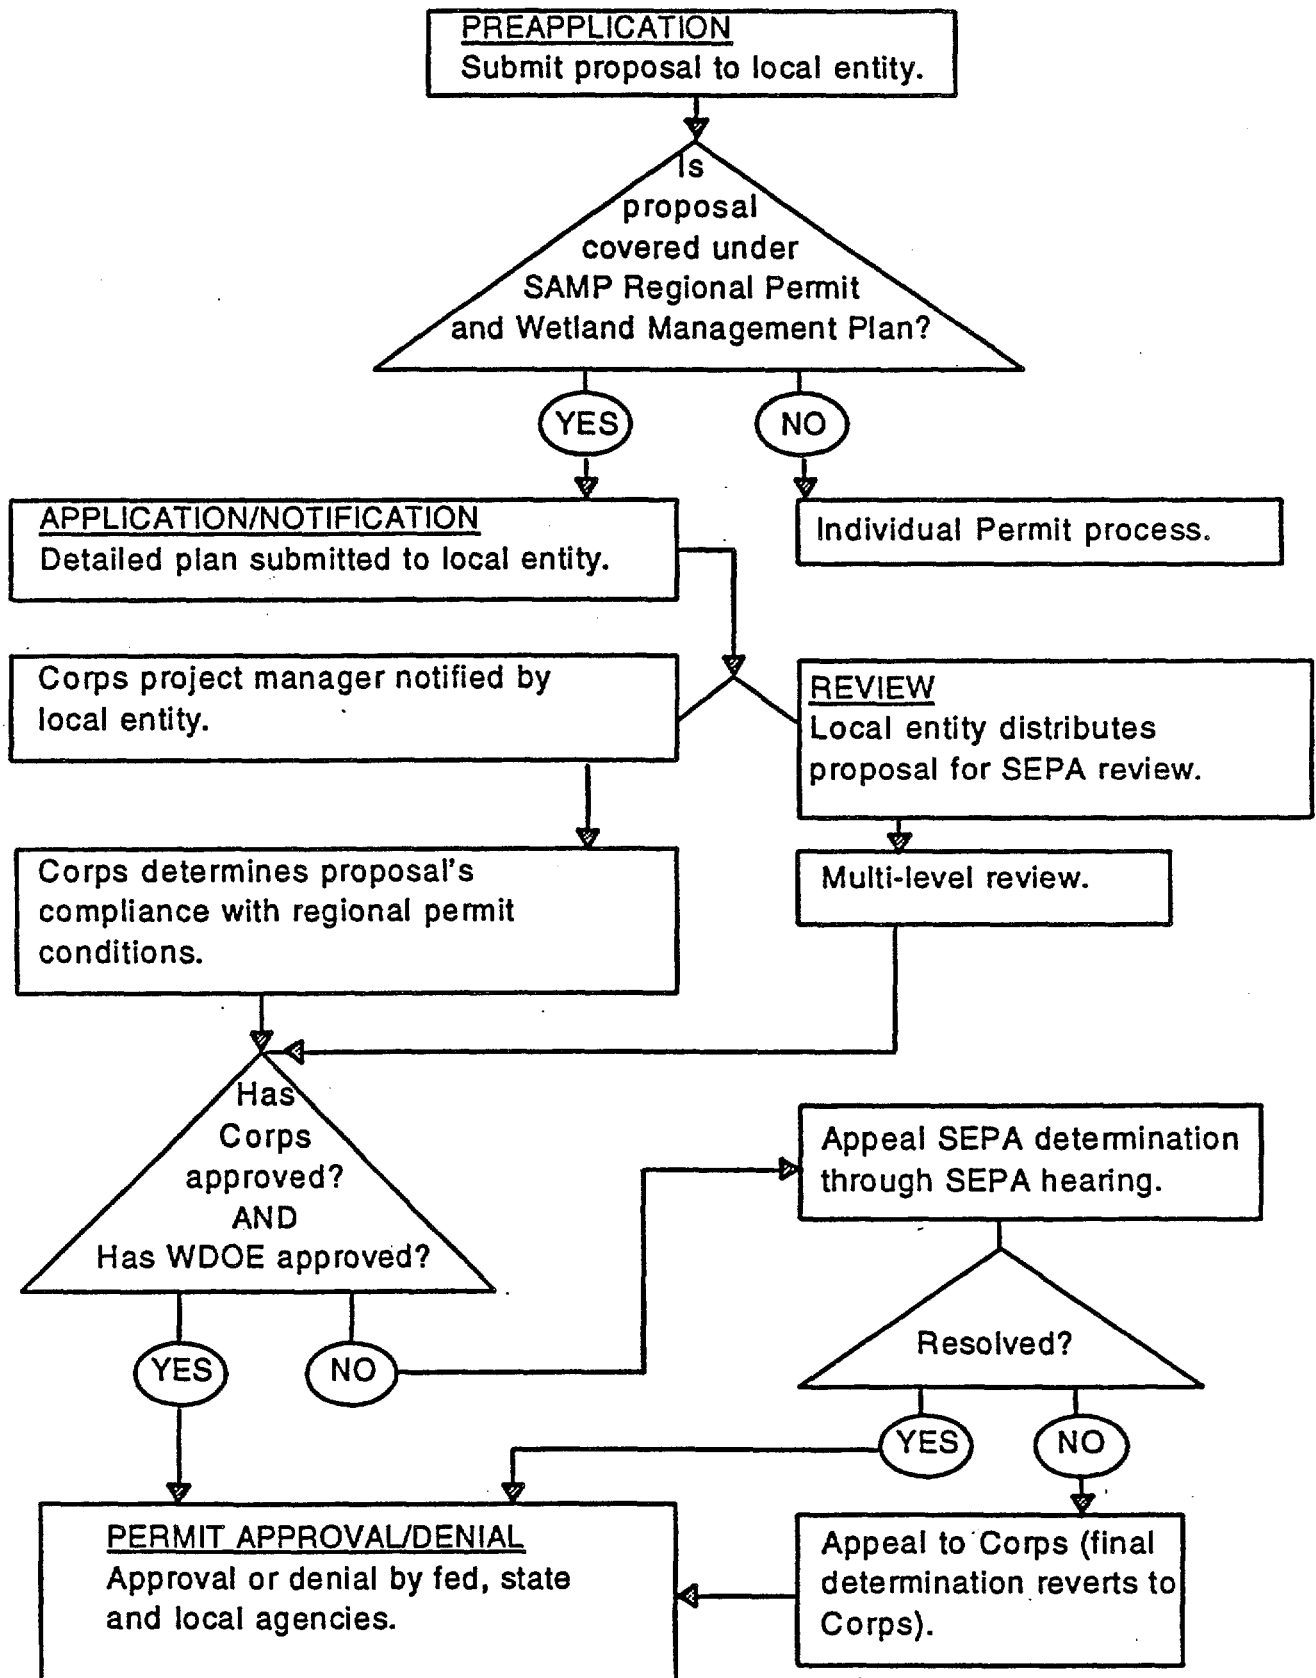
Figure...: Mill Creek SAMP Permit Process
