*STATEWIDE ASSESSMENT  
OF  
PROPELLER DAMAGE TO SEAGRASS*

STATEWIDE ASSESSMENT OF PROPELLER DAMAGE TO SEAGRASS

FINAL REPORT

Department of Natural Resources  
Division of Marine Resources  
Florida Marine Research Institute

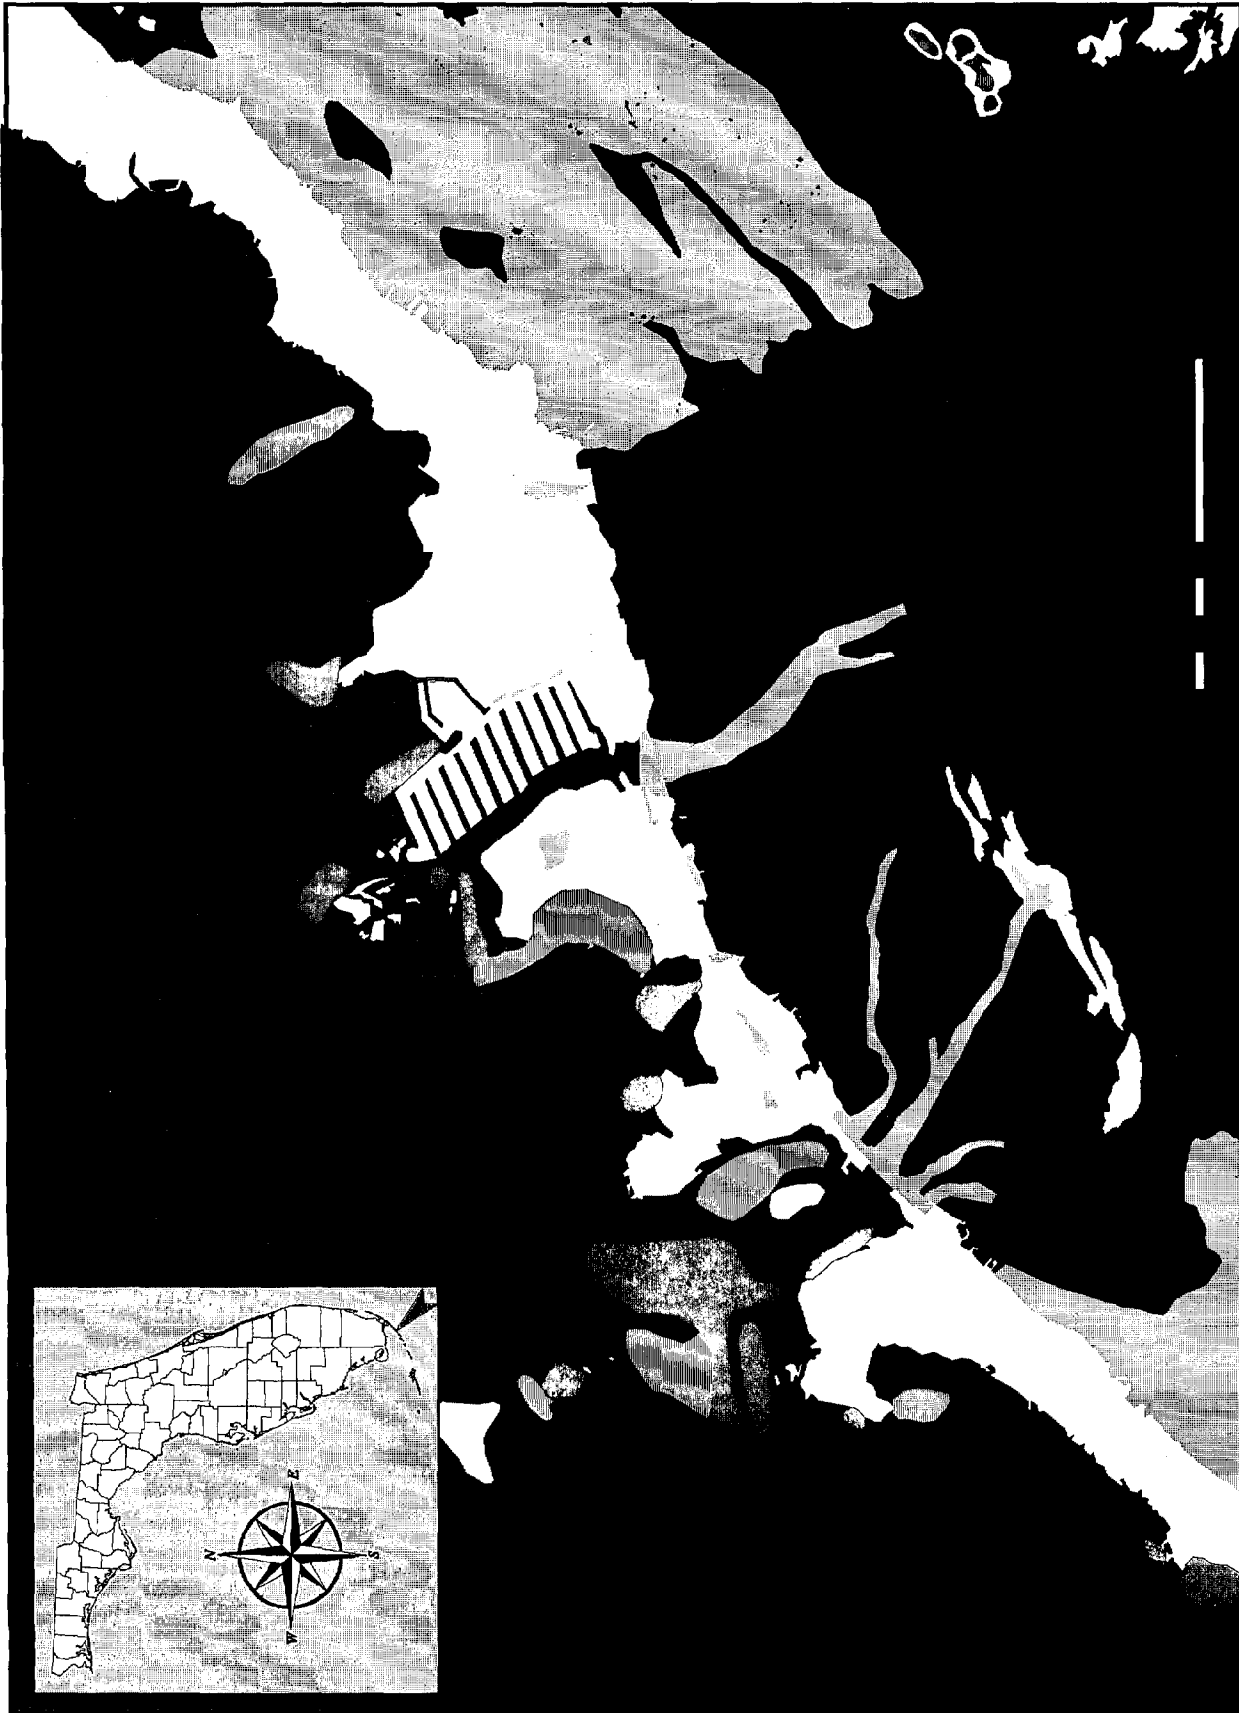
# DETAILED PROPELLER SCAR DAMAGE TO THE SEAGRASS AREAS OF WINDLEY HARBOR, FLORIDA BAY

Figure 4. (refer to facing page) Areas of propeller scar damage at Windley Key, Monroe county, an area targeted for implementation of management action to protect shallow water seagrass habitats.

Examples of paper maps which can be produced by the MRGIS are presented as Figures 3 and 4. Examples of larger maps accompany this report. All of these maps are preliminary and are to be used as examples only. These maps were generated on a Calcomp 68436 Electrostatic Plotter. A wide variety of sizes and formats of maps can be produced by the MRGIS. Customized maps can be produced in only a few hours if they are not too complicated. The

Specific management actions to protect the shallow water seagrasses of Windley Key, Monroe county, have been proposed and are discussed in detail in Appendix C. A map depicting the propeller damage around of Windley Key is provide as Figure 2. The southwest Florida Aquatic Preserves office utilized data from this study to develop an aquatic preserve management plan which incorporates measures to protect seagrass from propeller damage. An area of heavy damage in Pine Island Sound has been targeted for implementation of a management action (Refer to Figure 1). Assistance was provided to Pinellas County, Hillsborough County, and the Florida Park Service in the refinement of management plans for specific localities.
