Harford County Shoreline Study

*Harford County Department of Planning and Zoning
1981*

Abstract

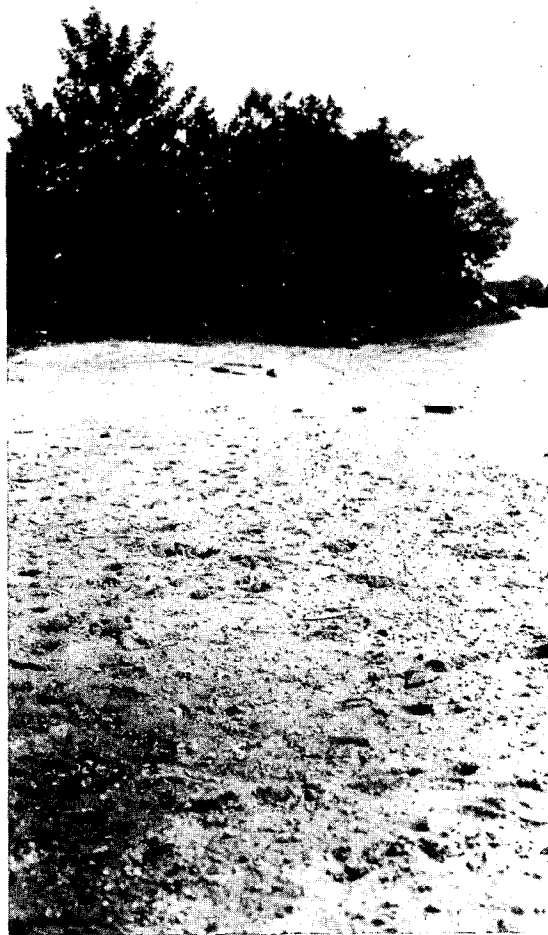
Sandy/Vegetation

A sandy beach with mixed hardwood vegetation. In-shore landscape is usually recessed (sloping), but some are bluffed. Found along the Bush and Gunpowder Rivers.

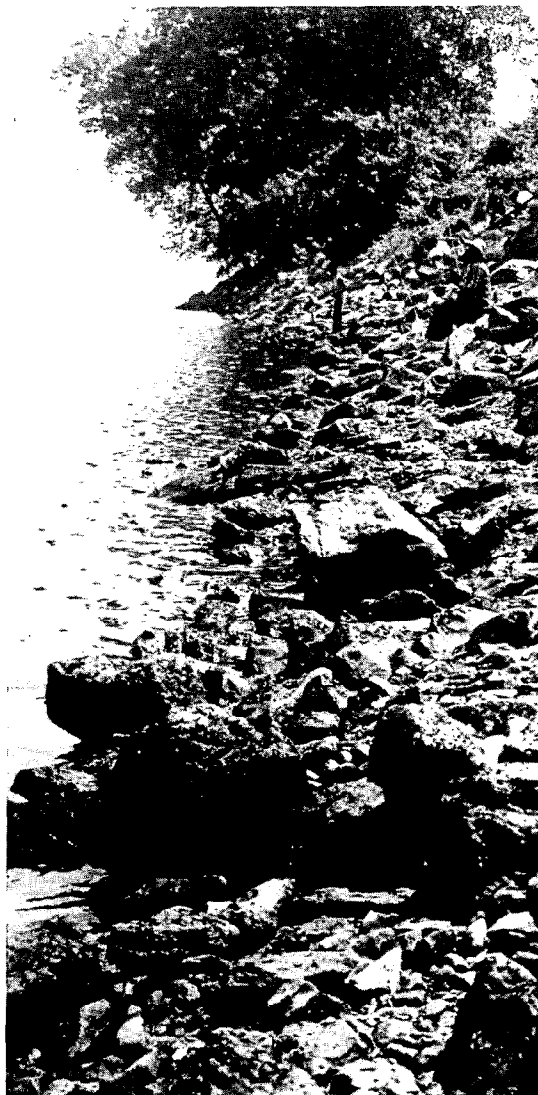
Gravelly/Vegetation

Gravelly beach with mixed hardwood vegetation. Found along the Susquehanna River and the Chesapeake Bay.

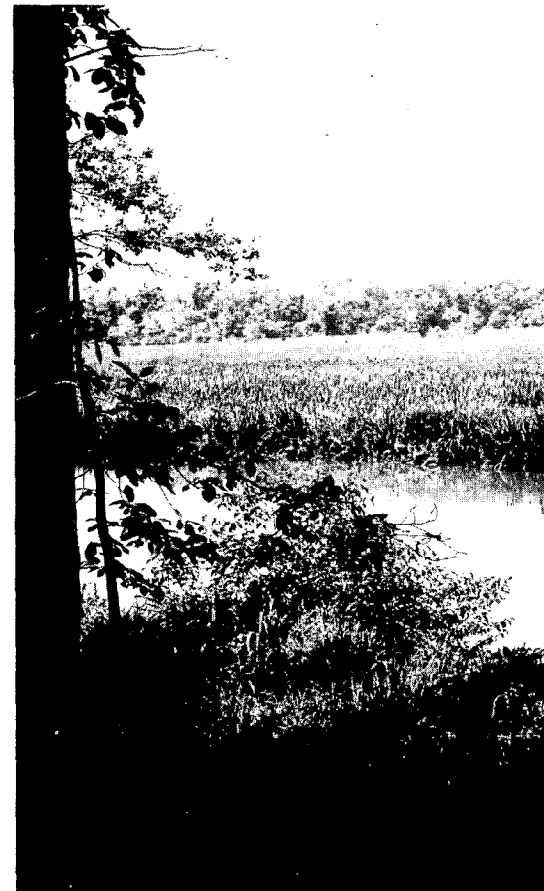
Marsh

Low wetland, periodically inundated. Considerable growth of grasses, sedges, cattails, and rushes. Found in the Swan Creek and the Bush and Gunpowder Rivers.
