# SHORELINE EROSION IN VIRGINIA

Educational Series No. 31

Virginia Institute of Marine Science Sea Grant  
Program

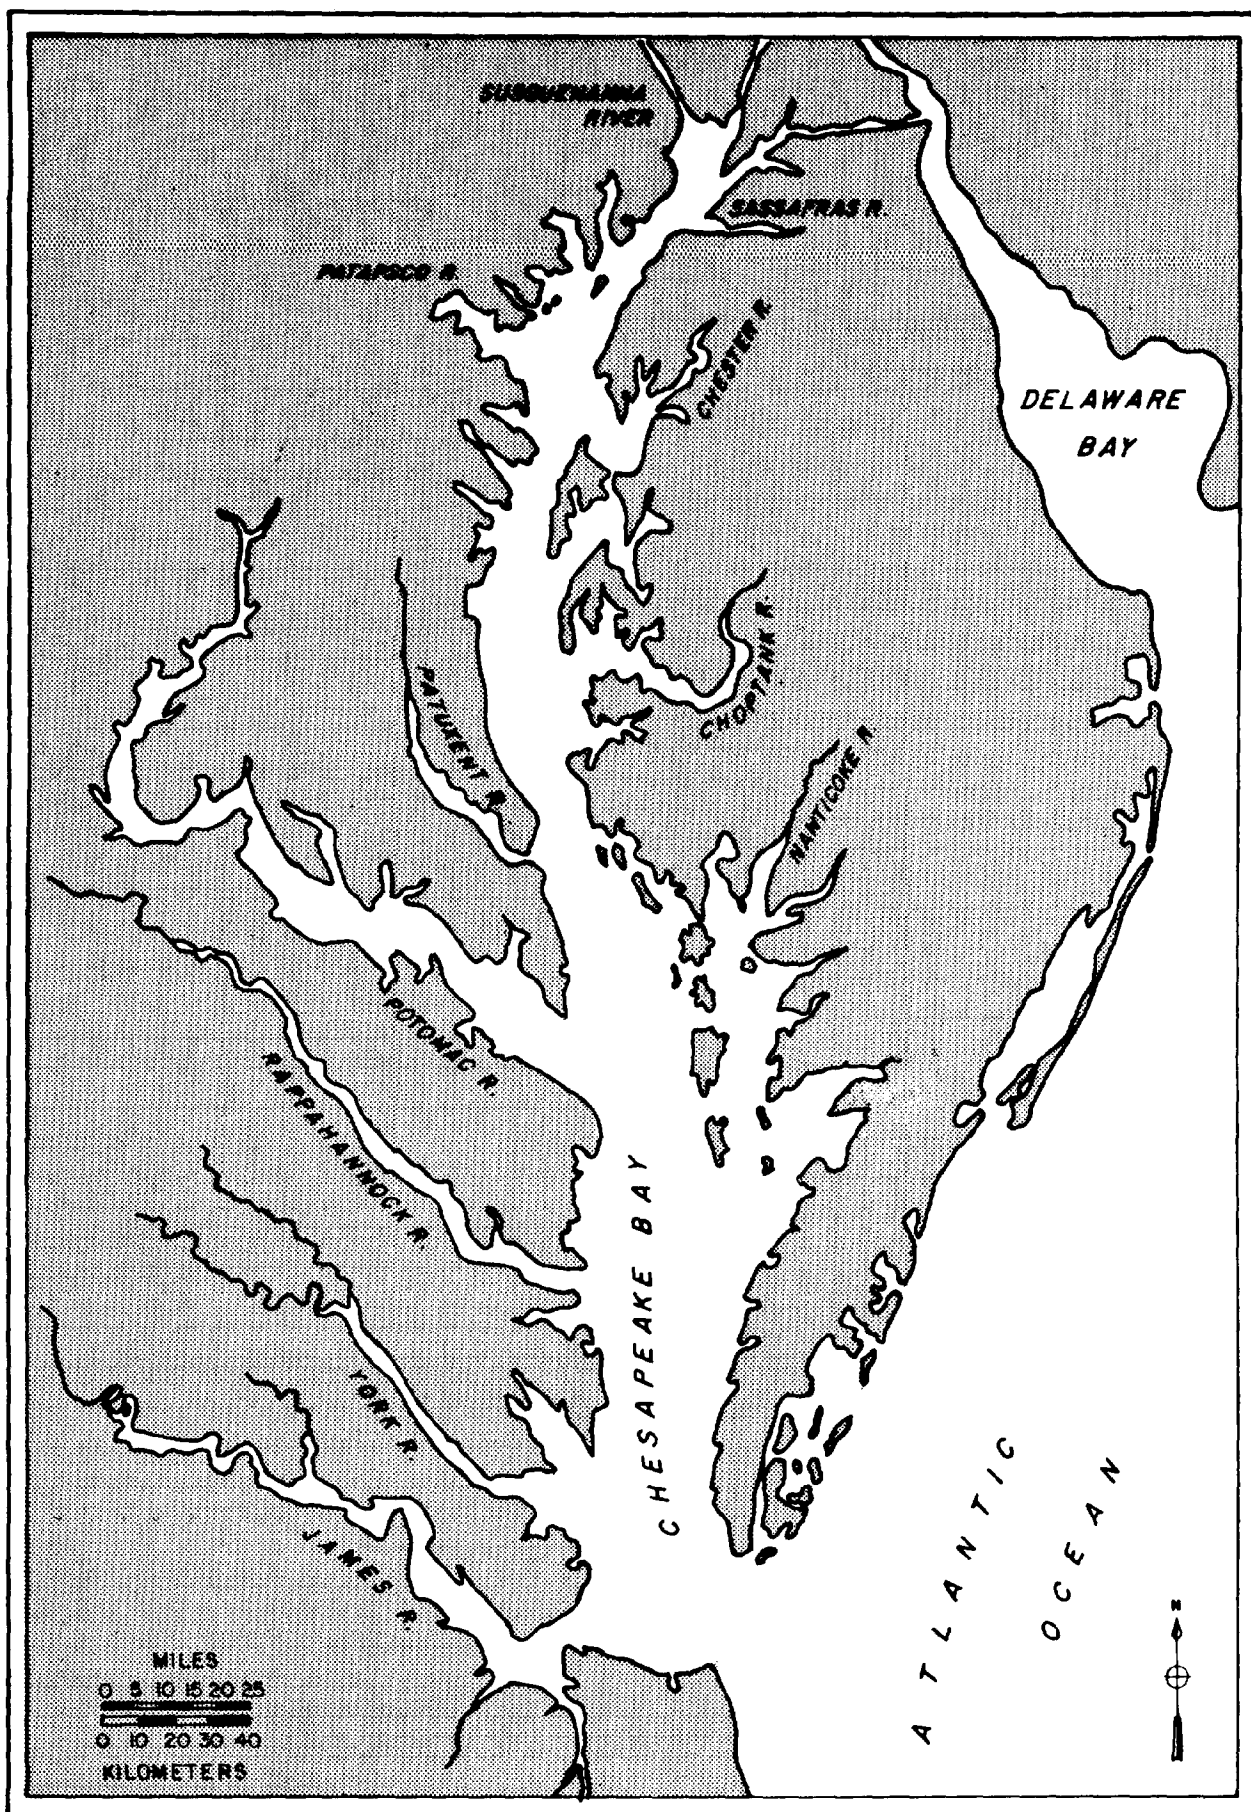
Figure 1 — Chesapeake Bay and its tributaries.

The Chesapeake Bay and its tributaries are drowned river valleys of the ancestral Susquehanna River system (Figure 1). Drowned river valleys where seawater from the ocean and freshwater from upland rivers mix freely are called estuaries. The circulation in the estuaries is influenced by the astronomical tidal conditions, the amount of fresh water run-off and the shape of the basin.

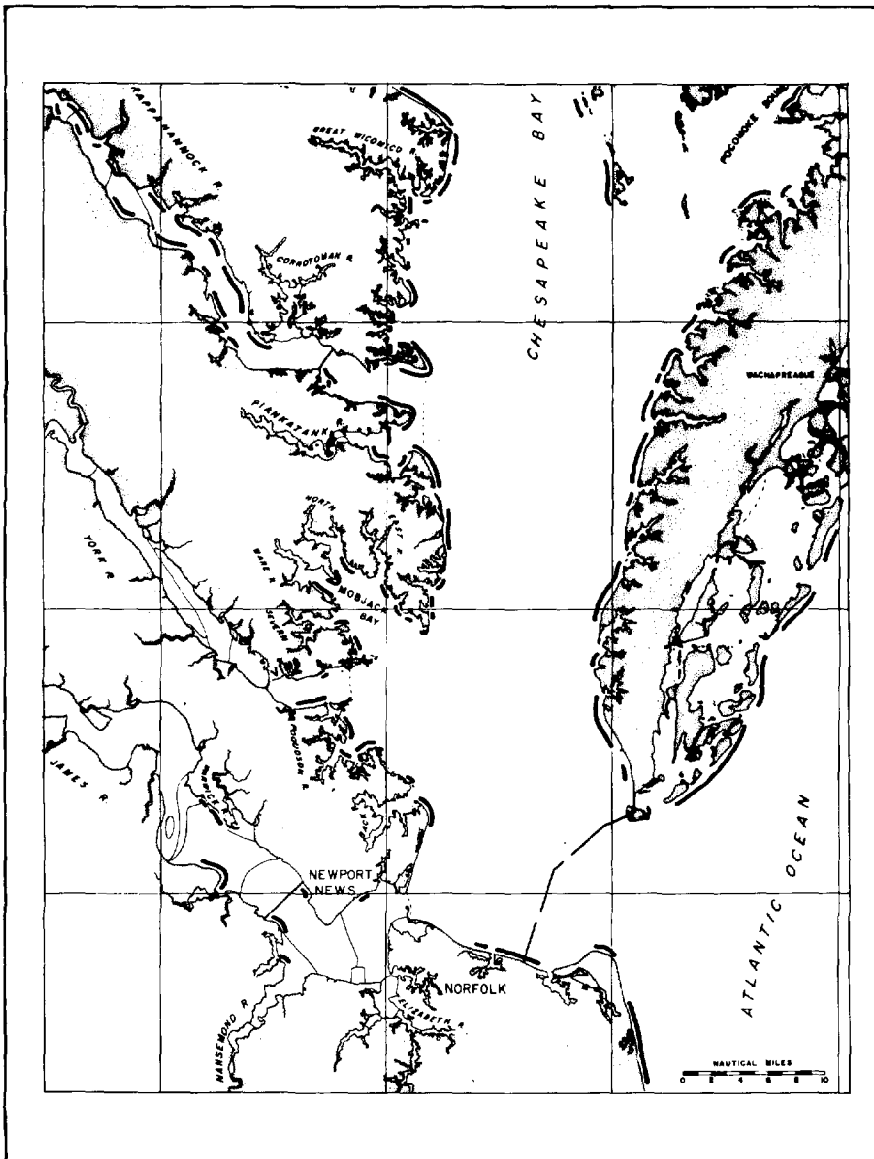
Figure 2 - Green lines indicate erosion rates of two or more feet per year.

line exposure to the northwest, north and northeast directions from where the severest seasonal winds originate. Individual segments of shoreline have experienced erosion rates of more than seven feet per year. However, one or two feet per year is more common. For the 2,365 miles of estuarine shoreline measured, the average rate of erosion is about 0.7 feet per year (Byrne, et al., 1979). The Virginia Institute of Marine Science defines severe erosion as any shoreline segment with a rate of two or more feet

per year (Figure 2). Shoreline erosion becomes a problem when coastal property with improvements (house, cottage, etc.) are threatened by a rapidly receding shore bank.

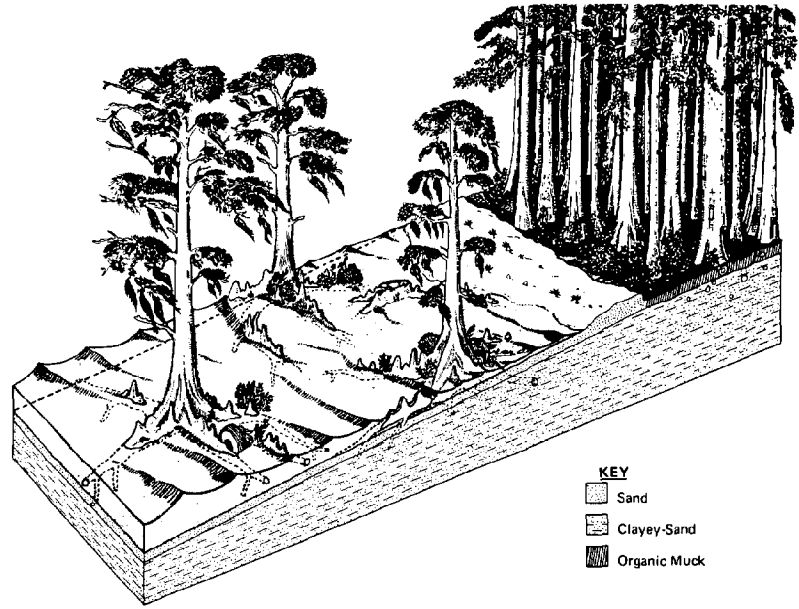
**Figure 4 — The cypress fringe damping erosion wave forces and trapping sediments is illustrated in this figure. The cypress trees can form a natural bulkhead which dissipates wave energy and traps sand.**

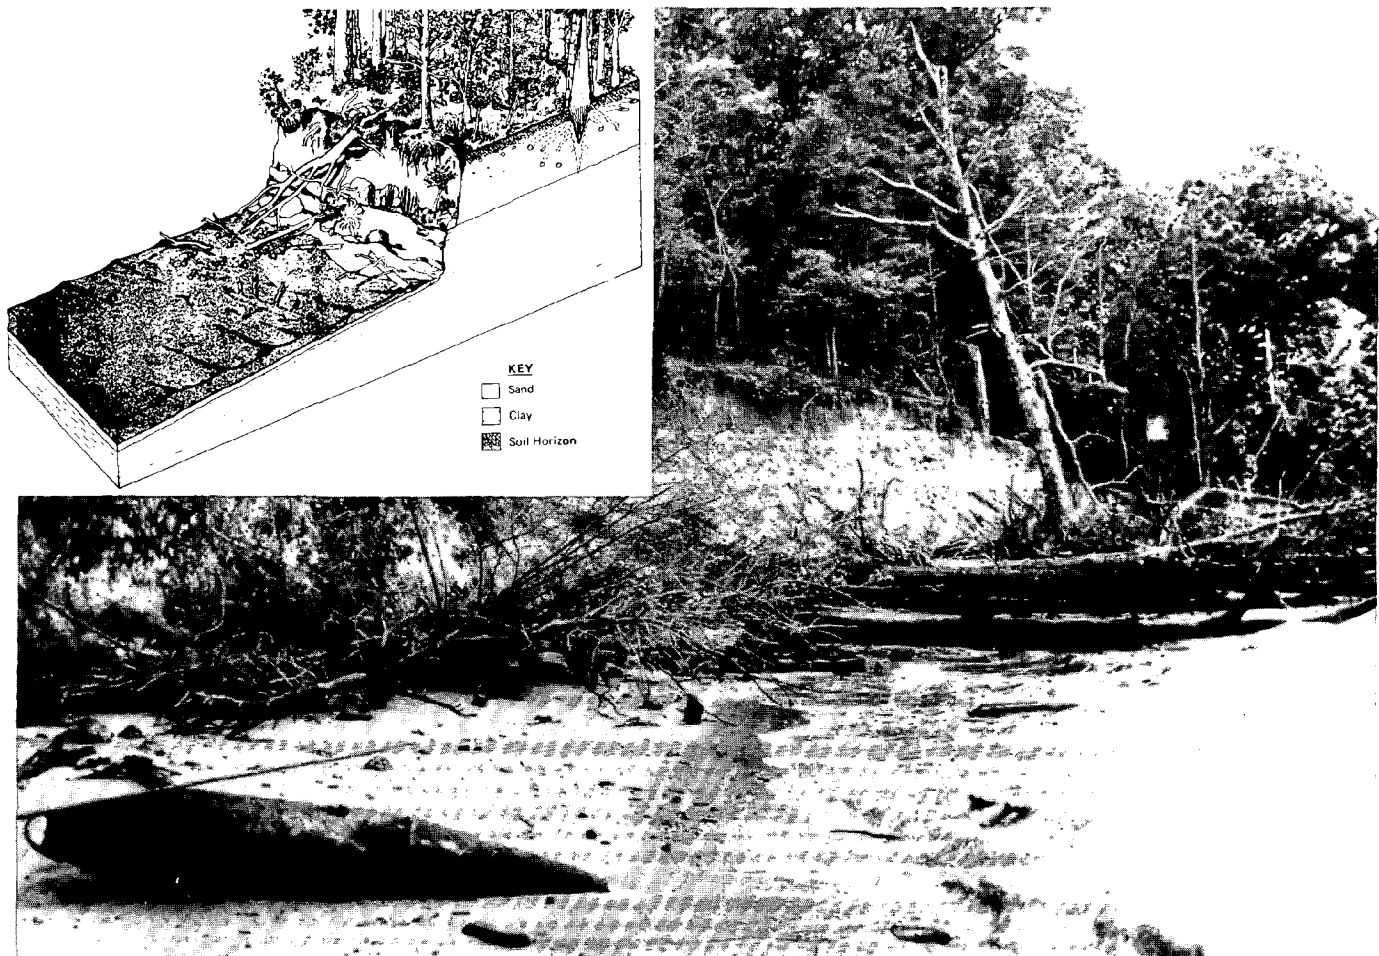
**Figure 5 — Erosion of sediment banks is the primary source of material for the beaches along the estuarine shoreline. (Upper right) storm waves undercut the high bank causing slump blocks, along with the vegetative cover, to slide onto the beach. In this illustration, the slump blocks are reduced by further wave action, leaving behind debris of fallen timber.**

Active erosion of sediment banks produces almost vertical exposed scarp with fallen trees and logs littering the beach and nearshore area. Erosion of high banks is caused by rainwash and groundwater which saturates the face of the bank causing sliding and slumping. Wave action during storms causes additional slumping by undercutting the base of the high bank. Low banks are most vulnerable to wave activity which will overtop the bank during storms and carry

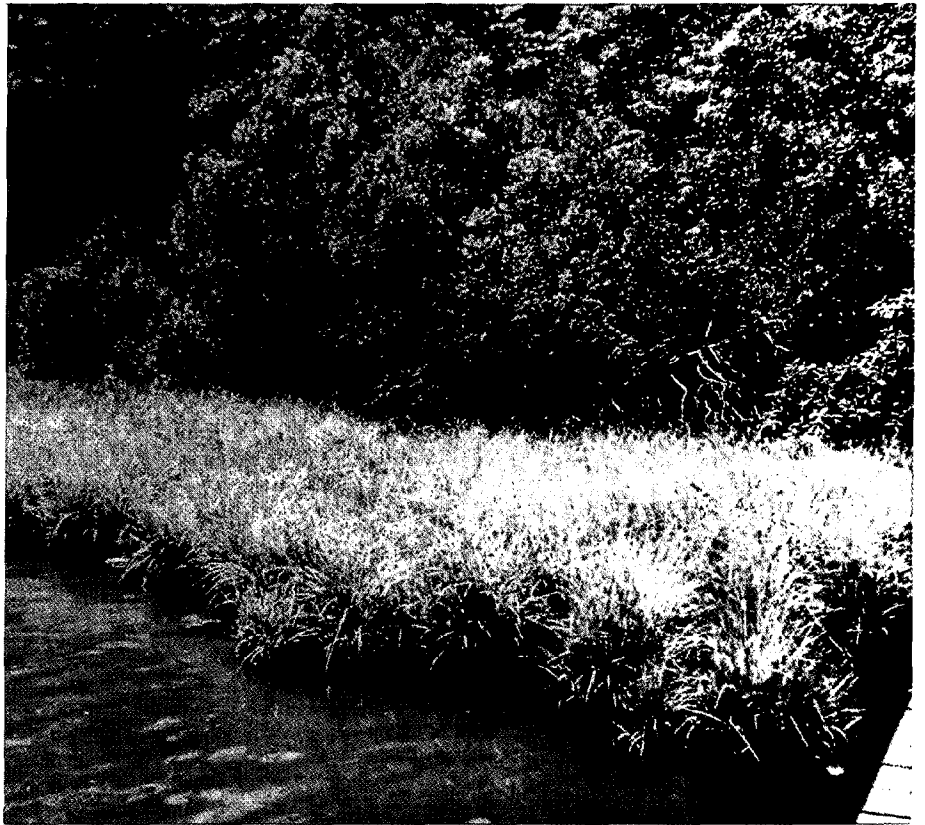
**Figure 6 — Fringe marshes offer excellent natural buffers to erosion. The marsh grass greatly reduces wave energy acting on the shoreline.**

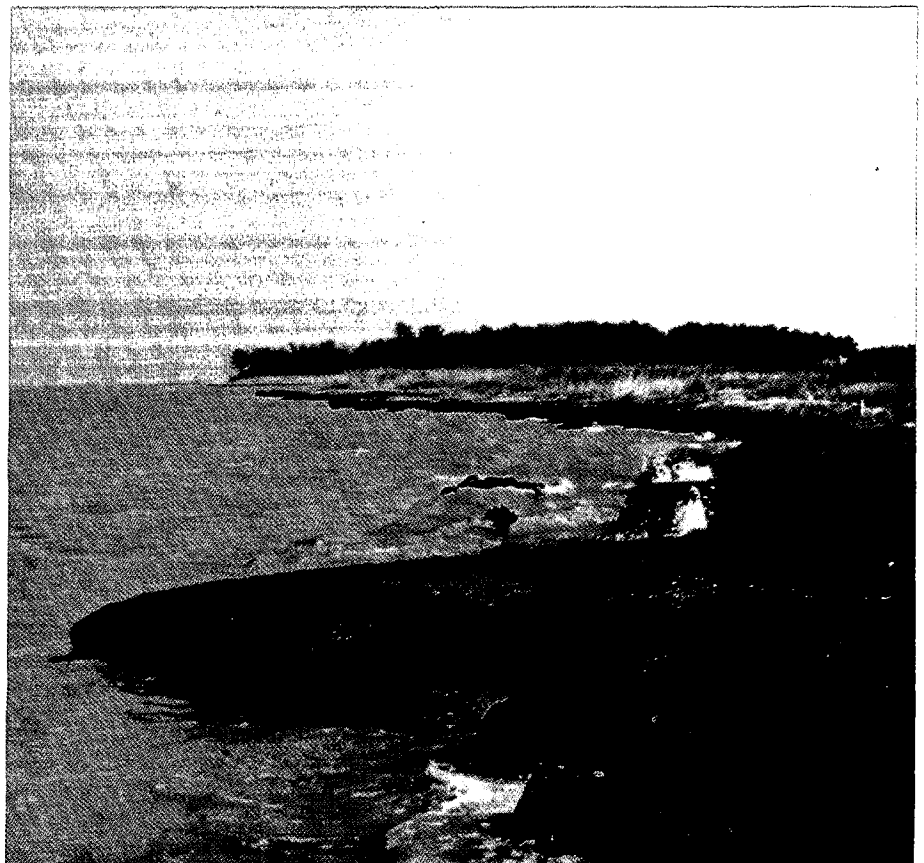
**Figure 7 — Extensive marsh plains occur along many low lying areas bordering the Chesapeake Bay.**

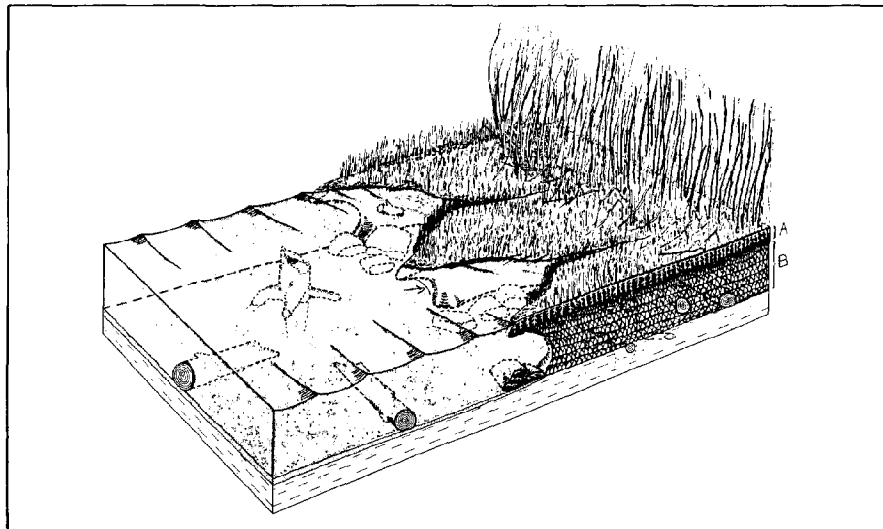
Figure 9 — The factors involved in erosion of the brackish marsh shoreline are illustrated. During low tide, wave action erodes the softer underlying peat (B), undercutting the firm surface layer (A). The peat shelf breaks into blocks that fall into the water, leaving U-shaped notches along the bank.

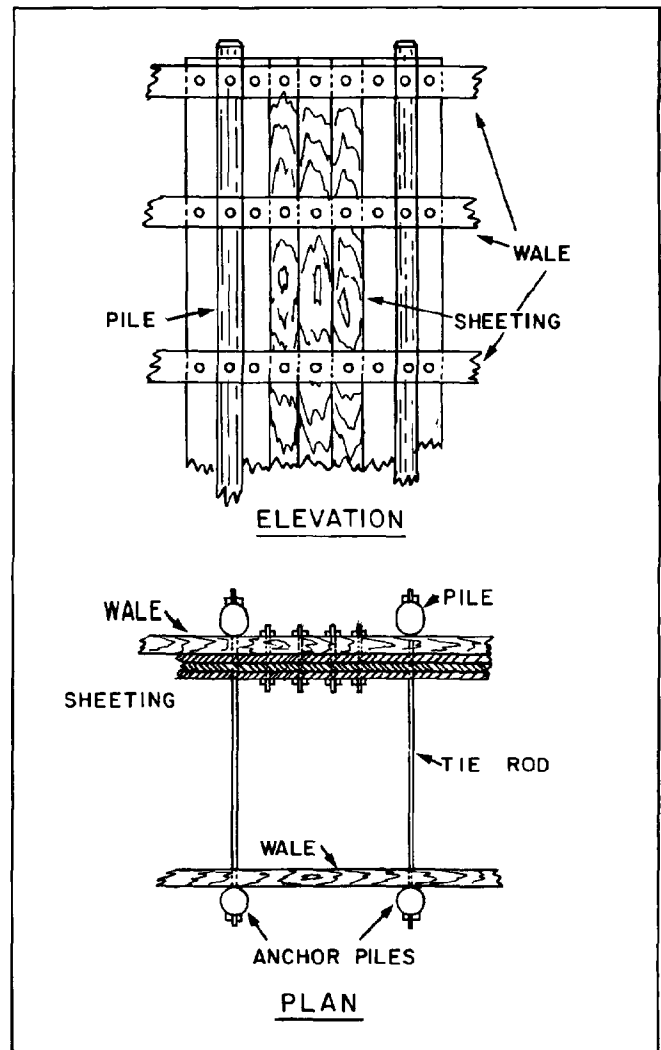
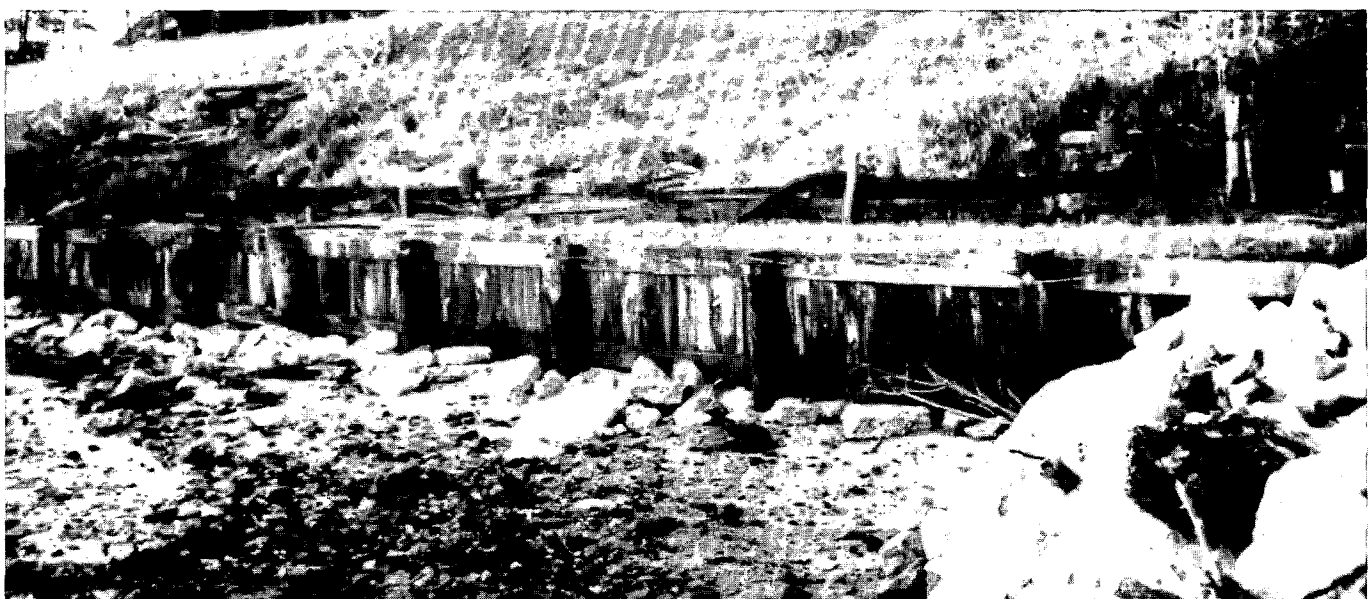
Figure 14A — Wooden bulkhead. Figure 14B (top right) timber sheet - pile bulkhead.

The respective definitions of these structures vary little although different construction materials are sometimes associated with each structure (*Figures 14A & B, 15, 16A & B*). Vertical structures act to retain the fastland material and to prevent wave induced erosion. In one way, they can be thought of as defensive structures. However, in many situations, vertical structures lead to the loss of the beach which may front them.

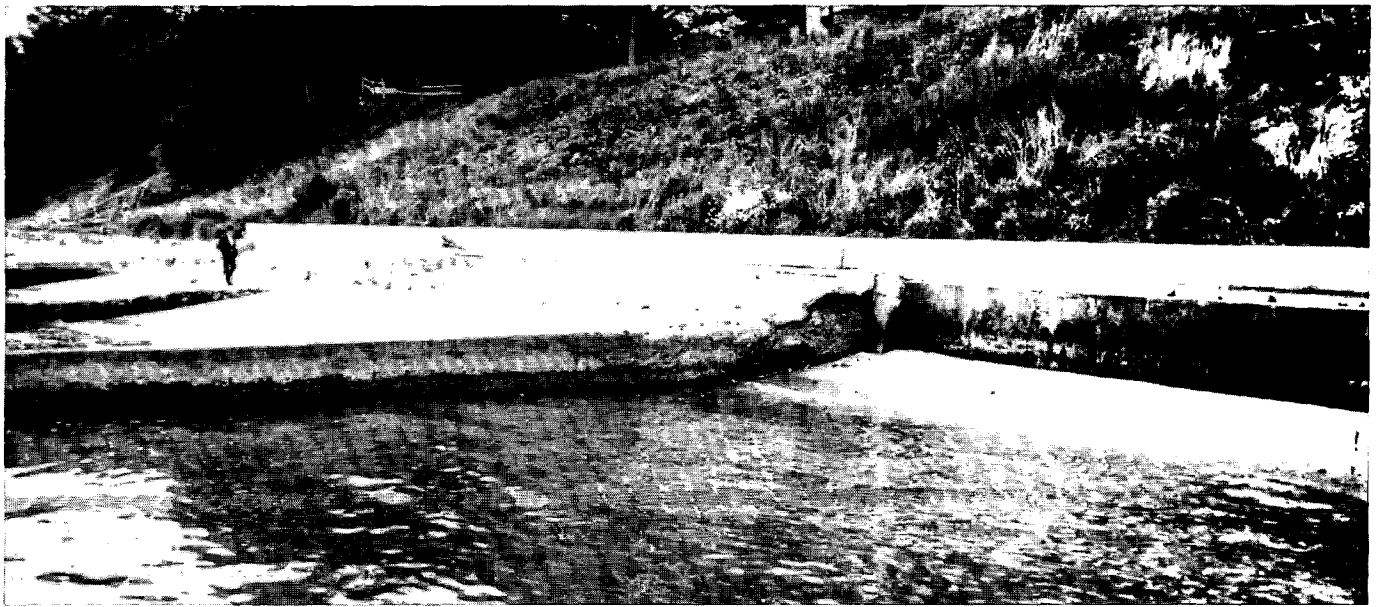
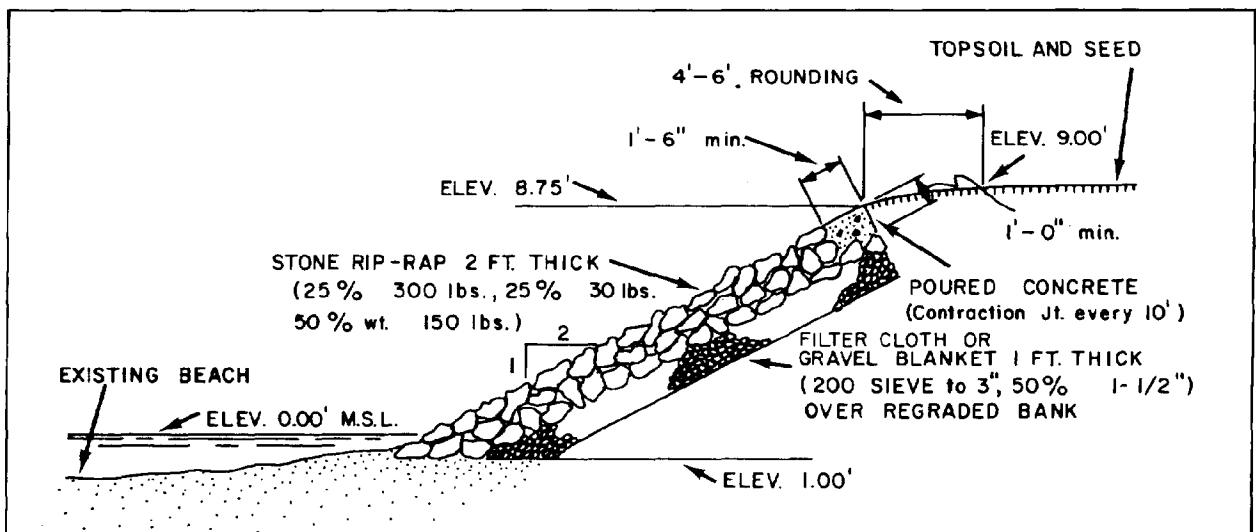
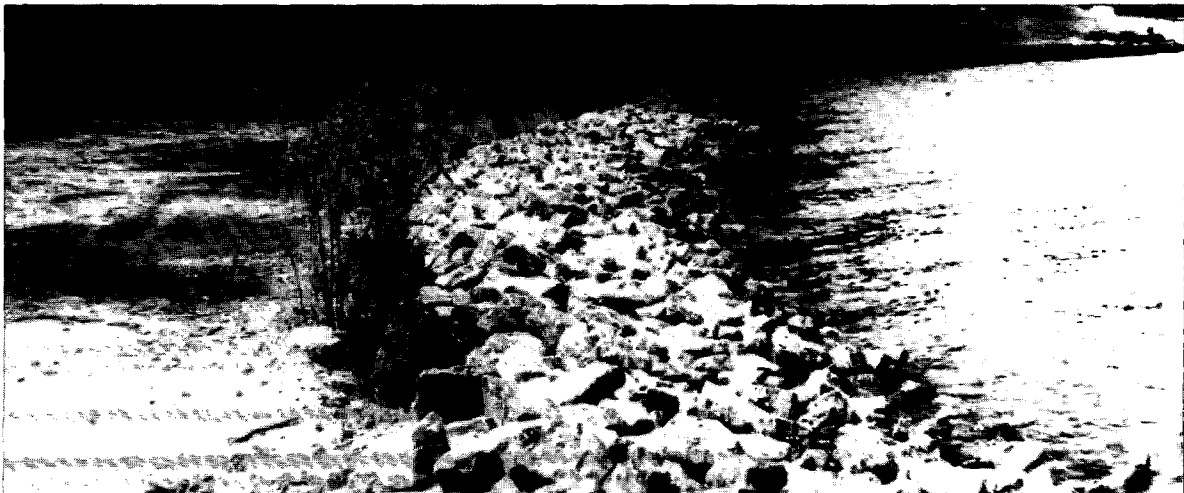
Figure 15 — Concrete seawall (top). Figure 16B (bottom) small riprap revetment. Figure 16A (middle) riprap revetment.

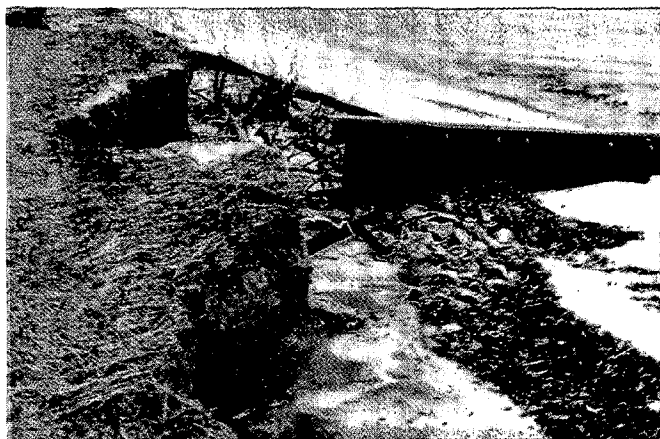
Figure 18 — Groin which has been flanked by severe erosion.

Imperative in the success of groins is an adequate supply of sand to quickly fill the groins and then begin bypassing sand. An inadequate supply of sand can lead to accelerated erosion downdrift of the groin. In some cases, this accelerated erosion can flank the groin rendering it totally useless (see Figure 18).

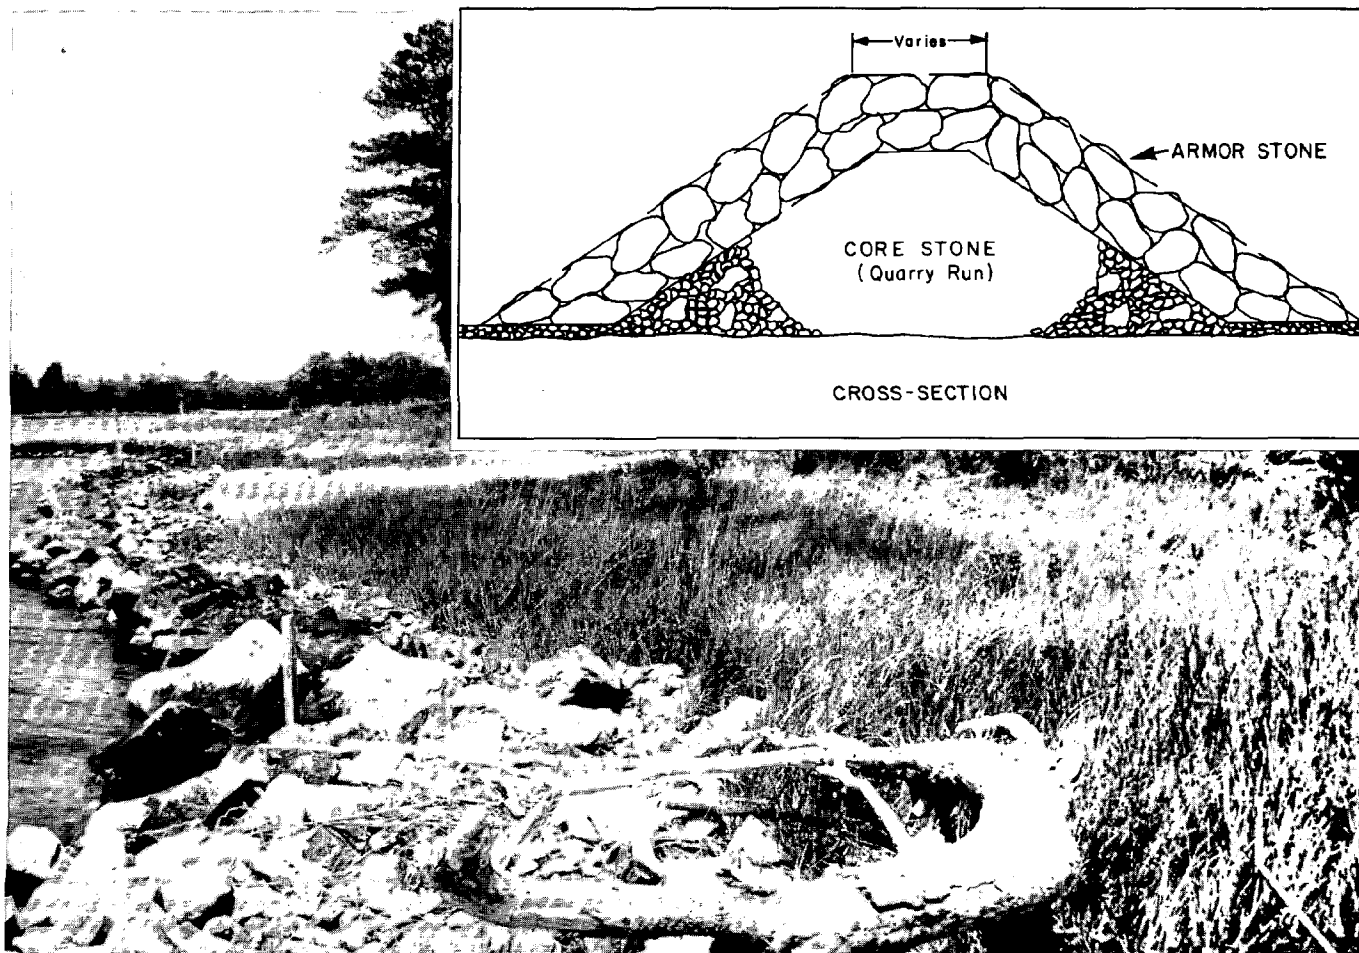
Figure 19A — Small stone breakwater. Figure 19B (upper right) generalized cross section of a large stone breakwater.

A solid breakwater is a structure usually constructed of stone, which serves to reduce wave height (*Figures 19A & B*). This reduction of wave height reduces the erosive power of the waves striking the beach or entering a harbor. As solid breakwaters work to resist the full power of the incoming waves, the structure must be massive. If not designed and placed properly, they can lead to accelerated nearshore currents which can cause erosion. Used incorrectly, they can halt the parallel littoral sand transport leading to accelerated erosion downdrift.

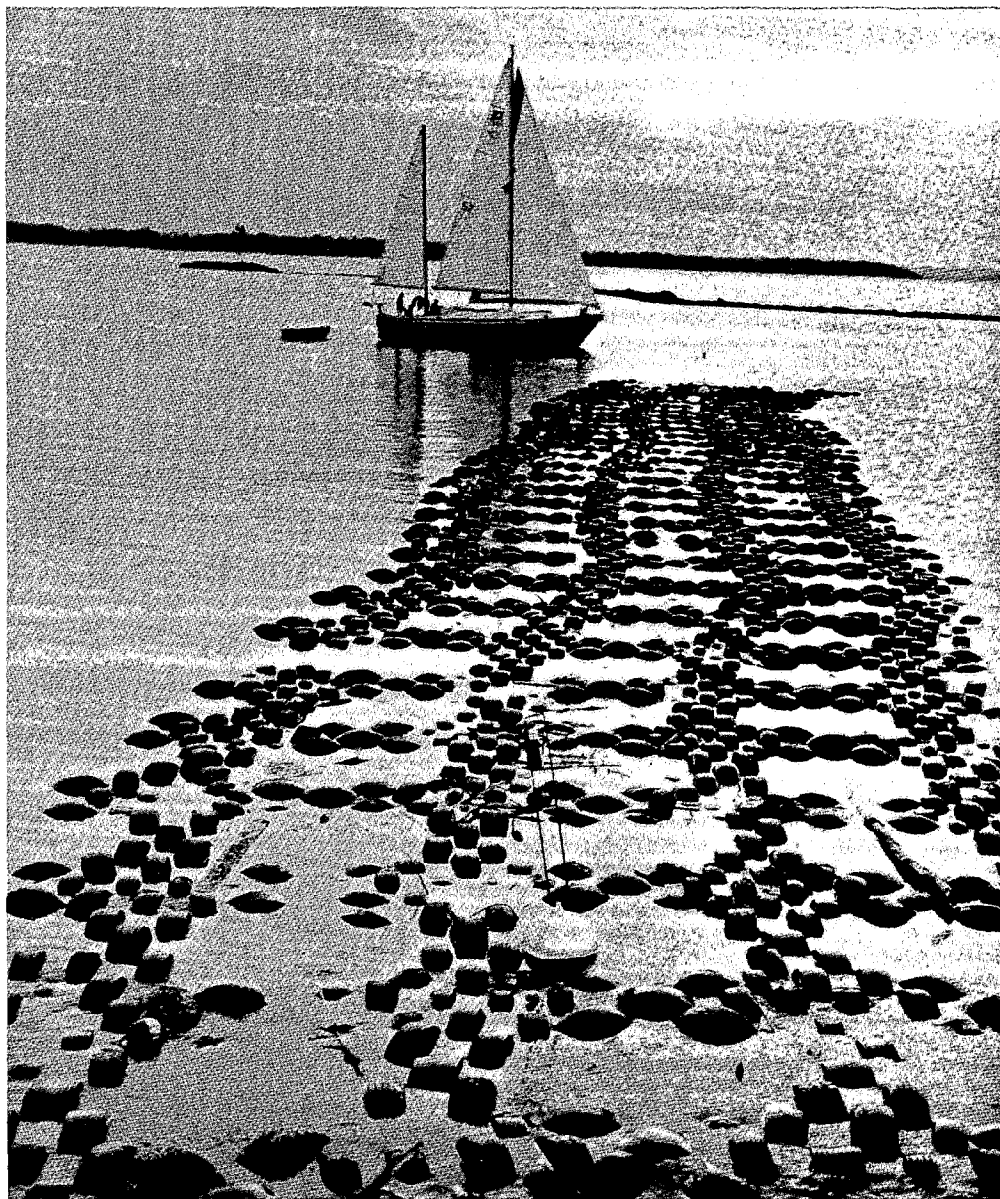
Figure 20 — Floating tire breakwater.

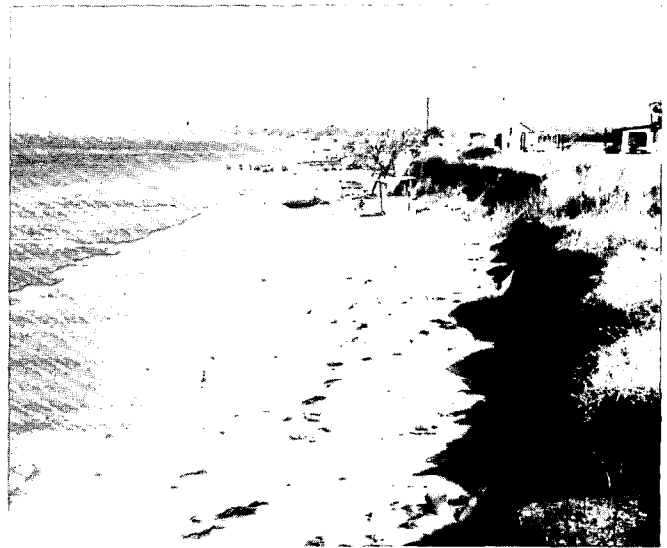
Figure 21A — Sandbag sill.

The principle involved is known as a perched beach. As illustrated (*Figures 21A & B*) the desired effect is to elevate the profile of the beach. If successful, a protective layer of sand exists at the base of a cliff or bulkhead. Because this layer is significantly higher than the unprotected backshore height, additional protection is afforded during storm elevated water levels. This system offers protection from all wave angles and at higher water levels. In essence, it resembles a "permanent" bar situated at the step of the beach.

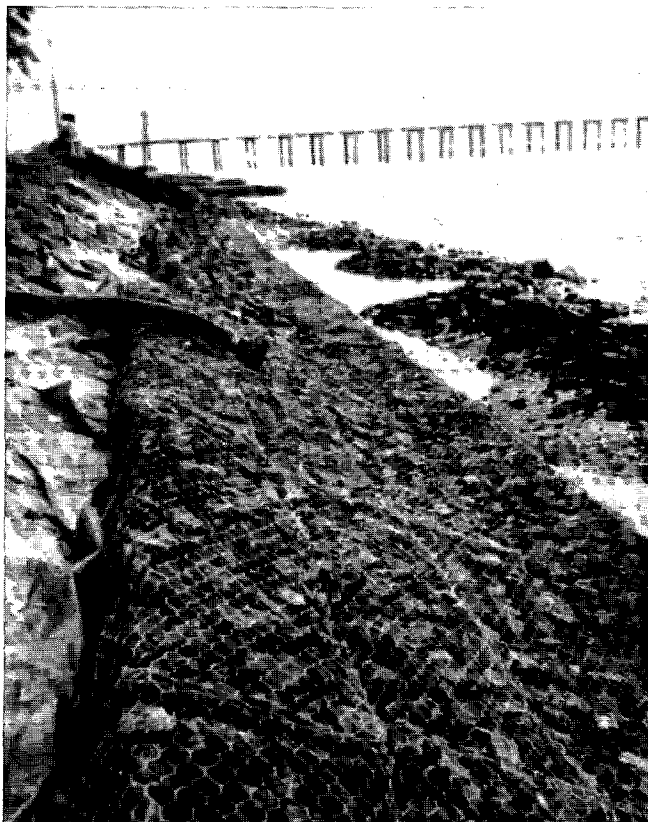
Figure 22 — Gabion revetment.

Rationale: As with other vertical structures, some scour can occur on the seaward side of the structure. Gabions placed on top of sand will be undermined, causing the structure to fail.

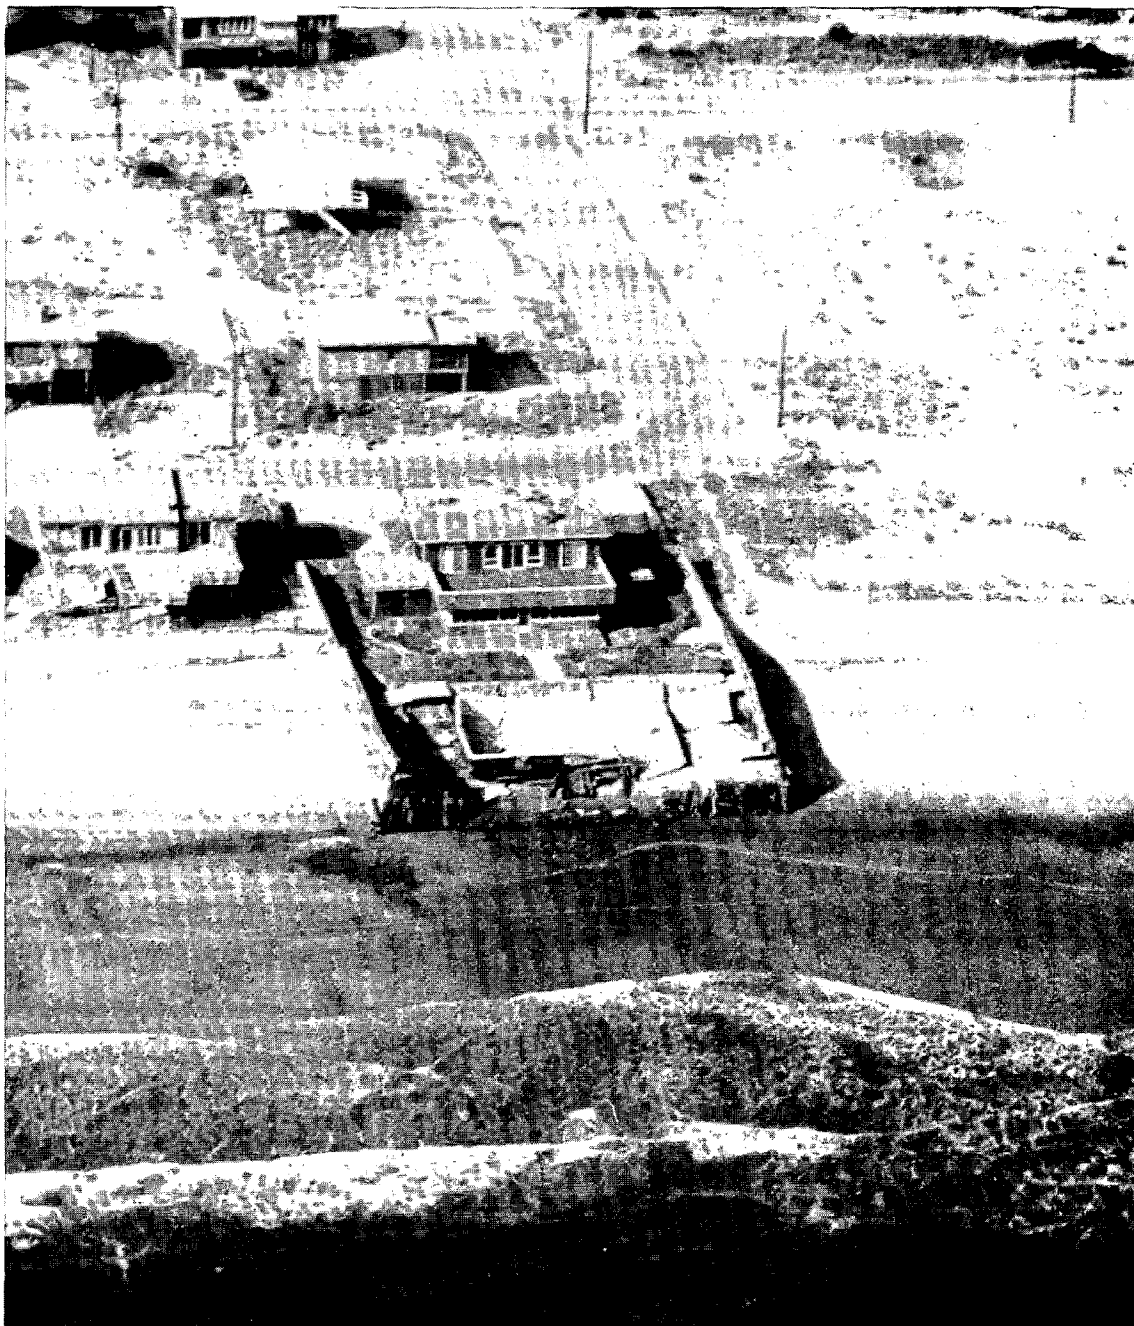
Building a structure close to the Atlantic Ocean may result in severe damage during storm events. The photograph on page 11 shows a Virginia coastal residence with pool in the Summer of 1978. The photograph on this page was taken in October 1979 after a storm of moderate intensity.

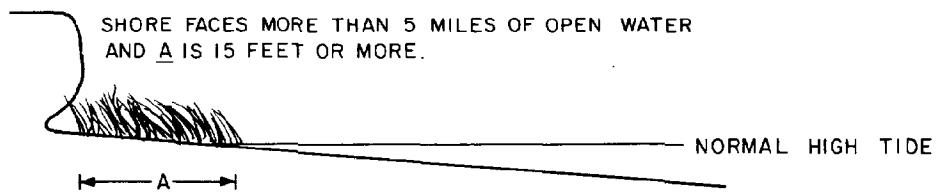
Figure 23 — Marsh site suitability scheme.
