October 2006

# Low-Water Crossings: Geomorphic, Biological, and Engineering Design Considerations

Kim Clarkin, Hydrologist  
San Dimas Technology and Development Center

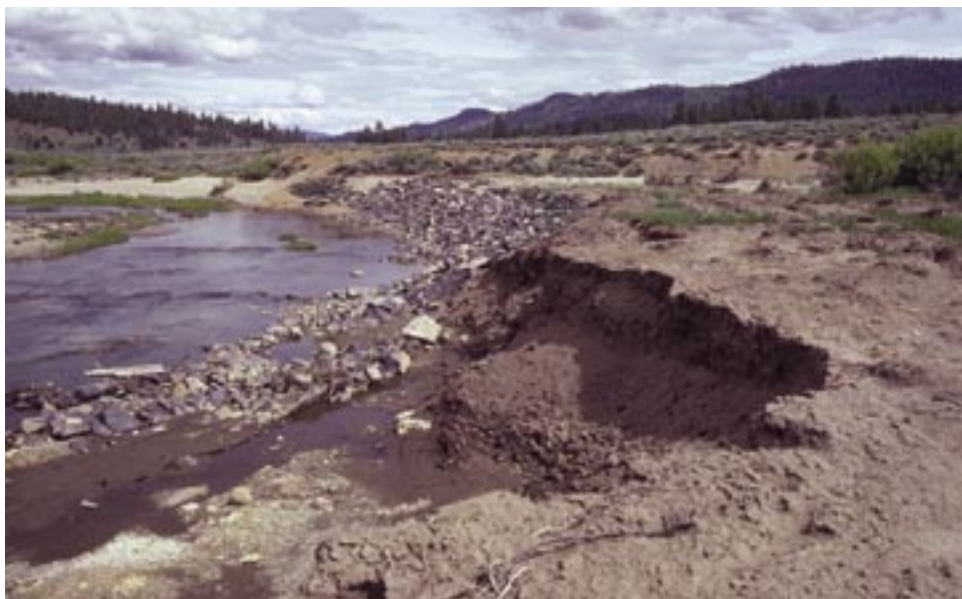
Figure 4.16—Looking downstream at a failed riprap installation on Red Clover Creek, Plumas National Forest.

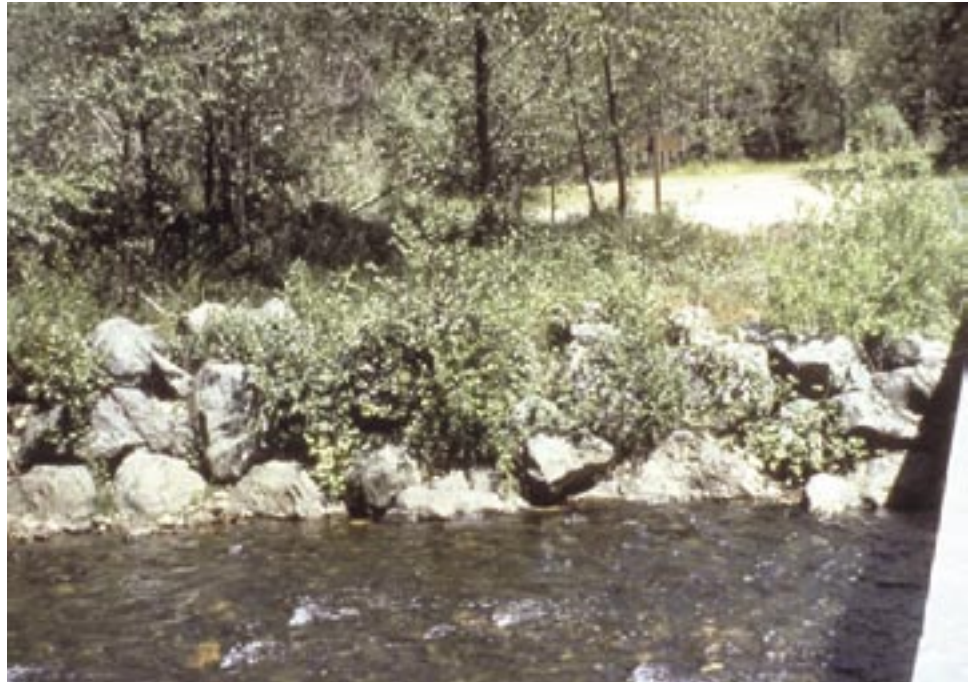
Figure 4.17—Large riprap with vegetation used for streambank stabilization, French Creek Crossing, Plumas National Forest.

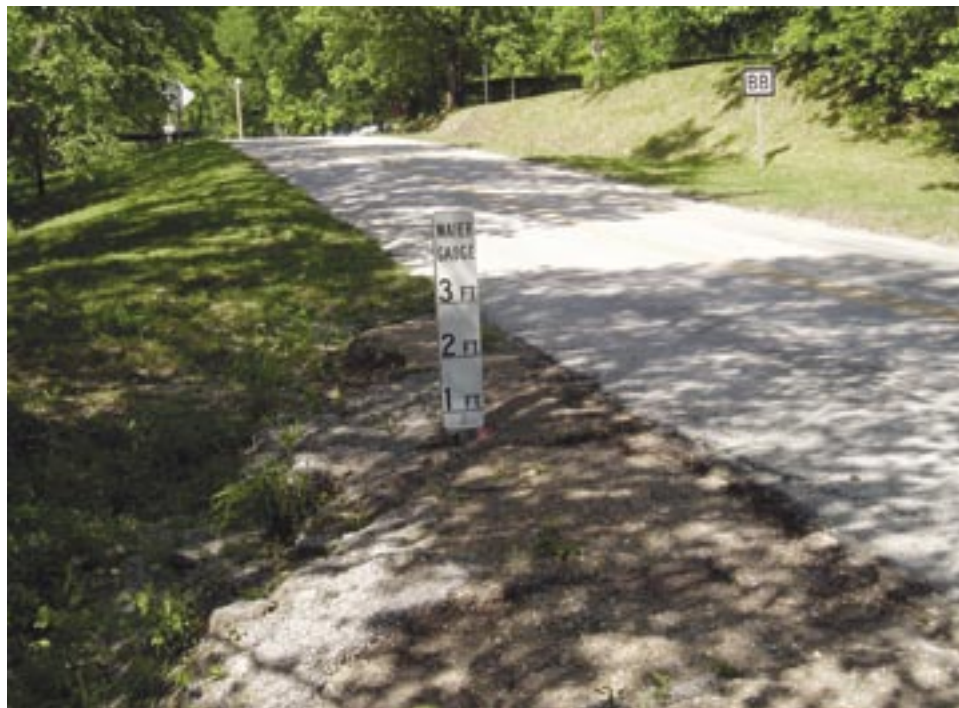
Figure 4.22—Typical depth marker, Missouri county road.

Where practical, use depth markers to indicate the depth of flow over the structure (fig 4.22). Depth markers may be impractical or require periodic maintenance in channels carrying a lot of debris. Alternatively, a system of colored posts could be used where flow level green suggests safe passage, flow level yellow suggests marginally safe conditions, and flow level in the red zone indicates an unsafe condition.

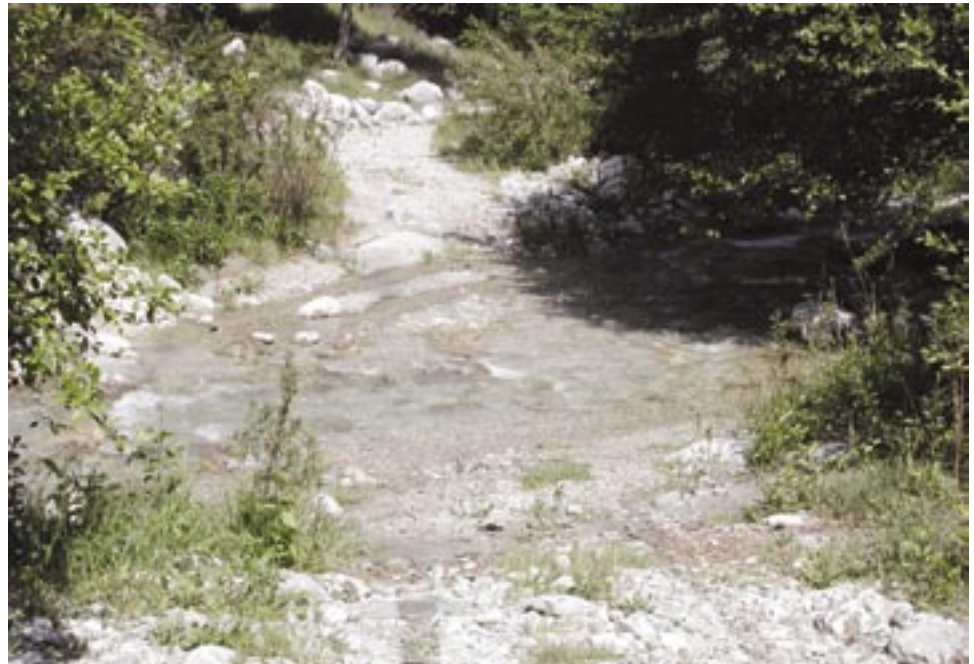
Figure 5.1—Unimproved rock ford on the East Fork San Gabriel River, Angeles National Forest, California.

Unimproved at-grade fords are crossings where vehicles simply drive across the channel without the benefits of hardening or grading. The ideal site for an unimproved ford is one with rocky, hard substrate (fig. 5.1) or bedrock. Even where the channel bottom is hard, the streambanks can be soft and erodible. In such cases, traffic generally causes the stream to widen as the banks break down and wash away. This problem can be fixed by “improving” the ford—removing soft soils and replacing them with select coarse rock.

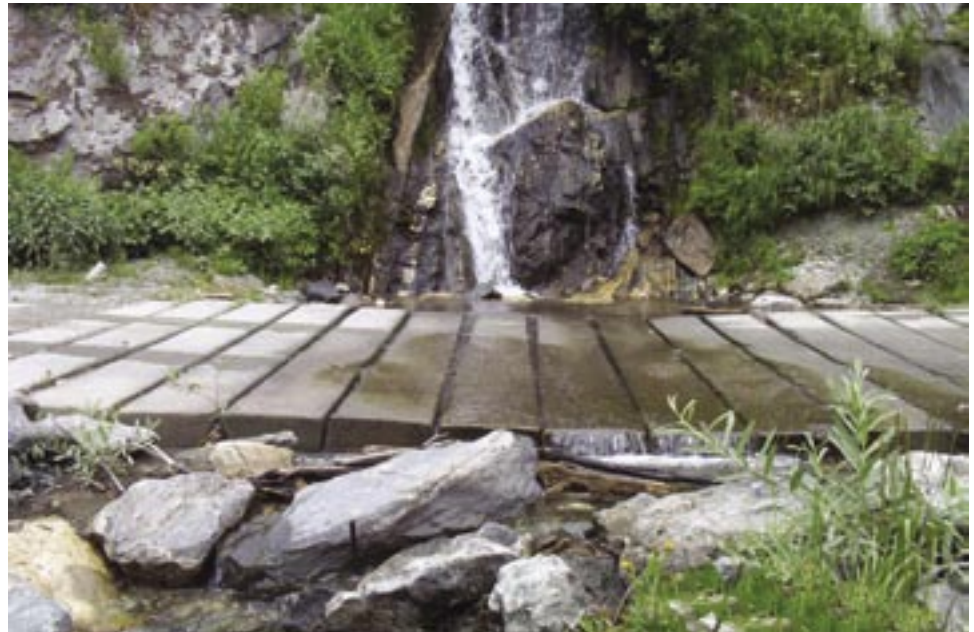
Figure 5.5—Concrete plank ford at edge of the North Fork Clearwater River, Clearwater National Forest, Idaho.

Precast concrete planks also are used in at-grade fords to provide a concrete-hardened driving surface. The structure typically consists of individual 12-inch by 12-inch by 16- to 20-foot long, steel reinforced, precast concrete “planks” or logs, bolted together with iron flanges to hold their spacing (McNemar 1983). The planks are placed upon a prepared, graded rocky surface. The outlet may be armored with riprap to protect against the increased flow velocities across the planks and through the small channels between the planks (case study 5). The structure acts like a vented ford (with small vents) at low flow, with a dry driving surface and with flow going between the planks (fig. 5.4).

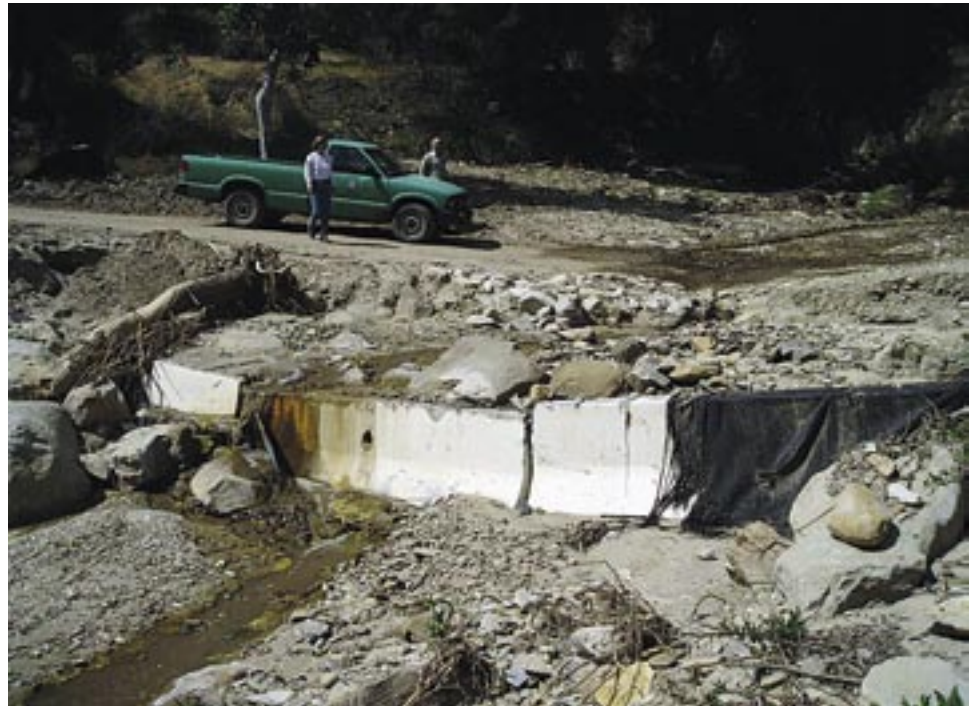
Figure 5.12—Jersey barriers used for a temporary ford after the Ojai wildfire in 2004, Los Padres National Forest, California.

If Jersey barriers are set too high, the crossing may be too flat and sediment may deposit on the road during high flows. The waterfall over the downstream edge of the ford will also promote toe scour, and the barriers may be pushed over by the lateral pressure of the road fill (fig. 5.12). Ideally, Jersey barriers should be set into the stream channel at roughly half their height to prevent them from overturning or sliding downstream. Actual grade and height of the sill will depend on the channel gradient and other conditions.

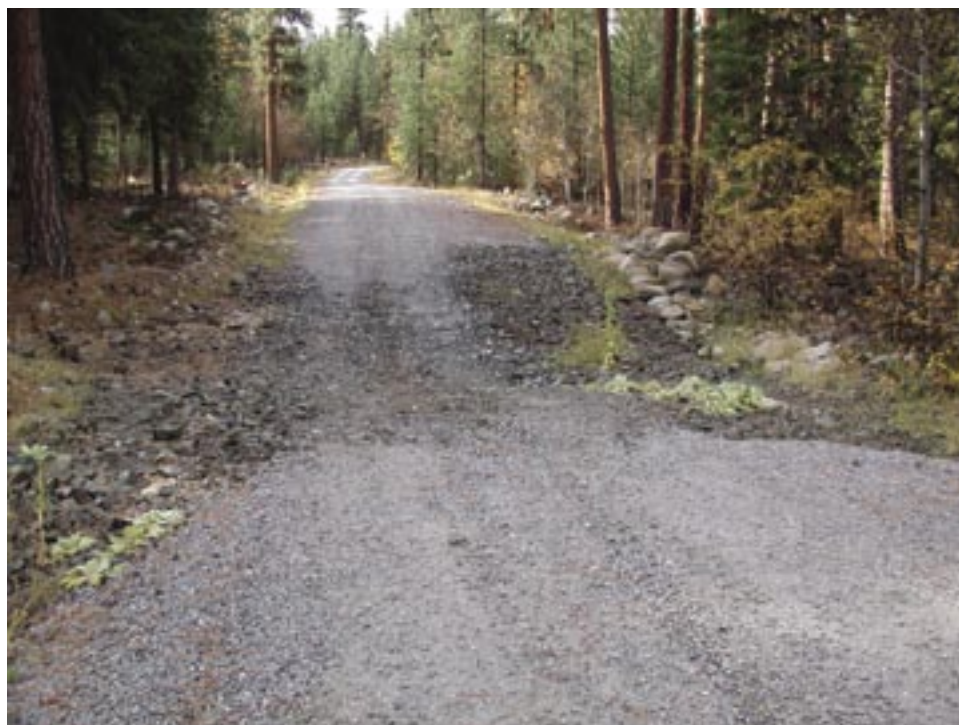
Figure A4. Hardened rock ford on East Chewuch Road.

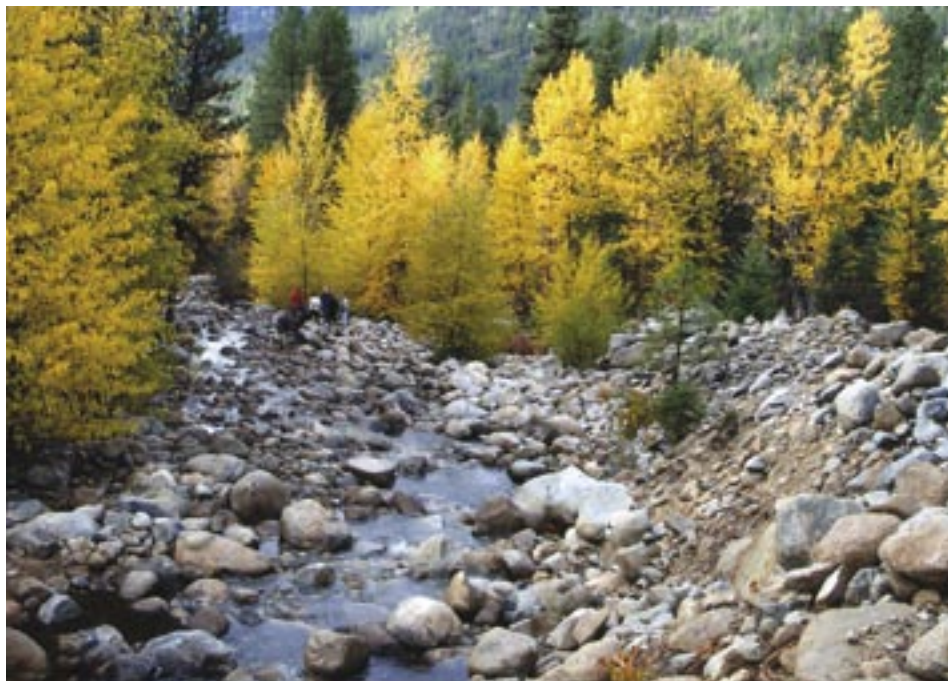
Figure A5—Twenty-mile creek was channelized near the top of the alluvial fan. Note levee at right of photo.

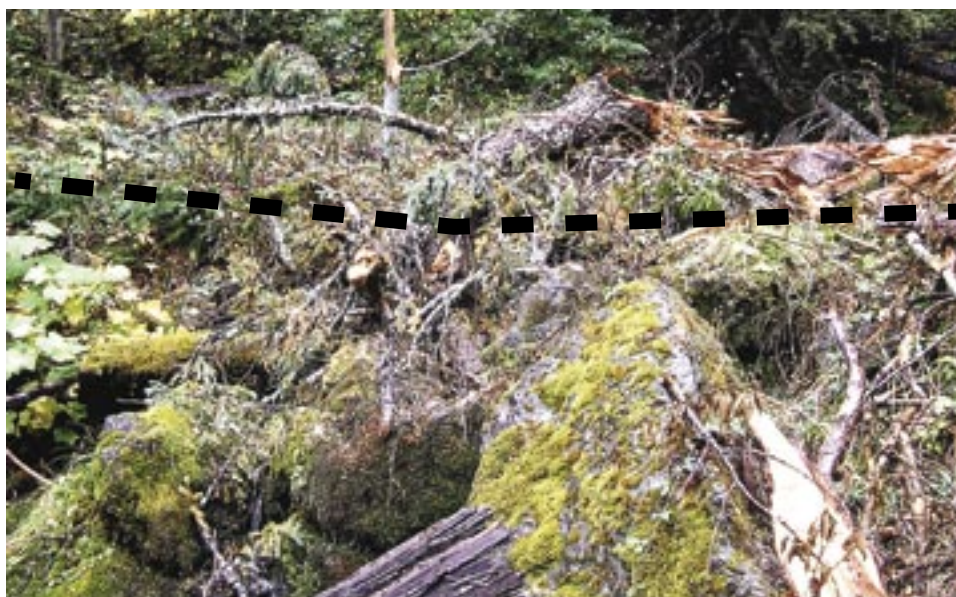
Figure A13. Stable, moss-covered rocks on the splash apron with pieces of fallen snag. Dashed line indicates approximate road surface.

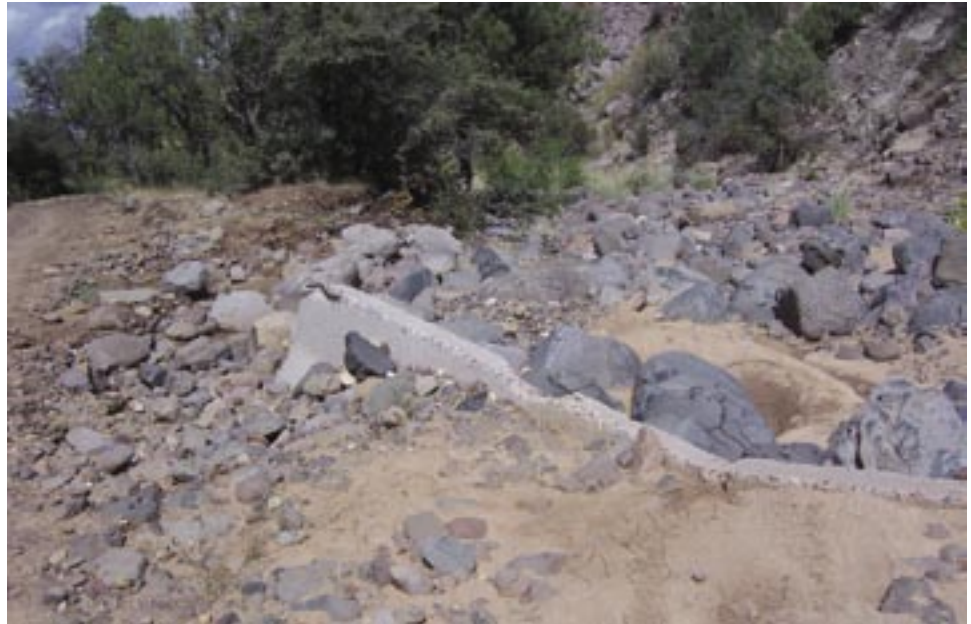
Figure A19. High flows have outflanked one of the ford structures.

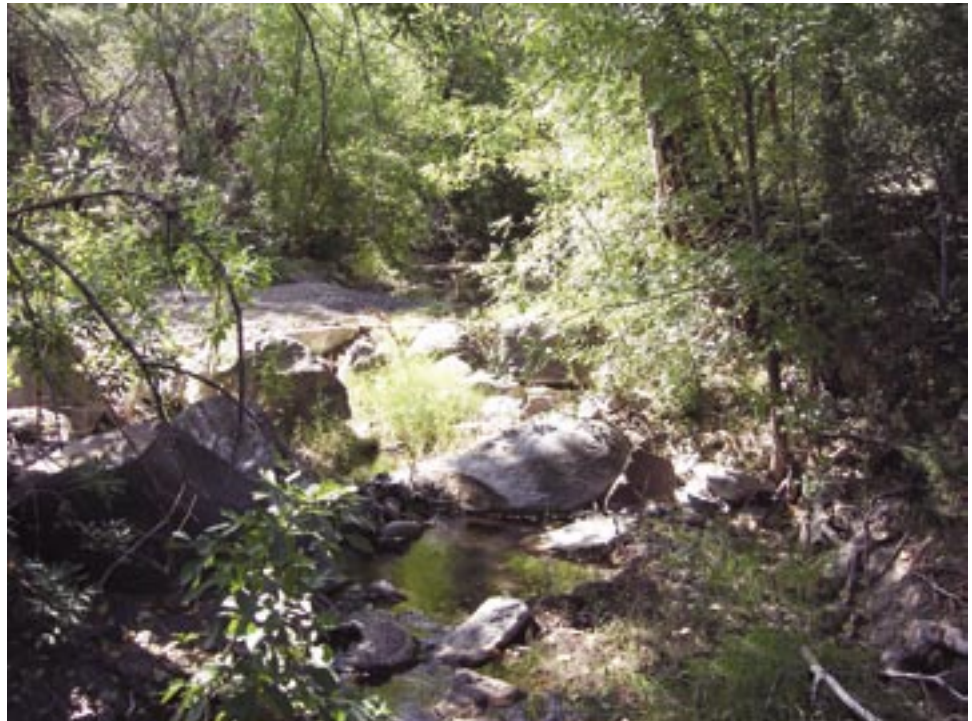
Figure A20. Jersey barrier ford on FR 136 has helped control channel downcutting and restore the riparian area in Copper Canyon. Photo is looking upstream at the ford.

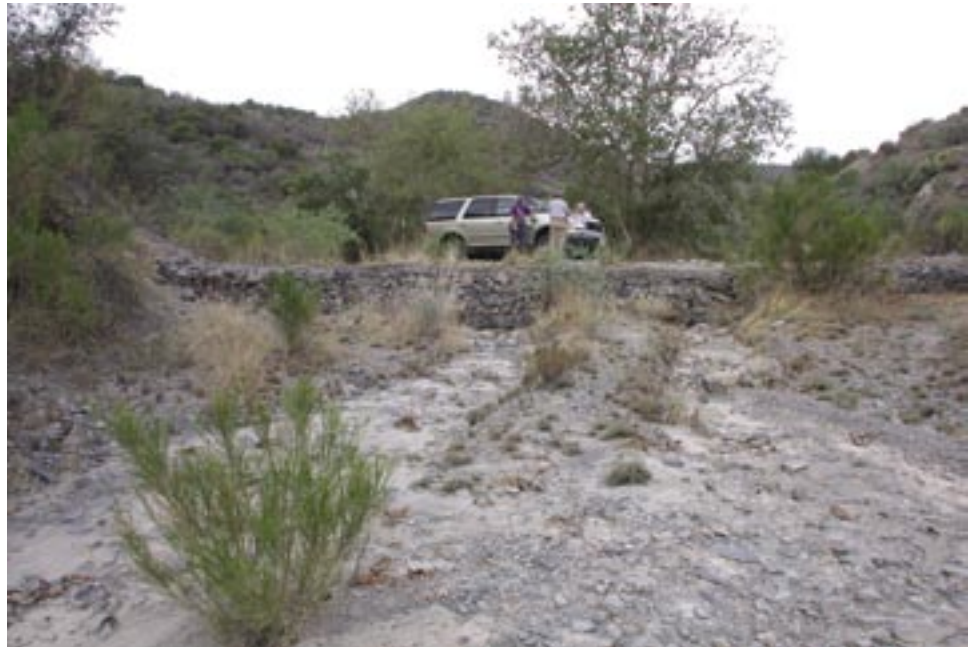
Figure A21. This jersey barrier-gabion ford on the 7-Springs Road on the Tonto replaced a bridge washed out in a flood.

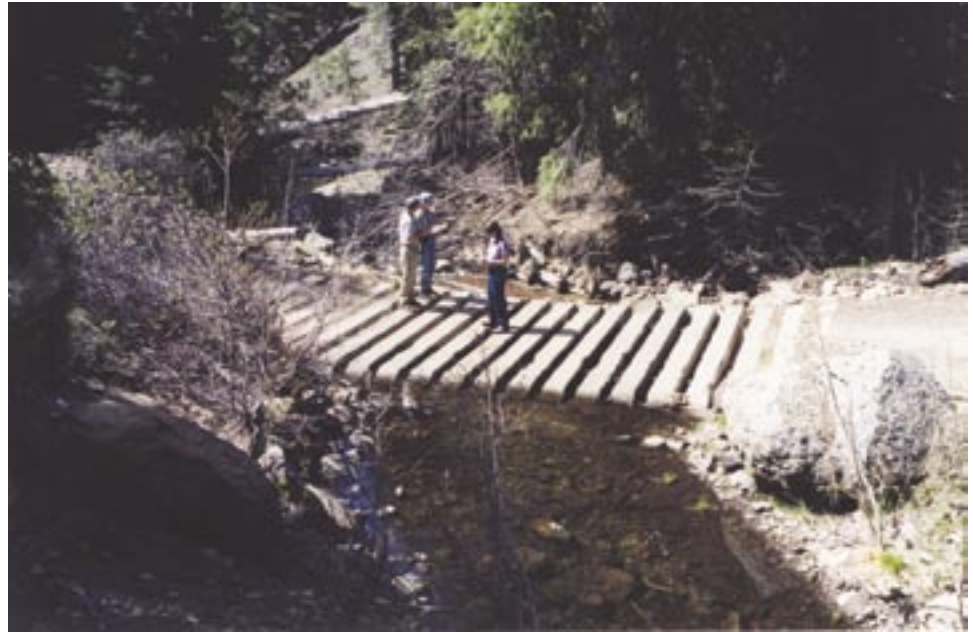
Figure A23. Looking downstream: ford is just above a tributary junction where an old diversion structure blew out and caused streambed to degrade.

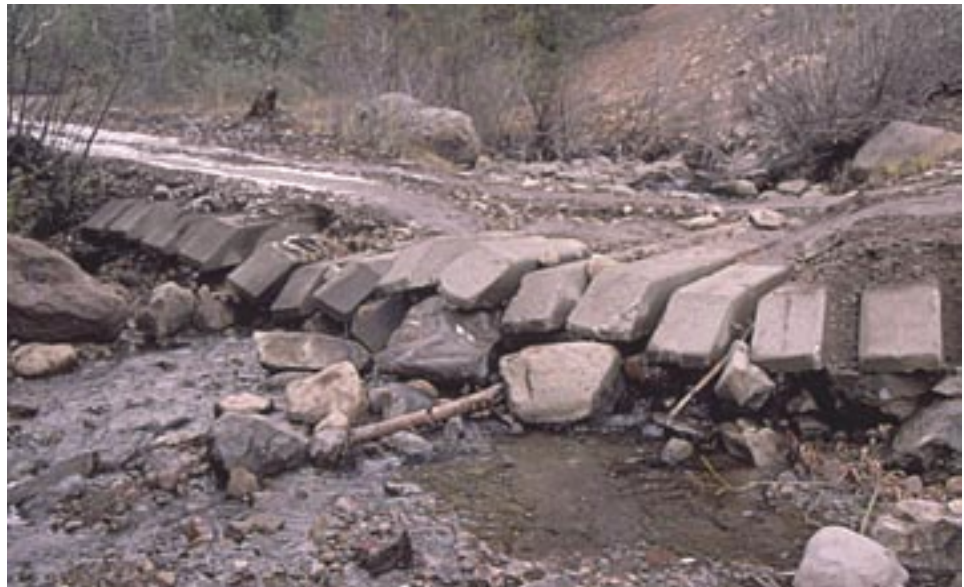
Figure A26. The crossing was damaged in the 1997 flood by scour of fine bedding materials under the planks. The planks had to be reset into coarser materials and the downstream edge protected with riprap.

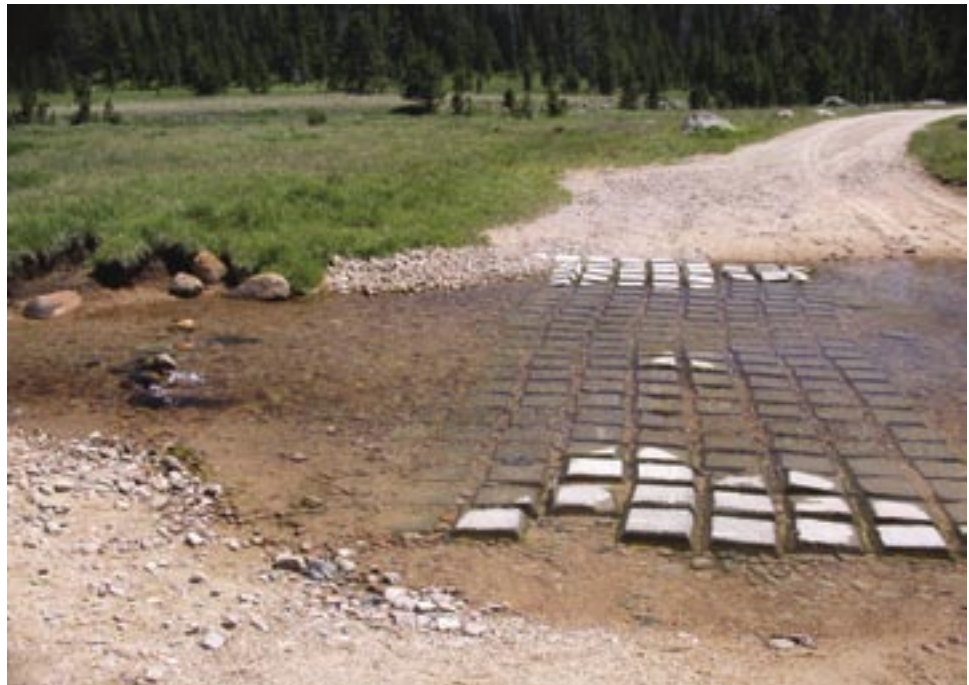
Figure A32. East Fork South Tongue River cable concrete block mat crossing. Note tilted blocks, exposed cables, and short mat length. Traffic is driving around the mat and the river has outflanked it.

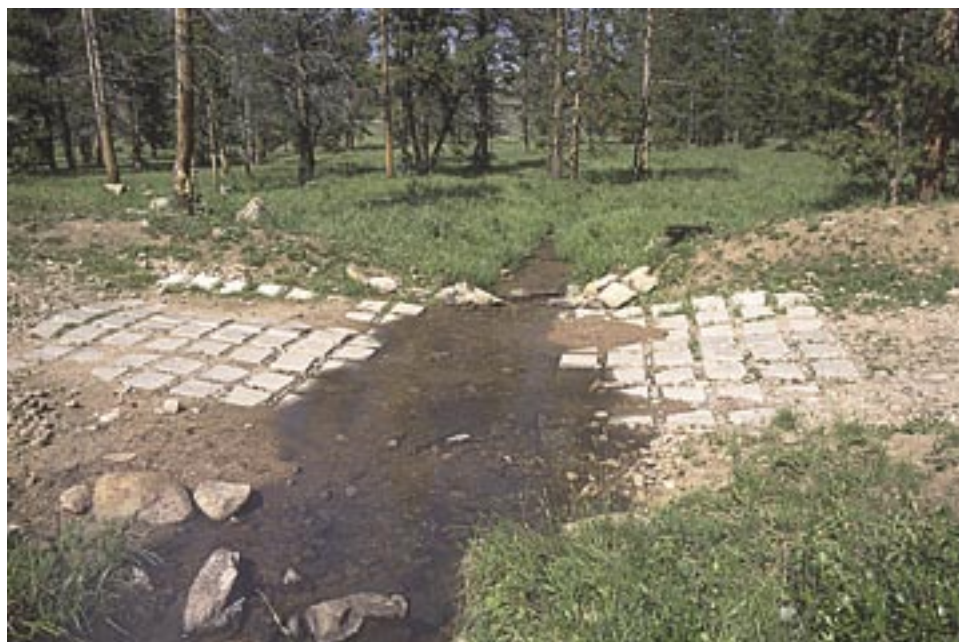
Figure A33. Copper Creek tributary, Bighorn National Forest. At this drier site with less traffic, the mat is considered the best crossing option because of its low maintenance requirement and installation cost.

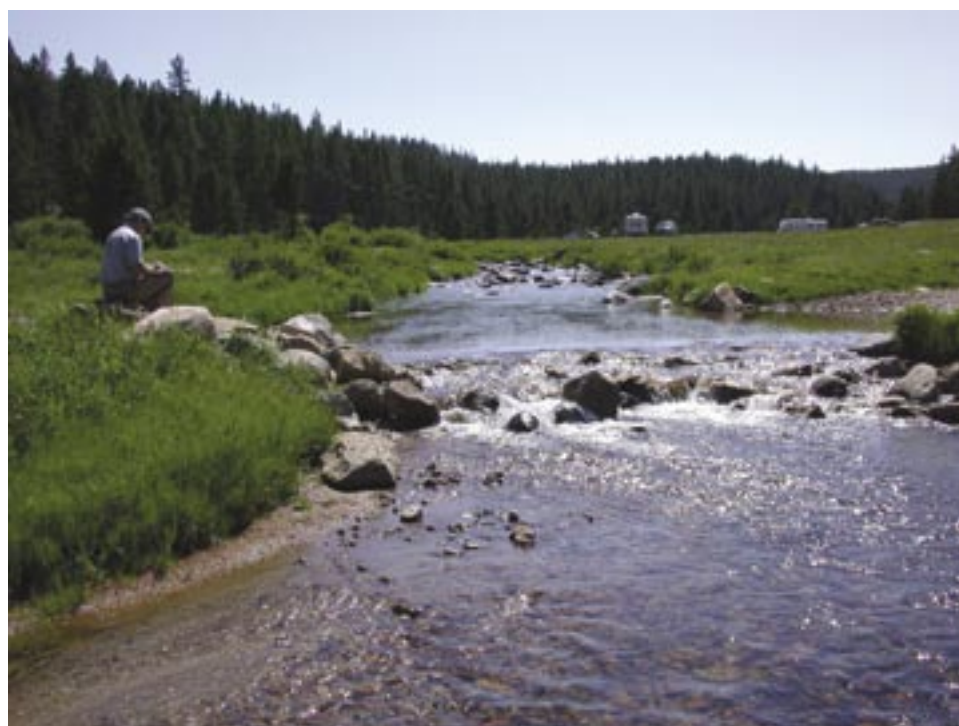
Figure A35. A boulder cascade was constructed at the downstream edge of the ford to control scour caused by placing the GEOWEB very slightly above streambed elevation.

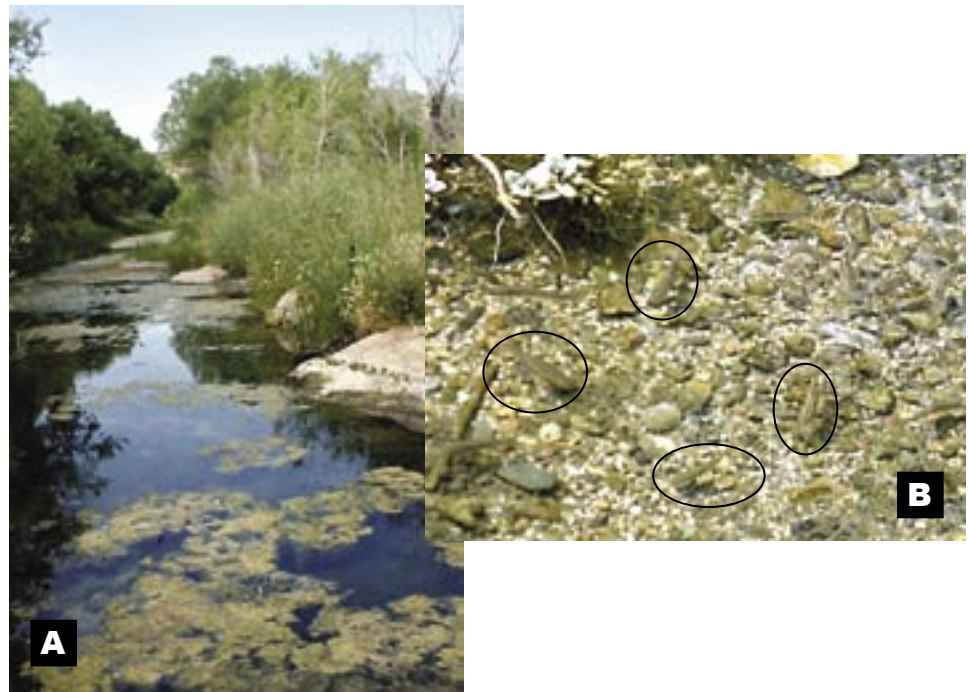
Figure A43a and A43b. Agua Fria River A43a. Pool several hundred feet upstream of ford in August 2003. A43b. Fish are in isolated pools both upstream and downstream of the dry ford.

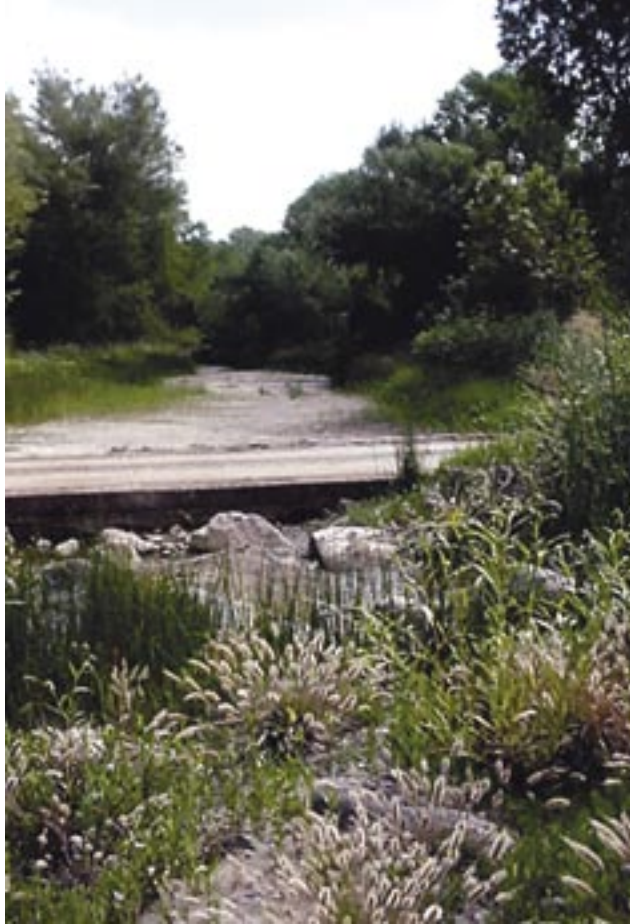
Figure A47. Looking upstream at ford and Agua Fria channel. Fish can move across the ford only when it is submerged.

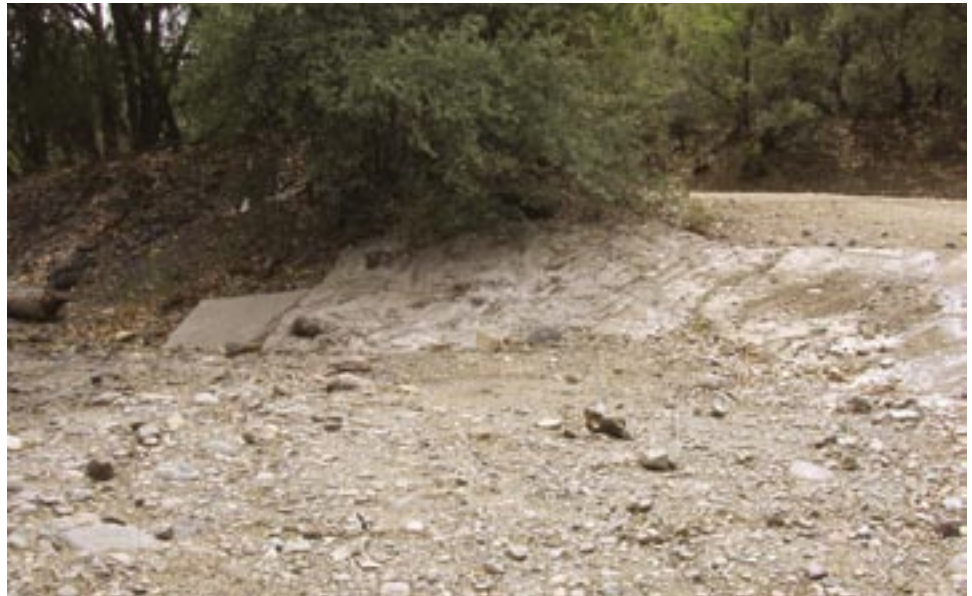
Figure A51. Concrete apron and grouted riprap prevent downstream scour and scour around edges of the ford.

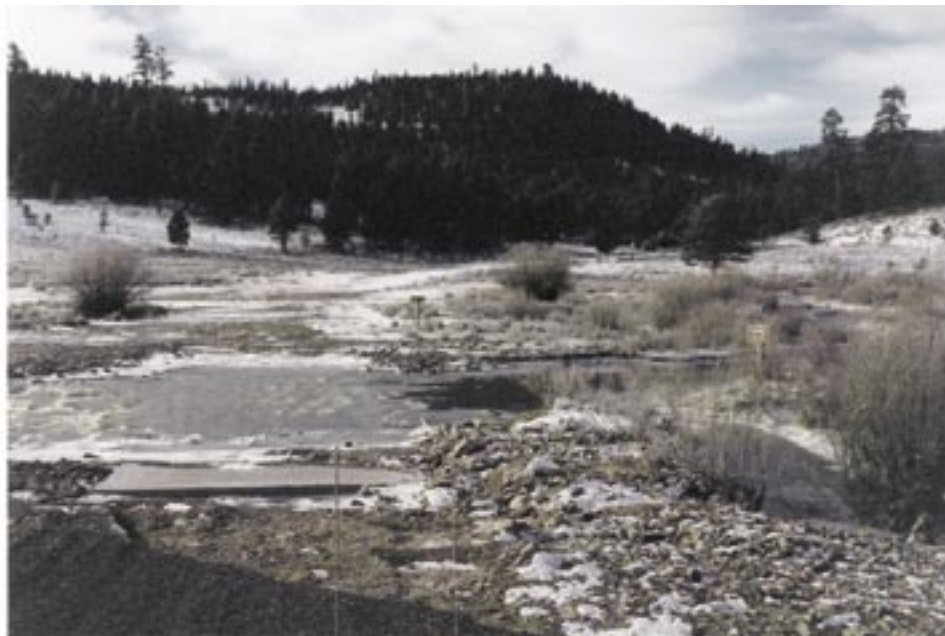
Figure A59. Shortly after the 1997 New Year's Day flood. Some gravel washed from the approaches (in foreground) was the only damage from the largest flood on record.

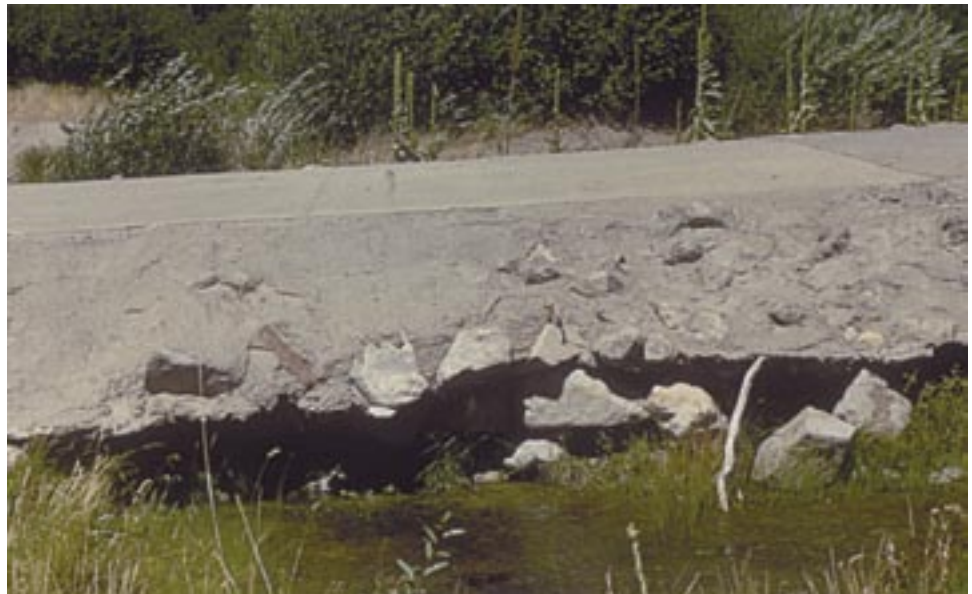
Figure A65. Downstream scour under the slab after the 1982 flood. The repair was to add a 5-foot-deep vertical concrete cutoff wall.

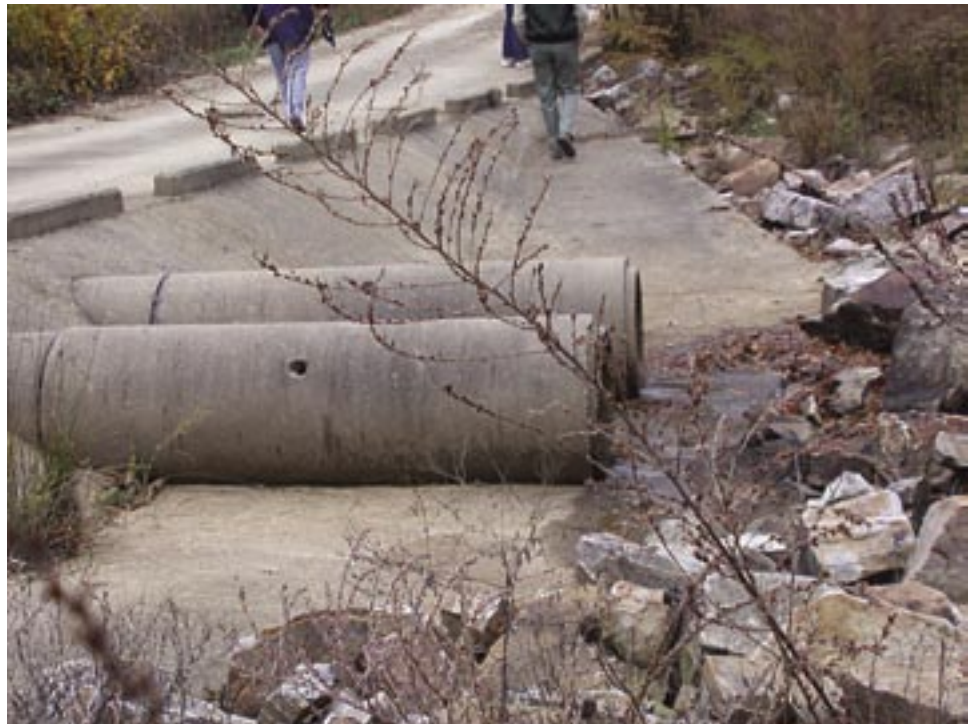
Figure A72. Concrete pipes outlet on splash apron with riprap downstream. Fillslope is also protected by concrete. Note erosion to side of fillslope concrete armor.

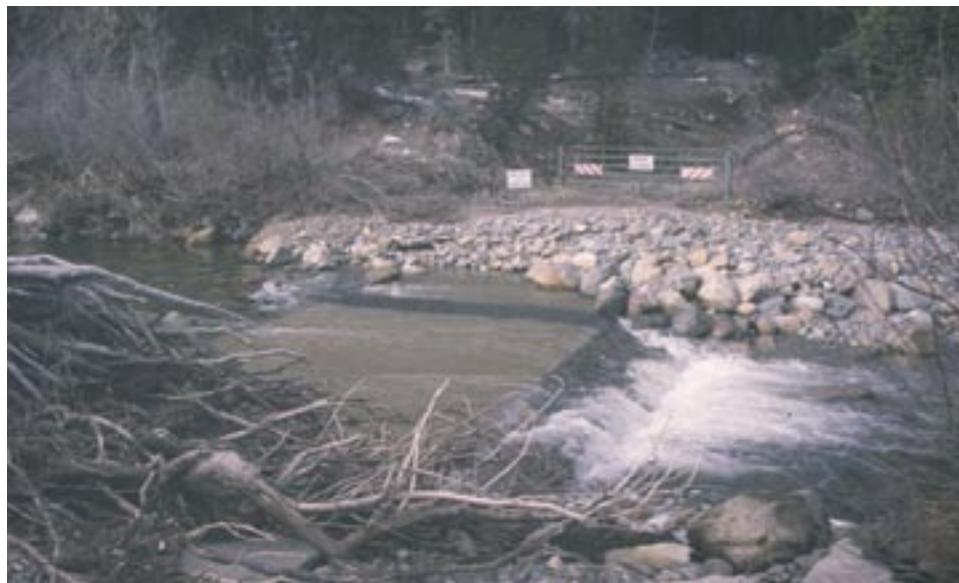
Figure A78. After a major storm, medium and large boulders and large root wads cover the ford, but the structure is undamaged.

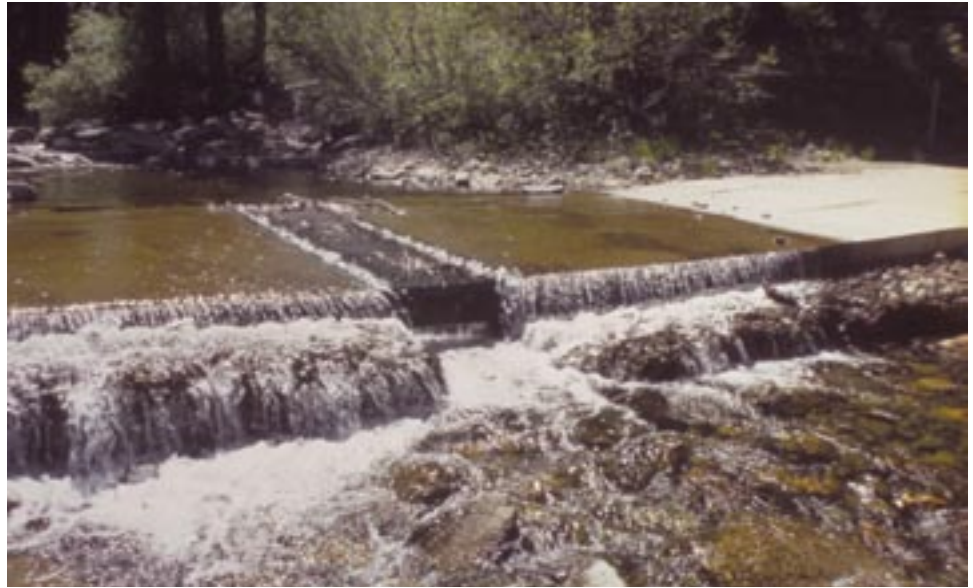
Figure A79. Grubbs ford immediately after construction in 1986. The vent appears to be a velocity barrier when it is not plugged.

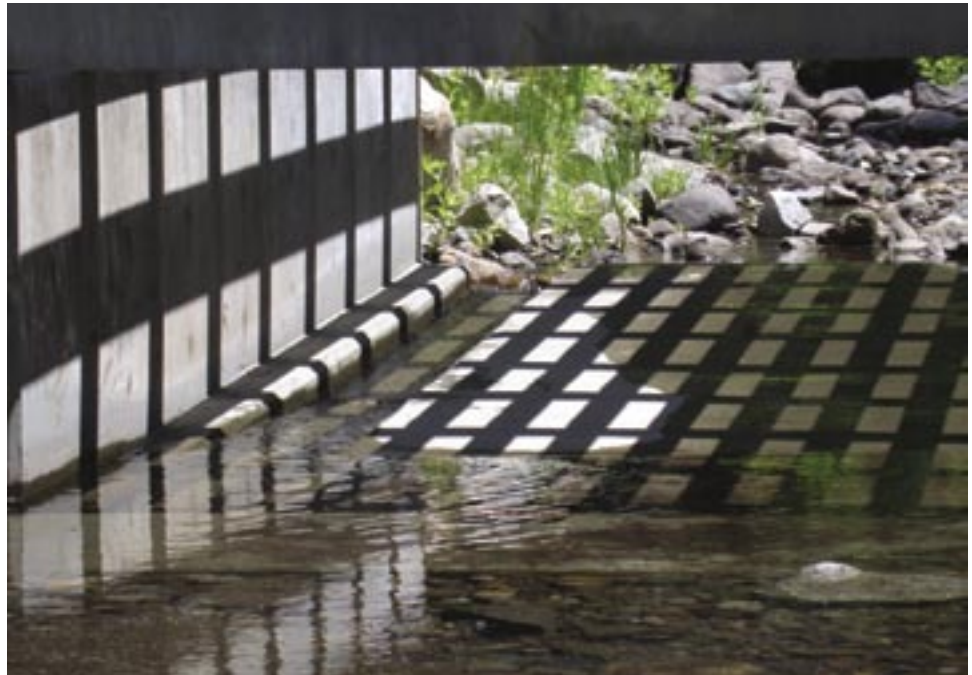
Figure A83. Vented ford showing low-flow trench at left and partial backwatering. Fish were attempting to move upstream in July 2002, but flow in the trench was too shallow and too fast.

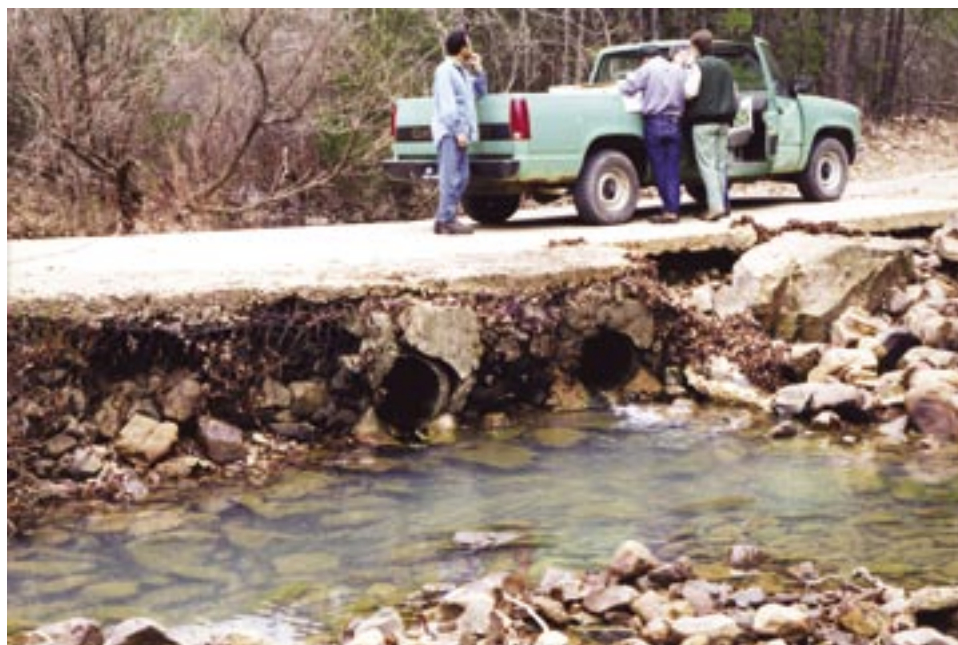
Figure A87. The previous crossing on road 887 at Rocky Creek was a gabion-culvert structure that was frequently damaged during high flows.

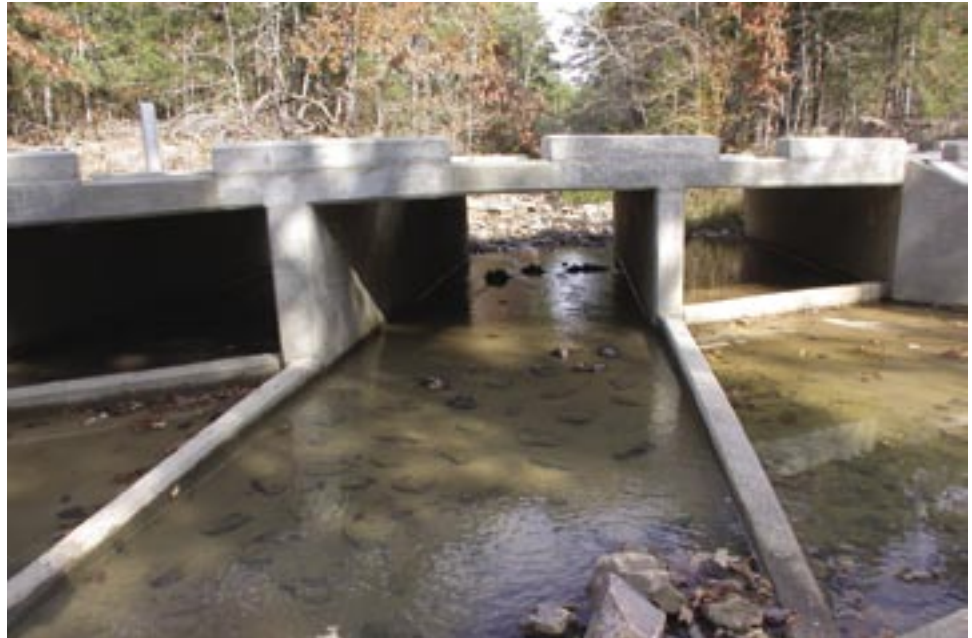
Figure A92. The floor of the central box has a thin veneer of sediment at low flow.

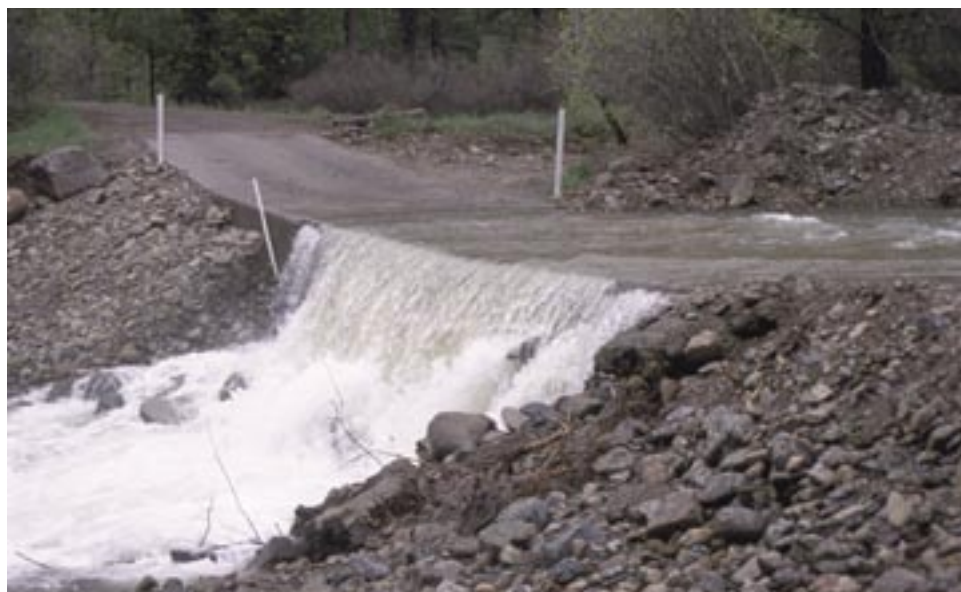
Figure A99. Damage to the Moonlight low-water crossing after the 1997 flood. The downstream rock armoring was undermined and washed away, partially undermining the concrete slab driving surface.

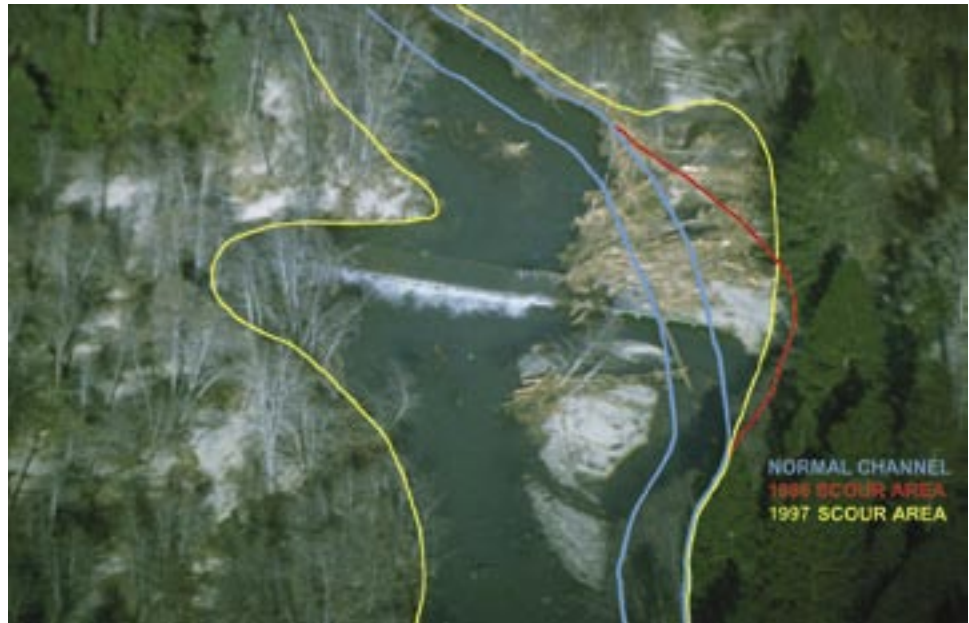
Figure A119. Debris dammed the structure during the 1997 flood event. The main thread of flow shifted to the west and is spilling over the elevated roadway. The white sand deposited everywhere except the higher forested ground in the upper left and lower right of the photo shows that almost the entire area was flooded in 1997. The area that was scoured east of the ford in 1986 is also delineated.

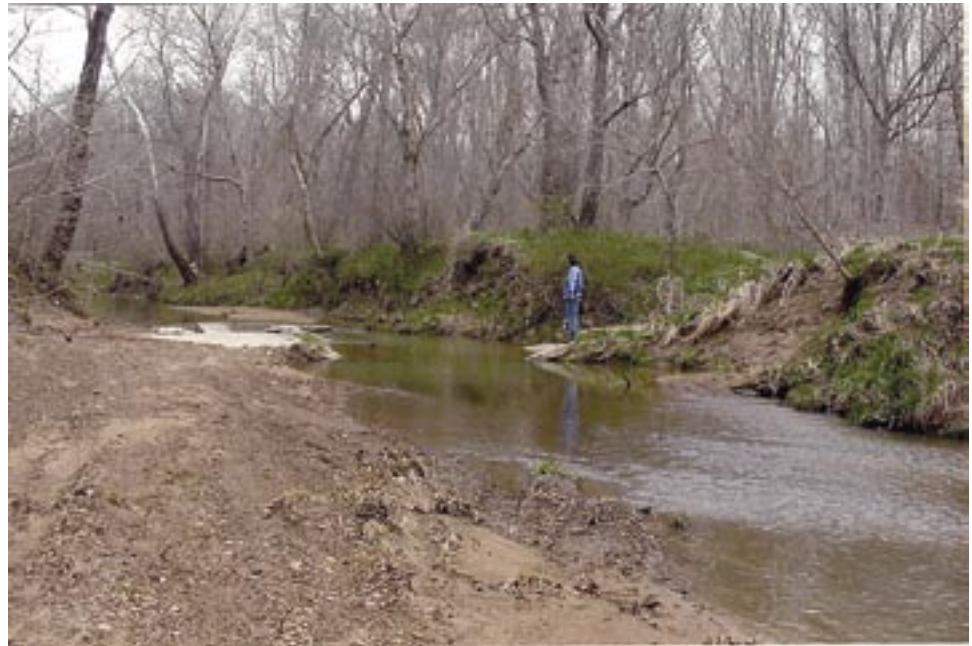
Figure A125. Looking upstream at failed Kinkaid Creek crossing, 2000. Stream slope is 0.3 percent.

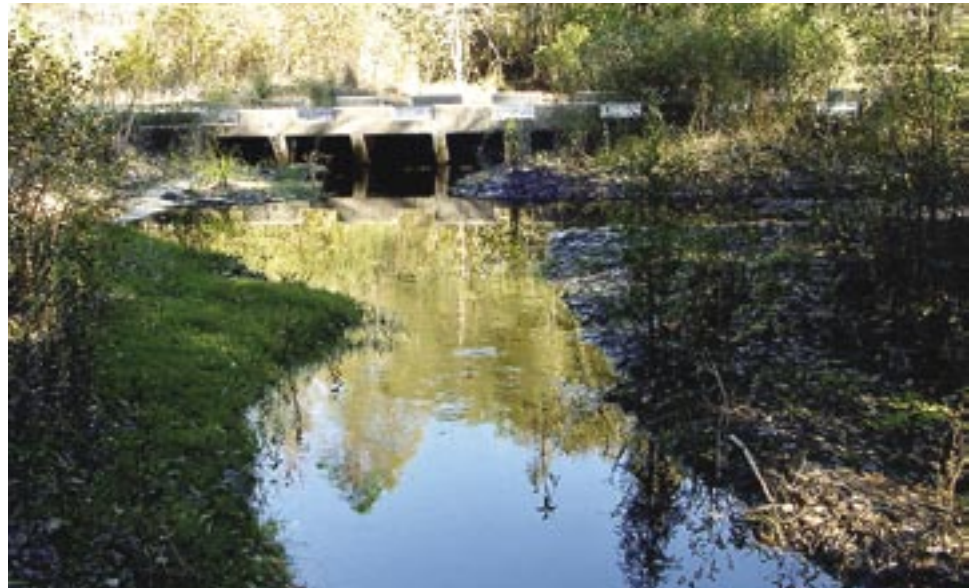
Figure A131. Sand and silt deposit downstream of the bridge (2003).
