## **STUDIES OF NOBLE-METAL THERMOCOUPLE STABILITY AT HIGH TEMPERATURES**

P. D. Freeze and D. B. Thomas

Prepared for  
**NATIONAL AERONAUTICS AND SPACE ADMINISTRATION**

Issued July, 1976

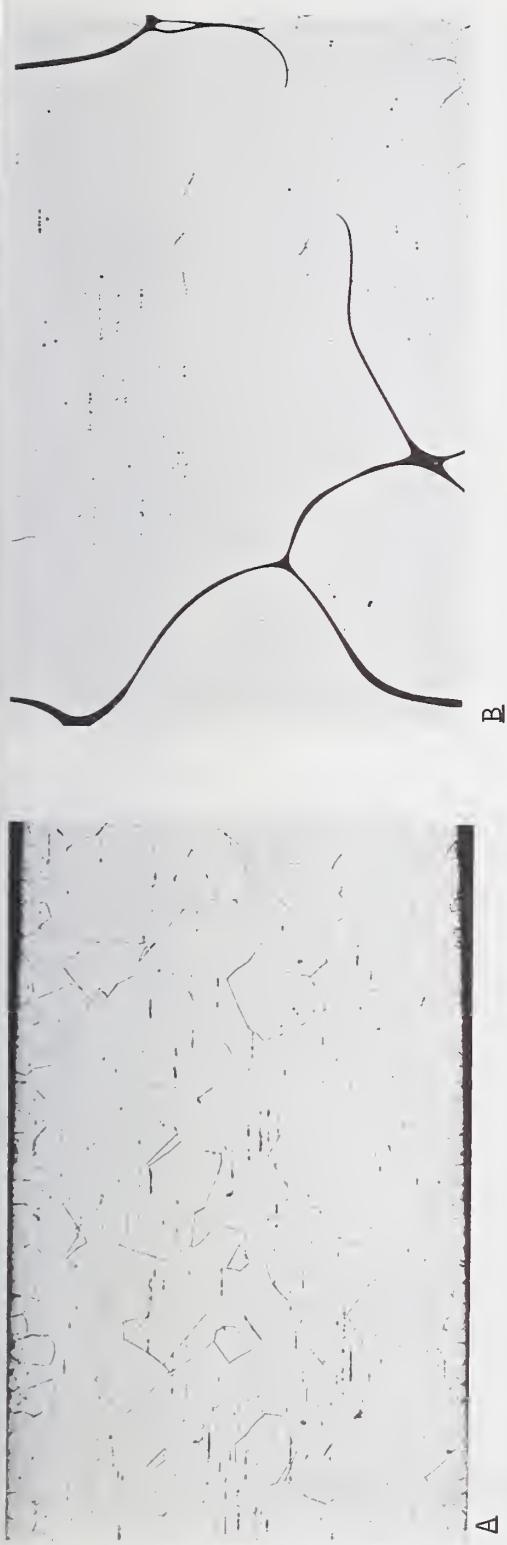
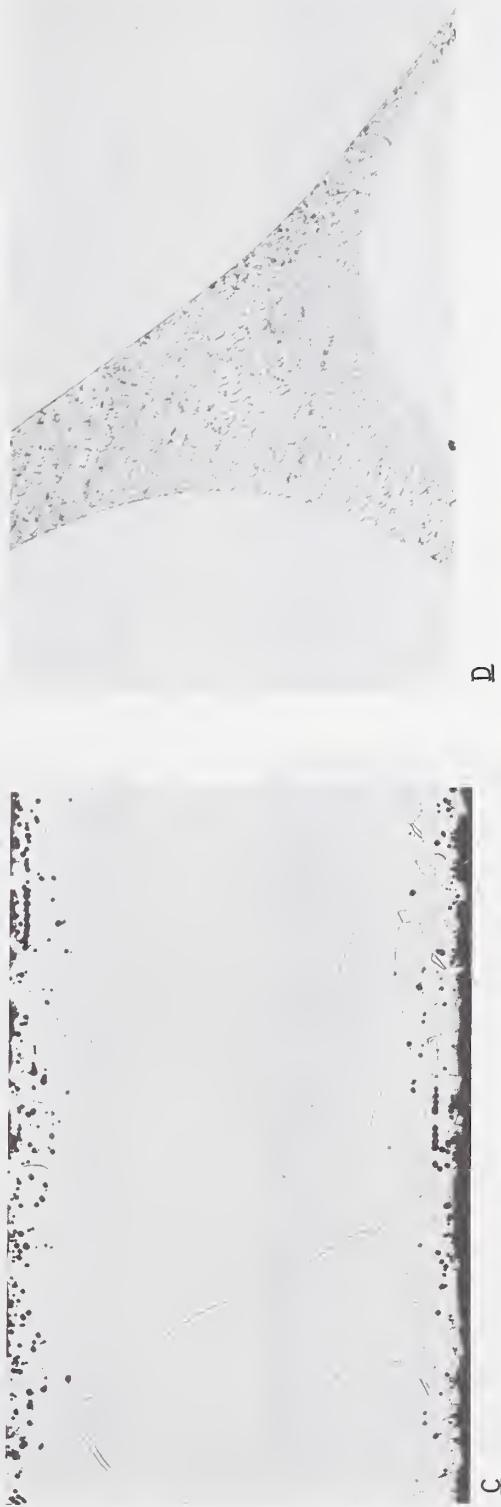
FIGURE 8: MICROGRAPHS OF SECTIONED IRIDIUM-40% RHODIUM COMPONENT OF A TEST THERMOCOUPLE AGED AT 1700°C FOR 359 HOURS. PHOTOGRAPHS A, B, AND C WERE TAKEN WITH A MAGNIFICATION OF 100X; D, AN ENLARGEMENT OF A GRAIN-BOUNDARY PHASE FROM B, AT 1200X. FURTHER DESCRIPTION IS IN THE TEXT, 2.7.2. THERMOCOUPLE SYSTEM: IRIDIUM-40% RHODIUM VERSUS IRIDIUM.

Figure 8 presents micrographs of the sectioned iridium-40% rhodium component of the test thermocouple. Photographs a, b, and c were taken with a magnification of 100X; d, at 1200X. The changes in structure appear greater than those experienced by the other components in either atmosphere and suggest the possibility that this alloy may have experienced a change in composition as well as structural deterioration. Photograph 8a shows a longitudinal section of the alloy wire microstructure in regions not exposed to any high temperature, for reference. Photograph 8b shows a longitudinal section of the alloy wire that was exposed to high temperatures in an air atmosphere. The microstructure reveals a grain-boundary phase and large, smooth-cornered grains, whose presence indicates that melting had occurred. Photograph 8c is a longitudinal section of the same wire about 2.4 cm from the thermocouple junction showing erosion of the surface and voids near the surface. Considerable grain growth is also shown. Photograph 8d is an enlargement of the grain-boundary phase in 8b.

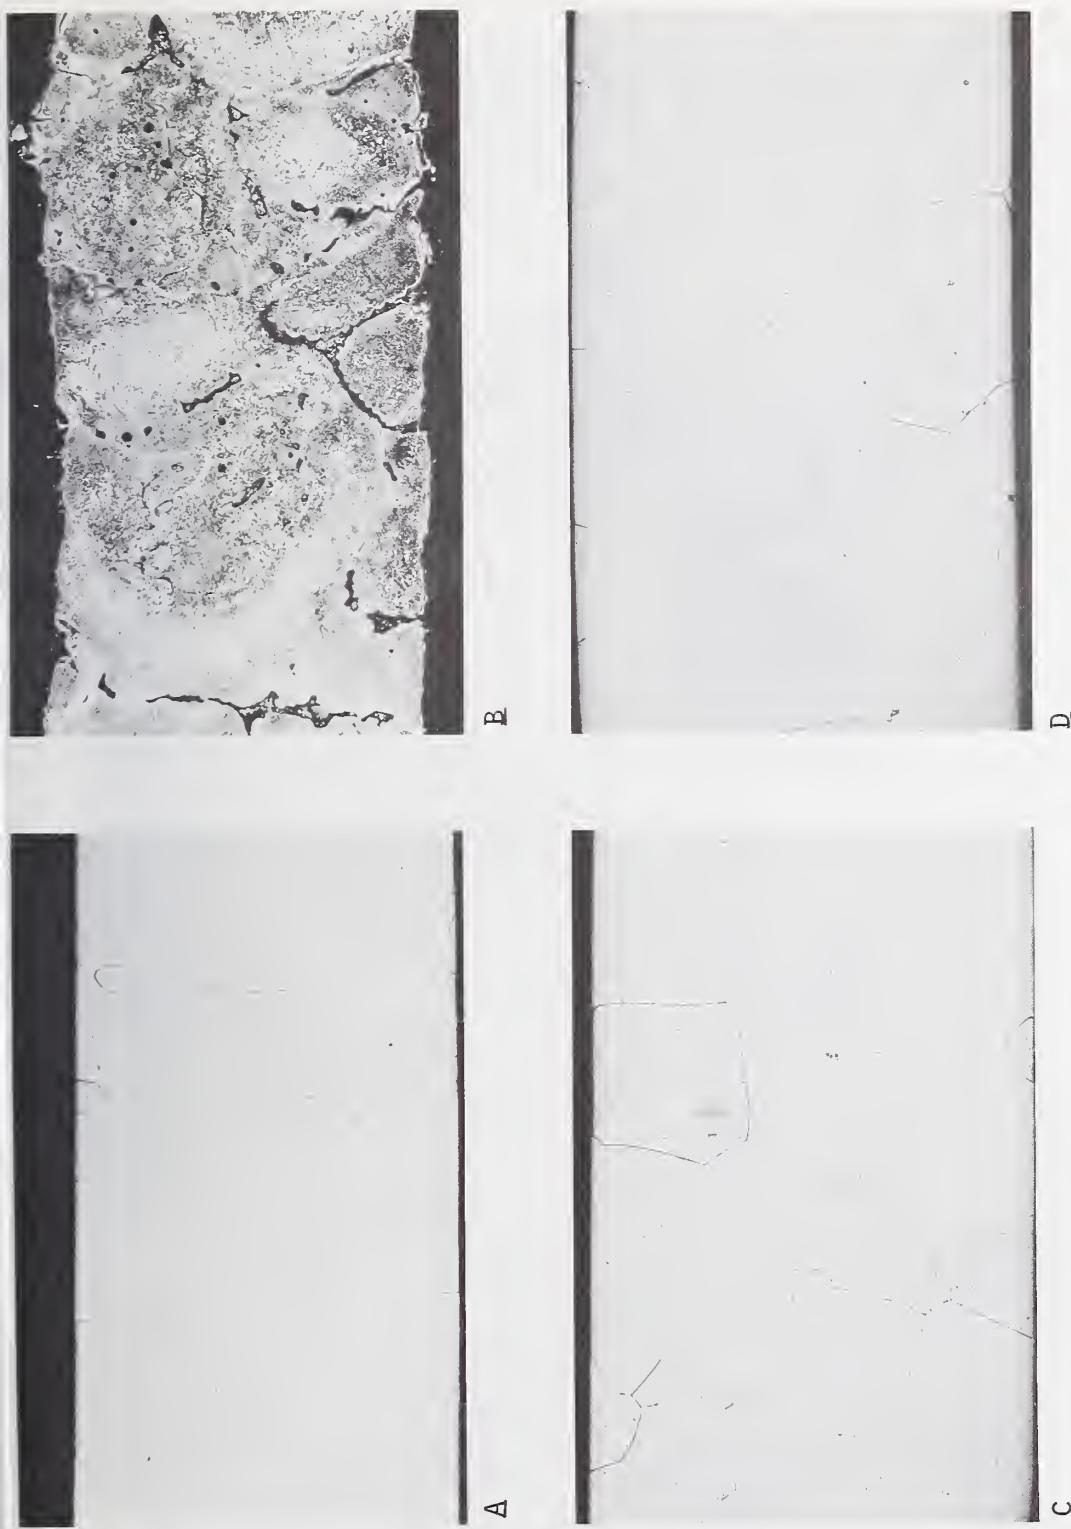
FIGURE 10: MICROGRAPHS OF SECTIONED COMPONENTS OF TEST THERMOCOUPLES UNHEATED (A, ALLOY AND C, IRIDIUM) AND AGED AT 2000°C FOR 8 HOURS (B, ALLOY AND D, IRIDIUM). THE MAGNIFICATION WAS 80X. FURTHER DESCRIPTION IS IN THE TEXT, 2.7.2. THERMOCOUPLE SYSTEM: IRIDIUM-40% RHODIUM VERSUS IRIDIUM.

Figure 10 consists of four micrographs at a magnification of 80X and illustrates changes in microstructure that may occur following exposure to a high-temperature oxidizing environment. Photograph 10a is of a specimen taken from an unheated portion of a thermocouple alloy component; photograph 10b is of a specimen taken from the same thermocouple component, but from a portion exposed to 2000°C, in air. Similarly, photograph 10c is of a specimen taken from an unheated portion of the iridium component of the same thermocouple, and photograph 10d is of a specimen taken from a portion of the same iridium component exposed to 2000°C, in air. The aged specimens were

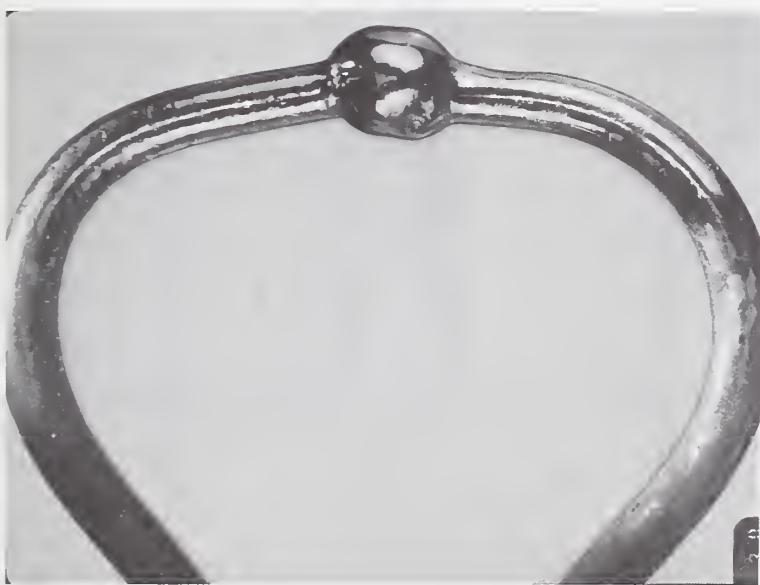
FIGURE 16: PHOTOGRAPHS AT MAGNIFICATION OF 15X OF WEDGE-CONFIGURATION (A) AND STIRRUP-CONFIGURATION (B) THERMOCOUPLES USED AT 1500°C AND AT A GRADIENT OF 1475°C/cm. THE PHOTOGRAPHS ARE DISCUSSED IN THE TEXT, 3.7.2. THERMOCOUPLE SYSTEM: PLATINUM-13% RHODIUM VERSUS PLATINUM.

*3.7.2 Surface, Microstructural, and Chemical Studies* — Figure 16 presents photographs at a magnification of 15X of the two thermocouples of figure 14.

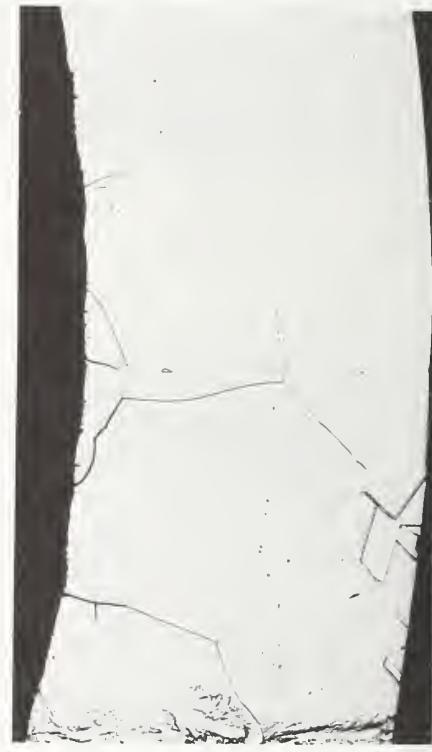
FIGURE 17: MICROGRAPHS OF SECTIONED ALLOY COMPONENT OF A TEST THERMOCOUPLE AGED AT  $1500^{\circ}\text{C}$  AND AT A GRADIENT OF  $1475^{\circ}\text{C}/\text{cm}$  FOR 60 HOURS. WIRE DIAMETER WAS 0.51 MM; THE MAGNIFICATION WAS 90X. PHOTOGRAPH A SHOWS A SECTION TAKEN 1.0 CM FROM THE JUNCTION; B, 0.5 CM FROM THE JUNCTION; AND C, 0.05 CM FROM THE JUNCTION. FURTHER DESCRIPTION IS IN THE TEXT, 3.7.2. THERMO-COUPLE SYSTEM: PLATINUM-13% RHODIUM VERSUS PLATINUM.

Figures 17 and 18 present micrographs (at 90X) of specimens taken from the alloy component (figure 17) and the platinum component (figure 18) of a platinum-13% rhodium versus platinum thermocouple exposed to a junction temperature of 1500°C and a gradient of 1475°C/cm. Wire diameter was 0.51 mm. The exposure time before failure was 60 hours. The emf values of this thermocouple are given in table 6. In each figure, photograph a shows a section taken 1.0 cm from the junction; b, 0.5 cm from the junction; and c, 0.05 cm from the junction. The temperatures at these points along the wires may be estimated to be 25, 760, and 1425°C, respectively, assuming a somewhat linear gradient. The photographs of the specimens closest to the junction show marked grain growth compared to the grain size in cooler areas. There is no evidence of severe surface erosion.
