NBS SPECIAL PUBLICATION 601

Implant Retrieval: Material and Biological Analysis

This book contains the proceedings of a conference on implant retrieval and analysis as well as a report on a workshop concerned with implant retrieval systems. Twenty-six invited papers that were presented at the conference are included. Four subject areas are specifically addressed: bulk phenomena, release phenomena, interface phenomena, and information utilization. Implants of both orthopaedic type and cardiovascular type were considered at the conference. Data on the failure modes of implants were presented. Specific consideration of biocompatibility problems was included. Several operating data/information systems were described in detail. Recommendations were made in the workshop concerned with uniformity and standardization of information systems dealing with implant retrieval data.

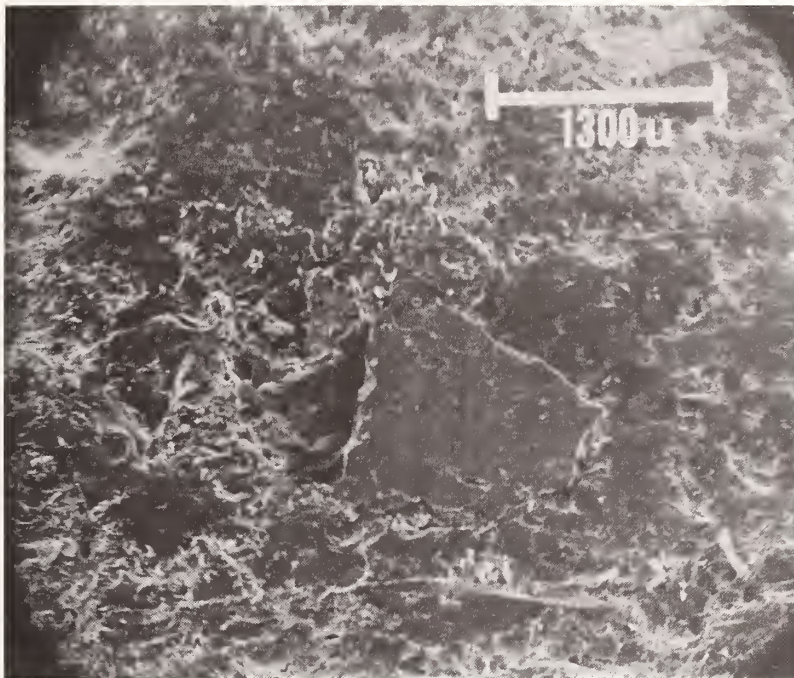
Figure 6. Lower magnification view of the same particle as in figure 5, showing fracture planes characteristic of embedded acrylic, and heavily abraded UHMWPE surrounding the particle.

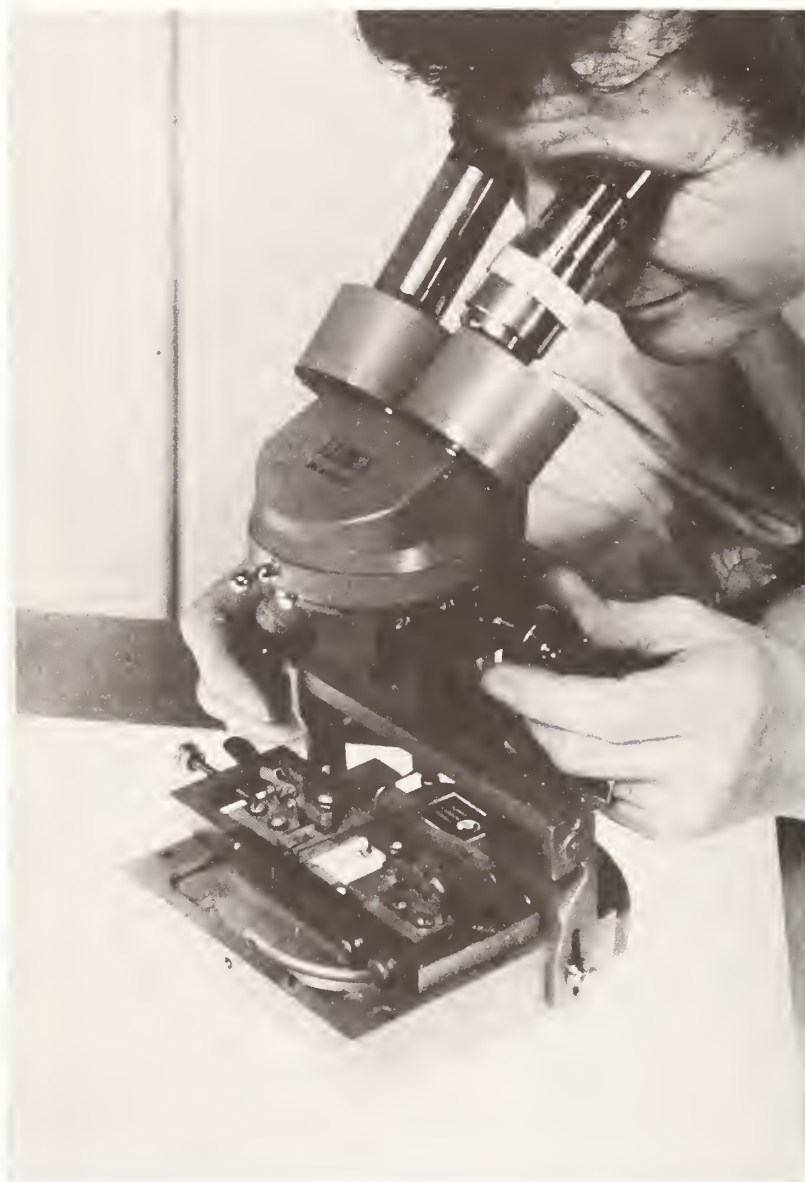
Figure 4 : Measuring the number of courses per centimeter of an explanted prosthesis with the pick counter in transmitted light.

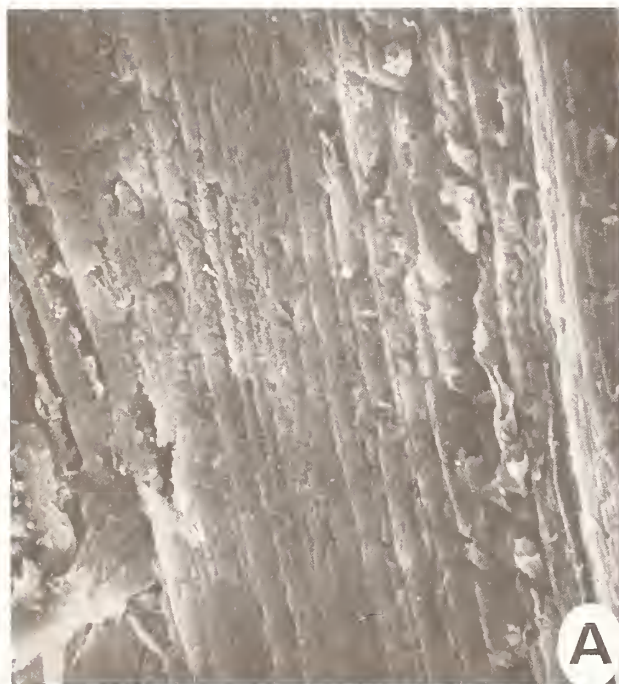
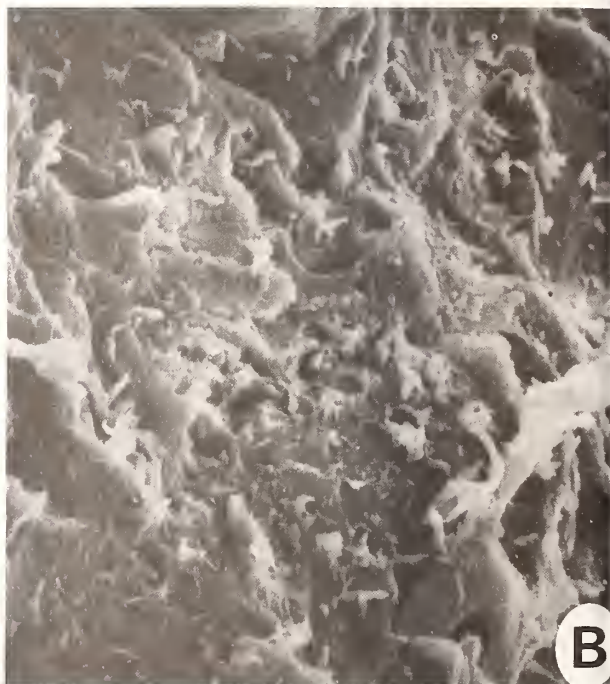
Figure 5.02 : Aorto femoral bifurcated graft (B04) implanted in a 65 years old female for 28 months; graft of unknown origin; similar phenomenon to figure 5.01 at higher magnification: A(x500) layers adjacent to the prosthesis wall, B(x500) lumen of the prosthesis.

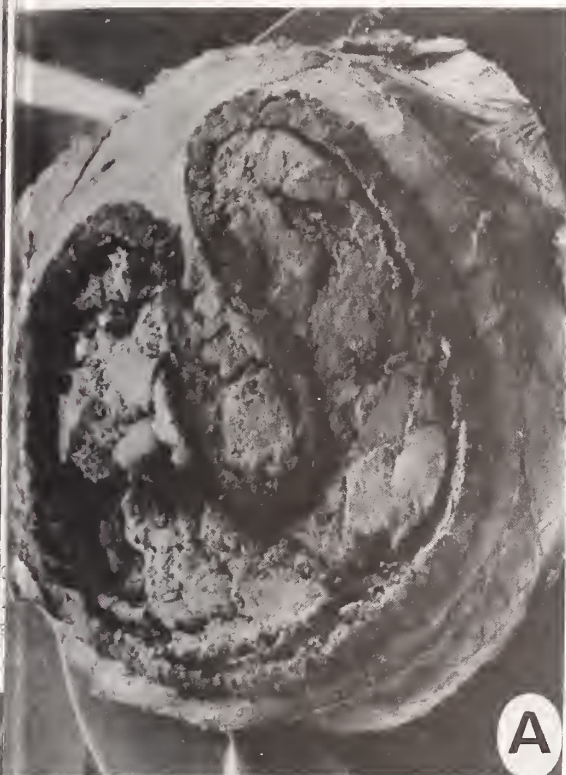
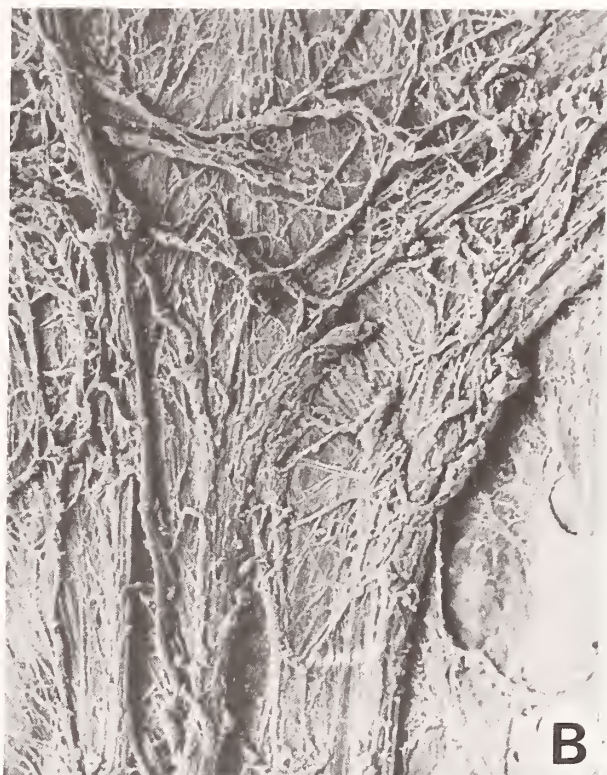
Figure 5.03 : Femoropopliteal graft, 14 months in situ (FP15) totally thrombosed in the distal segment (A:x30) and well healed proximally, SEM surface area shows an orderly layer of compacted fibrin (B:x150).

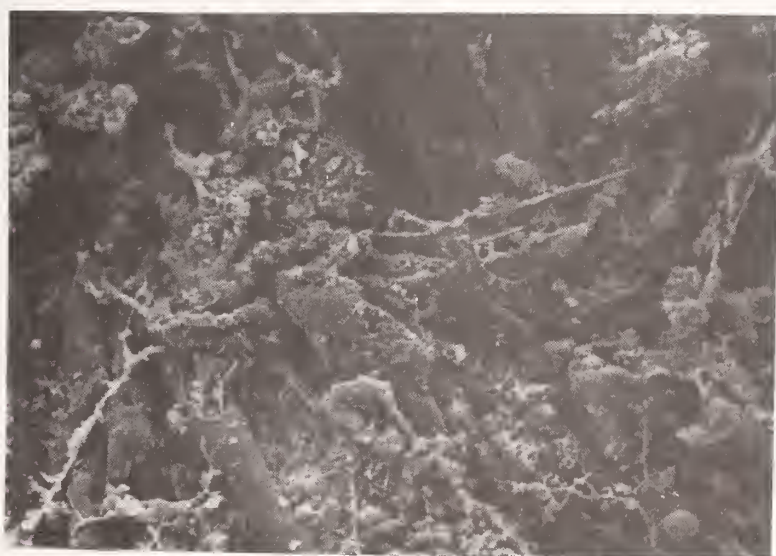
Figure 5.04 : B79; poorly healed internal surface of a prosthesis after 7 years in situ (standard knitted de Bakey). The patient was reoperated upon because of a false aneurism.

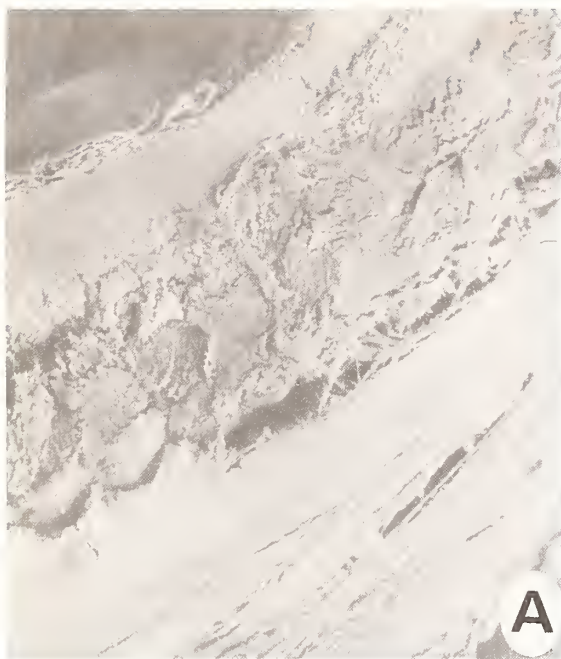
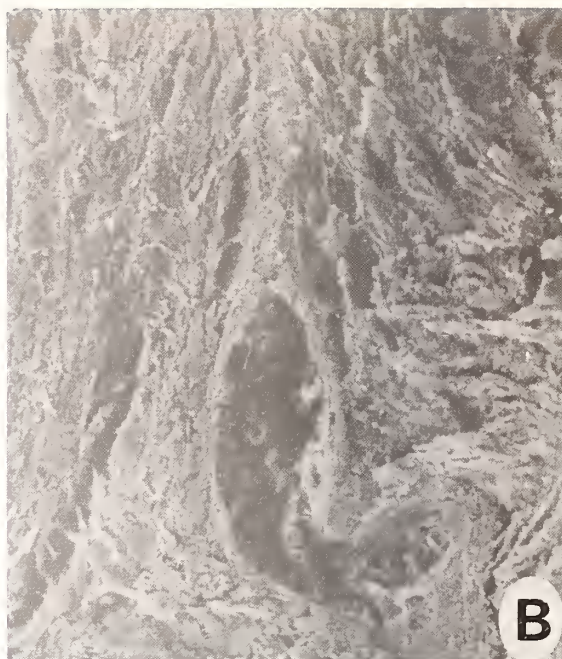
Figure 5.05 : Microvel aorto-femoral bifurcation (B05) implanted in a 54 years old male for one year; the patient was reoperated upon because of stenosis at both anastomoses. Note thick capsule with amorphous neointima and dense concentric layers of collagen surrounding the graft in Figure A (x60); Figure B is a higher magnification of Figure A showing the structure of capillaries in the internal capsule wall (xl200).

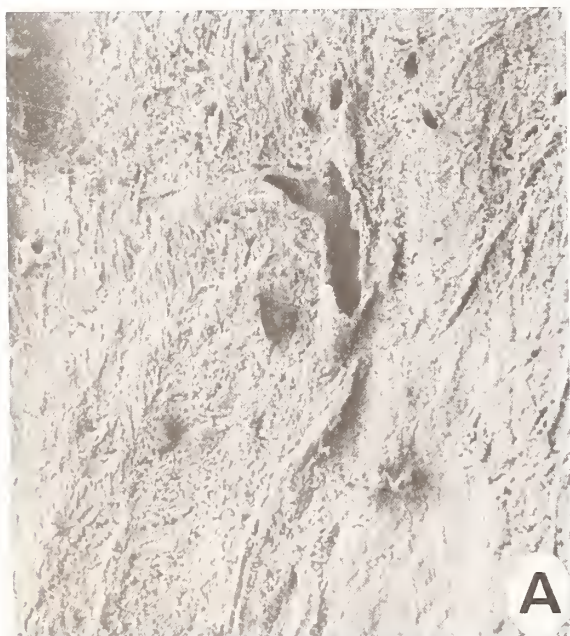
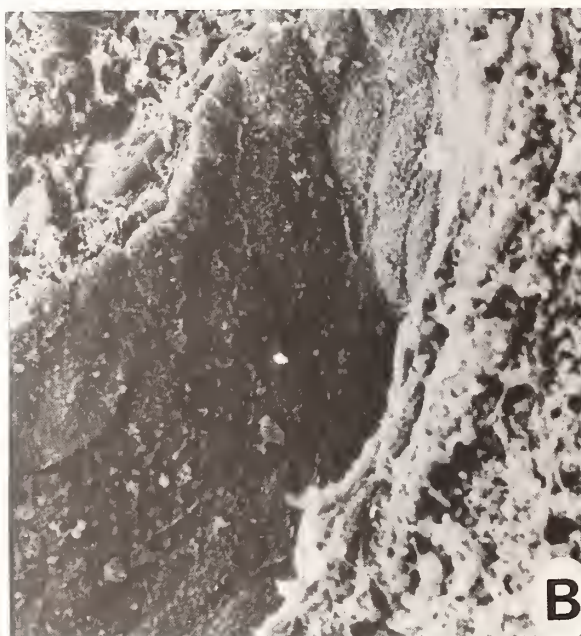
Figure 5.06 : Lightweight knitted graft of unknown origin implanted as a femore-popliteal by-pass in a 54 years old male (alcoholic) for 28 months; note the presence of capillaries in the internal capsule (A: x 150; B: x 1200)

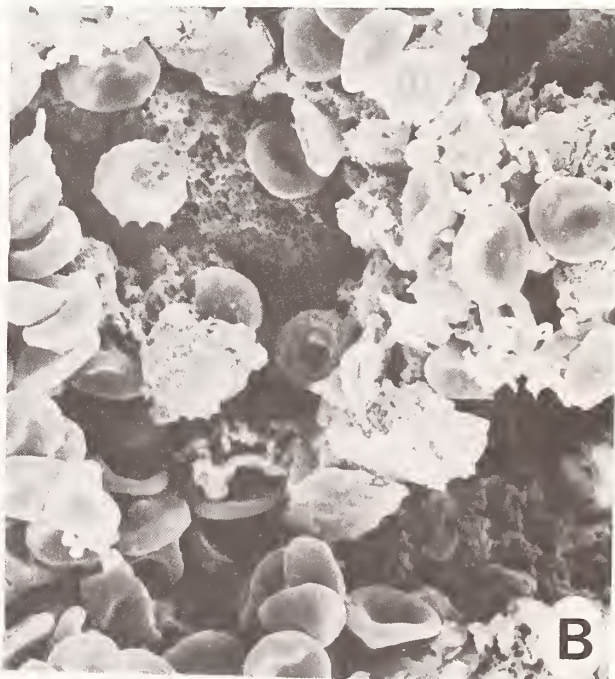
Figure 5.08 : FP13, staphylococcus aureus invasion after 6 months in situ (Microvel); infection sites coincide with protruding fibers, bare areas and zones of poor healing (A:150; B:x4000).

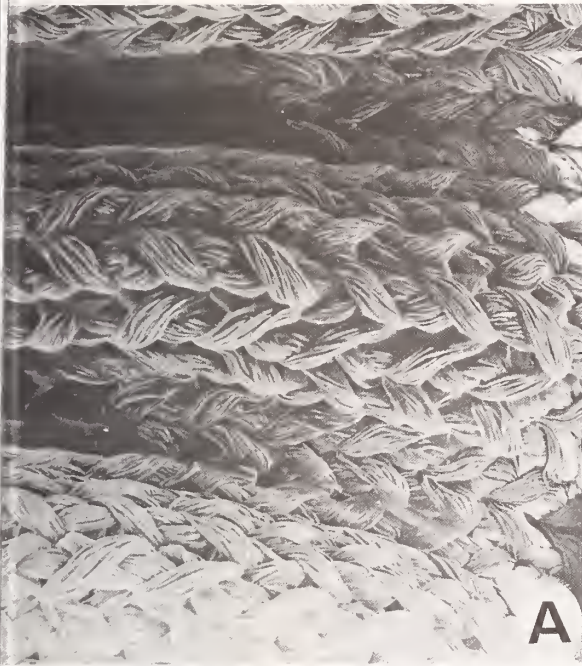
Figure 8.04 : (B55) A. External view of Knitted Cooley prosthesis explanted after 48 months. B. Internal lumen side view of filaments at the crest of a crimp showing flattened surfaces probably caused by contact of the mandrel during crimping.

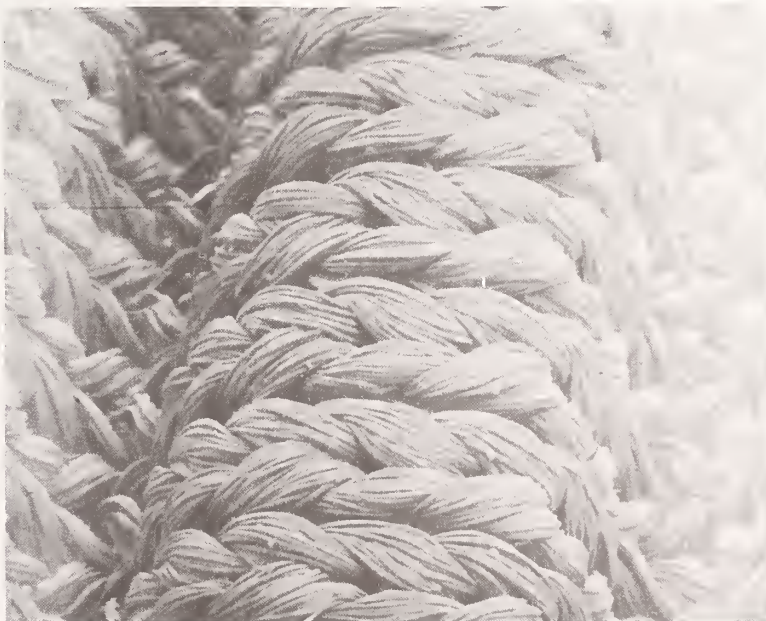
Figure 8.08 : (B74) Internal view of a Weavenit prosthesis with undamaged fabric structure and preserved crimp after 3 days in-vivo.

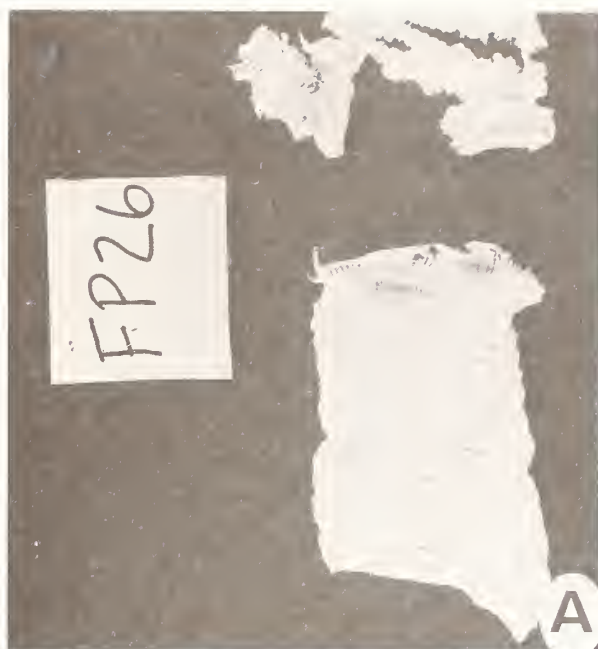
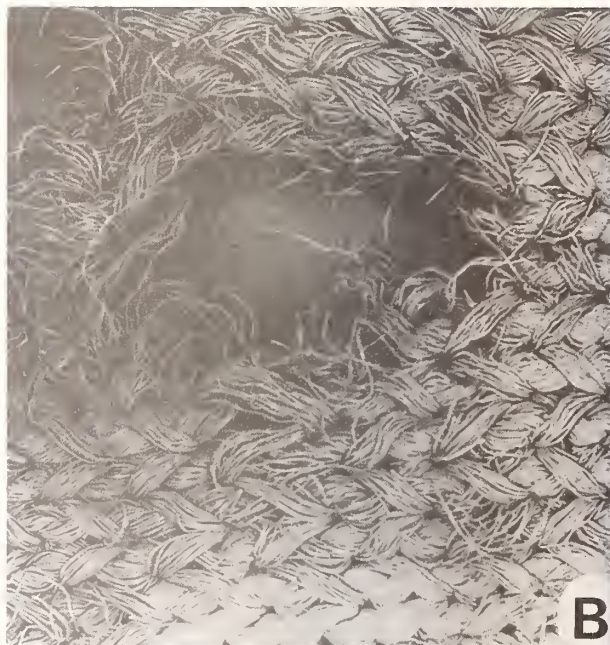
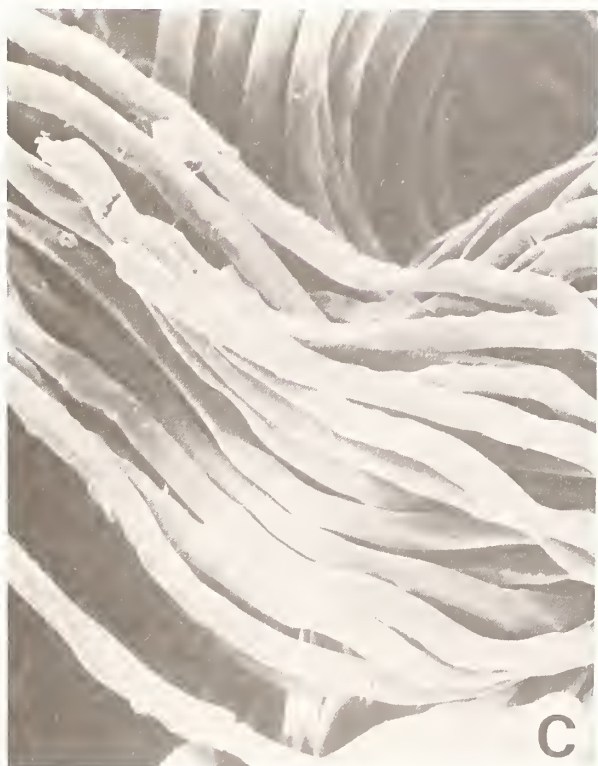
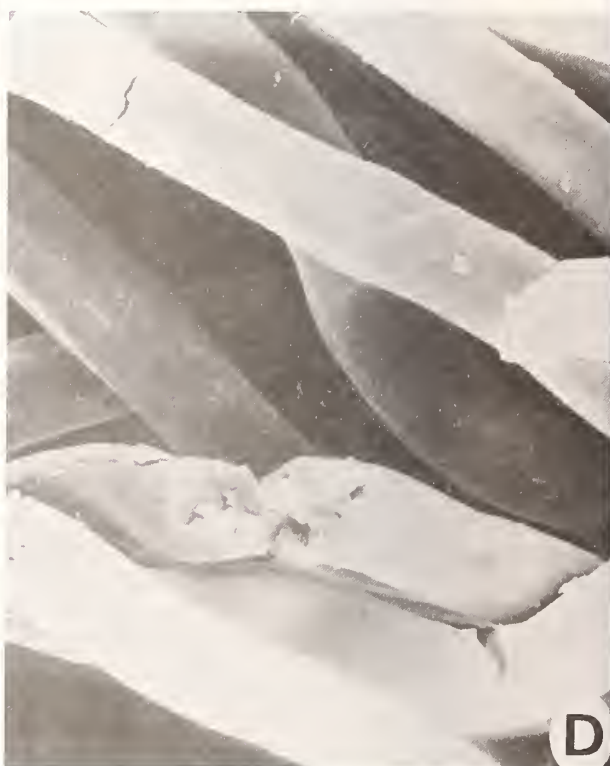
Figure 3.11 : (FP26) A. View of damaged Weavenit prosthesis after 84 months. B. Yarn failure. C. Non-circular filaments deformed pressure from adjacent yarns during prosthesis manufacture. D. Transverse cracks and fracture surfaces of embrittled filaments.

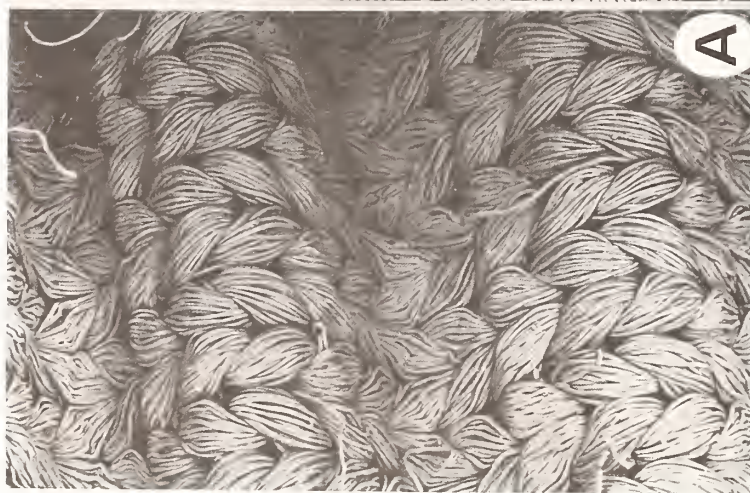
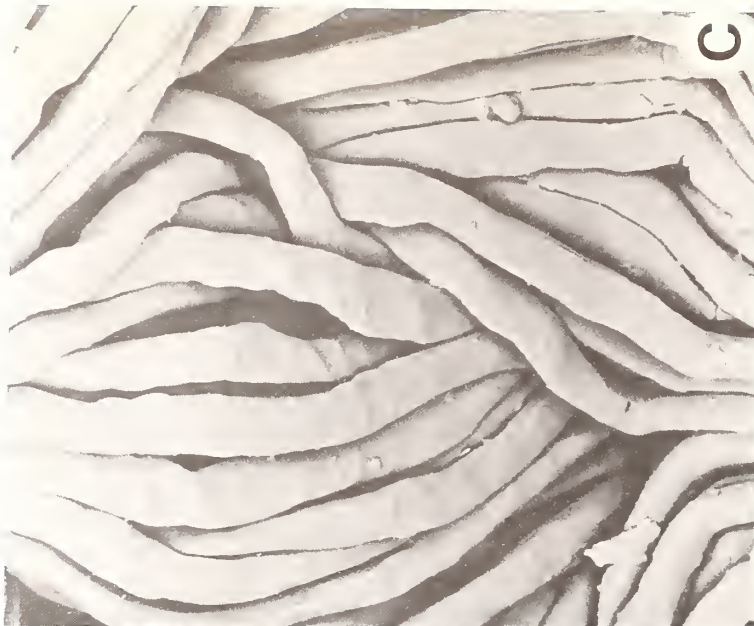
Figure 3.13 : (M022) A. External view of Ultralightweight prosthesis after 23 months in-vivo. B. Internal view of Ultralightweight prosthesis after 23 months. C. Non-circular cross-section filaments deformed by high pressure contact of adjacent yarns during prosthesis manufacture and showing incipient cracks under bending stresses.

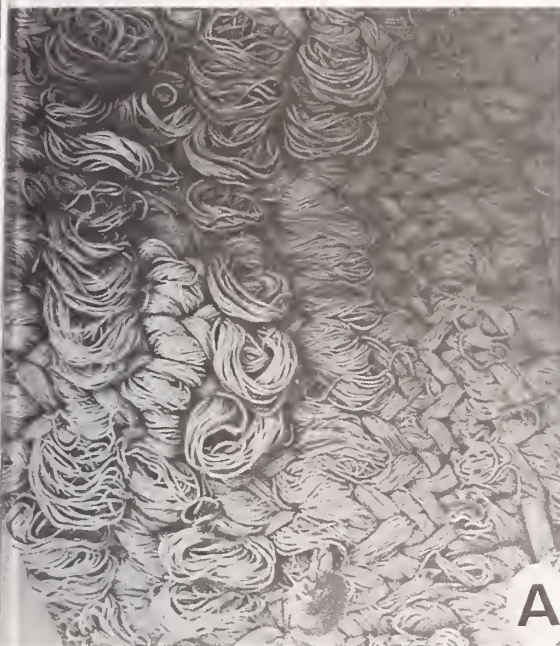
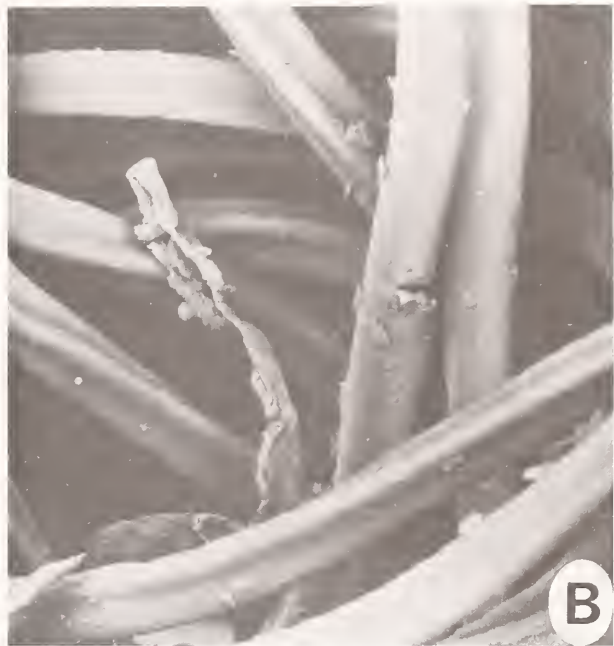
Figure 8.14 : (M018) A. External view of Microvel prosthesis after 17 months in-vivo. B. Velour trilobal cross-section filament with isolated transverse cracks.

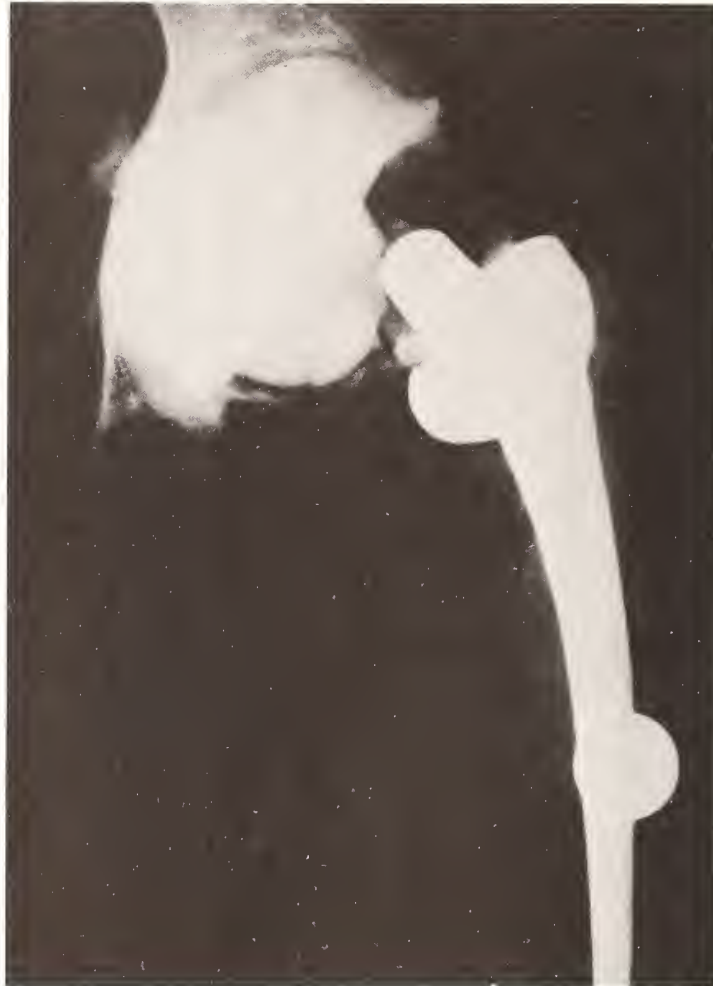
Fig. 3: a)

X-rays of Alumina/Alumina hip endo-
protheses after ball fracture
(two different designs and
manufacturers).

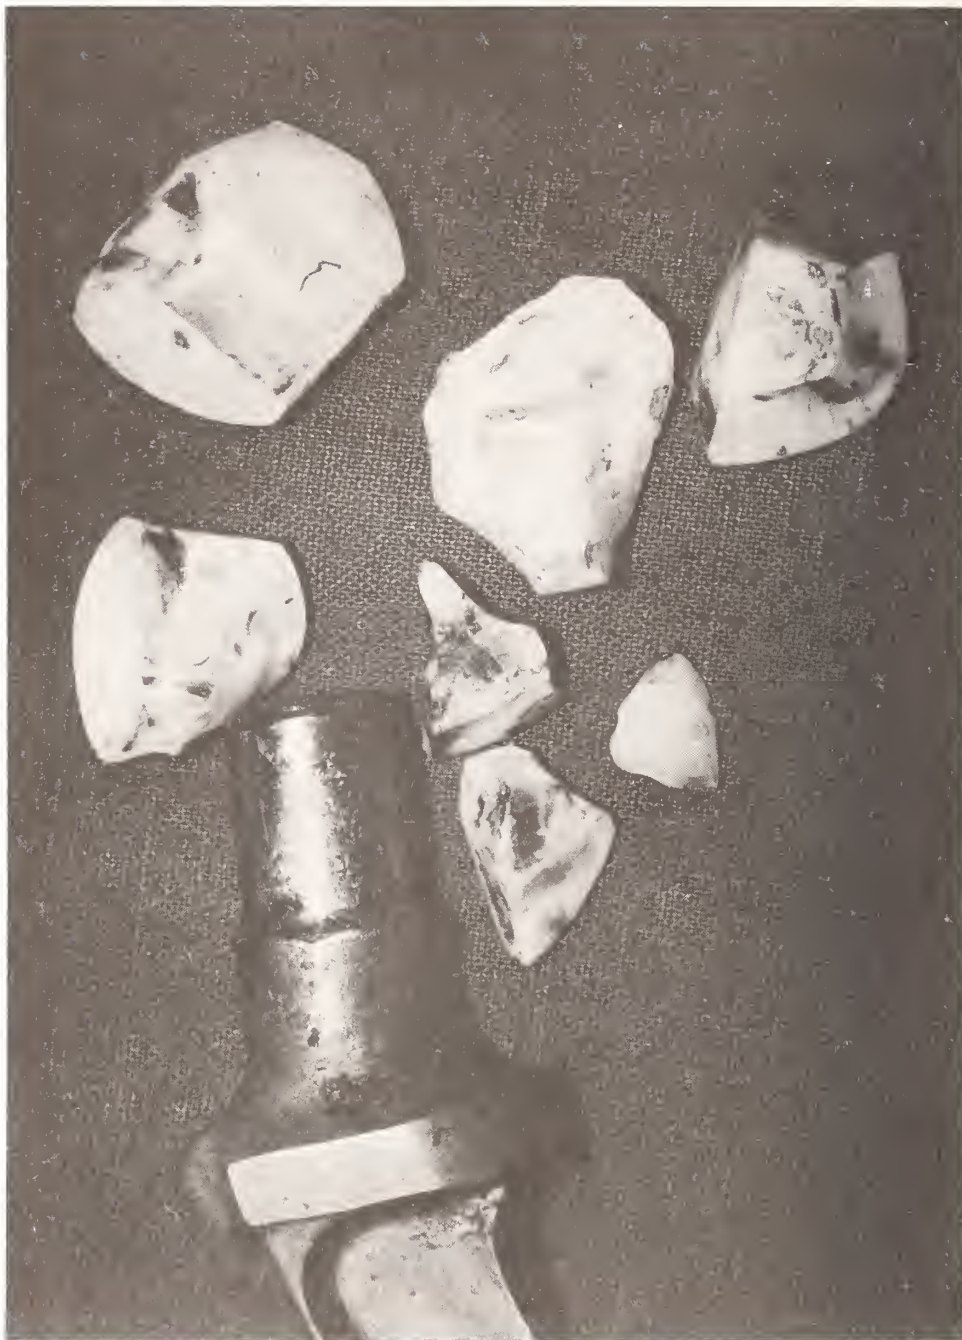
Fig. 4:

Macroscopic appearance of broken parts of a 26 mm ceramic ball.

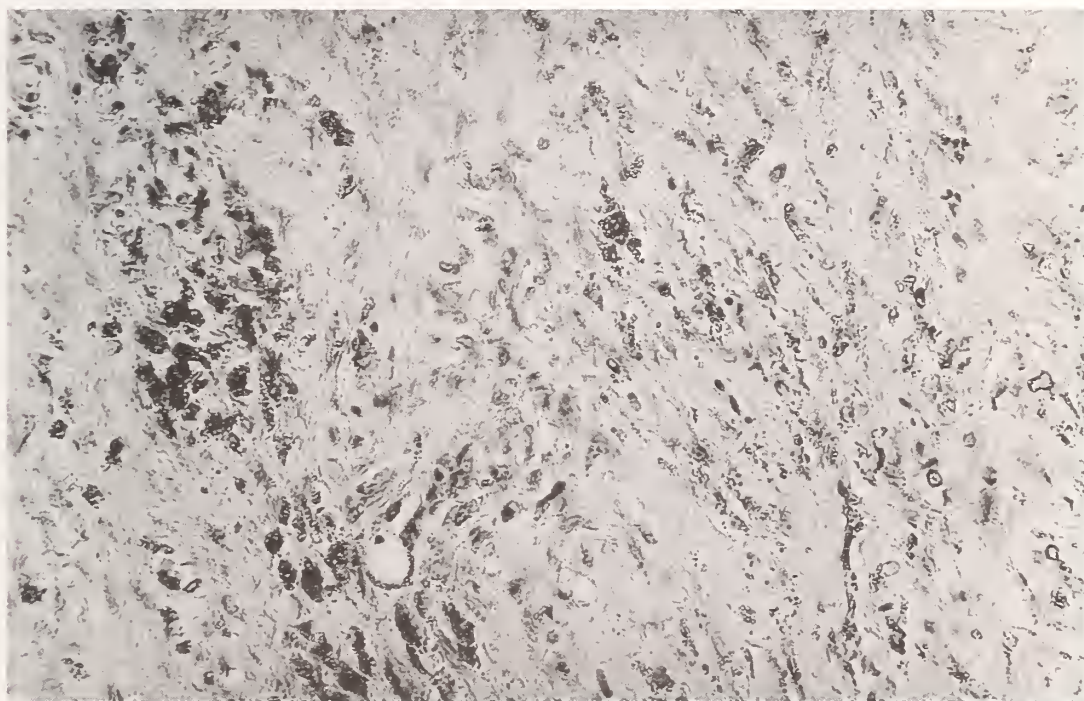
Fig. 5: a/b:

Histo-morphologic picture of ceramic wear deposits in human periarticular scar tissue.

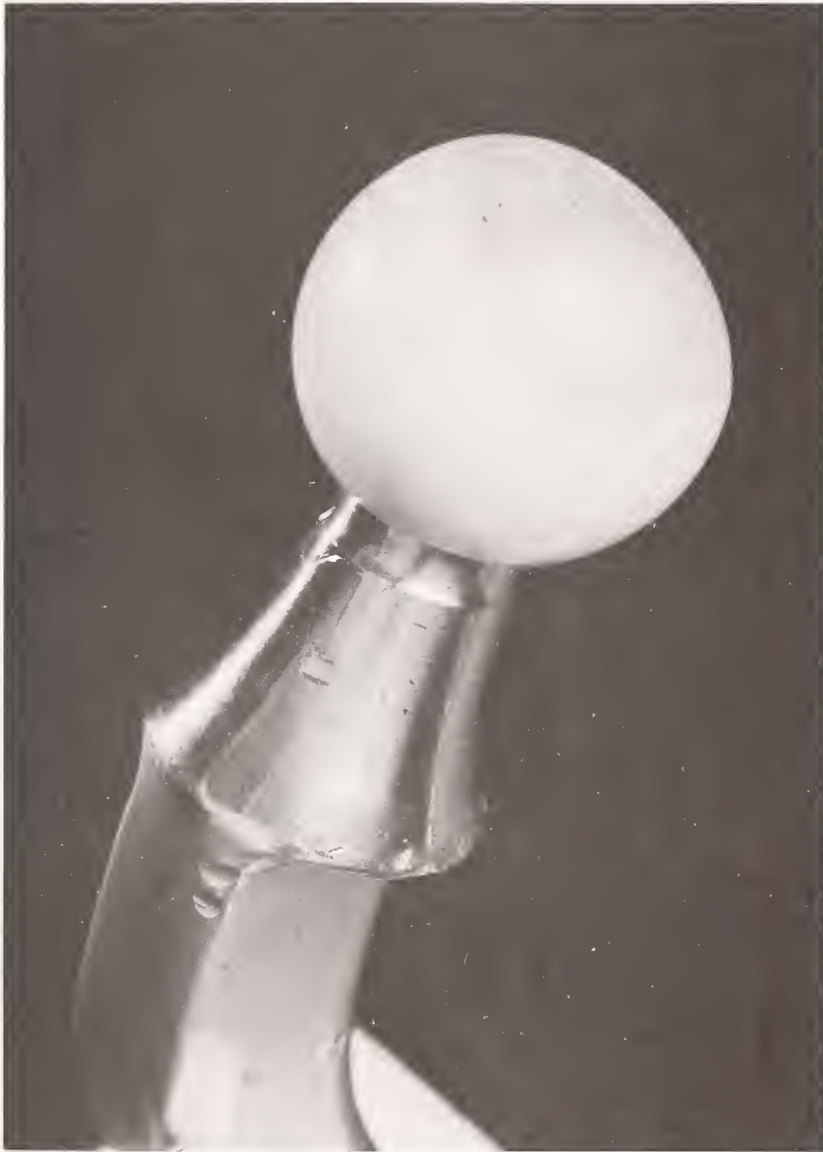
Fig. 8: Removed Al_2O_3 -ceramic hip joint prosthesis (implantation period 3 years).

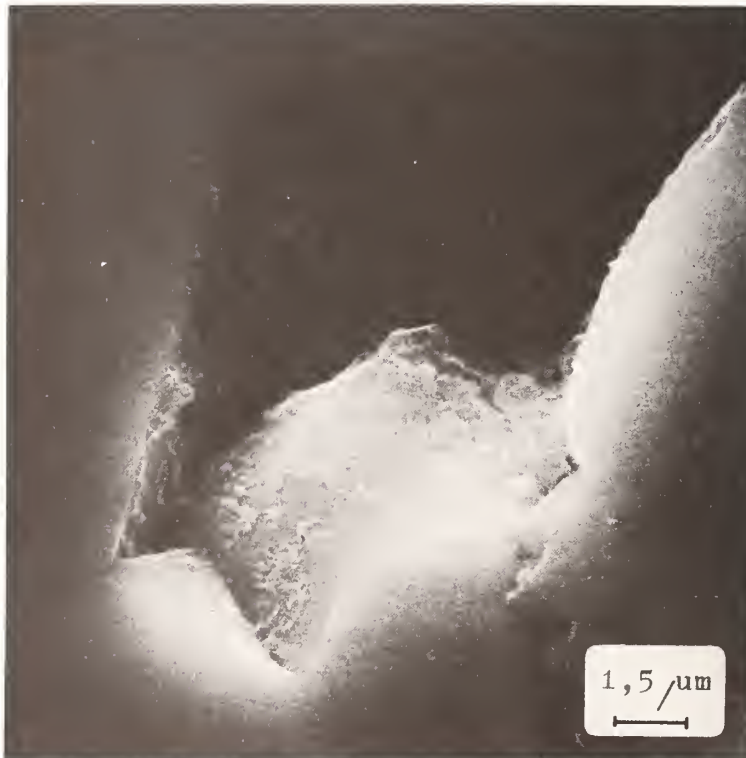
Fig. 13:

Grain Excavation in the ball-surface of the removed object shown in Fig. 11 (magn. 6300 x).

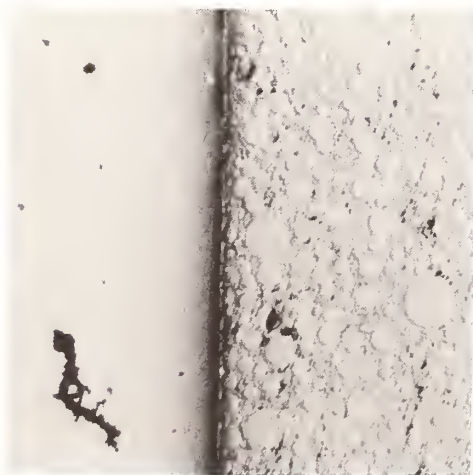
Figure 13, Cement-Prosthesis Interface: Sample A - "normal" interface x 75

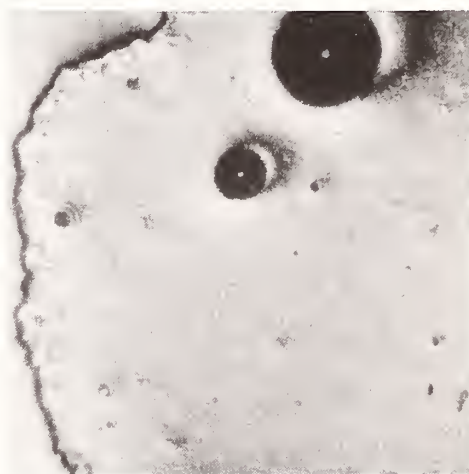
Figure 16, Cement-Bone Interface:
Sample H - central lateral region
x 75

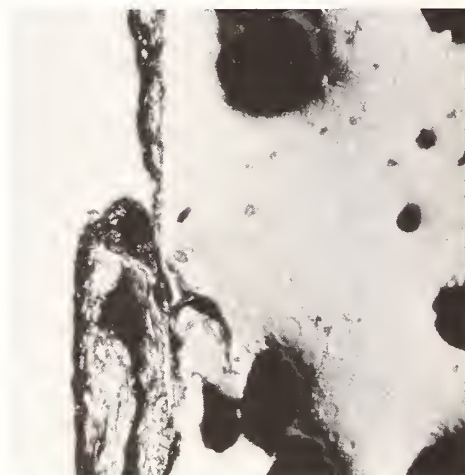
Figure 19, Bone Cement: (a) Simplex-
P in vitro polymerized x 75

d) Cement Morphology: Figure 19 (a) and (b) illustrate the structure of Simplex-P and Zimmer bone cement respectively; these sections were from cement mixed and polymerized in air in vitro at an ambient temperature of 23°C. The Zimmer cement contains non spherical particles of powder, typical of comminuted PMMA. Figures 20 and 21 illustrate examples of bone debris incorporated into the cement; the bone chips appear to be nonviable.

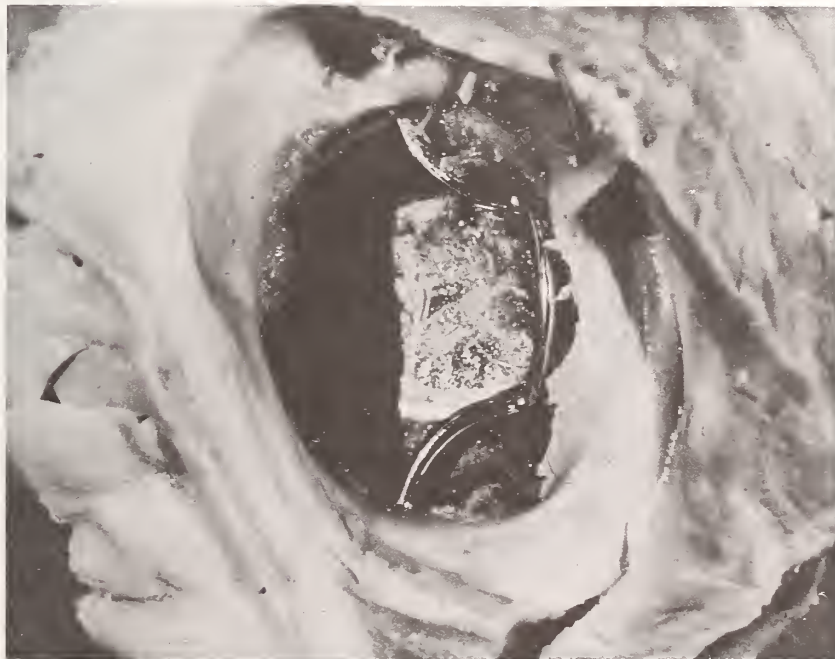
Figure 5. Upstream aspect of a Björk-Shiley aortic valve showing accumulation of thrombus between upstream hinge and the base ring of the valve.

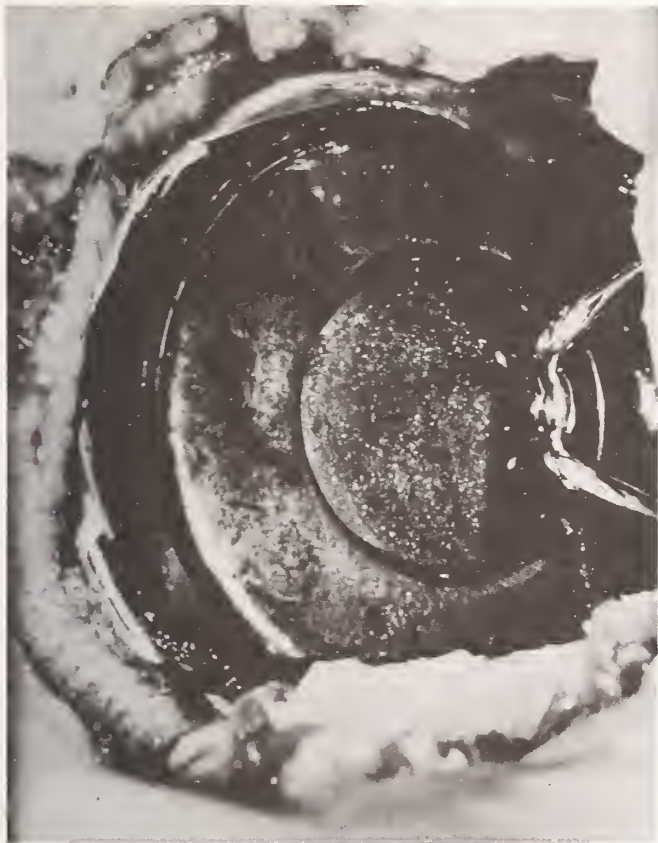
Figure 6. Undebridged tissue preventing the complete opening of a Björk-Shiley aortic valve.

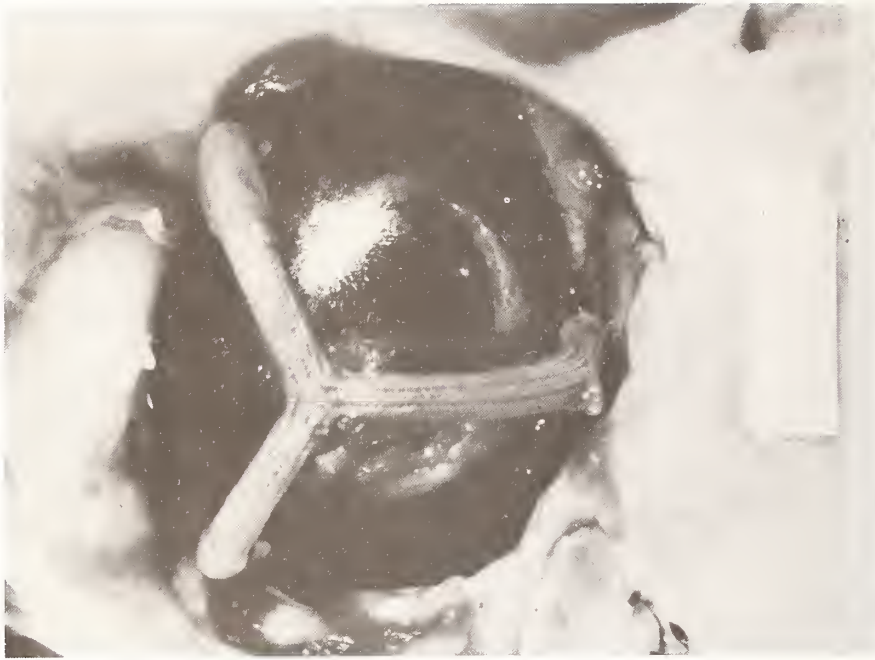
Figure 10. Recovered S-E 2320 aortic valve. Thrombus formation on apex of cage; tissue overgrowth on aortic side of sewing ring and along the base of the struts.

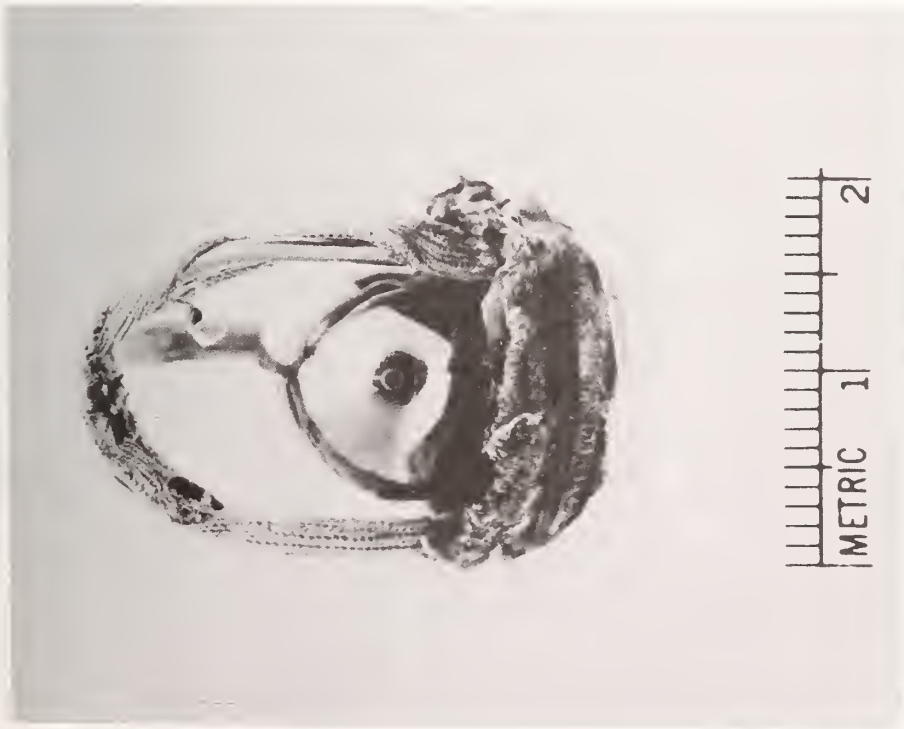
Figure 11. Recovered S-E 2320 aortic valve shows destruction of cloth covering on the metal struts. Valve caused severe hemolysis.

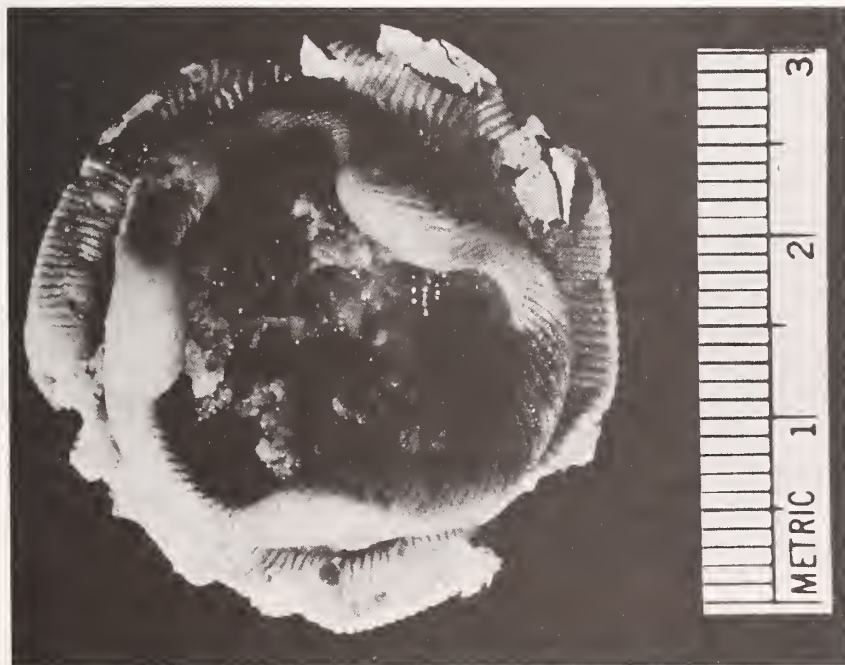
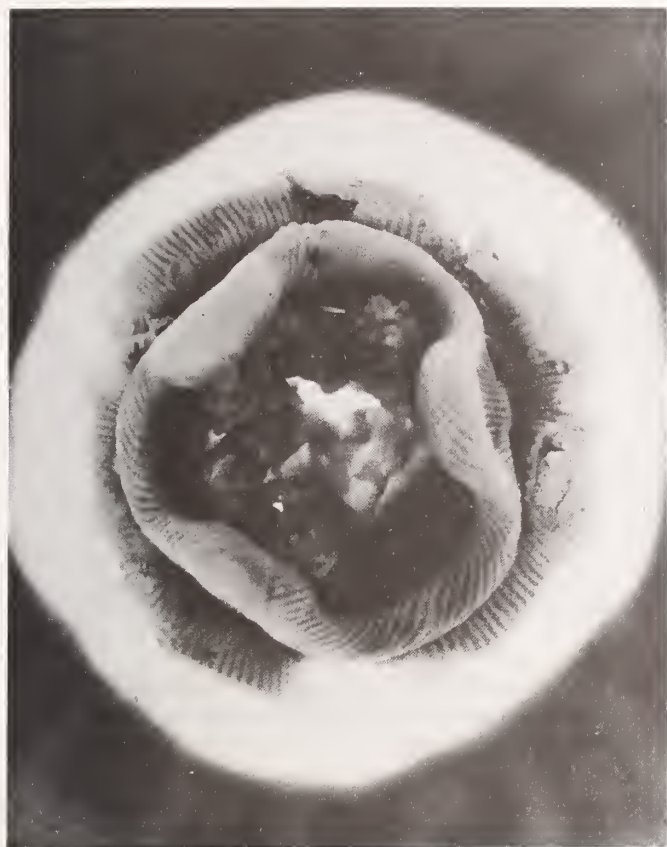
Figure 17 & 18. Recovered Hancock porcine aortic prosthesis. Downstream aspect of valve is shown demonstrating severe calcification of the leaflets. Figure 18 shows the valve transilluminated by back-lighting.

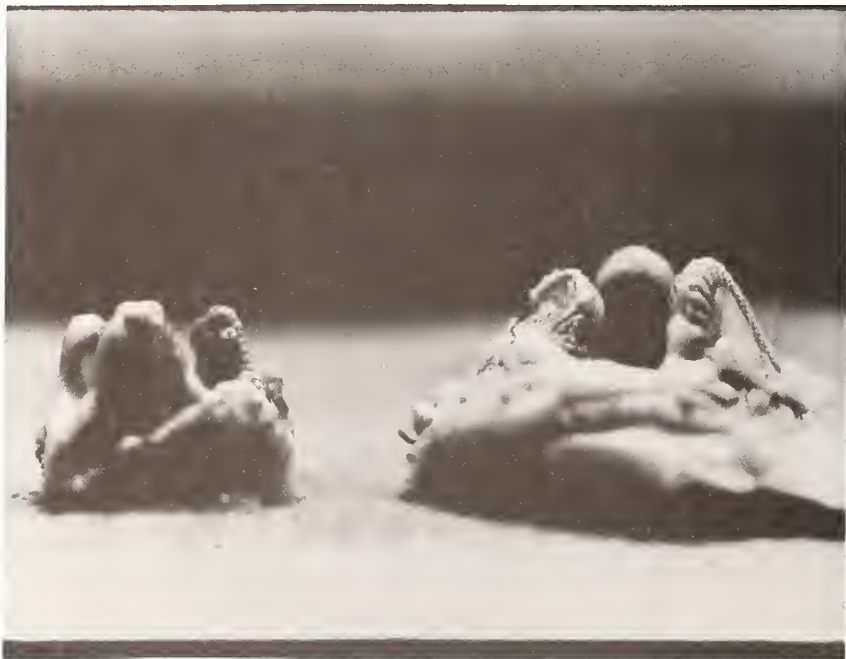
Figure 20. Same two recovered valves. This figure shows the phenomena of "creep" (drooping inwards) of the stents of the mitral valve.

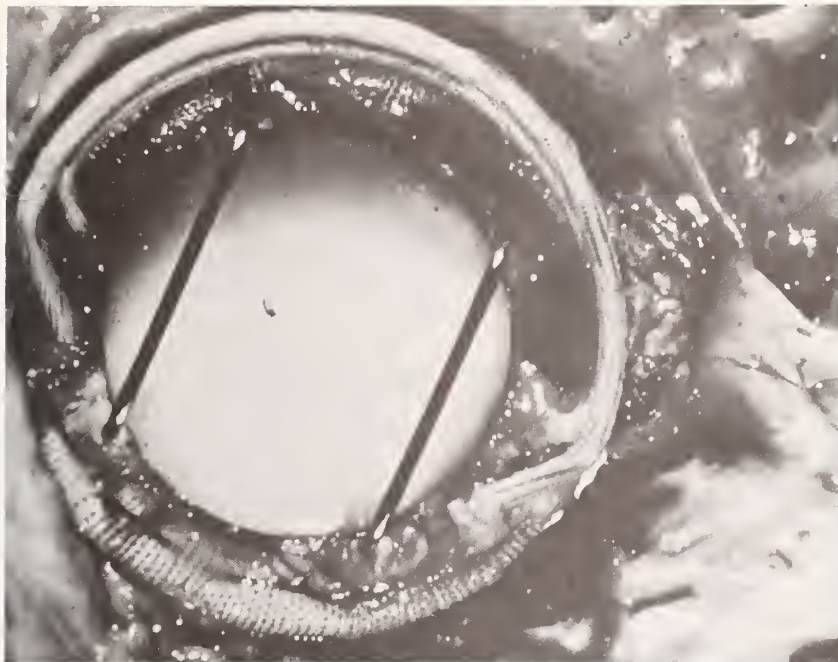
Figure 21. Recovered Kay-Shiley mitral valve. Thrombus formation at the base of the struts.

Our clinical experience with this valve stems from the study of 82 Kay-Shiley mitral valve recipients [37]. Of a group of 63 patients followed in the clinic the incidence of arterial thromboembolic events was 10.3/1000 patient months. Death due to thromboembolism occurred in seven of the 63 patients. Figures 21 and 22 show examples of recovered Kay-Shiley valves. Of the 20 Kay-Shiley valves examined at autopsy eleven had thrombus formation and/or tissue overgrowth on the valve superstructure. The thrombus formation mainly occurred at the base of the valve struts as shown in figure 21. Tissue overgrowth occurred along the ventricular side of the sewing ring. The thrombus formation and tissue overgrowth in some instances prevented the disc from seating properly and thereby causing the

valve to leak during ventricular systole. The thrombus formation and/or tissue overgrowth could be attributed to flow separation at the base of the struts.

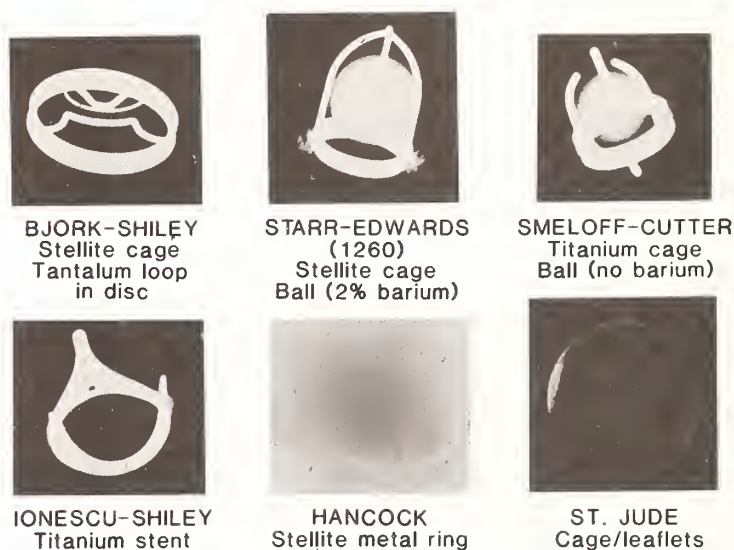
Figure 25. Radiographic visibility of various types of heart valve prostheses.

determined fluoroscopically if the poppet is opaque. In the case of tilting disc valves it is important to be able to assess both the opening and closing angle of the disc. It is also important to have a visible base ring in all valve types in order to assist in diagnosing valve dehiscence. Not only is it important to evaluate proper opening and closing of disc valves but it is advantageous to know if they are able to rotate. The Björk-Shiley valve can be readily seen radiographically. A tantalum loop has been implanted in the disc to assist in calculation of its opening and closing angle. The model 1260 Starr-Edwards ball valve can also be readily seen radiographically. Two-percent-by-weight barium sulfate in the silastic poppet allows an examiner to determine the completeness of both the opening and closing of the valve. The silastic poppet of the Smeloff-Cutter valve contains no barium and its motion can not be easily visualized fluoroscopically. The titanium stent of the Ionescu-Shiley valve and the stellite metal ring of the Hancock valve allow ready visualization of the base ring motion fluoroscopically. The leaflet motion, however, can not be visualized. As stated previously if viewed in the same projection during fluoroscopy the St. Jude valve can not be properly seen until the leaflets are in the open position.

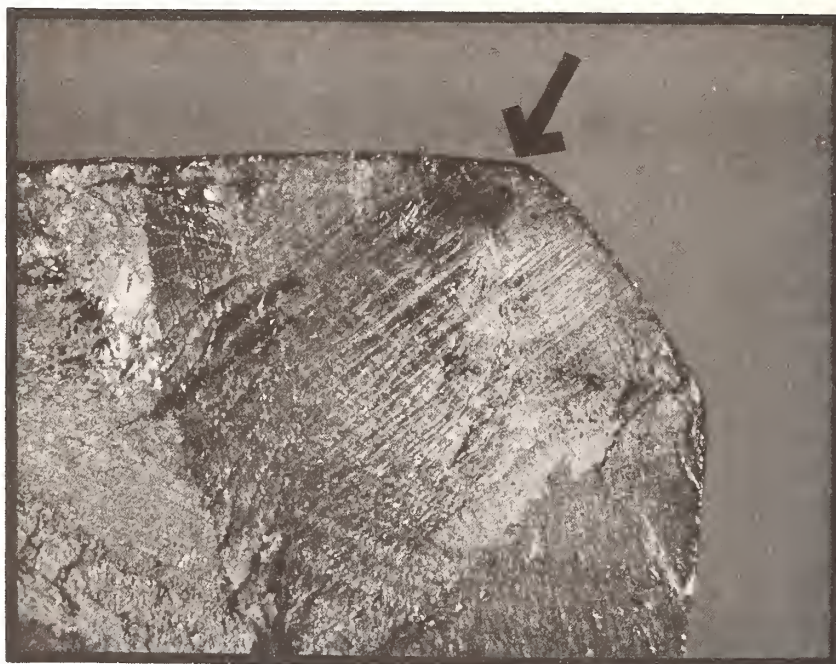
Figure 1. Photomicrograph (15X) of fatigue origin on the femoral stem portion of total hip prosthesis (ASTM F-75). The macro-fatigue striation emanates from the portion indicated by the arrow.

An example of the information that can be retrieved from visual and macroscopic examination is illustrated by figure 1. This is a photomicrograph of the fractured surface of a cobalt base (F-75) total hip femoral component. Note that the origin of the fatigue failure can be traced by the macro-fatigue striation lines, and is illustrated by the arrow. This evaluation also indicated that probably torsional components were involved in the fatigue loading.
