NBS SPECIAL PUBLICATION 601

Implant Retrieval: Material and Biological Analysis

This book contains the proceedings of a conference on implant retrieval and analysis as well as a report on a workshop concerned with implant retrieval systems. Twenty-six invited papers that were presented at the conference are included. Four subject areas are specifically addressed: bulk phenomena, release phenomena, interface phenomena, and information utilization. Implants of both orthopaedic type and cardiovascular type were considered at the conference. Data on the failure modes of implants were presented. Specific consideration of biocompatibility problems was included. Several operating data/information systems were described in detail. Recommendations were made in the workshop concerned with uniformity and standardization of information systems dealing with implant retrieval data.

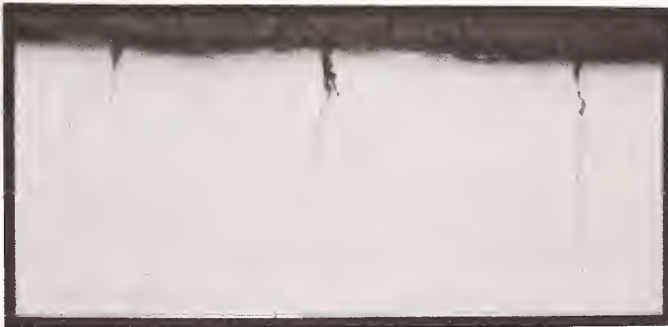
Figure 6. Photomicrograph (250X) illustrating an unetched metallographic cross section adjacent to a bone plate fracture of stainless steel (ASTM F-138) with a group of fatigue corrosion cracks adjacent to the primary fracture.

The identification of fatigue corrosion in stainless steel is made from the microscopic crack geometry, and the way it progresses through the grain structure. Many times stress corrosion and fatigue corrosion cracking of stainless steel surgical implants are confused, in that some aspects of the crack progression are similar. However, on the basis of the investigations performed, a literature search, and the reports of other authoritative investigators, it is apparent that stress corrosion cracking, in the true sense, cannot occur in stainless steel implants (12,13,14,15,16,17,18). One of the factors is the temperature dependence necessary to create the stress corrosion cracking process in a saline solution. Also fracture mechanics studies have shown that fatigue corrosion cracking may proceed in both intergranular and transgranular progressions similar to that of stress corrosion cracking. (Lacking the specific background, and not having studied surgical implants in their environment, some investigators mistakenly identify a fatigue corrosion crack as stress corrosion in stainless steel.)

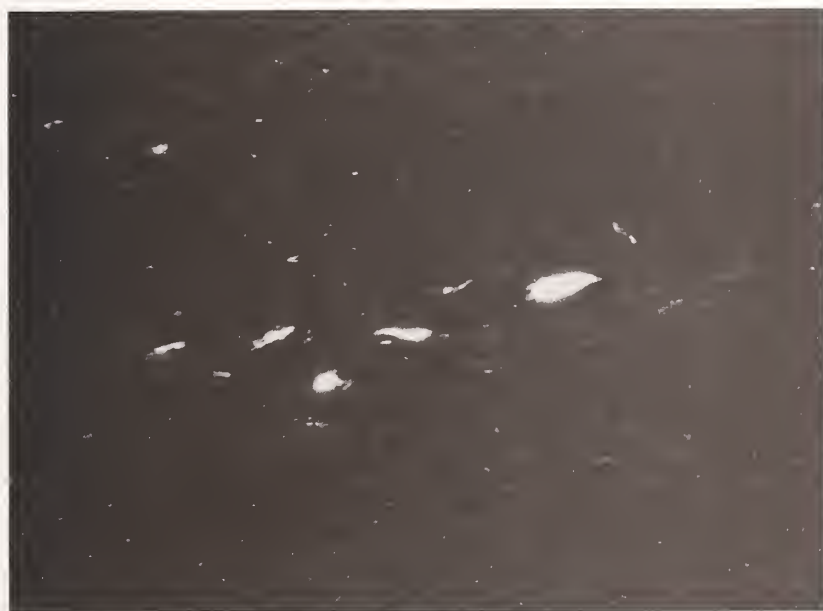
Figure 7. Microphotograph of tissue section, stained H&E, of capsular tissue surrounding a Müller total hip prosthesis after four years of function, material combination: CoCrMo-cast alloy on UHMW Polyethylene, 400 magnification, a) bright light, b) polarized light. Particles are visible by means of their birefringence.

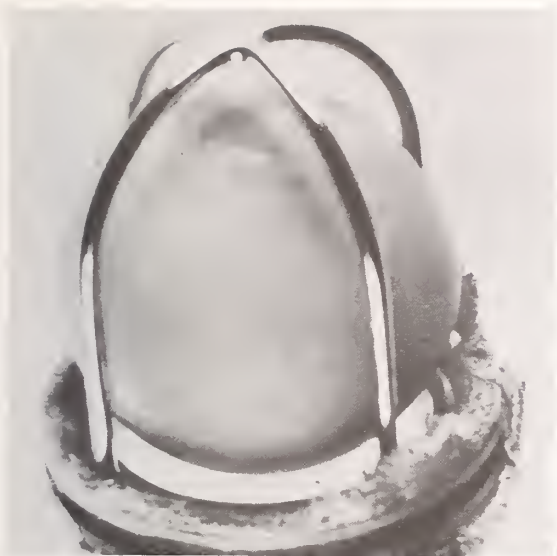
Figure 1. Ball variance in a Starr-Edwards mitral valve prosthesis. The silicone ball occluder is markedly swollen and fixed in position.

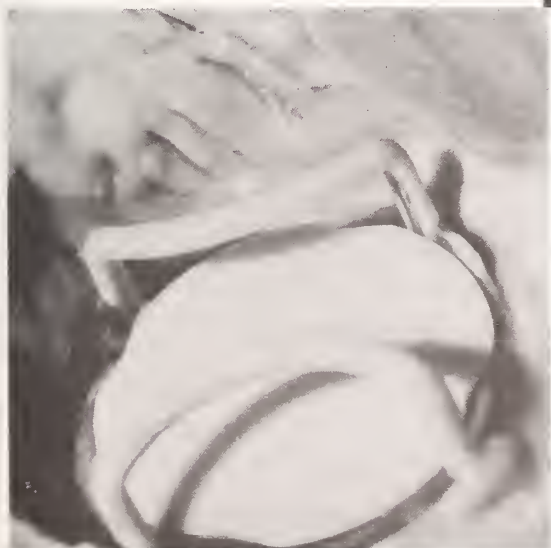
Figure 3. Beall mitral prosthesis with a Teflon disk and Teflon-coated cage struts. Notching of the disk and complete focal denudation of the Teflon coating exposing the underlying metal of one of the struts is apparent.

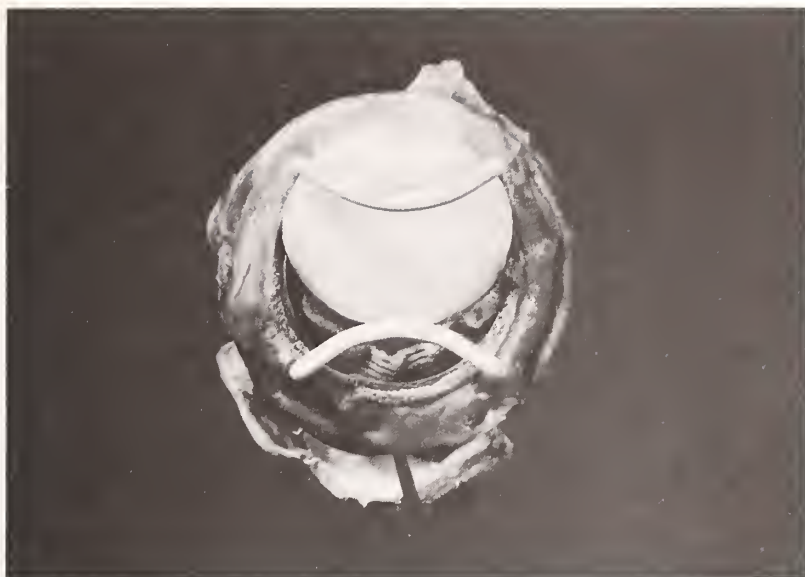
Figure 1. Ventricular view of a Beall model 104 mitral valve with marked sewing ring fabric wear. Implanted for 6.5 years, note exposed metallic frame.

An example of sewing ring fabric wear is shown in figures 1 and 2. This Beall-Surgitool 104 mitral valve had been implanted for 6.5 years and was surgically replaced following the clinical diagnosis of valve malfunction. It can be seen that the Dacron covering over the valve seat has worn away, causing the fabric to extend into the inflow tract and reduce the inflow surface area. In this case, the inflow surface area has been reduced by ca 35%. This reduction in inflow tract surface area can lead to a compromise in the patient's hemodynamics and increased turbulence and blood trauma. This extent of sewing ring fabric wear is usually accompanied by disc variance and strut wear.

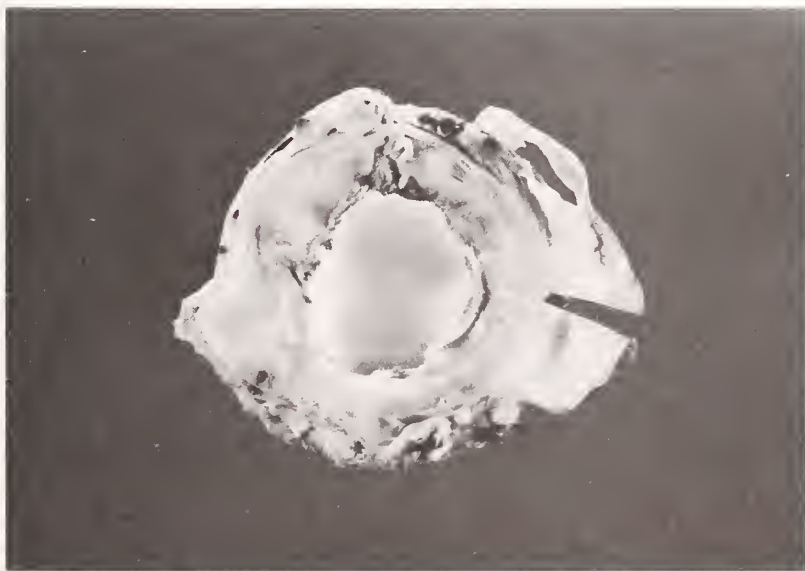
Figure 2. Atrial view of a Beall model 104 mitral valve with marked sewing ring fabric wear. Implanted for 6.5 years, note loss of neointima from frayed fabric in the inflow tract.

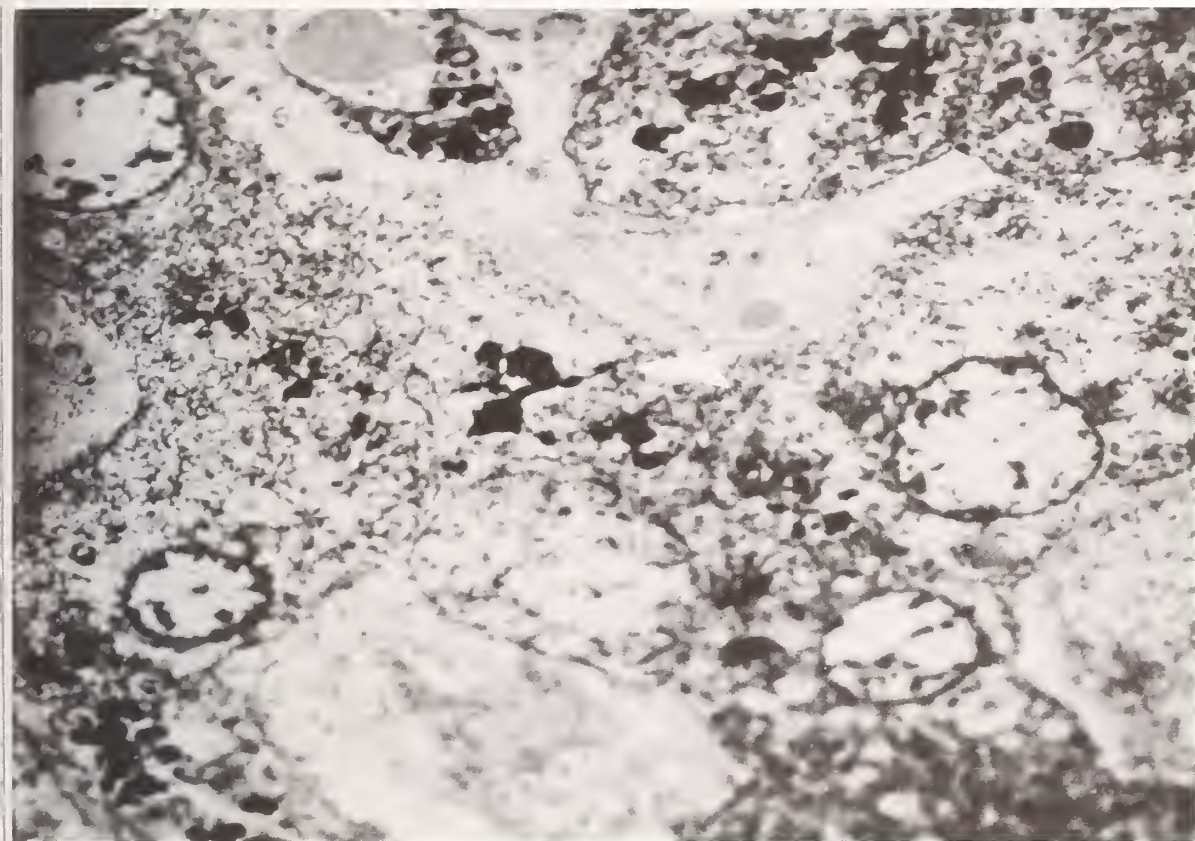
Figure 11. Scanning transmission electron micrograph of a typical inclusion in the foreign body giant cells in the liver. Braunwald-Cutter aortic valve implanted for 3 years.

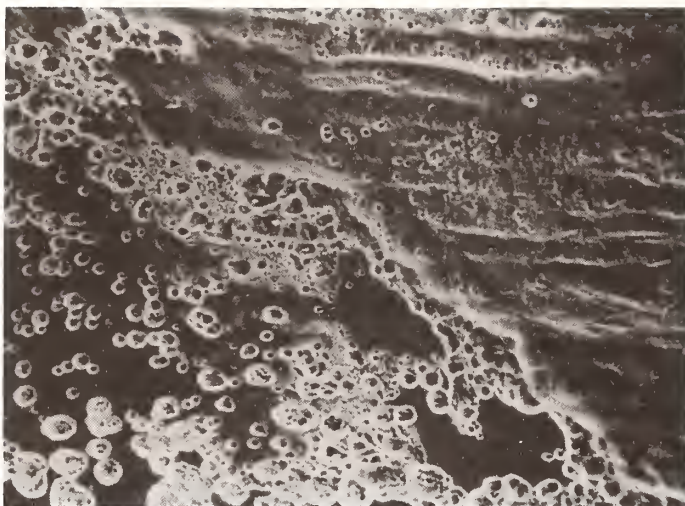
Figure 4
SEM photograph of
contact area on plate
position d2 from
patient #10 in plate
study. Contact area
is in upper right,
with edge running
diagonally. Pitting
is outside of primary
contact area.

original magnifica-
tion x500

One of the patients, #10, who at first glance appears to be a glitch in the data, is in fact a very interesting case, and points to the question of what is more important, total corrosion or local corrosion. This patient had a 7-hole plate on the tibia, which was removed at 6 months, primarily because the proximal most screw came loose. The average corrosion was 1/1, which is very low, yet the total was 10/9. Two of the distal plate/screw contact areas showed significant attack, especially in position d2. Position d2 showed three 2/1/6 (medium size/minimal depth/corrosion) contact areas on the plate, similar contact areas on the screw head, and a rainbow pattern indicative of corrosion products on the upper plate surface. The patient also presented with an itchy rash on his shin over this screw position. The plate and screw d2 from this patient were examined with the scanning electron microscope and examined metallographically.

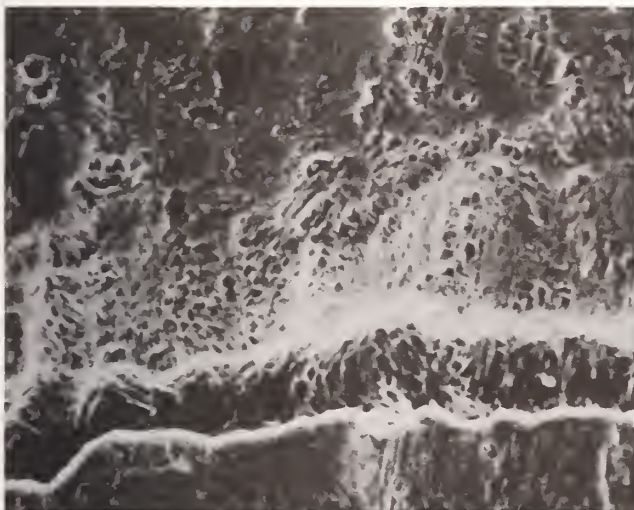
Figure 5
SEM examination of screw
d2 from plate patient #10.

(a) crack and corrosion
near center of contact
area

original magnification
x1200

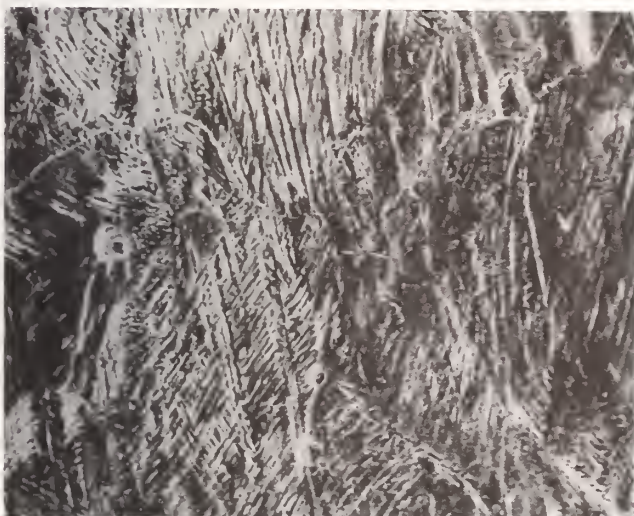
(b) corrosion revealing
cold work microstruc-
ture from middle of
contact area

original magnification
x600

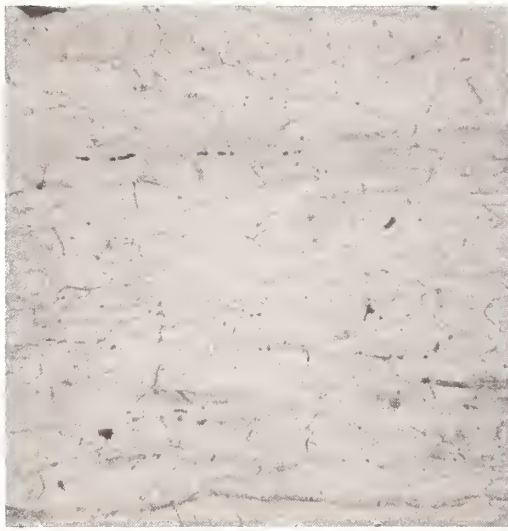
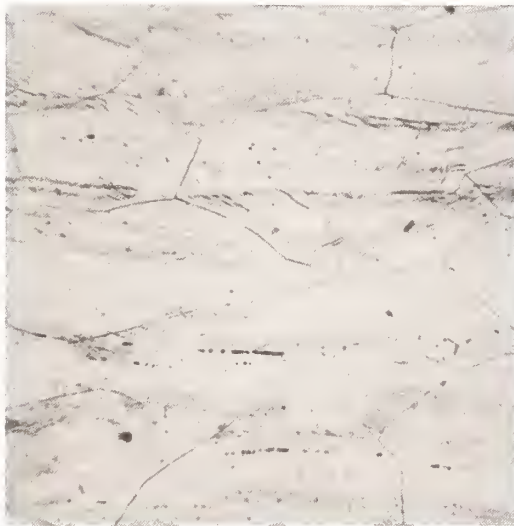
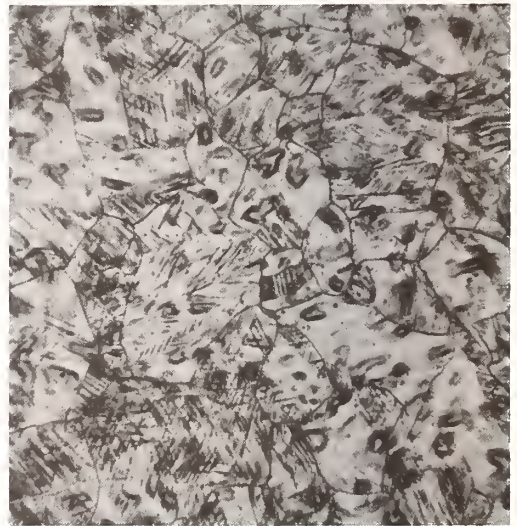
Longitudinal and transverse metallographic sections of the plate and screw d2 are shown in figure 6. The four sections were etched and photographed under identical conditions. So as not to over-etch the transverse section of the screw, the other sections are somewhat under-etched. Both plate and screw show a comparatively clean, fine-grained structure, with elongated grains in the longitudinal sections.

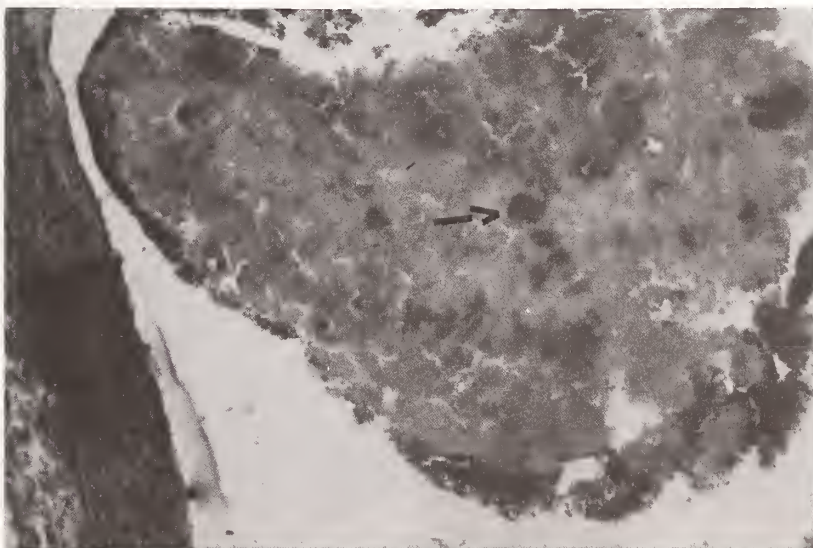
Figure 1b. Pulmonary infections complications of ventricular shunts. Septic embolus secondary to S. aureus, 40X.

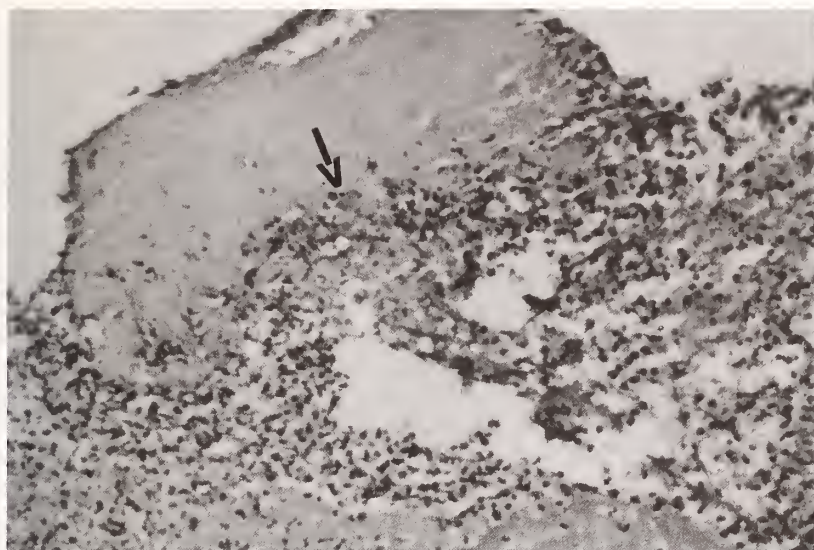
Figure 2a. Direct prosthesis infections.
Septic thrombus, H&E, 40X.

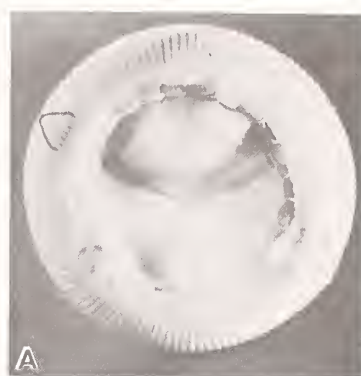
-Figure 2. Hancock bio-prostheses. (A) A-V Model 342 inflow aspect. (B) A-V Model 342 outflow aspect. (C) Valved conduit

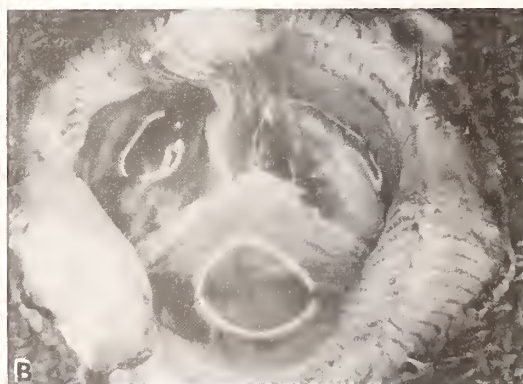
Figure 6.A. Non valvular reason for retrieval.
B. Outflow aspect of 92 month implant removed because of patient degenerative aortic root disease. Valve showed well conserved tissue at gross and microscopic levels.

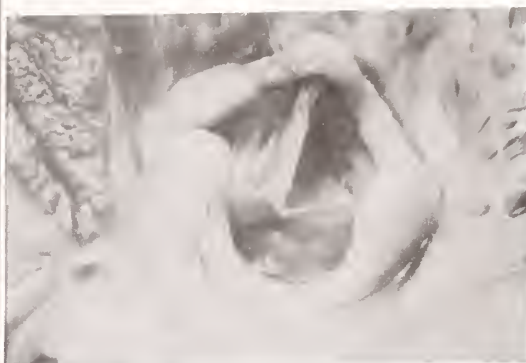
Figure 7. A. Time course of valve retrieval for unknown reasons.

B. Valve in situ, removed for unknown reasons.

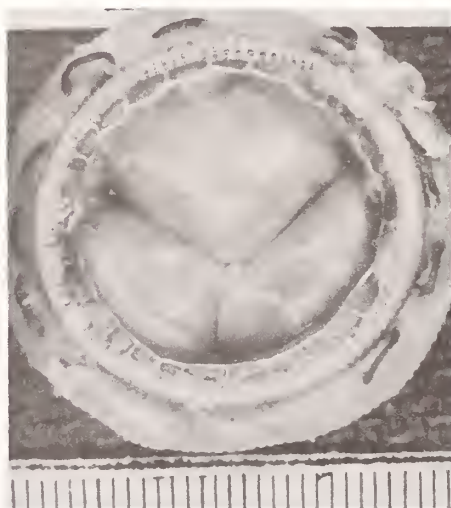
Figure 8. A. Chronology of retrieval in the face of active infective endocarditis or bioprosthetic endocarditis.

B. Valve removed at 6 months because of unhealed infective endocarditis. Histological sections revealed abundant aggregates of coccal organisms.

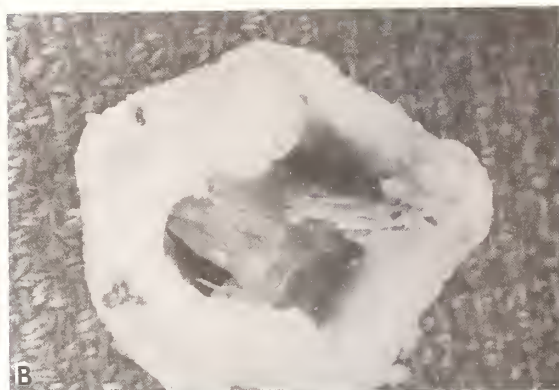
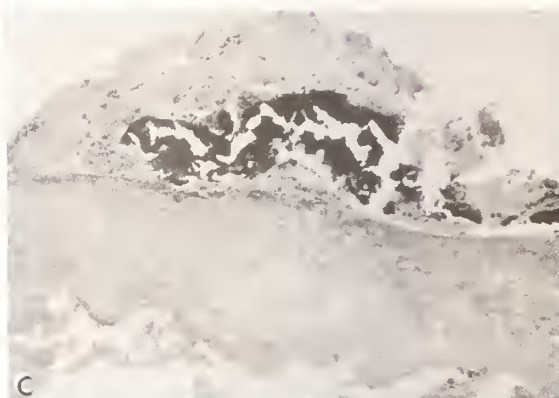
Figure 9.A. Extrinsic mineralization as reason for valve removal. B. Gross photograph of extrinsically calcified valve. Note mineralized verrucous deposits along commissural edges of valve leaflet. The remaining tissue is smooth and glistening. C. Fibrin accumulated on surface of valve demonstrates positive von Kossa (black) material indicative of calcific deposit. The architecture of the leaflet is well conserved.

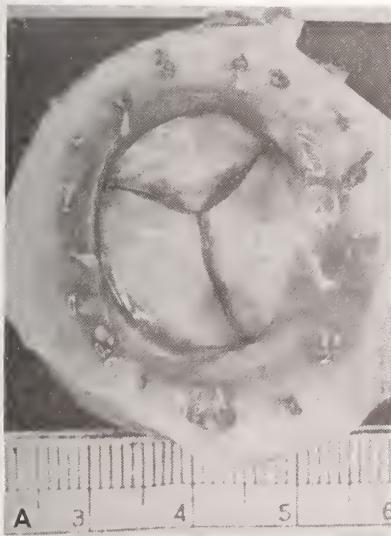
Figure 14. A and B. Inflow (A) and outflow (B) aspects of valve explanted 5 years 10 months (70 mos.). Exuberant host fibrotic ingrowth into the sewing ring stops at points of leaflet flexure.

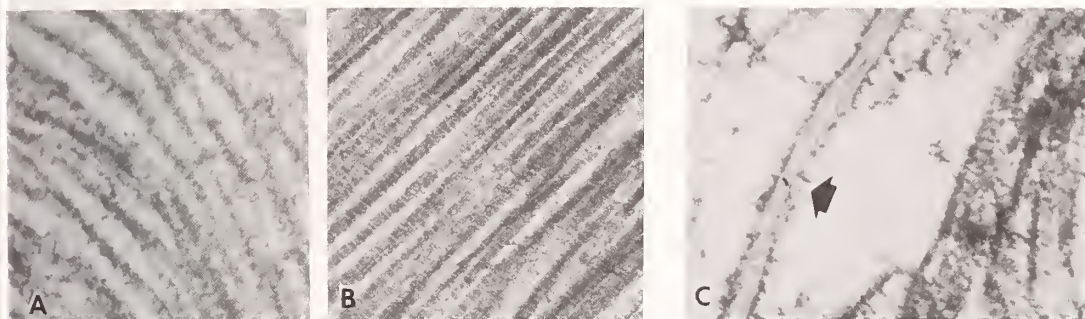
Figure 16 A. Ultrastructural view of collagen from leaflet of valve explanted at 92 months. Notice blurring of collagen fiber crossbanding and ubiquitous adherent material. B. Ultrastructure of preimplant collagen. C. Adherence of granular material to single elastin fiber (arrow). All X47,000

Comparison of collagen from leaflets of the explanted valves (fig. 16 A) with that from comparable regions of the unimplanted controls (fig. 16 B) revealed (1) a variable loss of contrast or blurring of the collagen fiber crossbanding pattern, (2) electron dense granular material associated with the collagen fiber surface, and (3) an accumulation of similar material in the interfiber spaces. Close examination of individual fibers showed associated granular and filamentous material which appeared to be attached to the fiber surface and possibly within the fiber intermolecular interstices (fig. 16 C).

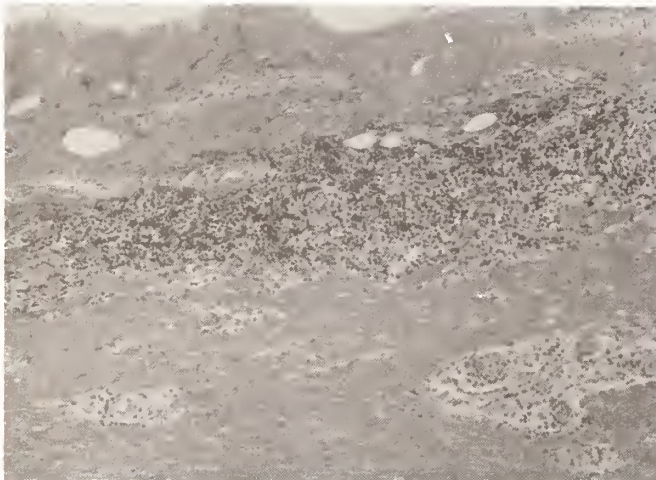
Figure 4
Cluster of lymphocytes
and lymphocytes
scattered with some
perivascular cuffing.

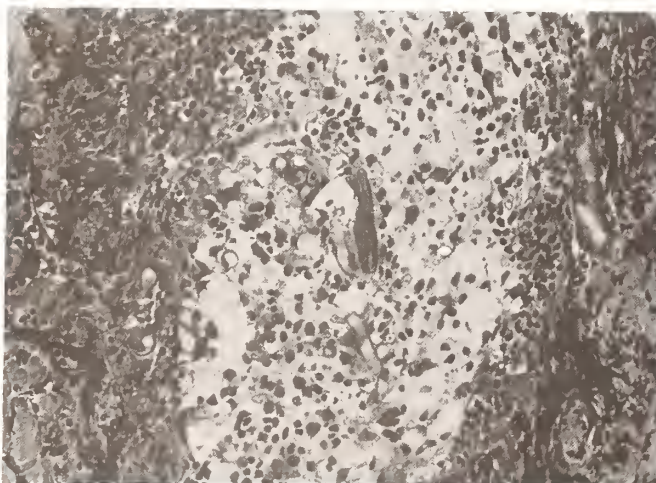
Figure 5
Macrophages in center
of lymphocytic nodule.

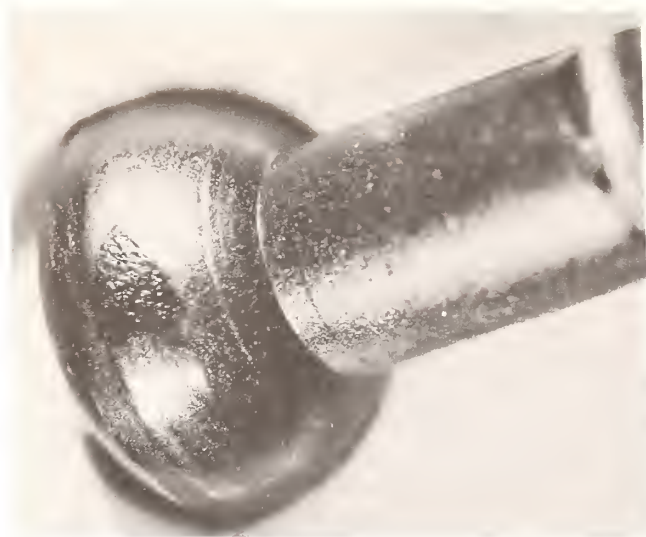
Figure 13

a. Contact area on a titanium screw, size 2, degree 2, nature 3.

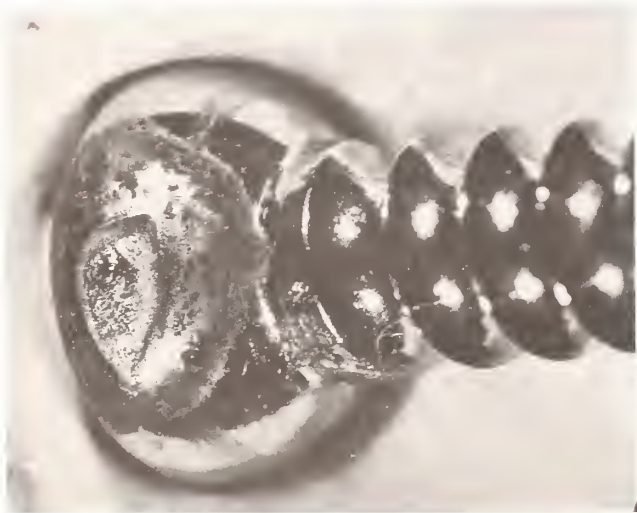
c. Contact area on a stainless steel screw, size 2, degree 3, nature 5, 6.

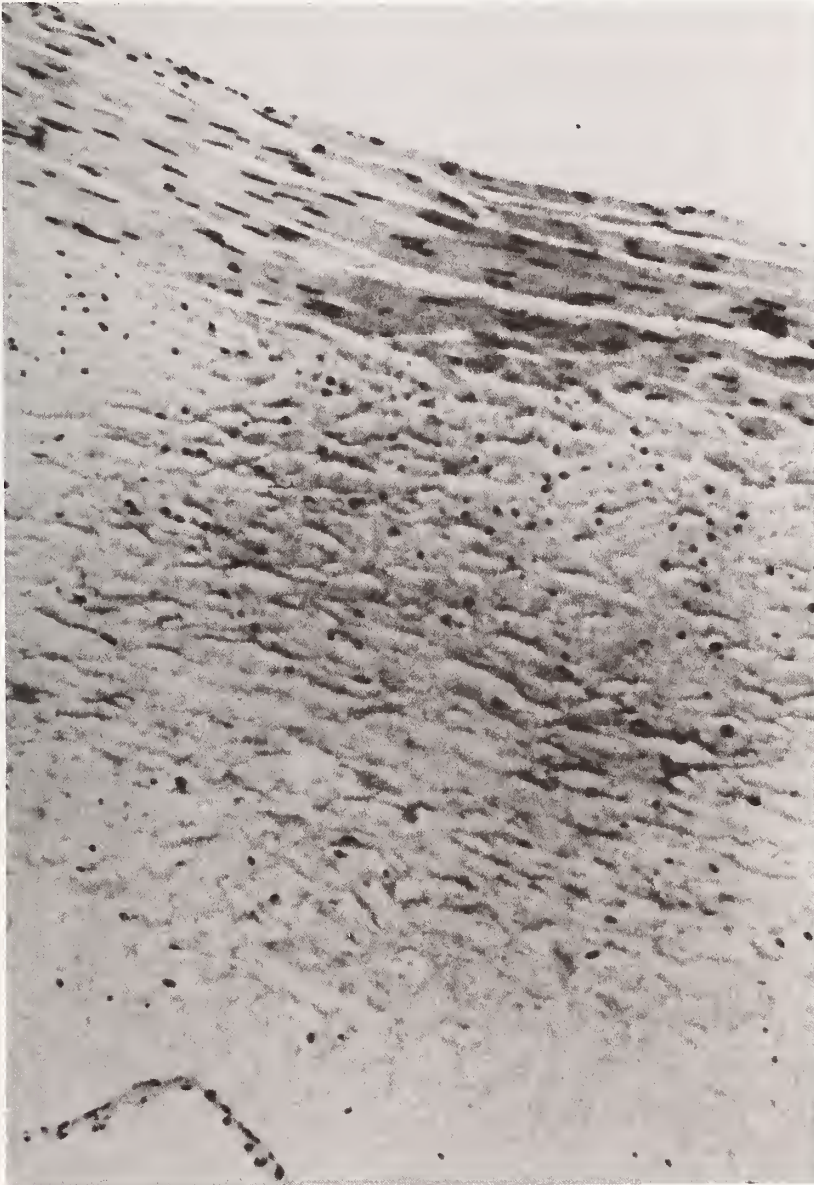
Figure 9. Histological section of pre-implant sample demonstrating the intact media and adventitia.

Morphological studies of explanted Biografts® included procedures ranging from gross evaluation to transmission and scanning electron microscopy. Typical histological changes seen in a patent graft are demonstrated by a comparison of figures 9 and 10 which represent a pre-implant and 8-month explant samples, respectively. Shortly after implantation the graft becomes compacted due to the hydrodynamic forces imposed upon the graft material.

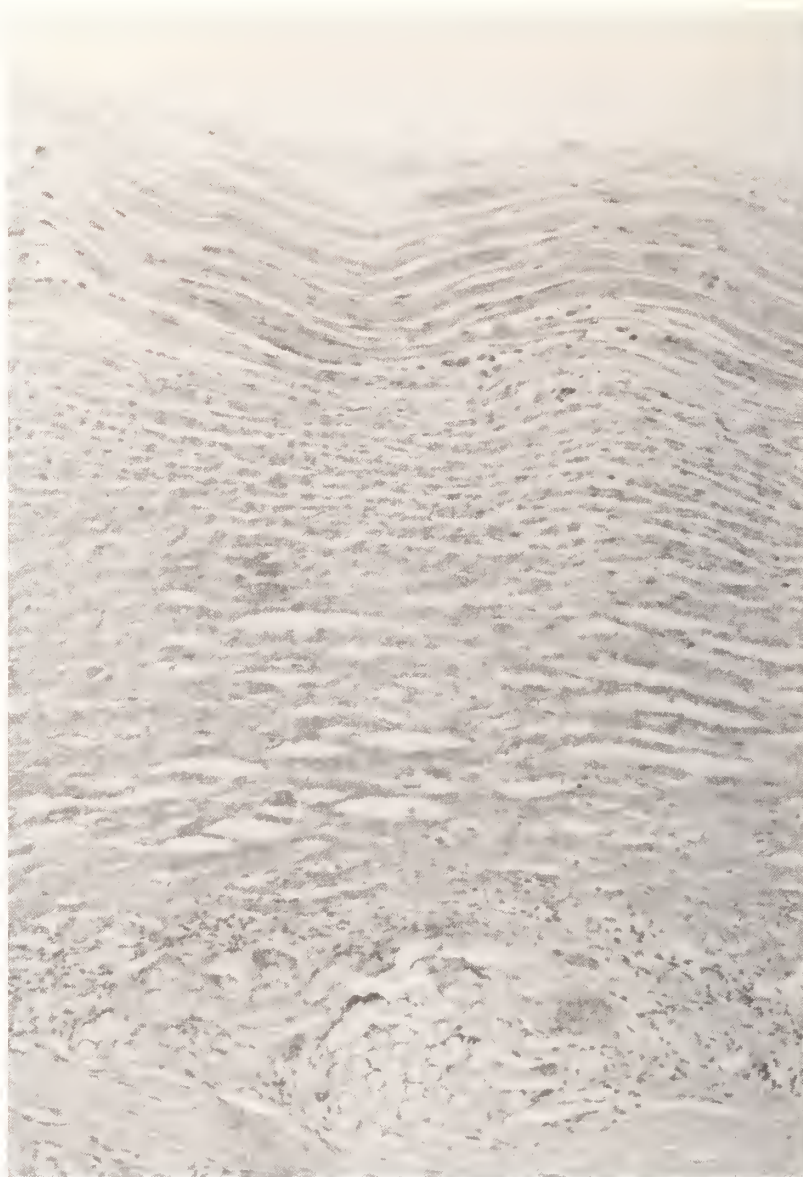
Figure 10. 8-month explanted sample demonstrating graft compaction and mild reaction around the mesh.

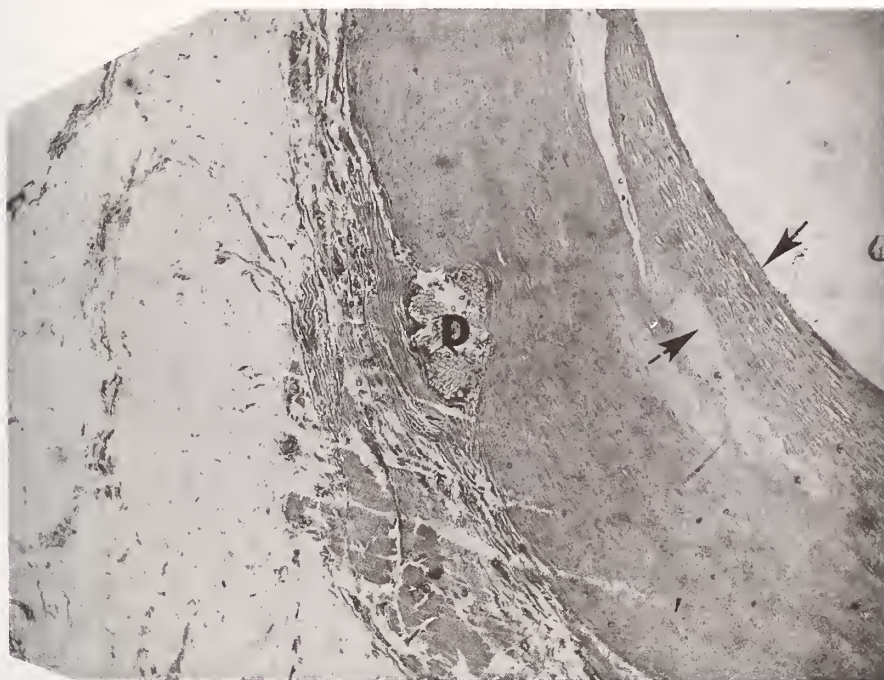
Figure 11. 3½ year explanted sample showing mesh material (D) and the compressed media (arrows).

As time progresses, the cellularity of the graft decreases leaving the 42-month sample almost acellular (figure 11). Initially, the reaction to the Dacron mesh is relatively mild and, as can be seen in the 42-month sample, this reaction decreases with time (D). The compressed media is represented by the arrows and still can be distinguished from the connective tissue zone.

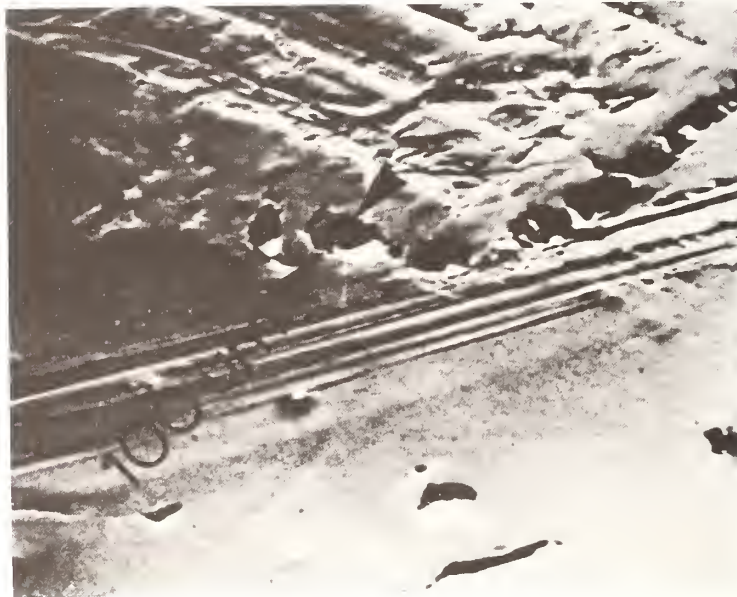
Figure 2: Highly polished wear areas in dome of acetabular cup (19 months implantation; original SEM magnification x48).

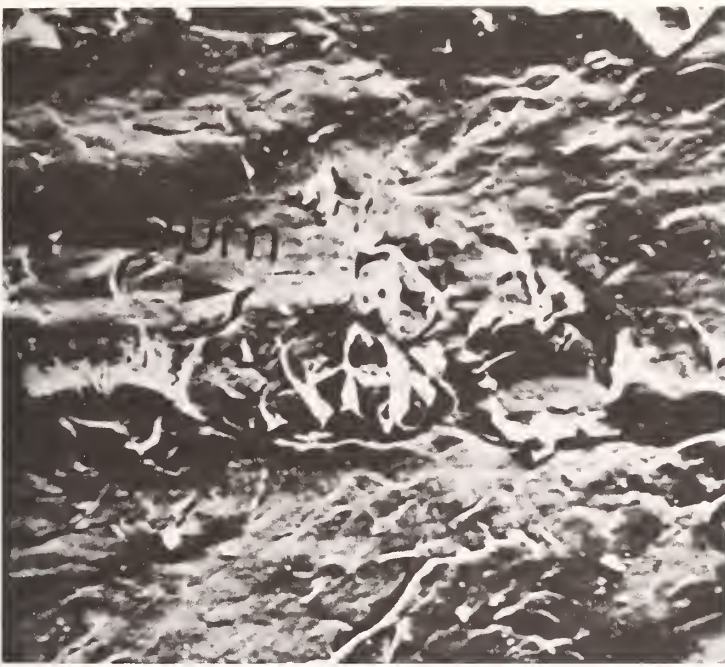
Figure 3: Disrupted areas of polyethylene surface in acetabulum (SEM magnification x330).

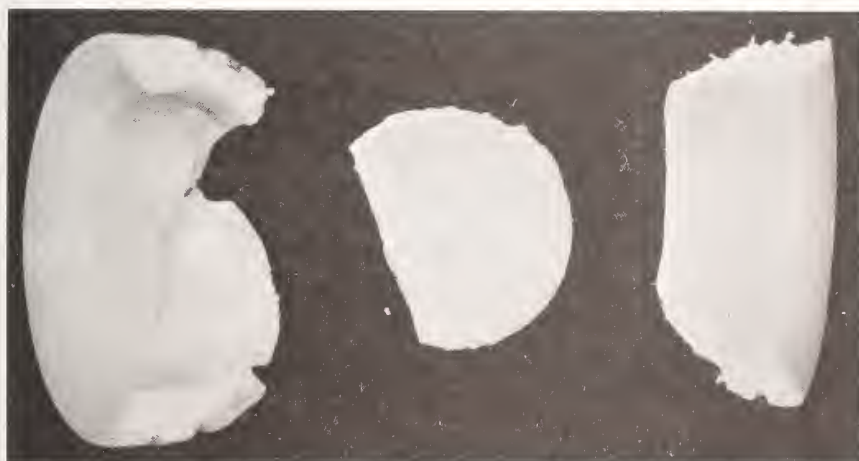
Figure 5: Worn and fractured polyethylene acetabulum described by Salvati et al. [51].

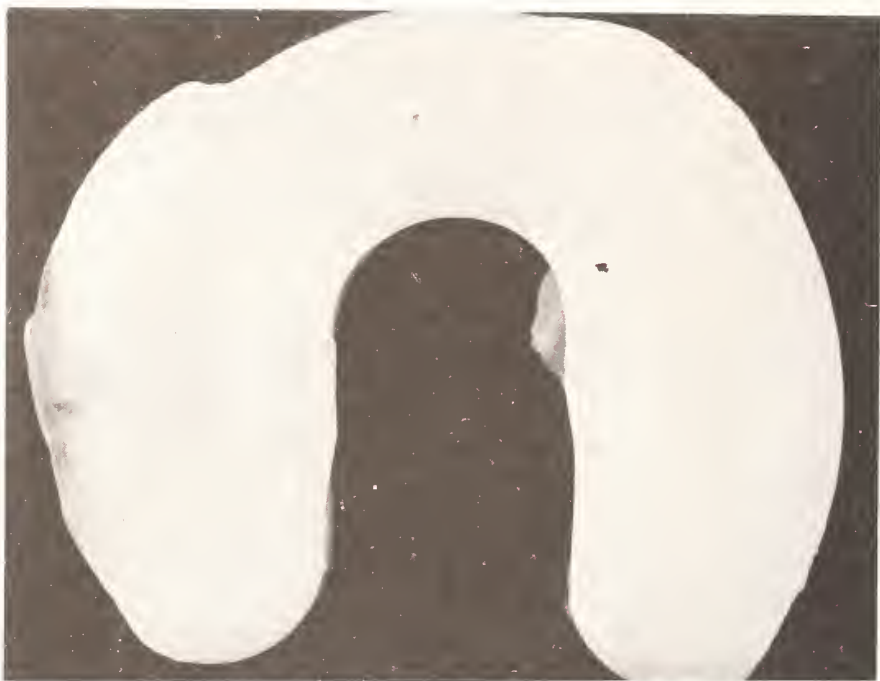
Figure 8: UCI knee component removed after 3 years use.

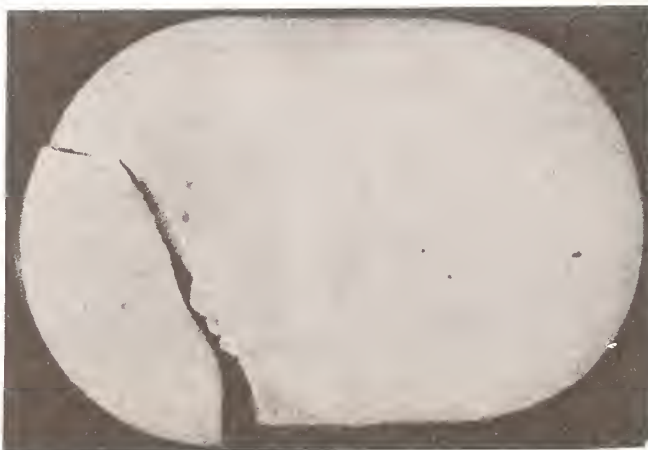
Figure 9: Fracture of a small ICLH polyethylene tibial component, history unknown [66].

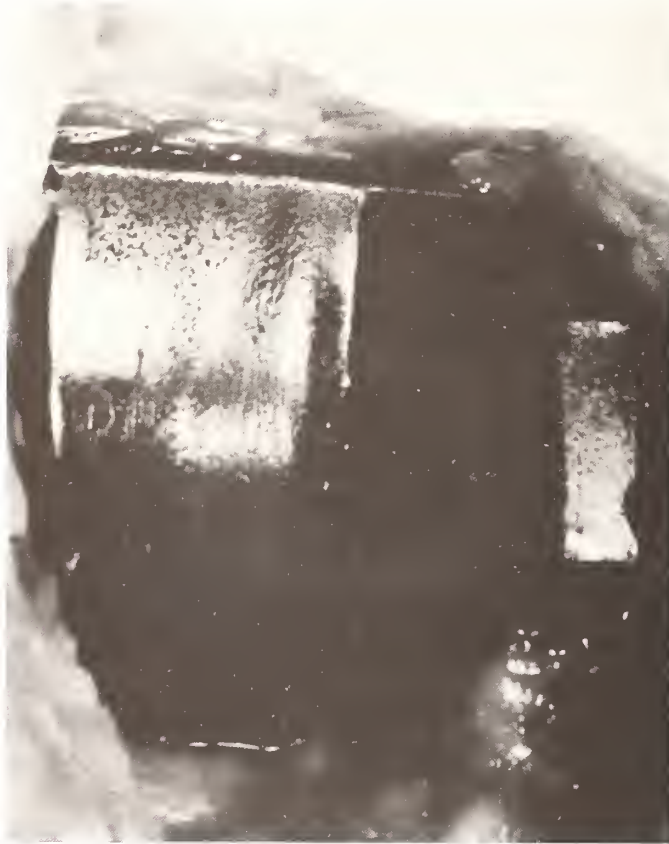
Figure 11: Carbon-fiber reinforced tibial component of Oregon ankle removed after 12 months [30] in the same patient as the component shown in Figure 10.

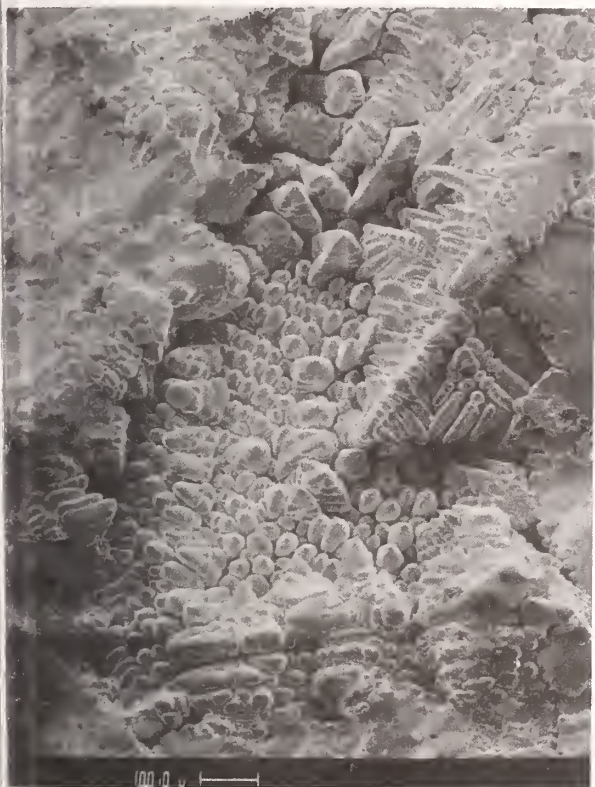
Figure 2. Scanning electron photomicrograph of the fracture surface of a Charnley stem cast from cobalt alloy showing dendritic structure at the crack initiation site. A 100 micron reference bar is included at the bottom. Time implanted was 74 months.

material defect was interdendritic porosity in stems cast from cobalt alloy. At least four of the fourteen cast cobalt alloy stems showed significant porosity in the region of crack initiation (fig. 2).

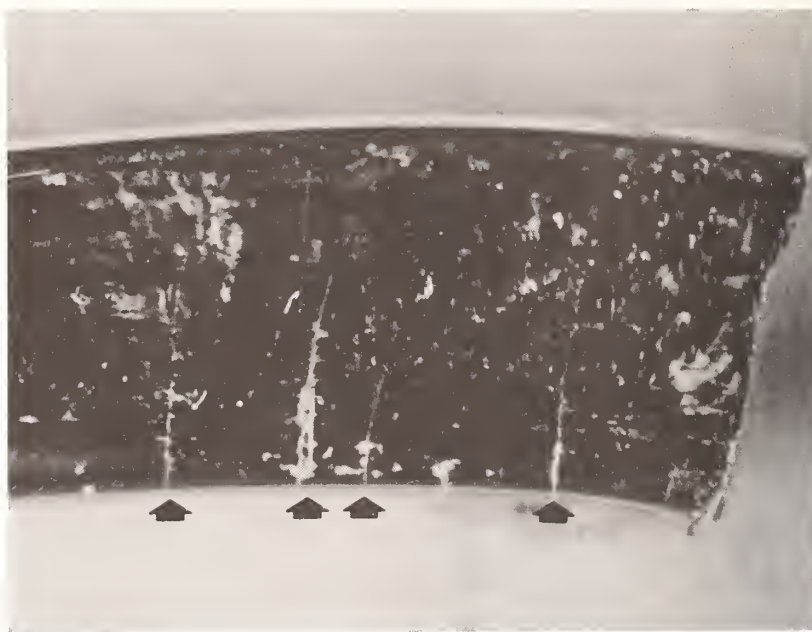
Figure 3. Multiple cracks emanating from the medial side of a fractured small stem T28 prosthesis made from stainless steel. Time implanted was 52 months.

Two forms of stress concentration also lead to crack initiation. A stainless steel Charnley fractured in fatigue which initiated at a nick on the anterolateral corner of the stem cross-section. It was not possible to determine if the nick had been caused by a drill bit during reattachment of the greater trochanter or by subsequent migration and rubbing of the reattachment wire against the stem, though clearly one or both were responsible. Another form of stress concentration occurred in four of the five fractured T28 stems. All four stems fractured in fatigue and all had multiple cracks (always more than three) in addition to the crack causing failure (fig. 3). These cracks often initiated on the medial side of the stem. Their presence can be attributed to the trapezoidal cross-sectional shape, which causes higher stresses on the medial side than on the lateral side. When the stem is overstressed, the medial side yields first in compression, causing areas of residual strain which with continued cyclic loading can become tensile and act as a stress concentration. All four of the femoral components were the small stem size and all four were implanted in relatively active male patients weighing over 31.0 kilograms, so the potential for high stresses was present.

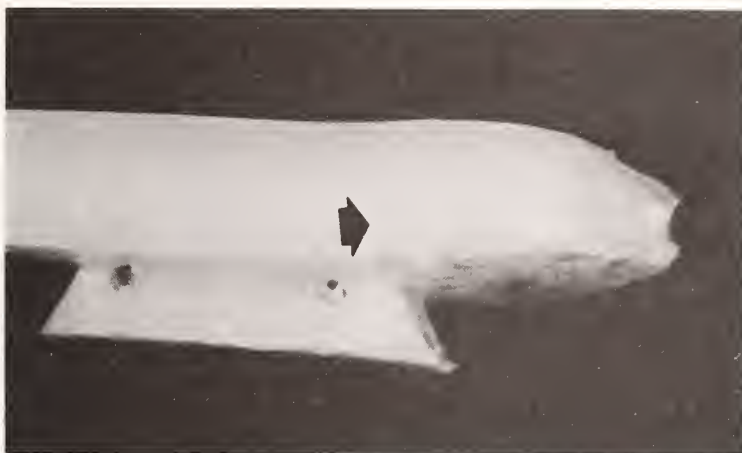
Figure 4. Freeman-Swanson type polyethylene tibial component showing partial fracture (arrow). Time implanted was 60 months.

As with the metallic femoral stems the fracture mechanism in the polyethylene components was primarily fatigue. Once again the initiation of the fatigue process often occurred at a stress concentration. For example, fracture in acetabular cups originated at the base of the circumferential grooves machined in the components to provide good fixation to cement [17]. The lack of adequate structural support from surrounding cement and cancellous bone was often associated with the fracture. For example, poor cancellous bone under the medial side of a Freeman-Swanson tibial component combined with the fact that the extreme medial and lateral edges of the component were supported on the cortical shell of the tibia lead to the fracture shown below in figure 4.
