NIST Technical Note 1635

A Case Study of a Community Affected by the Witch and Guejito Fires

April 2009

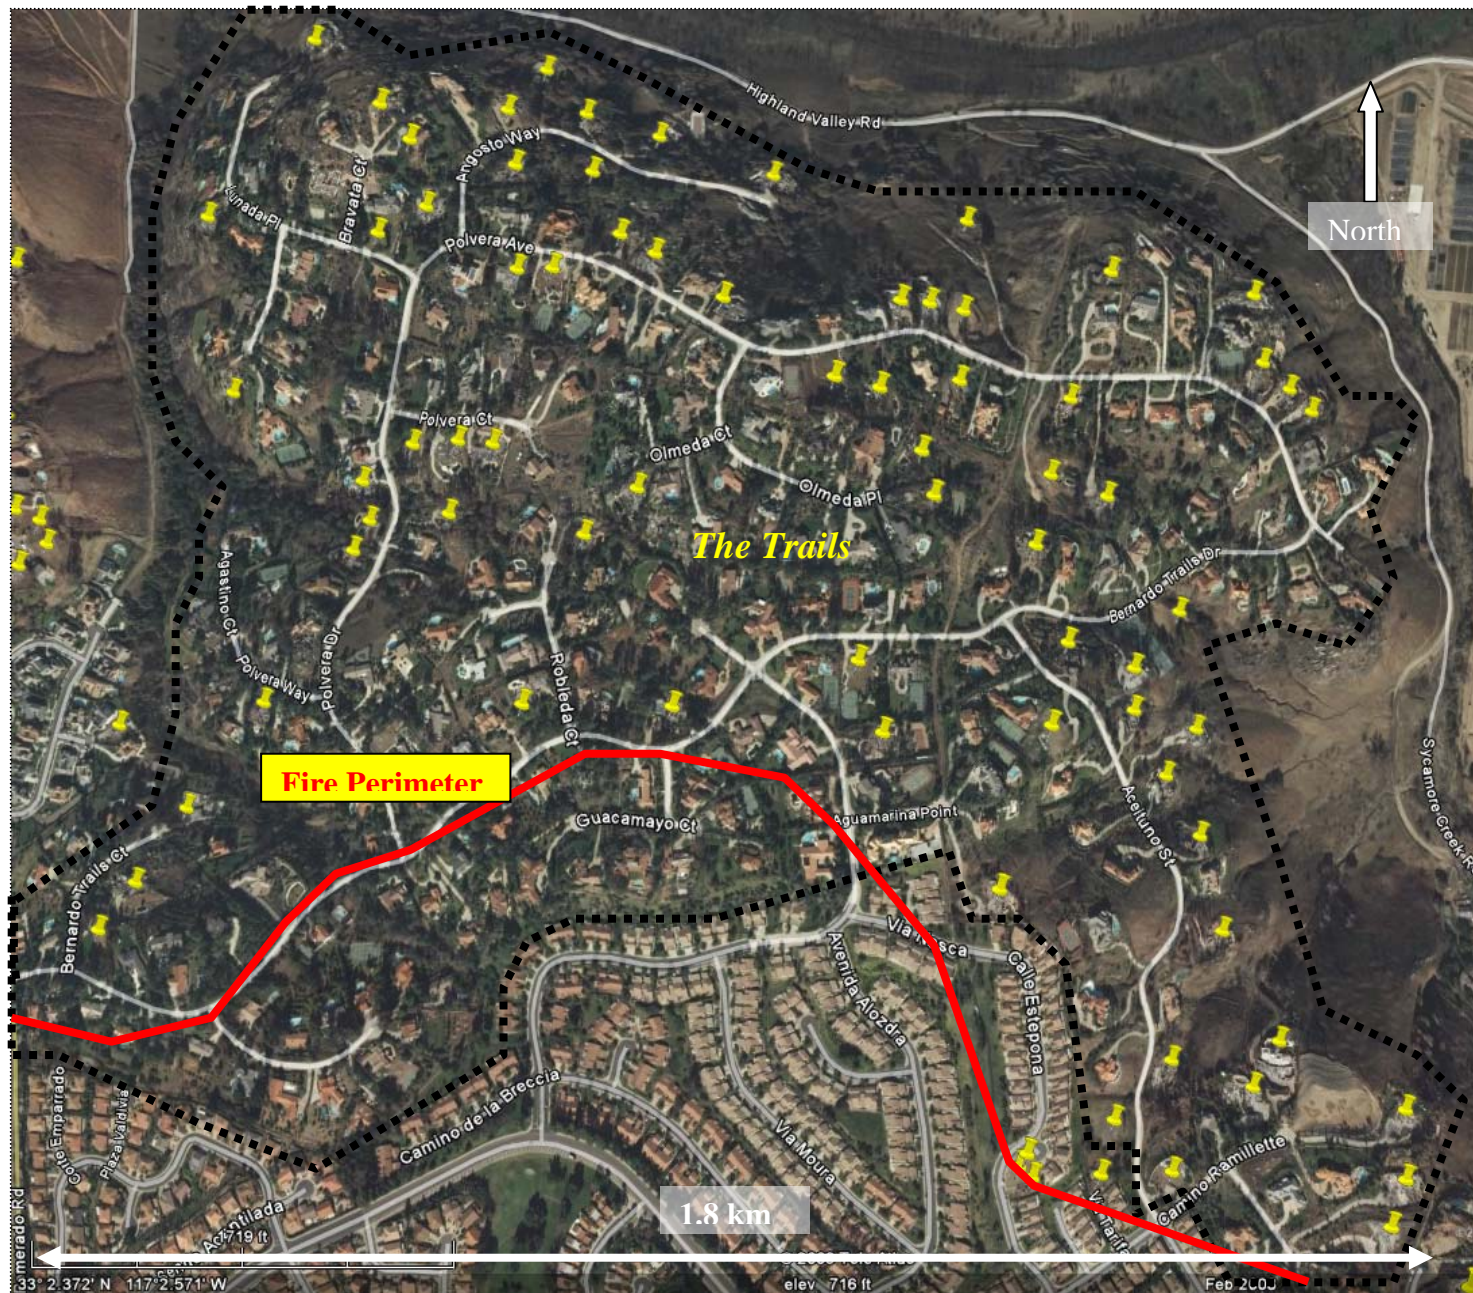
Figure 1: *The Trails* Community, Destroyed Homes (in Yellow) and Fire Perimeter after the Guejito and Witch Fires

The NIST WUI Team was invited by the California Department of Forestry and Fire Prevention (CAL FIRE) to collect post incident data from the California October 2007 fires. Early on, the NIST WUI Team initiated a case study within the Witch Fire perimeter. The case study is focused on The Trails development at Rancho Bernardo, 40 km (25 miles) north of the City of San Diego. There were 274 homes in The Trails, with 245 within the fire perimeter (Figure 1). Seventy four homes were completely destroyed and 16 were partly damaged.

445 feet). The community is 23 km (14 miles) east of the Pacific Ocean. The community consists of 283 residential lots (Figures 1 and 2). Although some lots on the perimeter of the community are larger, typical lots are approximately 6000 m² (1.5 acres). At the time of the fires there were 274 residences. Out of the 245 residences within the fire line, 74 were completely destroyed and an additional 16 sustained various degrees of damage. Housing density is approximately 116 homes per km² (300 homes per square mile). Figure 3 illustrates three different housing densities. The Trails is represented on the left, a community in Rancho Santa Fe, California is shown in the middle and a low density housing area is shown on the right. Note that the houses are not evenly distributed as the “density” becomes lower. The housing density within The Trails is greater than the densities seen outside of Rancho Bernardo but lower than the densities seen to the west of The Trails (Figure 2).

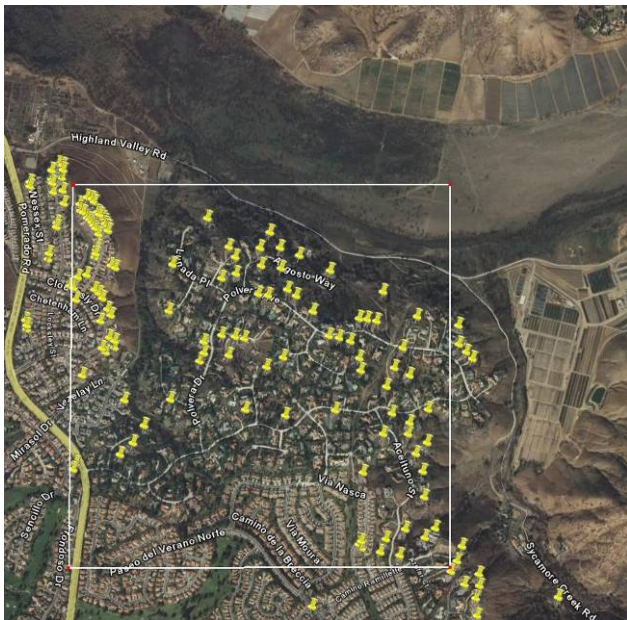
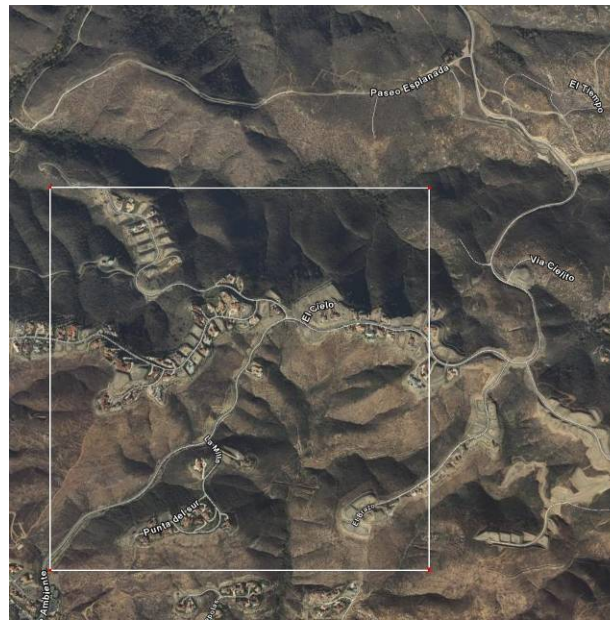
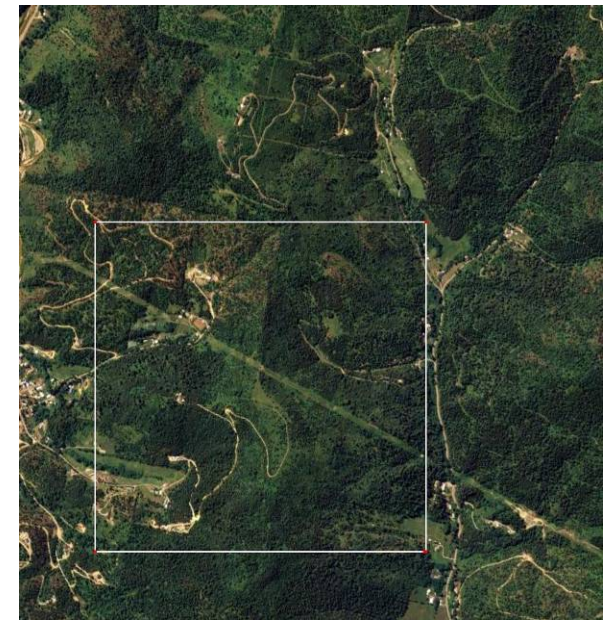
The Trails
116 homes per km²
(300 homes per square mile)

Rancho Santa Fe
31 homes per km²
(80 homes per square mile)

Rural Setting
4 homes per km²
(10 homes per square mile)

Figure 3: Structure Densities in Three Different WUI Settings

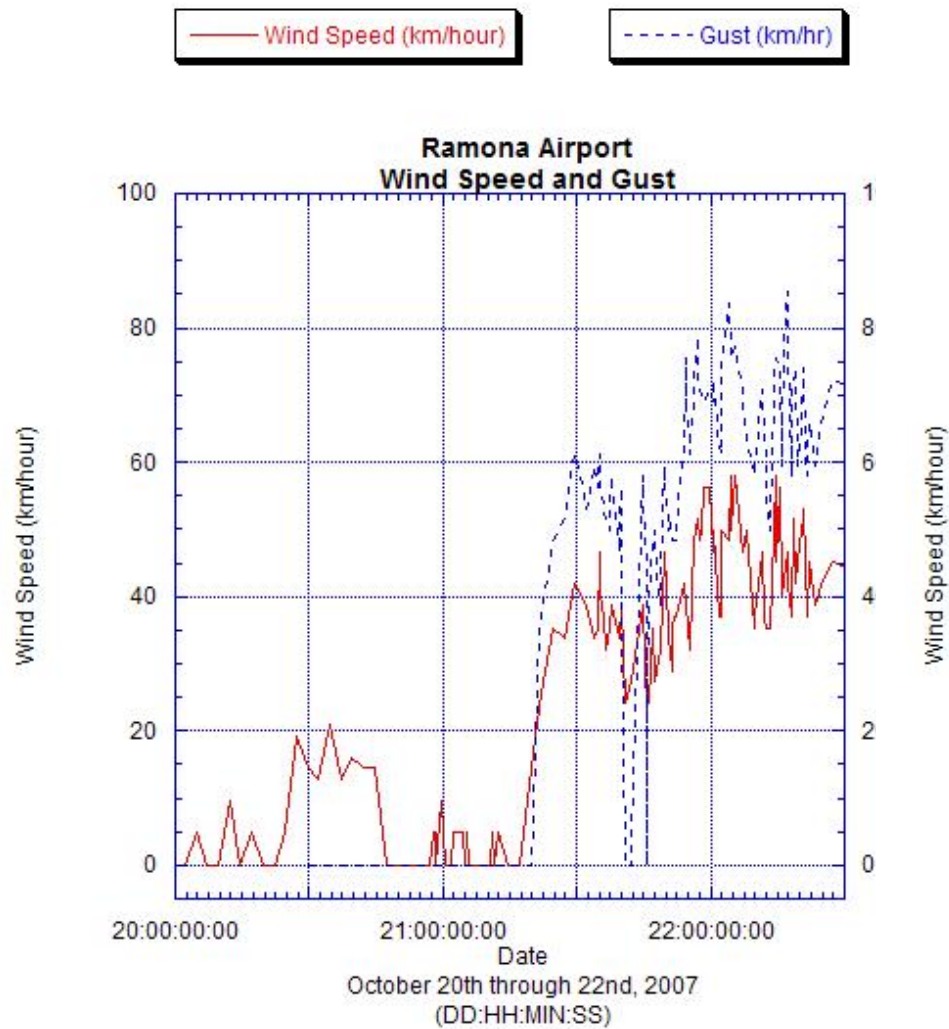
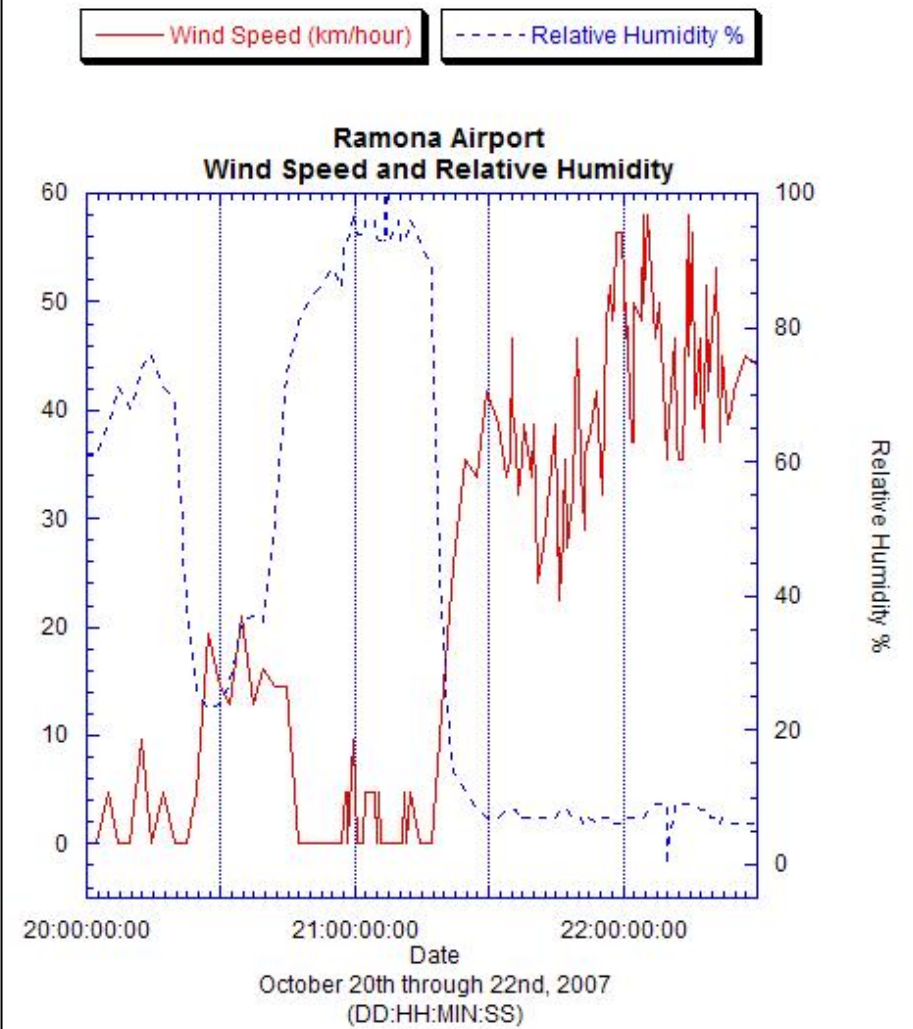
Figure 5: Weather data from Ramona Airport

The Ramona Airport weather station is 13 km due east from The Trails. The station recorded a dramatic drop in humidity while also recording a rapid increase in wind speed. Similar behaviors were recorded by the Poway NE1 station, located 10 km SSE of The Trails, and are summarized in Table 2. Figure 5 displays wind speed, wind gusts, wind direction and relative humidity at Ramona airport between October 20th and October 22nd.

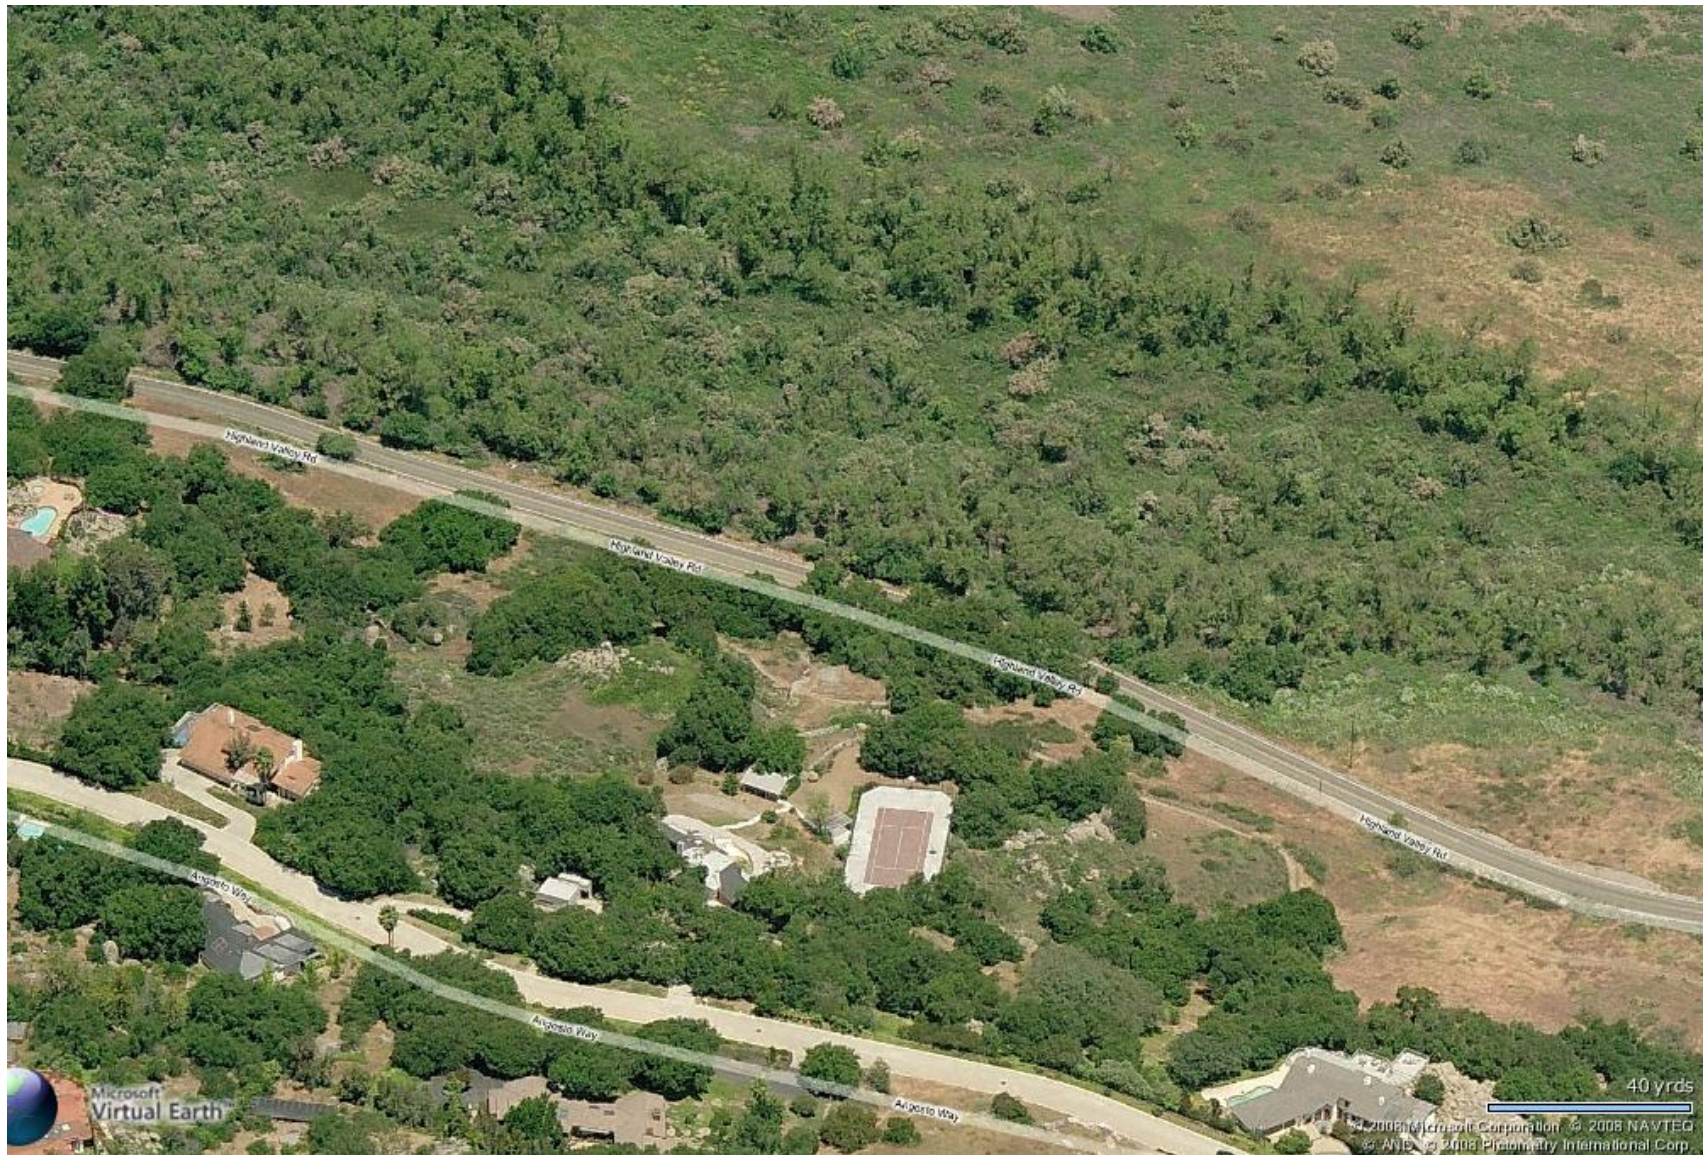
Figure 12: Angosto Way before October 22nd, 2007 (circa 2005)

The CALFIRE Witch Incident Fuel Map¹⁶ contains information on the Witch fire perimeter and wildland fuel type. Thirteen different fuel types were involved within the perimeter of the Witch Fire. The Highland Valley is covered primarily by Barren/Rock/Other (Fuel Model 99), with Brush (Fuel Model 5) on the western side and Agricultural Lands (Fuel Model 97) on the eastern side. The mount occupied by the Trails is surrounded by Hardwood/Longpole Pine (Fuel Model 8) to the north and west. A small amount of Brush (Fuel Model 5) can also be found on the western side of the mount and in the main ravine/chute on the northern side. The eastern side is primarily Brush, with a couple of patches of Grass (Fuel Model 1). At the base of Sycamore Creek, there is Barren/Rock/Other (Fuel Model 99) surrounding the Creek. Figures 5 through 11 show the inhomogeneities in wildland fuel on the slopes surrounding The Trails before the Witch and Guejito fires. Wildland fuels surrounding The Trails vary in type as well as density. Figures 12 and 13 show Angosto Way, which borders the northern edge of The Trails, before

and after the fires. The extent of damage to the canopy on the northern side of Highland Valley road is clearly evident as is the lack of canopy damage up slope, near the structures. Just before the fires reached The Trails, dead fuel moisture for 1 hour fuels is estimated at less than 10 %.

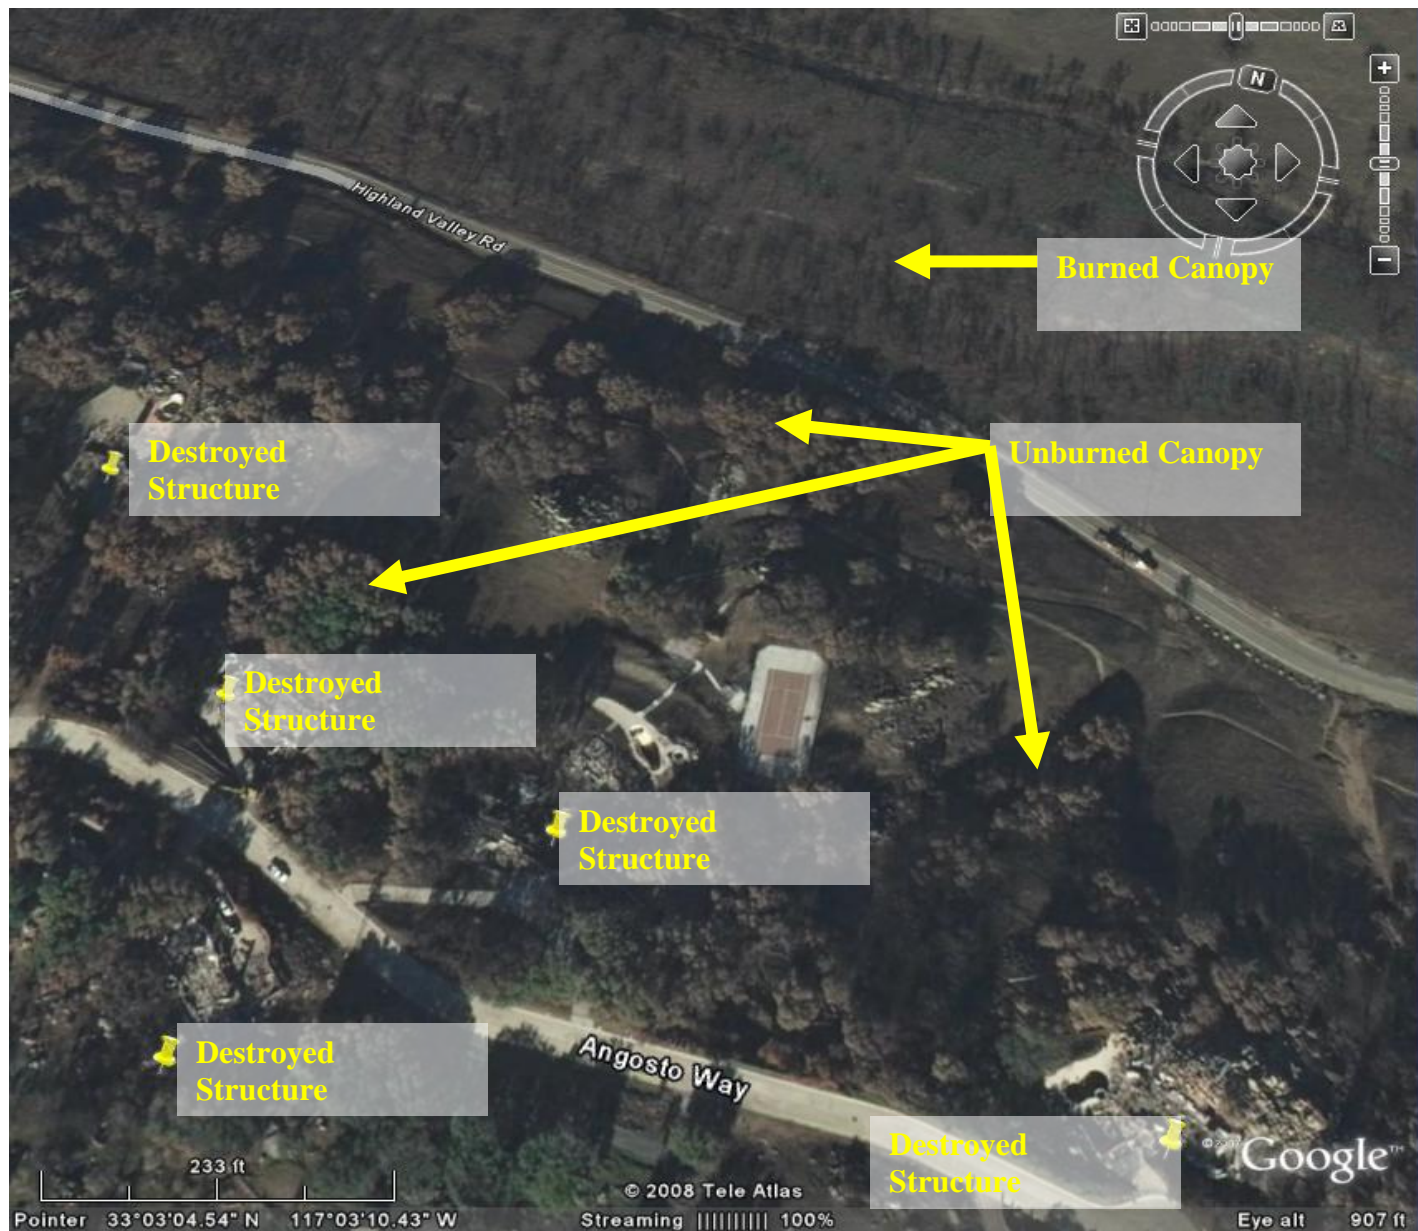
Figure 13: Angosto Way after October 22nd 2007

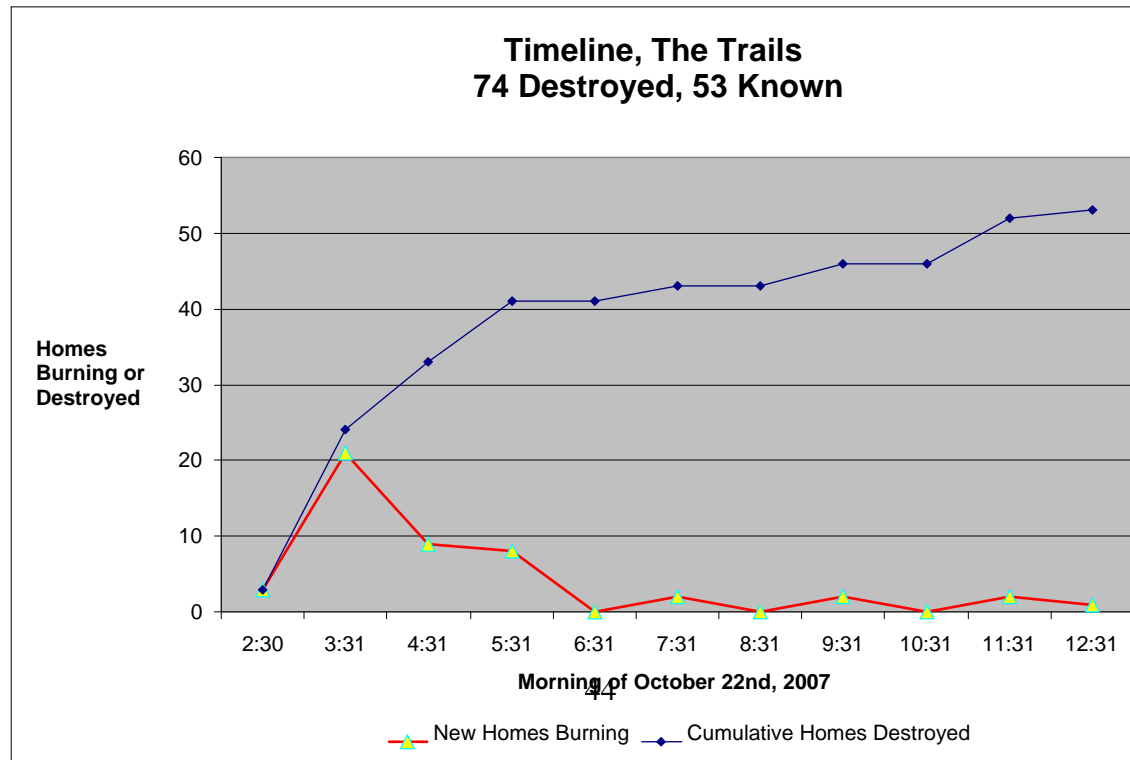
Figure 16: Timeline of Structures Burning in The Trails

Time window	2:30	3:31	4:31	5:31	6:31	7:31	8:31	9:31	10:31	11:31	12:31	Total
Ignited- some flames visible	3	11	7	2				1		2	0	
Fully involved	0	10	2	4		2			0		1	
Almost completely destroyed	0	0	0	2				1	0		0	
New burning	3	21	9	8	0	2	0	2	0	2	1	
No longer burning*	0	0	0	0	0			1	0	4		
Total	3	21	9	8	0	2	0	3	0	6	1	
Cumulative Total	3	24	33	41	41	43	43	46	46	52	53	53
Partial data*	2	7	3	3								15
Unknown												6
Grand Total												74

Burning
occurred
after listed
time

¹ 3:45 deck fires
put out by SDFD,
9:30 deck fires
put out by resident

In the following time reconstruction for destroyed structures, burning structures were reported along with their degree of burning, when the observation was made (Figure 16). In that respect, structures that are fully involved during a time interval and binned in one time step could possibly have ignited during the previous time interval. There is therefore potentially a significant temporal uncertainty associated with the actual ignition times of the structures. Even though smoldering could have been present for hours before the flaming occurred, it is estimated that initiation of flaming combustion can be estimated to within one hour. An attempt is made to estimate structure ignition times and total number of homes burning during each time interval. This is reported later in this section. Structure burning observations are documented in Figure 17.

Table 3 lists the breakdown of destroyed structures as a function of time. The category, “No longer burning” refers to structures that were already destroyed at the time of the first observation. The category “Partial data” refers to structures where observations were made prior to structure ignition, i.e.: subsequently destroyed home was not burning at the time of observation. The data in the table shows that new structure burning observations peak at 22 structures / hour between 3:30 to 4:30 am. The fire spread very rapidly within the community igniting over 50 % (41/74) of the destroyed structures within three hours after the first reported ignition. After 6:30 am, the number of new structure ignitions dramatically tapers off from eight, to one or two per hour. An expanded timeline table can be found in Figure 16.

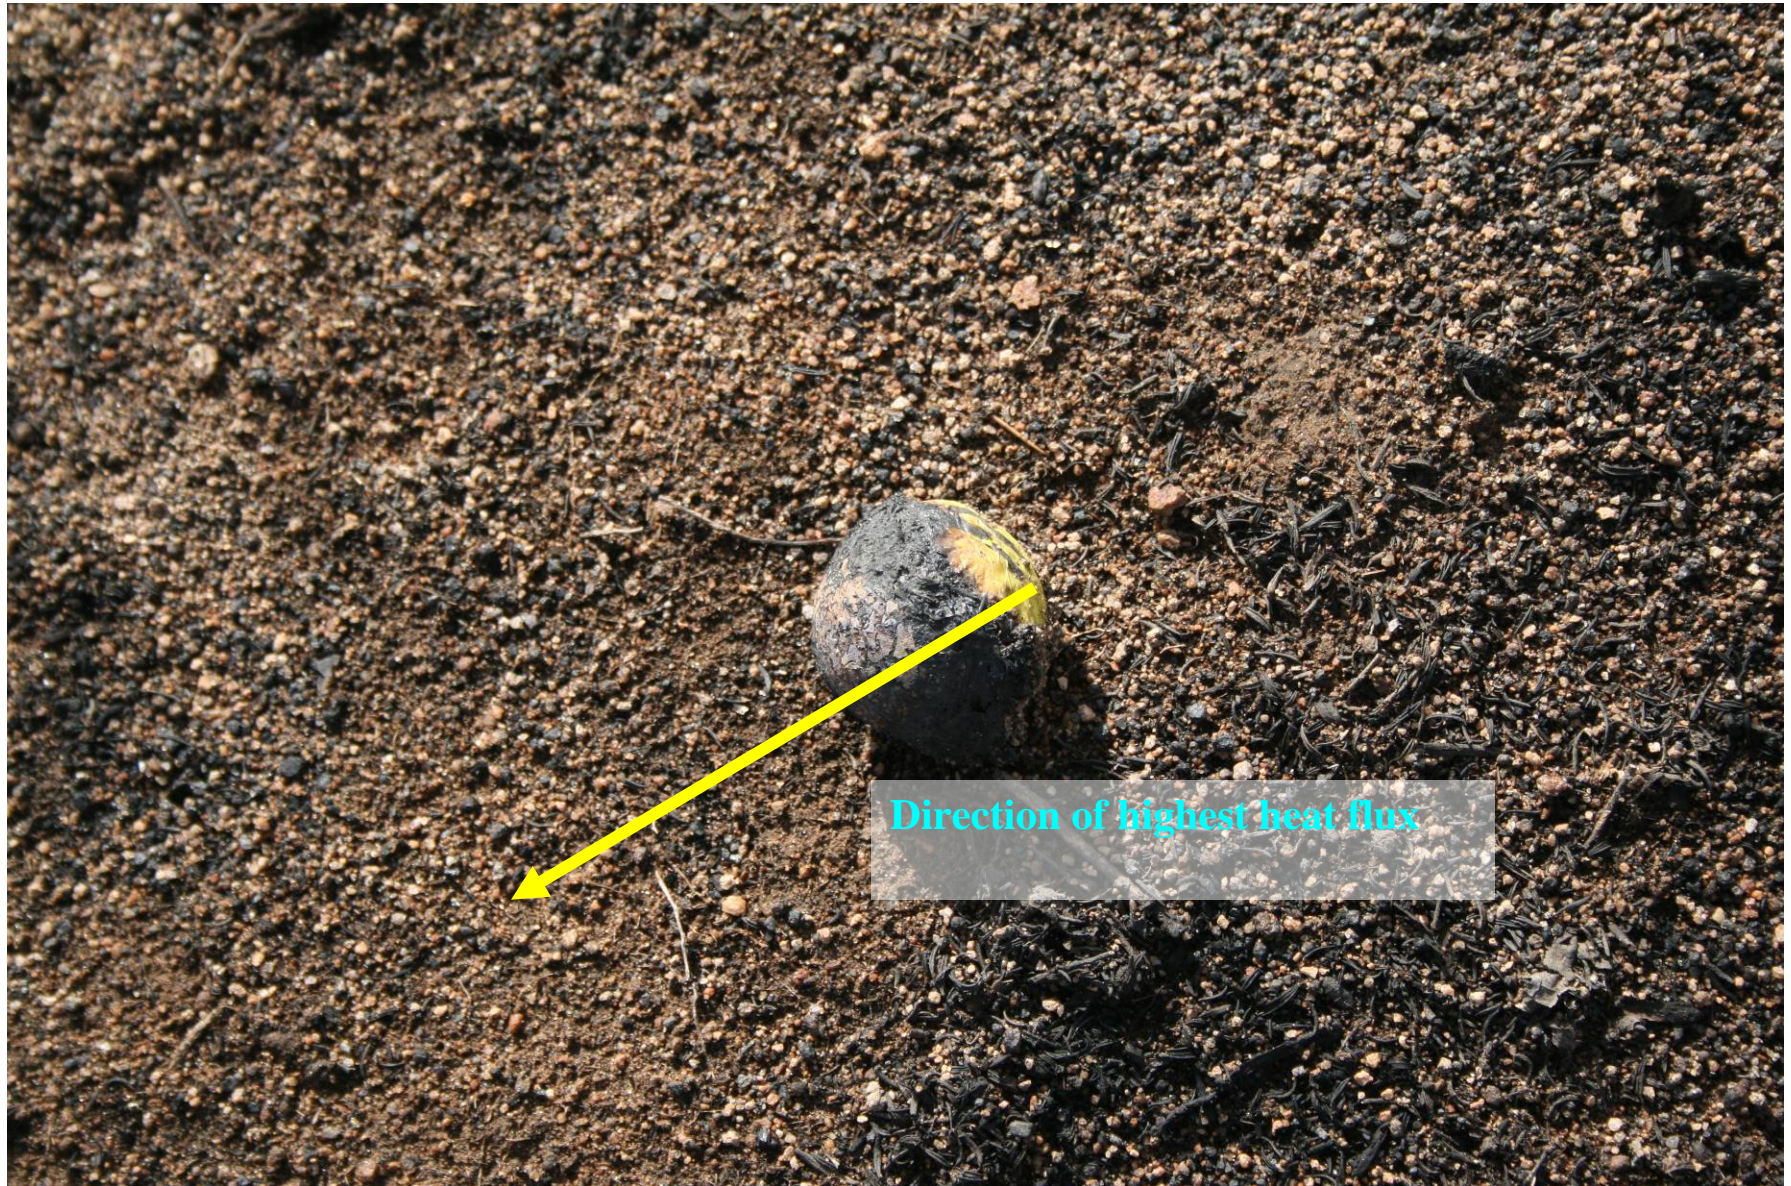
Figure 19: Golf Ball Providing Direction of Highest Heat Flux

Different tools were used to document fire spread within The Trails. The extent of burned vegetation was documented along with the locations the fire jumped a road. Several different indicators were used to determine the direction that the fire spread. The use of the different indicators will be explained in this section. In the wildlands, needle freeze as defined below, directional degree of damage to wildland vegetation and the presence of partly damaged golf balls were all used to determine directionality of fire spread. In this document, the perimeter of The Trails is defined by all lots that have direct contact with the wildlands.

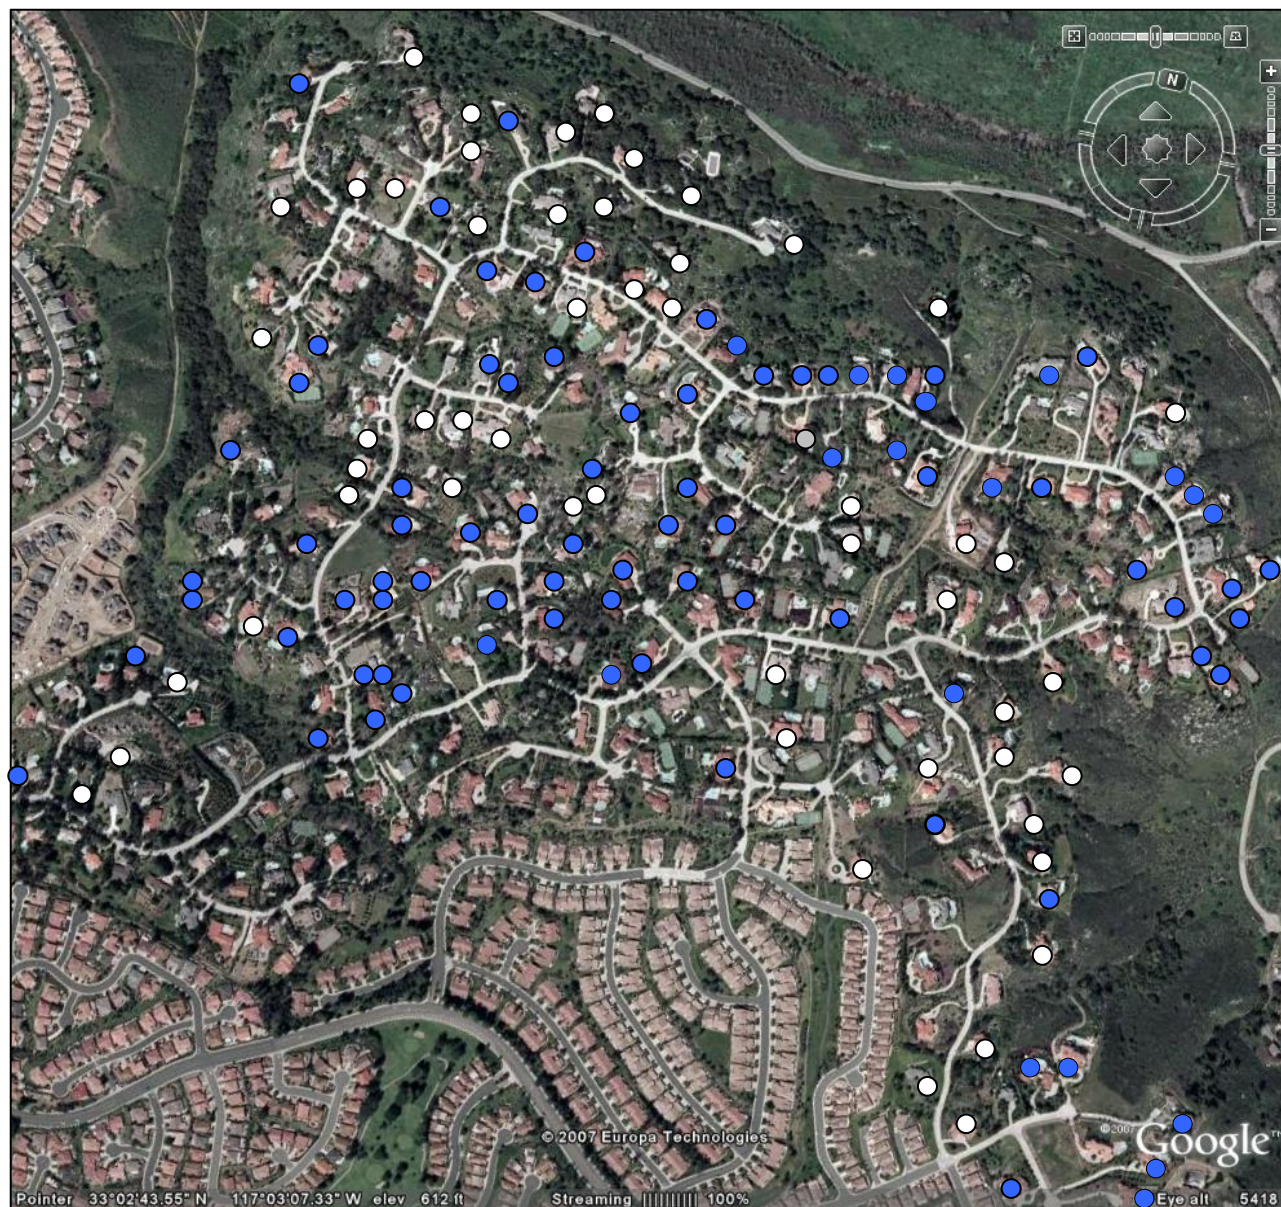
● (85) Defensive actions taken, including on 21 destroyed homes

○ (54) Destroyed home – unknown actions

Figure 22: The Trails Defensive Actions

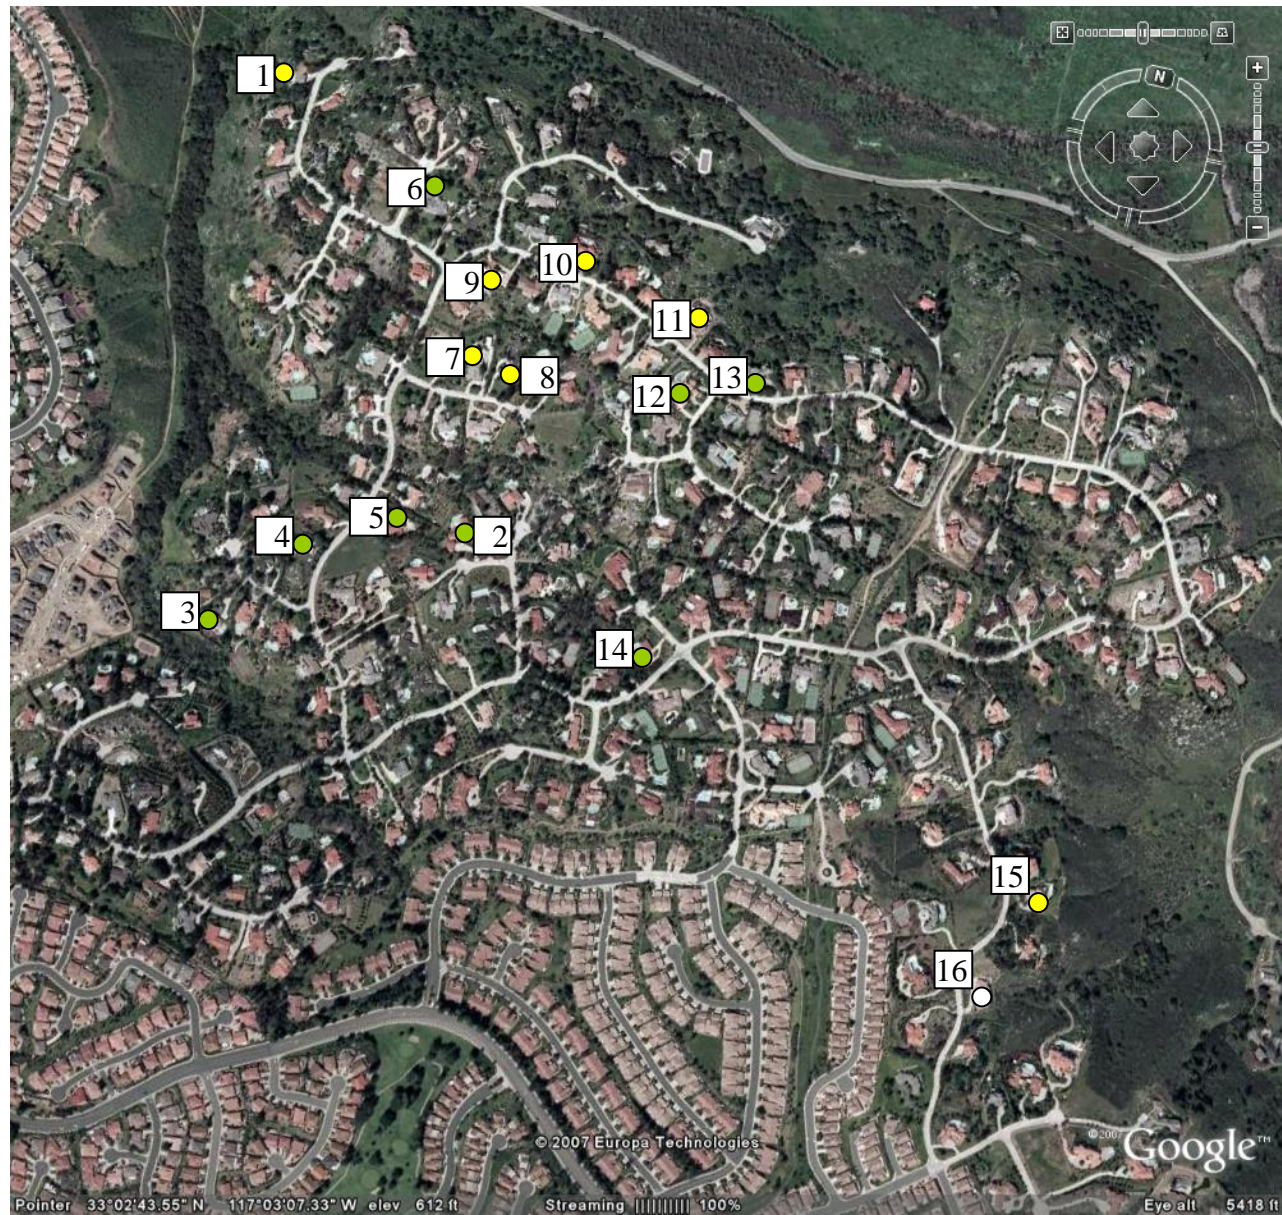
Figure 24: Damaged Structures. See Table 6 for further information on each house according to number on figure.

Identified defensive actions were taken on 15 out of the 16 homes. Table 6 lists type of damages and the time, if known, and type of detailed defensive action taken. Out of the fifteen defended structures, eight were defended by SDFD and five by residents or SDPD. For one damaged structure no defensive actions has been reported to date. Four out of the fourteen defensive actions occurred before 6:00 am, while the remaining seven occurred after 8 am, and the times for two defensive actions have not been identified. Figure 24 contains the locations of the damaged homes; numbers on Figure 24 correspond to House Number in Table 6.

House Number	Damaged area/ ignition location	Defensive Action (party responsible)	Time Action was Taken
1	decking and railroad ties	Garden hose used to extinguish fires (resident or SDPD)	before 6:00 am
2	detached garage and corner of main house/ unknown	Fire contained in garage (SDFD)	10:00 am to noon
3	detached garage/ unknown	Fire contained in garage (SDFD)	10:00 am to noon
4	Structure addition under construction	Water from suppression evident (SDFD)	unknown
5	main structure/ outside column (stucco over wood)	Fire contained to outside column (SDFD)	after 3:00 pm
6	detached garage/ unknown	Fire contained in garage (SDFD)	10:00 am to noon
7	detached structure/ unknown	Fire contained in detached structure (resident or SDPD)	7:00 am
8	main structure/ exposed wood beam	Garden hose used to extinguish fires (resident)	8:00 am
9	decking	Garden hose and bucket (resident)	9:00 am
10	main structure/ gutter	Garden hose used to extinguish fires (resident)	3:00 am to 5:00 am

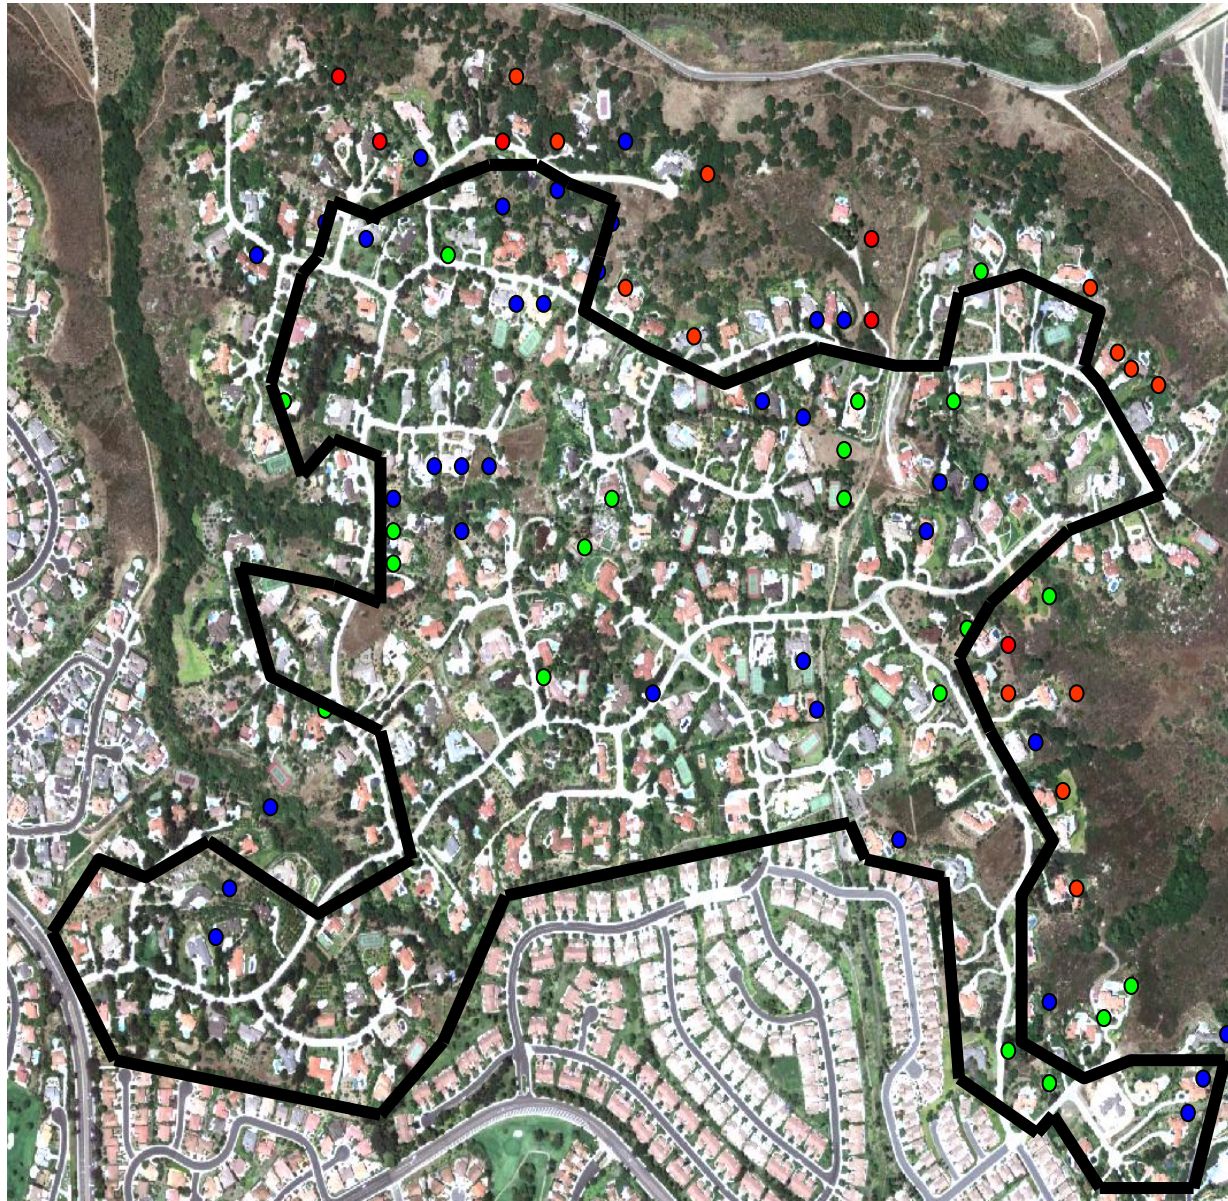
- A – Uninterrupted fire to structure
- B - Fire spotting
- C – Structure ignition from Embers

Figure 25: The Trails - Ignition categories of destroyed structures and perimeter/interior outline

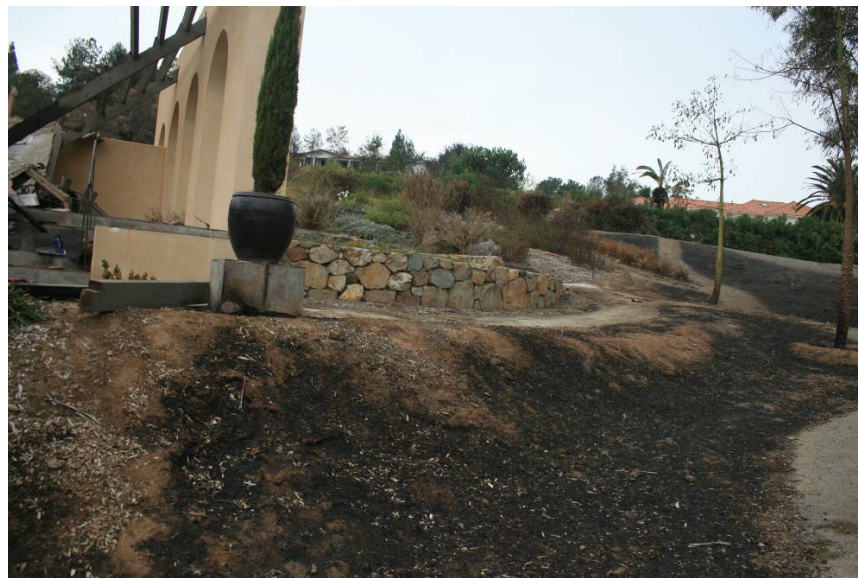
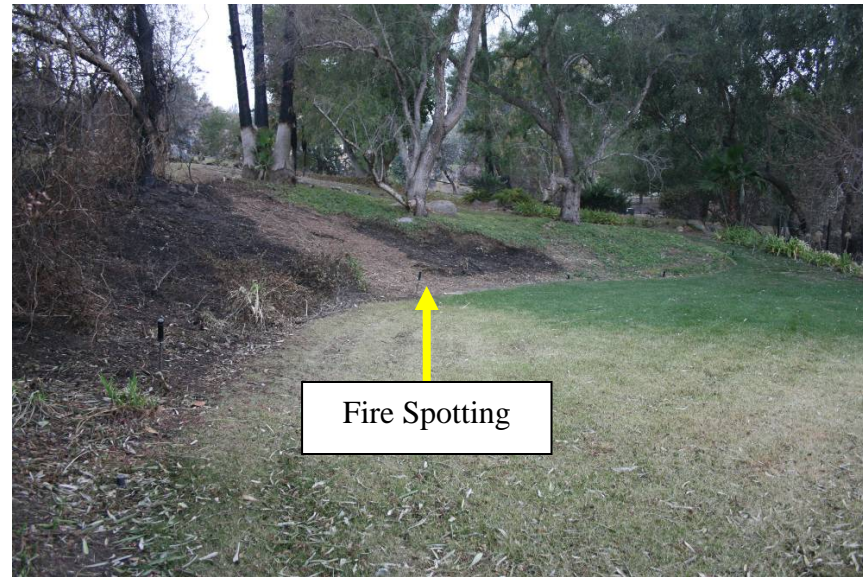
Figure 27: Structure Ignition Category B

Fire spotted to vegetation next to structure and possibly onto structure

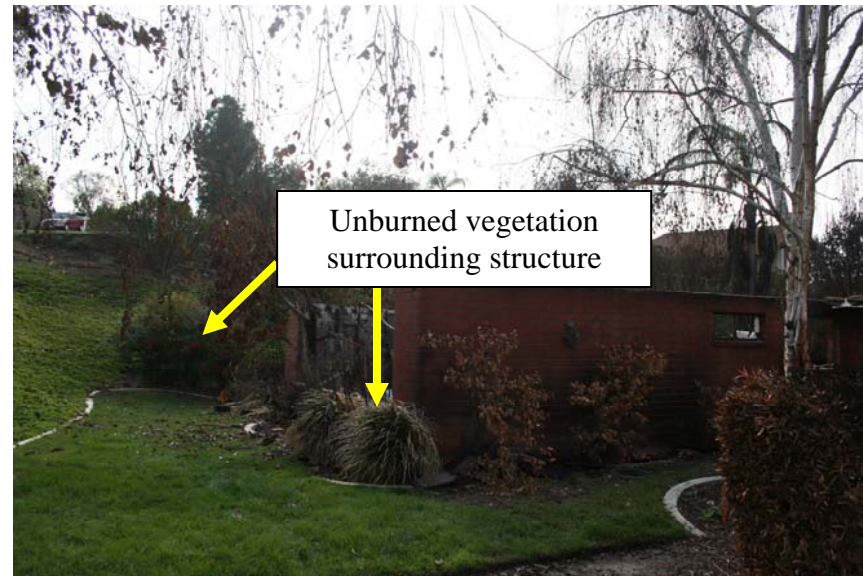
Figure 28: Structure Ignition Category C
