**NISTIR 7393**

# **A Study of Metal Truss Plate Connectors When Exposed to Fire**

Harman, K. A.  
Lawson, J. R.  
*Fire Research Division  
Building and Fire Research Laboratory*

January 2007

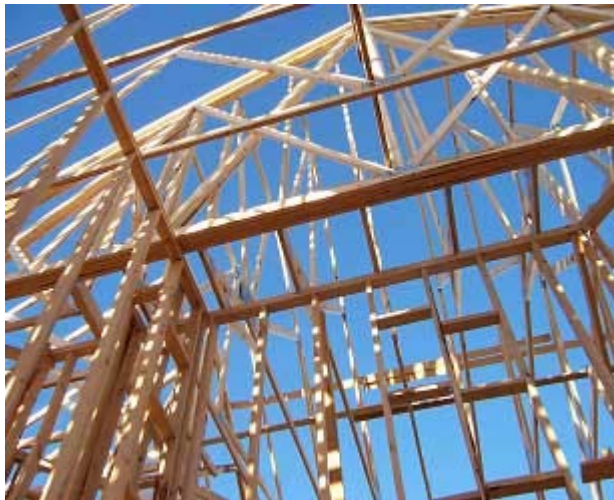
However, it is noted that these data **Figure 1 – Typical lightweight wood construction** do not identify the types of building construction where the injuries and deaths occurred.

The popularity of lightweight, metal plate connected wood truss construction is increasing due to cost effectiveness, versatility, and ease of construction. These assemblies, as seen in Figure 1, are typically constructed of two-by-four members connected with light gauge metal connectors. This construction brings many concerns to the firefighting community [1]. Many in the fire service believe that lightweight construction does not have the fire resistance that typical solid joist and rafter construction offer.

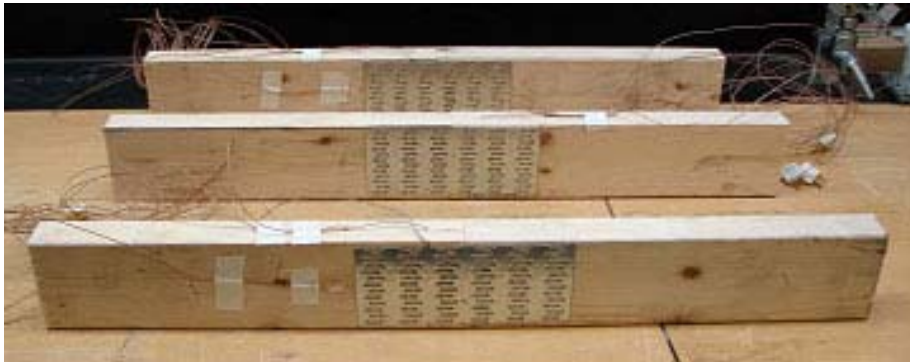
**Figure 2 – Typical set up of test members**

Sets of three different test specimens were constructed for this investigation, all using the same grade of dimension lumber. Dimension lumber is rated by its stress grade. Two by four and wider dimension lumber can be found in grades of No. 1, No. 2, No. 3, and select structural. They often appear in combinations of No. 2 and better (No. 2 & BTR) or No. 3 & BTR [6]. Spruce-Pine-Fir (S-P-F) lumber with a No. 2 & BTR rating, a cross-section of 1.5 in. (38 mm) by 3.5 in. (89 mm), from here on referred to as 2 x 4, with a moisture content of 11.5 percent, and an average density of 490 kg/m<sup>3</sup> was used. Moisture content was measured using a commercially manufactured, automated, precision, thermo-gravimetric moisture analyzer. Each specimen consisted of two 2 x 4, one ft. (0.30 m) long members connected by two 3 in. (76 mm) by 6 in. (152 mm) galvanized steel truss plates of 20 gauge (0.95 mm) with punched teeth approximately 0.31 in. (7.9 mm) long, one on each side. Figure 2 shows this arrangement. No load was applied to these specimens before, during, or after testing.

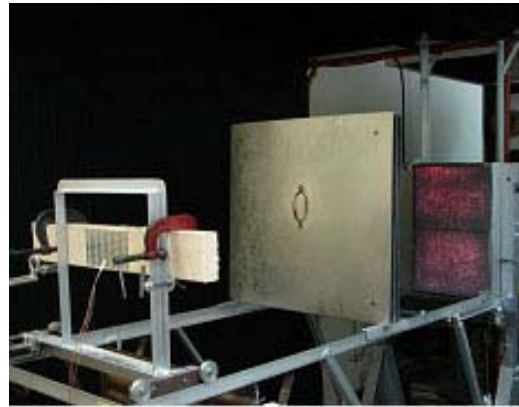
**Figure 5 – Testing apparatus**

The tests were conducted using a gas fired thermal radiant panel that was calibrated in order to subject the wood to a nominal constant exposure of  $20 \text{ kW/m}^2$ . This situation simulates initial flashover conditions during fire growth. At flashover, all

combustible items in the room begin to burn almost simultaneously, causing a rapid increase in both heat release rates and temperatures. After flashover, the fire is often referred to as a “fully developed fire” [9]. The testing apparatus used is shown in Figure 5. The wood/metal plate joint was exposed to a piloted ignition

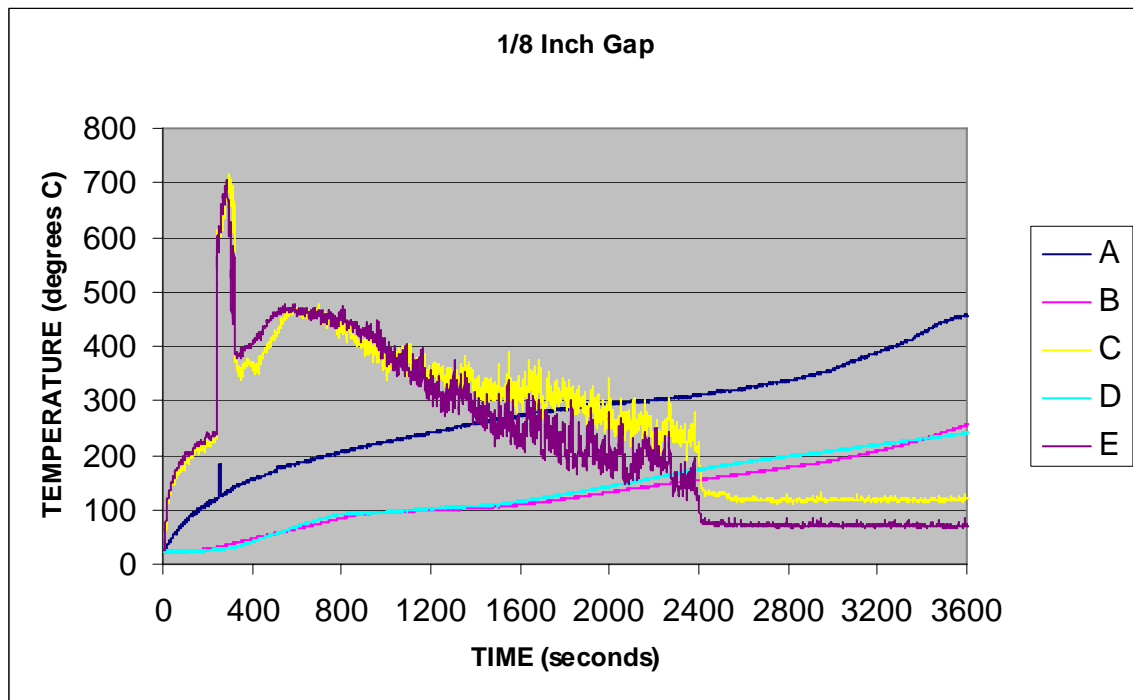
**Figure 10 – Example: thermocouple measurements from a 1/8 in. joint gap specimen**

(Note that thermocouples “C” and “E” lost contact with the surface at around 1700 seconds.) The highest temperature reached for an individual test during ignition and flaming, was 1007 °C while the lowest temperature was 605 °C. These differences have to do with the variability of fire development, variations in thermocouple placement, and the uniformity of wood. Despite the fact that the wood specimens came from the same member and the testing apparatus was calibrated, each piece burned slightly different. Figures 9 and 10 show the temperatures measured (averaged over three tests each) during the 1/32 in. (0.8 mm) wood/plate gap tests and the 1/8 in. (3.2 mm) joint gap tests, respectively. The gap between the plate and the wood leads to considerably higher temperatures measured behind the plate with thermocouple “A” (See Fig. 9). The joint gap also increases the temperature of thermocouple “A” when compared to the normal specimen. Qualitatively speaking, the trends for the remaining thermocouples are all similar.

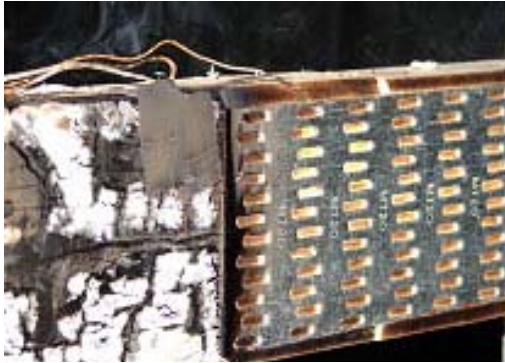
**Figure 11 - 10 minutes into the test the plate is still shiny**

Over time the metal plate, as seen in Figures 11 and 12, began to collect soot and lose its shininess. The temperature at the thermocouples behind the plate increased at a

constant rate. While the discoloration of the plate caused the plate to change its heat reflective properties, it is not clear how much this affected the subsequent heat transfer. One is also able to see in Figure 11 how the wood beneath the plate is still its original color. Thirty minutes later in Figure 12 the plate has become quite discolored and the wood beneath the plate has also begun to char.

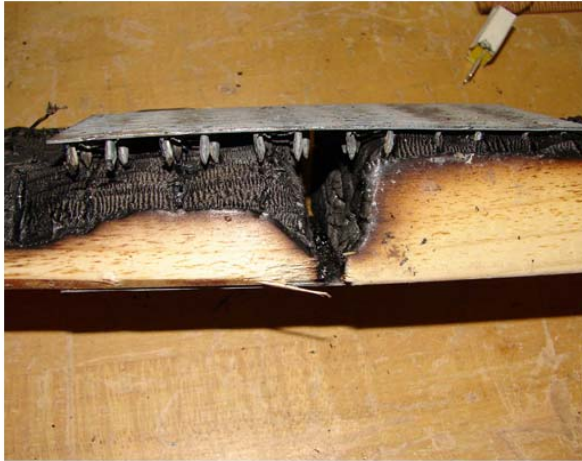
**Figure 13 - Post burn - 1/8 in. joint gap specimen**

(3.2 mm) joint gap. In this arrangement fire was able to make its way between the wood members and char a large area behind the metal plate. This can be seen in Figure 13.

There were a few obvious differences in the specimens with manufacturing tolerances. The 1/8 in. (3.2 mm) joint gap specimens recorded on average 40 °C higher temperatures on thermocouple “B” which is located in the center of the wood behind the plate, than in the normal specimens. This was due to fire easily making its way between the two pieces of wood behind the plate. These also caused a large area

of wood to burn away and char behind the plate exposing a number of the metal teeth.

This can be seen when comparing Figure 13 to Figure 15. On average, charring that took place in the space between butt-joint ends for the 1/8 in. (3.2 mm) joint gap specimens grew from the starting point gap of 0.15 in. (3.8 mm) to a width of 0.57 in. (14.5 mm), whereas little or no area burned away or charred between the normal spaced wood joint specimens. The 1/8 in. (3.2 mm) joint gap specimens recorded the greatest char depths; the 1/32 in. (3.2 mm ) wood/plate gap specimen, as seen in Figure 14, and only one of the normal specimens, Figure 15, recorded char depths great enough to completely expose the bottom row of metal teeth. The range of char depth measurements for each type of specimen is presented in Table 1. The char depth measurements were made using precision drafting tool calipers with measurements transferred to and read from a machinist scale. All char depth measurements reported (between the wood members and behind the plate) were made at locations along the edge of the metal plate. The char depth measured between the wood members was measured at the surface of the wood/metal interface and perpendicular to the wood gap or across the gap. The char depth measured behind the metal plate was measured at the surface of the wood/metal interface and perpendicular to the metal plate or in the direction of the teeth.

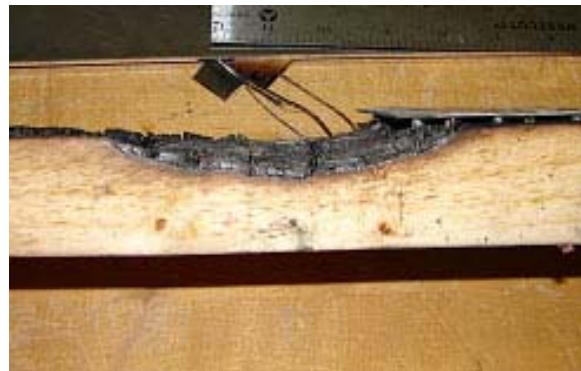
**Figure 16 – Char pattern on the left side of the plate.**

While the bottom side of each member burned in a similar fashion in the normal and 1/32 in. (3.2 mm) wood/plate specimens, fire was able to penetrate into the wood under the plate charring directly behind the plate in the case of the 1/32 in. (3.2 mm) wood/plate gap. Because of this more than just the bottom rows of teeth were exposed. Similar char patterns on the surface were seen in each specimen, each having the maximum surface char depths at a distance of 0.79 in. (20 mm) or greater from the edge of the metal plate on the left side and a distance of 0.55 in. (14 mm) or greater from the edge of the metal plate on the right side.

This can be seen in Figure 16. It was noted earlier that higher temperatures were recorded at a location further from the plate than closer to the metal plate which would result in this pattern.

Char depth measurement locations varied based on where flames burned the most on the wood's surface. The average surface char depth 0.75 in. (19 mm) was measured on average 1.54 in. (39 mm) from the left edge of the metal plate, and on the right edge of the metal plate an average surface char depth of 0.47 in. (12 mm) was measured on average 1.22 mm (31 mm) from the right edge.
