Success by Design: Progress Through Failure Analysis

Proceedings of the 21st Meeting of the
Mechanical Failures Prevention Group,
held at the National Bureau of Standards,
Gaithersburg, Maryland, November 7-8, 1974

SUCCESSFUL REDESIGN AND LAUNCH PERFORMANCE
OF THE ERTS/NIMBUS ADAPTER
AFTER AN ACCELERATION TEST FAILURE

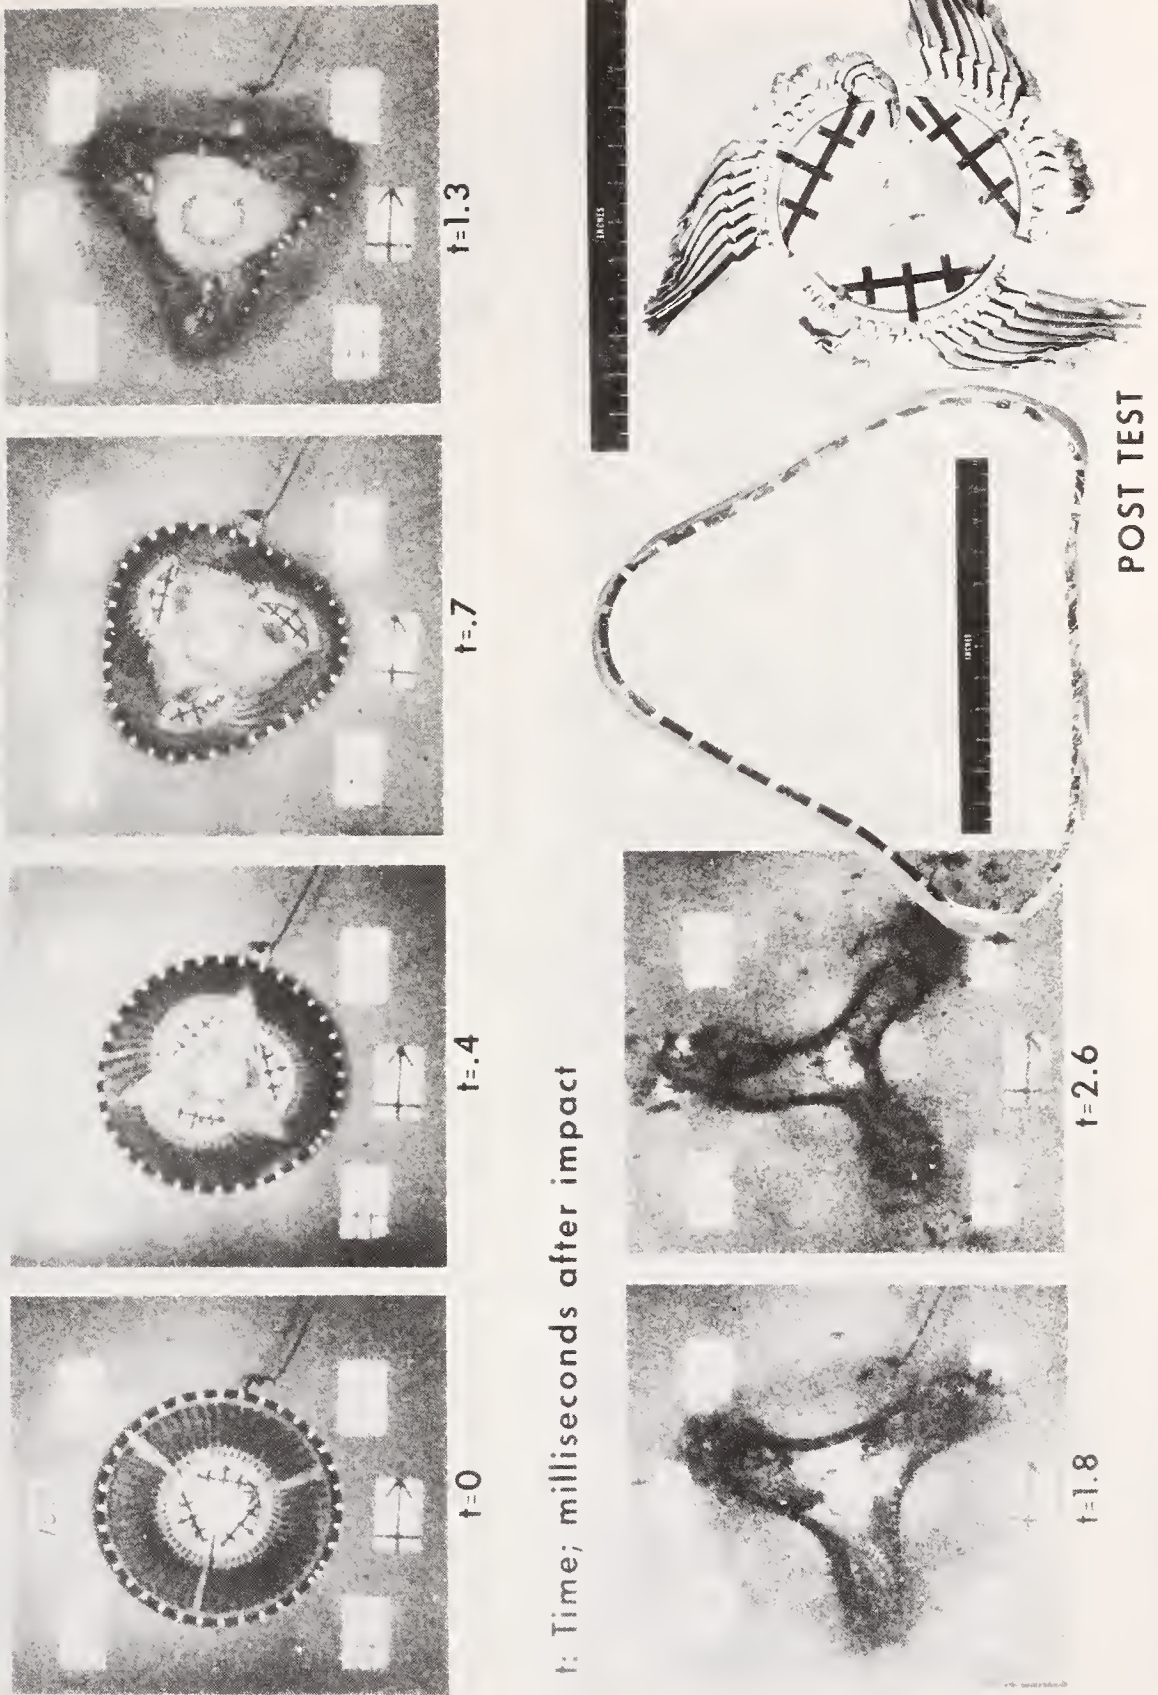
FIGURE 7

3 FRAGMENT ROTOR BURST INTO A TRIP STEEL RING

t: Time; milliseconds after impact

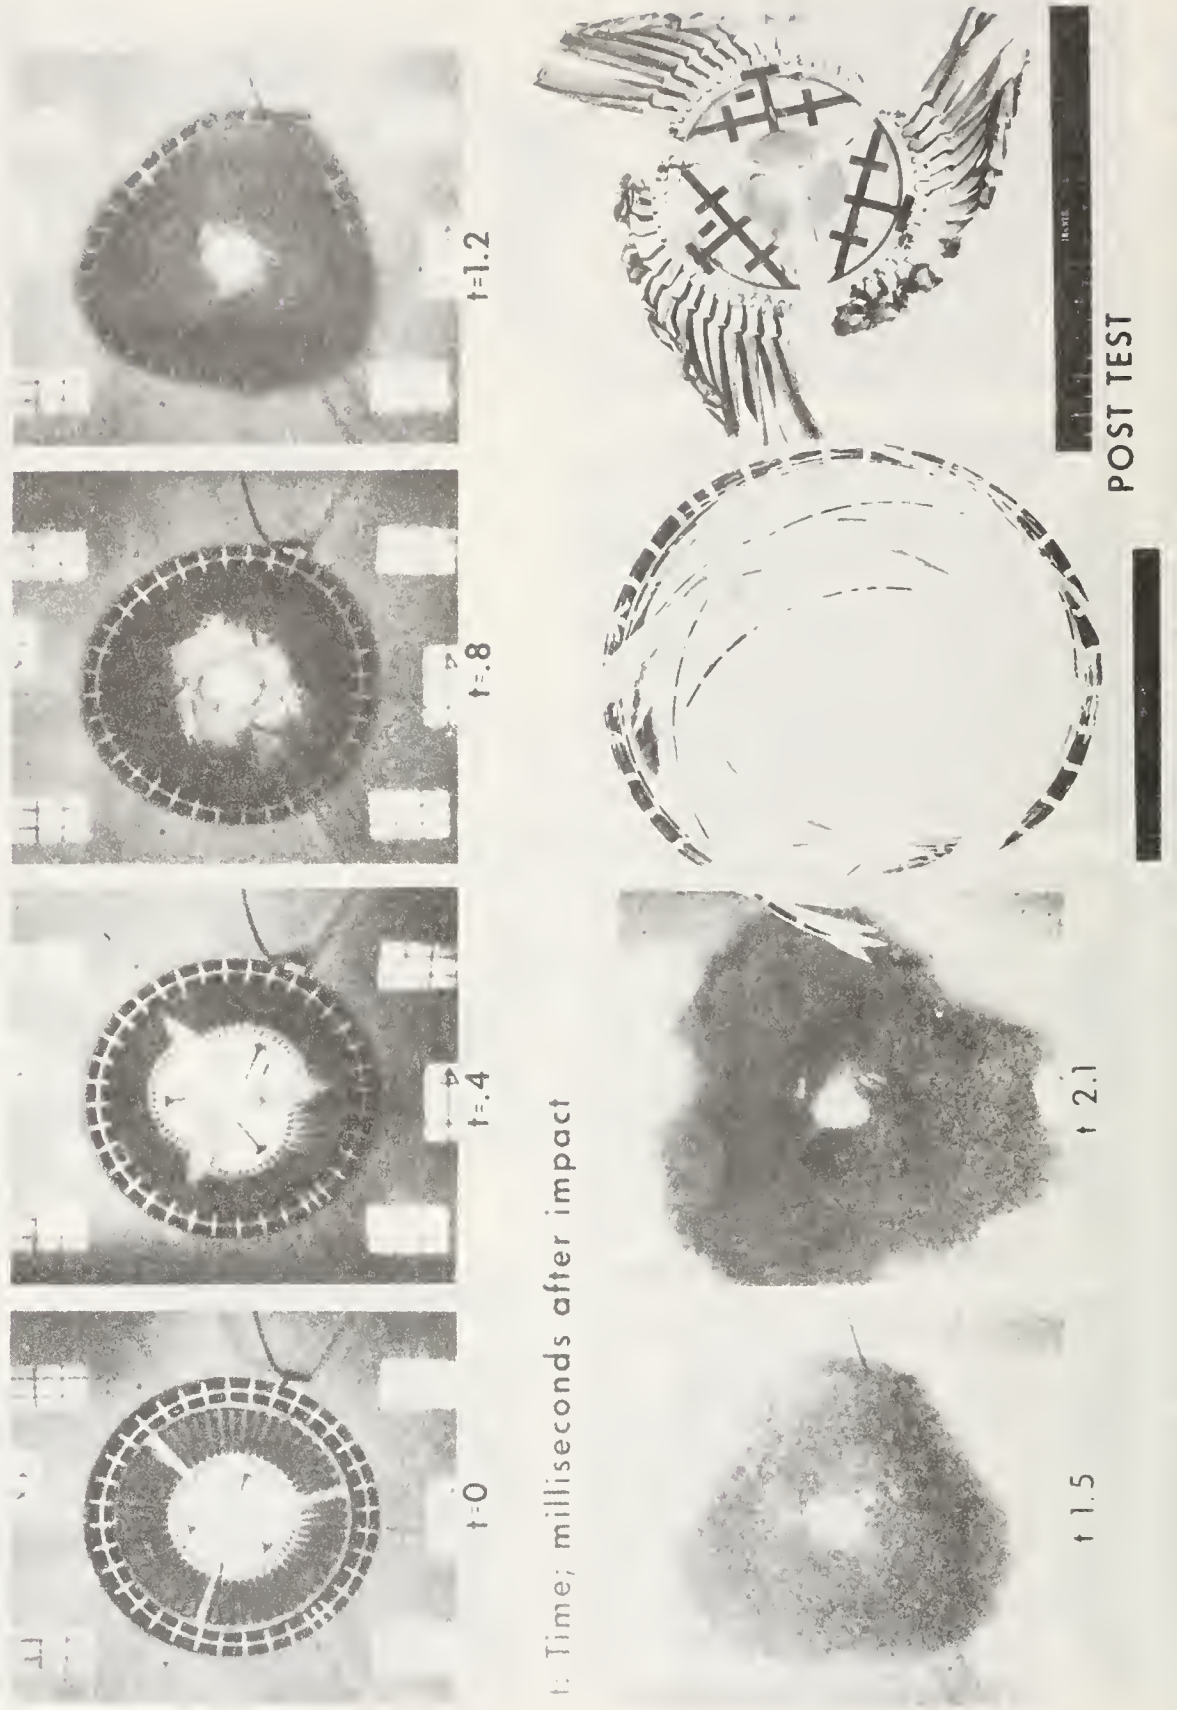
FIGURE 10

3 FRAGMENT ROTOR BURST INTO A FILAMENT WOUND FIBERGLASS RING

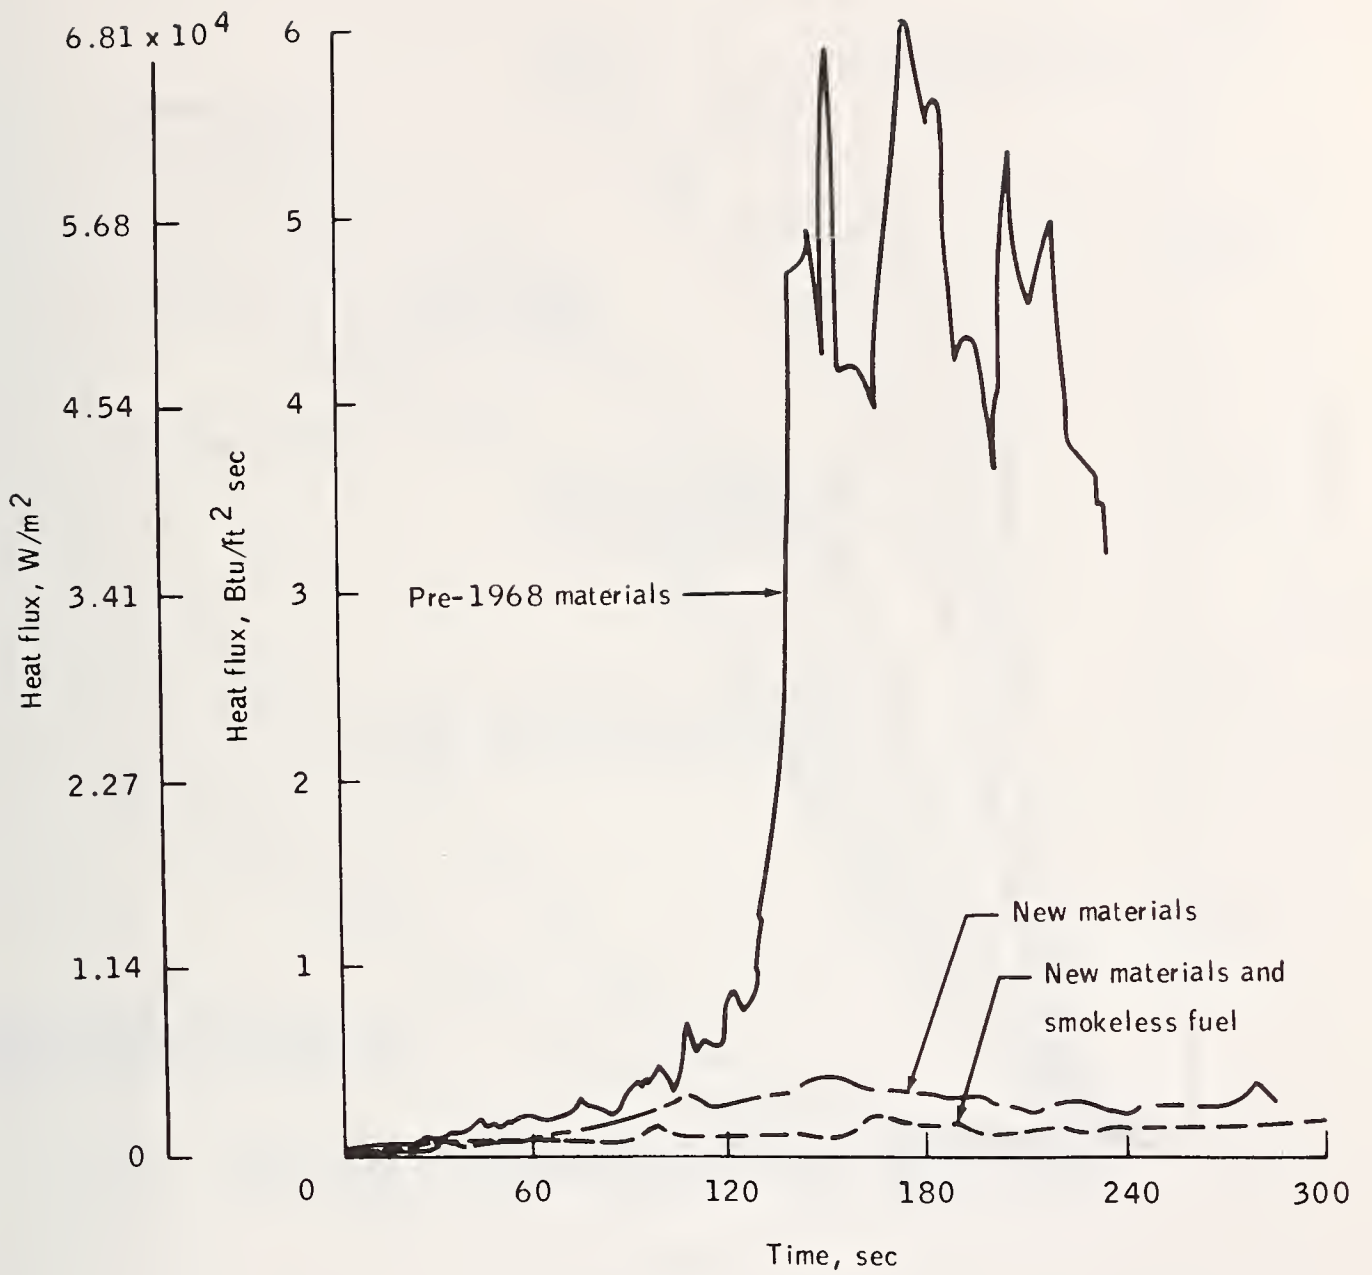
Figure 3. Heat Flux at Center of Test Section, Center Aisle.

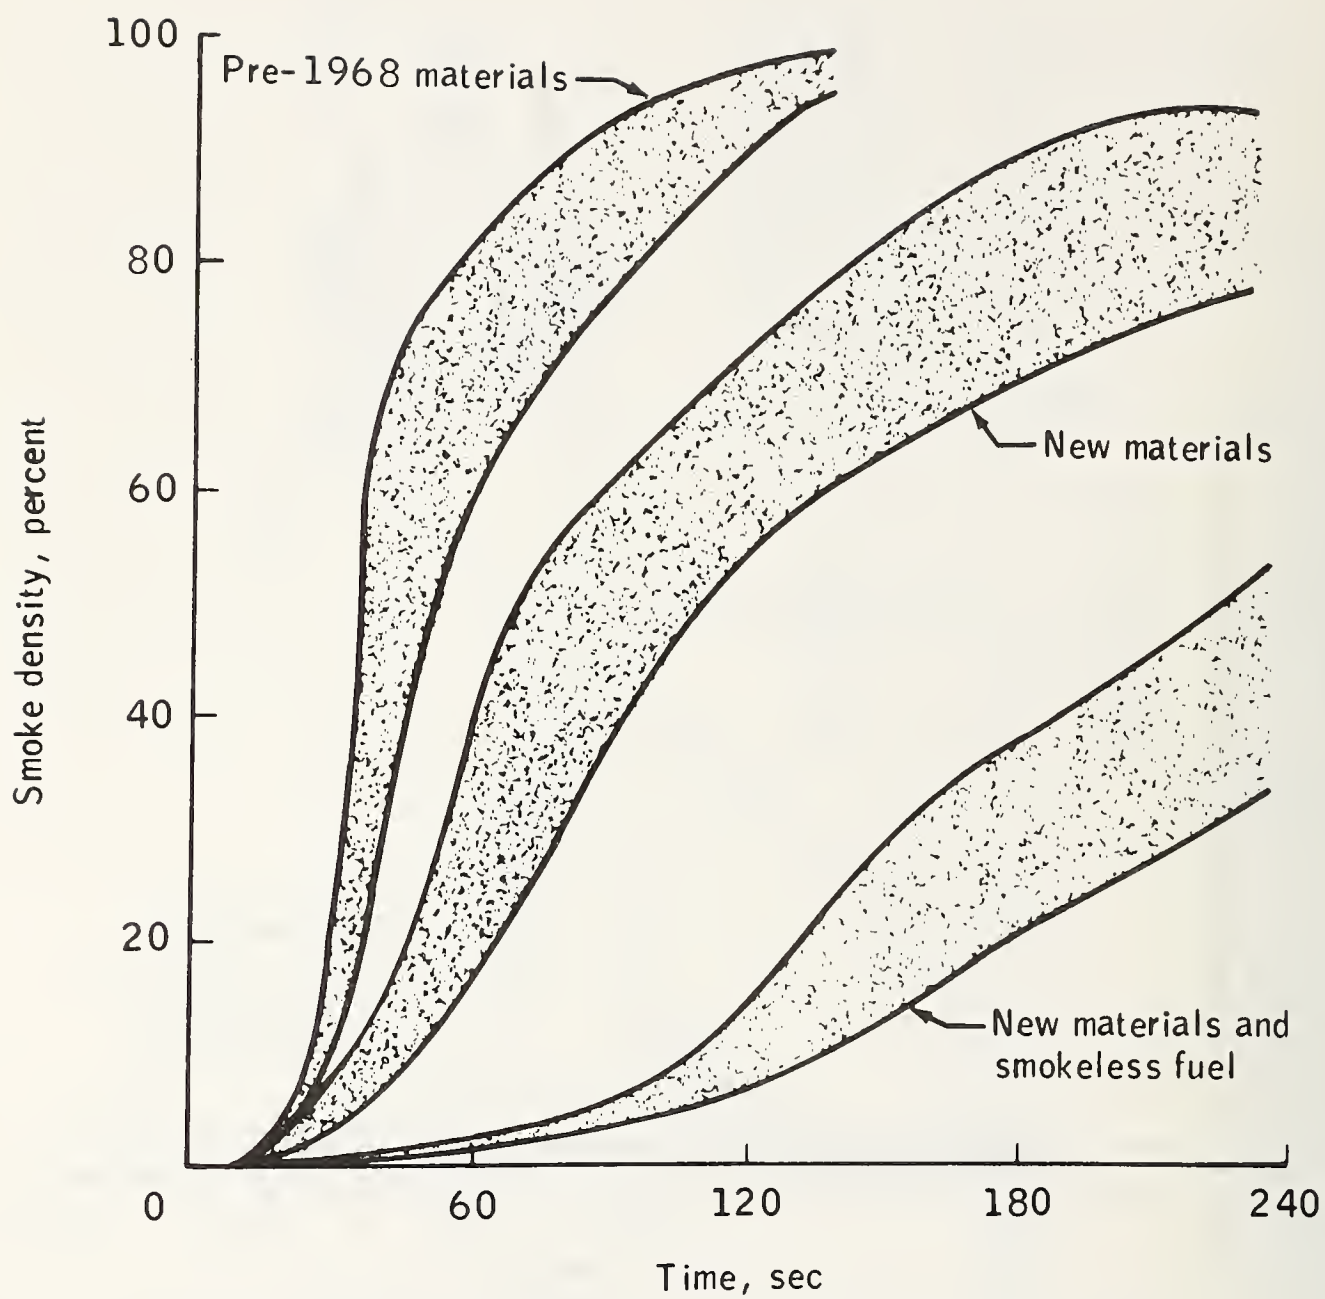
Figure 4. Minimum and Maximum Smoke Density Levels.

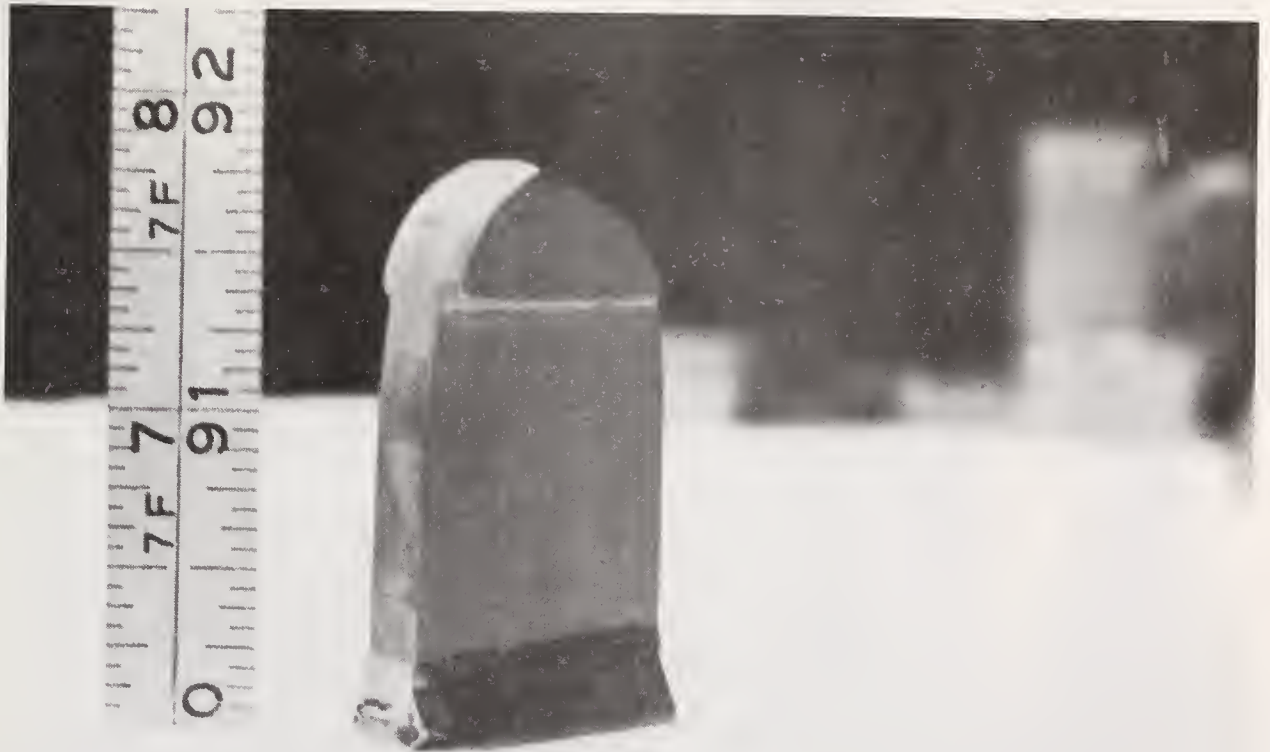
Figures 7 & 8: Complete wearing off on the top part of the hammer.

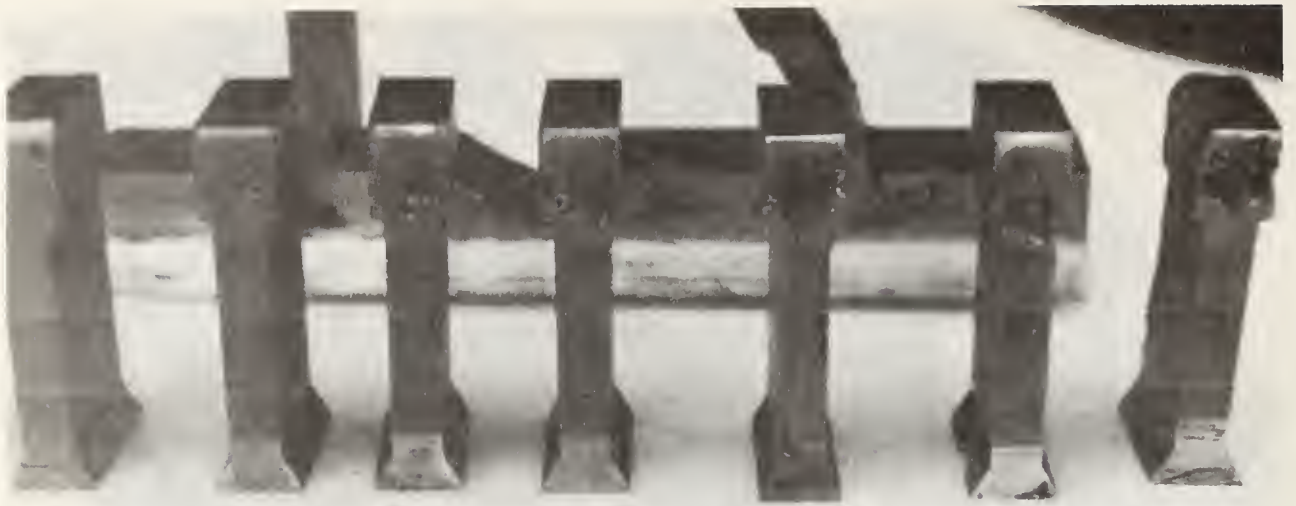
Figures 9&10 : Pitting- Erosion at the top part of the hammer .

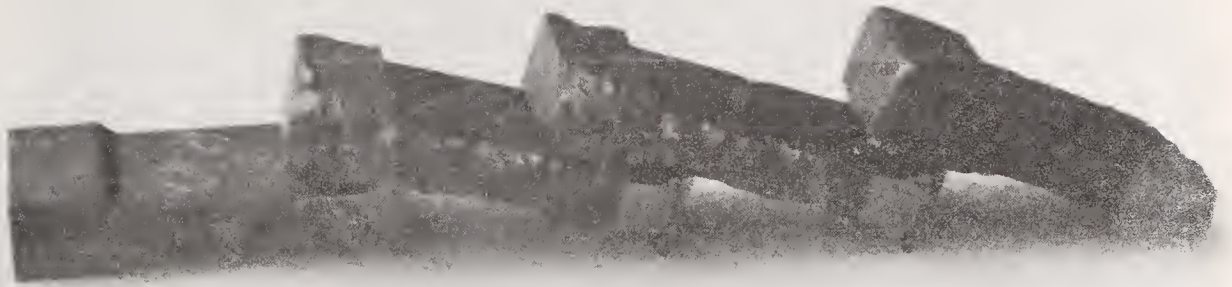
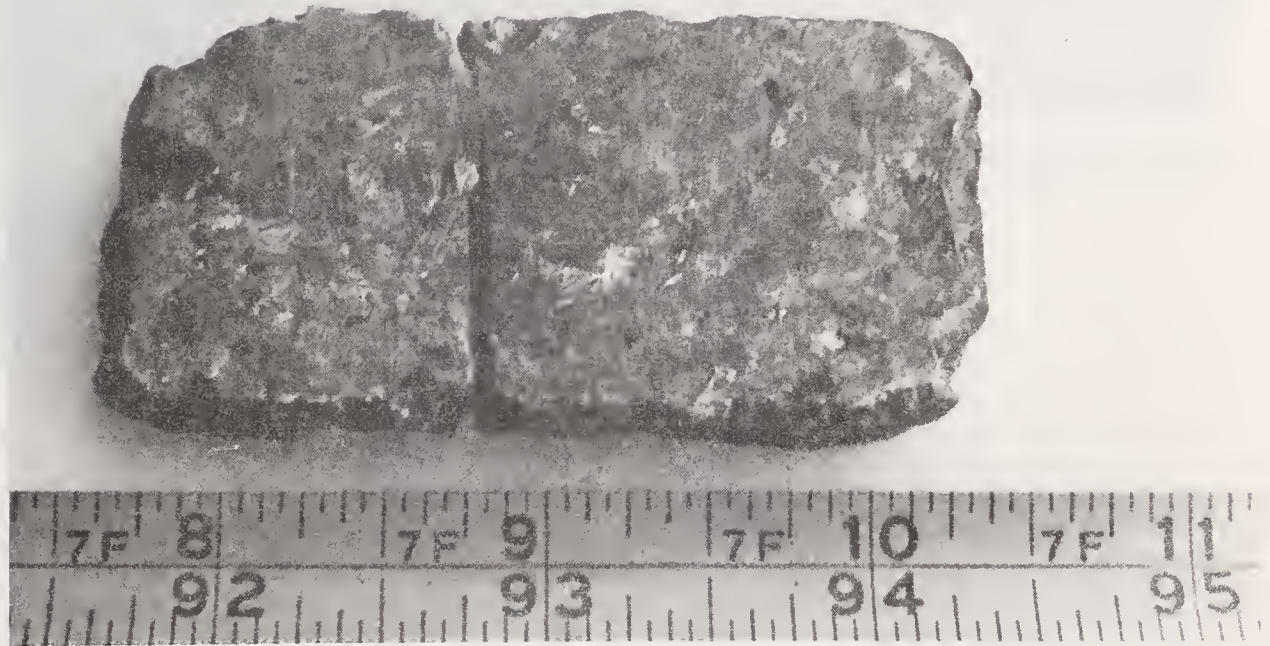
Figures 11&12 : Cracked and Broken Hammers.

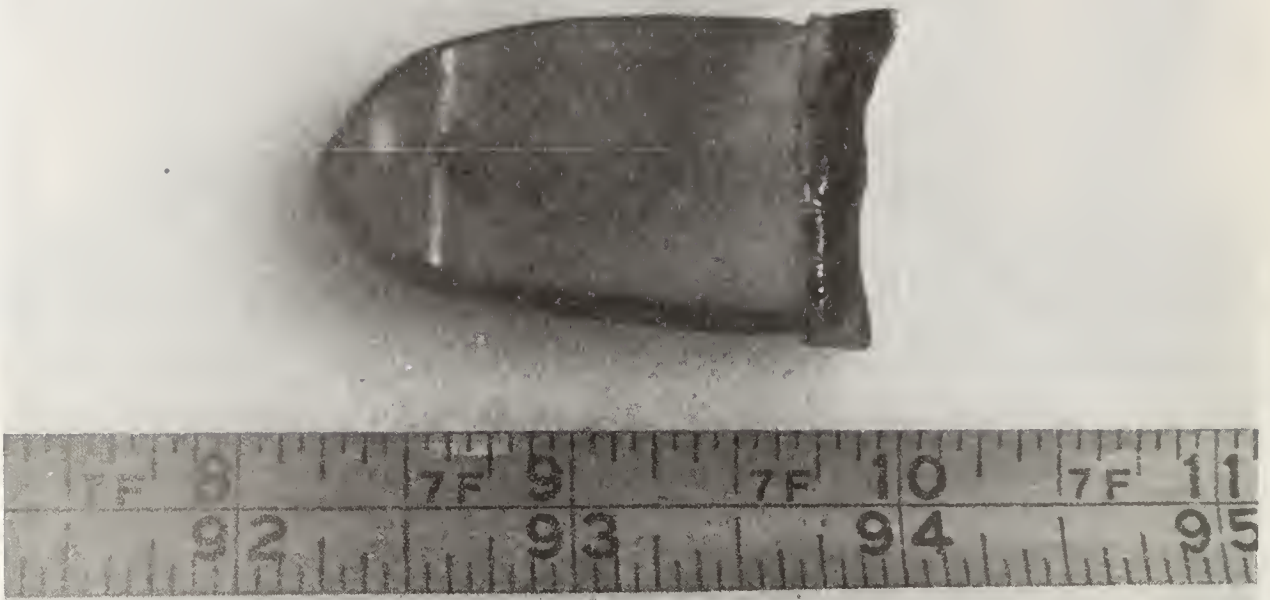
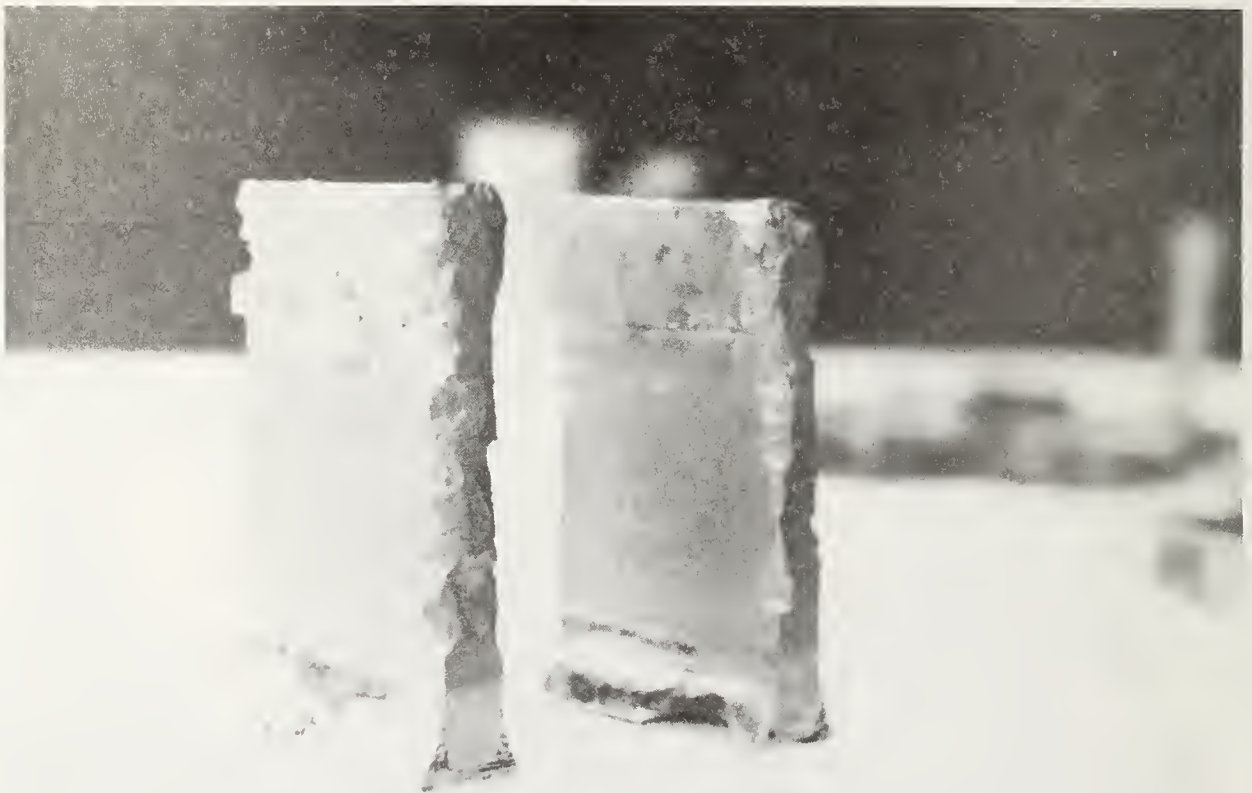
Figures 13&14 : Hammers broken at the base.

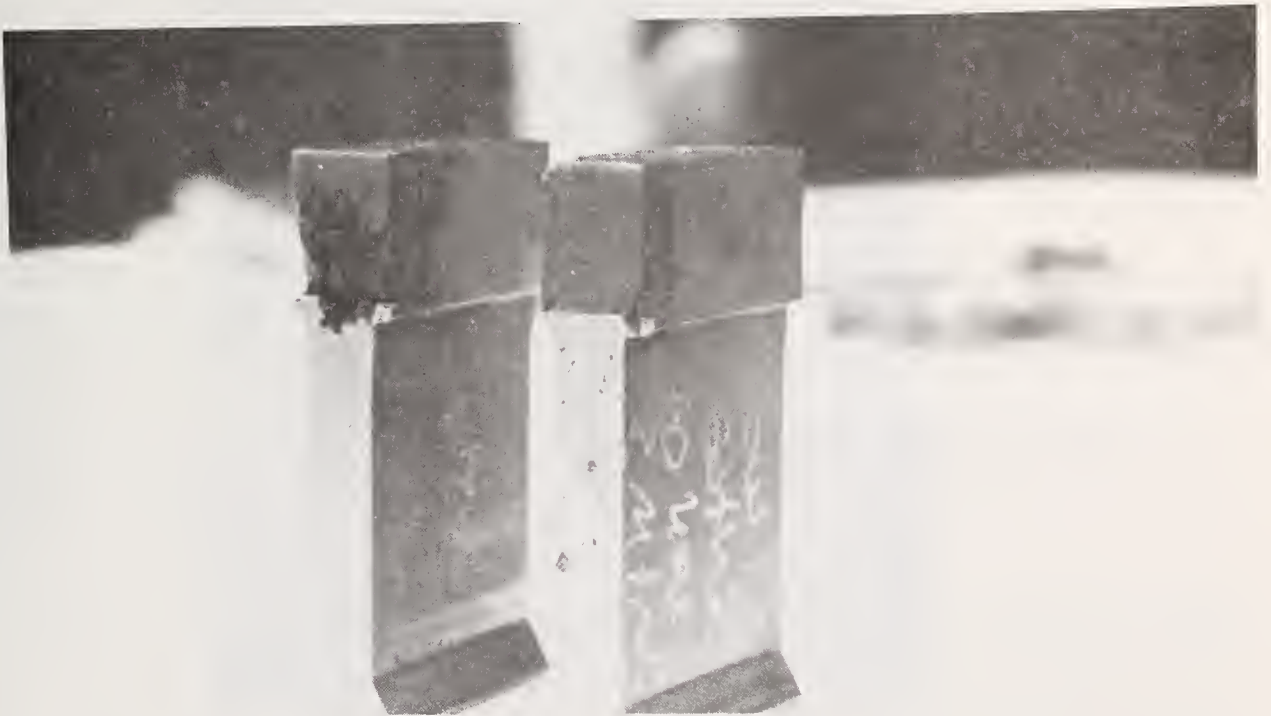
Figure 16 : Failure of the hammers with carbide insert.

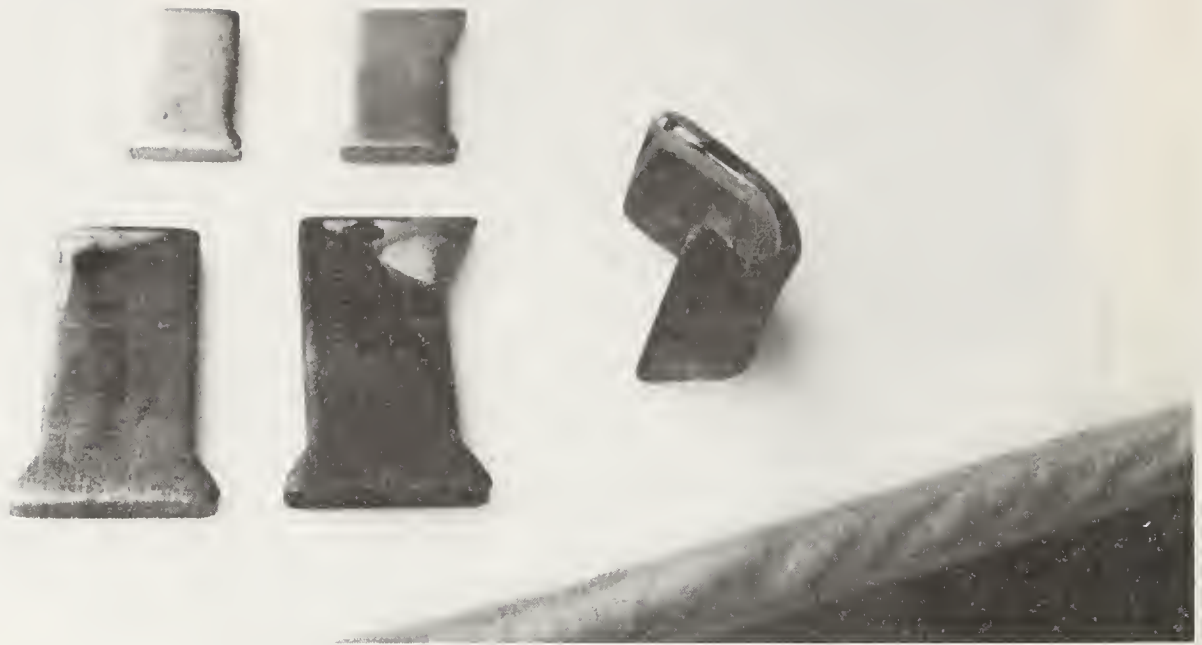
Figure 17 : Stamped Hammers with and without the Stellite hard facing. The bent hammer shows the ductility of stainless 316.
