NIST Special Publication 1139

**Progress Report, National Institute of
Standards and Technology (NIST)**

**Technical Investigation of the May 22,
2011, Tornado in Joplin, Missouri**

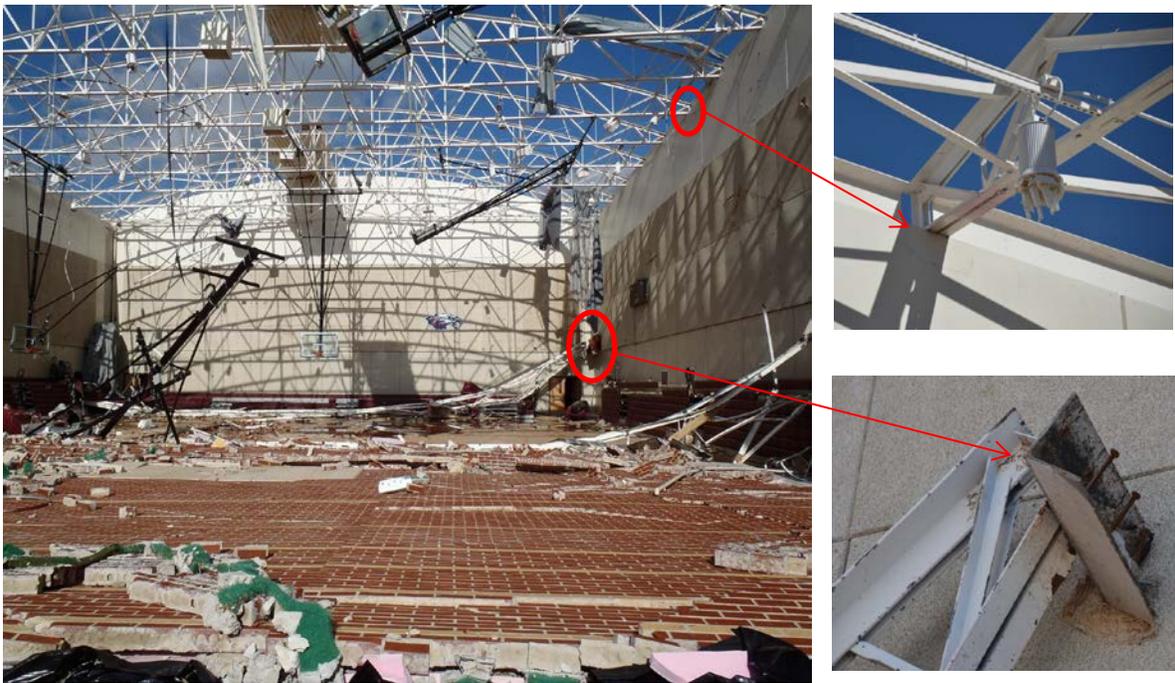
Figure 4 shows an example of the field data collected. These photographs, which show a failure observed at Joplin East Middle School's gymnasium, are being used to develop the failure hypothesis for this building. Using the results from work performed pursuant to study Objective 1, wind speed and direction time histories can be obtained at specific building locations. These estimated wind velocities are being used in combination with collected field performance data and design information to develop and refine failure hypotheses for the surveyed buildings.

Figure 4. Example of photographic field data used in developing a failure hypothesis for the gymnasium at Joplin East Middle School. (Photo source: NIST)
