# NBSIR 79-1955

## Analysis of Scaffolding Accident Records and Related Employee Casualties

January 1980

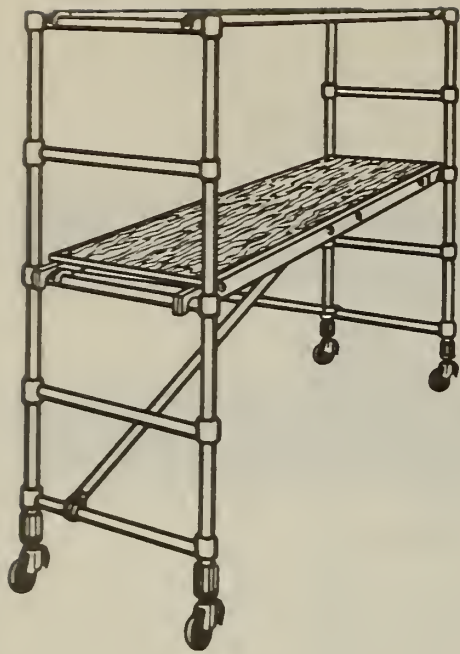
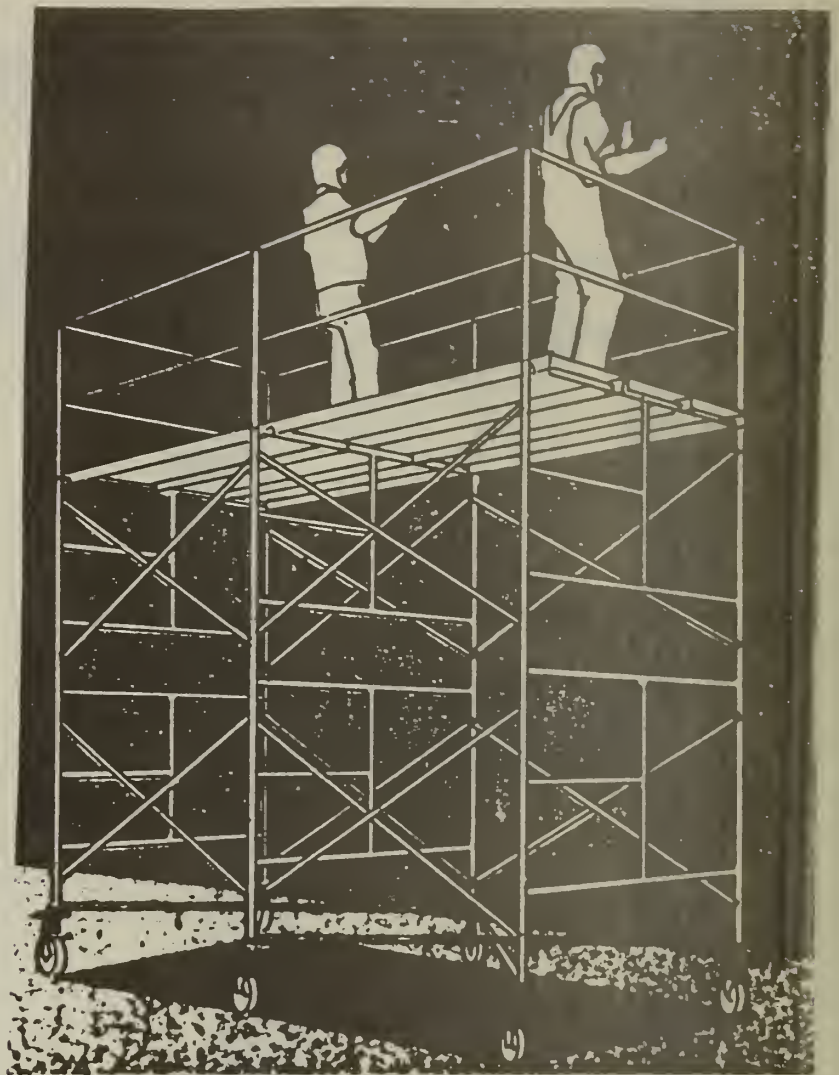
Figure A.6. Manually propelled mobile (a) ladder stand and (b) scaffold (tower).

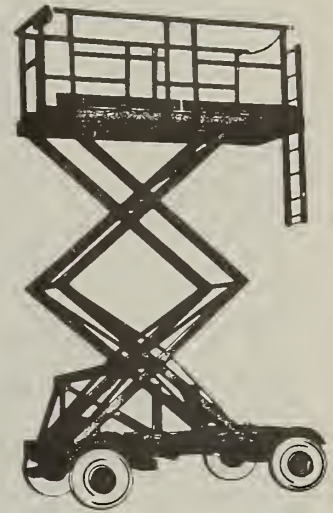
Figure A.7. (a) Vehicle-mounted elevating and rotating, (b) telescoping, and (c) self-propelled elevating work platforms.
