NIST NCSTAR 1-2B

**Federal Building and Fire Safety Investigation of the
World Trade Center Disaster**

**Analysis of Aircraft Impacts into the
World Trade Center Towers
Chapters 9, 10, 11 & Appendix A**

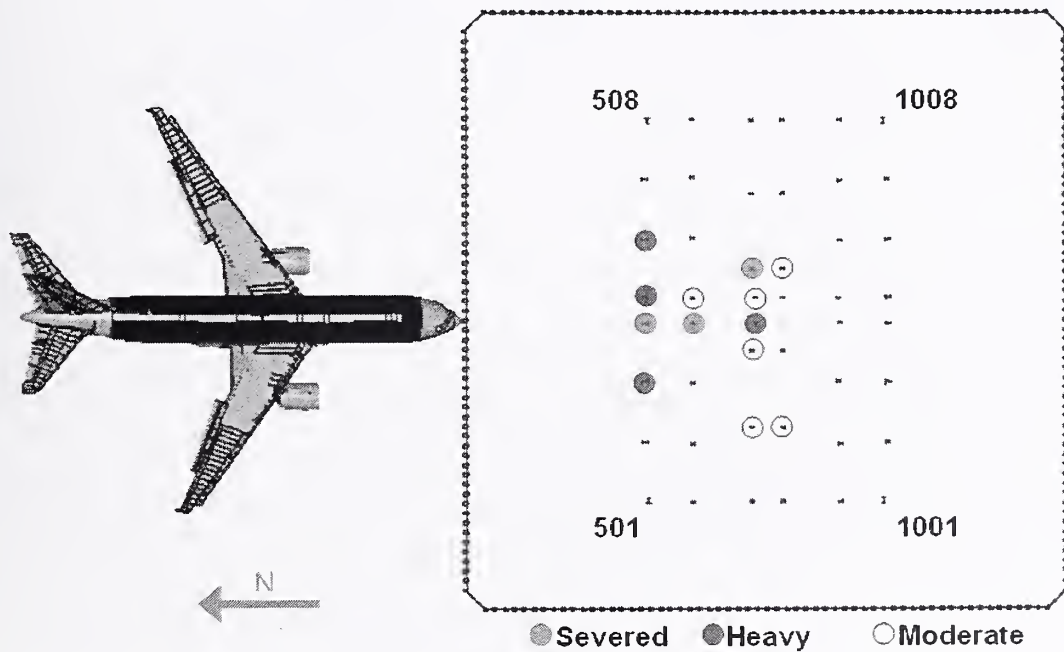
**Figure 9–11. Summary of core column damage for the base case WTC 1 impact.**

Column	Location	Damage Level	Lateral Deflection of Column Centerline (in.)
Column 503	Floor 96	Heavy	18
Column 504	Floors 92–96	Severed	
Column 505	Floors 93–96	Heavy	20
Column 506	Floors 93–94	Heavy	10
Column 604	Floors 92–96	Severed	
Column 605	Floors 94–95	Moderate	
Column 702	Floor 96	Moderate	
Column 703	Floor 96	Moderate	
Column 704	Floor 94	Heavy	18
Column 705	Floor 95	Moderate	
Column 706	Floors 93–95	Severed	
Column 802	Floor 96	Moderate	
Column 805	Floor 94	Moderate

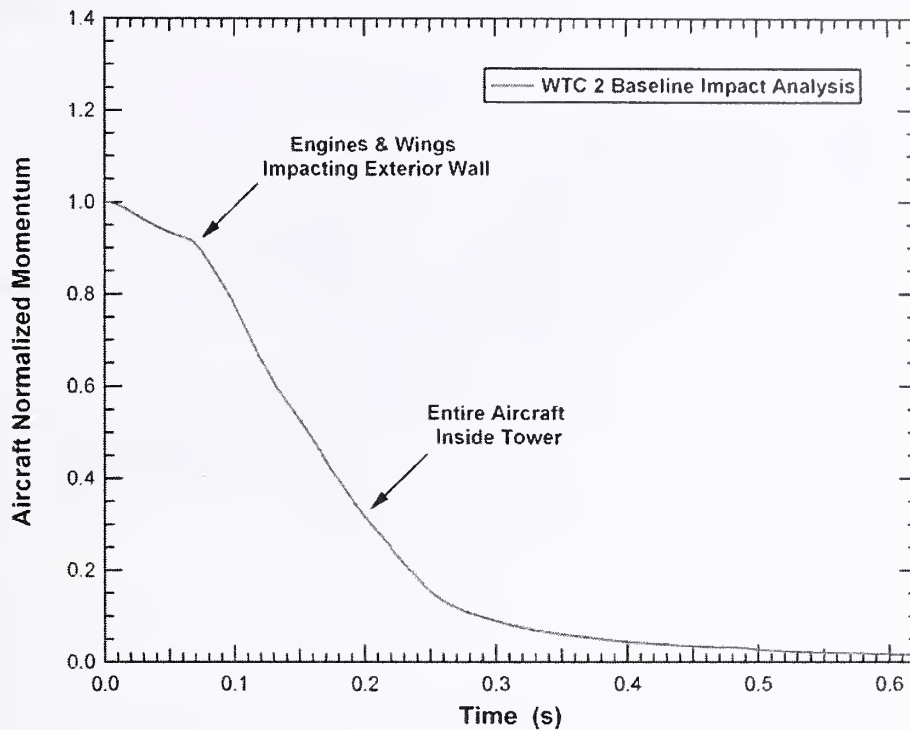
Figure 9–28. Normalized aircraft momentum for the WTC 2 base case impact.

The load transfer of the base case WTC 2 aircraft impact can be shown by the history of the resultant momentum as shown in Figure 9–28. The curve illustrates an initial rate of load transfer during the first 0.1 s of impact as the forward fuselage penetrated the exterior wall and impacted the interior structures. Between 0.1 s and 0.2 s, a more rapid load transfer rate was observed, as the area of the impact was larger (extending outward in the wing impact regions), and a higher percentage of the aircraft mass was impacting the interior structures. At 0.2 s, as indicated in Figure 9–28, the aircraft completely penetrated the building and retained approximately 30 percent of its initial momentum. Beyond this time, the rate of load transfer was steadily decreasing with very little load transfer after approximately 0.4 s. The behavior was very similar to that of the base case WTC 1 impact, shown in Figure 9–6, but with a slightly compressed time scale resulting from the higher impact speed on WTC 2.

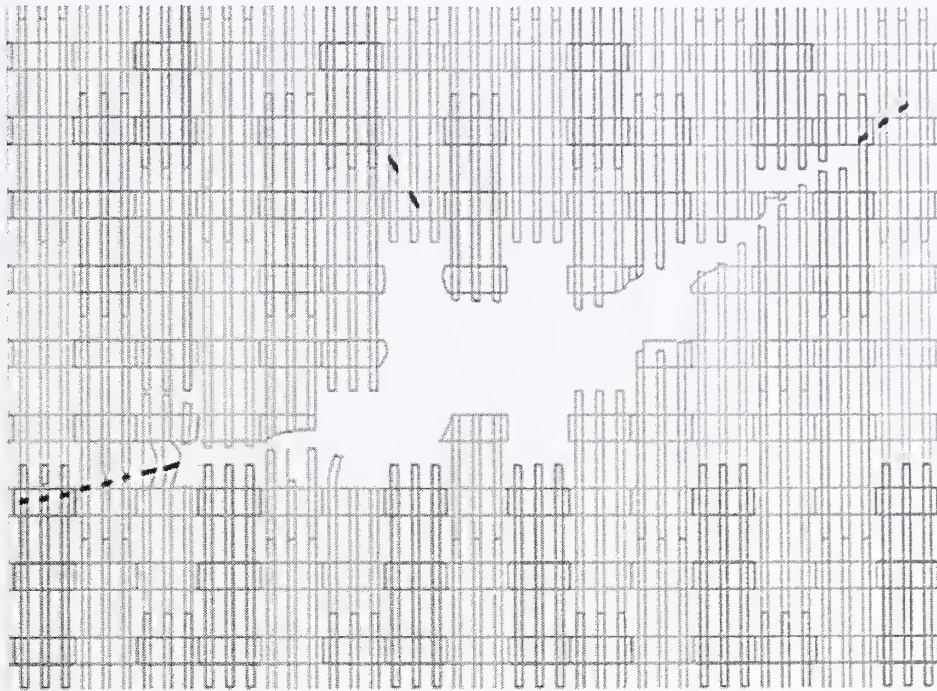
A comparison of the north exterior wall observed and calculated damage from the less severe WTC 1 global impact analysis is shown in Figure 9–62. The calculated impact damage to the exterior wall is shown with color fringes representing plastic strain magnitude, with undamaged sections in blue and strains at or above 5 percent shown in red. The wall regions shown in Figure 9–62 are from column 108 to column 152, extending from floor 91 to floor 100 (spandrels at floors 92 through 100). The magnitude and mode of impact damage on the exterior wall were still in good agreement with the observed damage for this less severe impact scenario.

(a) Schematic of observed damage

(b) Calculated damage (t=0.735 s)

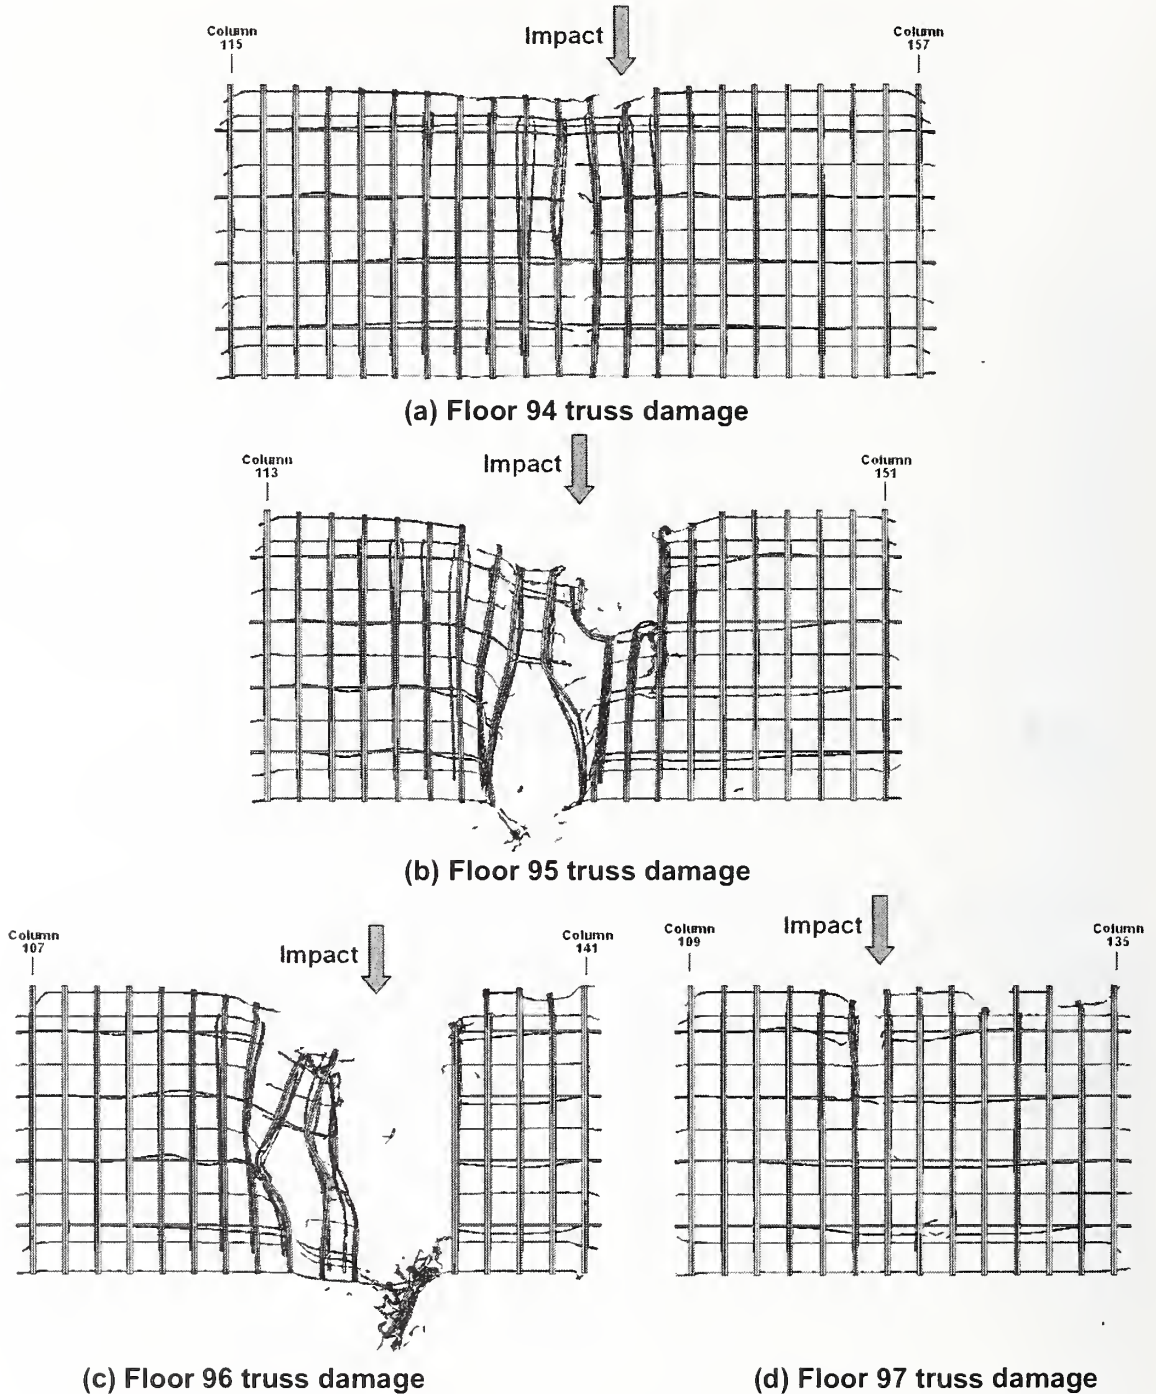
Figure 9-68. Less severe impact damage to the WTC 1 floor truss (plan view).

The magnitude of truss floor damage was very similar for the base case and more severe global impact analyses. When the floor-by-floor damage was compared for the base case and less severe impact analyses, Figure 9-15 and Figure 9-68, respectively, the damage was slightly increased for the less severe impact analysis. The parameters used in the less severe global impact analysis would primarily contribute to a reduced damage magnitude for the tower structures. However, the downward impact trajectory angle was increased from the 10.6 degree angle in the base case analysis to a 13.6 degree angle in the more severe impact analysis. This would have the effect of directing more of the impact energy downward, increasing the normal force on the floor structures in the impact zone. As a result, the combined effects of the analysis parameter variations produced a small increase in the damage to the truss structure in the less severe impact analysis scenario.

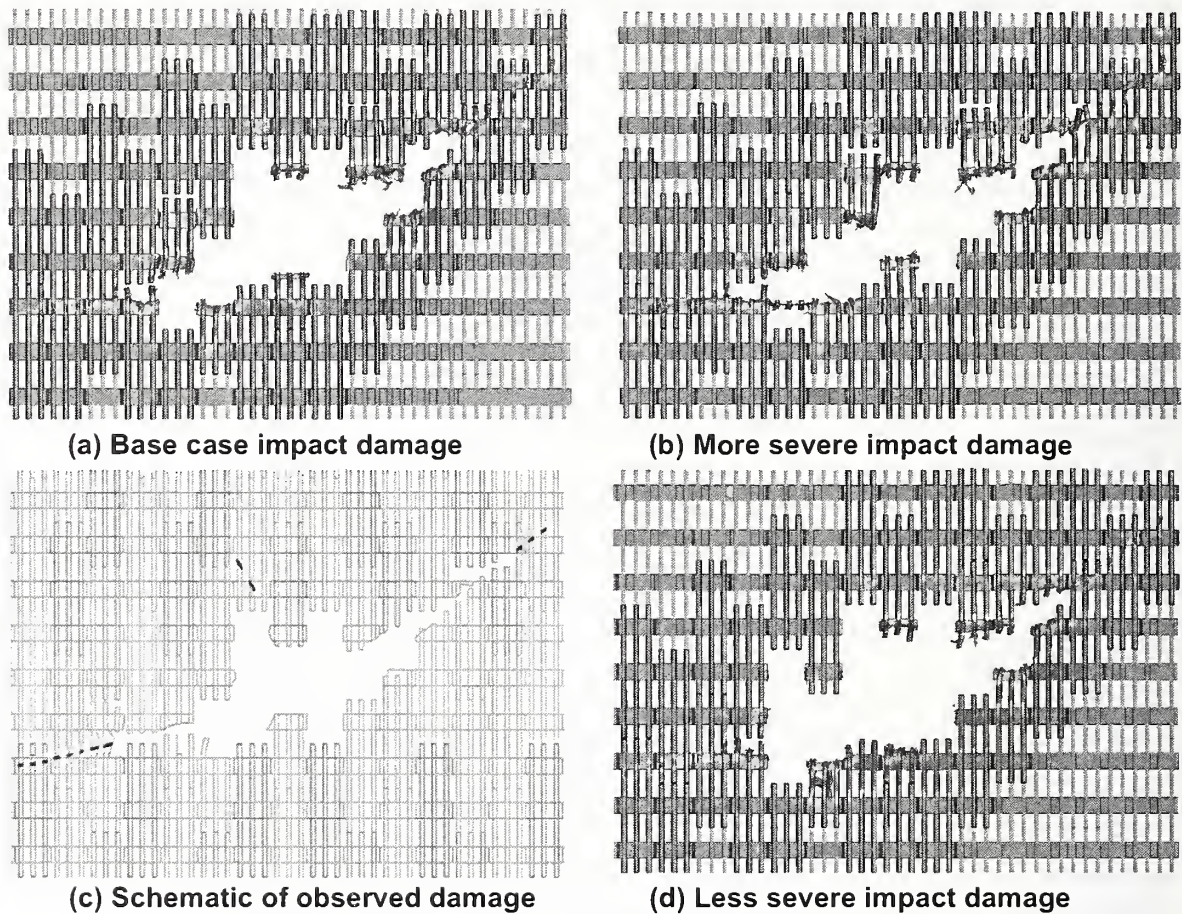
Figure 9–107. Impact damage to the north exterior wall of WTC 1.

material toughness, resulting in a transition from column severing to connection bolt failure and panel removal.
