**NIST Special Publication 1000-5**

**June 2004**  
**Progress Report on the**  
**Federal Building and Fire Safety**  
**Investigation of the**  
**World Trade Center Disaster**

**Volume 3**  
Contains Appendices D, E, and F

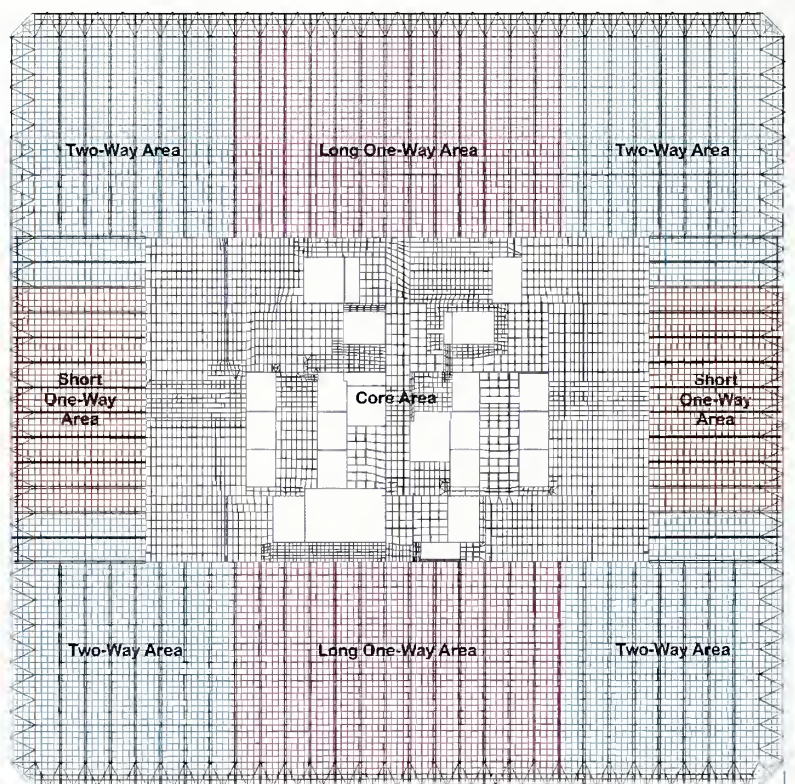
**Figure D-1. Plan of typical truss-framed floor with loading areas indicated.**

The detailed model of a typical truss-framed floor, floor 96 of WTC 1 (see Appendix B), was used to determine the actual loads on floors 85 through 106 of the reduced global model. The detailed floor model contains four distinct areas, each with its own load, as shown in Fig. D-1. The superimposed dead and live loads applied to each of these areas were determined from the design documents and are listed in Table D-2. In the core, the design live loads varied from 40 psf ( $1.92 \text{ kN/m}^2$ ) to 100 psf ( $4.79 \text{ kN/m}^2$ ) and were scaled to service live loads from 10 psf ( $0.479 \text{ kN/m}^2$ ) to 25 psf ( $1.20 \text{ kN/m}^2$ ), while the superimposed dead load varied from 29 psf ( $1.39 \text{ kN/m}^2$ ) to 49 psf ( $2.35 \text{ kN/m}^2$ ). The loads due to the slab, trusses, beams, columns, and spandrels were all calculated based on the actual weights of the members. The reactions at each column due to the loads and self-weight of this typical floor were calculated separately for the dead load and superimposed dead load cases. The weights of the columns and spandrels were then subtracted from the DL results to determine the load on each column from the floor system. These loads were then applied as point loads to the reduced global tower model. The loads due to the self-weight of the columns and spandrels were calculated by the analysis software (SAP2000) for the reduced global tower model.

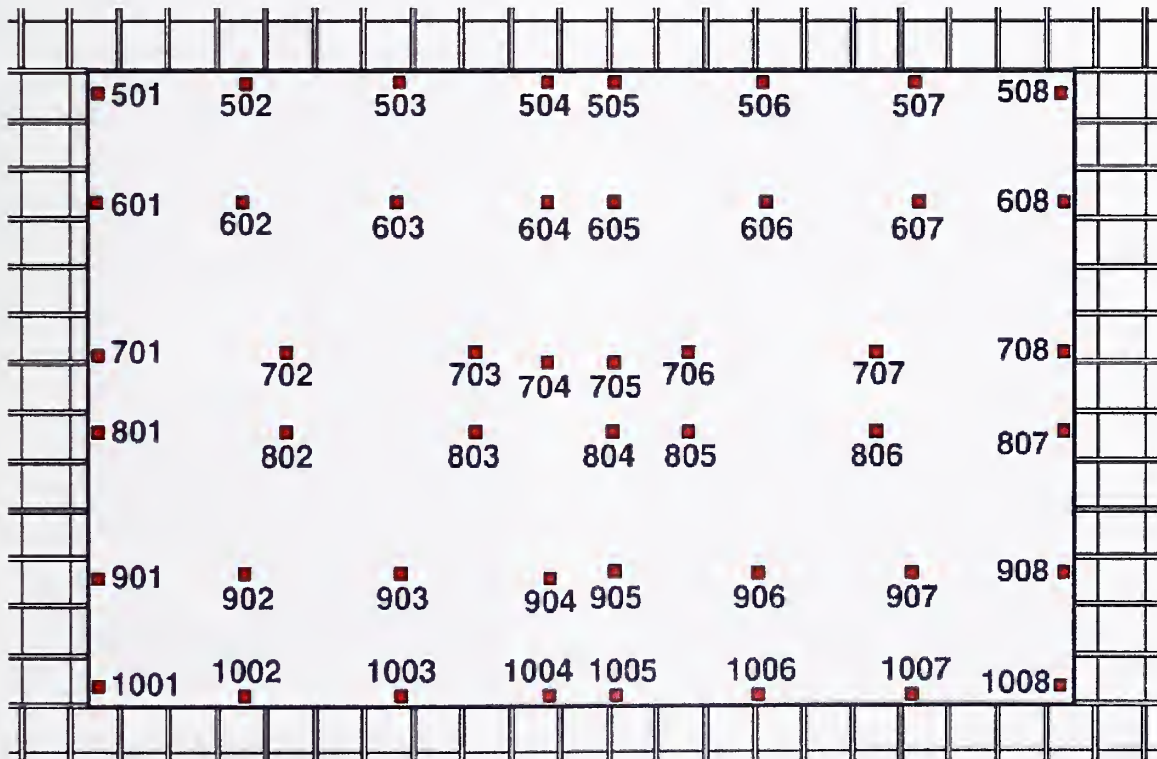
**Figure D-2. Plan of typical core column layout (courtesy FEMA).**

Two damage patterns in the core of WTC 1 were considered for this analysis: the first assumes destruction of fifteen columns (Core Damage Case 1), and the second assumes that only eight columns were severed (Core Damage Case 2). Table D-4 contains a list of core columns that were assumed to be destroyed for both damage cases (see Fig. D-2 for column locations).

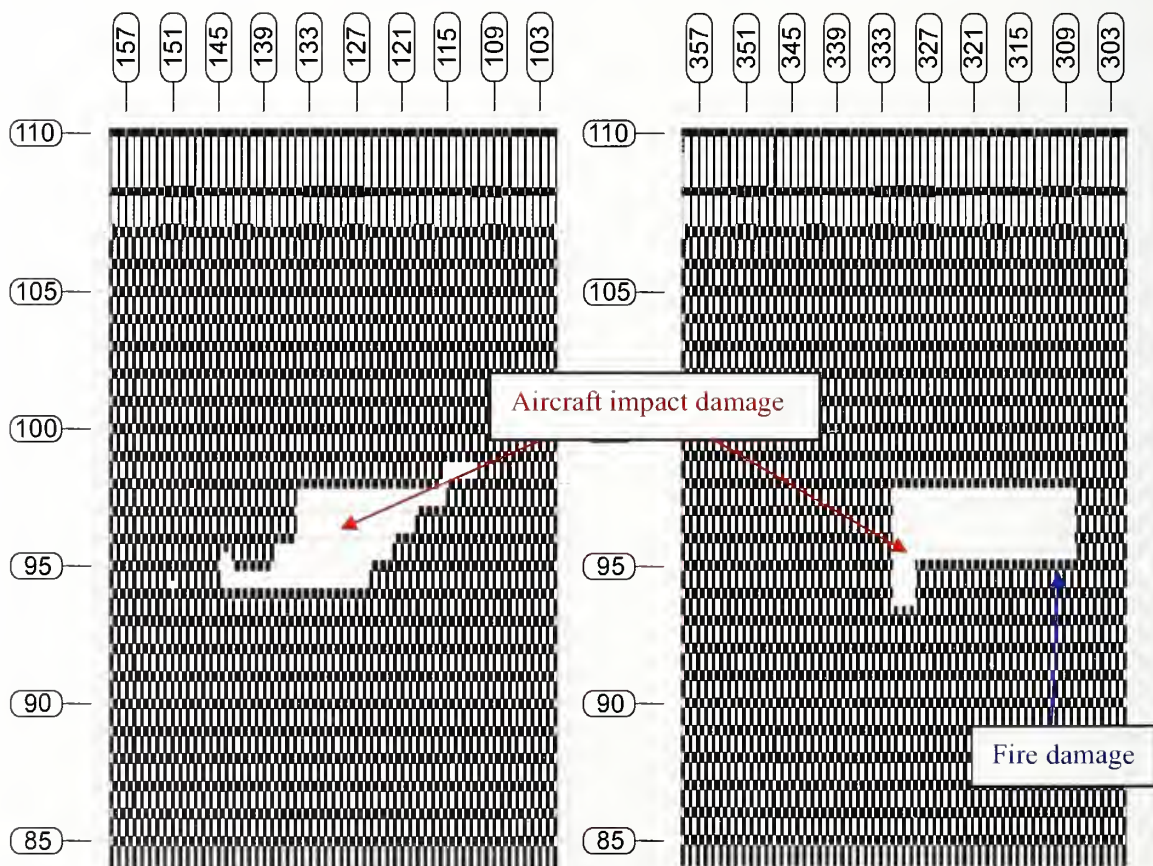
Figure D-3. North and south elevations of WTC 1 indicating columns and spandrels removed due to aircraft impact and fire effects.

- Representative aircraft impact damage: based on photographic evidence, members in the north exterior wall of WTC 1 that were visibly severed or missing were assumed to be incapable of carrying load and were removed from the model, while members that appeared to be mostly intact were assumed to be capable of still carrying full load. This damage case also includes an exterior panel in the south face of the tower (columns 329 through 331 between floors 94 and 96) that was destroyed by the aircraft impact. In addition, eight columns in the core were assumed severed (see Core Damage Case 2 in Table D-4).

- Representative fire damage: 24 columns on the south face of WTC 1 between floors 96 and 98 were assumed to have buckled and lost all load carrying capacity. This assumption is based on video evidence that indicates that columns in this area were visibly deformed inward a few minutes before the tower collapsed.

The exterior members that were removed in this damage scenario are indicated in Fig. D-3.

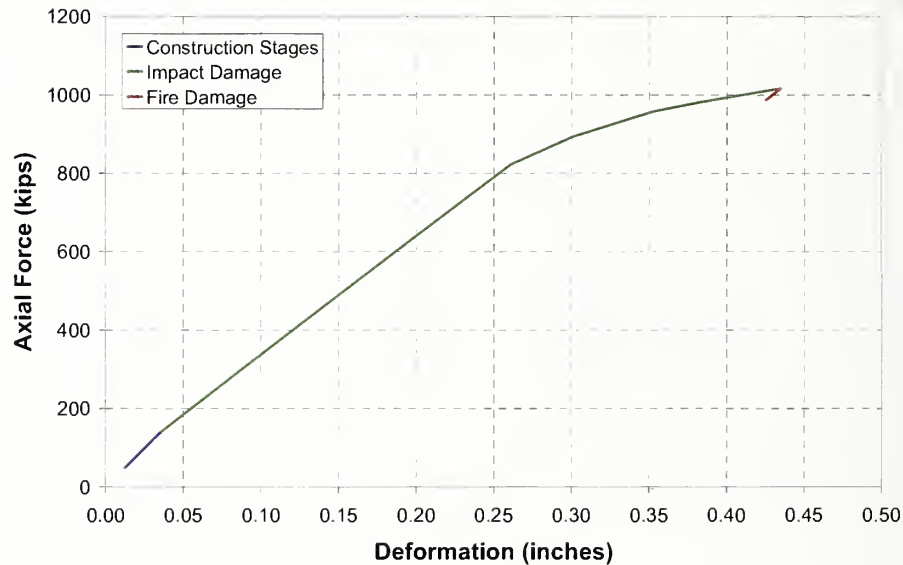
**Figure D-4. Load vs. deformation in column 111 at floor 98 (north face, west side of damage).**

Figures D-4 and D-5 show the load deformation curves for columns 111 and 145 (see Fig. D-3) on either side of the damage on the north face of the tower. Both of these columns yielded during the impact damage analysis, but had sufficient strength and ductility to resist the peak loads. Note that the loads on these two columns were slightly reduced during the fire damage analysis. This occurred because the south face of the tower lost stiffness when members were lost to the fire, which caused the upper portion of the tower to rotate slightly toward the south. This redistributed a small portion of the load on the north face through the hat trusses to the core. The columns at the edge of the damage on the south face experienced the opposite effect. As can be seen in Fig. D-6, column 332 on the west side of the damage on the south face (see Fig. D-3) did not have a significant change in its load during the impact damage stage, but received a large additional load during the fire damage analysis. This column remained within the linear response range throughout the analysis.

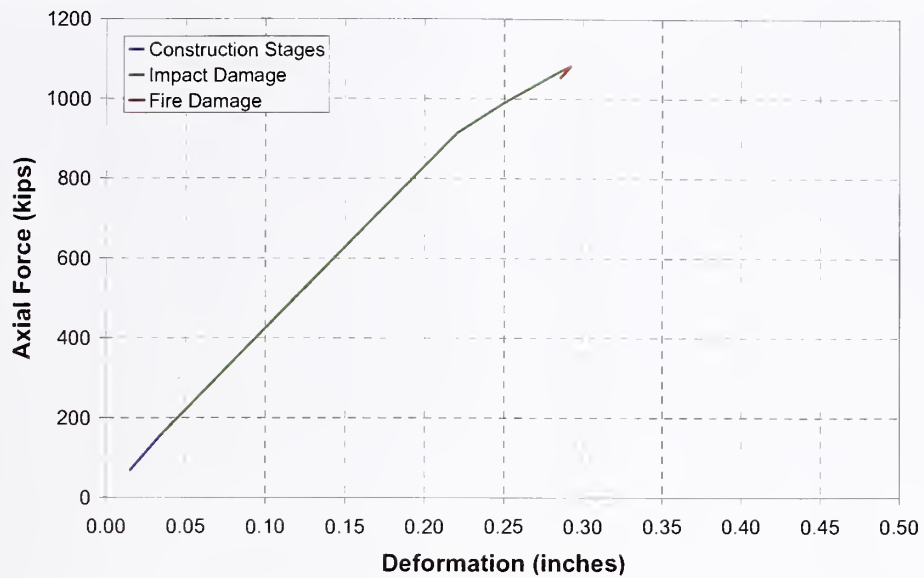
Figure D-5. Load vs. deformation in column 145 at floor 95 (north face, east side of damage).

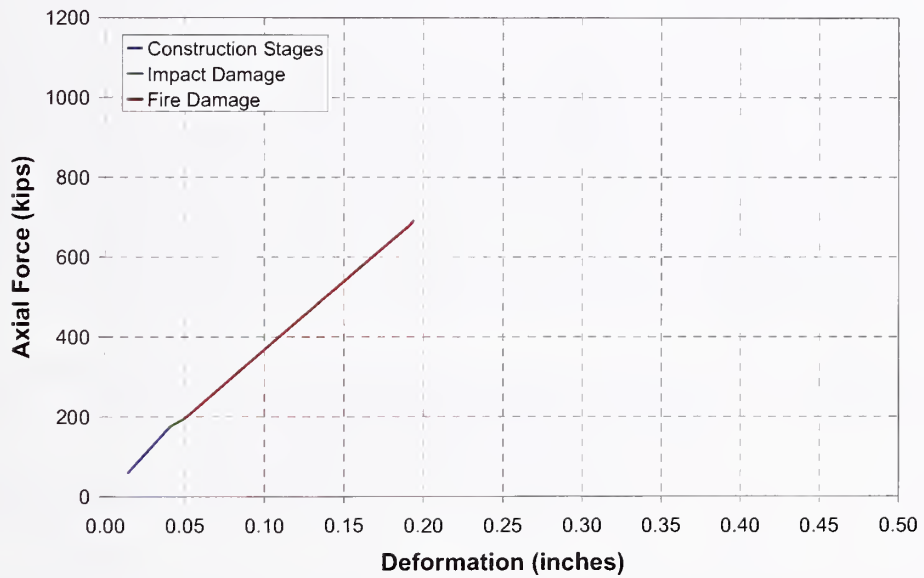
Figure D-6. Load vs. deformation in column 332 at floor 97 (south face, west side of damage).

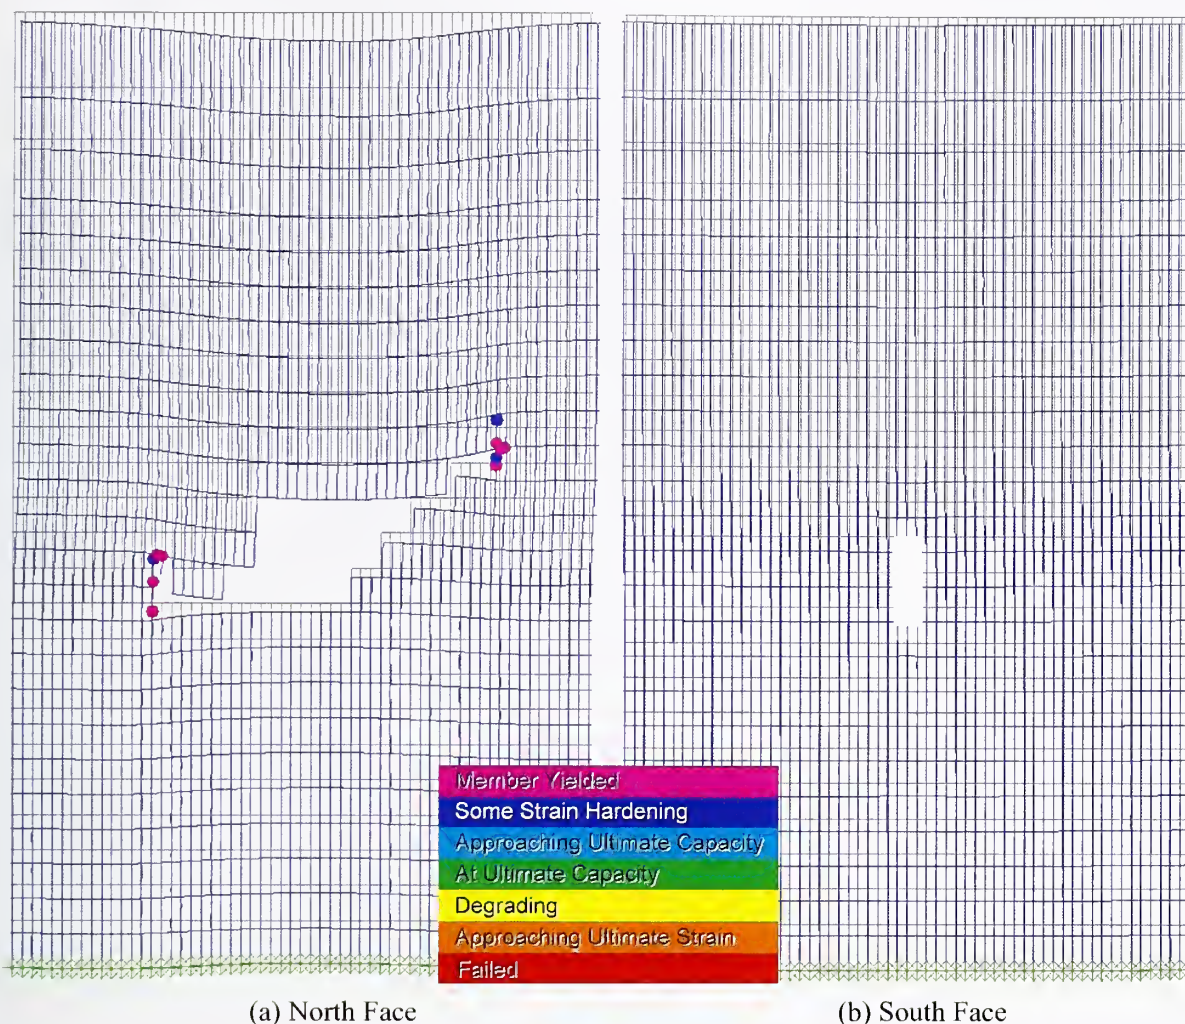
**Figure D-7. Displacements and locations of plastic hinges in the north and south exterior walls of WTC 1 after impact.**

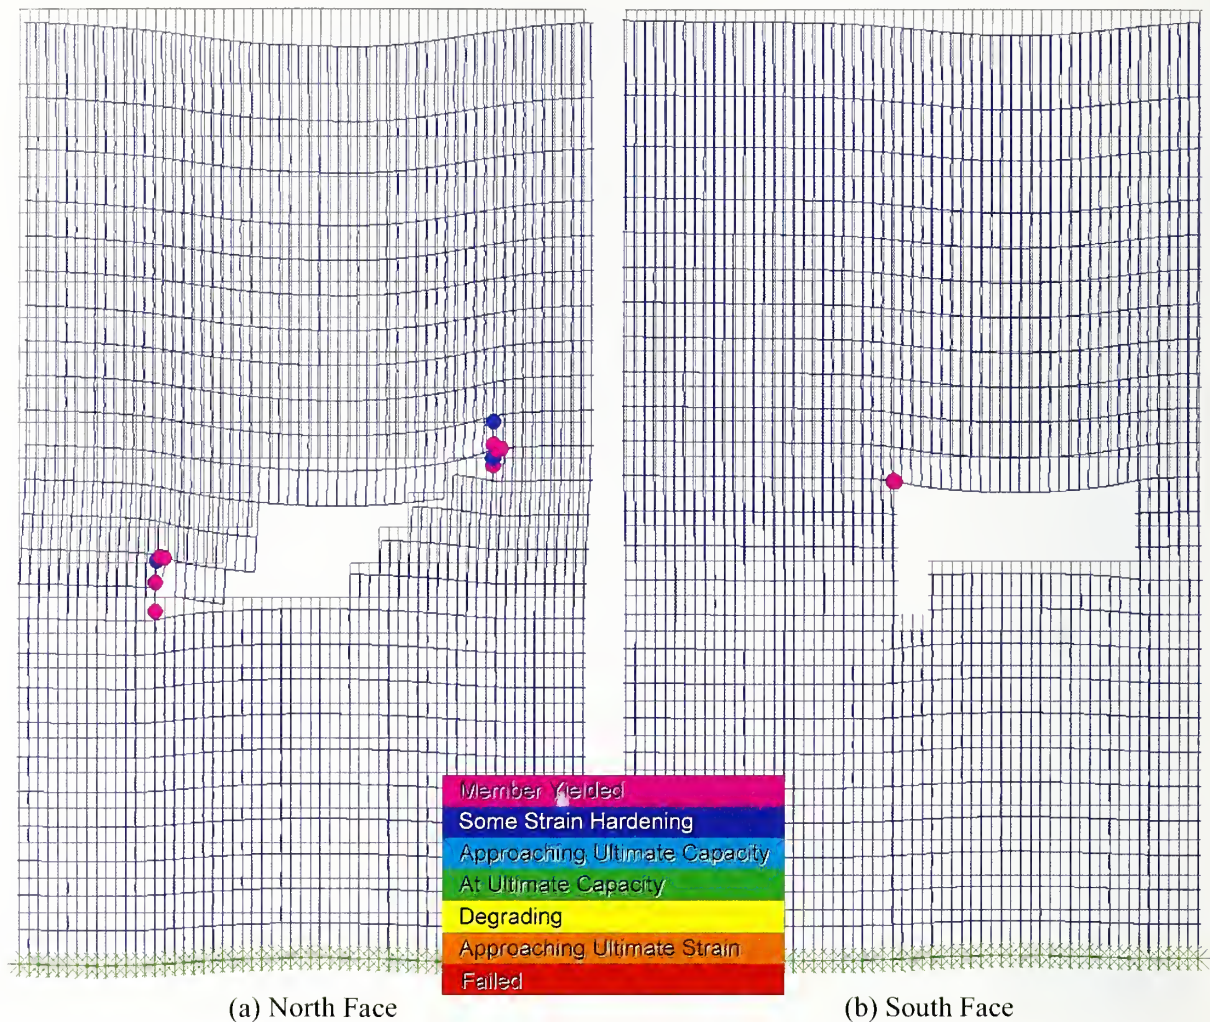
**Figure D-8. Displacements and locations of plastic hinges in the north and south exterior walls of WTC 1 after impact and fire.**

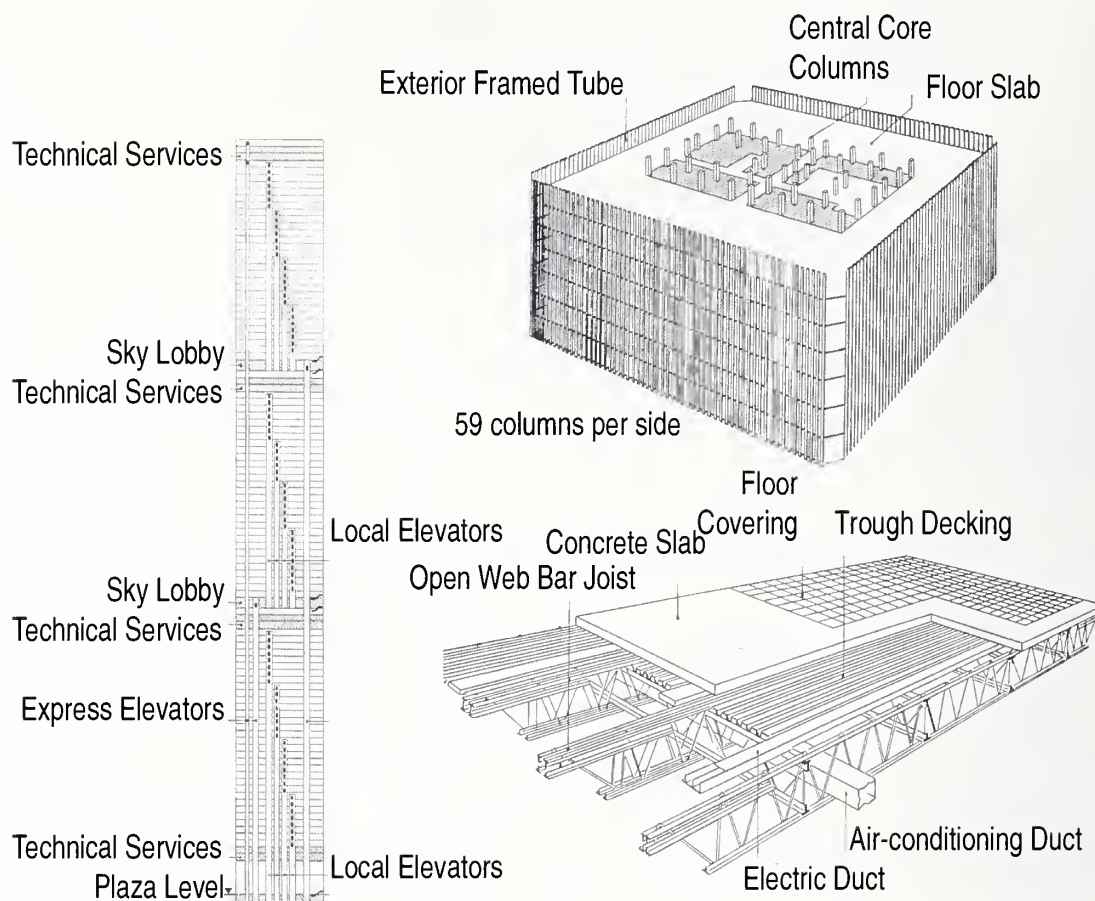
**Figure E-1. Schematic diagram of the tower structure.**

The WTC tower buildings had a frame-tube construction consisting of closely spaced perimeter columns coupled to a rectangular service core (Fig. E-1). The buildings had a square footprint, 207 ft 2 in.

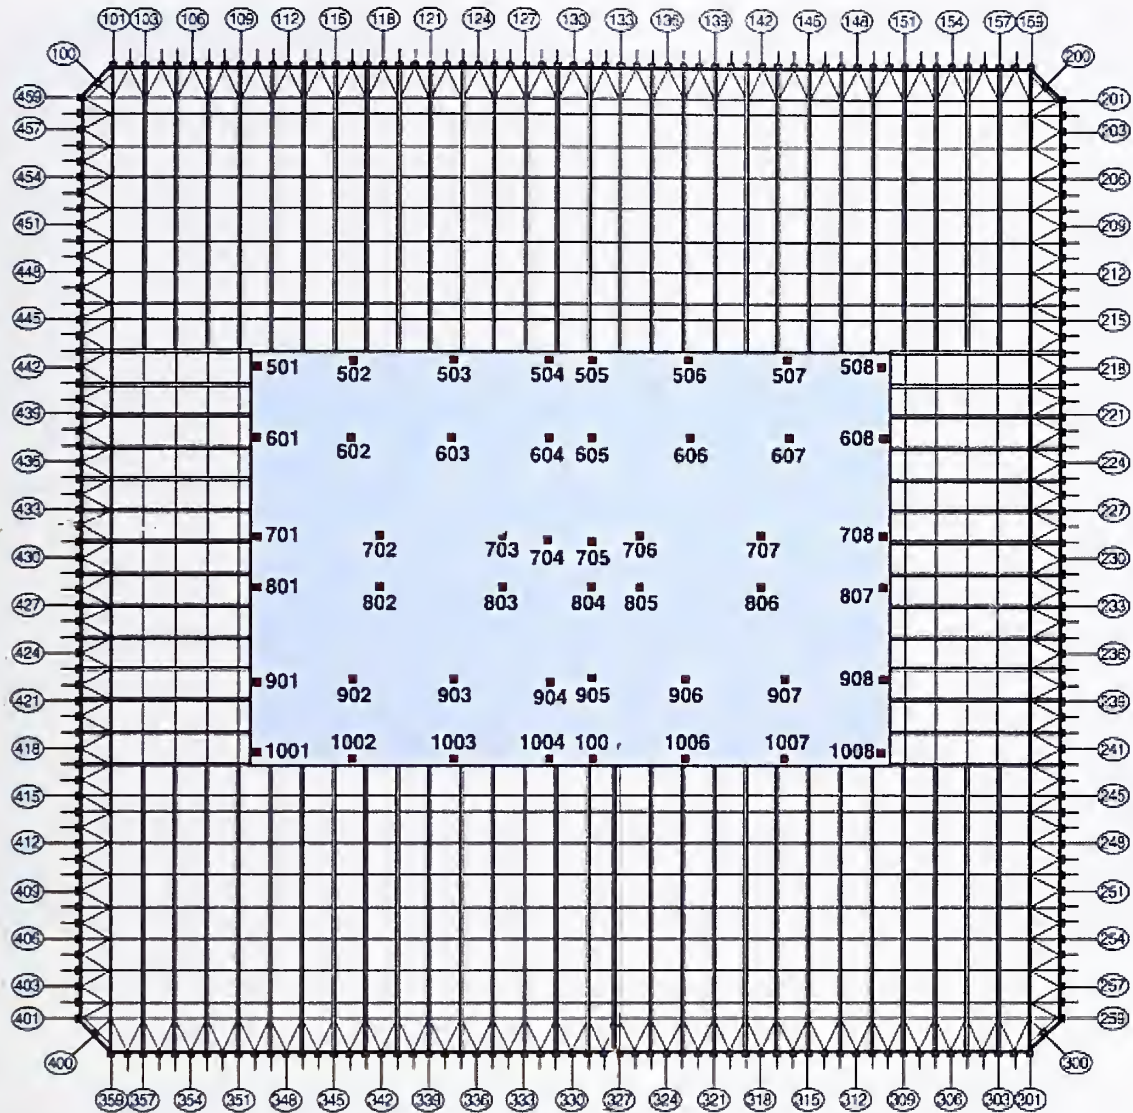
**Figure E-2. WTC tower floor plan and column numbers.**

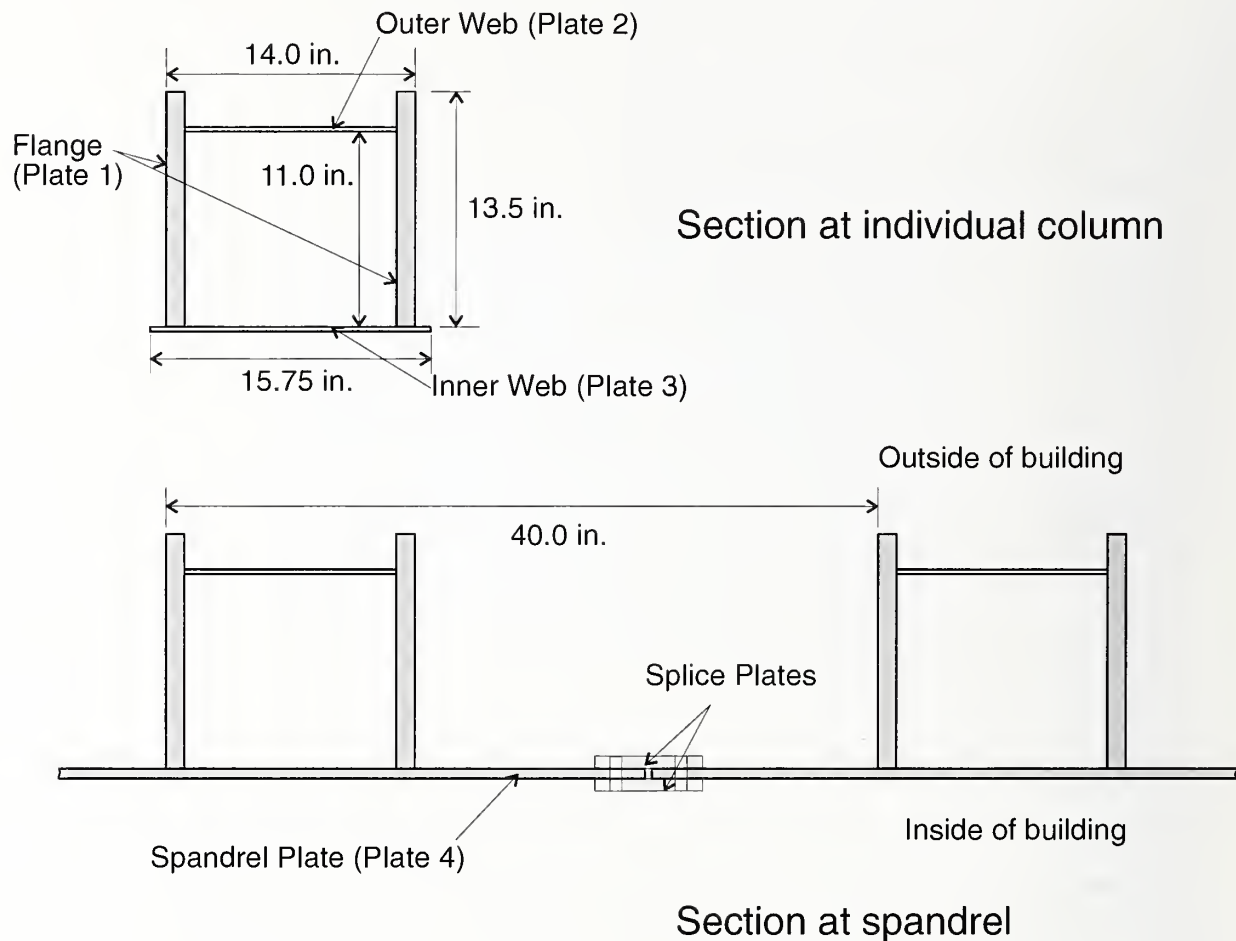
**Figure E-3. Cross-section of perimeter columns; sections with and without spandrels.**

welding plates of steel to form an approximately 14 in. (0.36 m) square section (Fig. E-3). Adjacent columns were interconnected at each floor level by deep spandrel plates, typically 52 in. (1.32 m) deep (Fig. E-4).

The spandrels formed an integral part of the columns: there was no inner web plate at spandrel locations. (Fig. E-3). Spandrels were generally specified with a yield strength lower than that of the column webs and flanges, as well as a heavier gage than the adjacent inner webs.

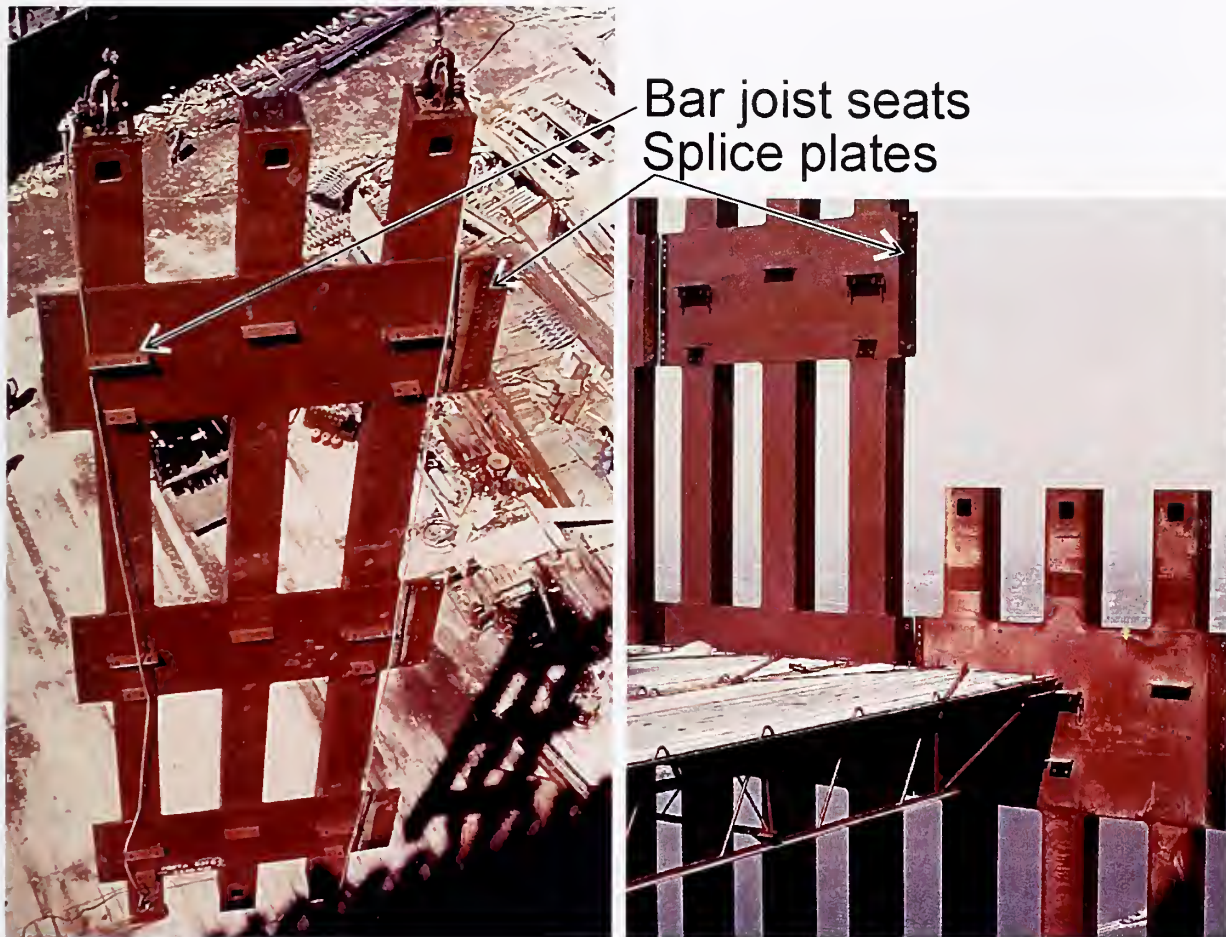
**Figure E-4. Characteristic perimeter column panel consisting of three full columns connected by three spandrels.**

The perimeter columns were prefabricated into panels, typically three stories tall and three columns wide (Fig. E-4). Heavy end, or "butt" plates with  $F_y = 50$  ksi and 1.375 in. to 3 in. (3.5 mm to 7.6 mm) thick were welded to the top and bottom of each column. Fillet welds were used inside the columns along three edges, with a groove weld on the fourth, outside edge. During erection, abutting spandrels were bolted together, and columns were bolted to the adjacent columns, all using ASTM A 325 bolts except for the heaviest butt plates, which used ASTM A 490 bolts. Other than at the mechanical floors, panels were staggered (Fig. E-5) so that only one third of the units were spliced (i.e., connected) in any one story. At the mechanical floors (75 and 76 in the upper level of the buildings), however, every perimeter column was spliced at the same level, floors 74 and 77. These splices were both welded and bolted.

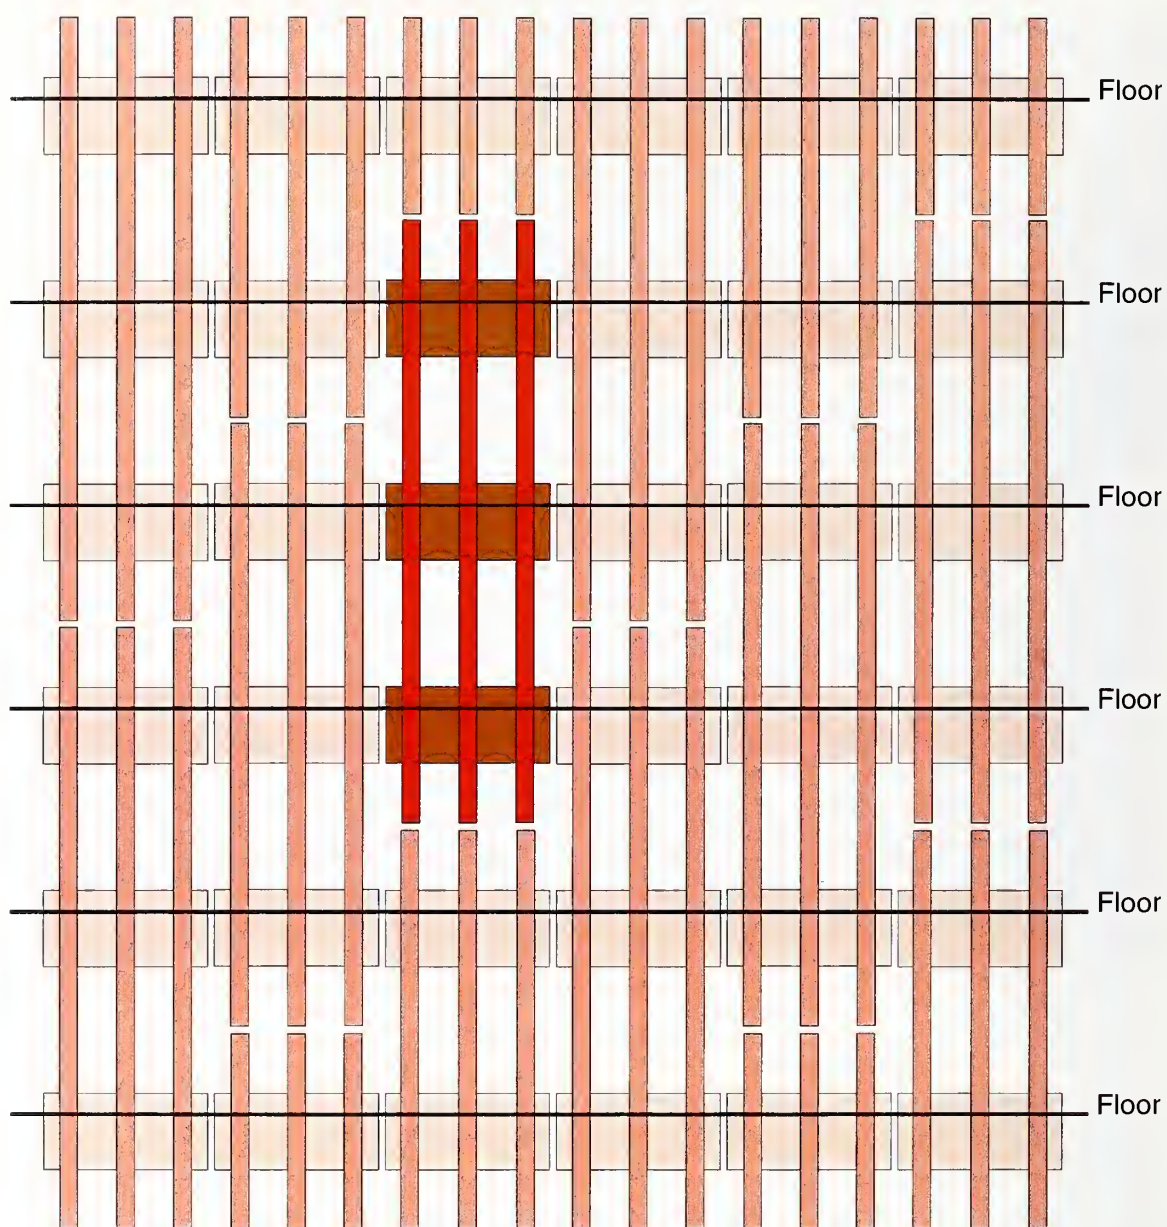
**Figure E-5. Partial elevation of exterior bearing-wall frame showing perimeter column panel construction. Highlighted panel is three stories tall (36 ft) and spans four floors. Distance between panels has been exaggerated.**

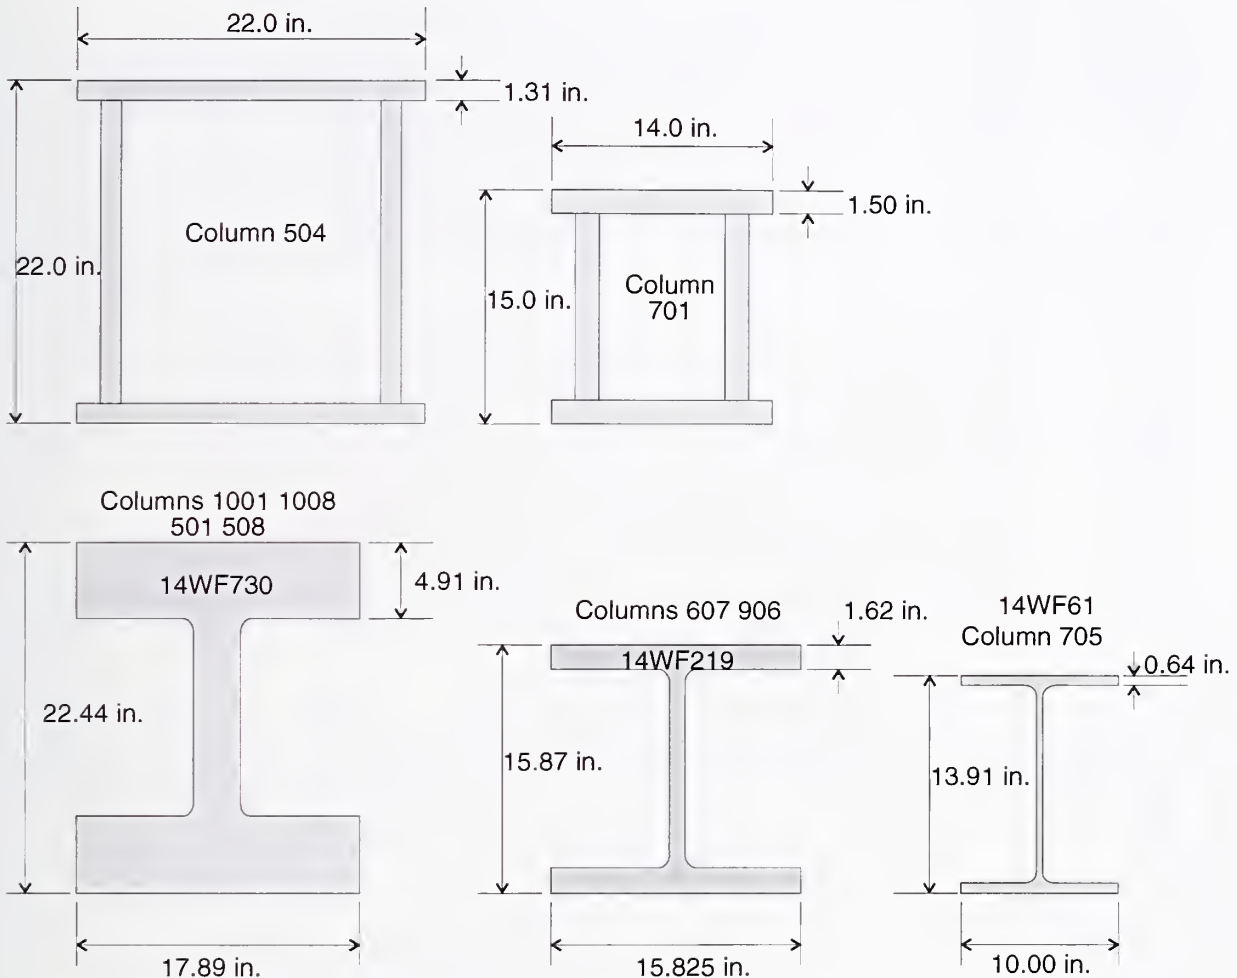
**Figure E-6. Typical welded box members and rolled wide flange shapes used for core columns between floors 83 and 86 (to scale).**

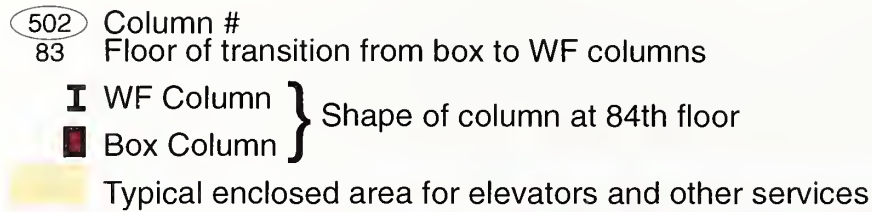
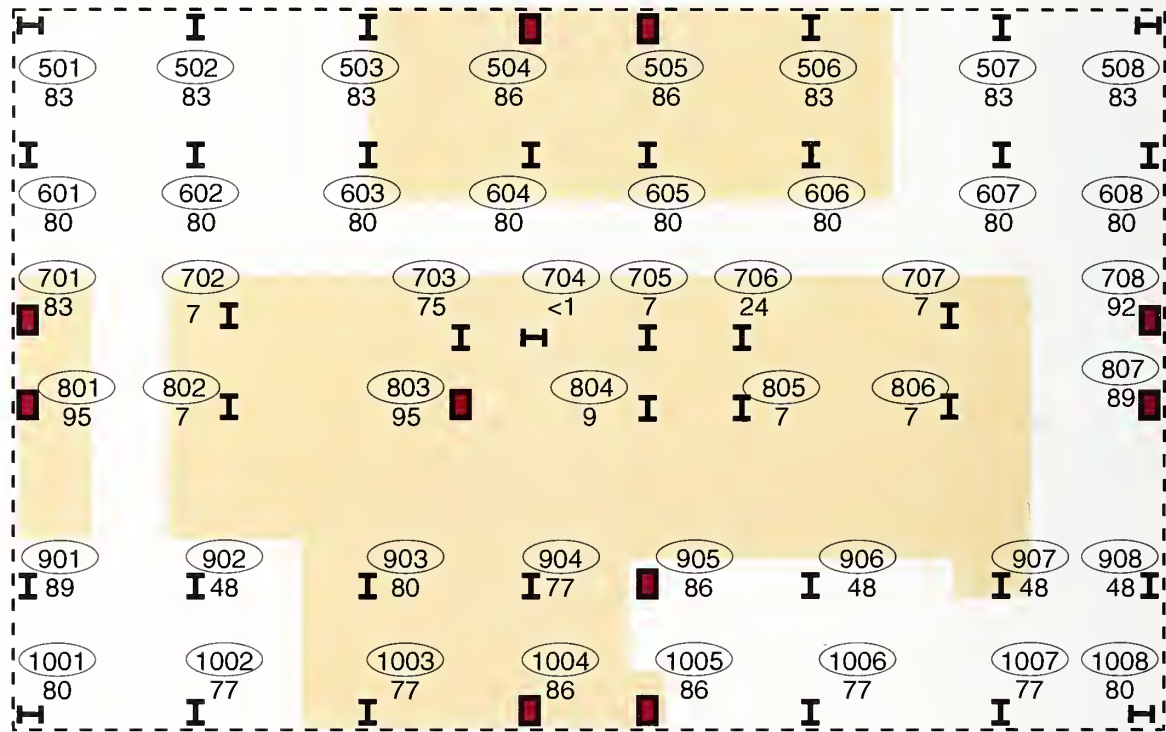
Figure E-7. Core column layout in WTC towers.

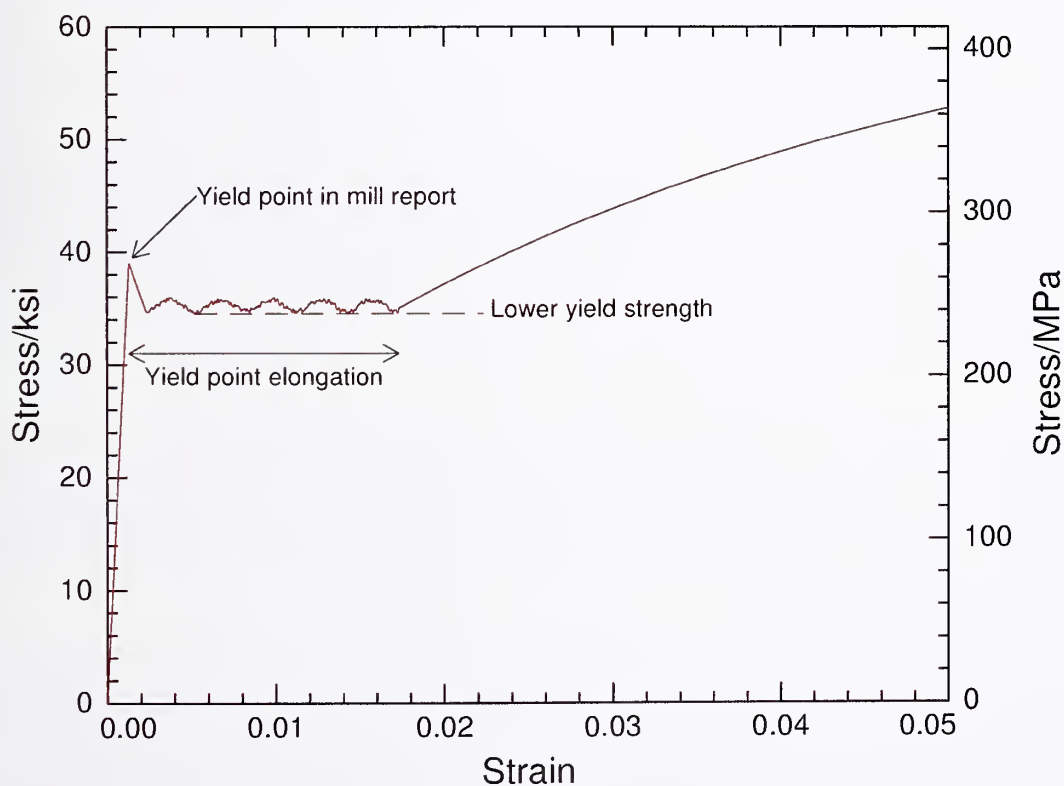
**Figure E-10. Schematic diagram of the stress-strain behavior of a structural steel.**

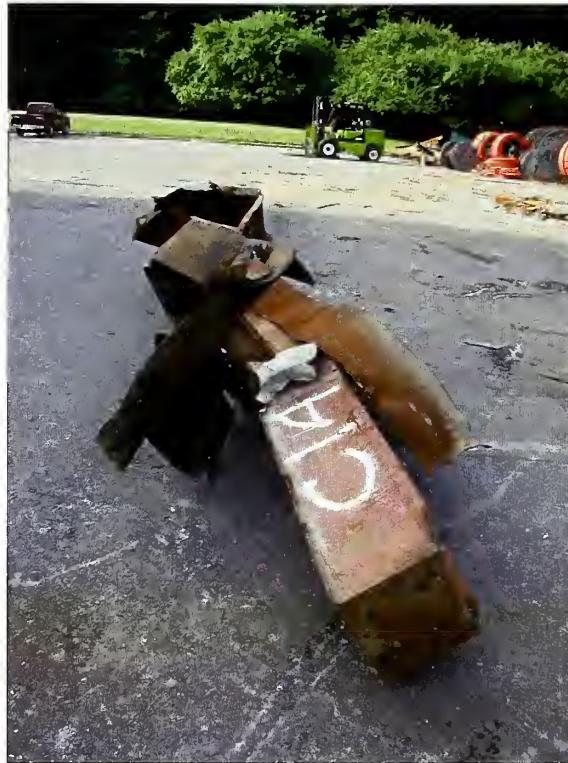
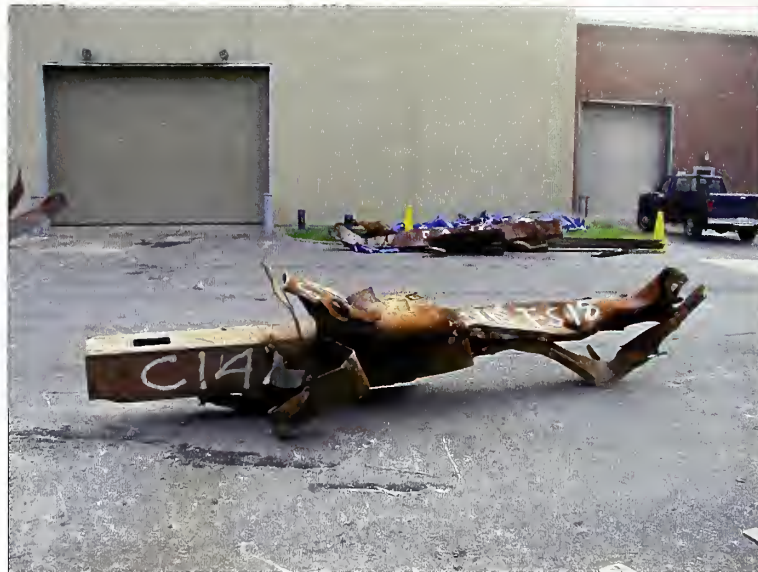
**Figure F-1. Characteristic “overall” view of the samples taken for each piece received. Sample shown here is C-14.**

As samples were delivered, overall images of the pieces were taken for record-keeping purposes. An example is shown in Fig. F-1. Samples are identified by their original alphanumeric identification codes assigned by SEAoNY to be consistent with the FEMA report. However, there were cases in which two different codes were found on one piece. In these instances, if the pieces were already undergoing

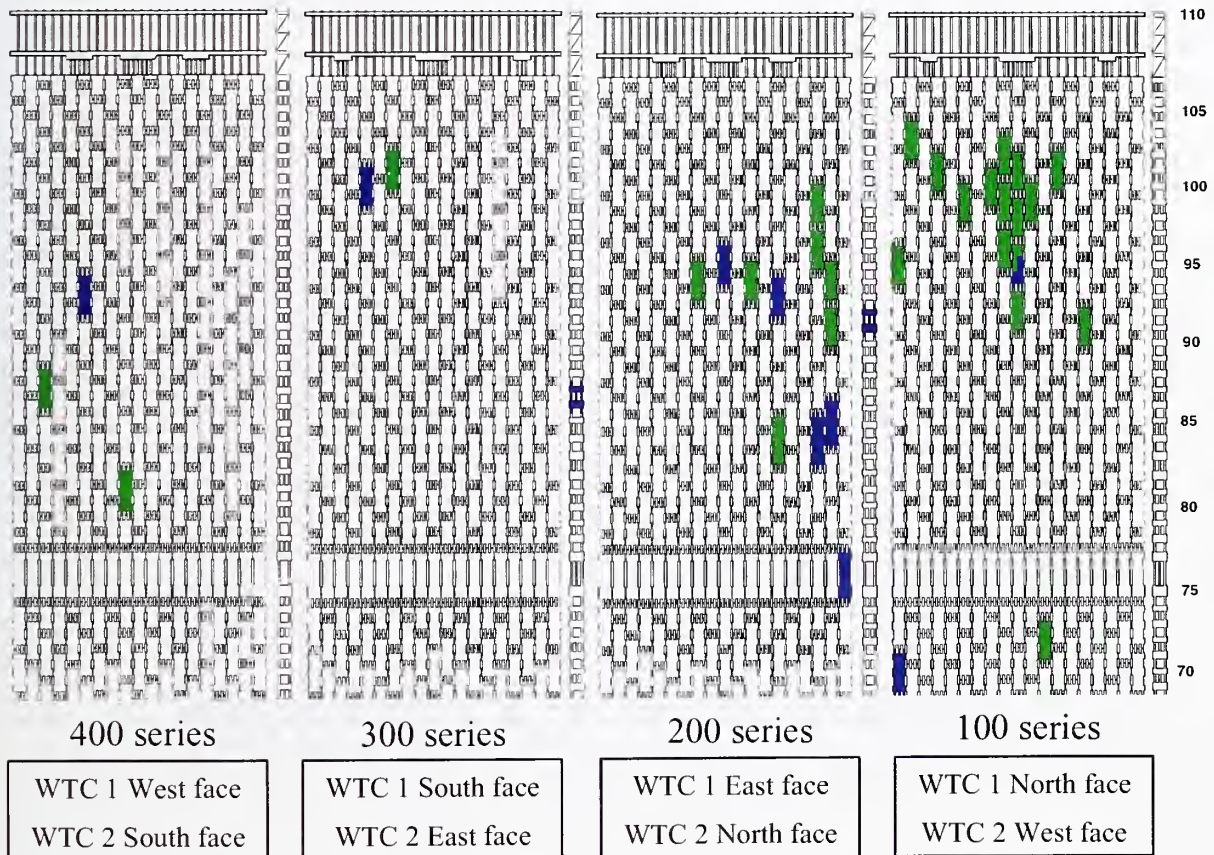
**Figure F-2. Location of the exterior panels recovered from the top third of WTC 1 and 2.**

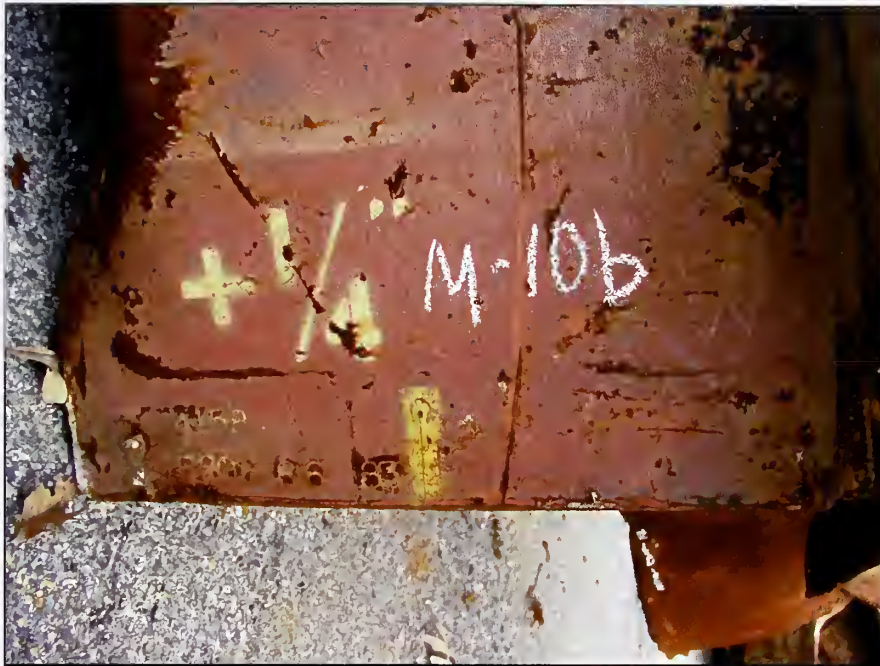
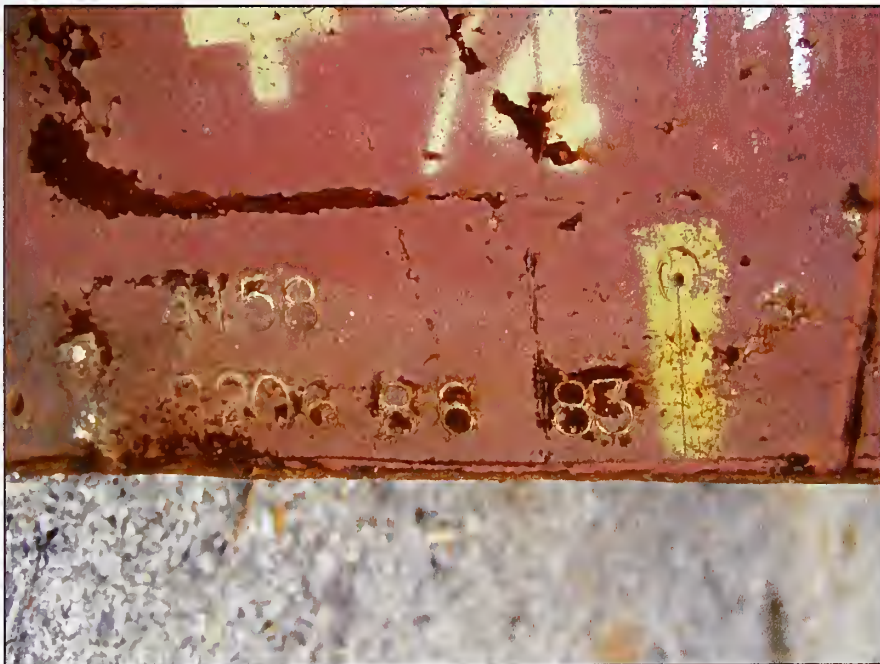
**Figure F-3. Example of stampings on the interior base of the middle column for each panel.**

NIST is still investigating the significance of these codes. All of these stampings typically reside within 1 meter from the bottom of the column.

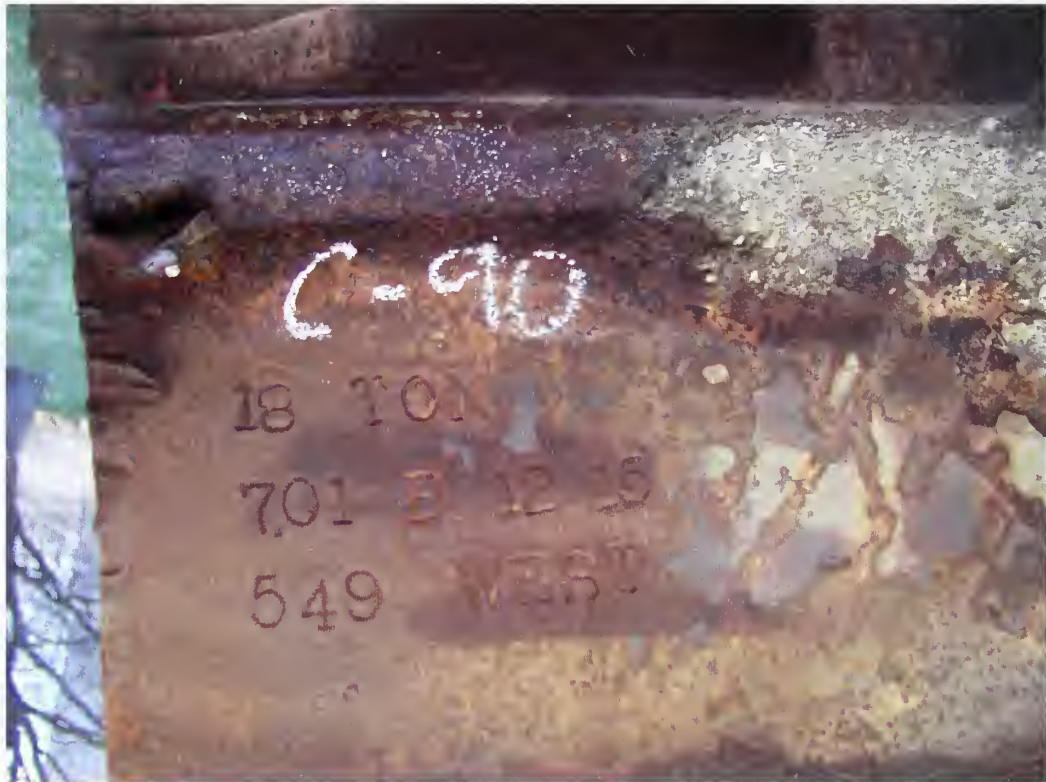
**Figure F-4. Example of stampings placed on one end of a core column.**

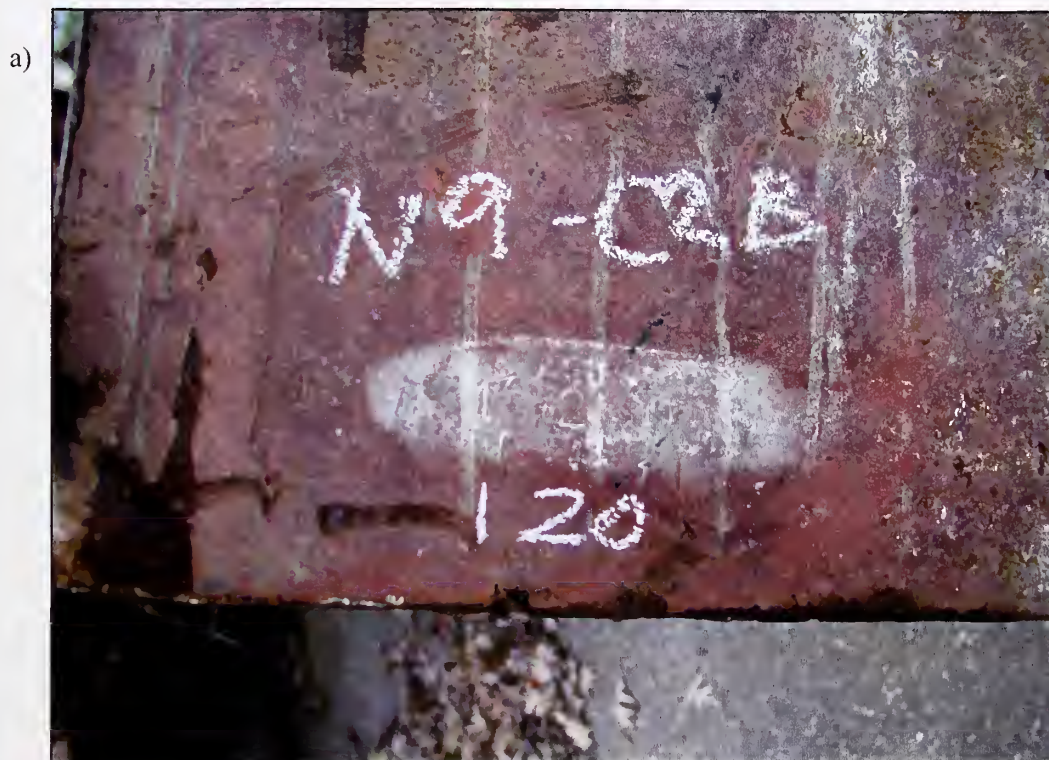
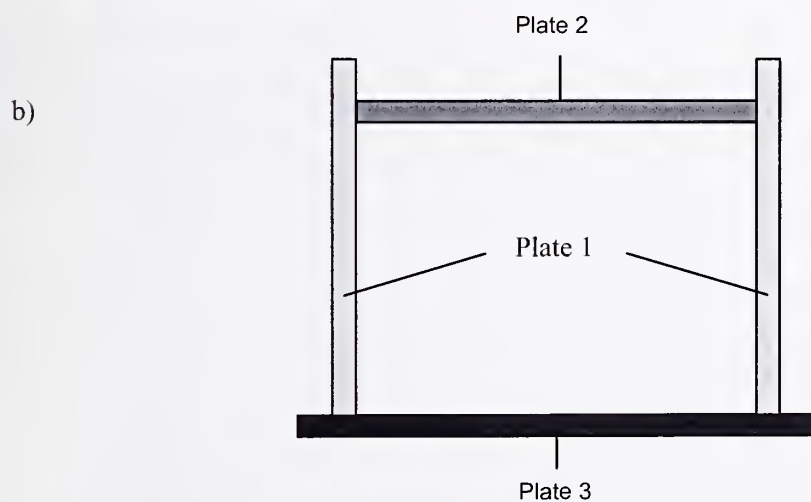
Figure F-5. (a) Example of stamping placed on flange indicating the column type (120), and (b) schematic indicating the various plates corresponding to Table F-5.
