**NIST Special Publication 1000-5**

**June 2004**  
**Progress Report on the**  
**Federal Building and Fire Safety**  
**Investigation of the**  
**World Trade Center Disaster**

**Volume 3**  
Contains Appendices D, E, and F

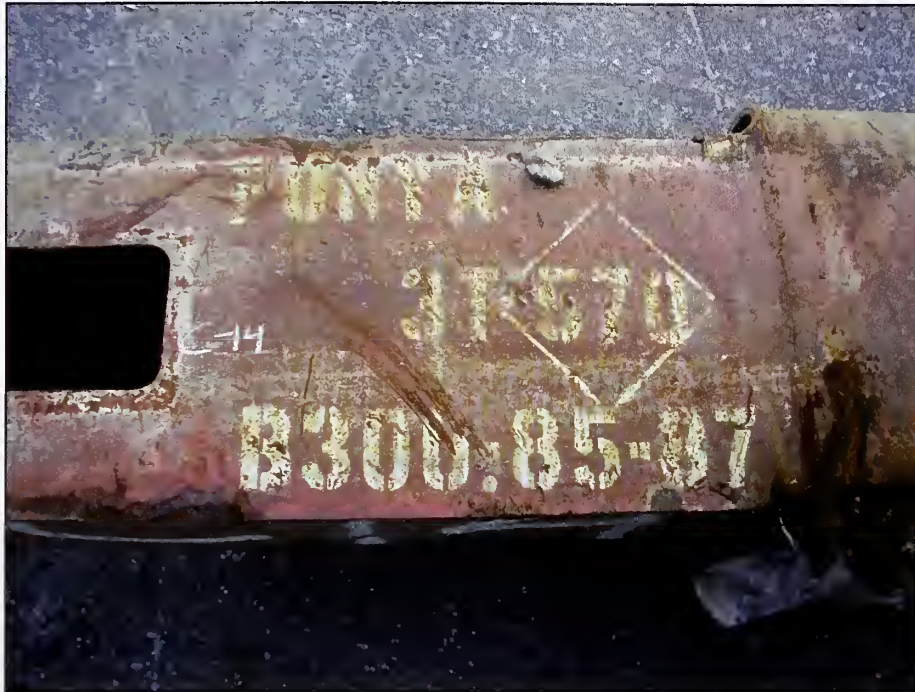
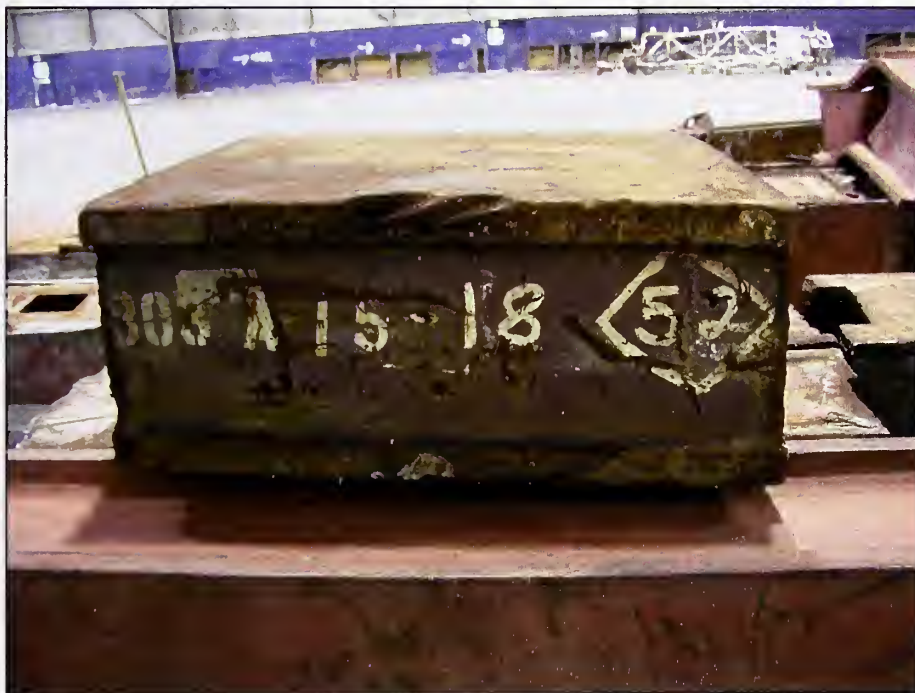
Figure F-6. (a) Characteristic stenciling found on the lower portions of the exterior column panels for sample C-14. (b) Characteristic stenciling found on an interior core column for sample B-6152.

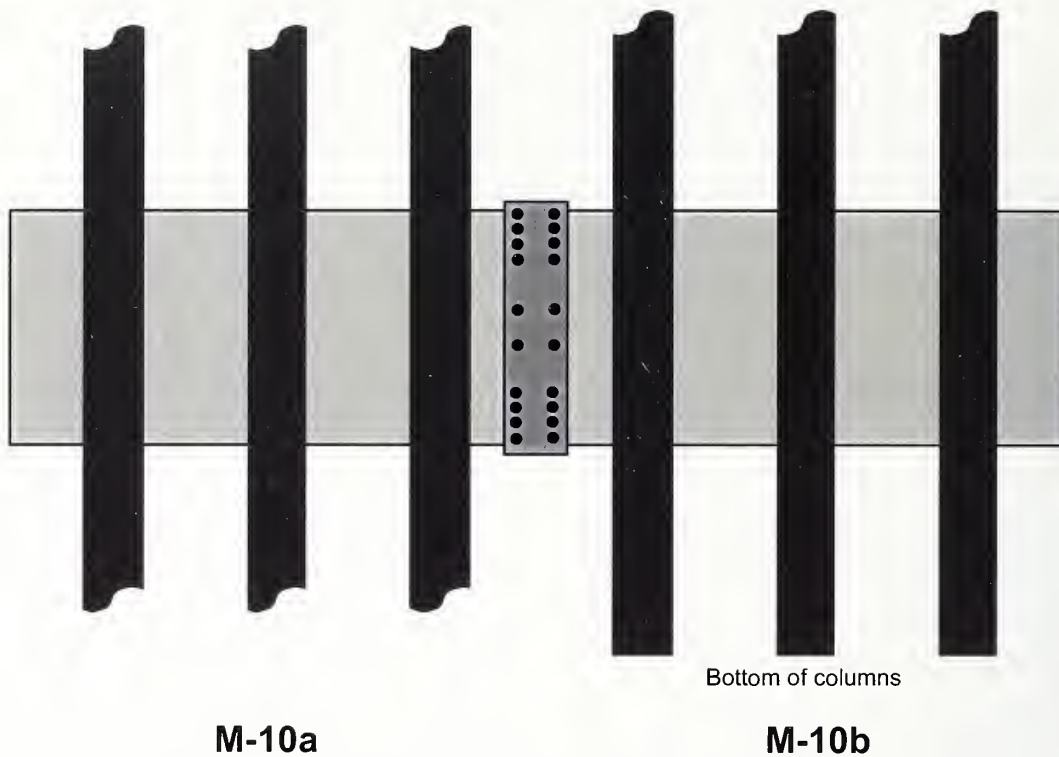
**Figure F-8. Schematic showing the sample M-10 as two separate exterior column panels, M-10a and M-10b.**

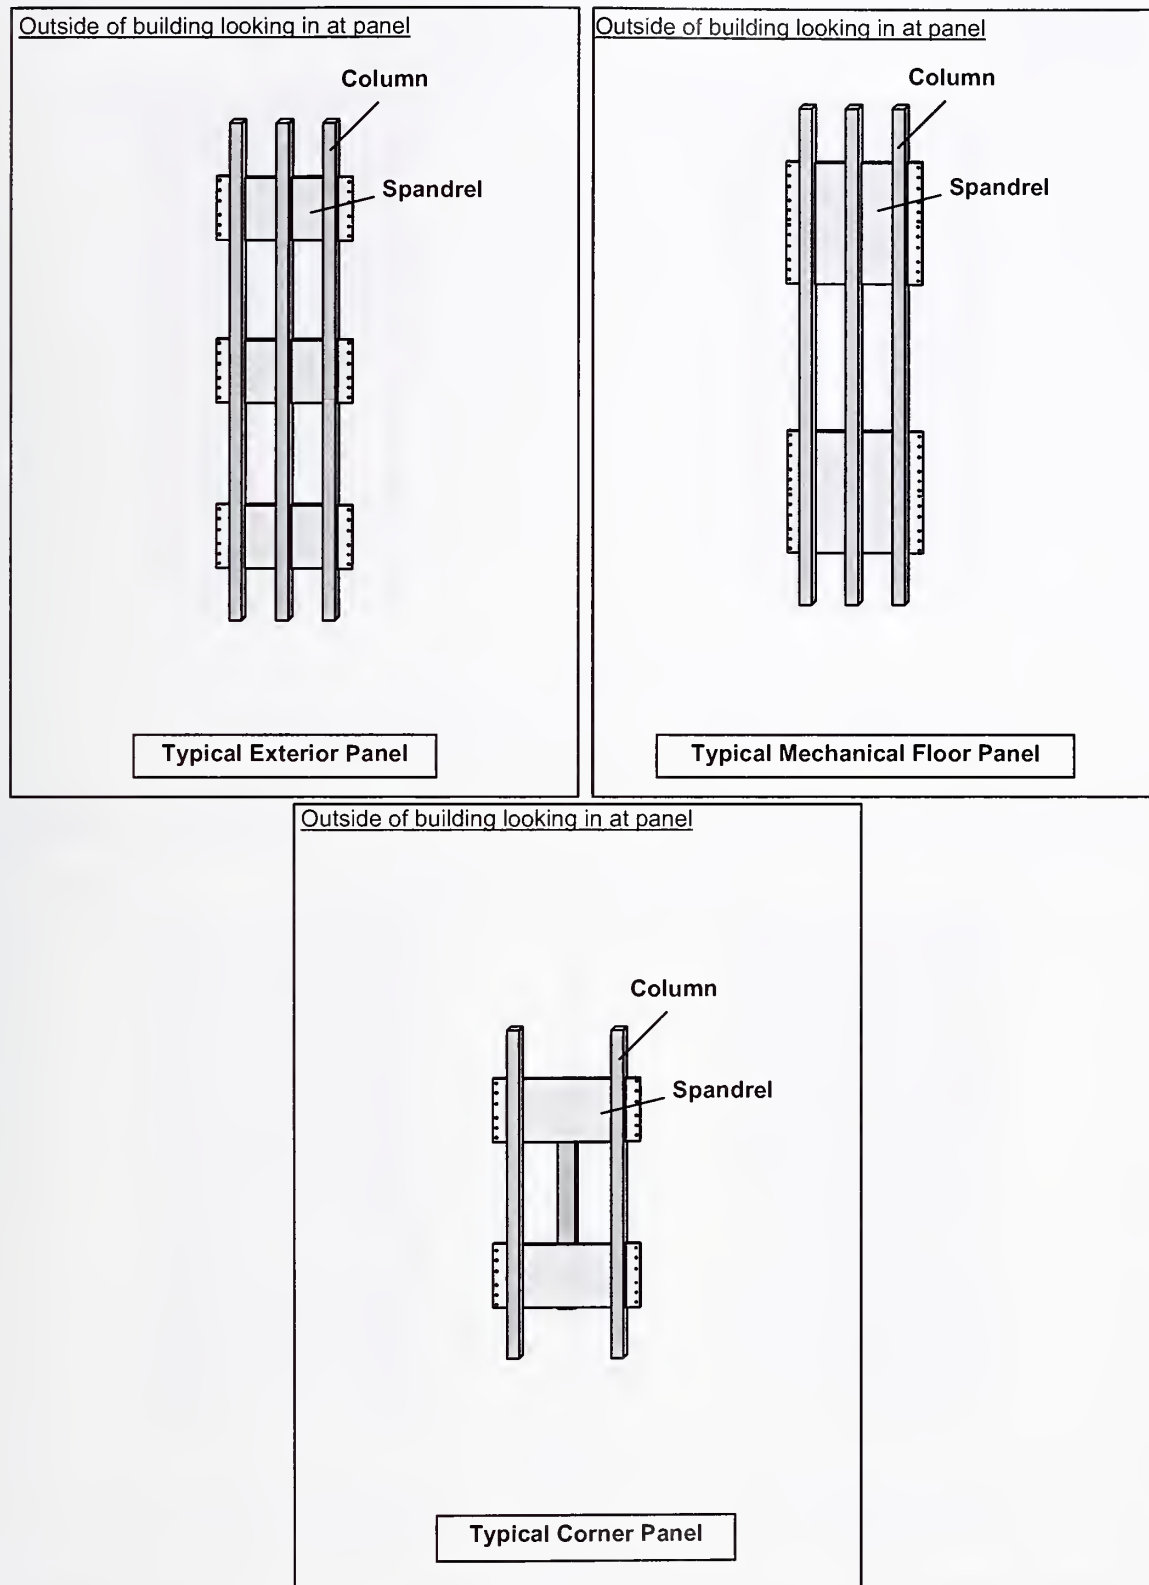
Figure F-9. Schematics displaying the various types of exterior column panels.

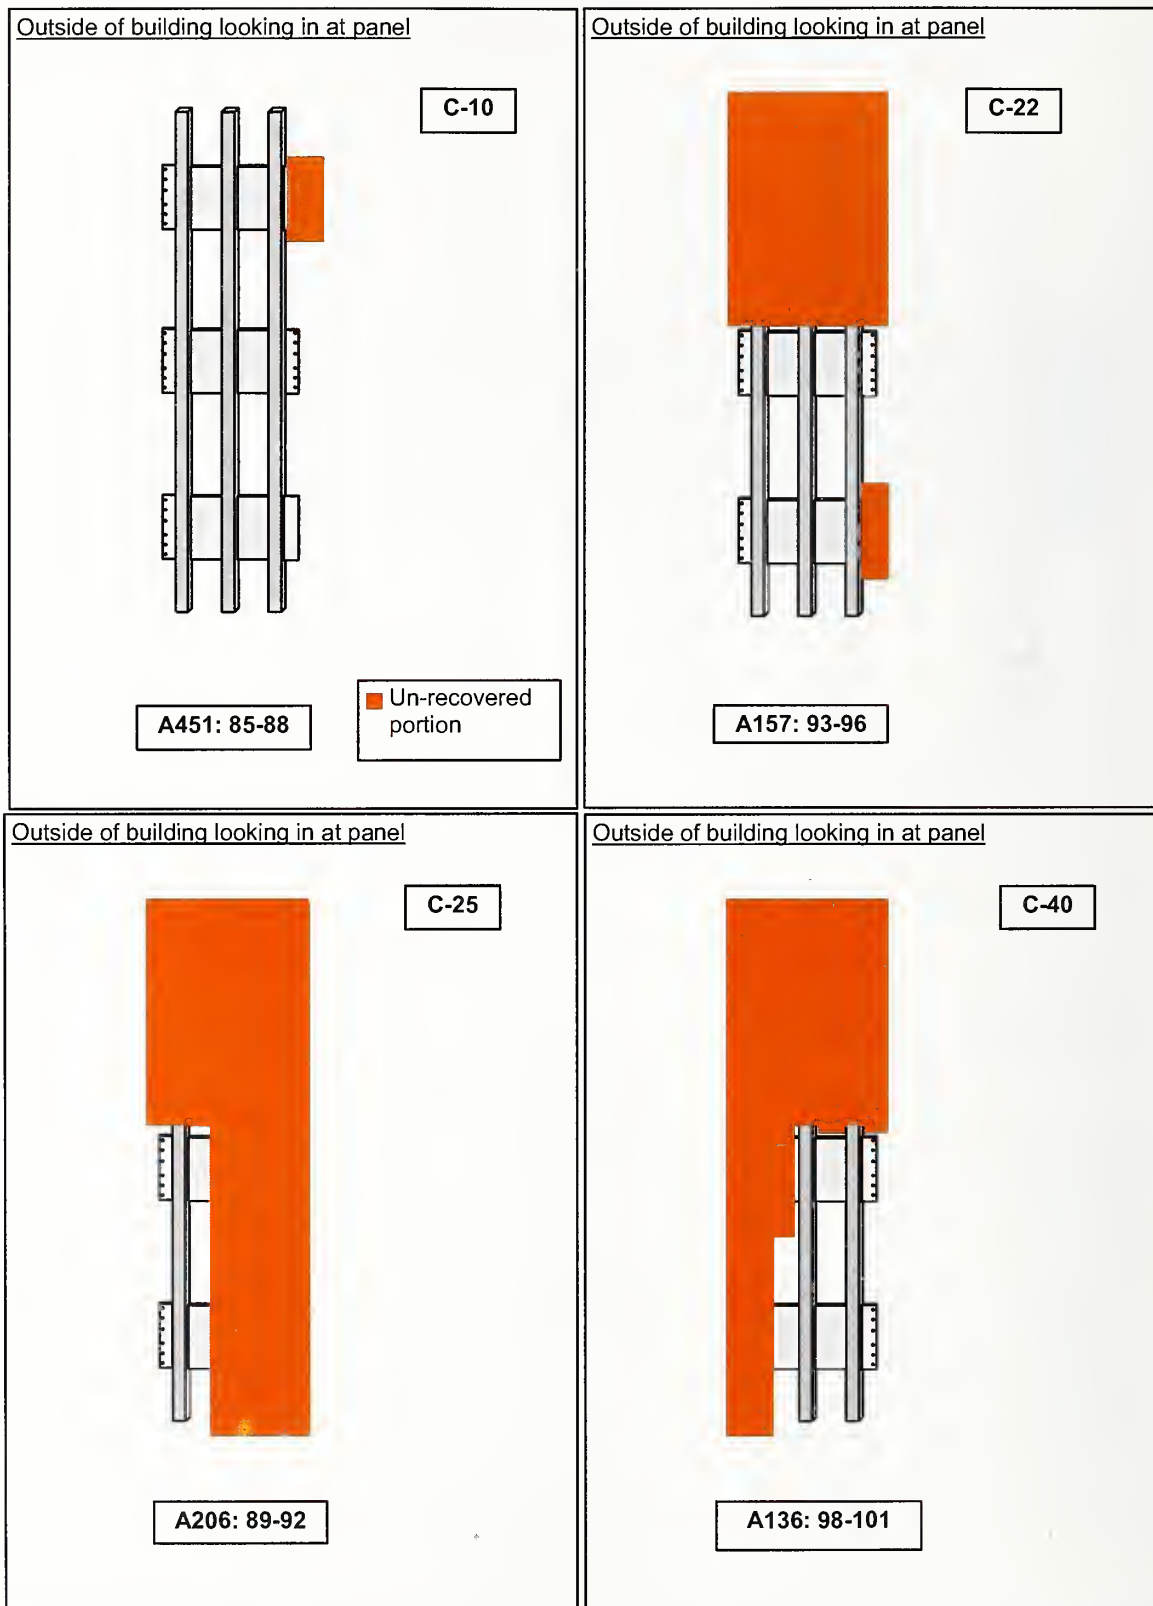
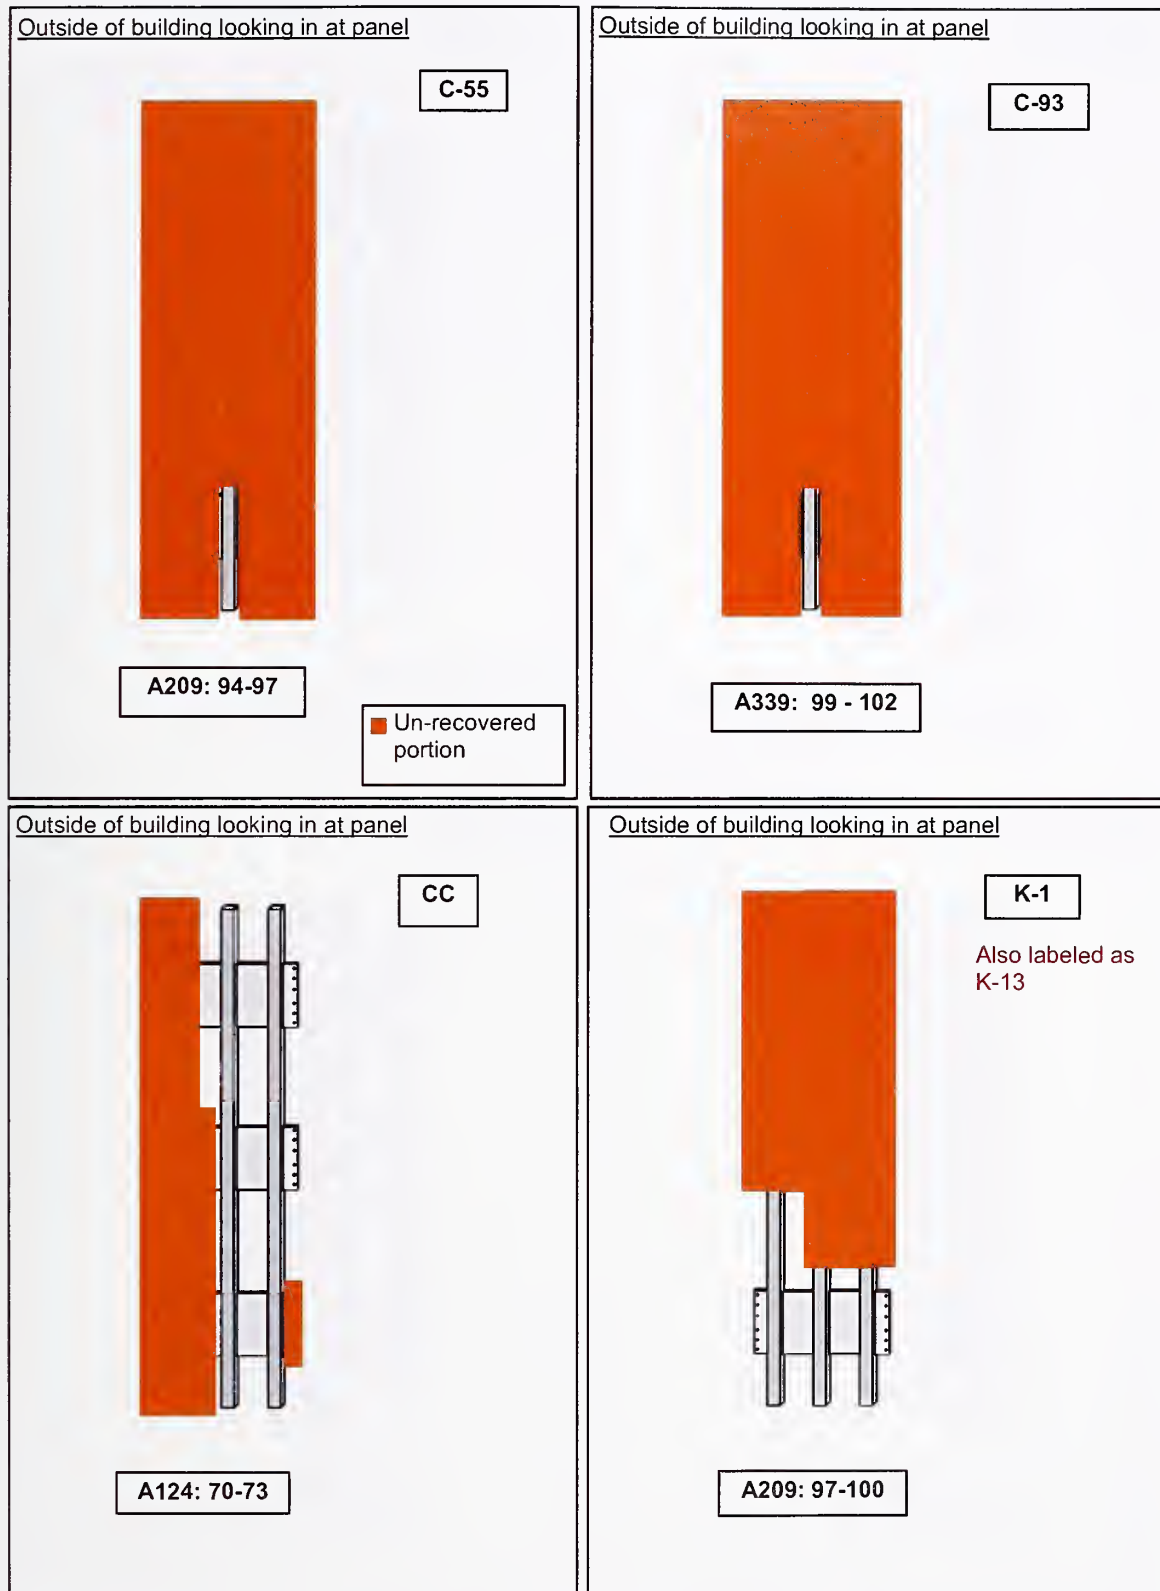
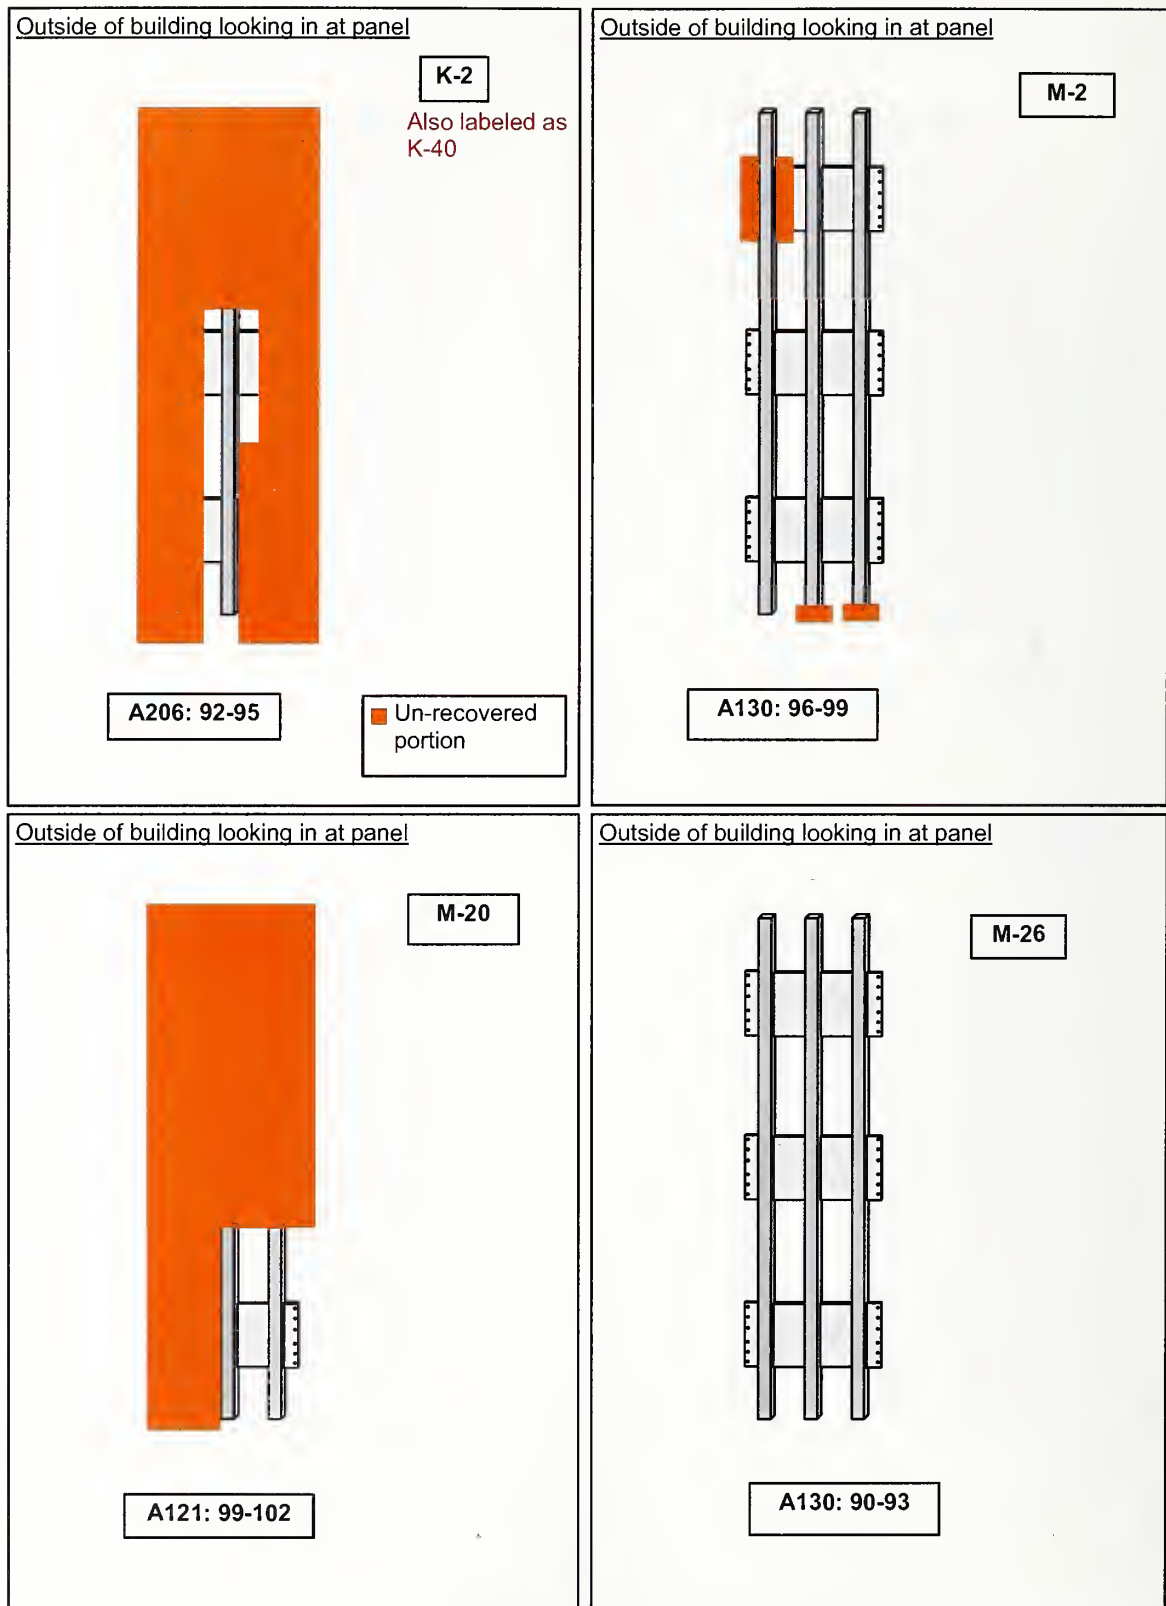
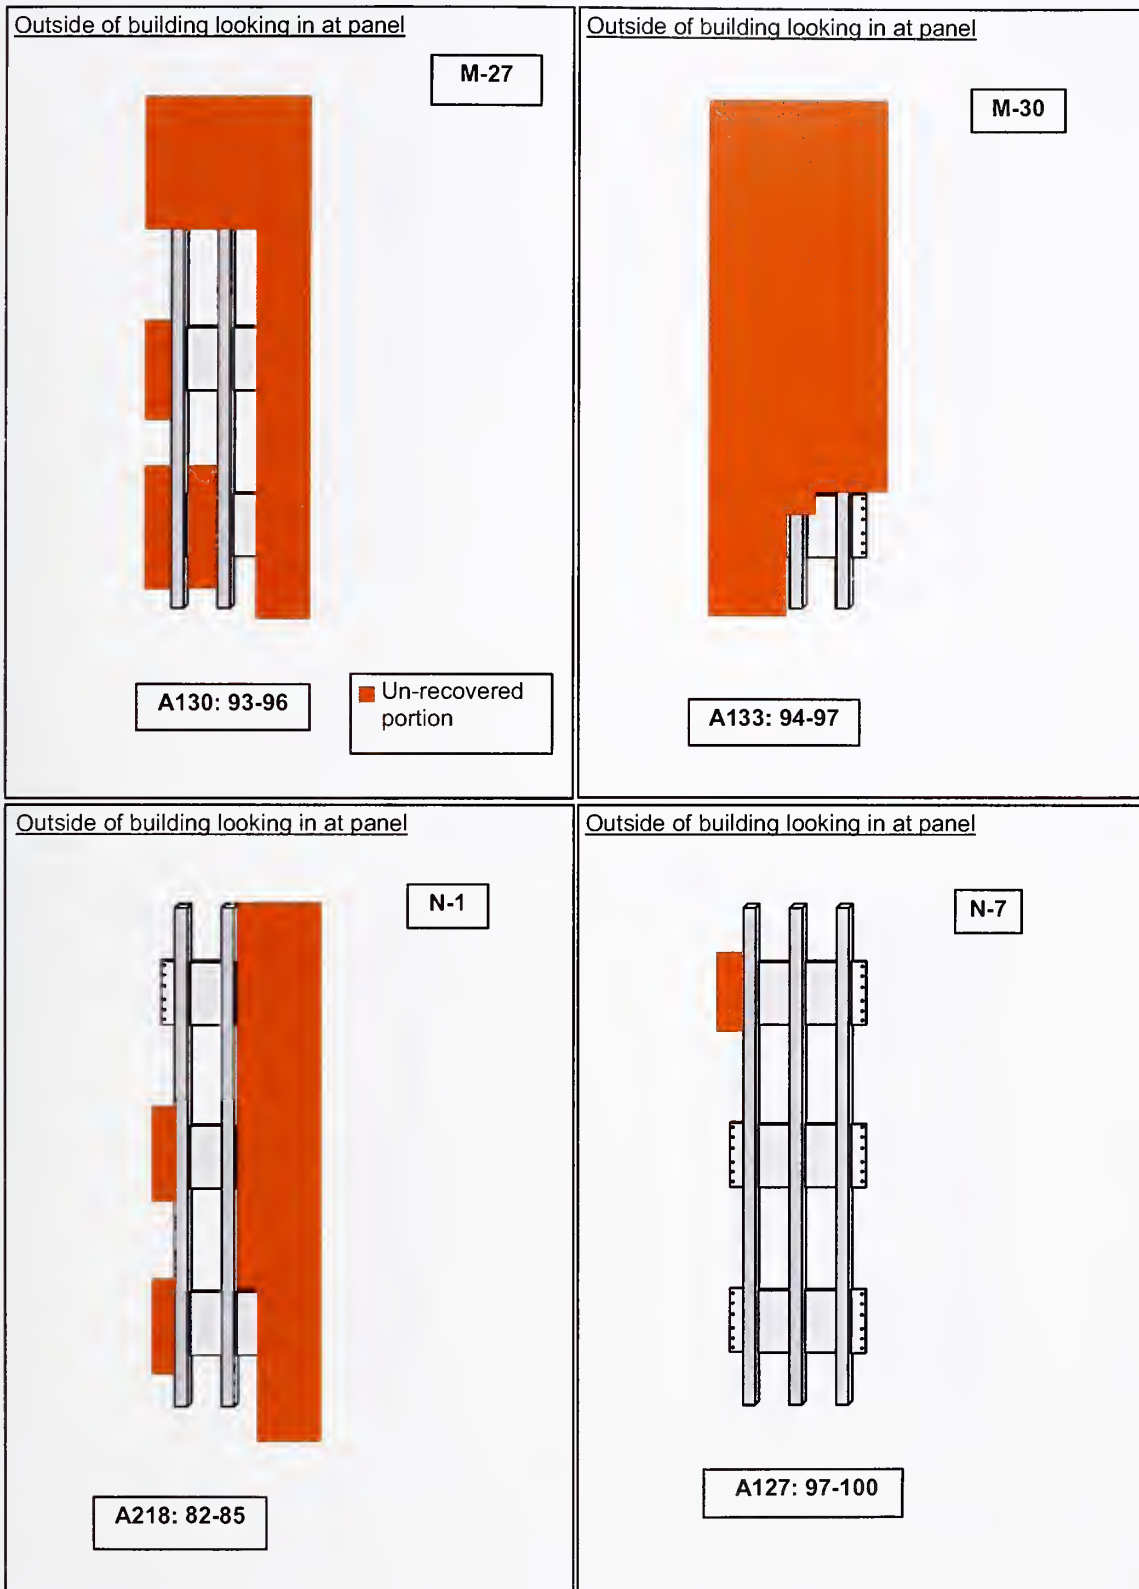
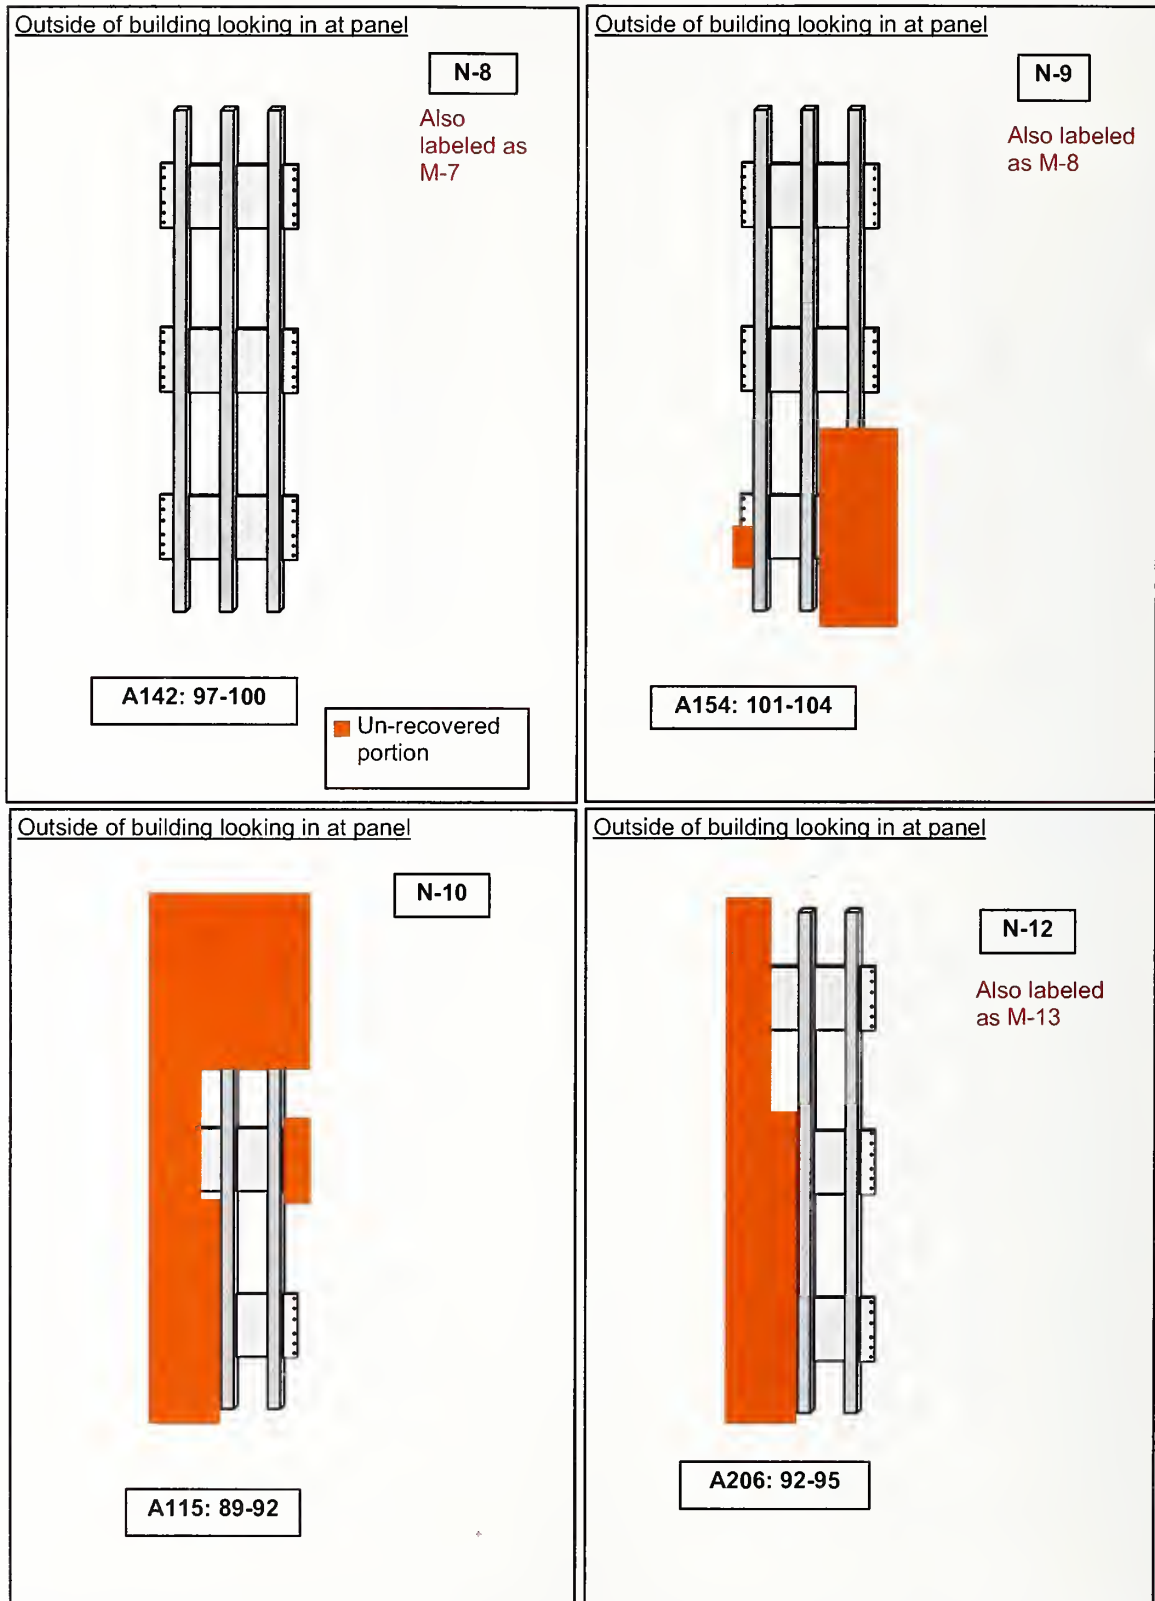
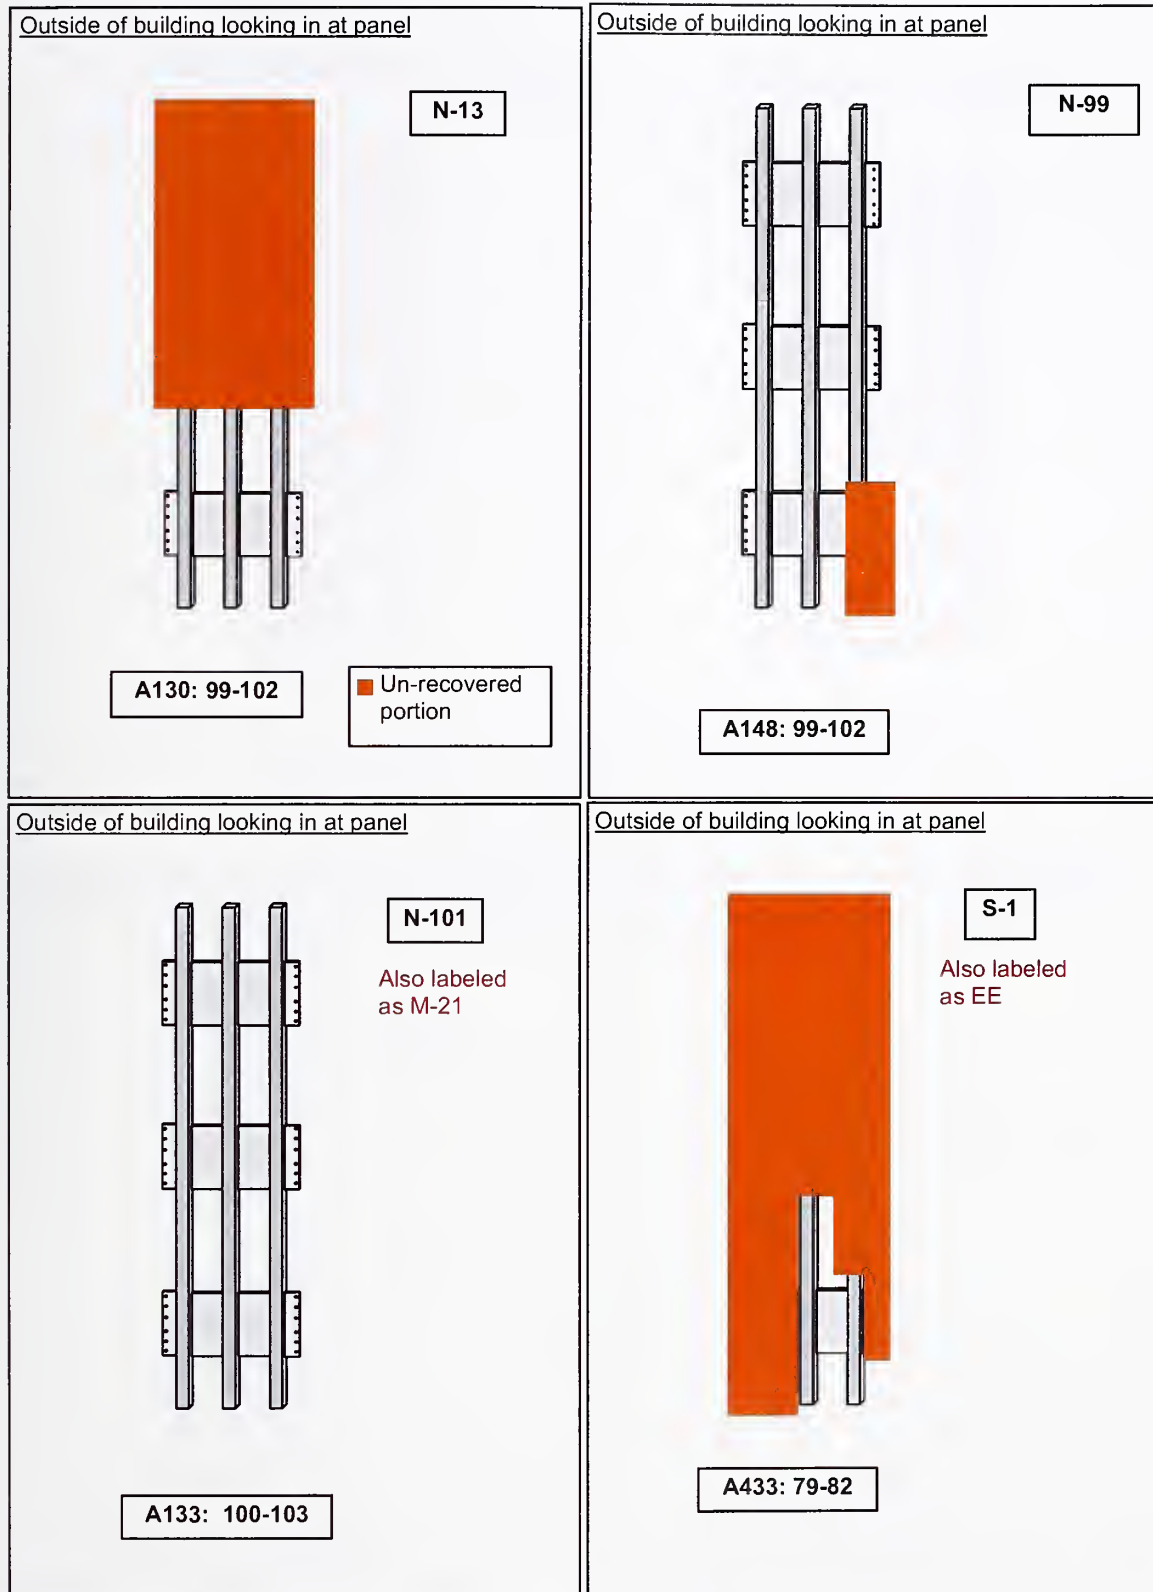
Figure F-10. Exterior column panel maps indicating the portion of the specific exterior column panel section recovered from WTC 1.

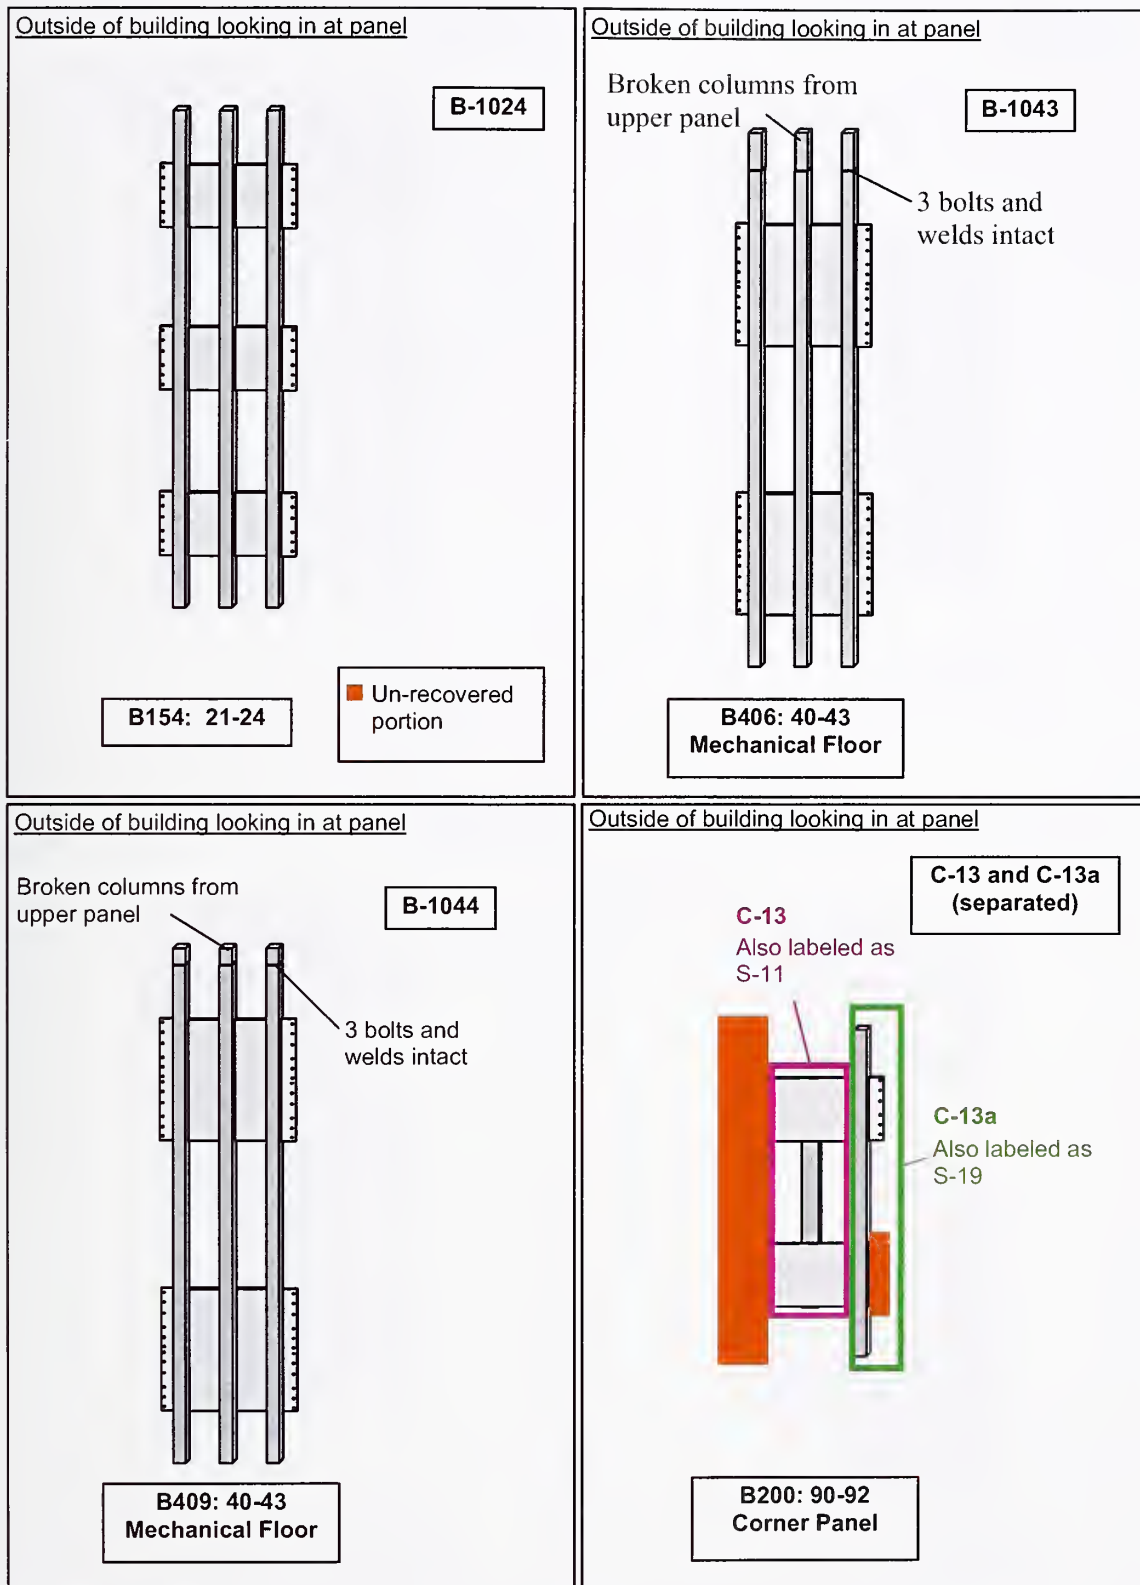
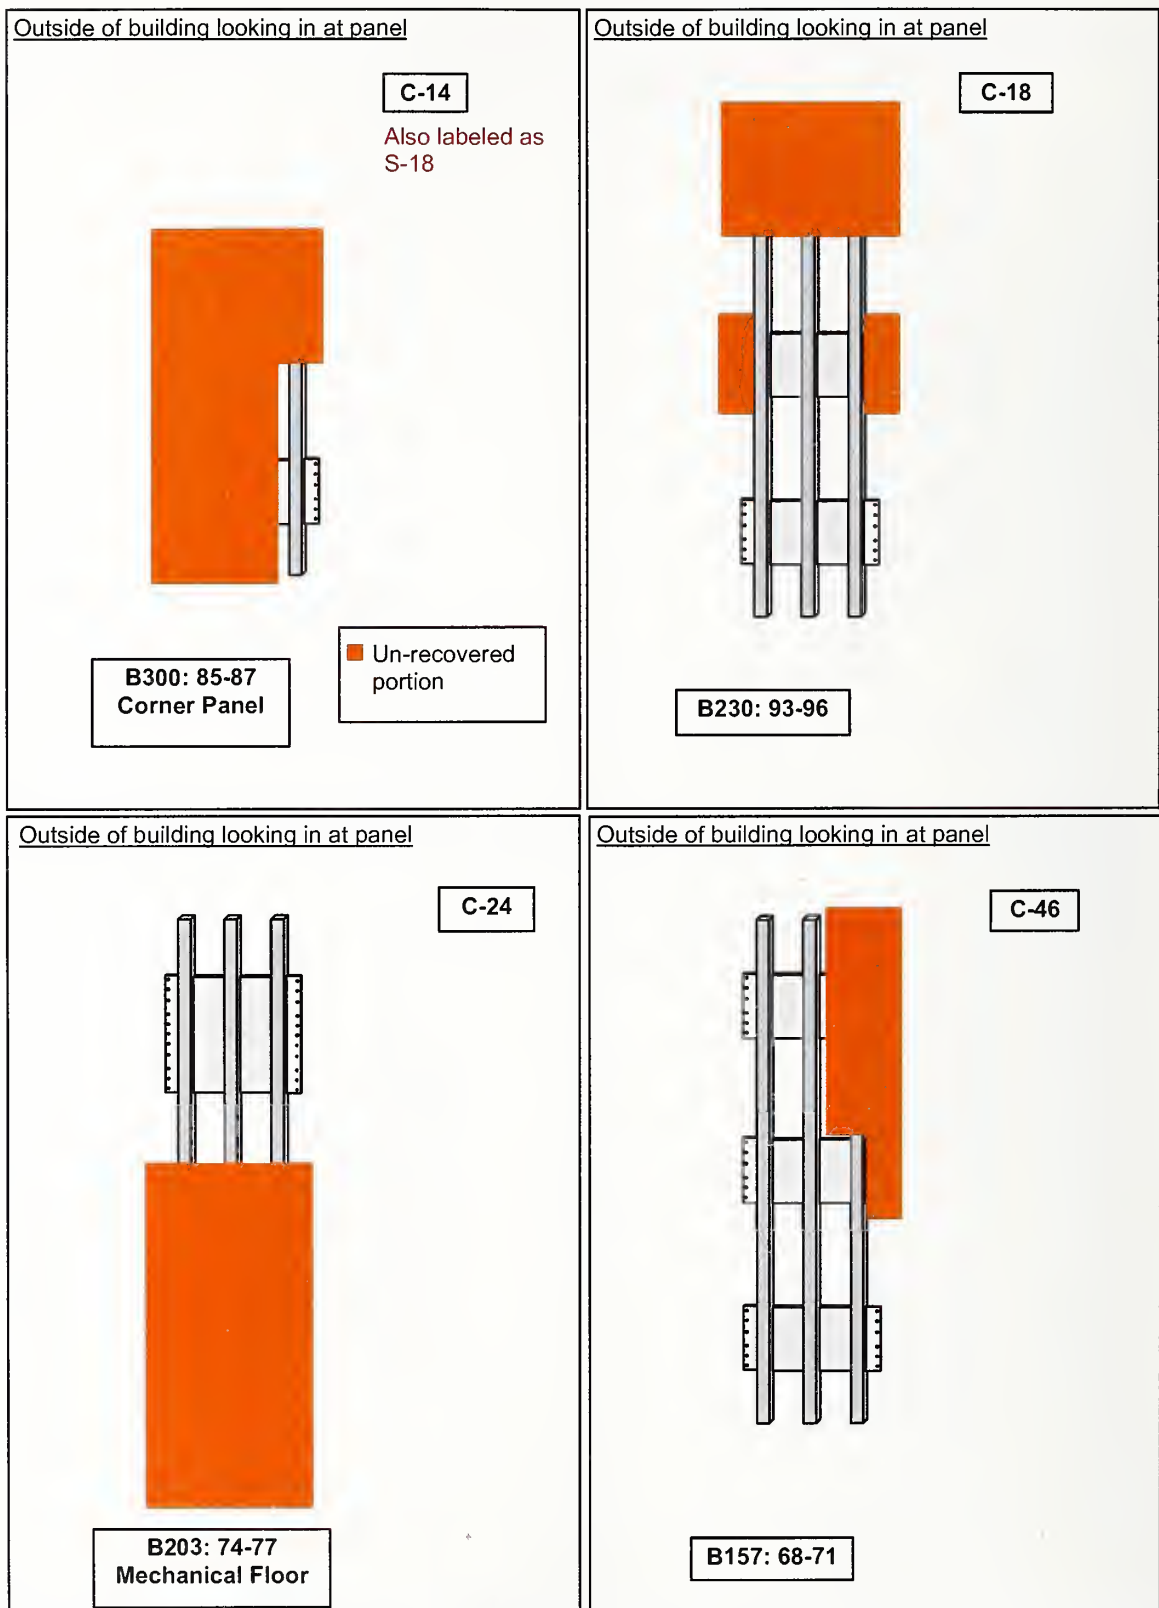
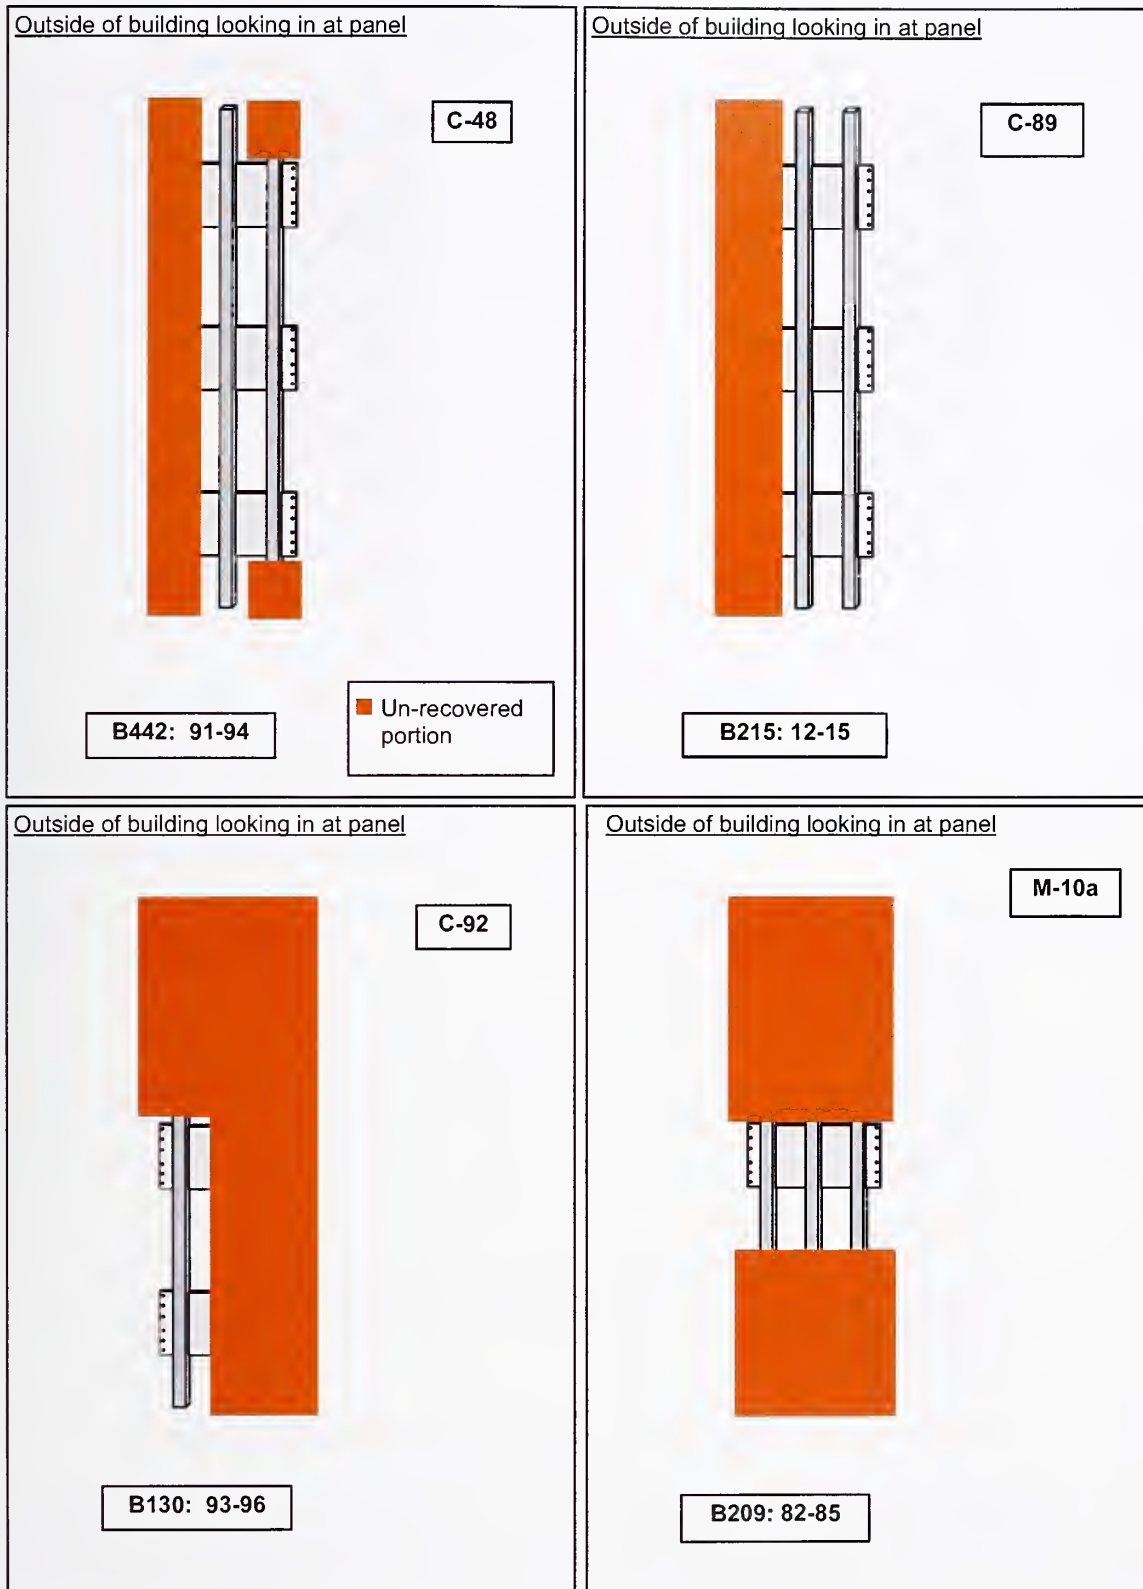
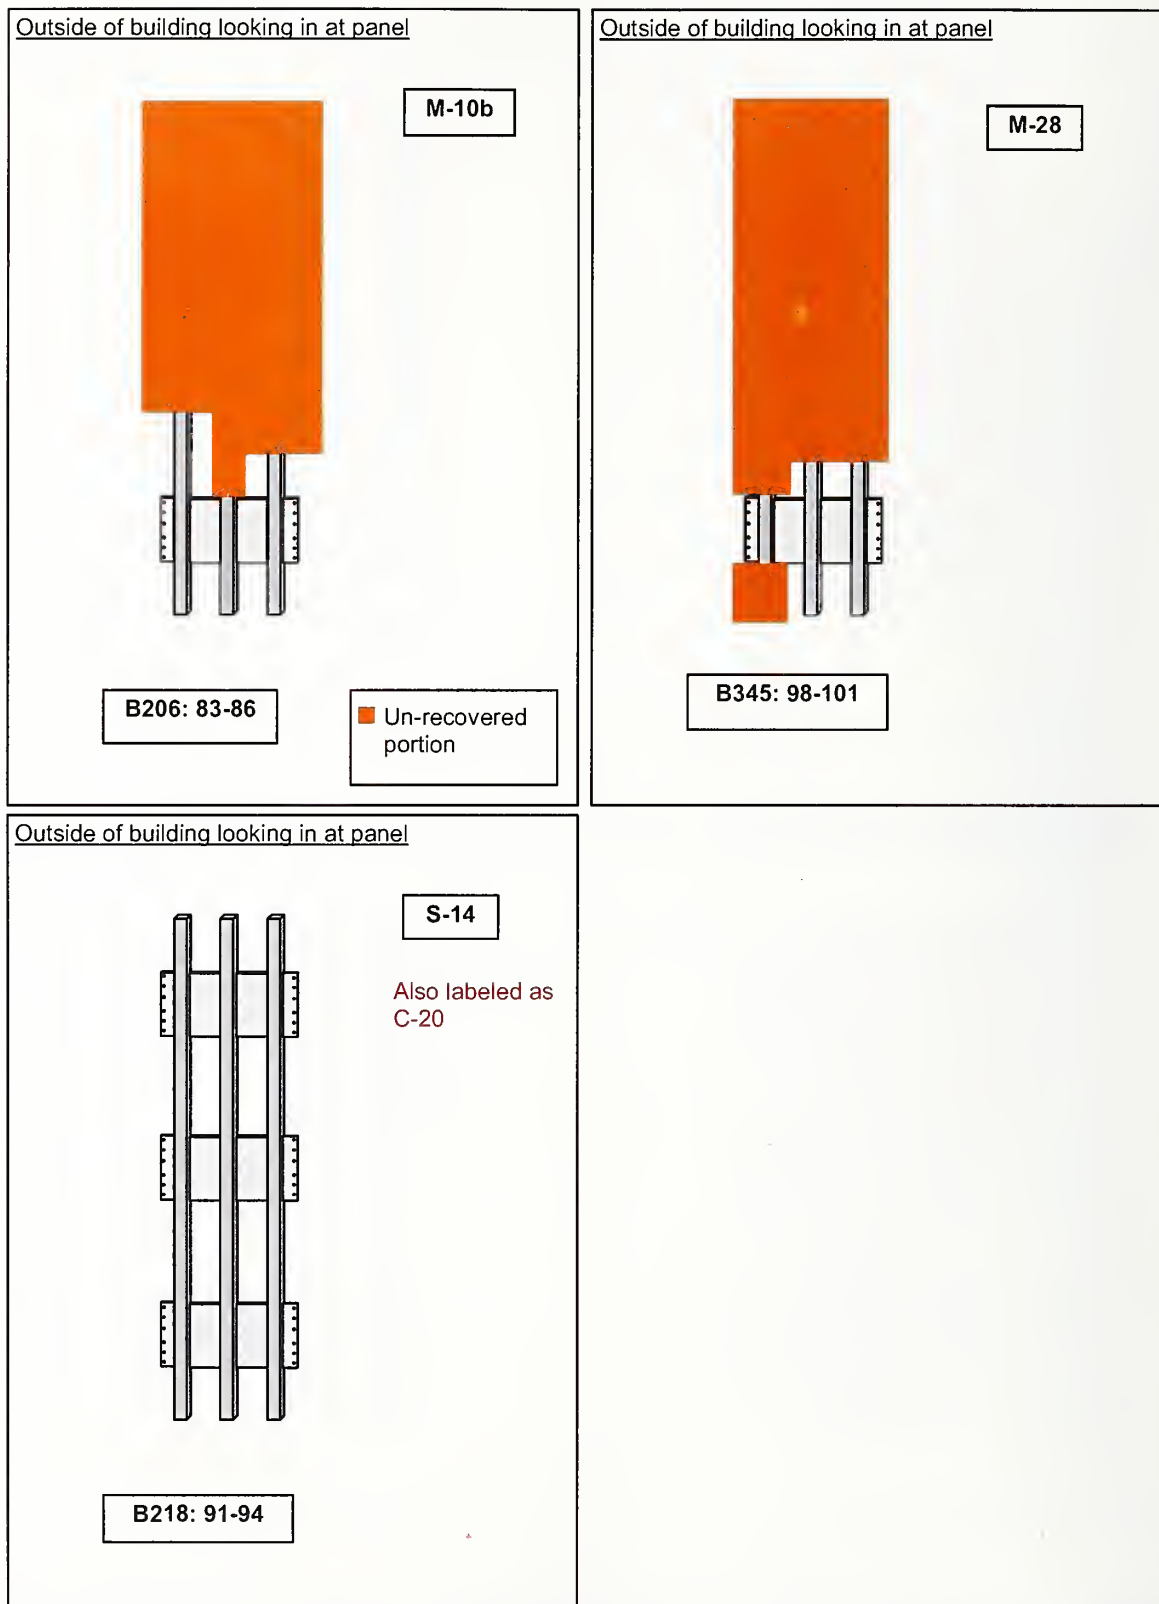
Figure F-11. Exterior column panel maps indicating the portion of the specific exterior column panel section recovered from WTC 2.
