**NIST Special Publication 1000-5**

**June 2004**  
**Progress Report on the**  
**Federal Building and Fire Safety**  
**Investigation of the**  
**World Trade Center Disaster**

**Volume 3**  
Contains Appendices D, E, and F

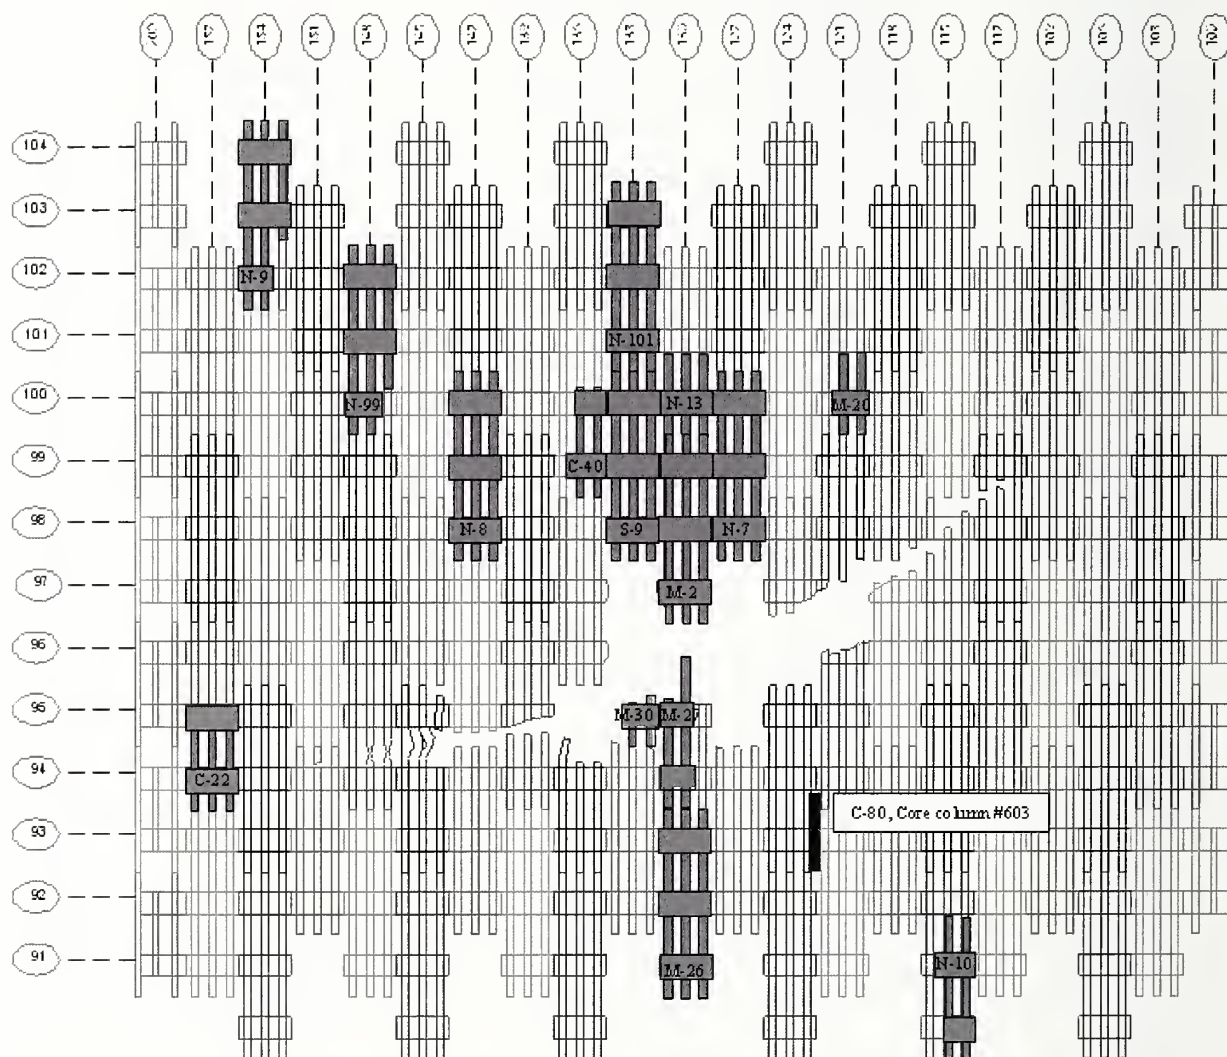
**Figure F-12. Interpreted column damage, from photographic evidence, to WTC 1, with overlay of samples in NIST's possession.**

south face of WTC 2 to complete the analysis. From this information, NIST was able to determine which perimeter panels and core columns could be used to comment on damage and possible failure mechanisms in this area. Figure F-12 shows the sample overlay of the exterior panels in NIST's possession in and around the impact zone of WTC 1. Sample C-80, a core column, was also identified as residing near the impact zone. The recovered portion of each column is approximately represented in this image. Unfortunately, there were no similar corresponding exterior panels for WTC 2, but two core columns were recovered, (Fig. F-13). Later reports will describe the type of damage and failure mechanisms associated with each sample.

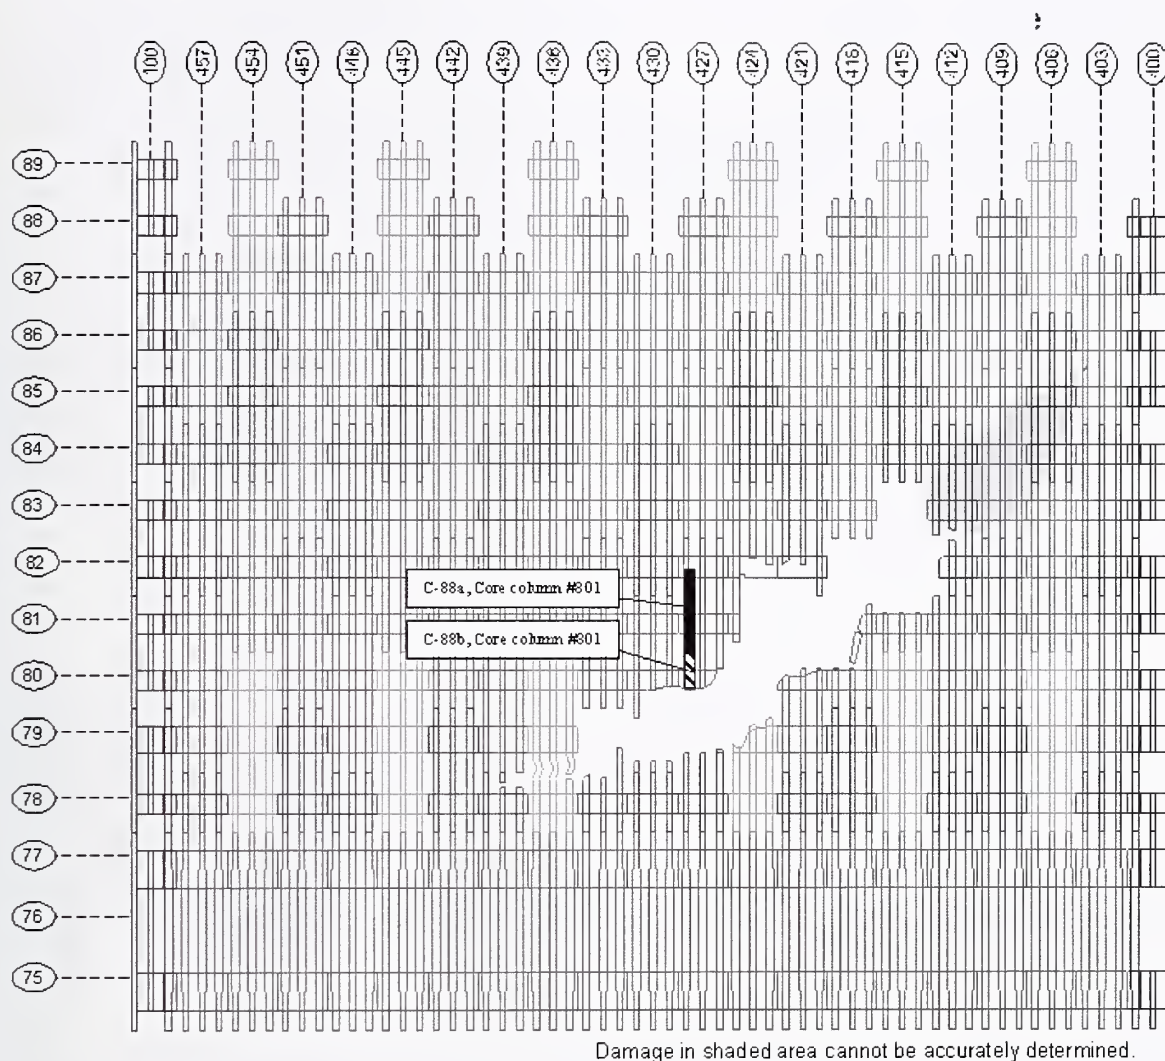
**Figure F-13. Interpreted column damage, from photographic evidence, to WTC 2, with overlay of samples in NIST's possession.**

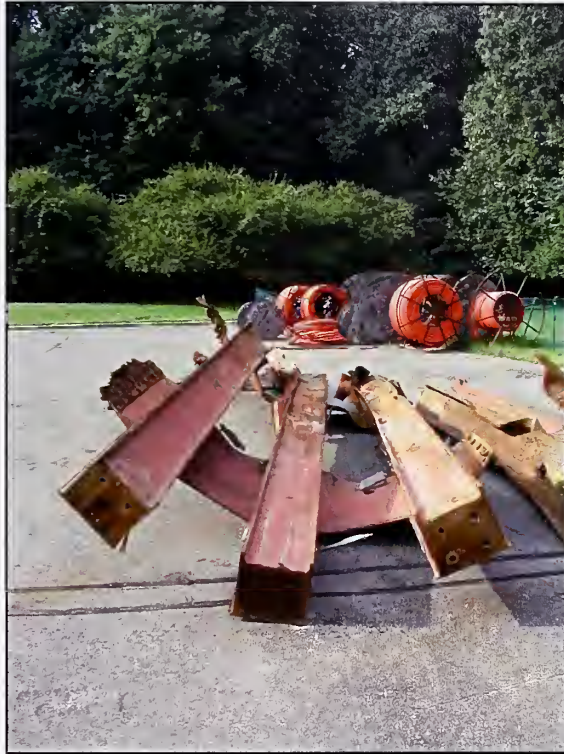
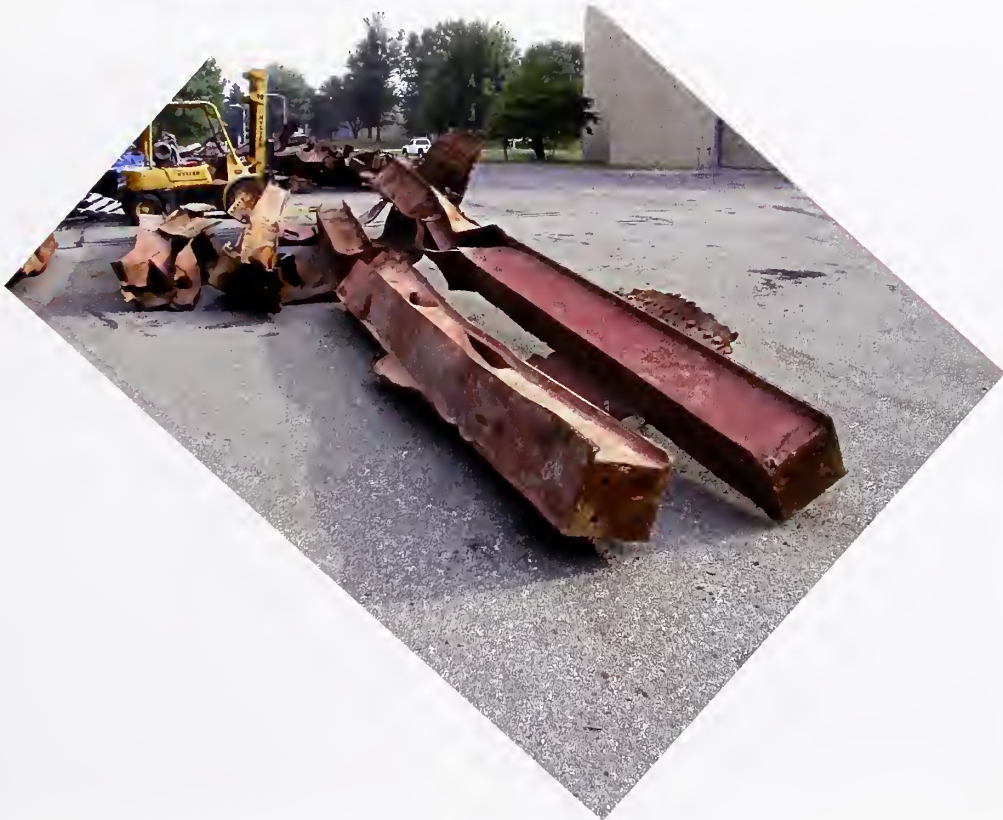
**Figure 1-1. Exterior column panel, sample C-46 shown.**

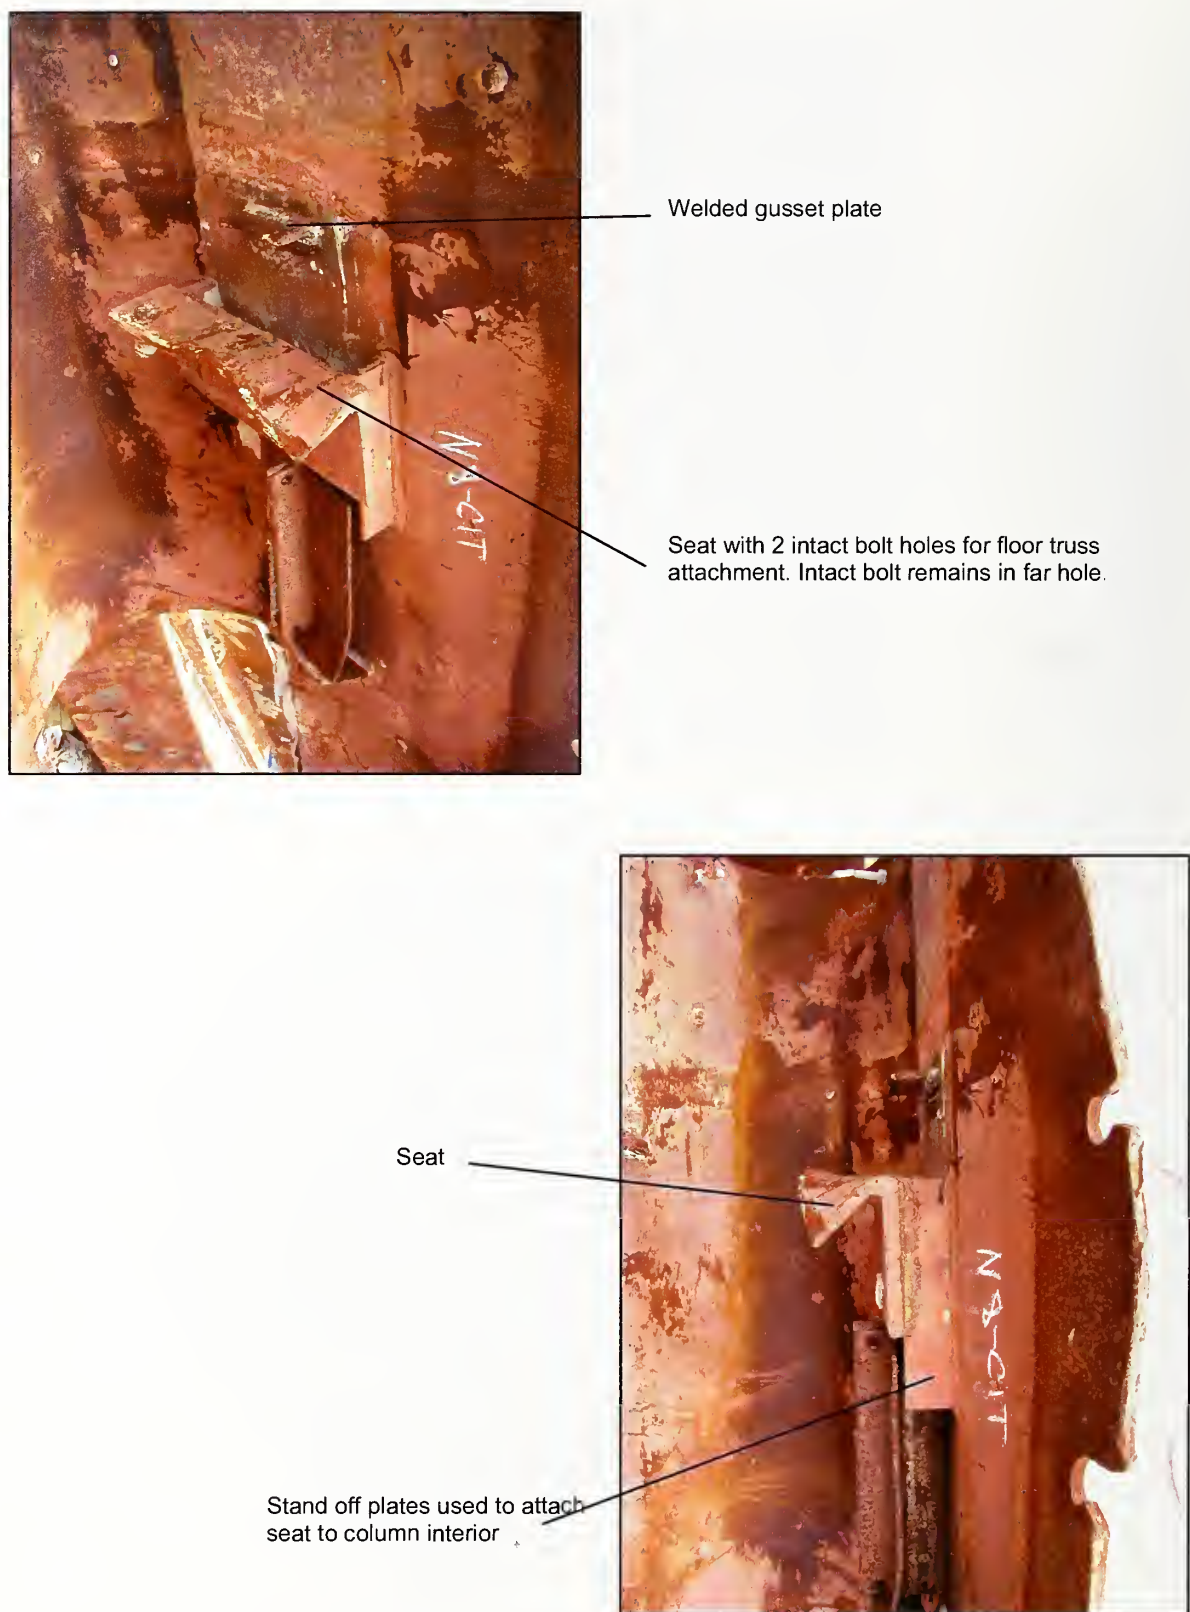
Figure 1-2. Floor truss seats shown from sample N-8.

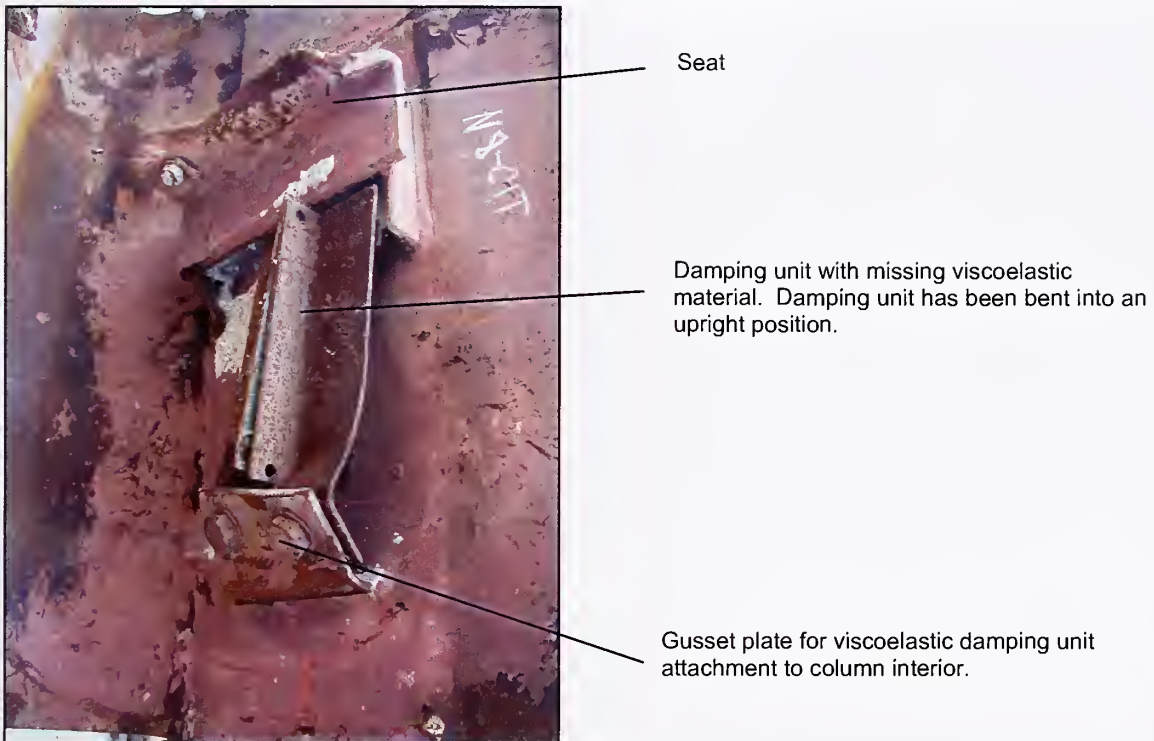
Figure 1-3. Damping Unit shown from sample N-8.

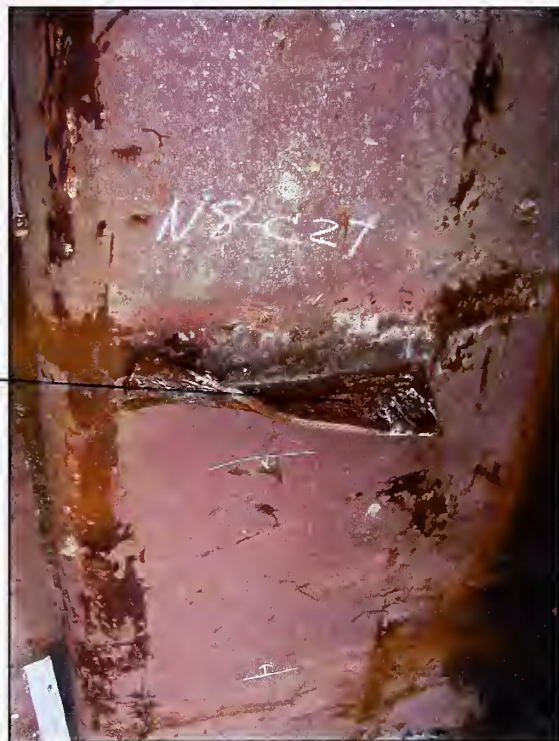
Welded gusset plate used in place of seat on alternate column/spandrel intersections. One method used to attach diagonal bracing strap to exterior wall

Figure 1-4. Gusset plate shown from sample N-8.

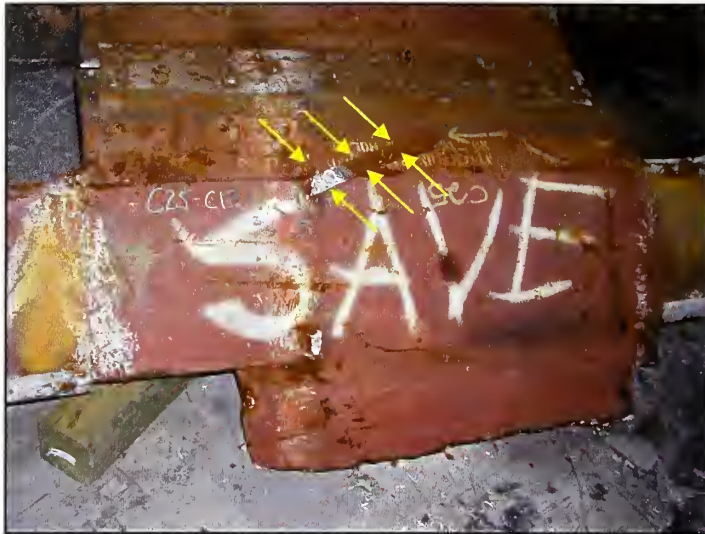
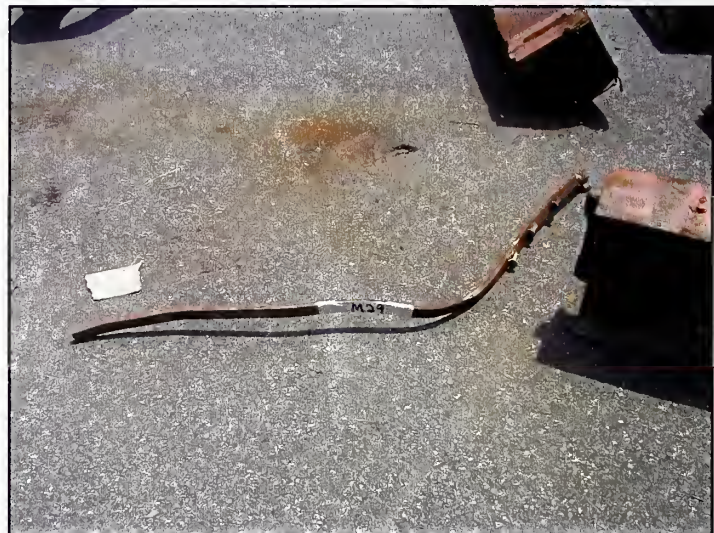
Diagonal bracing strap attached  
directly to exterior column

**Figure 1-5. (left) Diagonal bracing strap shown on sample C-25, (top), and single strap labeled M-29 (bottom).**

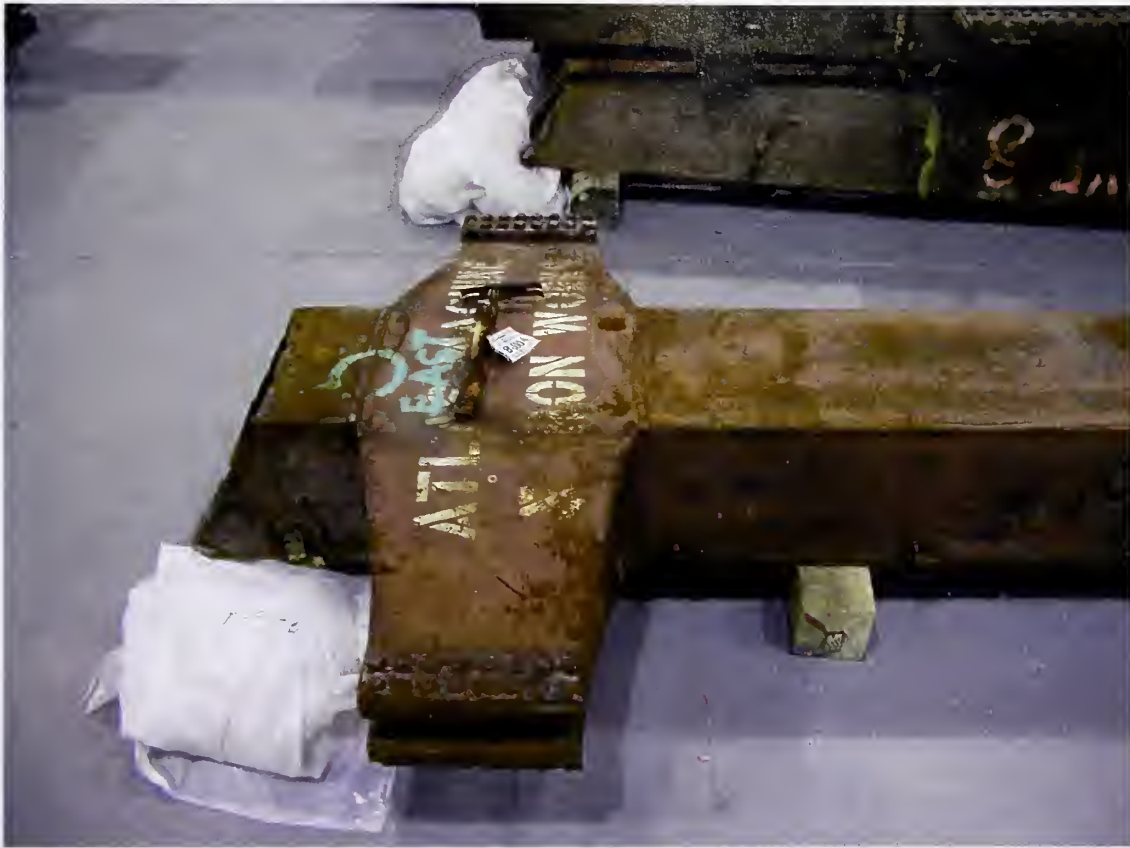
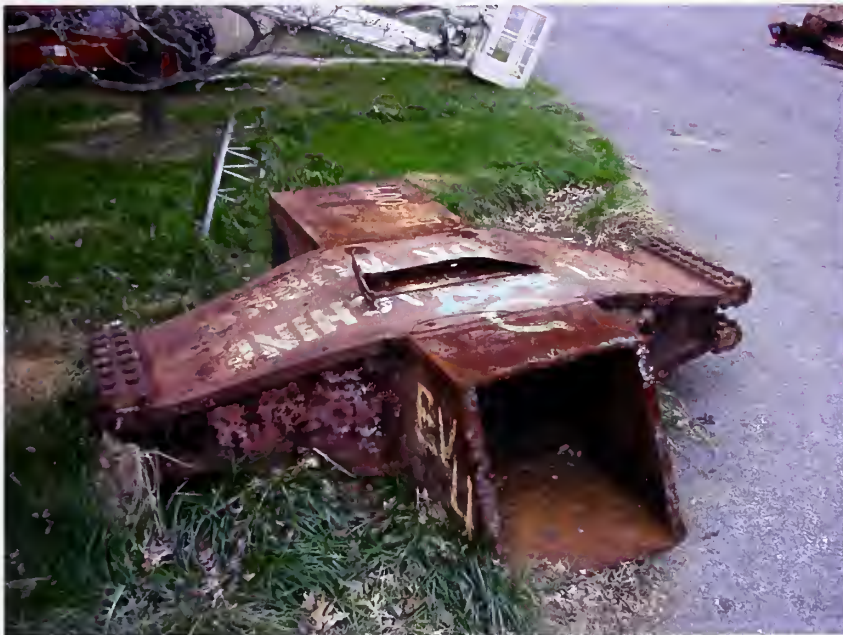
**Figure 1-6. Bowtie section of exterior wall.**

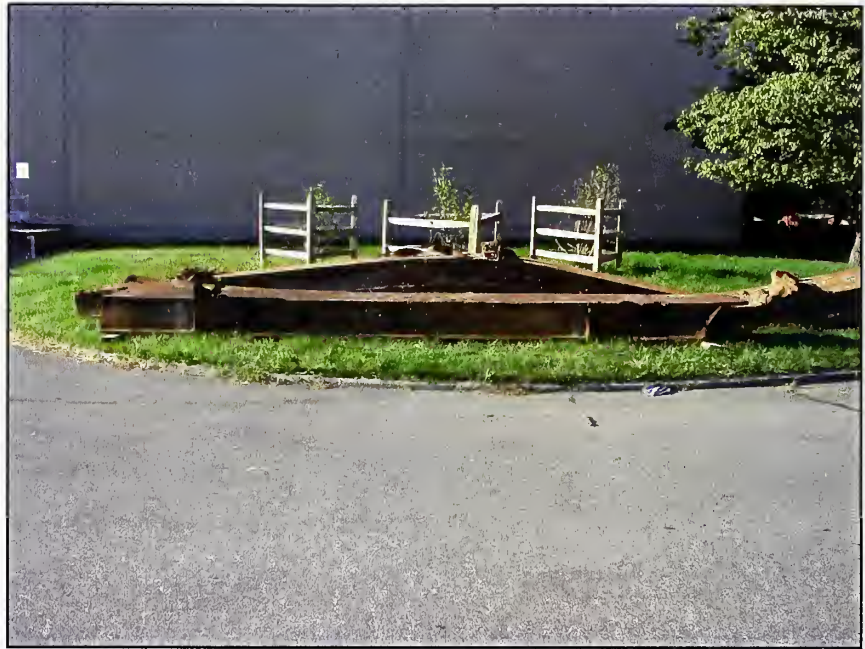
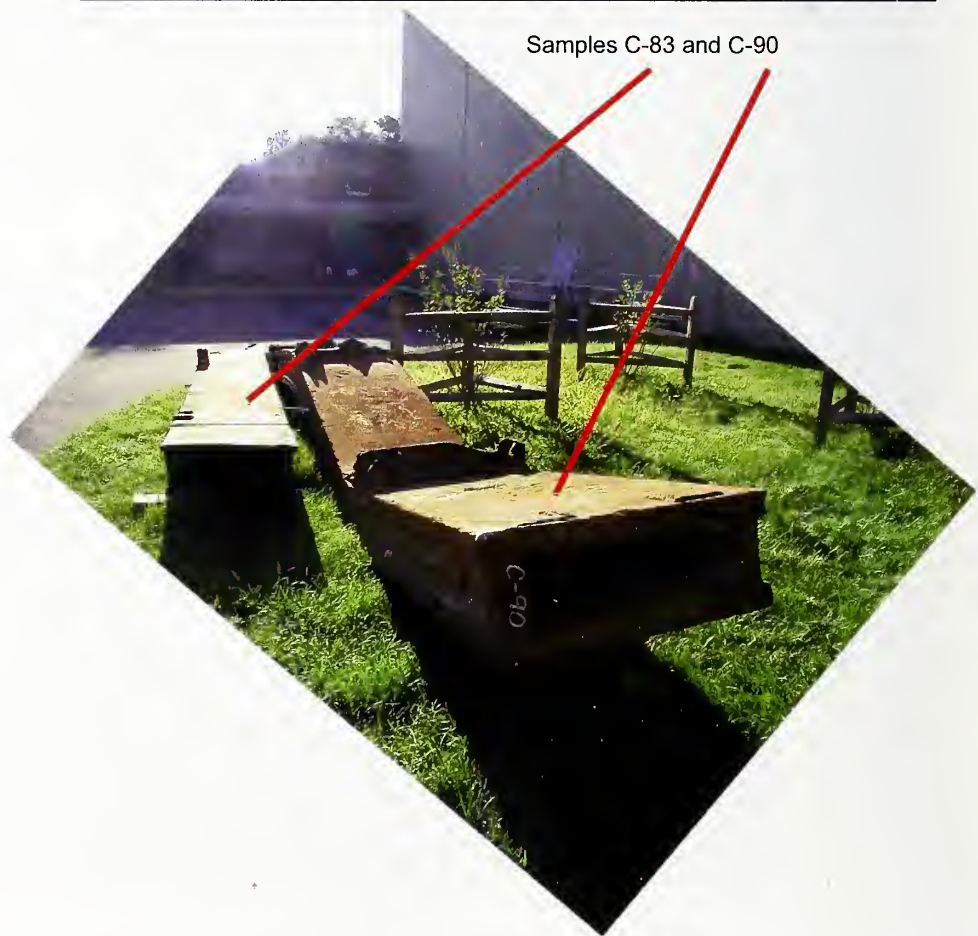
Figure 1-7. Recovered rectangular built up box sections used as core columns.

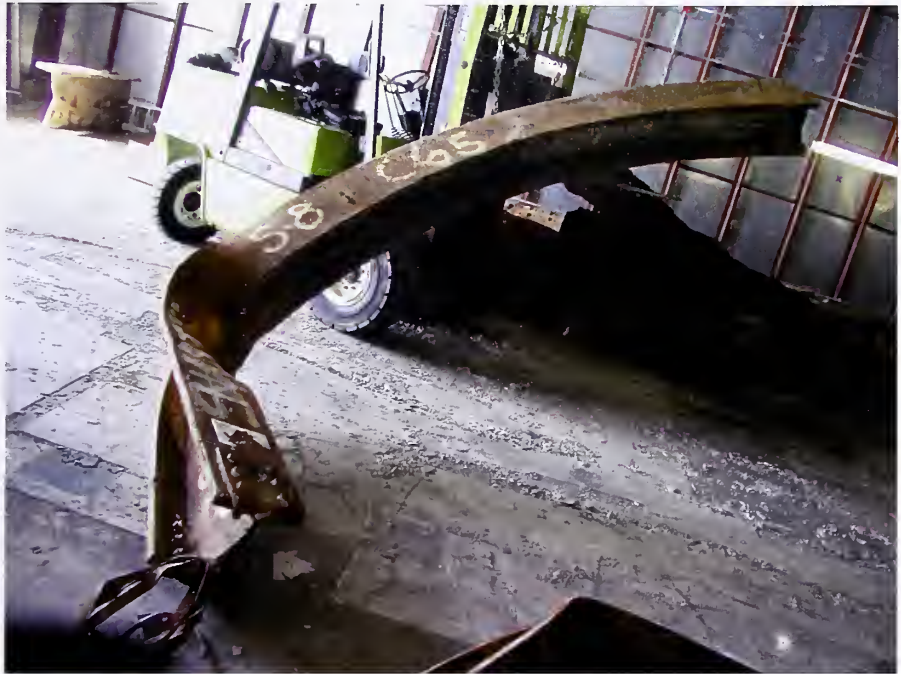
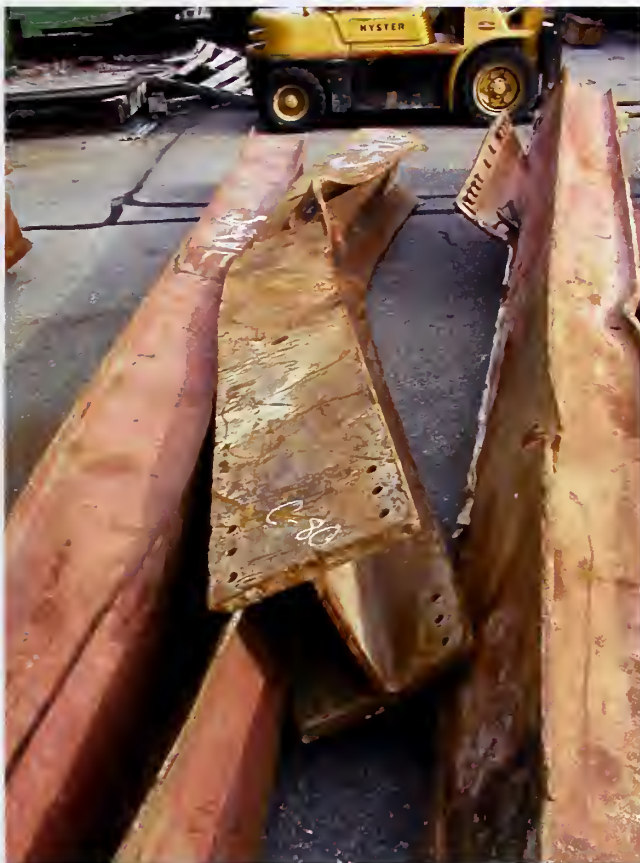
Figure 1-8. Recovered wide flange sections used as core columns.

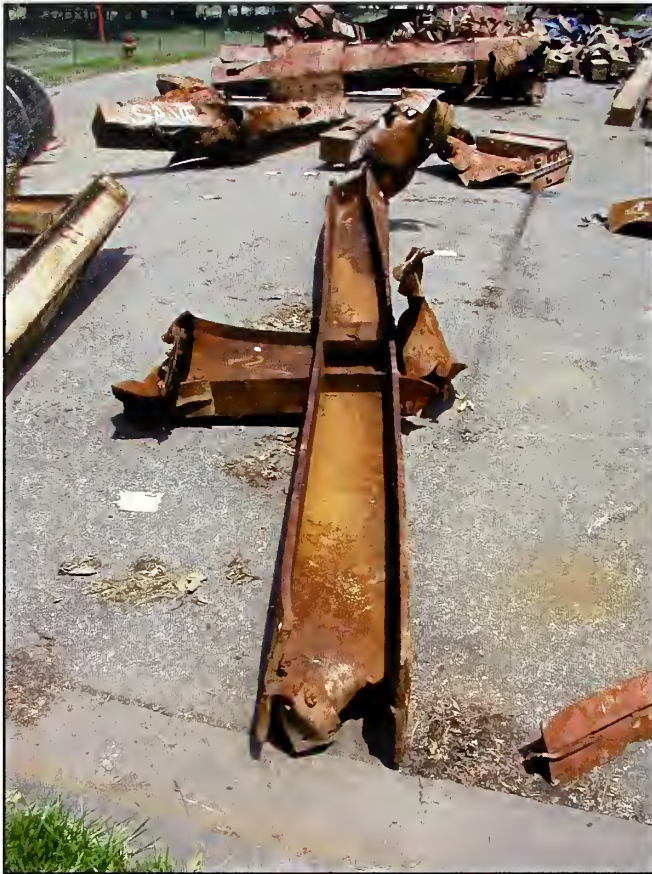
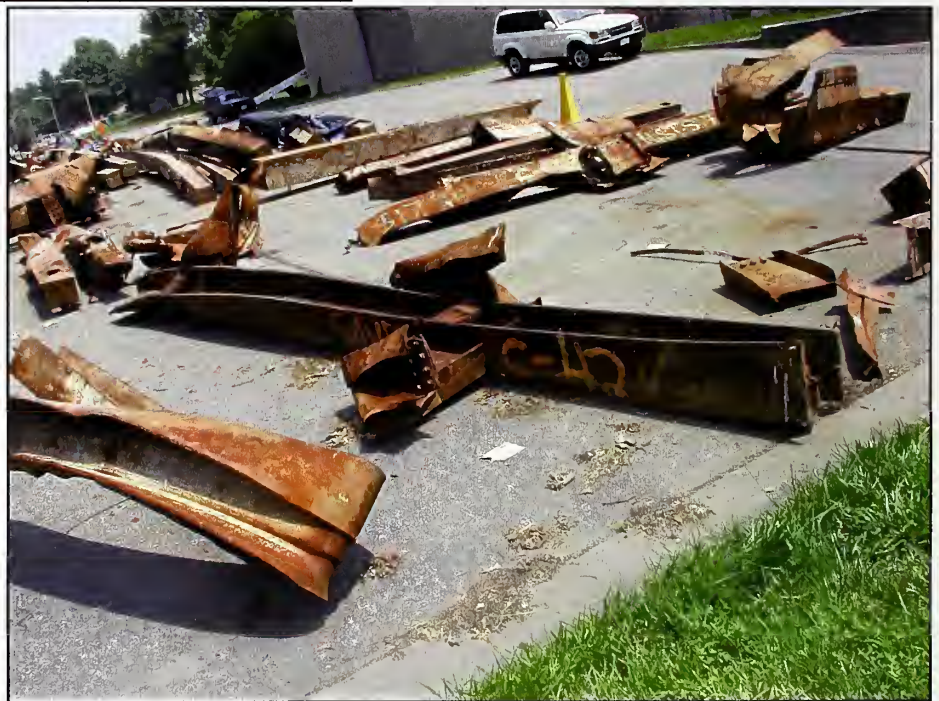
Figure 1–9. Other recovered wide flange sections, shown is sample C-42.

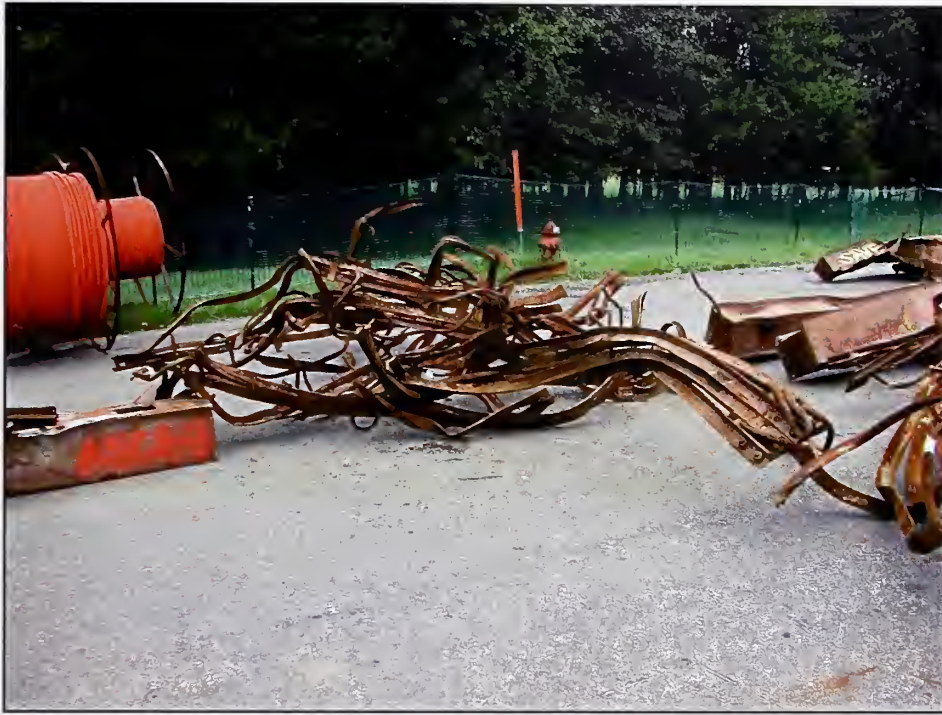
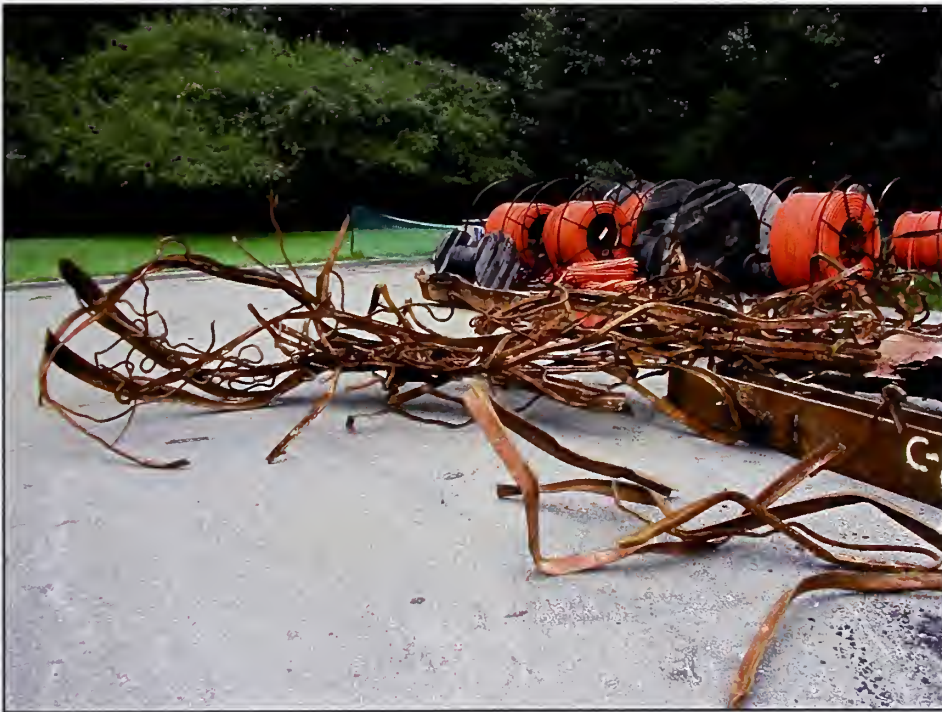
**Figure 1-10. Recovered floor truss material, shown are portions of sample C-53.**

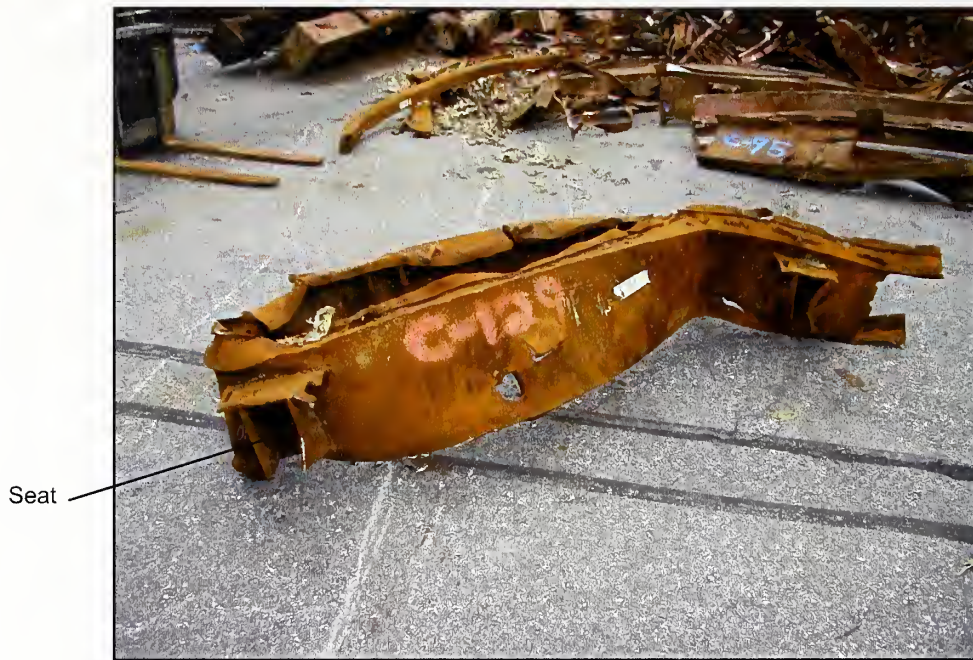
**Figure 1-11. Recovered inner channel material used to connect floor trusses to core columns; shown is sample C-129.**

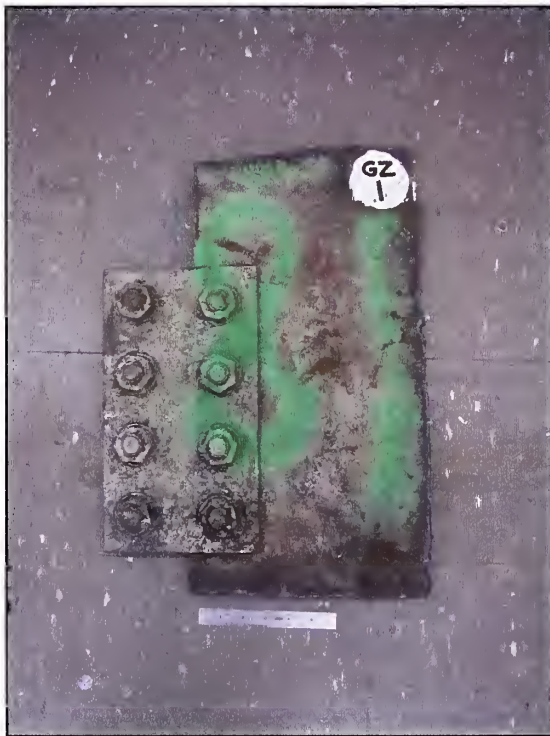
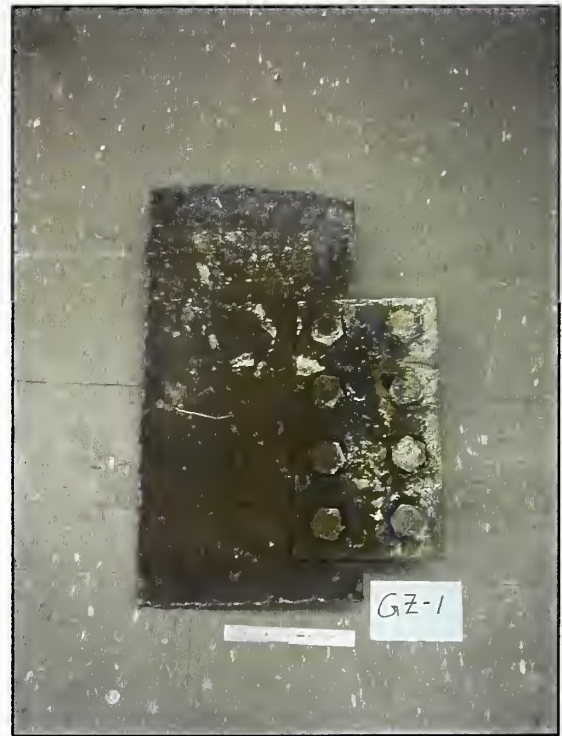
**Figure 1-12. Coupons removed in the field from WTC 5; shown is sample GZ-1.**

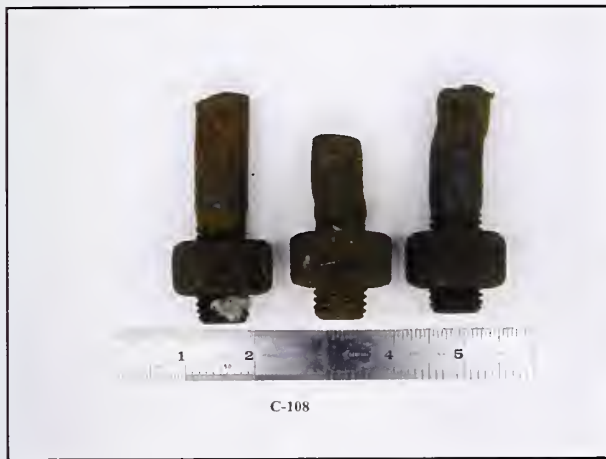
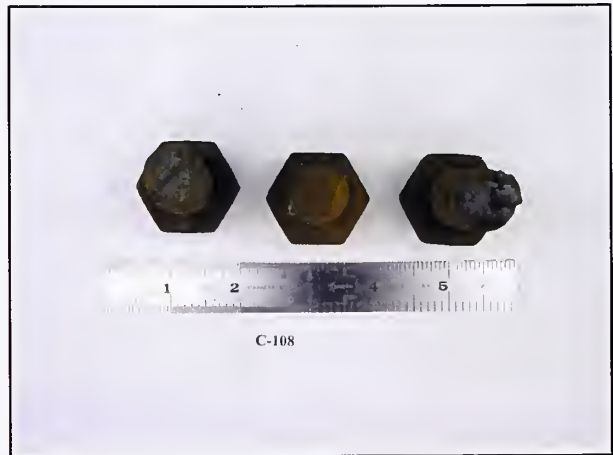
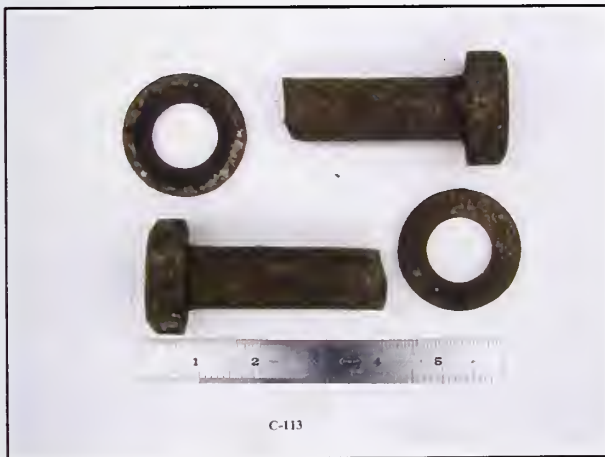
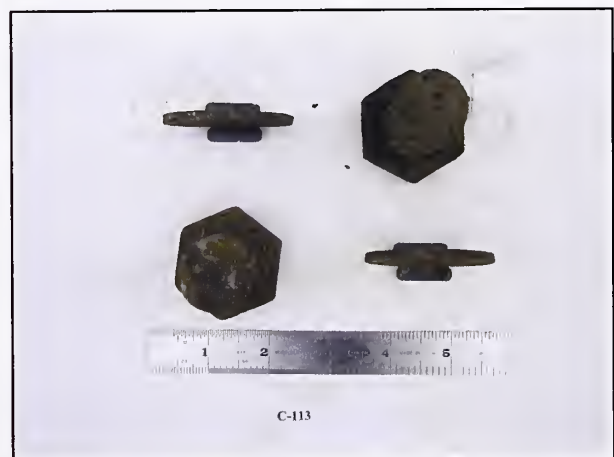
Figure 1-13. Examples of recovered bolts from various samples.
