# **Stress Corrosion Behavior of Clad 7050-T76 Aluminum Sheet**

**B. T. Sanderson and W. F. Gerhold**

**April 1978**

**Prepared for  
Naval Air Systems Command  
Department of the Navy  
Washington, D.C. 20360**

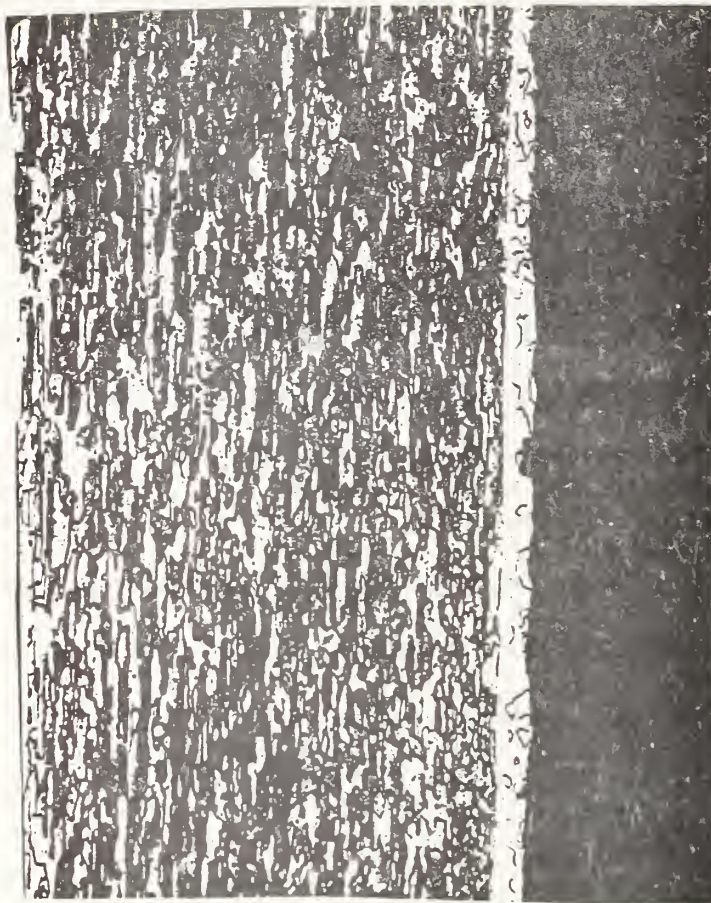
Figure 1. Photomicrograph of clad 7050-T76 aluminum alloy showing localized pitting corrosion in the cladding material and typical microstructure. Etched, Kellers Etch. X50.

Transverse sections were obtained from the exposed samples for metallographic examination (Fig. 1). The localized corrosion pitting is visible in the cladding material. In general, the microstructure revealed a uniform grain size in both the clad and core material.
