NIST NCSTAR 1-3B

Federal Building and Fire Safety Investigation of the
World Trade Center Disaster

Steel Inventory and Identification

Stephen W. Banovic

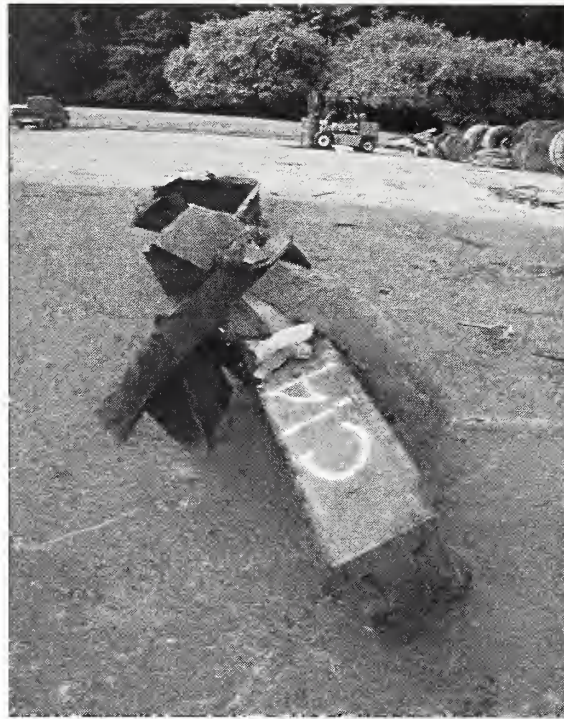
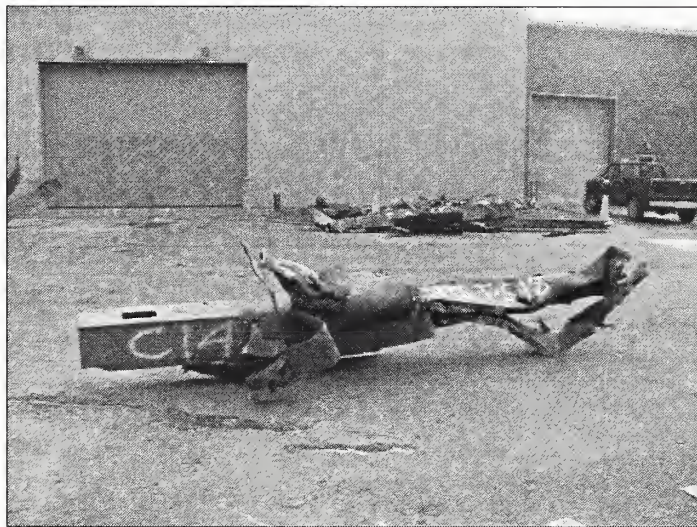
Figure 3–1. Characteristic “overall” view of the samples taken for each piece received. Sample shown here is C-14.

As samples were delivered, overall images of the pieces were taken for record-keeping purposes. An example is shown in Fig. 3-1. Samples are identified by their original alphanumeric identification codes assigned by Structural Engineers Association of New York to be consistent with the Federal Emergency Management Agency report. However, there were cases in which two different codes were found on one piece. In these instances, if the pieces were already undergoing documentation procedures, the first code noted was used. Samples that arrived lacking a code were labeled as part of the U series. Additionally, samples brought from Hanger 17 at John F. Kennedy International Airport maintained their "B"-series labels provided in the Voorsanger report.²

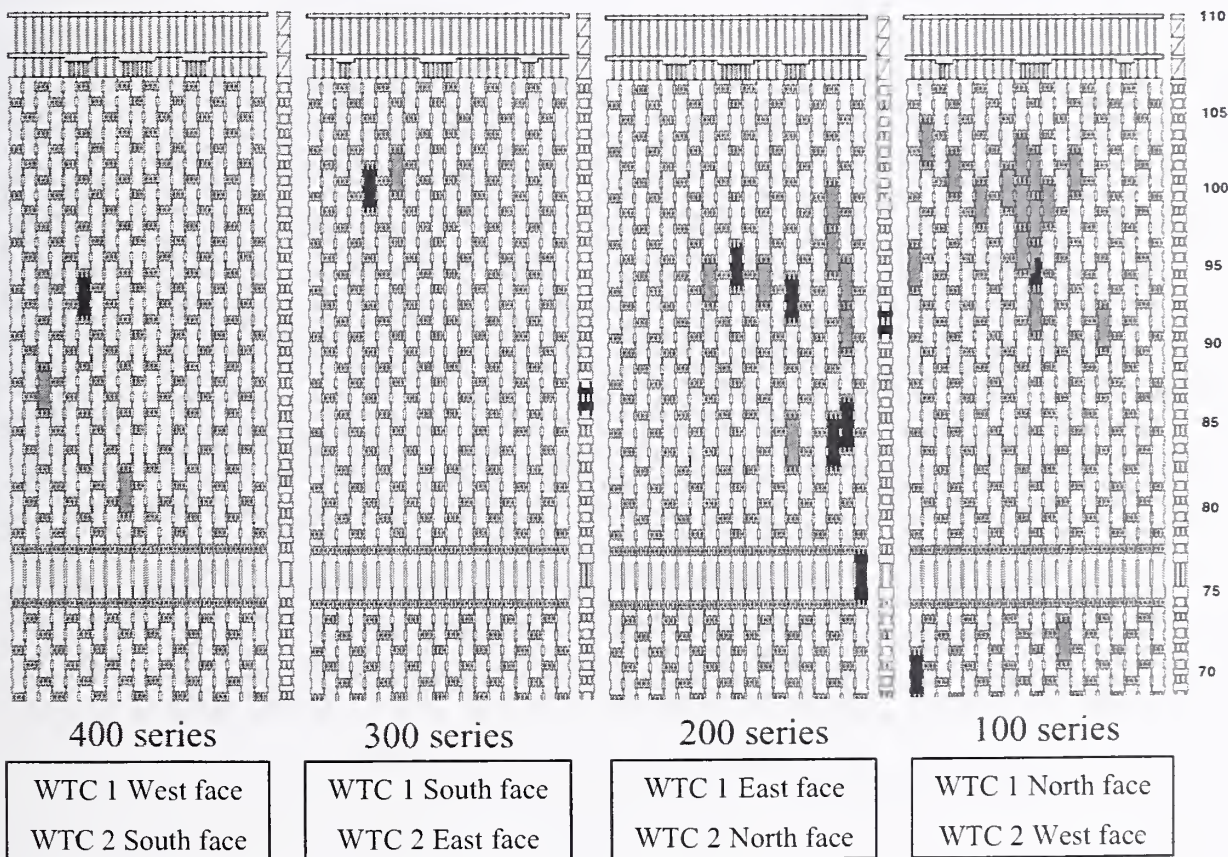
Note: WTC 1 panels are shown in green and WTC 2 panels are in blue.

Figure 3-2. Location of the exterior panels recovered from the top third of WTC 1 and WTC 2.

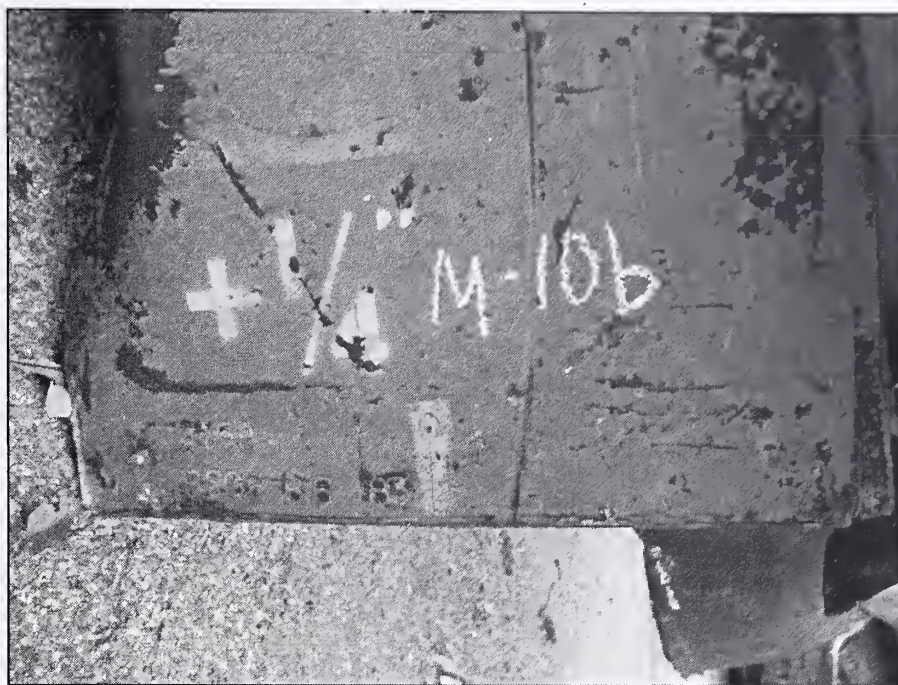
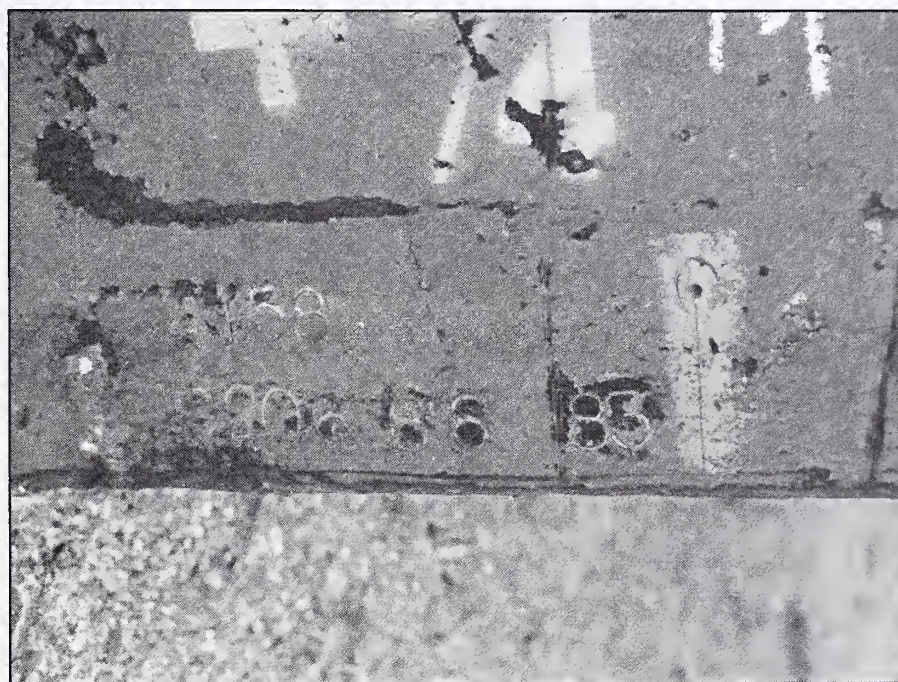
Figure 3–3. Example of stampings on the interior base of the middle column for each panel.

The positive identification of the structural elements was made possible by deciphering the stampings and/or stencils found on them. During the fabrication process, the exterior panel sections were stamped at the bottom of the center column on the inside face. These stampings indicated the building, center column line number, and floors spanned by the columns. The core columns had stampings placed at the lower end of the component near the connector. The building was typically represented as "A" for WTC 1 and "B" for WTC 2. An example of a stamping found on an exterior column is shown in Fig. 3-3, where the stamping indicates that the piece was from WTC 2, with center column line number 206, spanning floors 83 through 86. Core column material was found to have similar markings (Fig. 3-4). Other stampings have also been found on the flanges of the perimeter columns that indicated the column type (Fig. 3-5 and Table 3-5) as well as the specified minimum yield strength of the column. All of these stampings typically reside within 1 m from the bottom of the column.

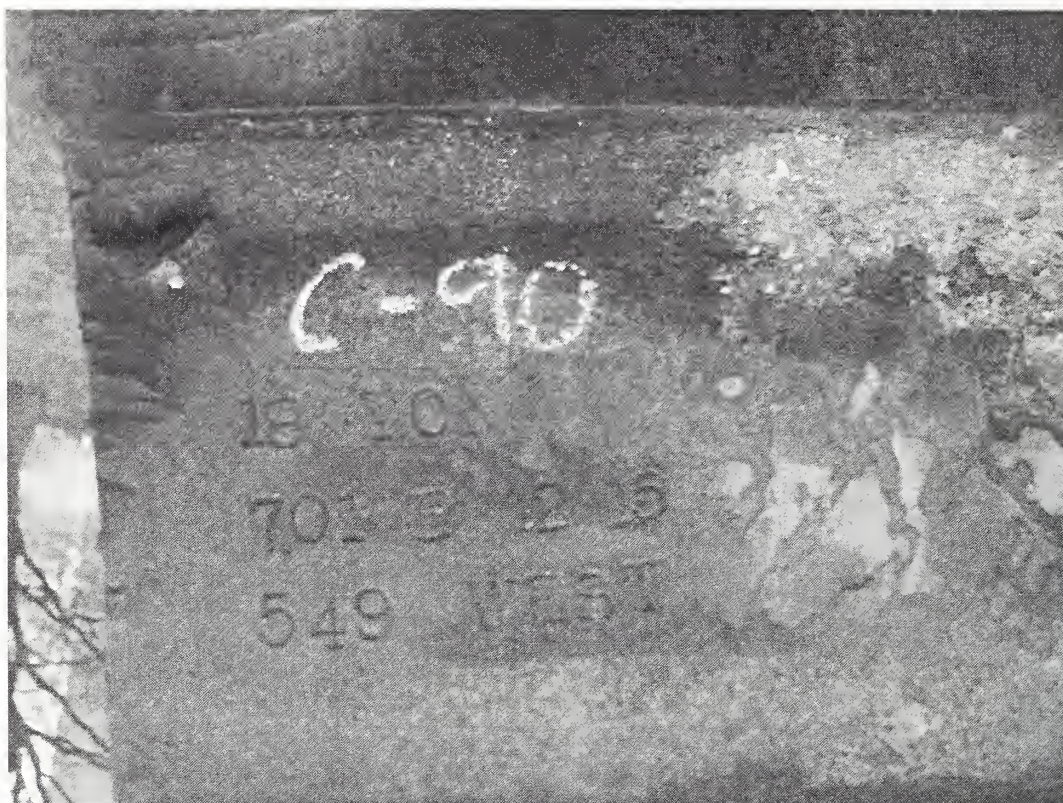
Figure 3–4. Example of stampings placed on one end of a core column.

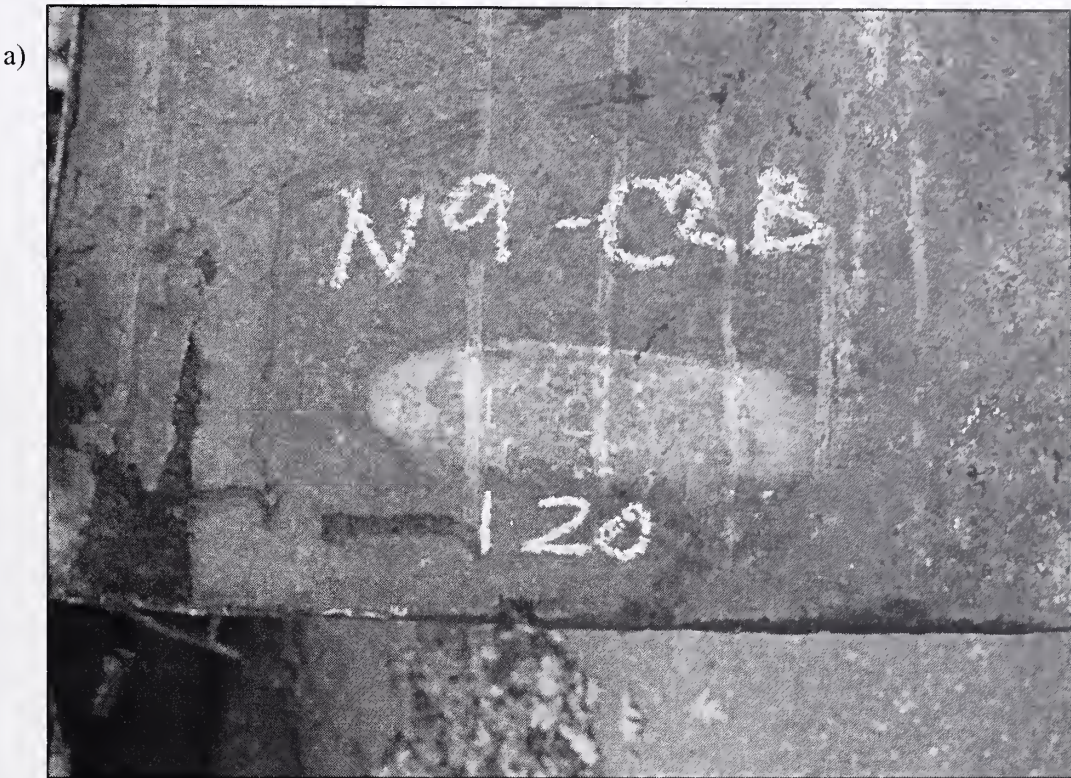
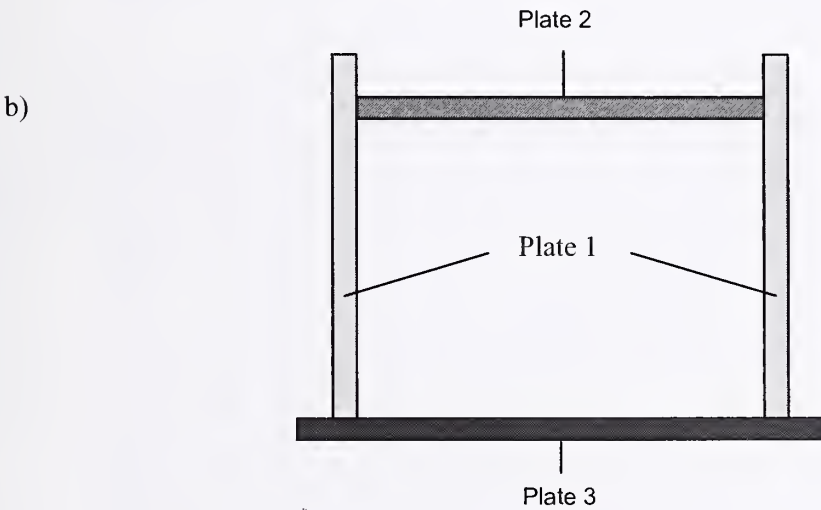
Figure 3–5. (a) Example of stamping placed on flange indicating the column type (120), and (b) schematic indicating the various plates corresponding to Table 3–5.

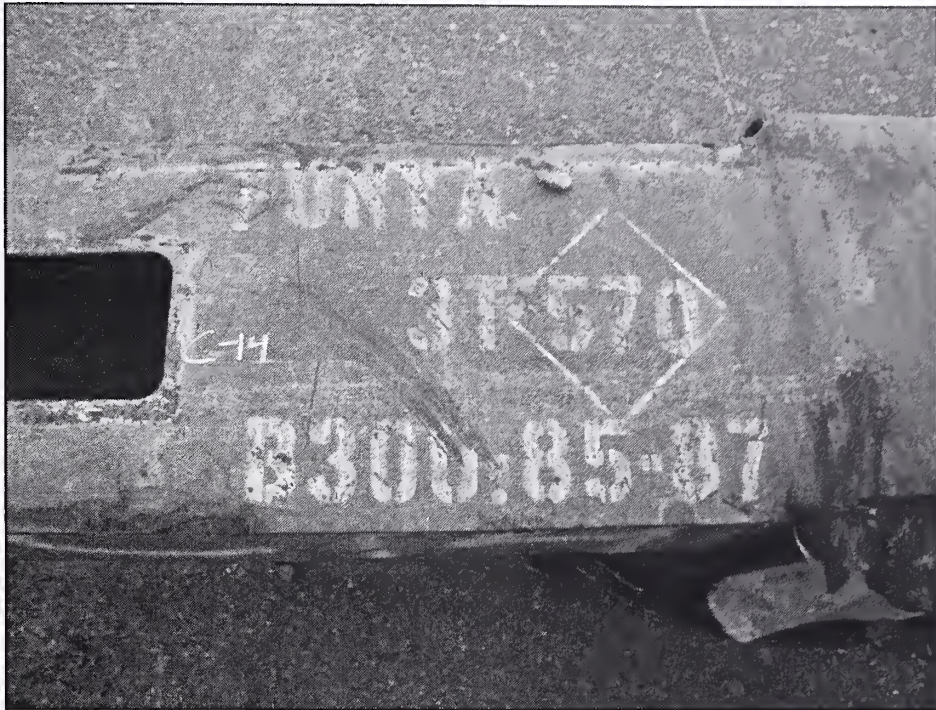
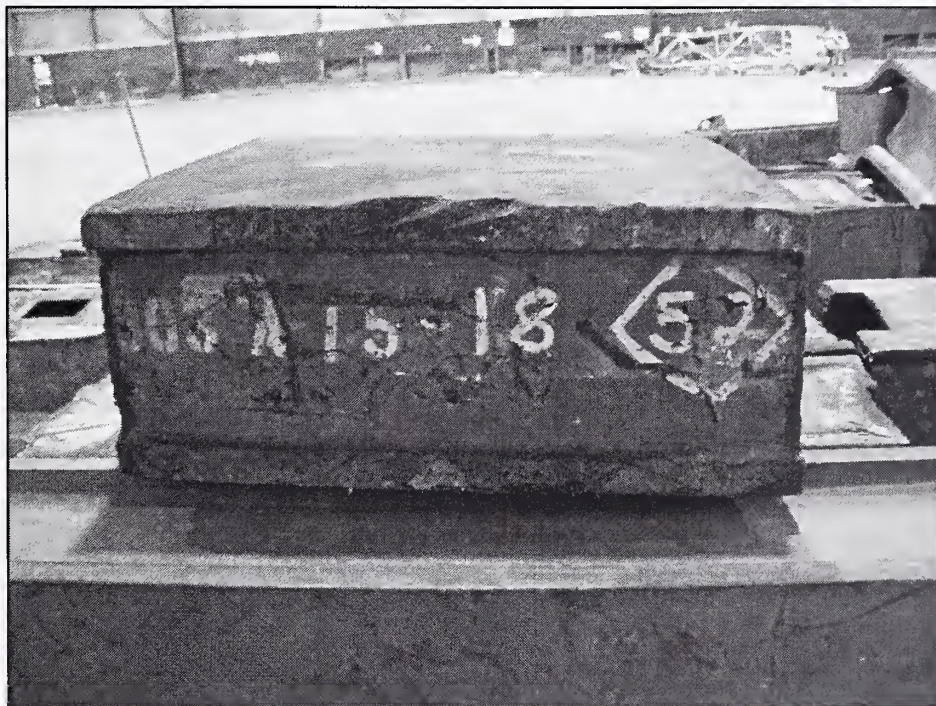
Figure 3-6. (a) Characteristic stenciling found on the lower portions of the exterior column panels for sample C-14. (b) Characteristic stenciling found on an interior core column for sample B-6152.

Each of the structural elements was additionally stenciled in white or yellow lettering with similar building information. For the exterior panel sections, the stenciling was located on or near the lower spandrel on the interior face. Figure 3–6 (a) shows a typical stenciling found on a perimeter panel, indicating this piece was in WTC 2, with center column line number 300, spanning floors 85 through 87. For the core columns, both stenciling and handwritten codes have been observed on the recovered pieces. Figure 3–6 (b) shows one of these stencilings from a core column located in WTC 1.

Also seen in Fig. 3–6 (a) are two other indicators, 3T and <570>, found on the exterior panel sections. These markings are the estimated piece tonnage (1 ton equals approximately 907 kg) and the erector's derrick division number, respectively. This information was also stamped on some of the core column pieces (see Fig. 3–4). The erector, Karl Koch Erecting Co., Inc., assigned derrick divisions 47 through 70 for WTC 1 and derrick divisions 547 through 570 for WTC 2.⁴ Each division was assigned to a specific area of the building and shared a crane with other nearby derrick divisions. Therefore, a single crane may have lifted pieces from derrick divisions 65, 67, and 69. Figure 3–7 shows the derrick division numbers that hoisted the specific columns for both buildings, according to the derrick numbers found on structural elements with positive identification (also shown in Tables 3–2 and 3–3).

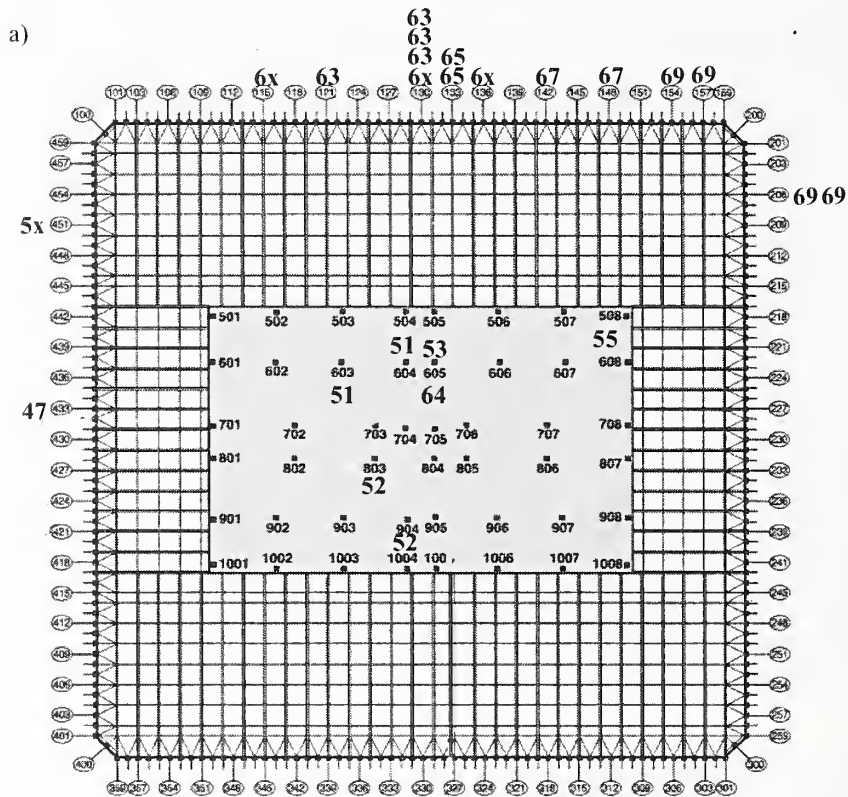
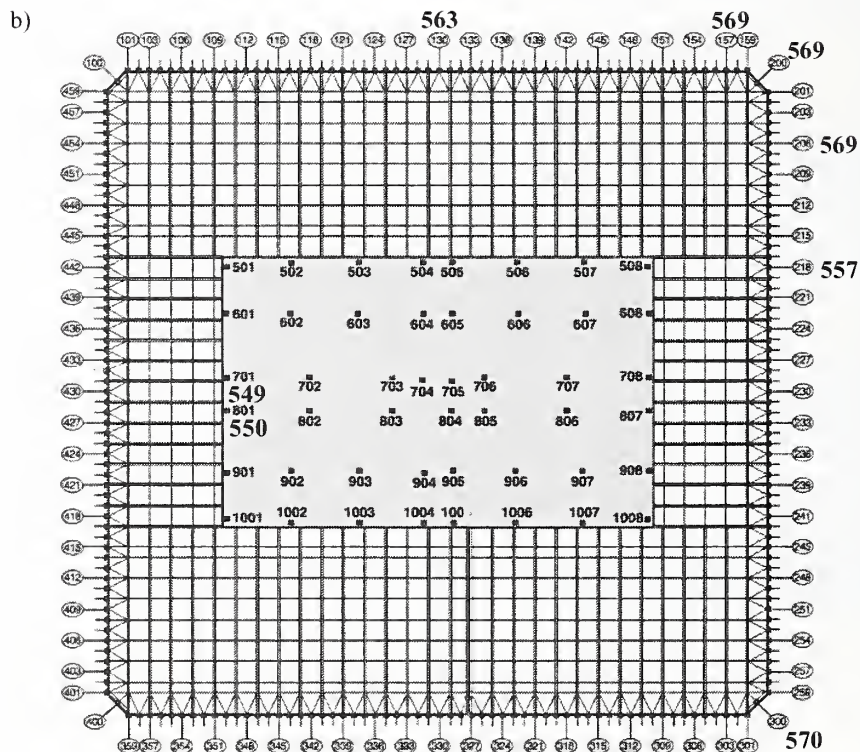
Figure 3–7. Schematic showing derrick divisions that hoisted the specific columns for (a) WTC 1 and (b) WTC 2. The “x” signifies the information that was not readable.

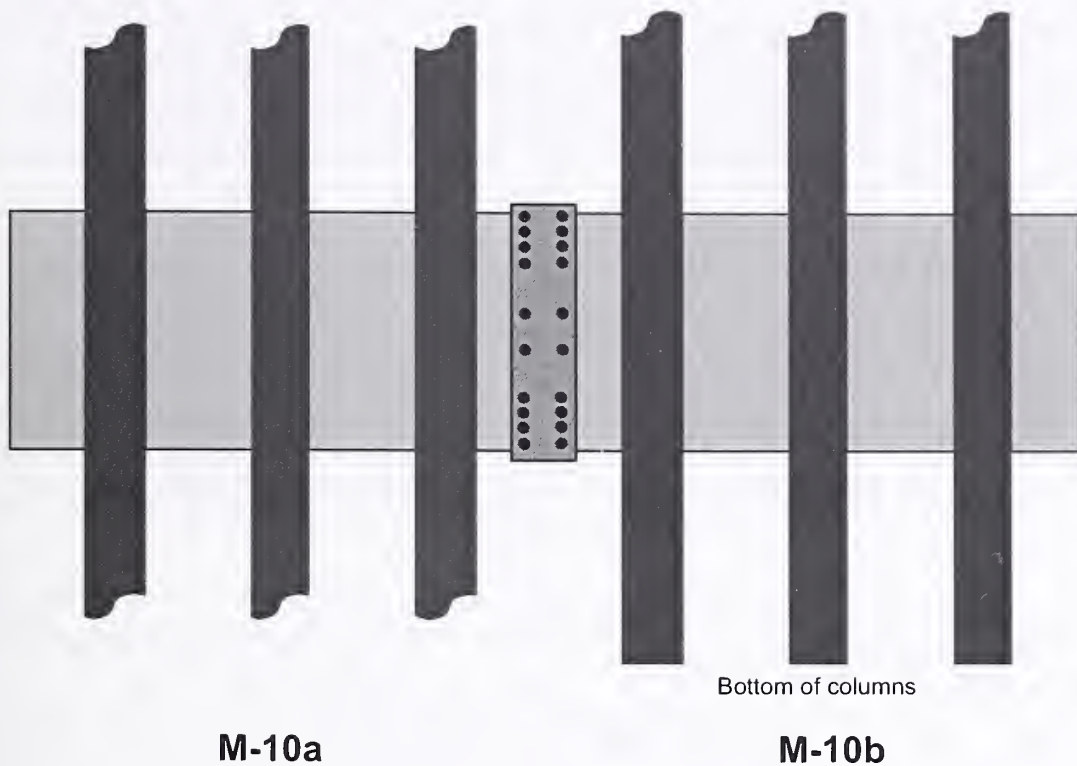
Figure 3–8. Schematic showing the sample M-10 as two separate exterior column panels, M-10a and M-10b.

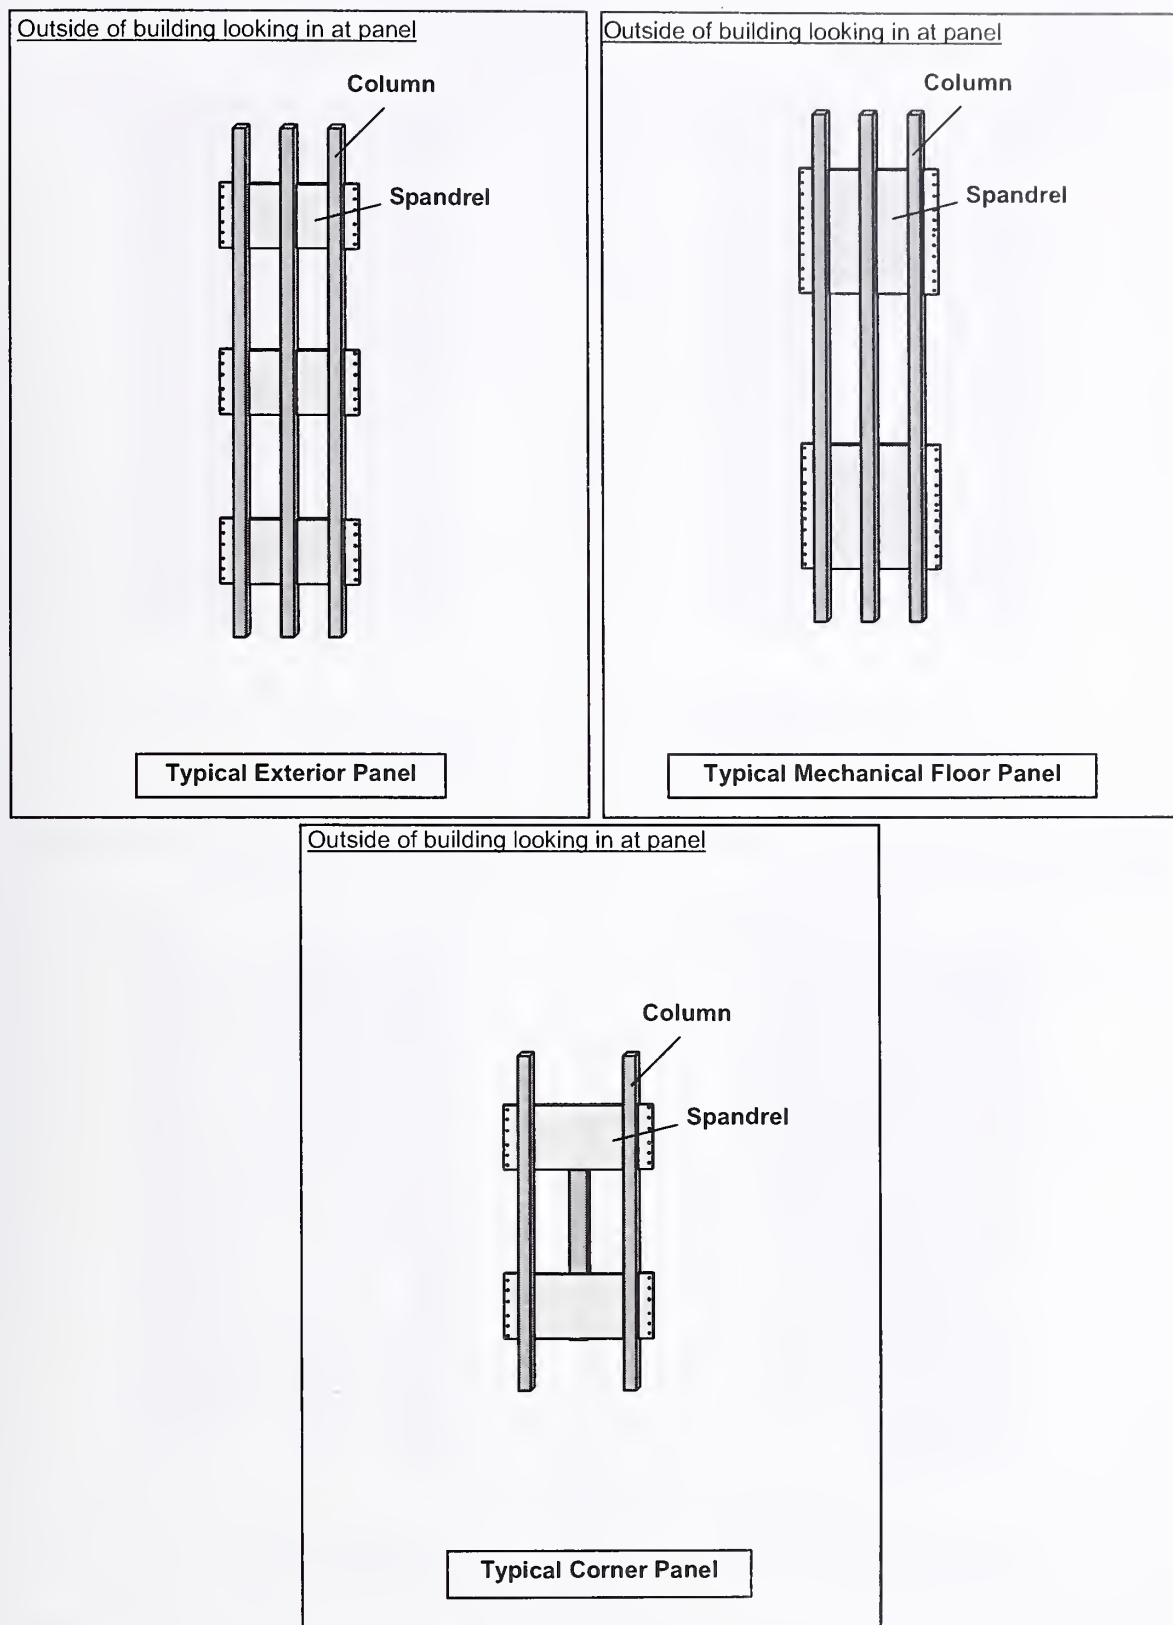
Figure 3–9. Schematics displaying the various types of exterior column panels.
