NIST NCSTAR 1-3B

Federal Building and Fire Safety Investigation of the
World Trade Center Disaster

Steel Inventory and Identification

Stephen W. Banovic

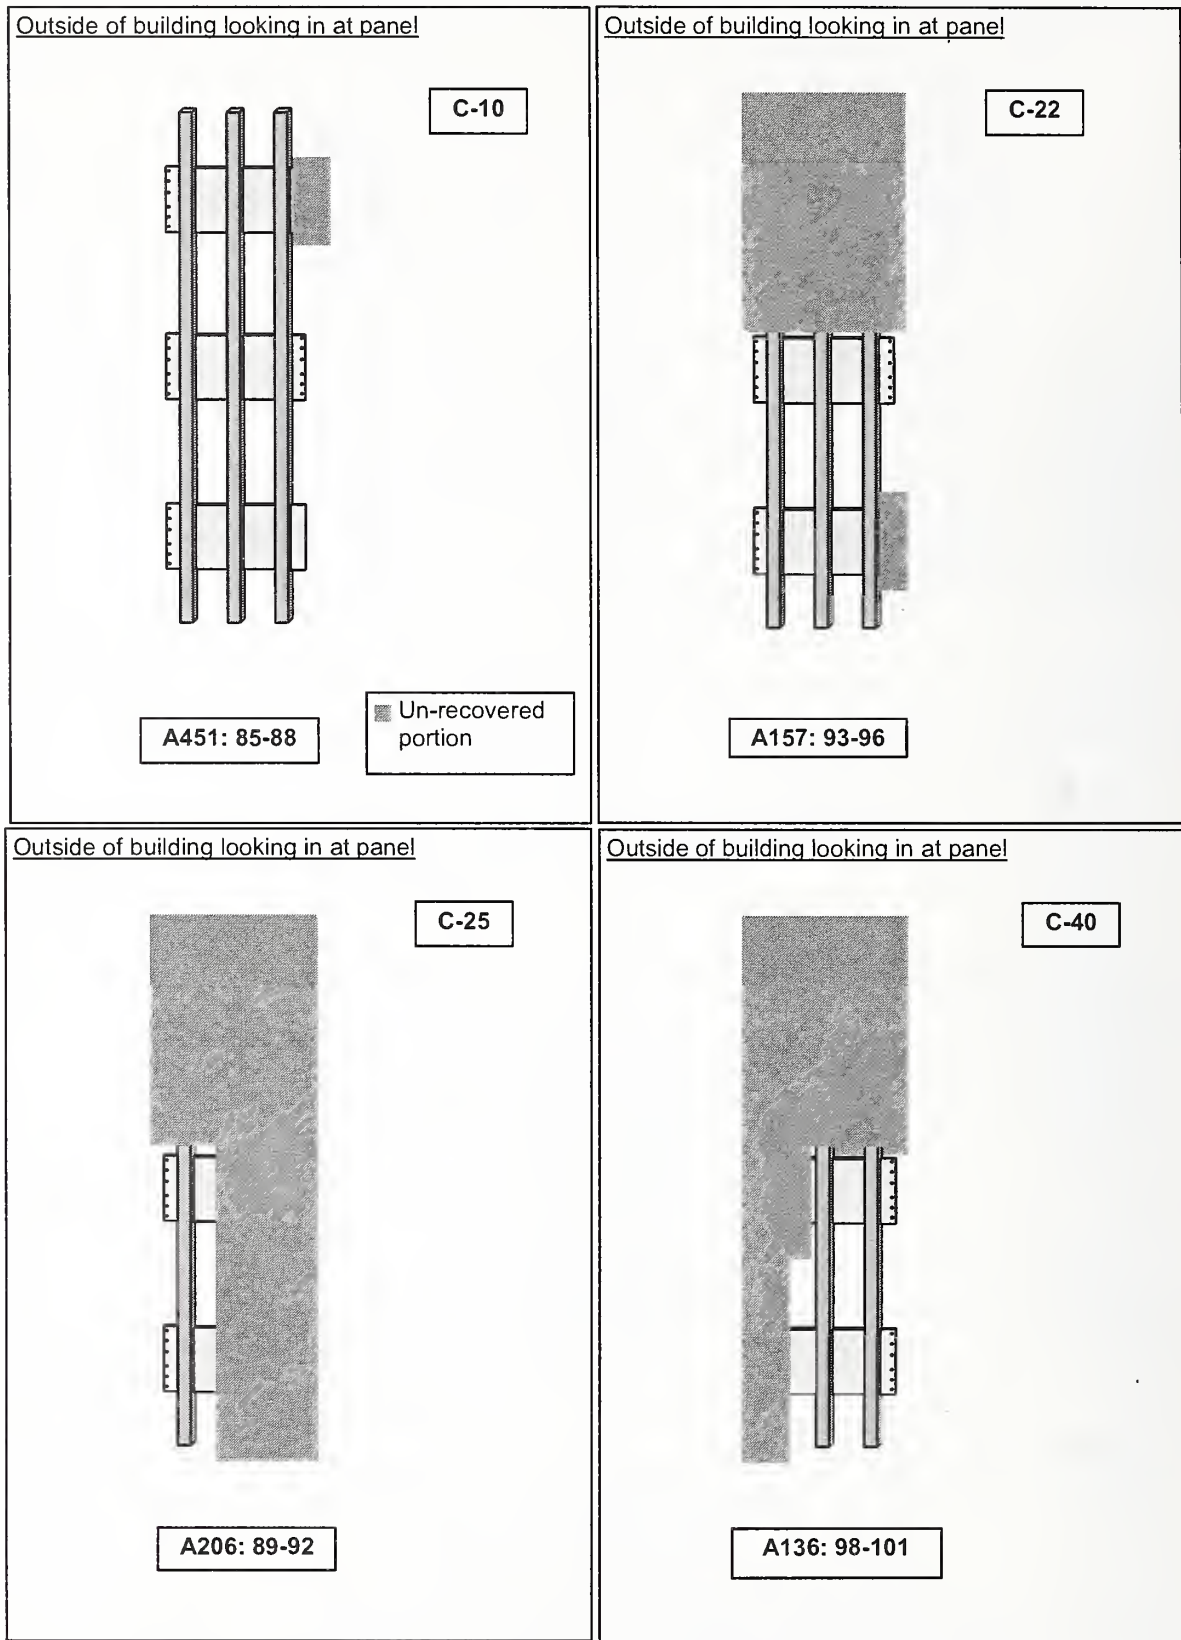
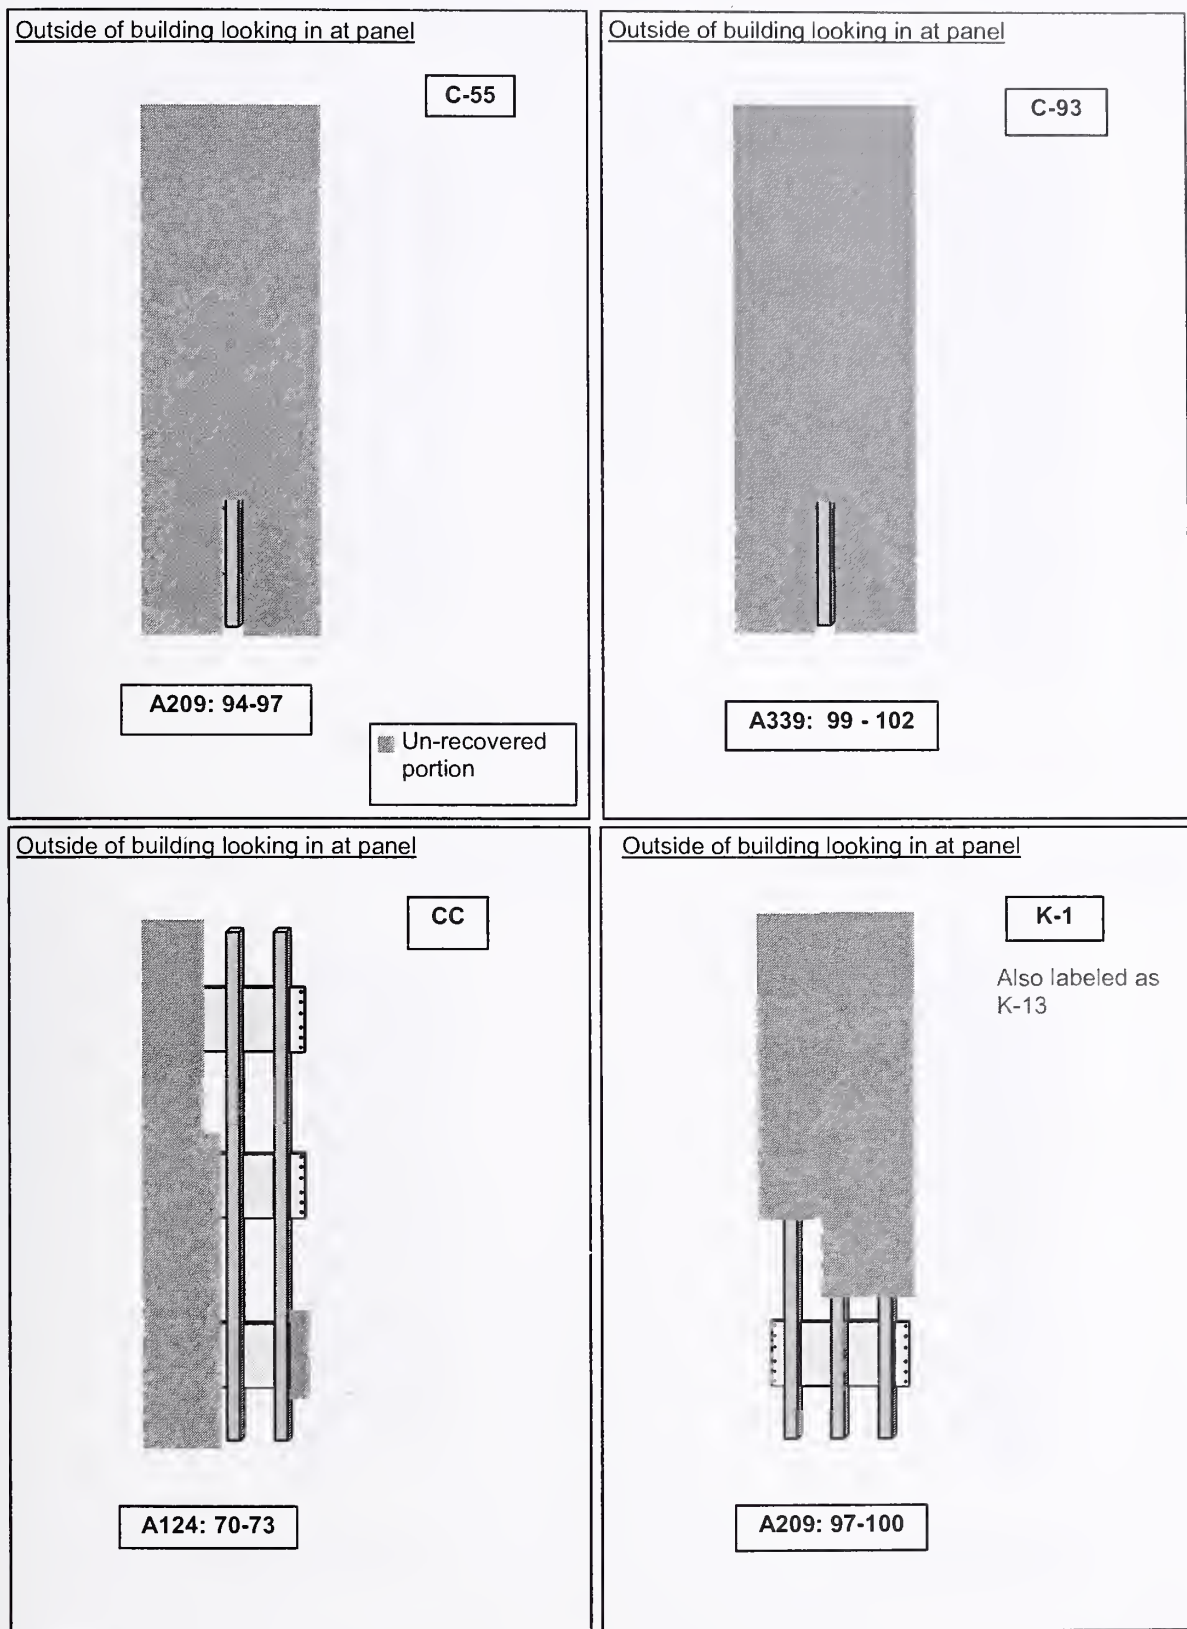
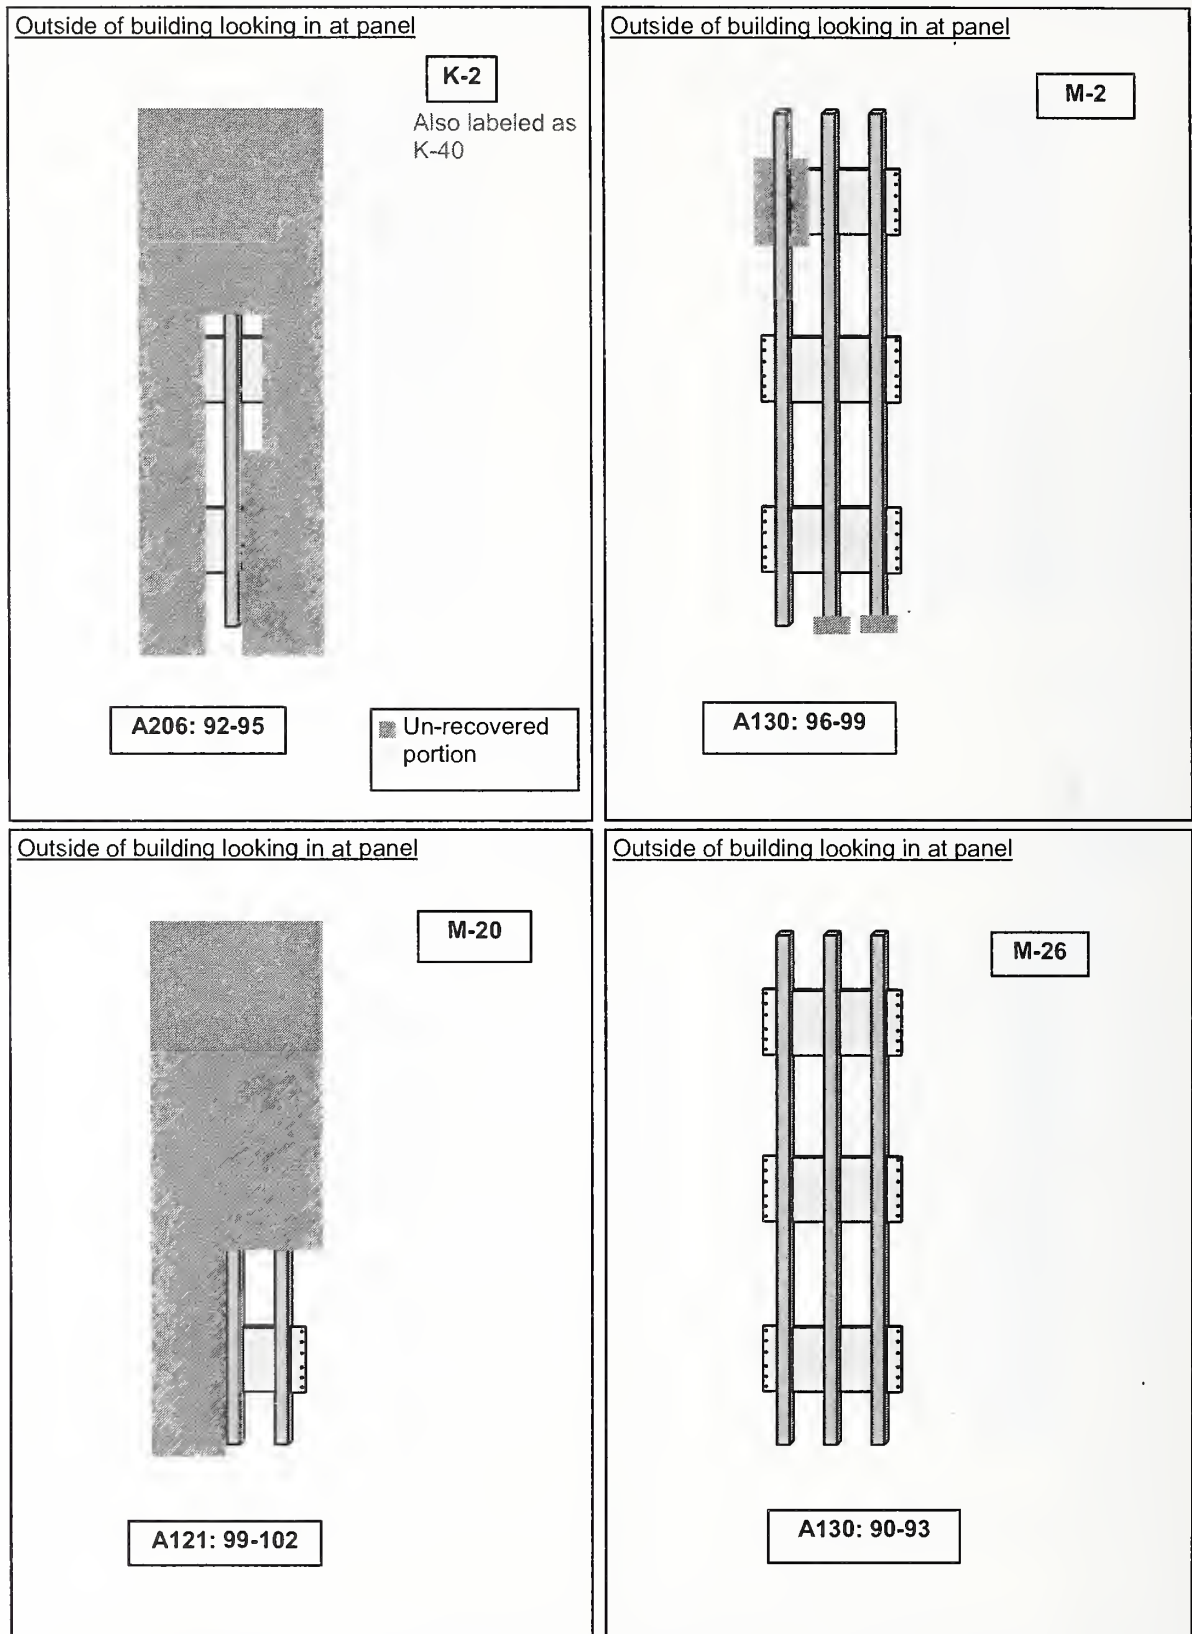
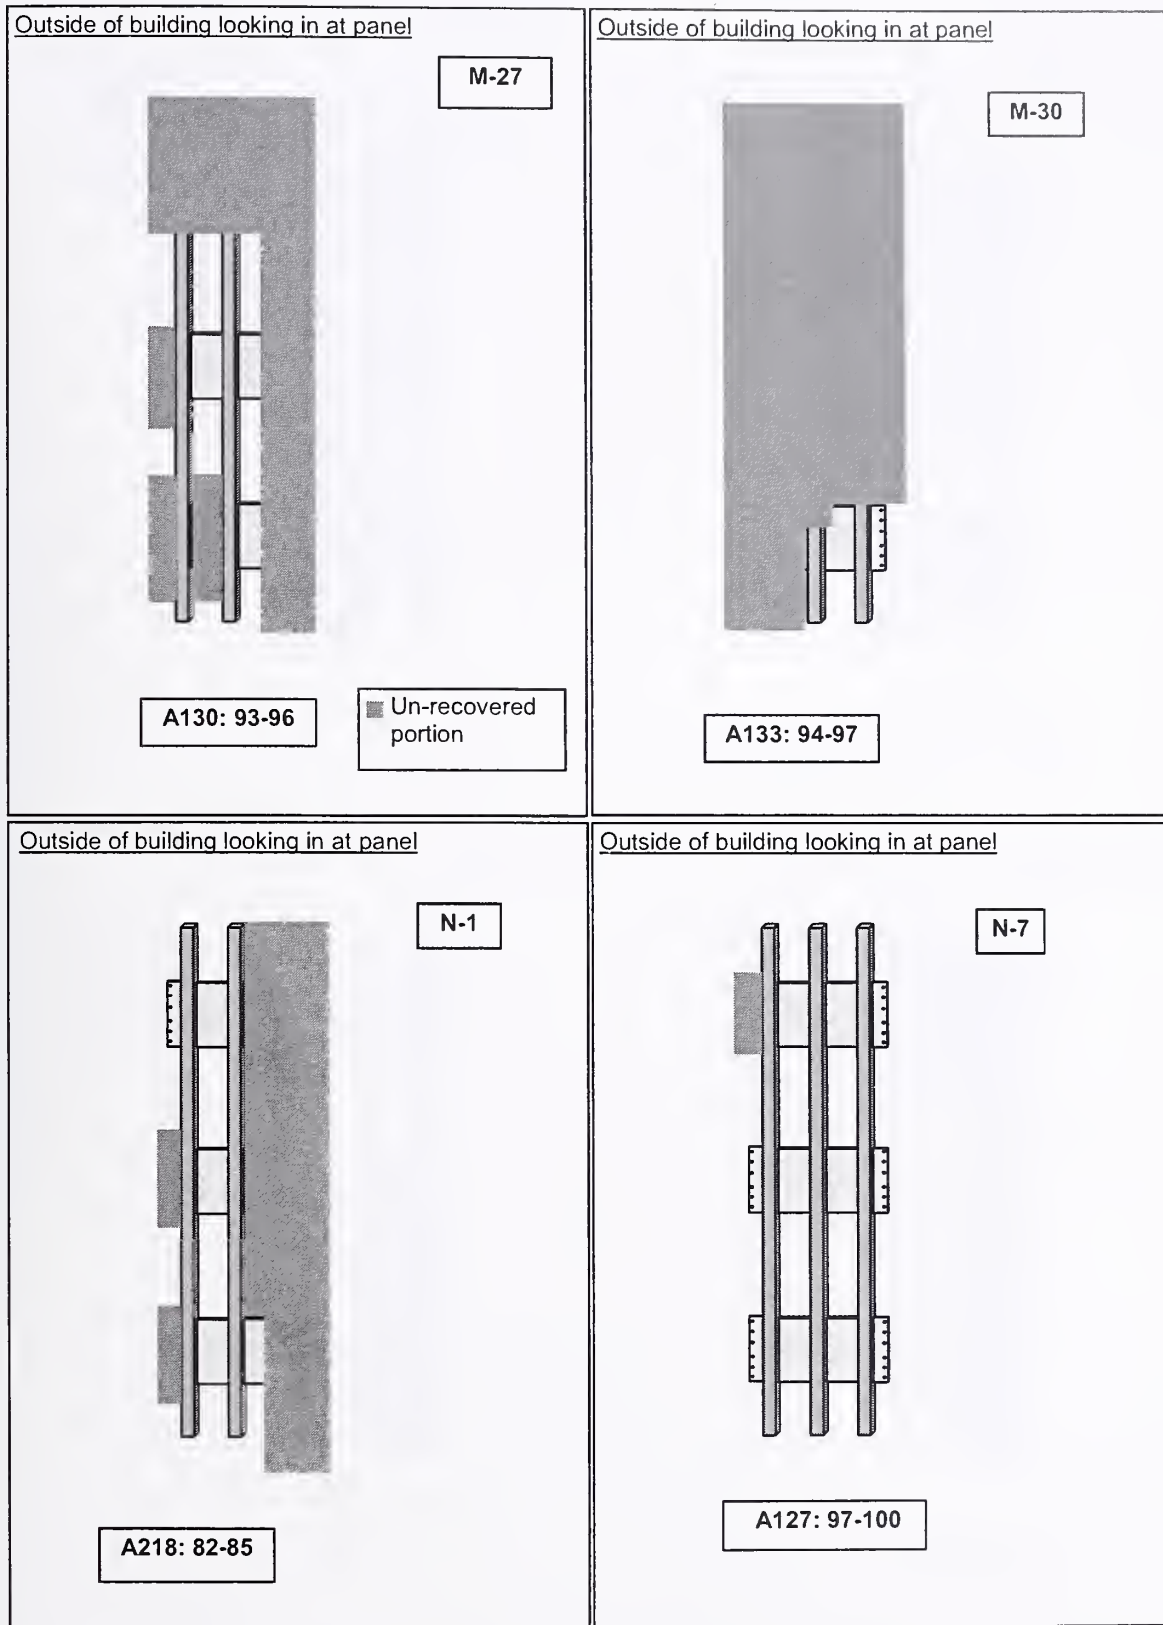
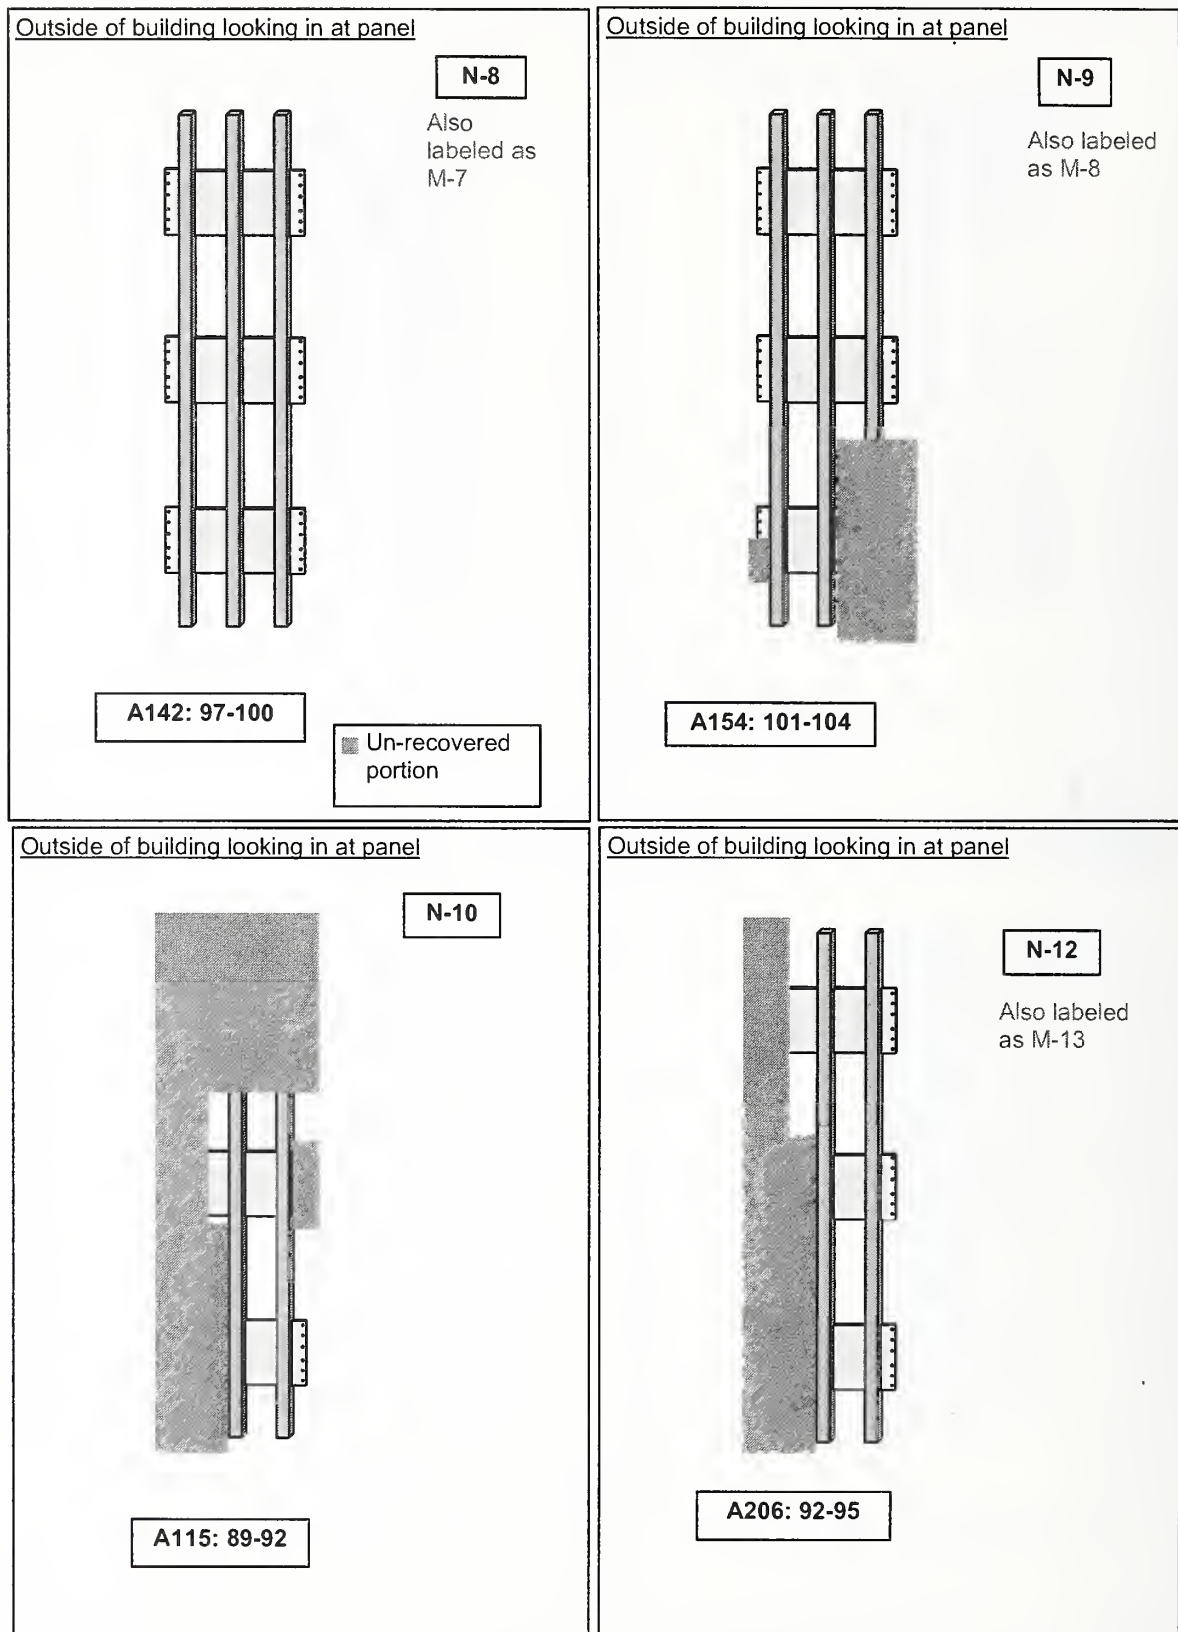
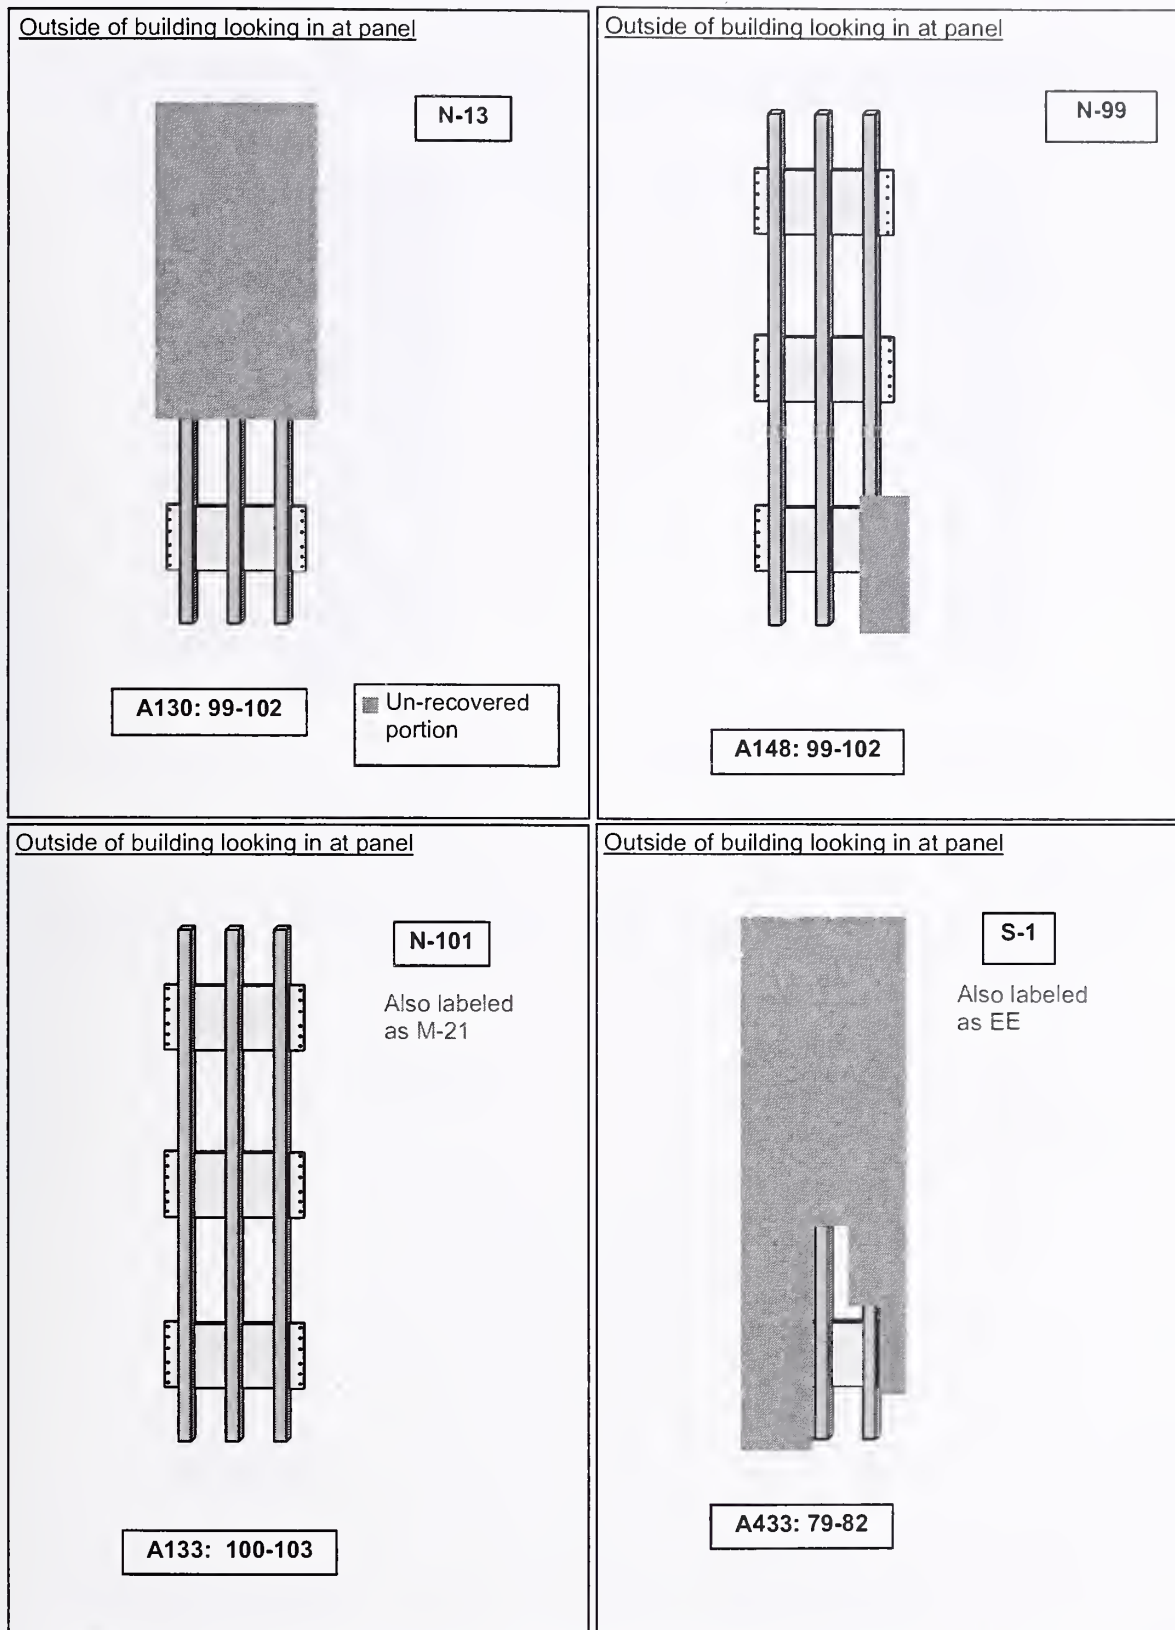
Figure 3–10. Exterior column panel maps indicating the portion of the specific exterior column panel section recovered from WTC 1.

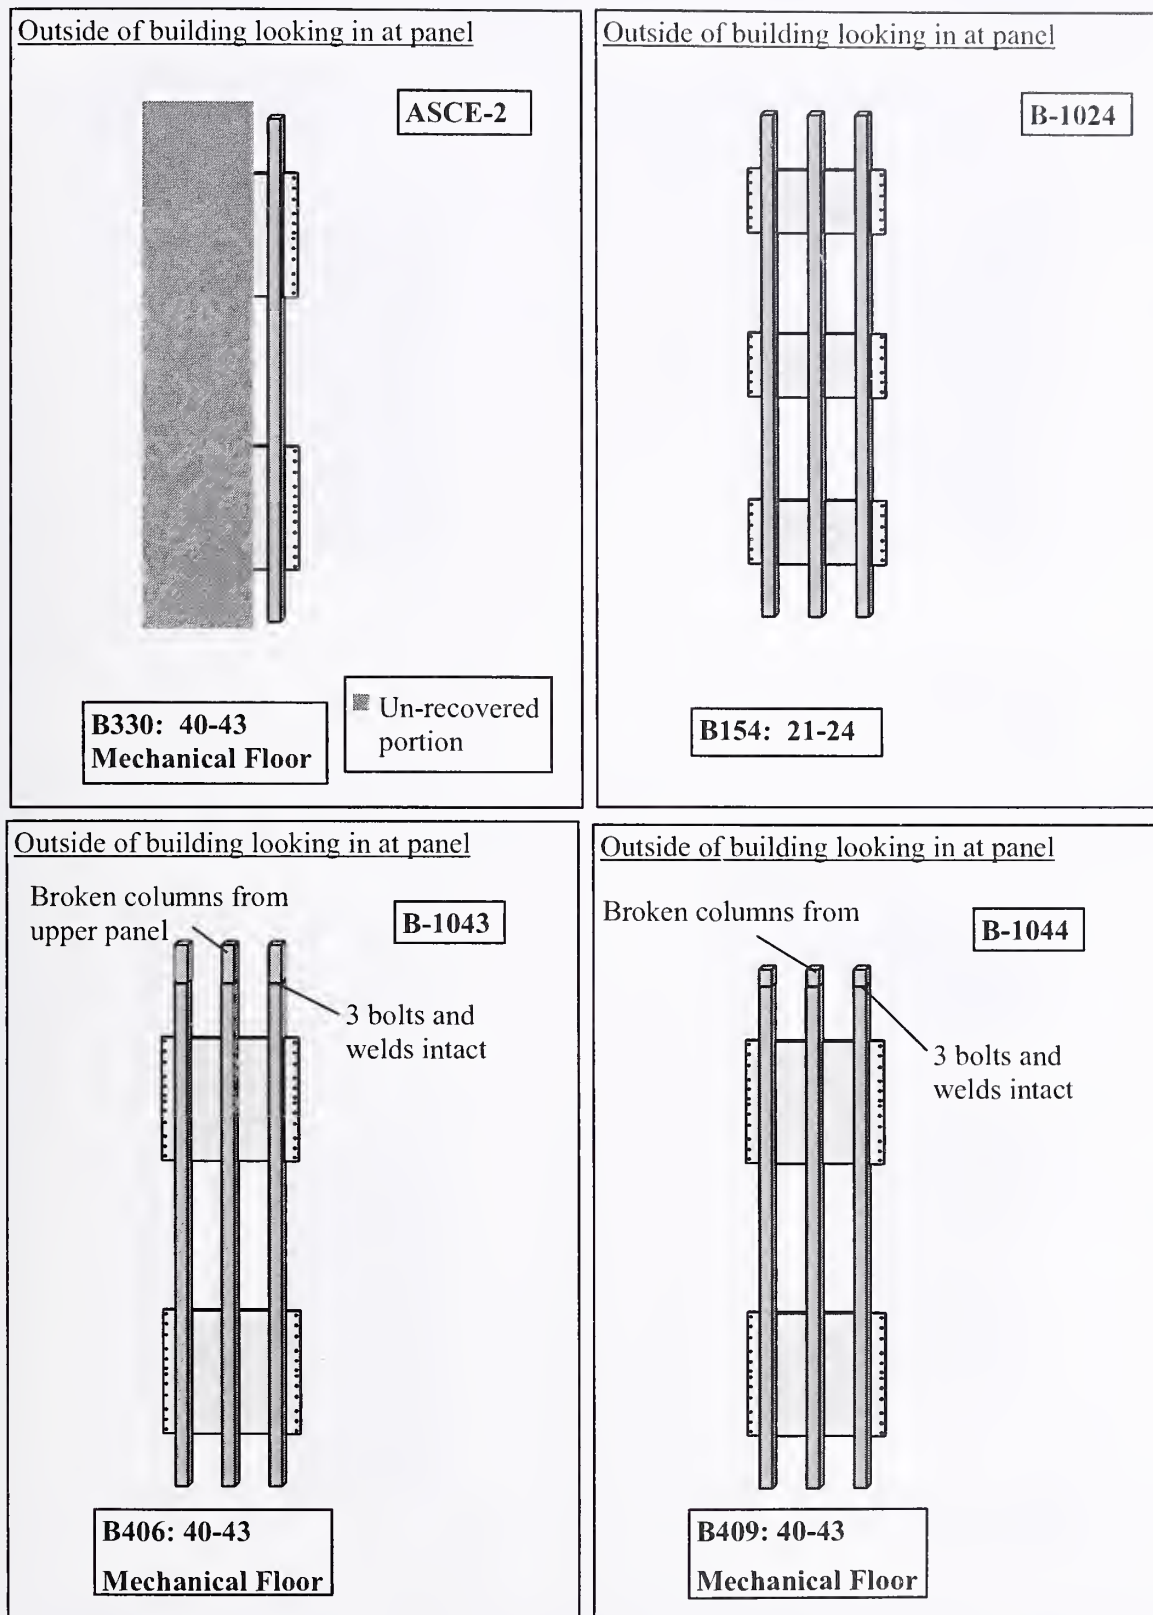
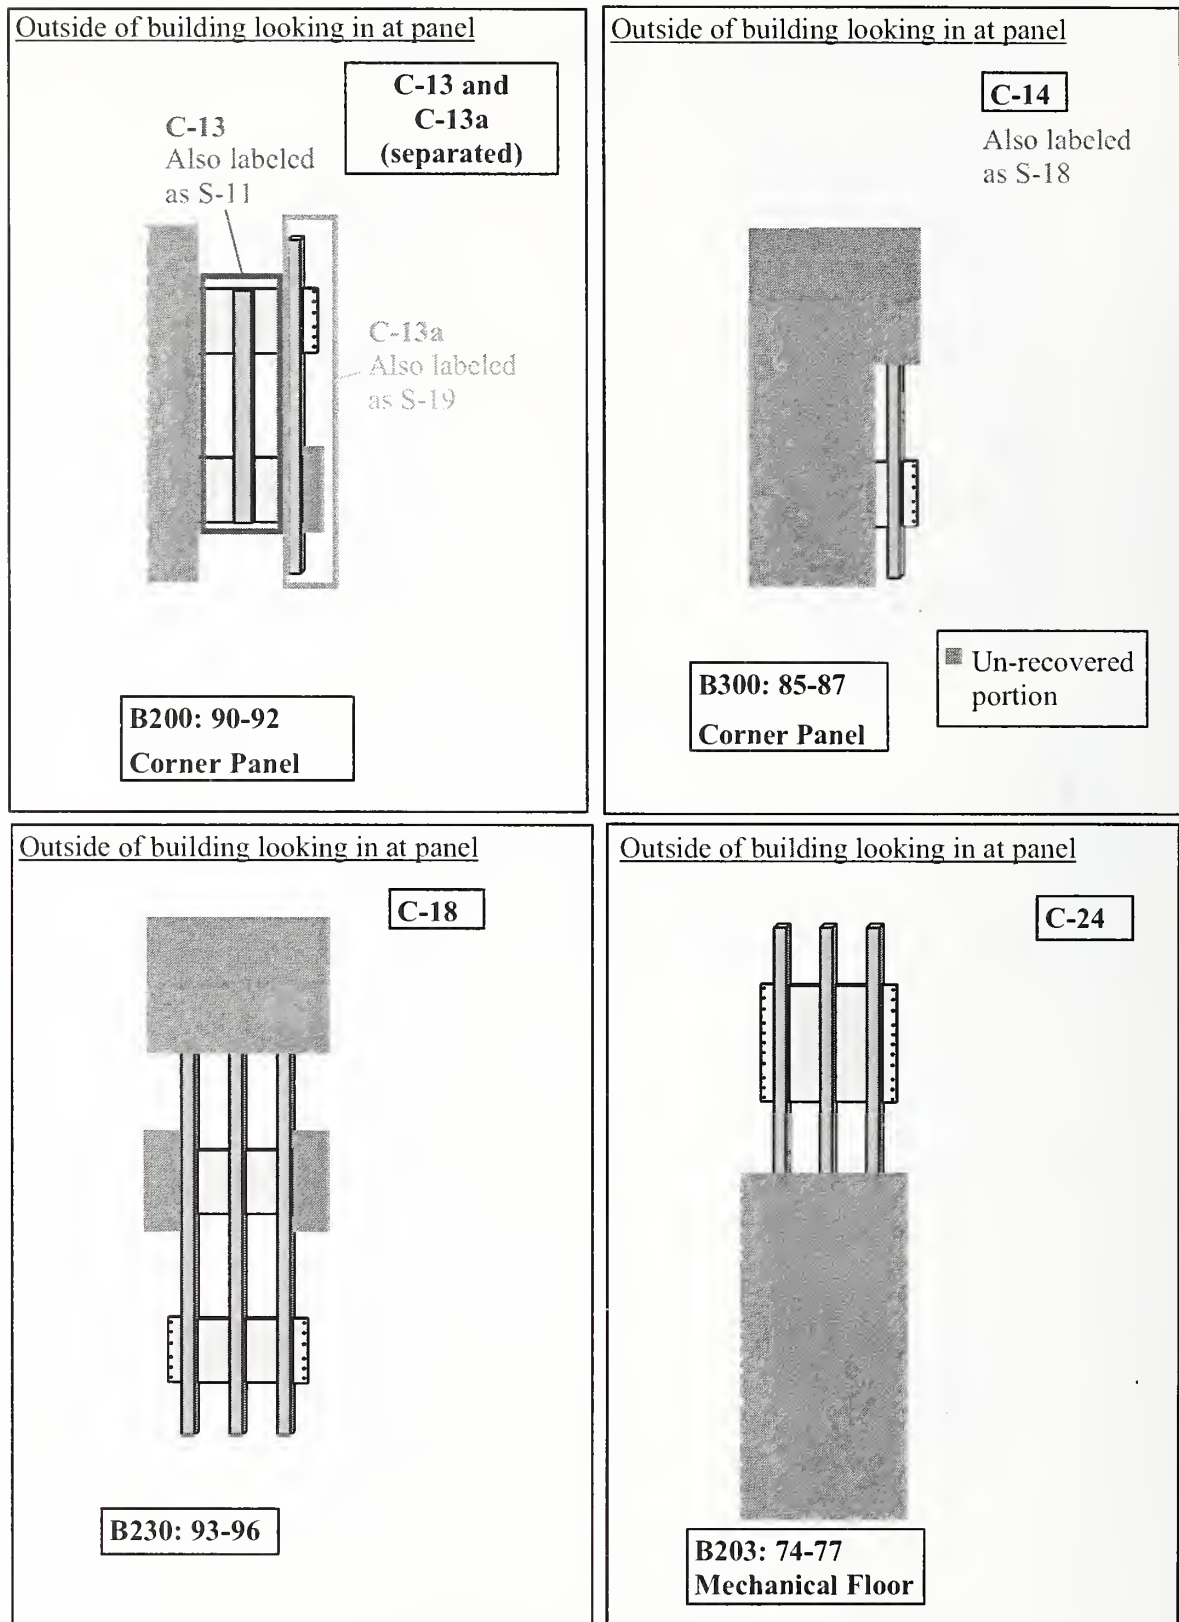
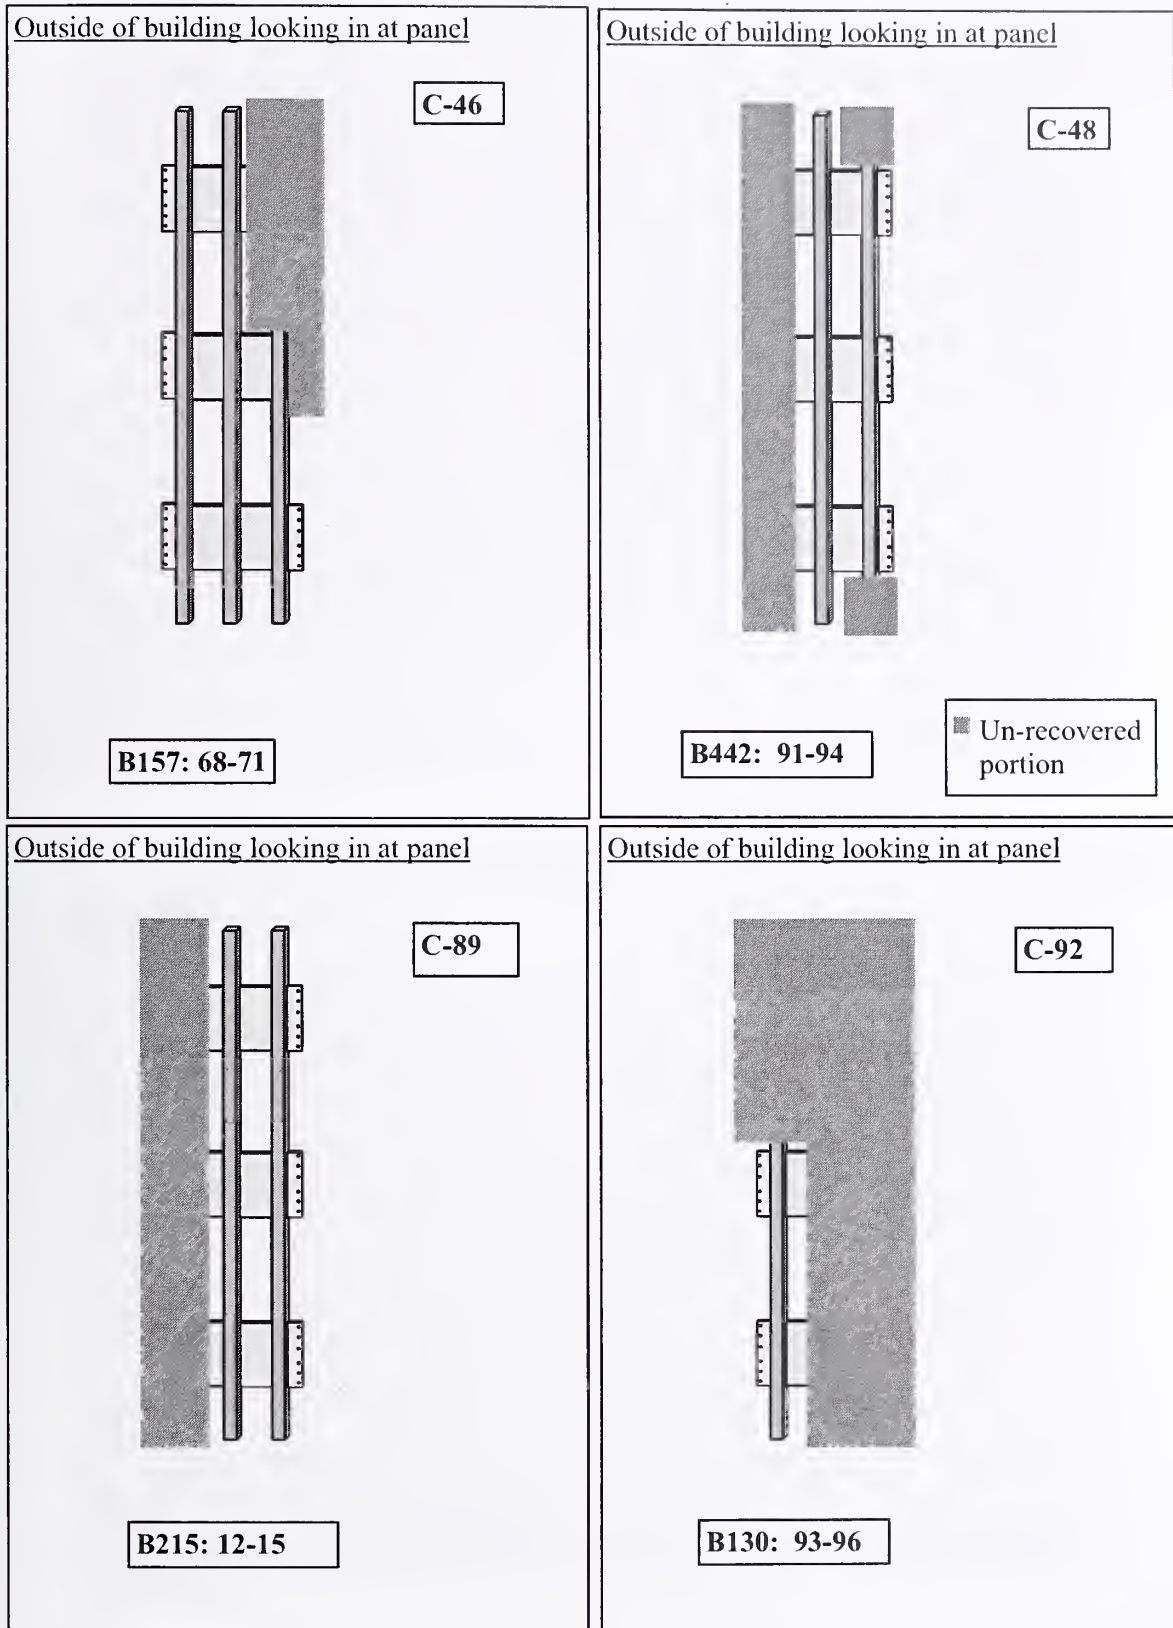
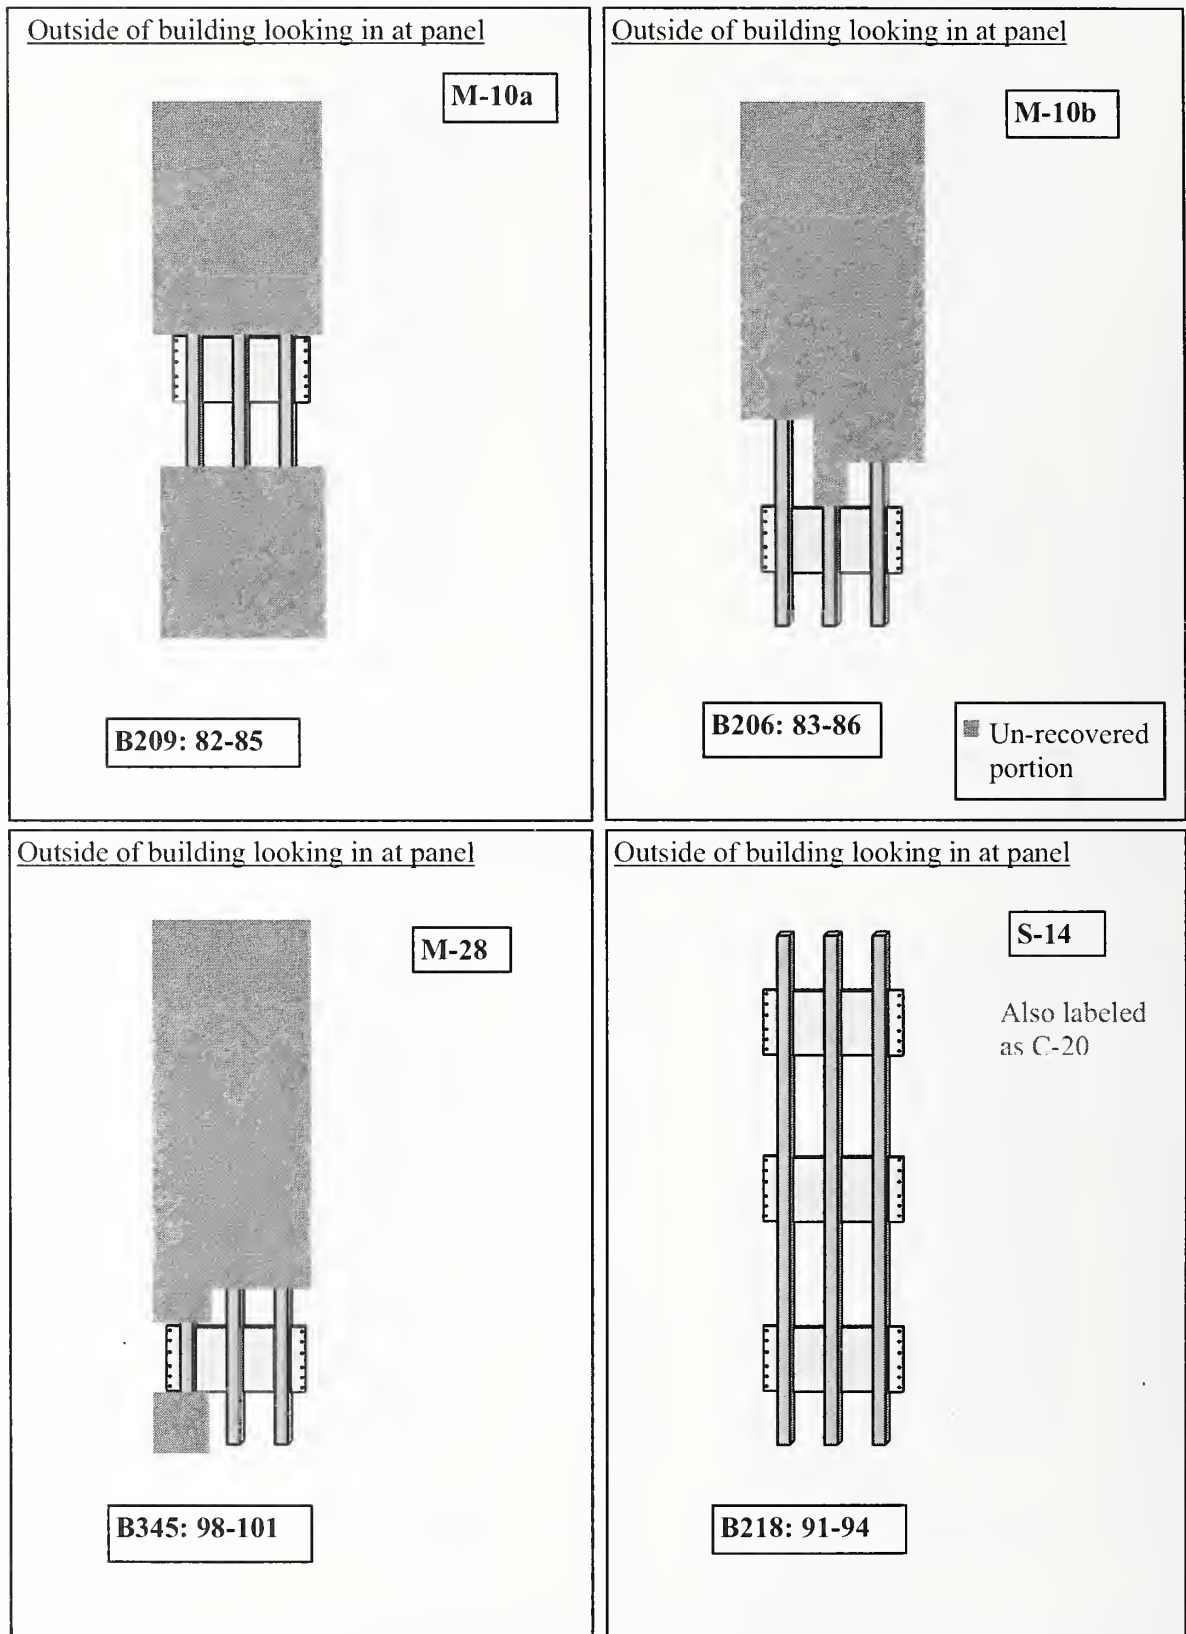
Figure 3-11. Exterior column panel maps indicating the portion of the specific exterior column panel section recovered from WTC 2.
