NIST NCSTAR 1-3B

Federal Building and Fire Safety Investigation of the
World Trade Center Disaster

Steel Inventory and Identification

Stephen W. Banovic

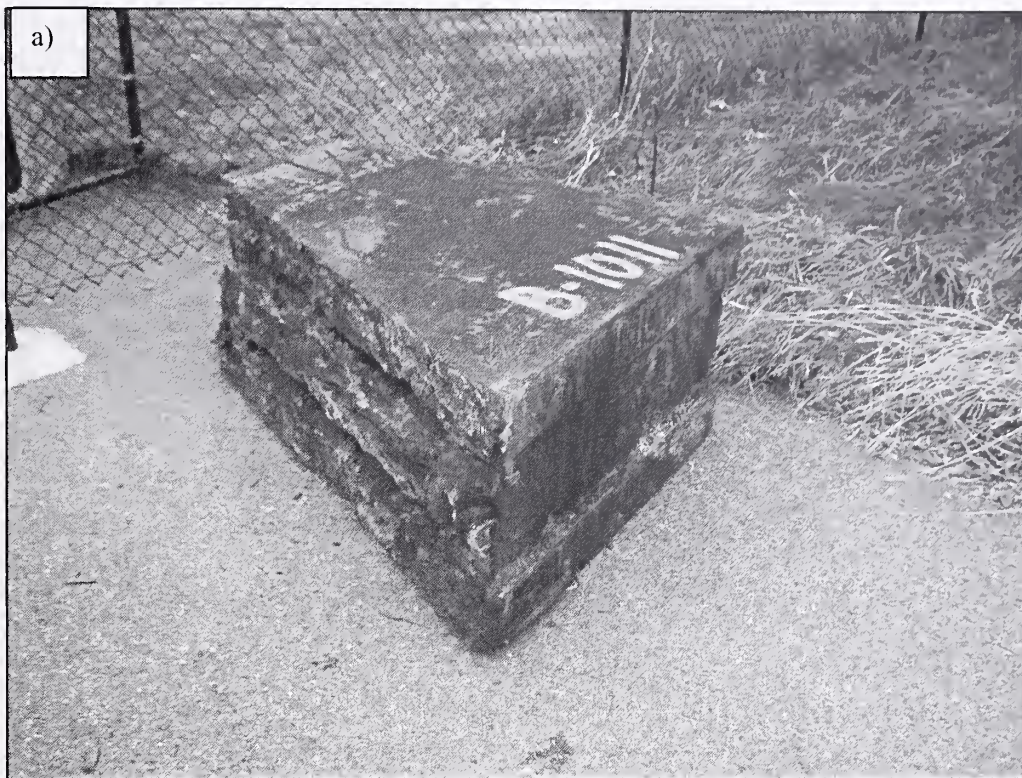
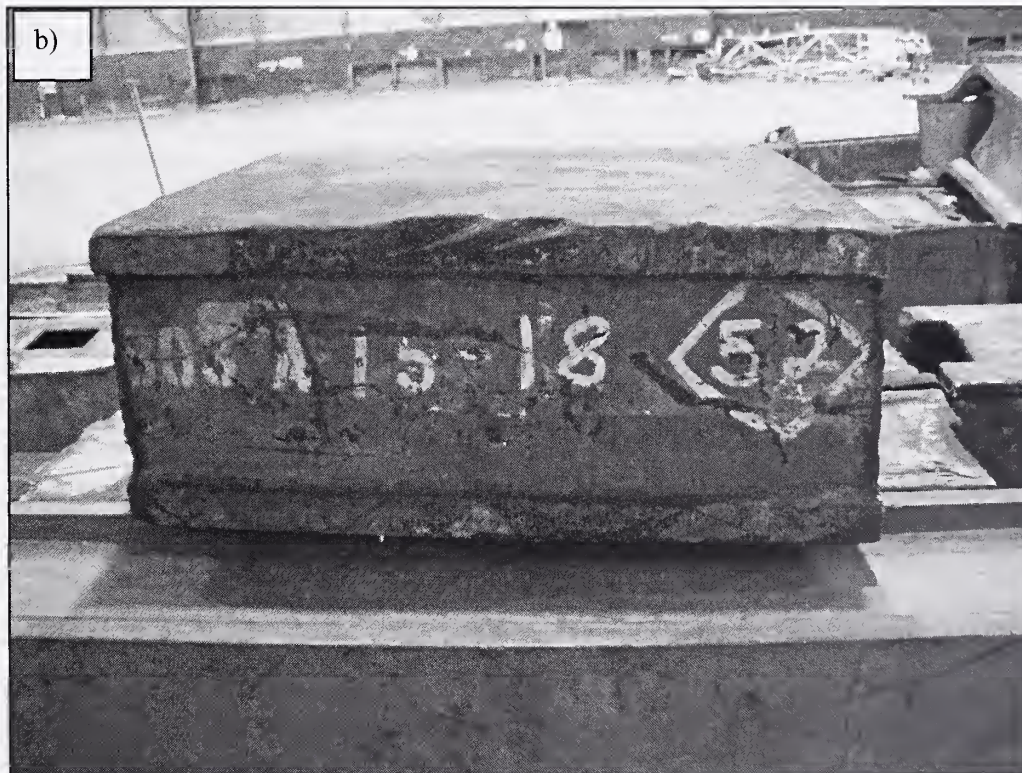
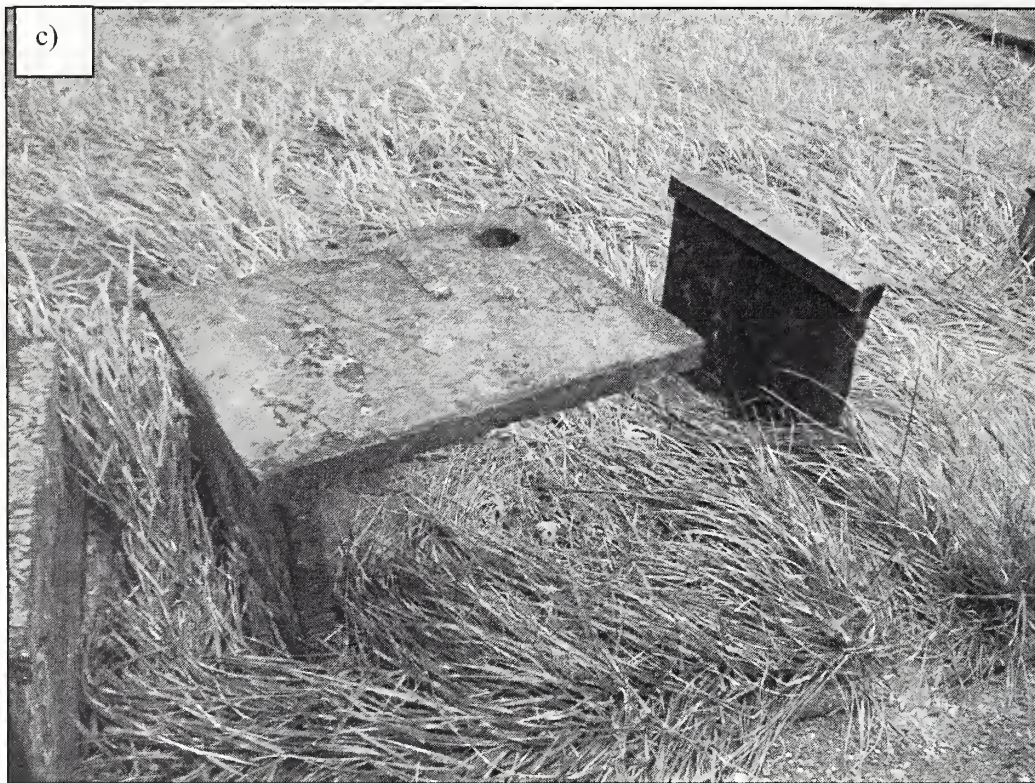
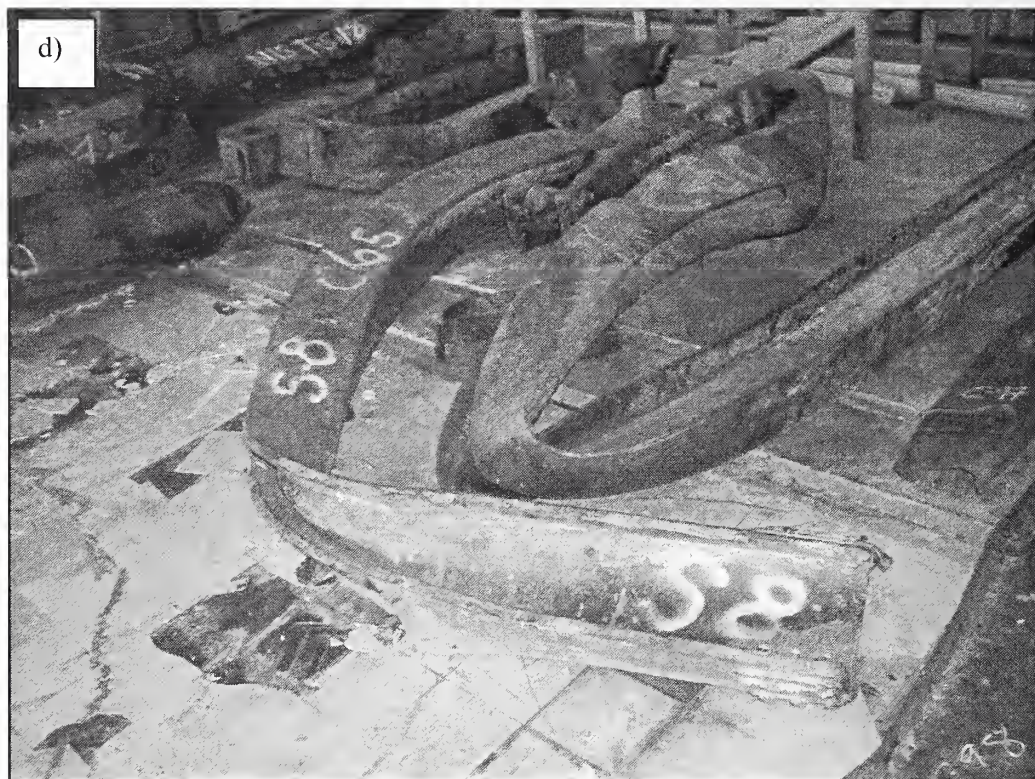
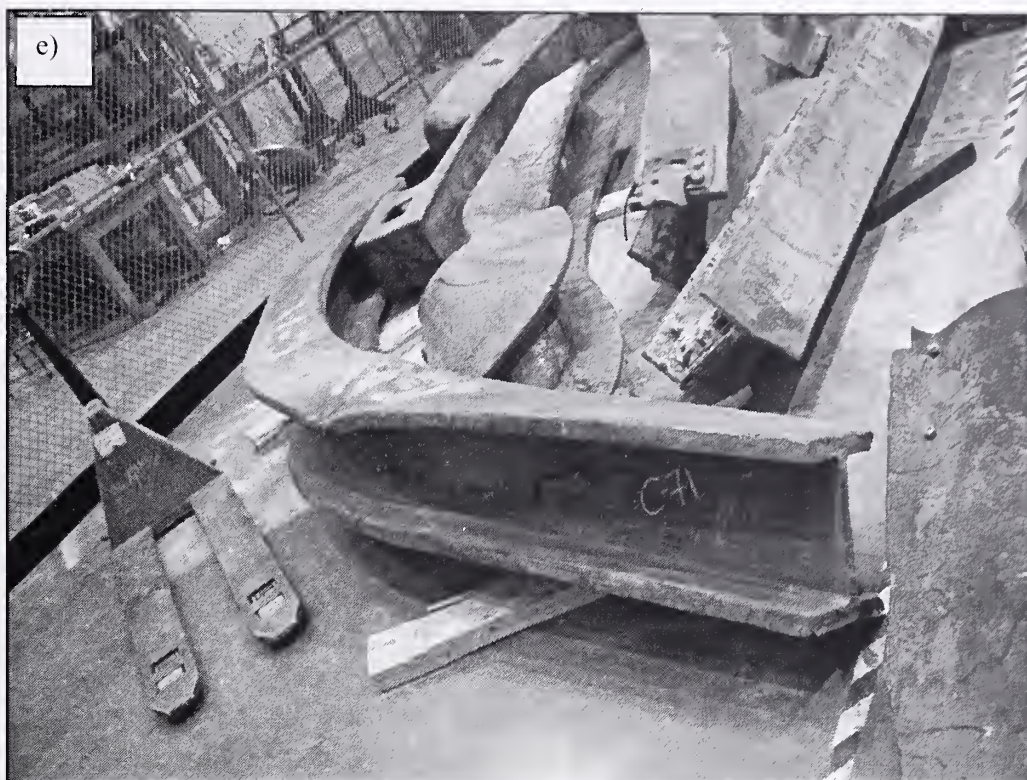
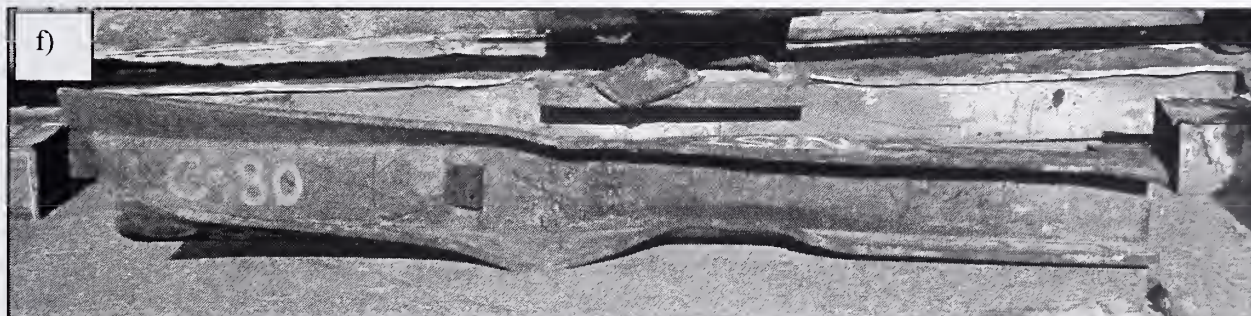
Figure 3–12. Core columns recovered from WTC 1. a) B-1011 (508A: 51–54), lower 2 ft to 3 ft of built-up box column, b) B-6152-1 (803A: 15–18), lower 3 ft of built-up box column.

Figure 3–12. Core columns recovered from WTC 1. c) B-6152-2 (504A: 33–36), lower 2 ft of built-up box column, d) C-65 (904A: 86–89), lower 24 ft of wide flange section (continued).

Figure 3–12. Core columns recovered from WTC 1. e) C-71 (904A: 77–80), lower 16 ft of wide flange section, f) C-80 (603A: 92–95), lower 13 ft of wide flange section (continued).

Figure 3–12. Core columns recovered from WTC 1. g) C-155 (904A: 83–86), lower 33 ft of wide flange section, and h) HH (605A: 98–101), lower 16 ft of wide flange section (continued).

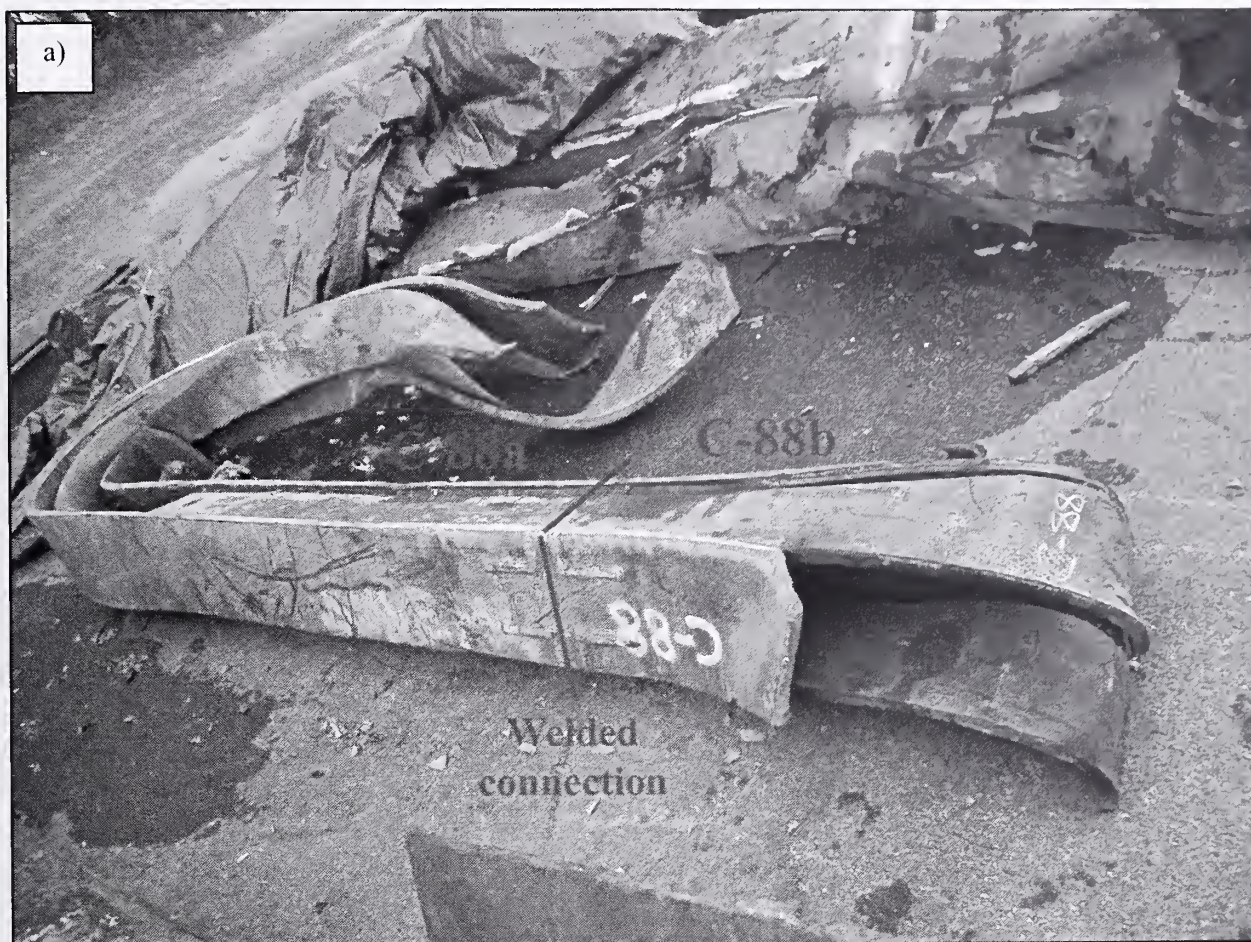
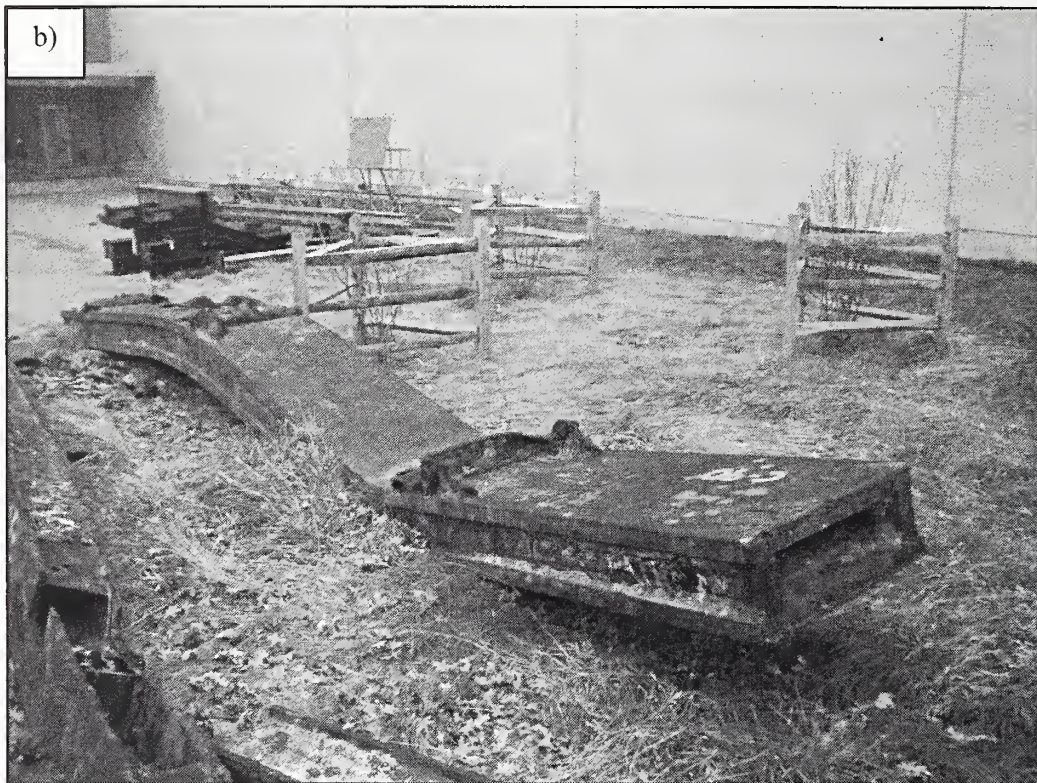
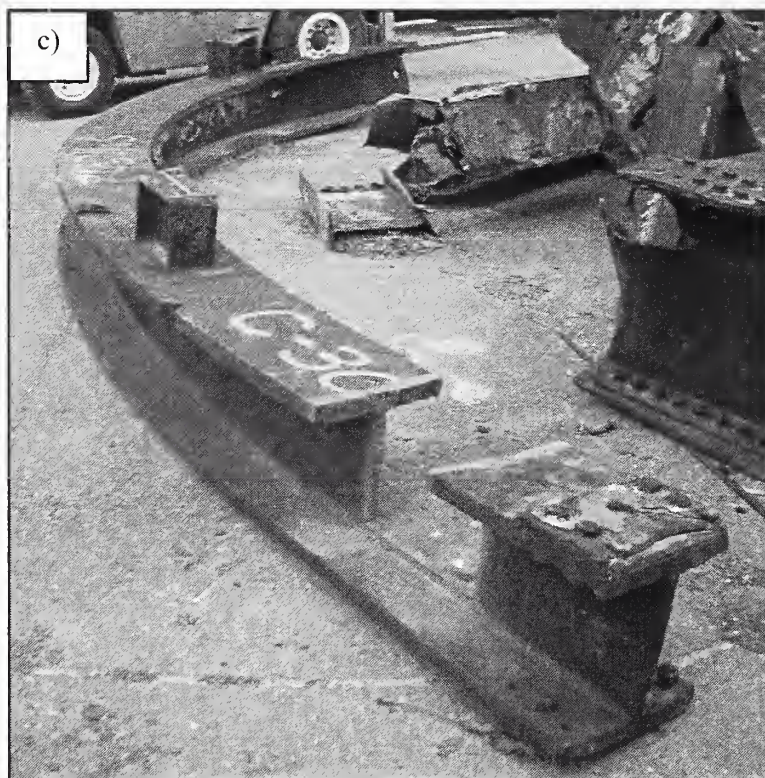
Figure 3–13. Core columns recovered from WTC 2. a) C-88a (801B: 80–83), lower 16 ft of built-up box column and C-88b (801B: 77–80), upper 8 ft of built-up box column.

Figure 3–13. Core columns recovered from WTC 2. b) C-90 (701B: 12–15), entire length of built-up box column, and c) C-30 (1008B: 104–106) entire length of wide flange section (continued).

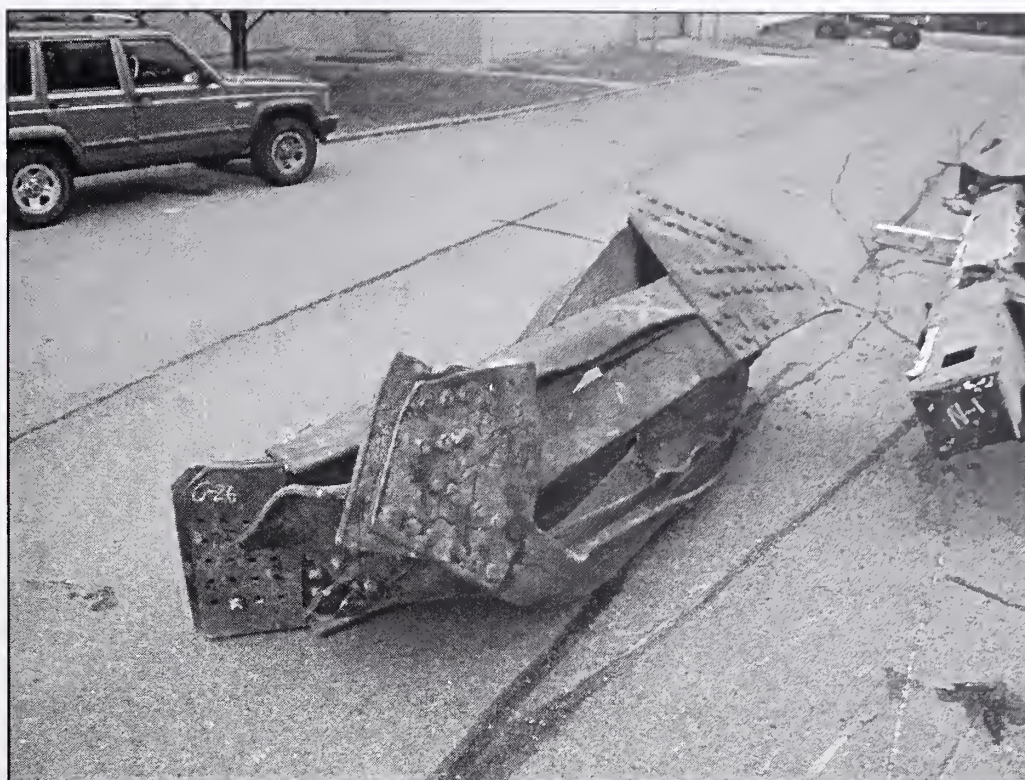
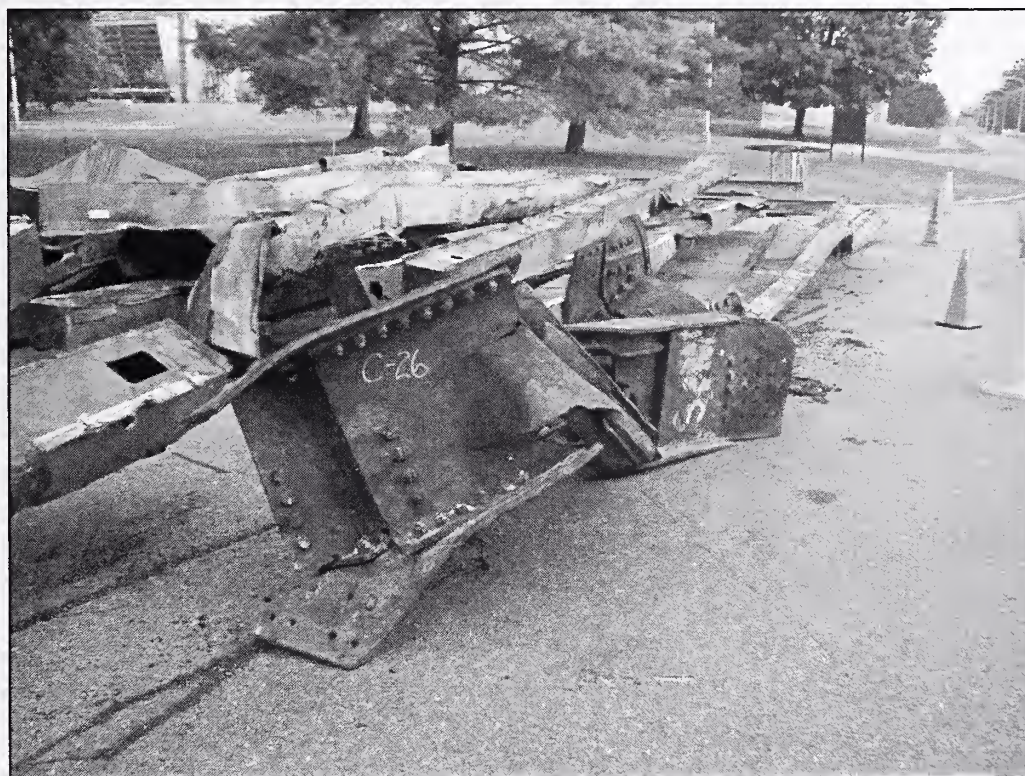
Figure 3–14. Structural element composed of three wide flange sections bolted together. The component was found to be from the framed floor area outside of the core on the 107th floor of WTC 1 (sample was C-26).

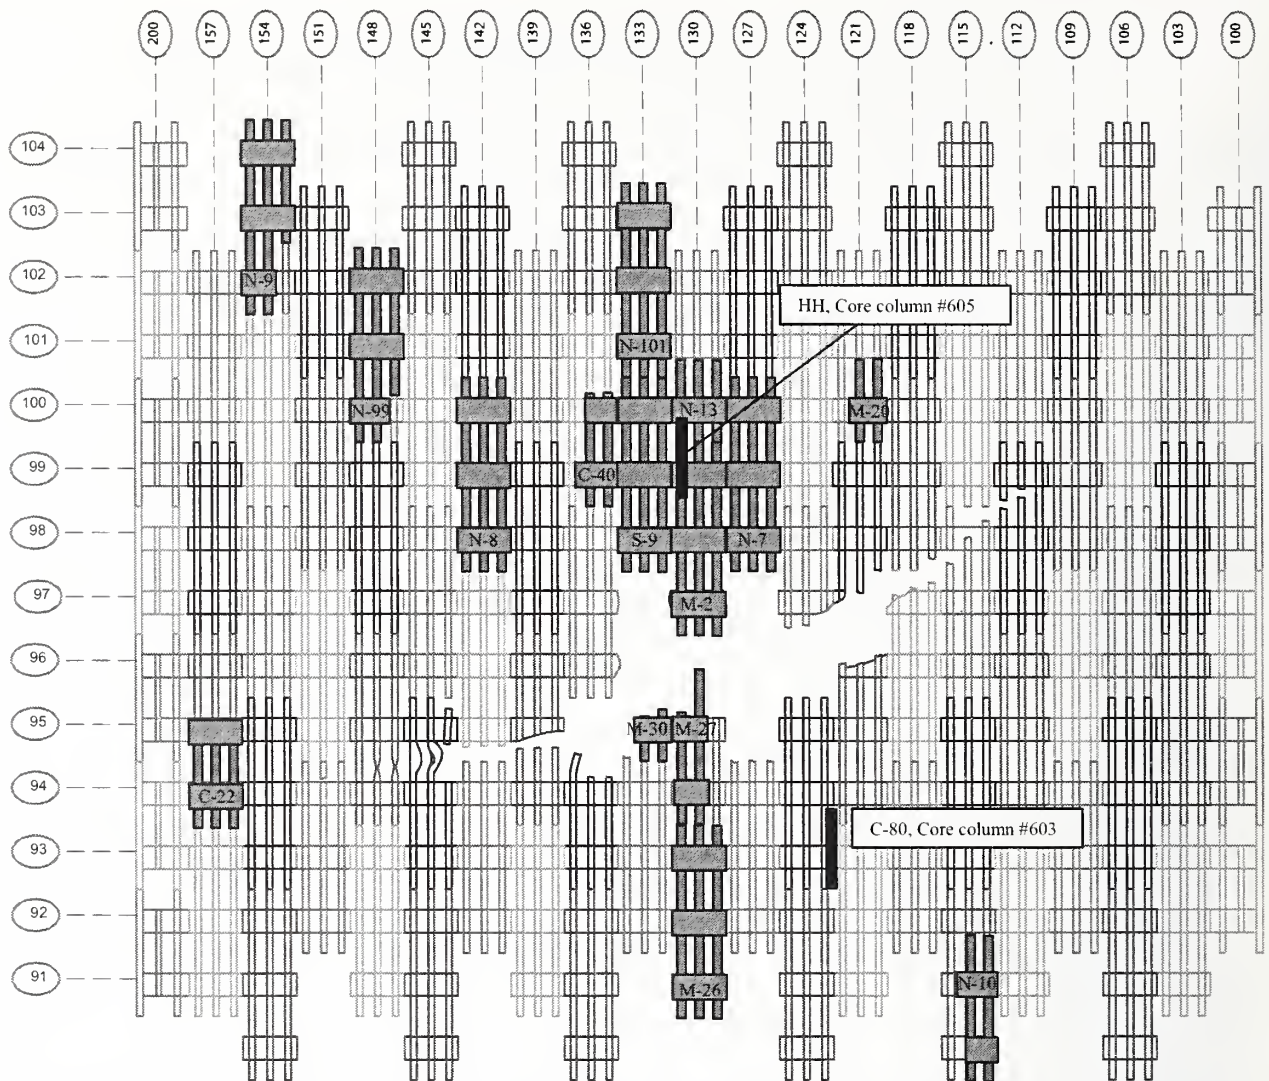
Figure 4–1. Interpreted column damage, from photographic evidence, to WTC 1, with overlay of samples in NIST’s possession. Samples shown represent recovered portions. Core columns 603 and 605 are in the second row from the north face of WTC 1.

Interpretation of the photographic evidence revealed that damage to World Trade Center (WTC) 1 due to aircraft impact occurred from floor 94 to floor 99 and was bounded by columns 111 through 152. For WTC 2, the impact area was lower with damage found from floor 77 to floor 85. While the damage appears to be bordered by column lines 411 and 440, columns closer to the southeast corner of the building may also have been affected. However, few images were obtained where smoke is not obscuring this portion of the south face of WTC 2 to complete the analysis. From this information, NIST was able to determine which perimeter panels and core columns could be used to comment on damage and possible failure mechanisms in this area. Figure 4-1 shows the sample overlay of the exterior panels in NIST's possession in and around the impact zone of WTC 1. Samples C-80 and HH, both core columns, were also identified as residing near the impact zone. The recovered portion of each column is approximately represented in this image. Unfortunately, there were no similar corresponding exterior panels for WTC 2, but two core columns were recovered (Fig. 4-2).

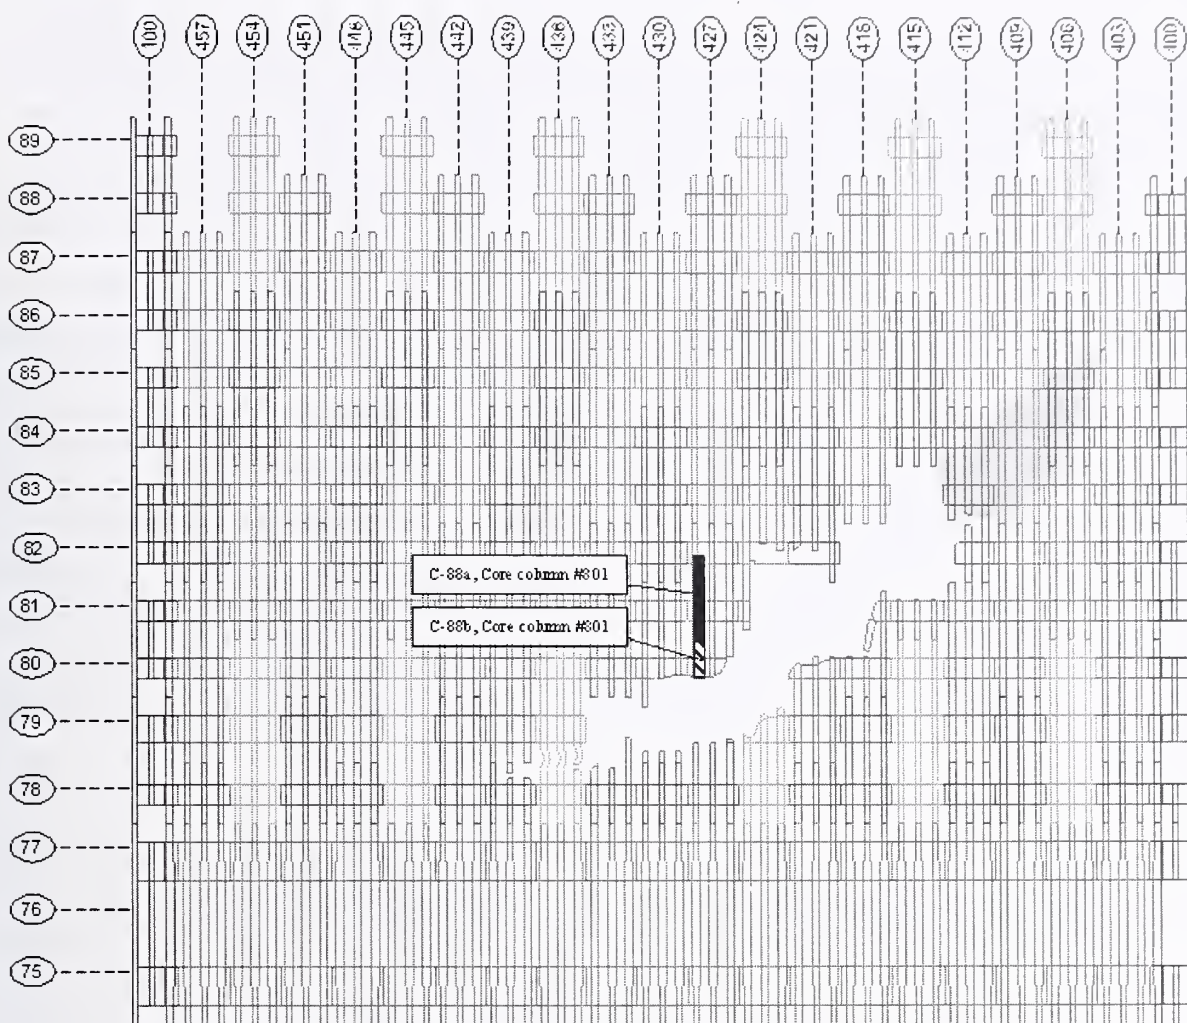
Damage in shaded area cannot be accurately determined.

Note: Core column 801 is in the closest row to the south face of WTC 2.

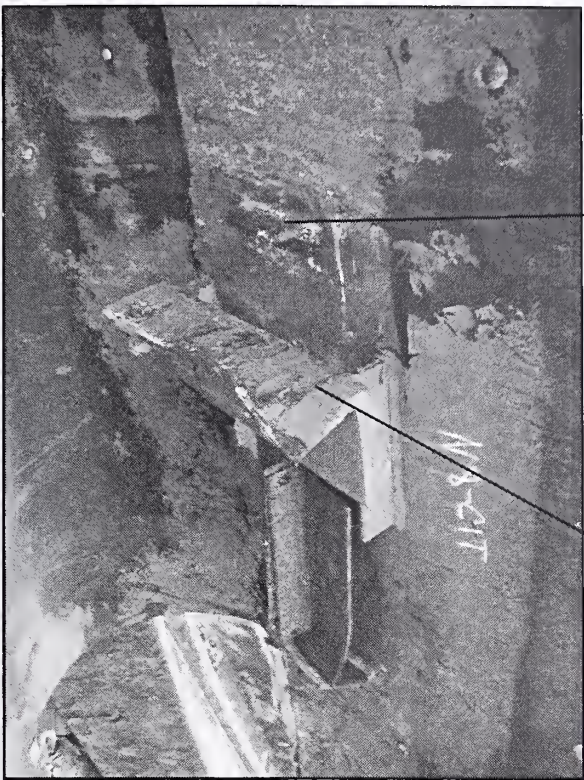
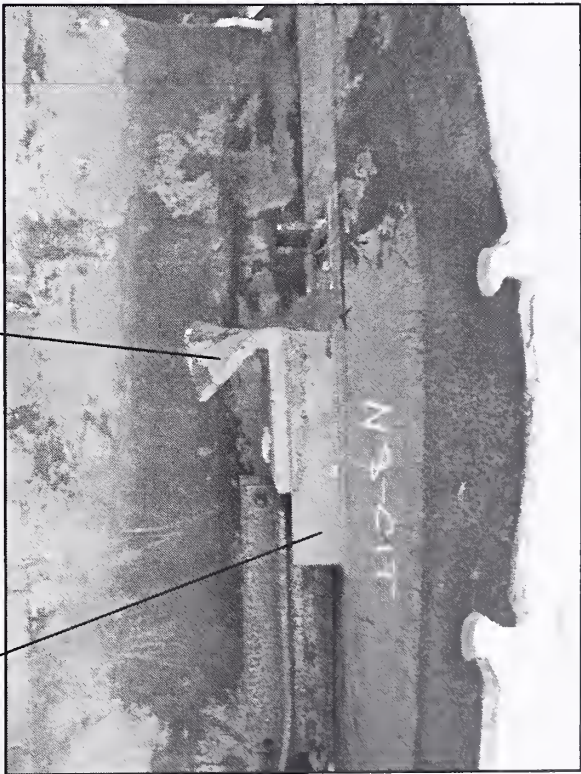
Welded gusset plate

Seat with 2 intact bolt holes for floor truss attachment. Intact bolt remains in far hole.

Seat

Stand off plates used to attach seat to column interior

Figure A-2. Floor truss seats shown from sample N-8.

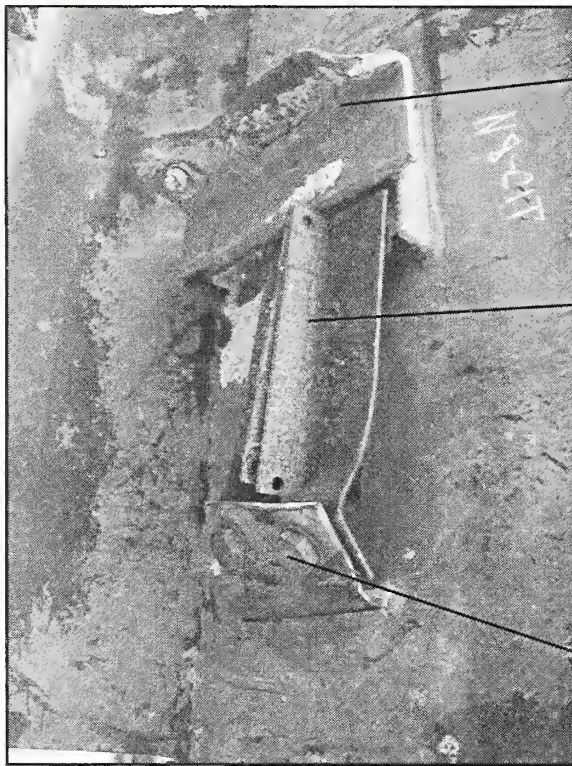
Damping unit with missing viscoelastic material. Damping unit has been bent into an upright position.

Figure A-3. Damping Unit shown from sample N-8.

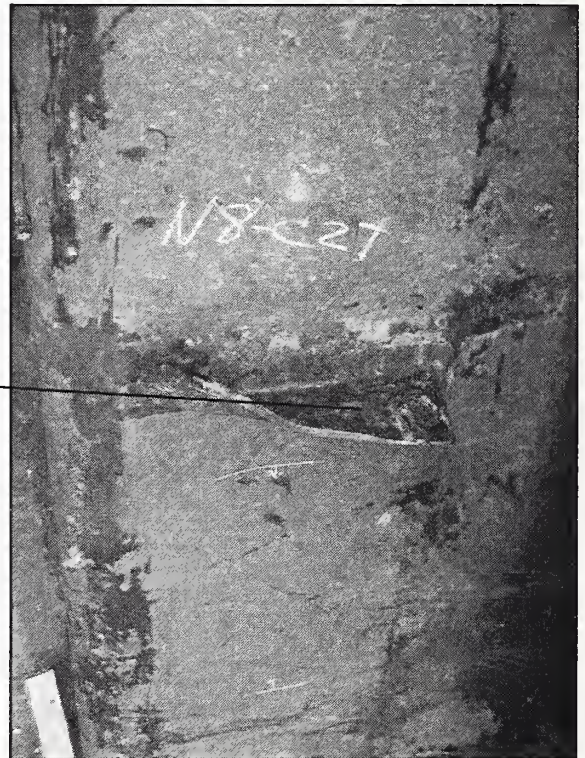
Welded gusset plate used in place of seat on alternate column/spandrel intersections. One method used to attach diagonal bracing strap to exterior wall

Figure A-4. Gusset plate shown from sample N-8.

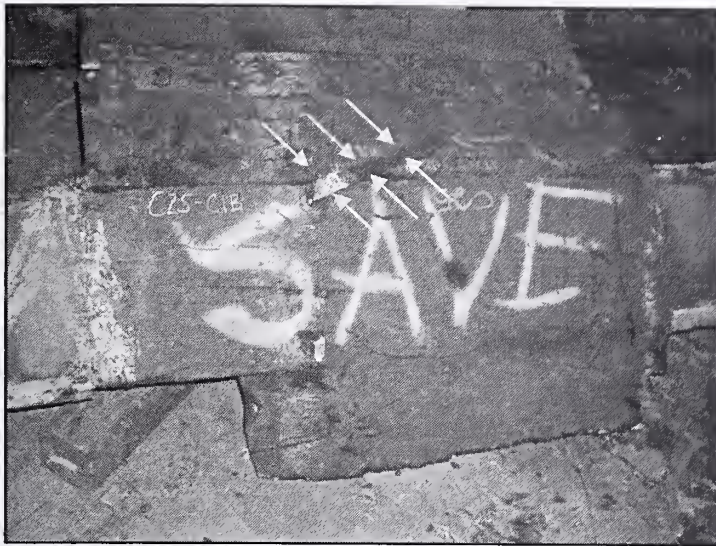
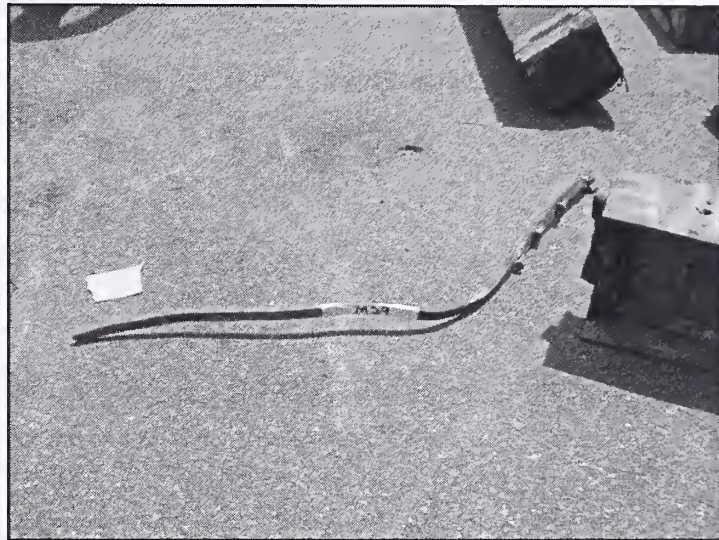
Diagonal bracing strap attached directly to exterior column

Figure A-5. Diagonal bracing strap shown on sample C-25 (top), and single strap labeled M-29 (bottom).

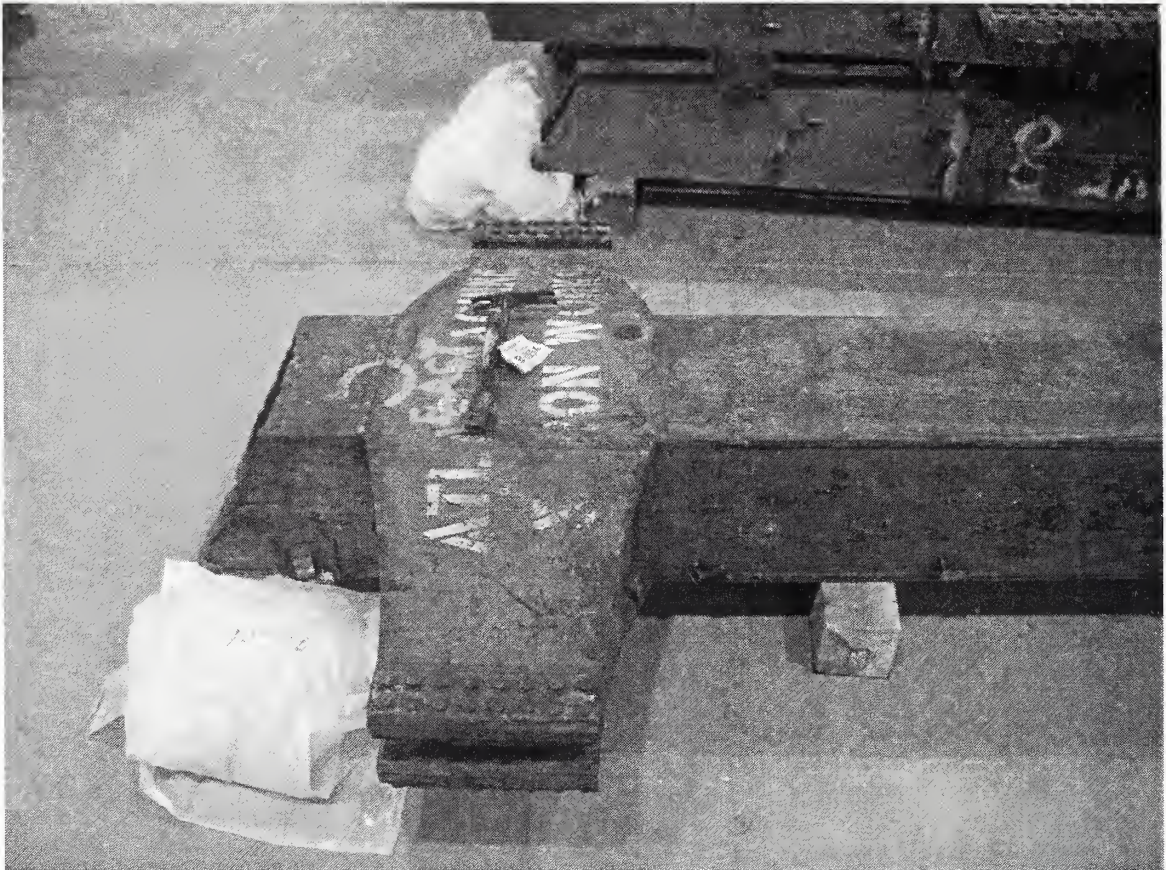
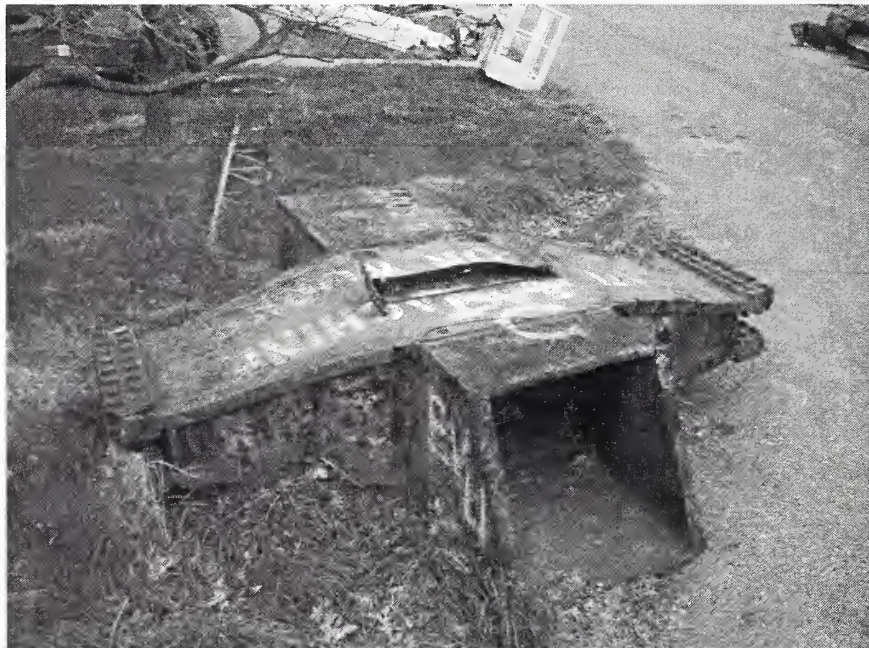
B-5004 at JFK

B-5004 portion cut and moved to NIST campus

Figure A-6. Bowtie section of exterior wall.

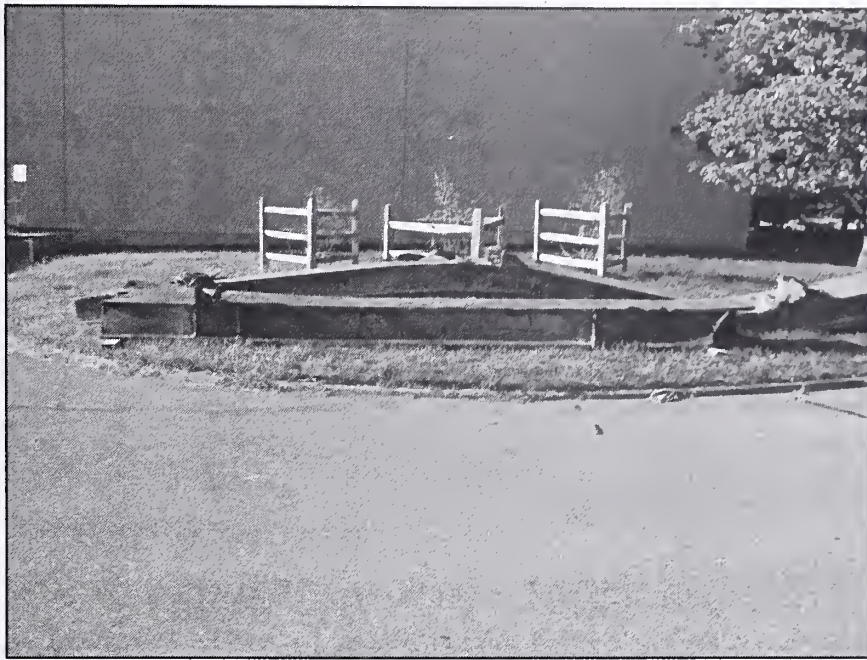
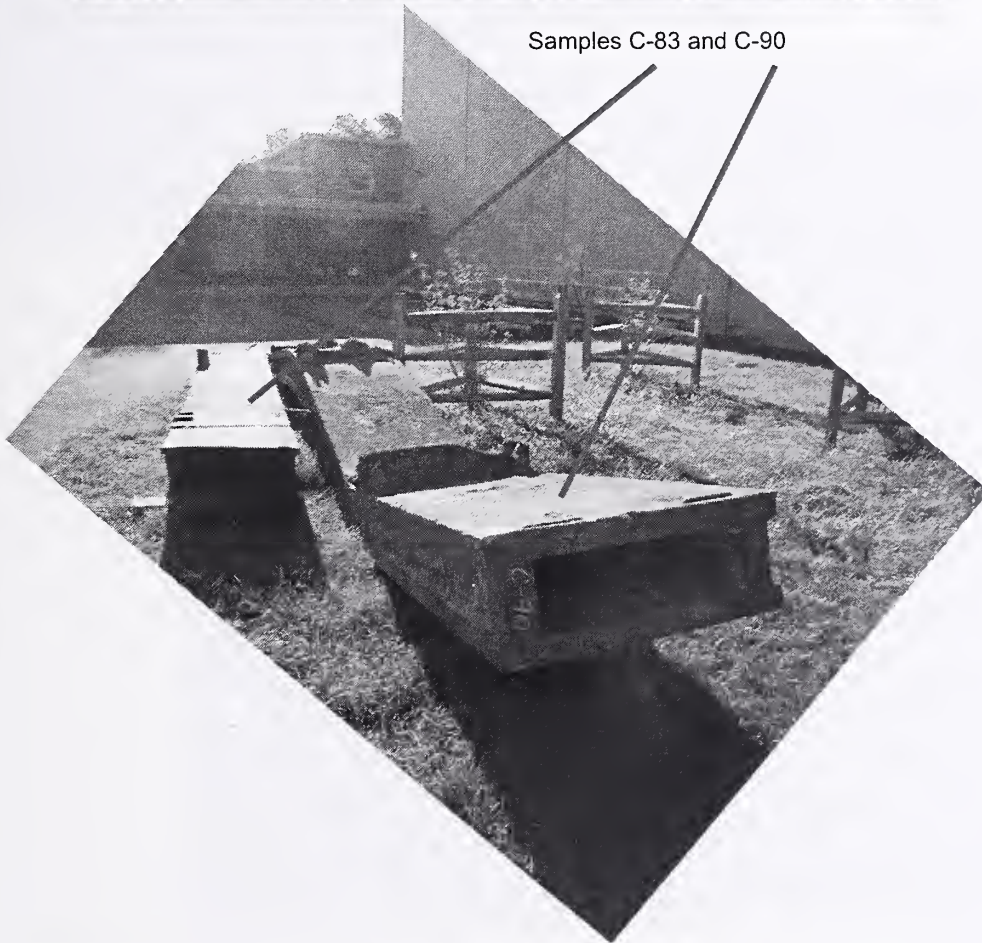
Figure A-7. Recovered rectangular built up box sections used as core columns.

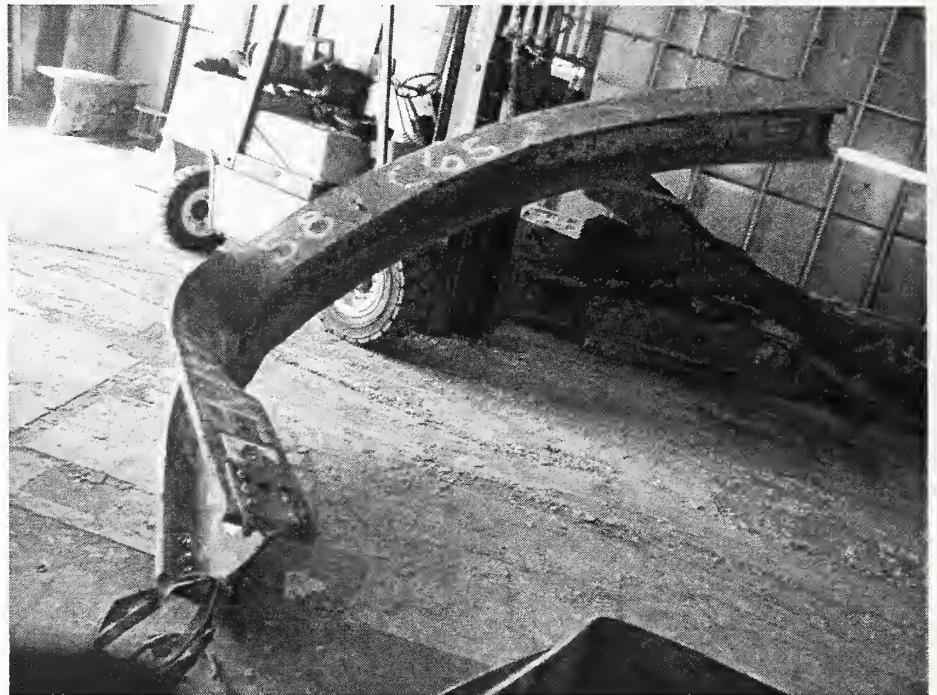
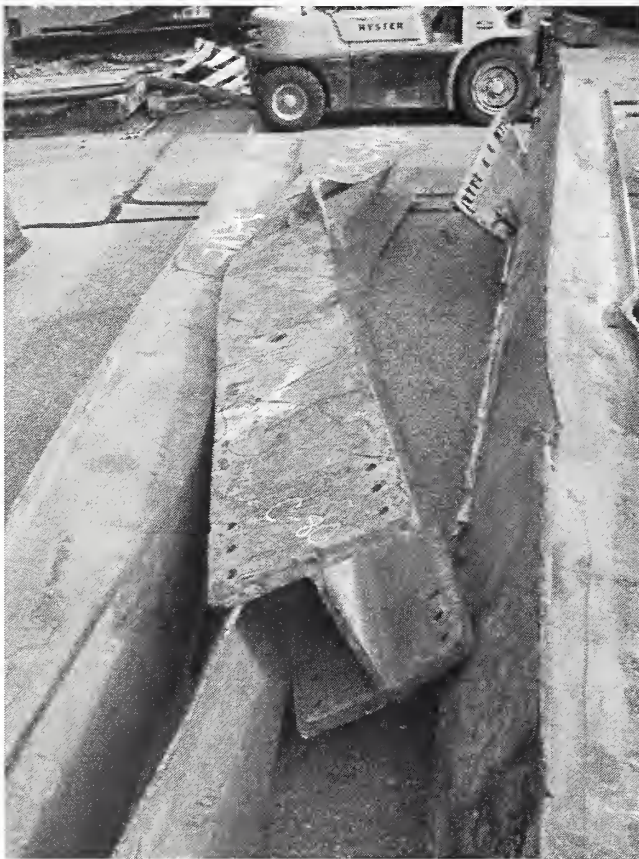
Figure A-8. Recovered wide flange sections used as core columns.

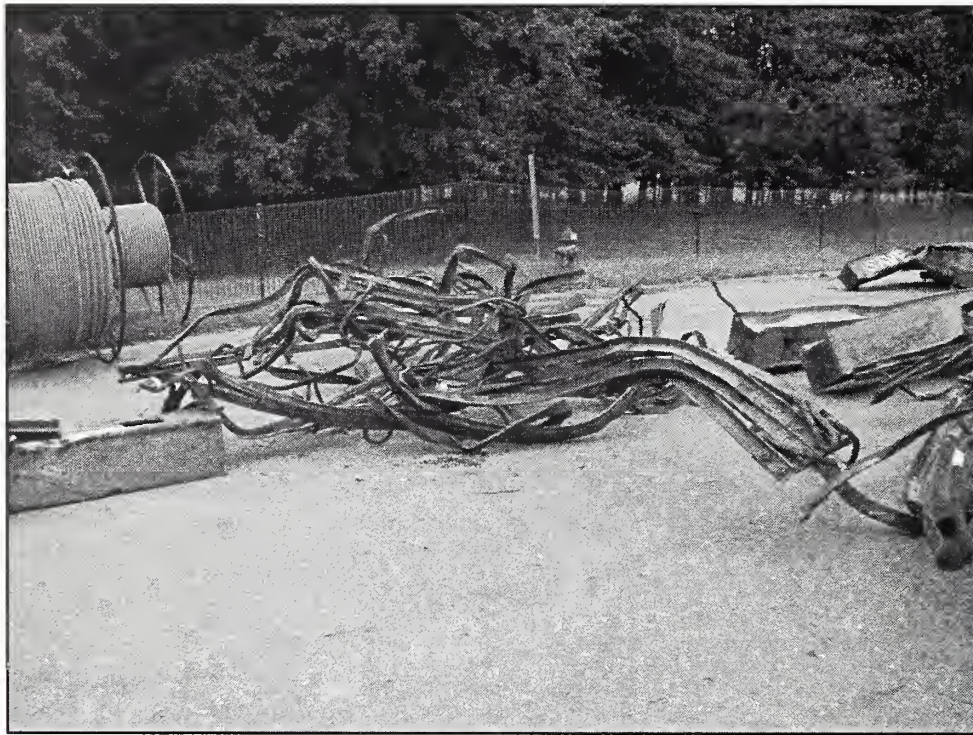
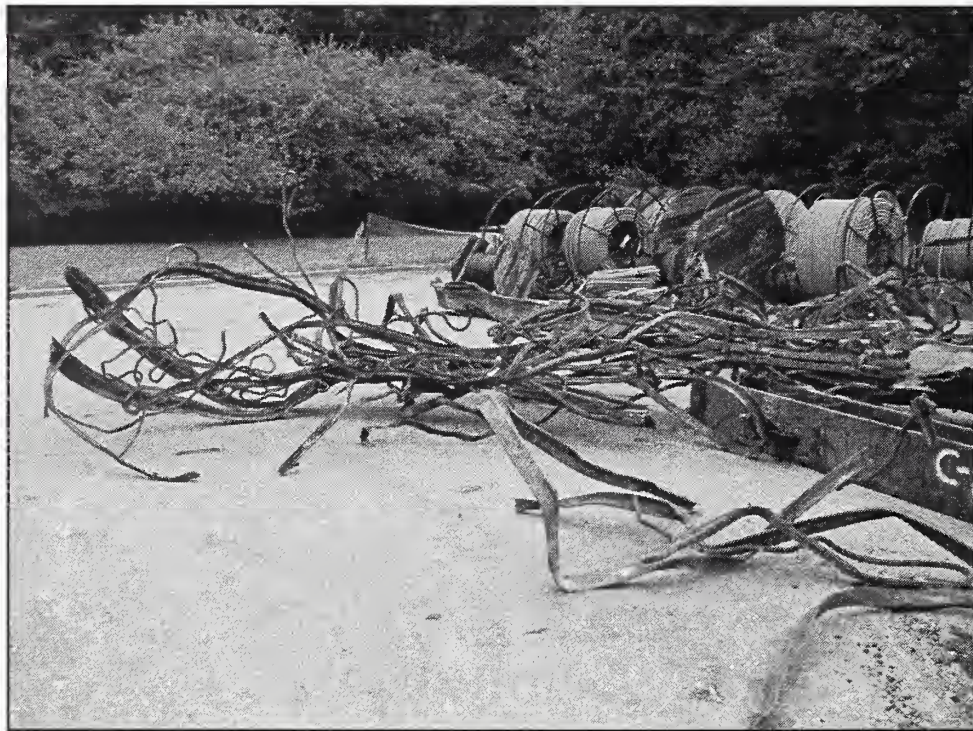
Figure A-10. Recovered floor truss material; shown are portions of sample C-53.

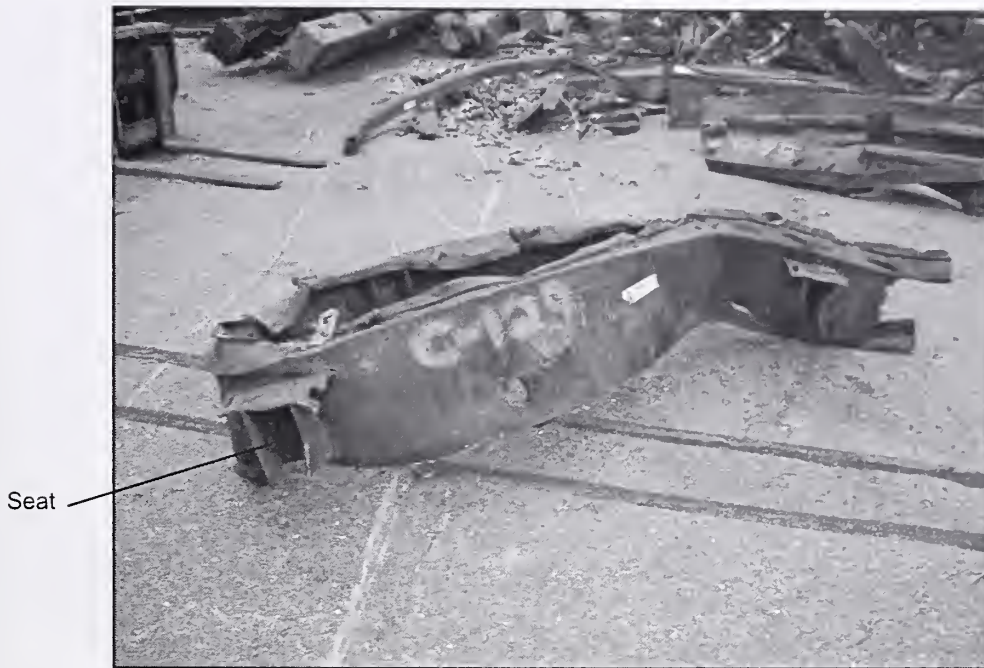
Figure A-11. Recovered inner channel material used to connect floor trusses to core columns; shown is sample C-129.

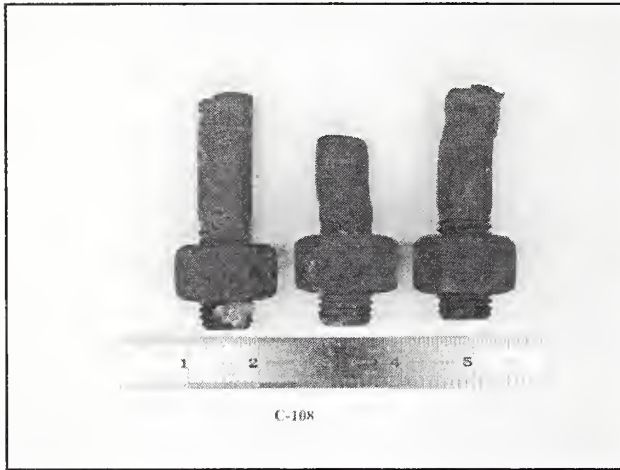
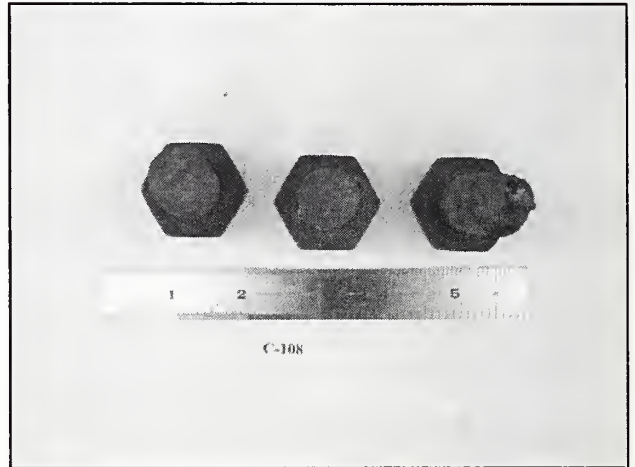
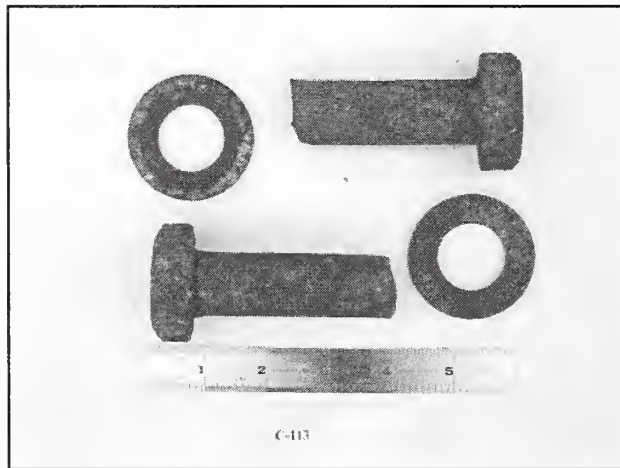
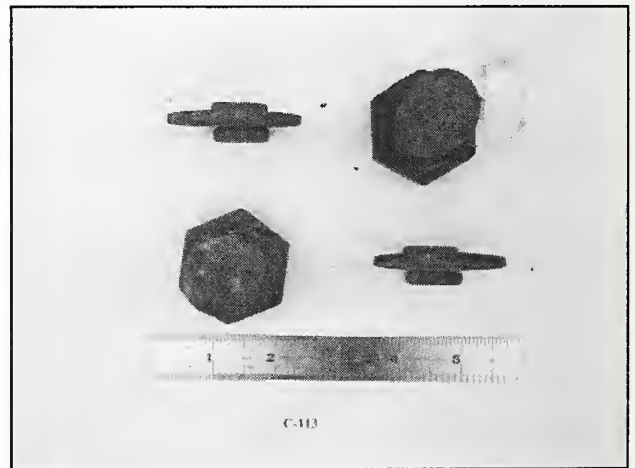
Figure A-13. Examples of recovered bolts from various samples.
