NISTIR 7837

Measurement and Evaluation of Visibility Experiments for Powered Industrial Vehicles

December 2011

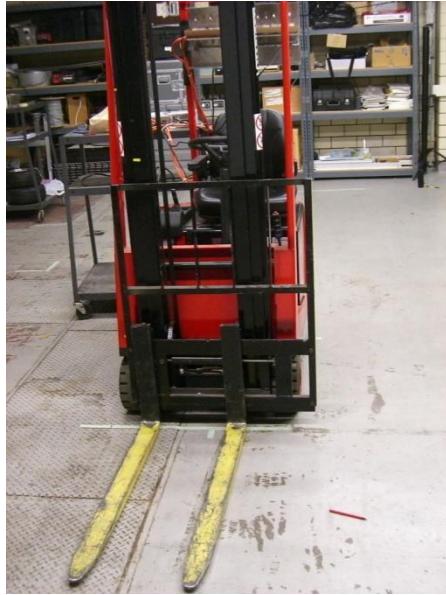
Figure 1. Forklift¹ used for Visibility experiments.

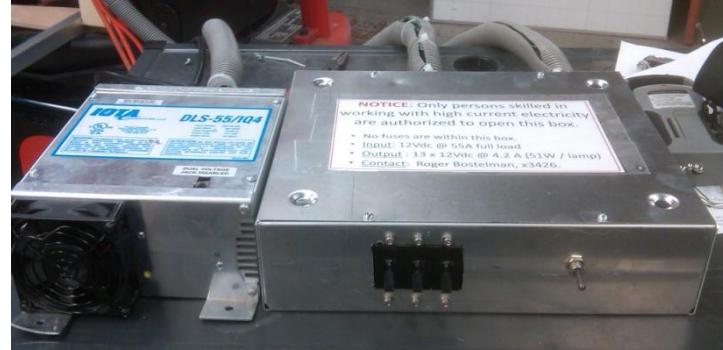
A lamp switch box was designed and built and powered by a 55 Amp power supply as shown in Figure 6 (a). The lamp switch configuration was designed as in ISO/DIS 13564-1 to turn on only the specified lamps. Four circuit breakers were used as switches to power various combinations of lights as shown in the schematic in Figure 6 (b).

Figure 6. (a) Electrical setup: (left) power supply and (right) lamps switch box; (b) Lamps wiring diagram.

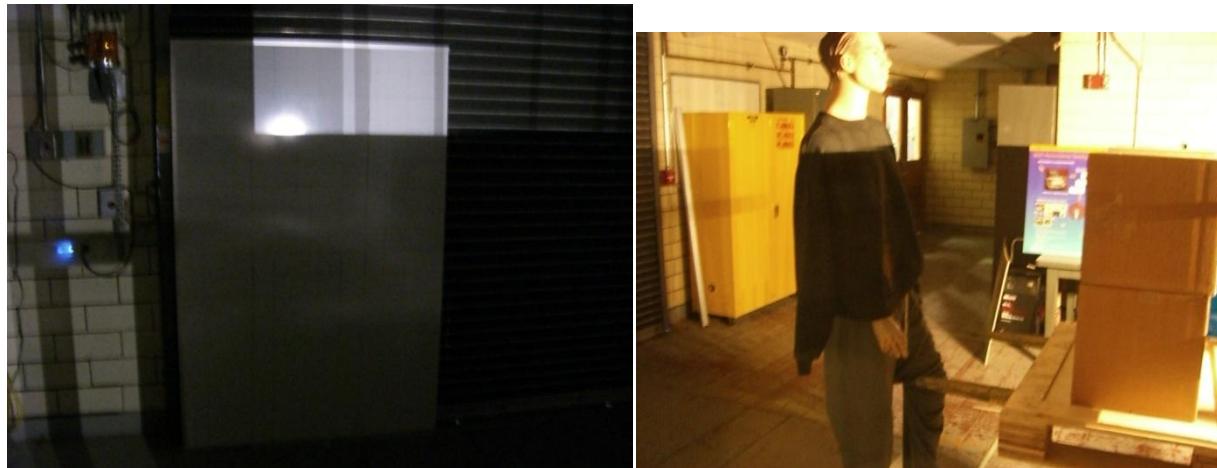
Table 5. Test results with forklift carrying a pallet of boxes. Fork arms height 90 cm, tests with four boxes, each 31 cm³. Tests 1, 3, 4 are in the forward direction. Tests in other directions were not affected by the pallet of boxes. See examples in Figure 10.

Figure 10: Photos of tests with pallet of boxes (left) using the test board and (right) using a mannequin.

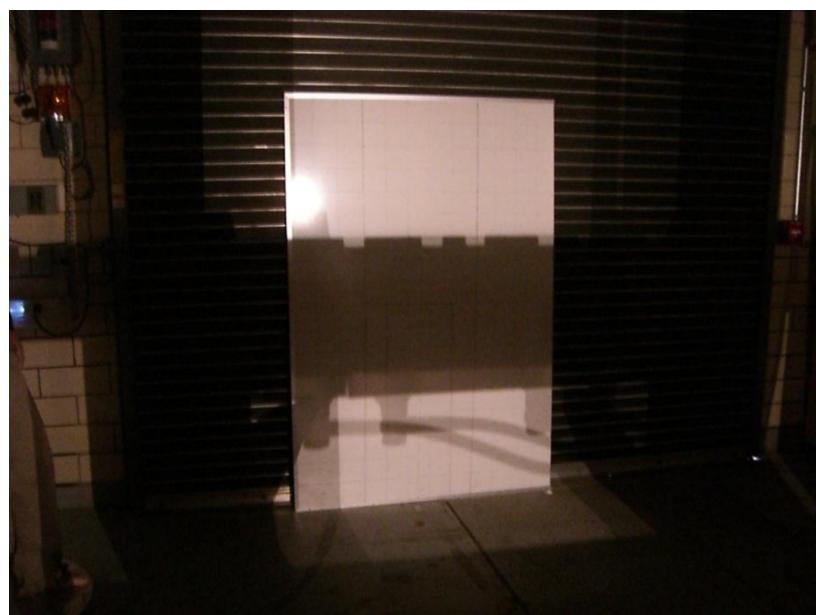
Table 6. Results when fork arms were raised to 117 mm above floor. See examples in Figure 11.

Figure 11. Shadows on the test screen when fork arms were raised to 117 cm

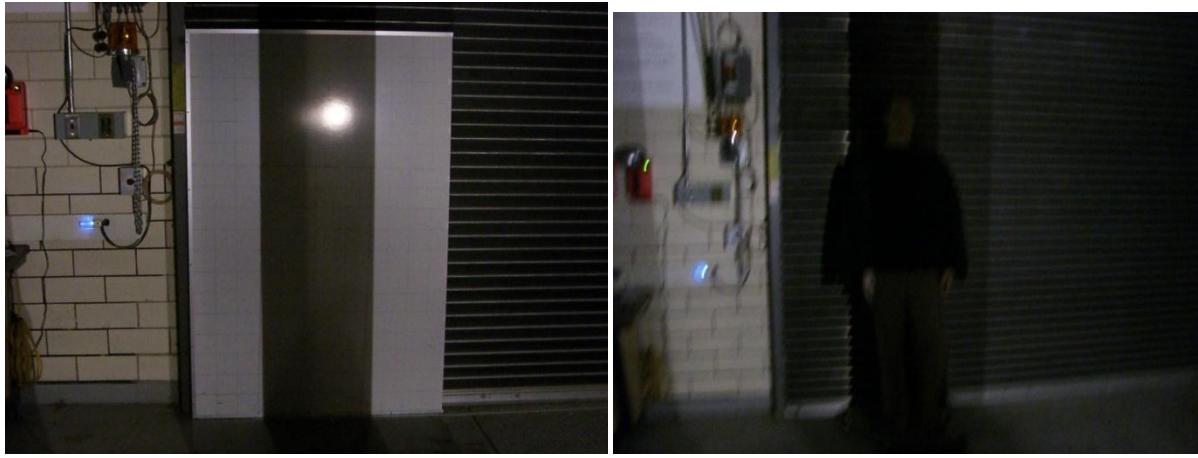
Since turning on all the lights at the same time did not effectively simulate the positions of two eyes of an operator, a change to the current method can be introduced and tested. Two lamps separated by 75 mm could be used to approximate the operator's eye spacing. The average human eye separation, as found in online web searches, is 65 mm. [6] Therefore, to simulate the two eyes of an operator, only two lamps (3 and 5) were turned on. To better simulate the movement of the head of an operator, the entire light source array was rotated from $+45^\circ$ to -45° . The two shadows at the same location P1.1 were compared when generated by the standard stationary method and the recommended rotated lamps method. The resulting illuminated area according to the standard method was 100 %. However, the illuminated area dropped to 0 % when the light source array was rotated to -30° . This meant that there was a blind spot that could not be detected by the standard method and therefore, by the operator. Figures 12 shows photos of shadows on the test screen when following the standard and also shadows on a mannequin. Figure 13 shows the same scene after rotating the lights -30° .

Figure 13. Shadows by rotating light source array -30°: (left) on the test board and (right) using a mannequin instead of the test board.

The first suggested change of the standard is, therefore, to rotate the lamp array with only two lamps turned on and separated 75 mm.

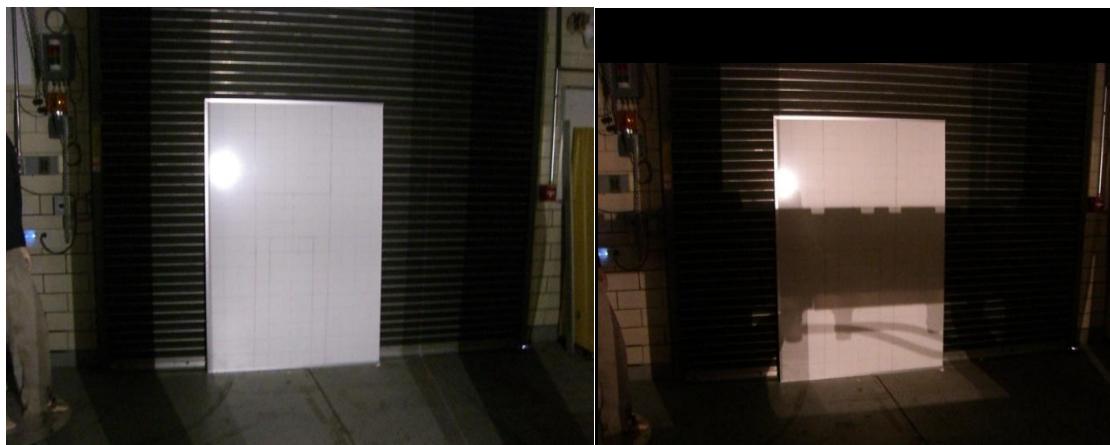
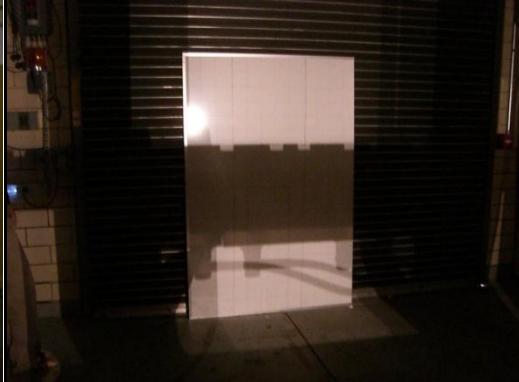
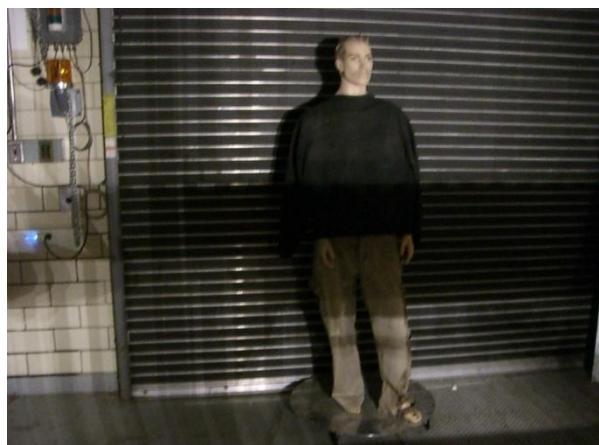
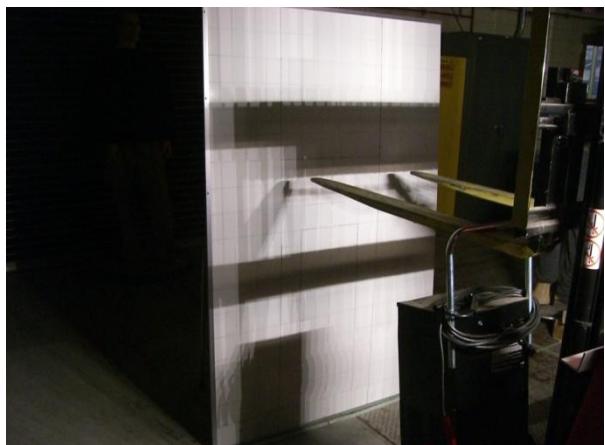
ISO/DIS 13564-1 mandates that the forklift be ‘unladen’ (unloaded) during testing. However, forklifts are used to carry and deliver loads. Tests were conducted with the forklift as if carrying a battery charger as shown in Figure 14 (a). The fork arms were raised and the fork frame structure blocked the operator’s visibility. Three test pieces were used in the test, including: test body, mannequin, ANSI/ITSDF B56.5 standard test pieces. When the fork arms were raised, the percentage of illuminated area decreased as expected due to additional forklift structure blocking lamps. When the fork arms were raised to 117 cm high, illuminated percentage of test body dropped from 100 % shown in Figure 14 (b) to 42% as shown in Figure 14 (c). Figure 14 (d) shows resulting shadows on a mannequin to interpret visibility results for pedestrians and Figure 14 (e) shows similar results as in Figure 14 (c) but on a closer test body path to the vehicle. A suggested change to the standard is that visibility tests should be tested with the forklift carrying underslung loads.

Figure 14 (a) Forklift with an underslung load used for visibility tests, (b) test body before the arms were raised, (c) test body when forklift tines were raised and resulting shadows: (d) on a mannequin and (e) on the test body at a closer path to the fork tines.

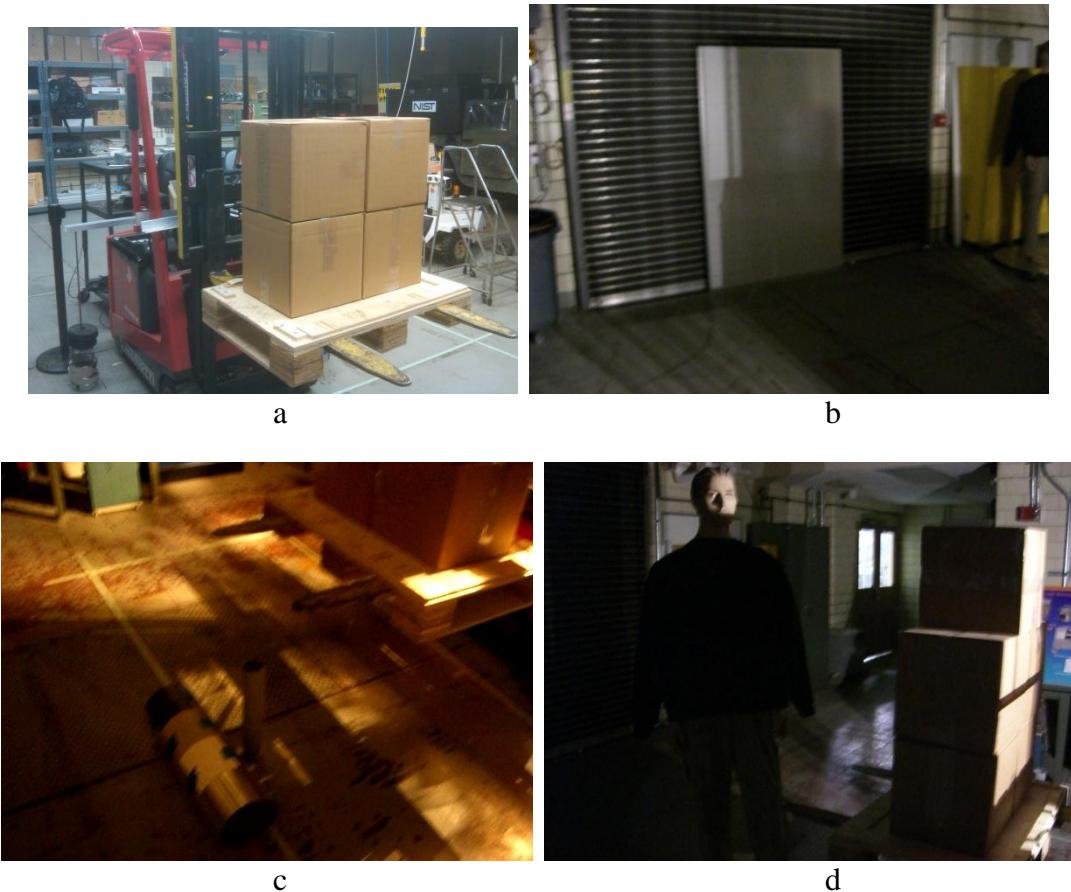
Similar to recommendation 3, recommendation 4 suggests visibility tests also be conducted while the forklift carries loads above the fork tines (see Figure 15 (a)), such as a pallet of chosen standard-size boxes. Specific load size should be specified. Illuminated area was 0 % with the test body at P1.2 as shown in Figure 15 (b). Other visibility test apparatuses were also used in NIST tests including a mannequin and ANSI/ITSDF B56.5 standard test pieces (see Figure 15 (c, d)). Illuminated area was 0 % with the mannequin and 0 % with the test pieces when they were located at the midpoint of P3.1 - P3.2.

Figure 15. (a) Forklift carrying a pallet of boxes for visibility tests with resulting shadows shown on: (b) the test body, (c) ANSI/ITSDF B56.5 standard test pieces, and (d) a mannequin.

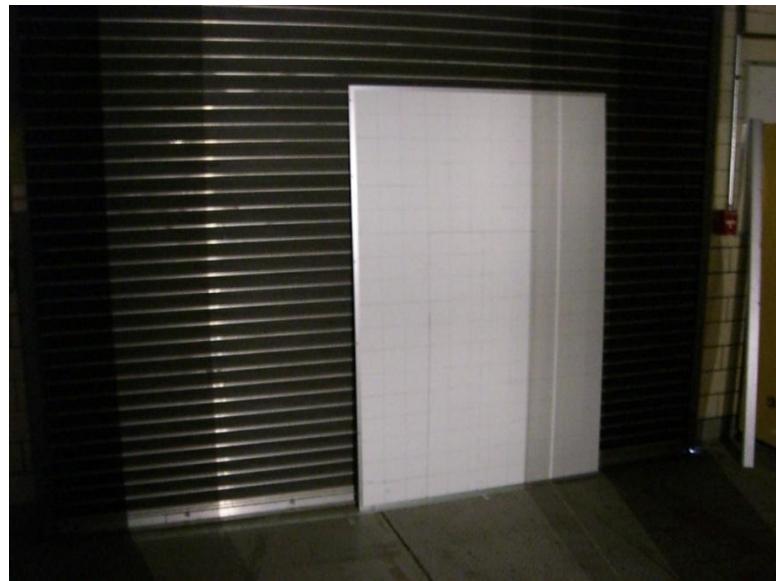
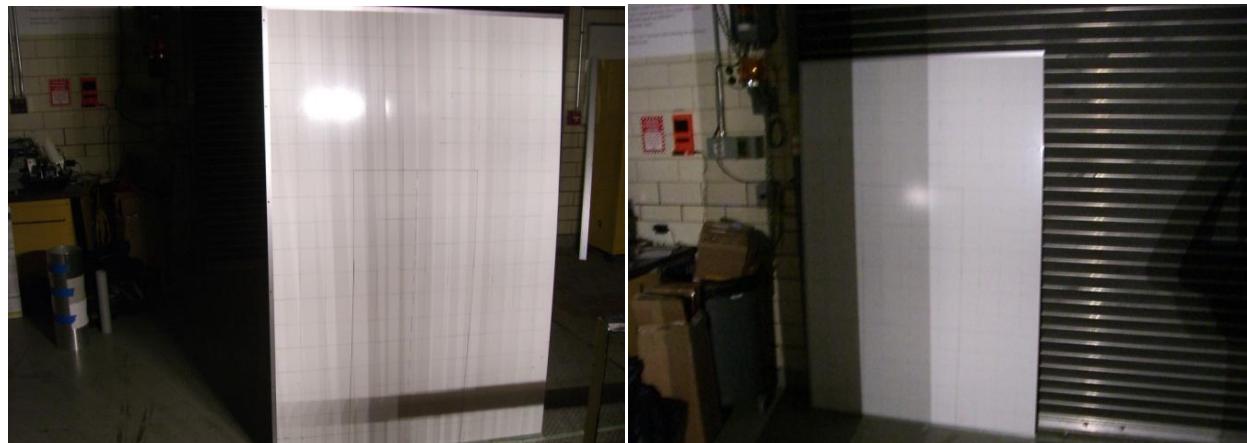
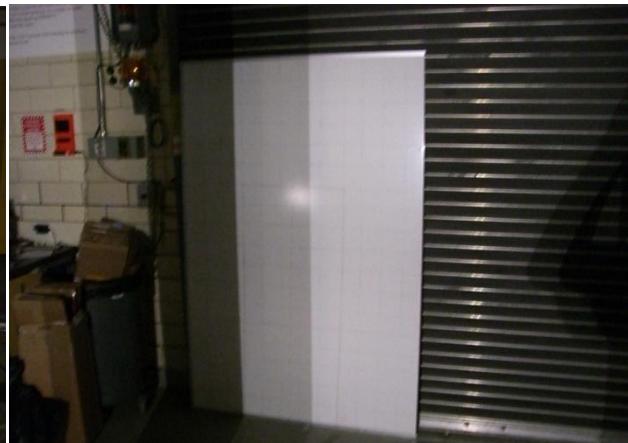
Figure 20. Examples of shadows of visibility tests, from: (a)Test 3, at location 3, (b) test 4, location 3, and (c) test 3, location is left edge of test screen at P1.1.
