NIST NCSTAR 1-9A

**Federal Building and Fire Safety Investigation of the
World Trade Center Disaster**

Global Structural Analysis of the Response of World Trade Center Building 7 to Fires and Debris Impact Damage

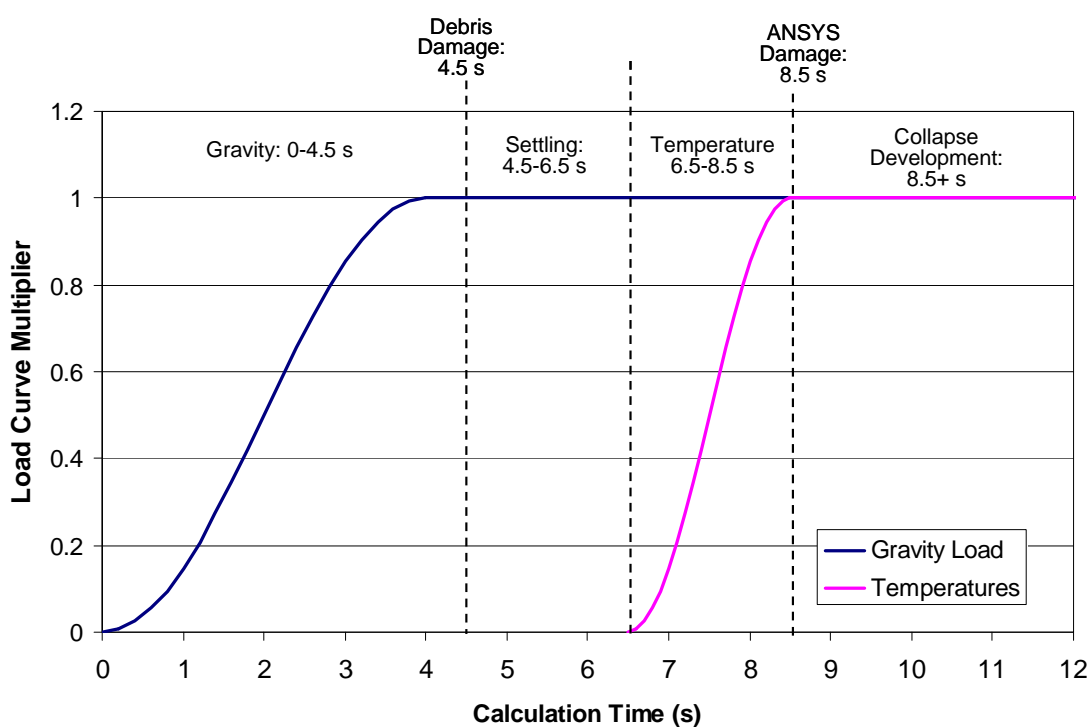
Figure E-3. Initialization sequence for global model.

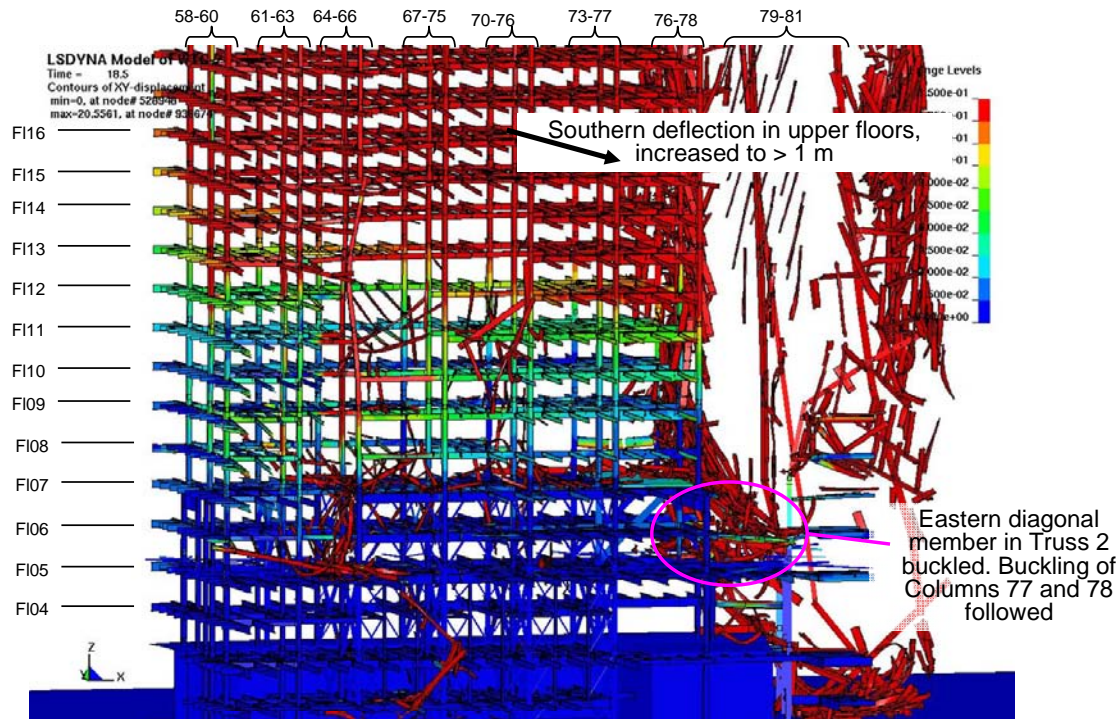
The buckling of the interior columns in the LS-DYNA analysis was followed by the buckling of the exterior columns.

Figure E-7. Core lateral displacement. Time: 2.5 (18.5) s, Columns 77 and 78 buckle when Truss 2 fails from debris loads.

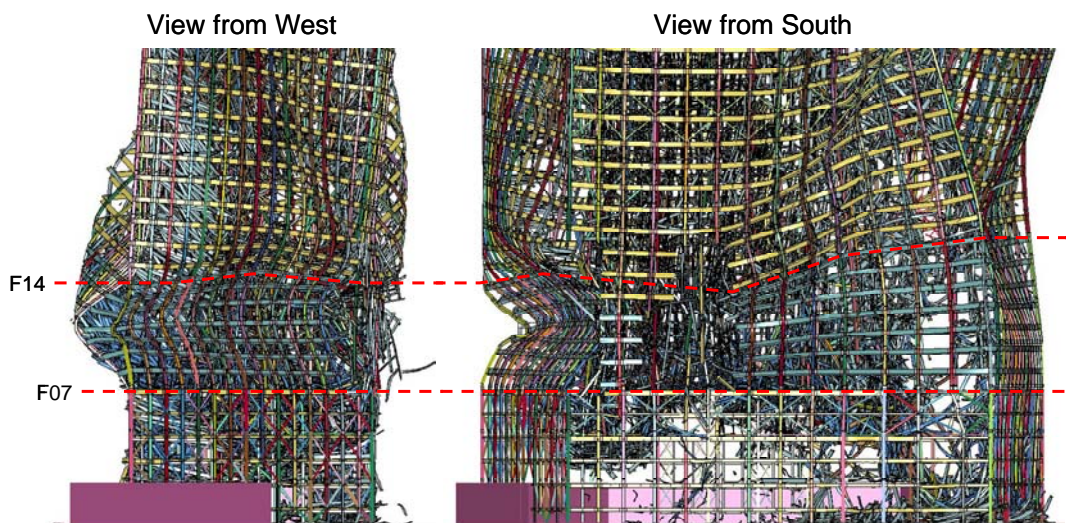
As the core columns buckled across the building, the exterior columns were impacted by falling debris and load redistribution from the interior columns. All exterior columns buckled between approximately Floors 7 and 14. The south and west columns buckled first around 6 (22) s, followed by the north and east face columns. Once column support was lost in the lower floors, the remaining structure above began to fall vertically as a single unit. Views of the lower floor exterior column buckle modes are shown in Figure E-8.

Figure E-8. Lower floor exterior column buckling (slabs removed from view).

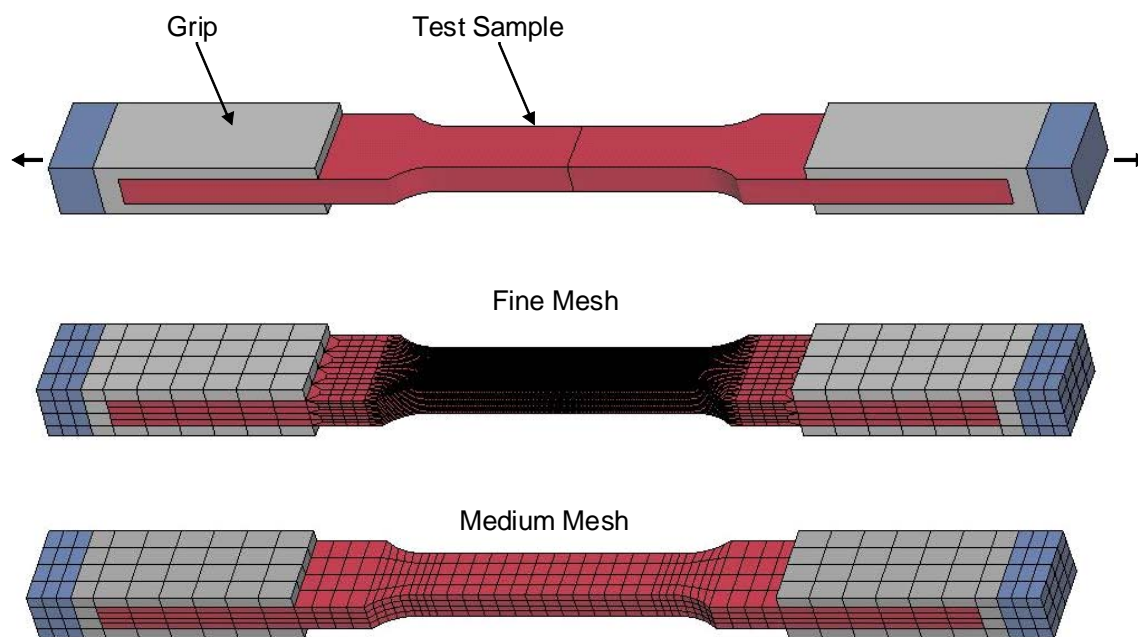
The tensile tests performed by NIST applied the ASTM 370 test standard (ASTM 2003). Example finite element models of the specimen models used for testing of the WTC core column steels are shown in Figure 2-1. The typical element length used in the gage section for the fine meshes was approximately 0.015 in (0.381 mm) and for the medium meshes was approximately 0.10 in (0.254 mm).

Figure 2-1. Example finite element models of the ASTM 370 tensile specimen.

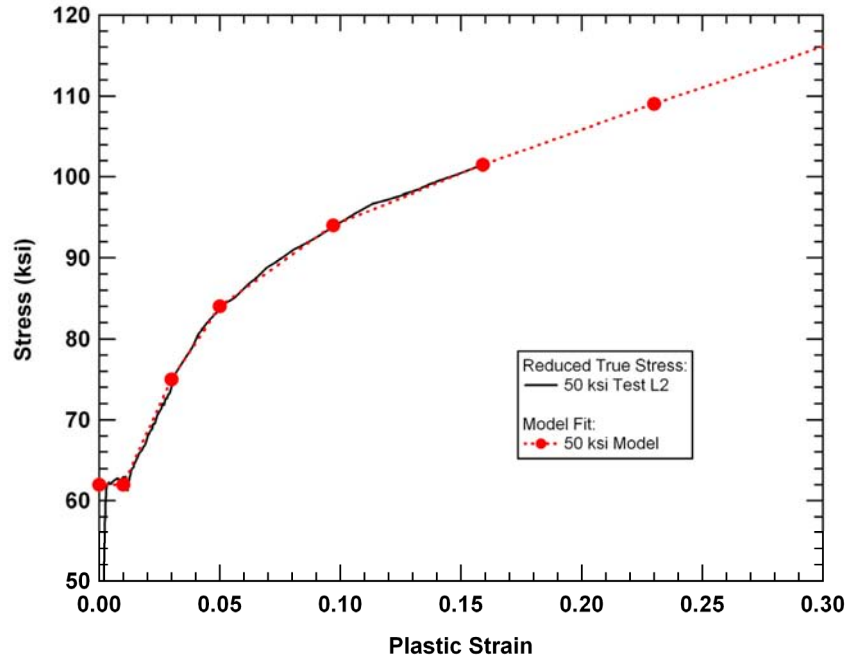
Figure 2-3. Tabular true stress-strain constitutive model curve for the 50 ksi (345 MPa) steel.

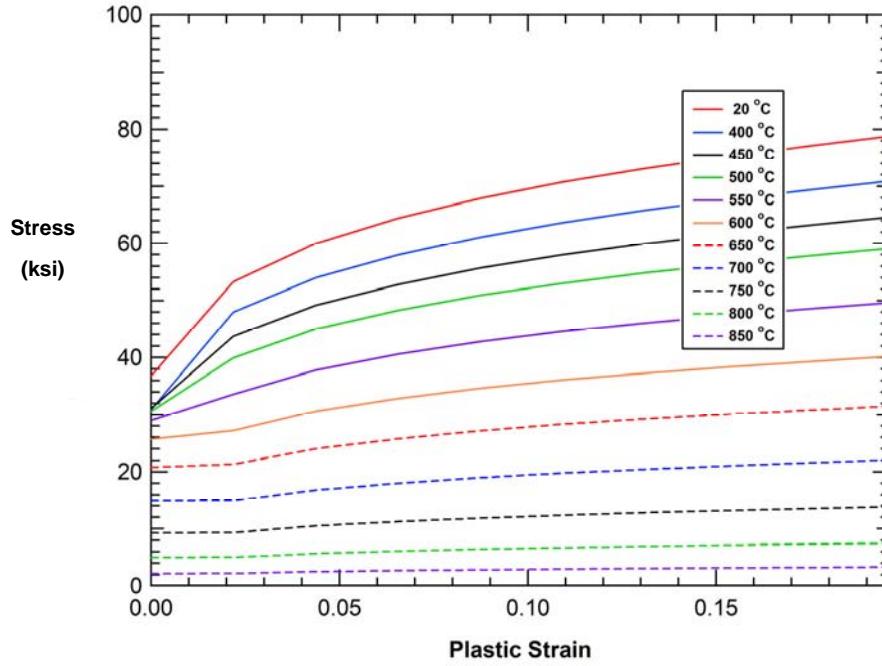
Figure 2-7. Stress-strain curves of the 36 ksi (248 MPa) structural steel as a function of temperature.

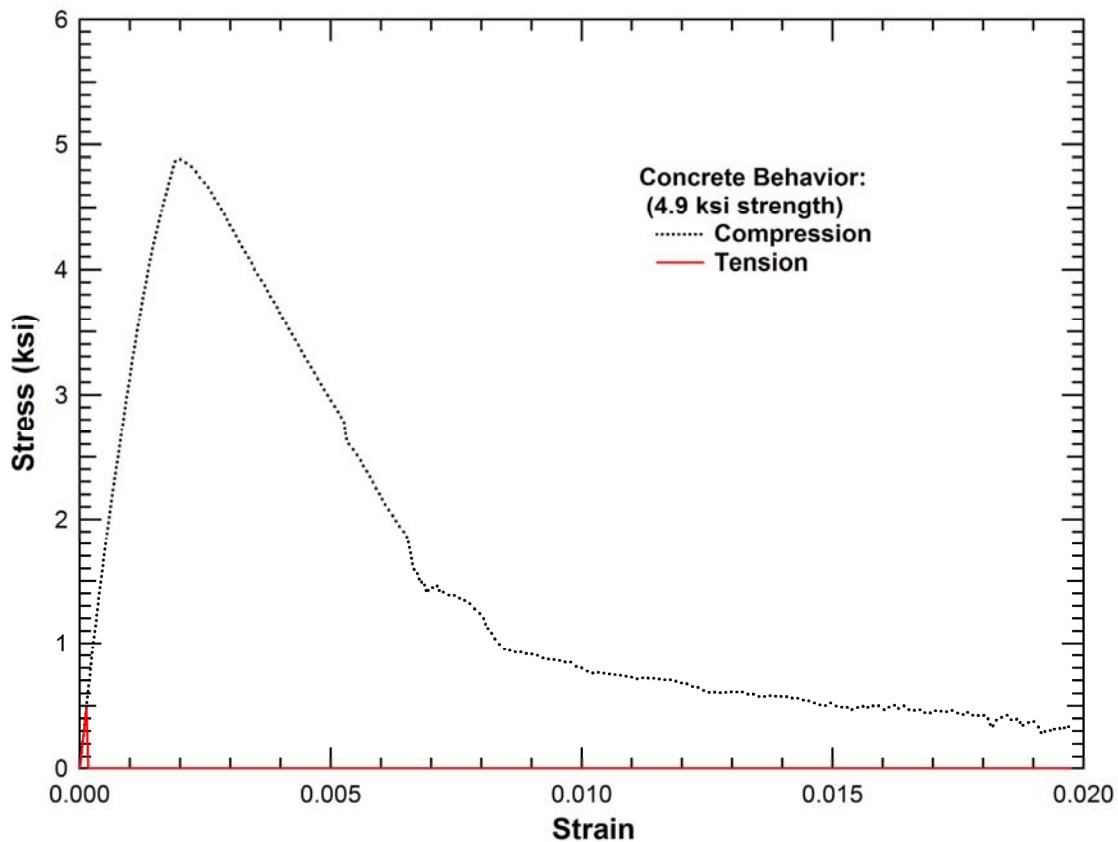
To offset the tensile deficiencies of concrete, reinforcement is added in structural applications to improve the tensile strength and damage tolerance. In this application, the concrete slab reinforcement was provided by the metal deck and wire mesh. The stress-strain behaviors of the metal deck and wire mesh are provided in Figure 2-12. By comparison, the strengths of the metal reinforcement were an order of magnitude higher than the concrete compressive strength and two orders of magnitude higher than the concrete tensile strength.

Figure 2-11. Concrete stress-strain behaviors in tension and compression.

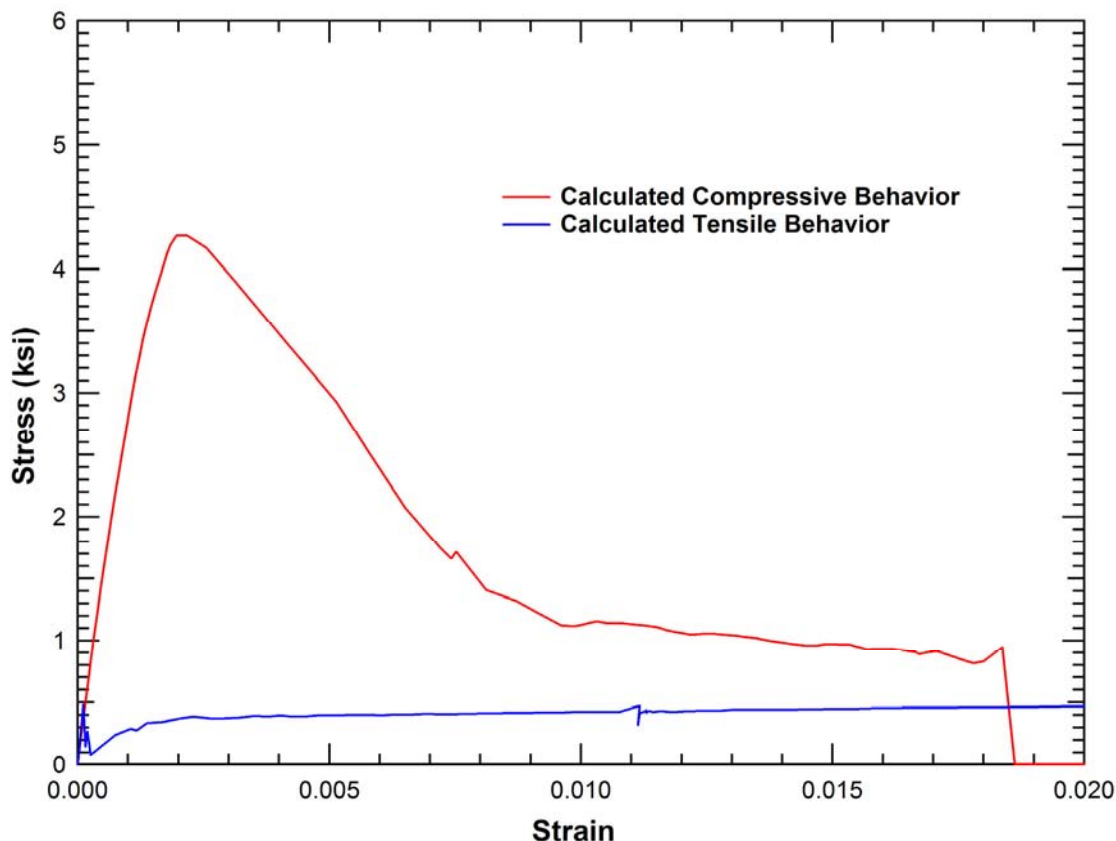
The final stage of the slab constitutive behavior development was to generate a model for a material test specimen and simulate the behavior in uniaxial tension and compression. The calculated tensile and compressive behaviors for the composite slab are shown in Figure 2-14. The calculated stress-strain curves in Figure 2-14 reproduced the desired material behaviors shown by the average curves in Figure 2-13.

Figure 2-14. Calculated composite slab behaviors in tension and compression.

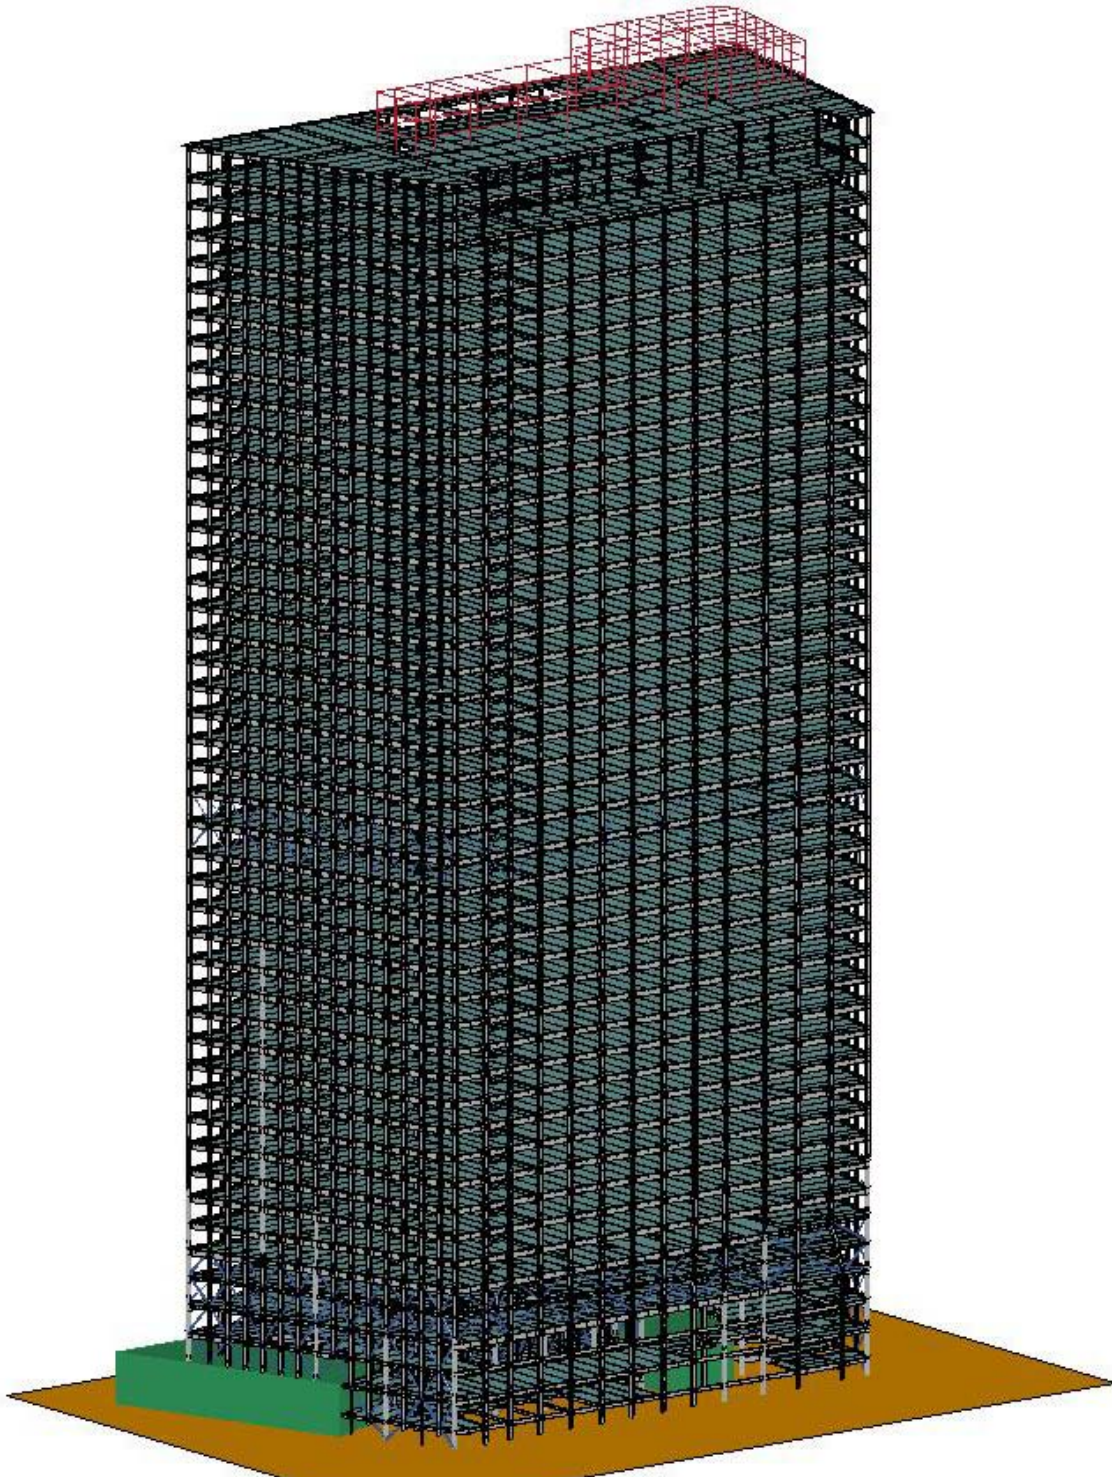
Figure 3-20 Global model of WTC 7, viewed from the southwest.

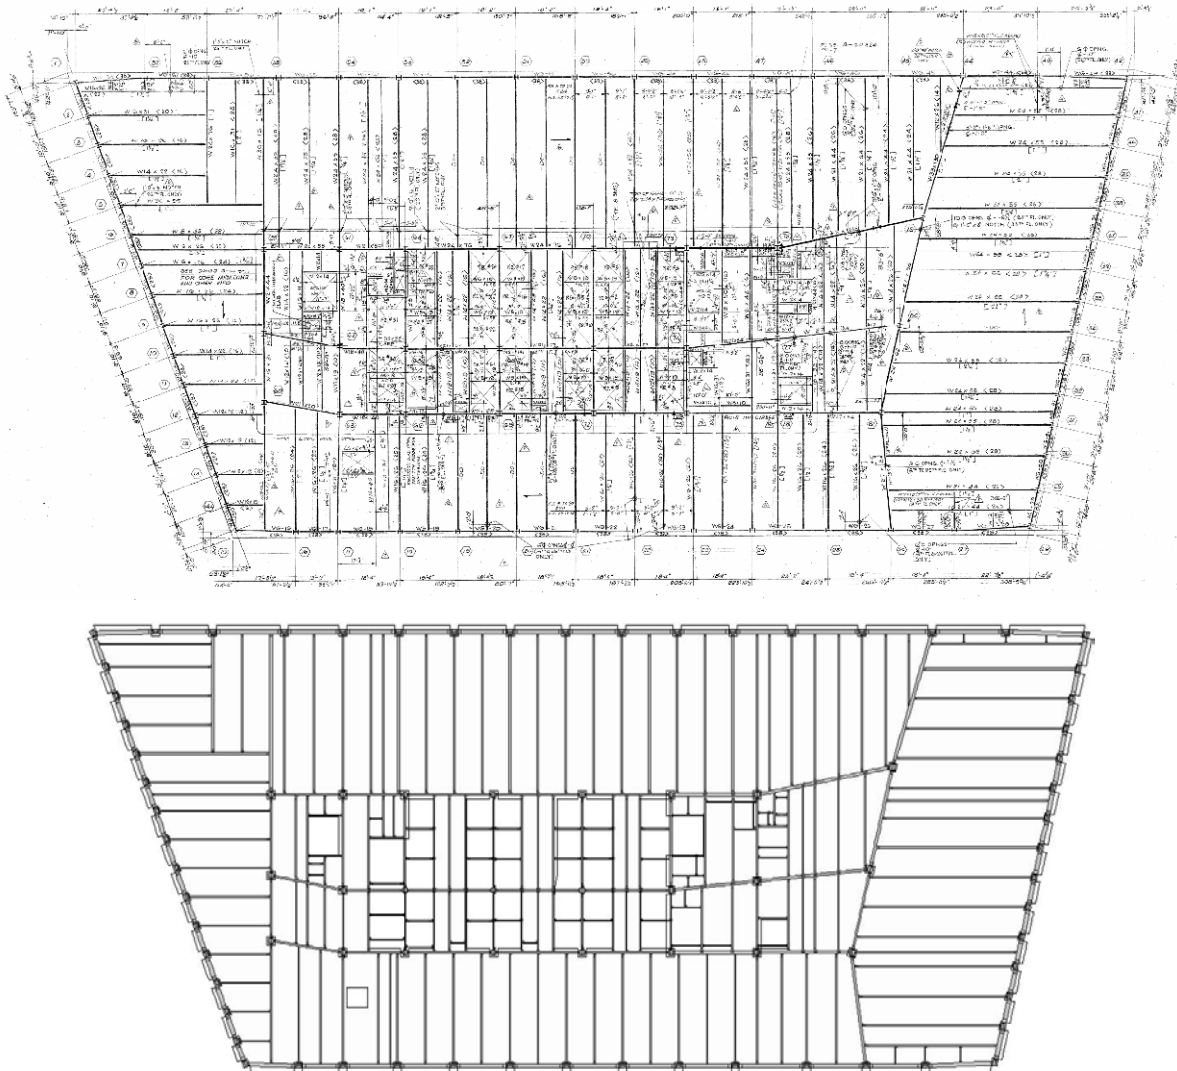
Figure 3-22 shows drawing S-8, the framing plan for a typical floor found on Floors 8 to 20 and 24 to 45, and the corresponding LS-DYNA model layout. All beams, girders, and columns were included in the model except for a few non-critical, small section beams in the core.

Based on structural drawings (Cantor 1985)

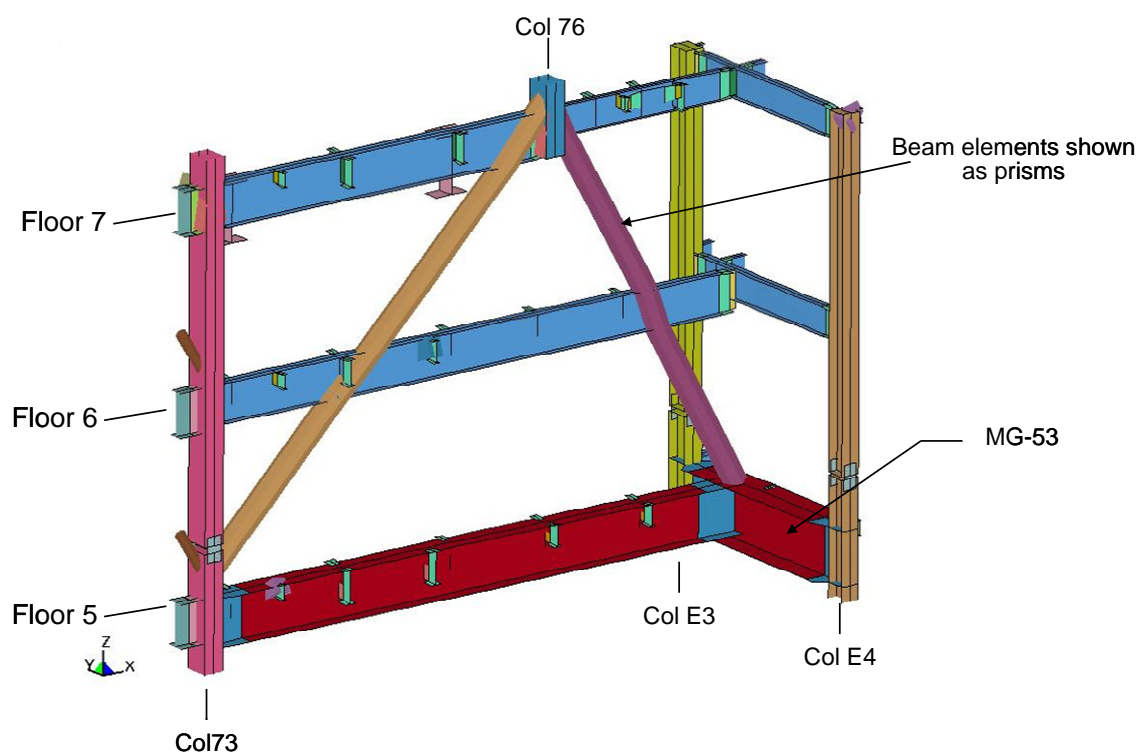
Truss 1 is shown in Figure 3-34. An elevation view of Truss 1 (looking from the south) is shown in Figure 3-35. The truss supported Column 76 and transferred Column 76 loads to Column 73 to the west and to columns E3 and E4 to the east. Columns E3 and E4 both started at Floor 7 and carried loads down to the foundation. Moment connections were used to frame the east-west beam at Floor 5 into Column 73 and girder MG-53.

Figure 3-34. Detail of Truss 1 in the WTC 7 global model.

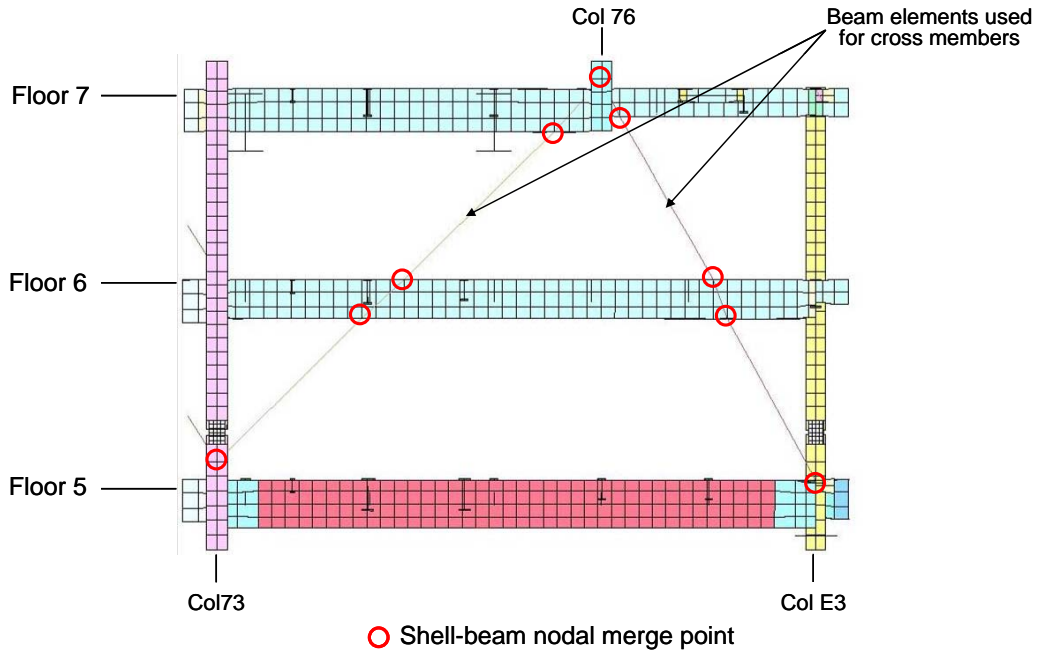
Figure 3-35. Framing connections for the beam elements used in Truss 1.

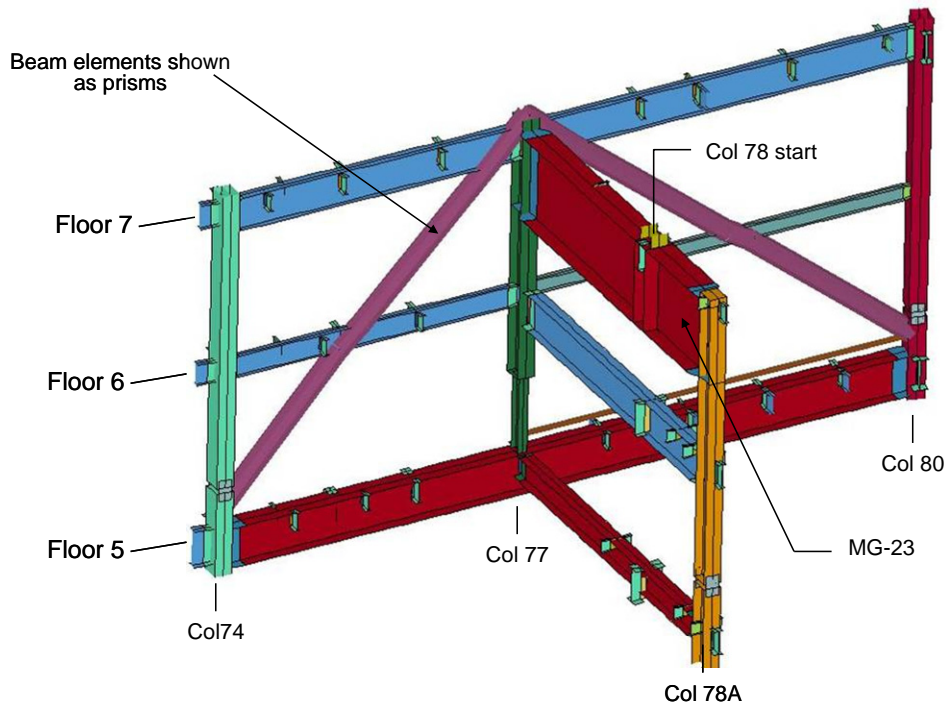
Truss 2 is shown in perspective and in elevation from the south in Figure 3-36 and Figure 3-37, respectively. Truss 2 supported Column 77 and transferred Column 77 loads to Columns 74 and 80. Girder MG-23 supported Column 78 and transferred Column 78 loads to Columns 77 and 78A. Column 78A started at Floor 7 and carried loads down to the foundation. Moment connections were used in the Floor 5 girder framing between Columns 74 and 80.

Figure 3-36. Detail of Truss 2 in the WTC 7 global model.

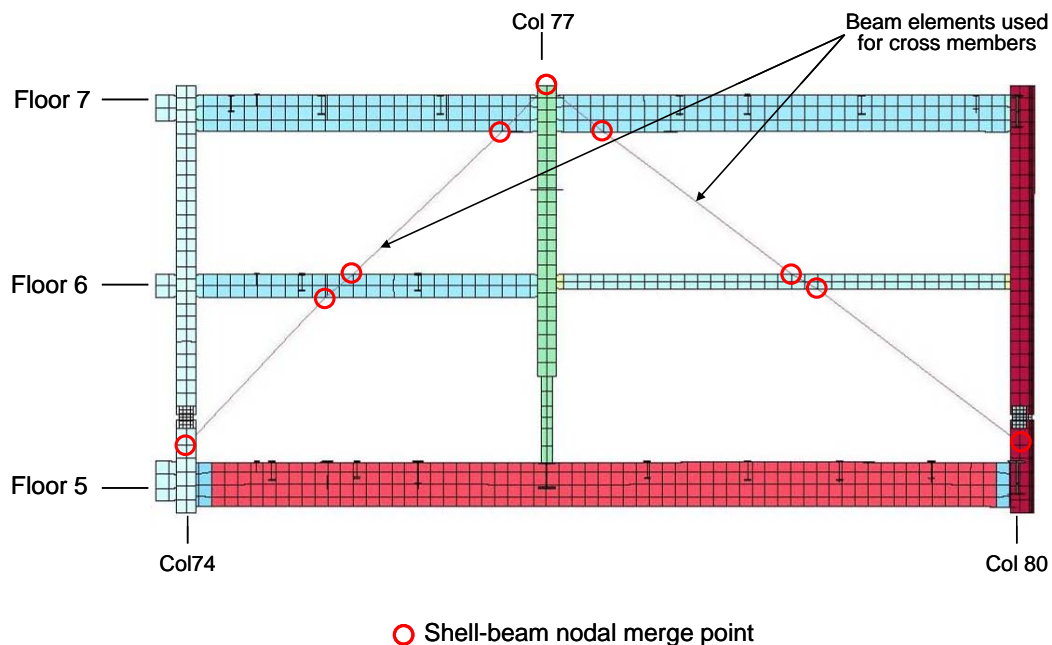
Figure 3-37. Framing connections for the beam elements used in Truss 2.

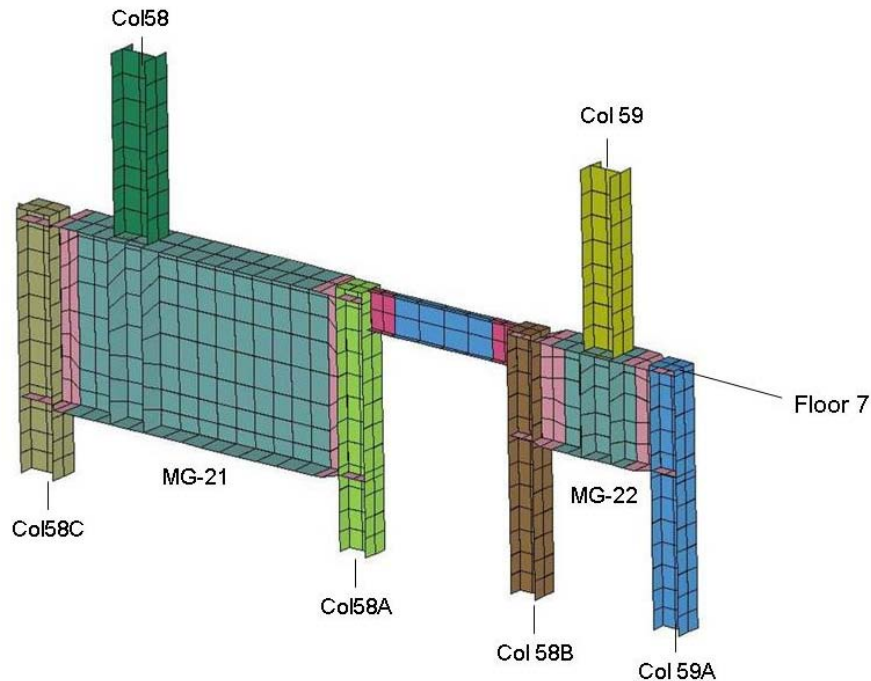
The transfer girders at the lower end of Columns 58 and 59 are shown in Figure 3-40. The transfer girders, MG-21 and MG-22, were handled as special cases in the TrueGrid models, separate from the standard wide flange beam model prototype used elsewhere. The stiffener plates for Columns 58 and 59 were included. Girder MG-21 supported Column 58 and transferred the Column 58 loads to Columns 58A and 58C. Girder MG-22 supported Column 59 and transferred the Column 59 loads to Columns 59A and 59B. Columns 58A, 58C, 59A, and 59B started at floor 7 and carried loads down to the foundation.

Figure 3-40. Detail of Columns 58 and 59 load transfer connections in the WTC 7 global model.

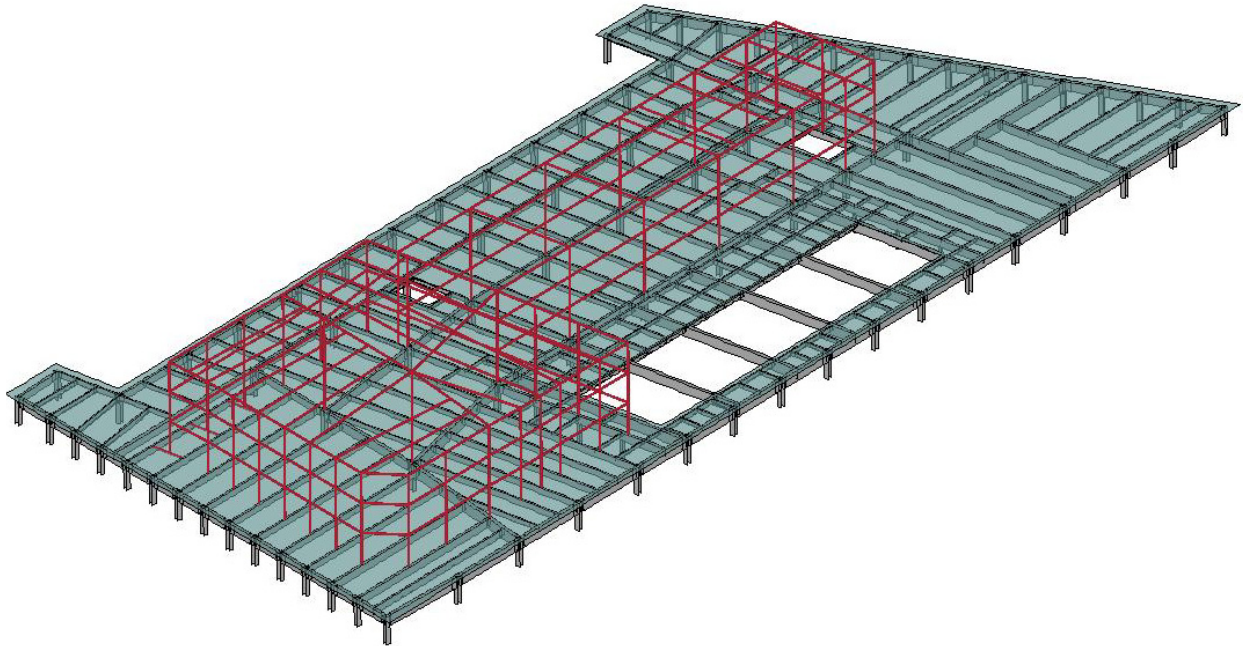
Detailed connection models were not included in the penthouse framing model. To approximate the weak connections between the east penthouse and the screening wall section of the western penthouse, the two structures were decoupled. That is, the beam elements directly connecting the screening walls to the eastern penthouse were deleted from the calculation, as illustrated in Figure 3-47. This operation was performed at the same time that debris impact damage from the collapse of WTC 1 was applied to the model, as described in Section 3.3.3.

Figure 3-46. Simplified beam element model of the penthouse structure.

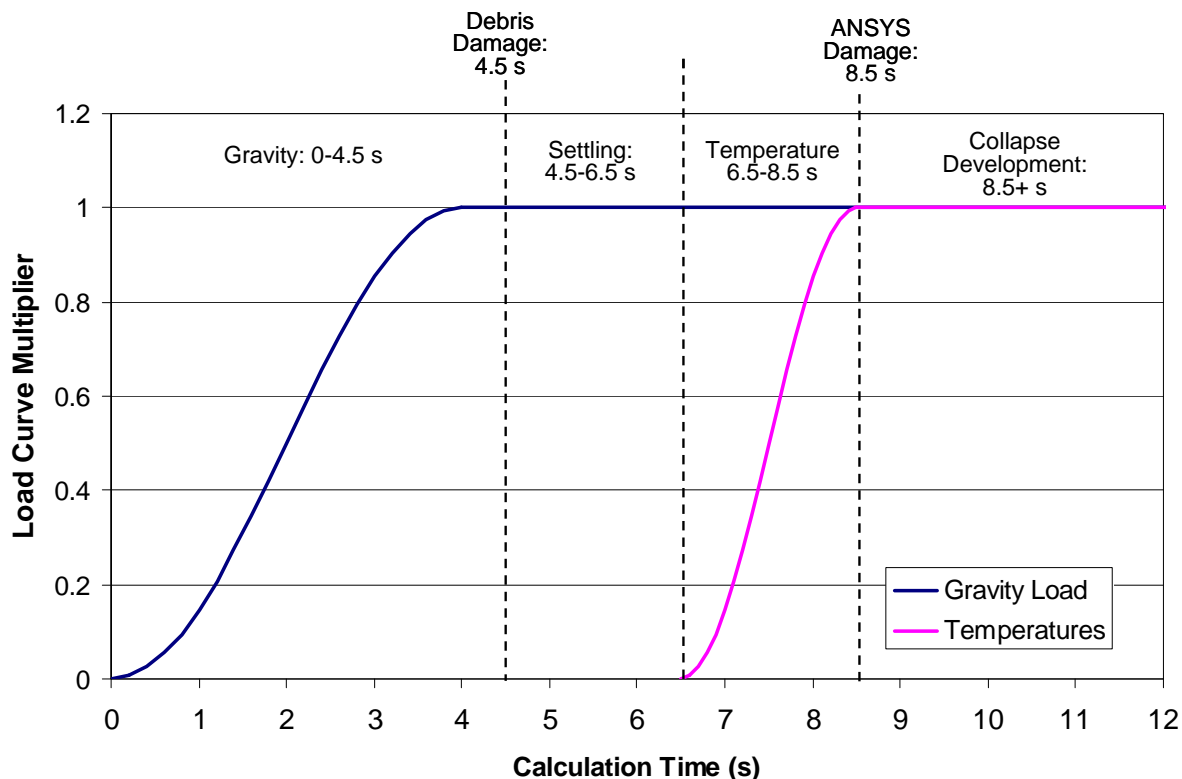
A chart showing the initialization sequence with the load curve profiles used is shown in Figure 3-48. The individual initialization steps and their effect on the global model are summarized in the following subsections.

Figure 3-48. Initialization sequence for the global model.

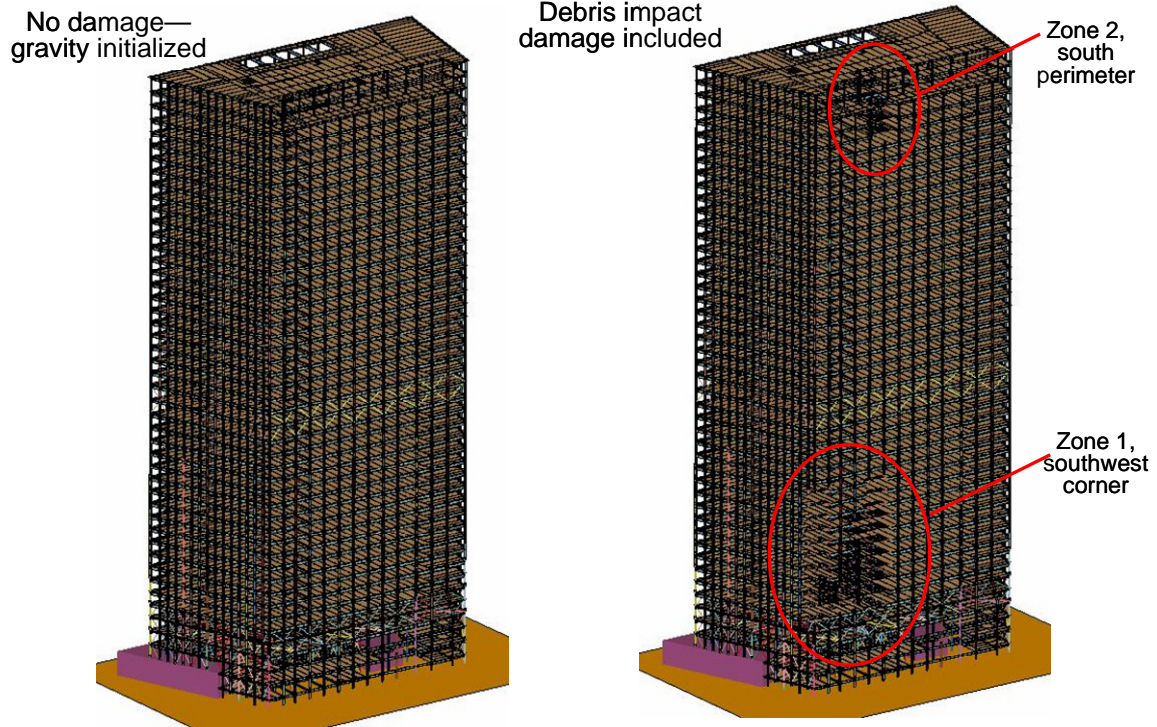
Figure 3-52. WTC 1 debris impact damage application to the global LS-DYNA model.

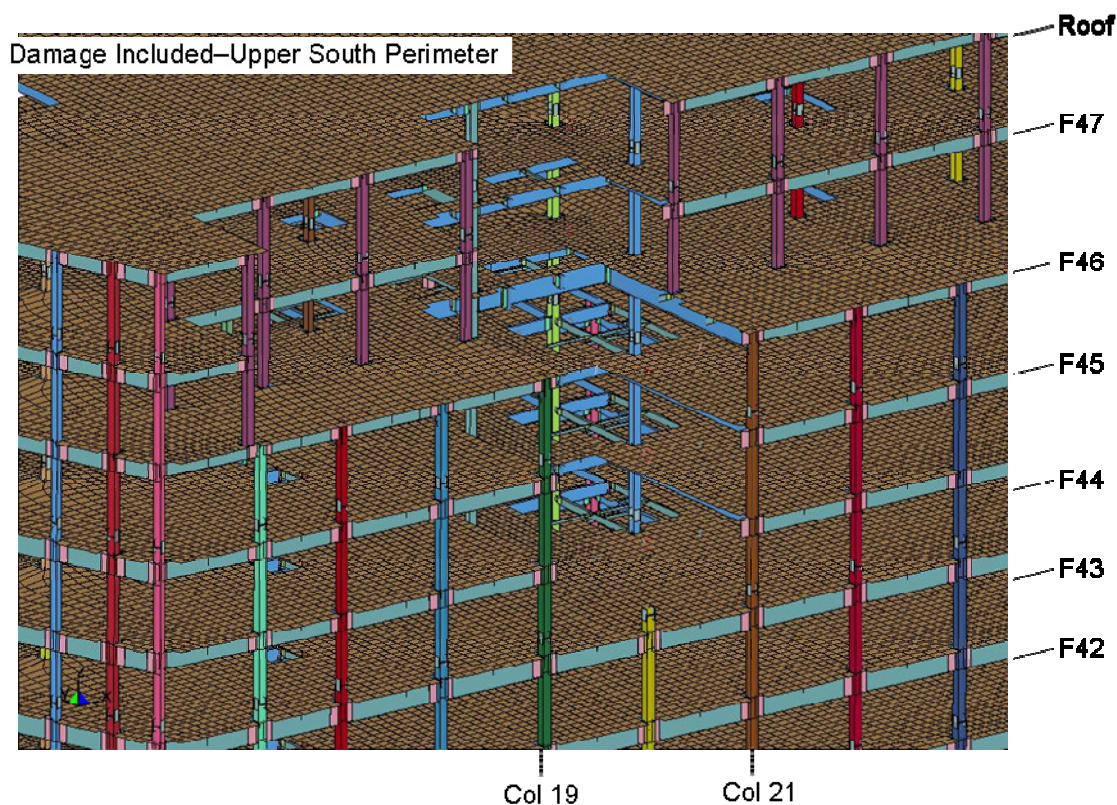
Figure 3-54. Detail view of Zone 2 impact debris damage in the LS-DYNA model.

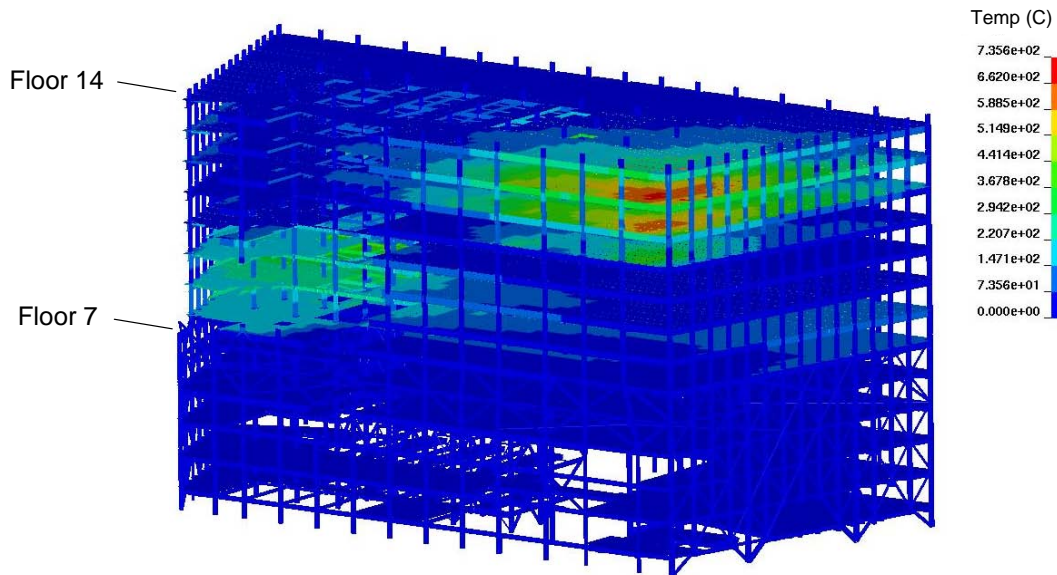
Figure 3-56. Detail view of the temperature profile in Floors 7 through 14.

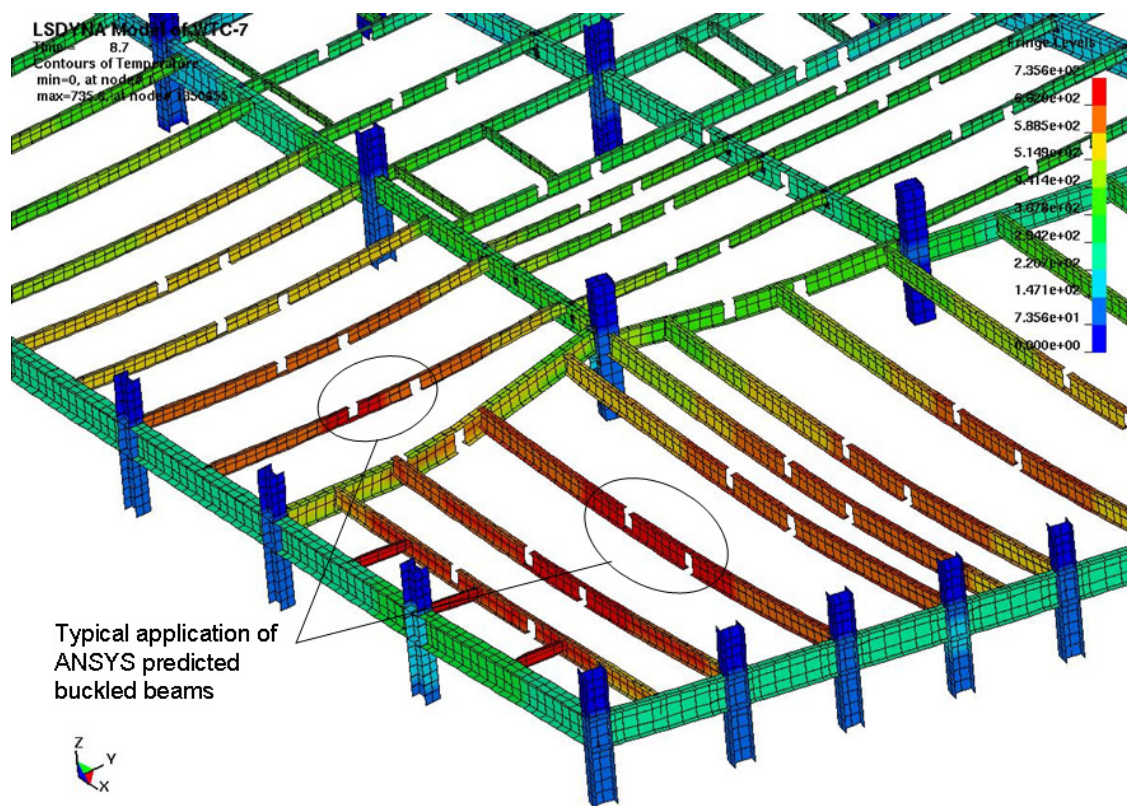
Figure 3-57. Application of ANSYS computed buckled beams in LS-DYNA model.

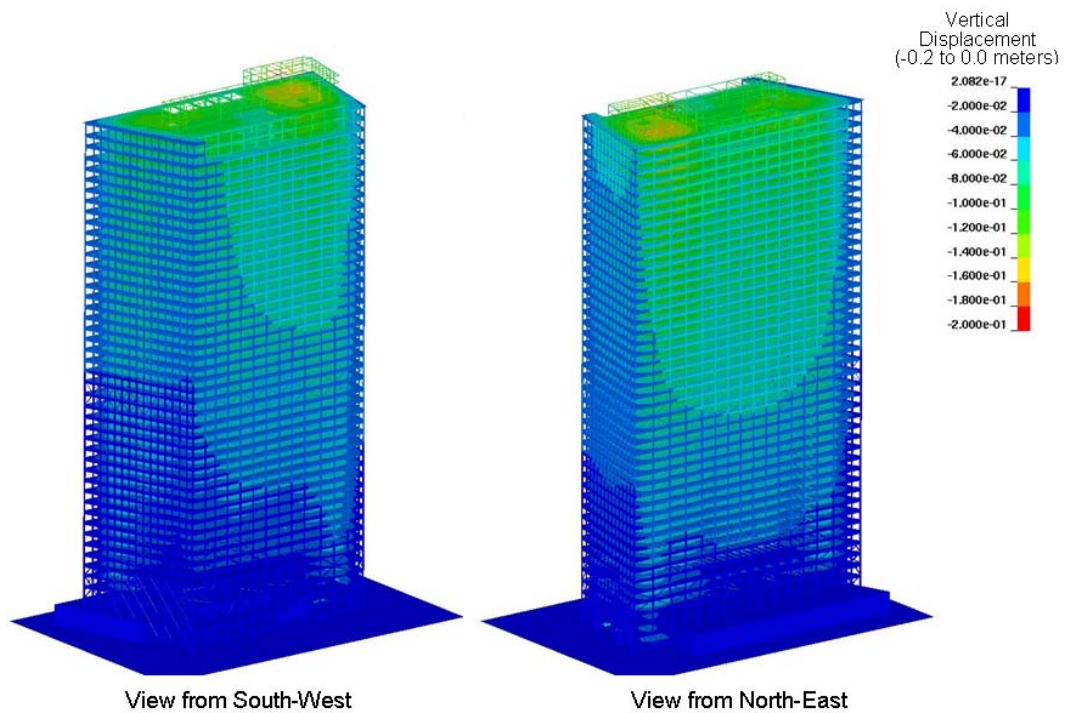
Figure 3-59. Calculated global vertical displacements after gravity initialization.

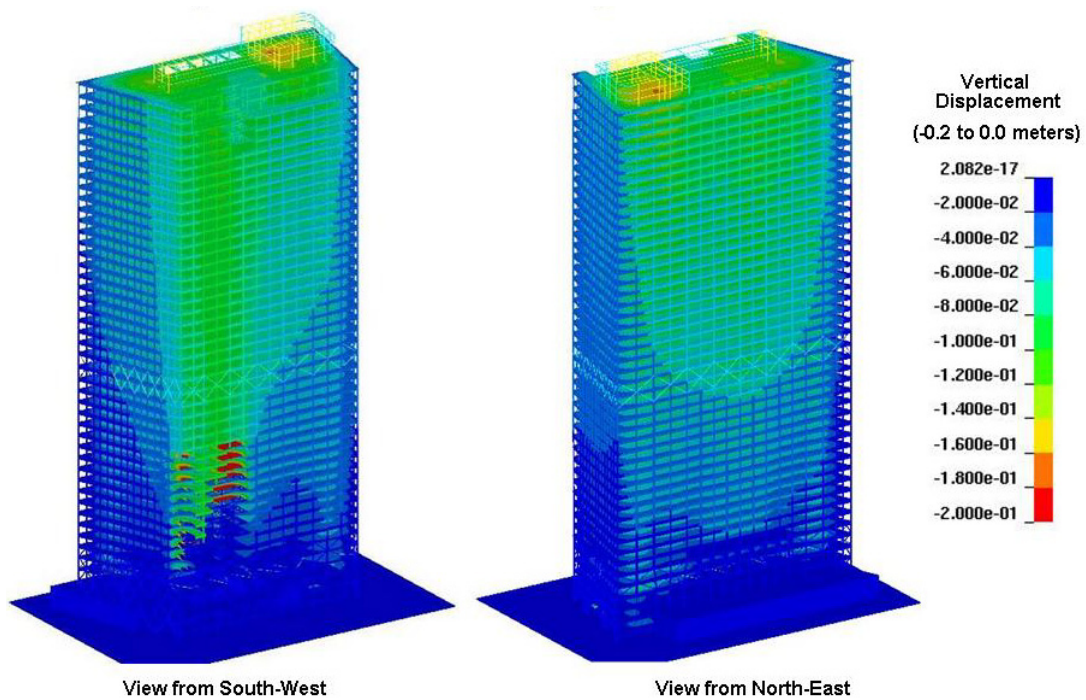
Figure 3-60. Calculated global vertical displacements after initial impact damage.

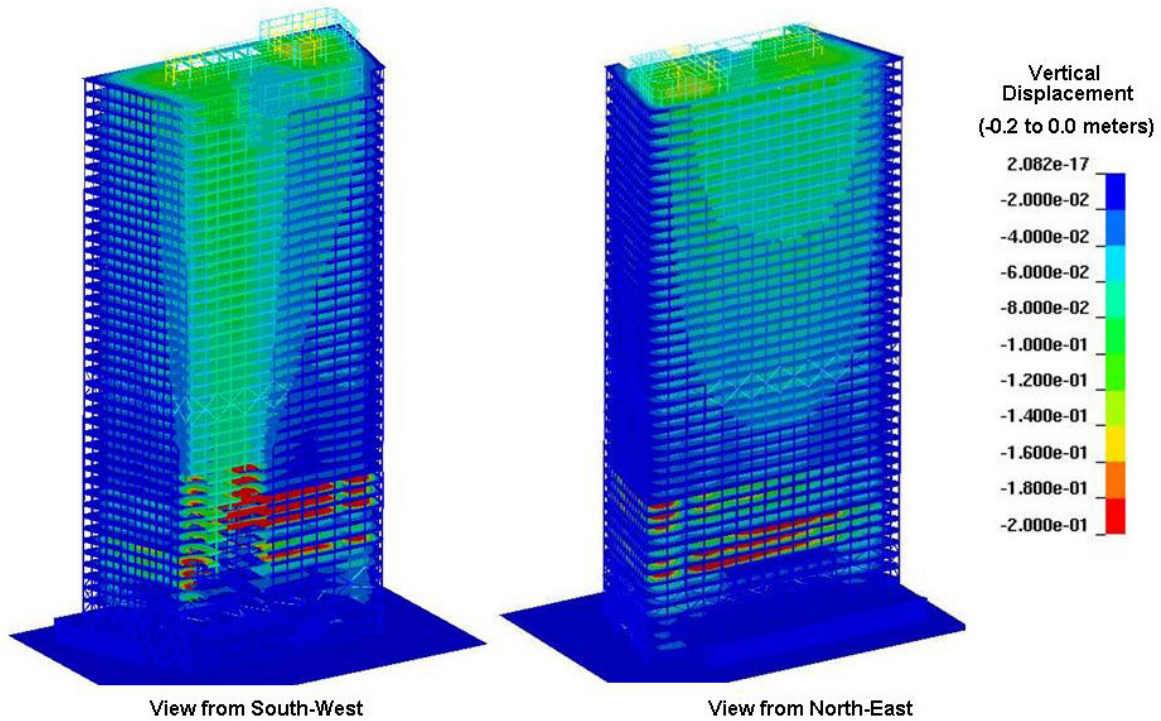
Figure 3-61. Calculated global vertical displacements after temperature initialization.

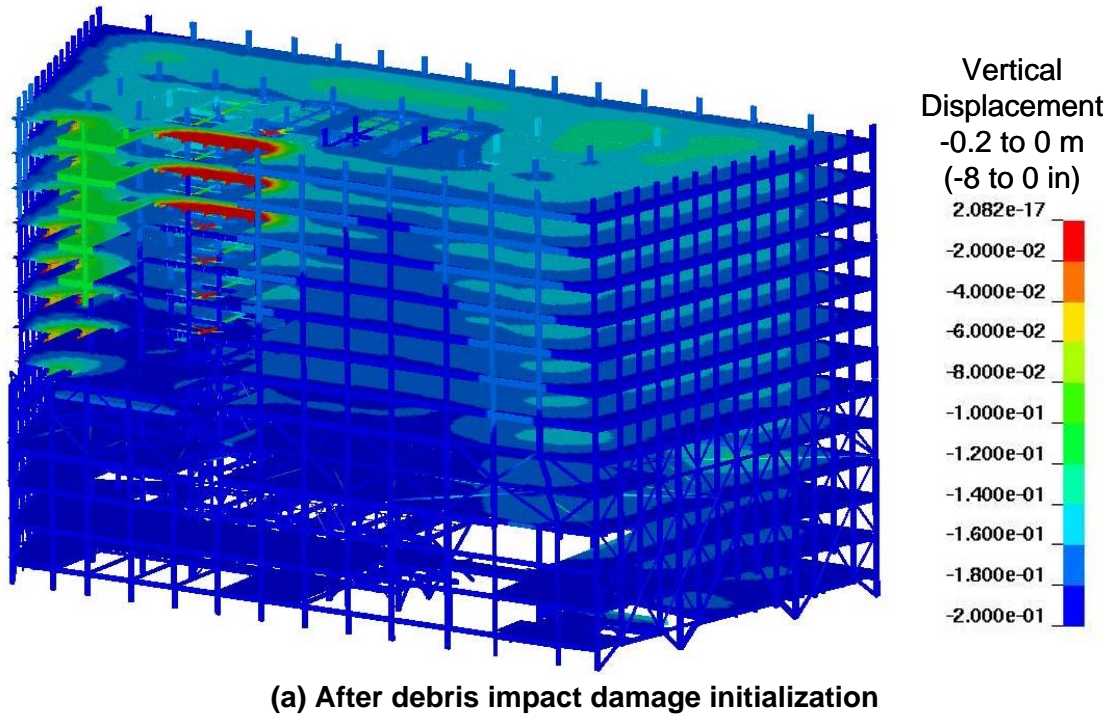
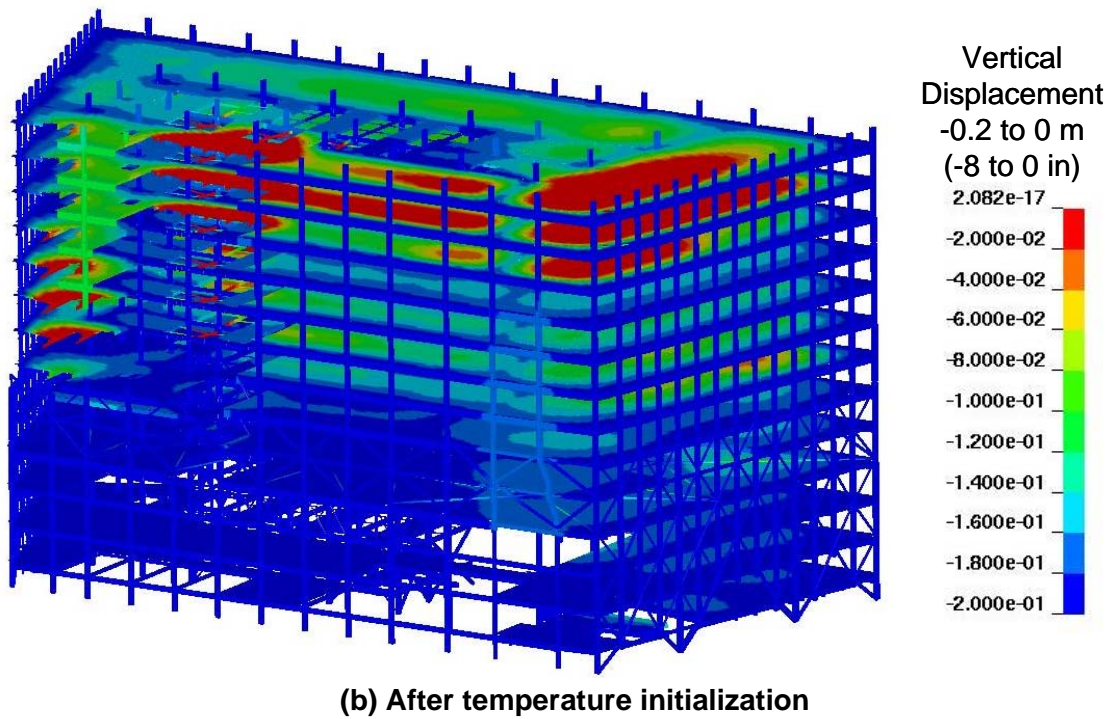
Figure 3-62. Detailed comparison of vertical displacements after damage and temperature initializations.
