NIST NCSTAR 1-9A

**Federal Building and Fire Safety Investigation of the
World Trade Center Disaster**

Global Structural Analysis of the Response of World Trade Center Building 7 to Fires and Debris Impact Damage

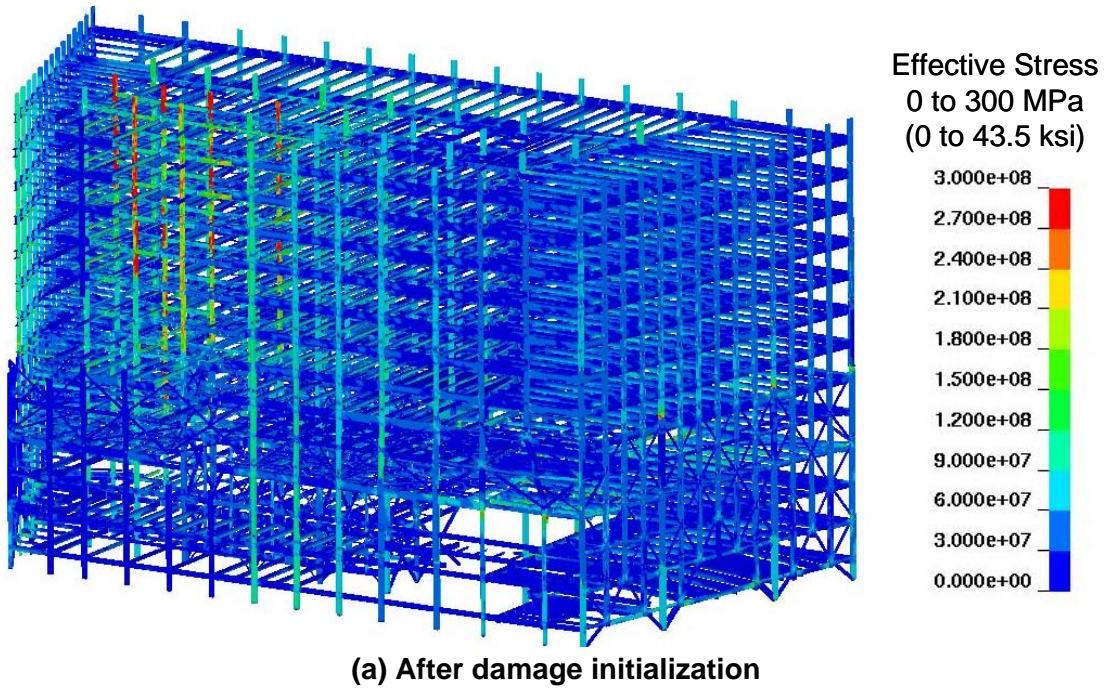
Figure 3-63. Detailed comparison of effective stress after damage and temperature initializations.

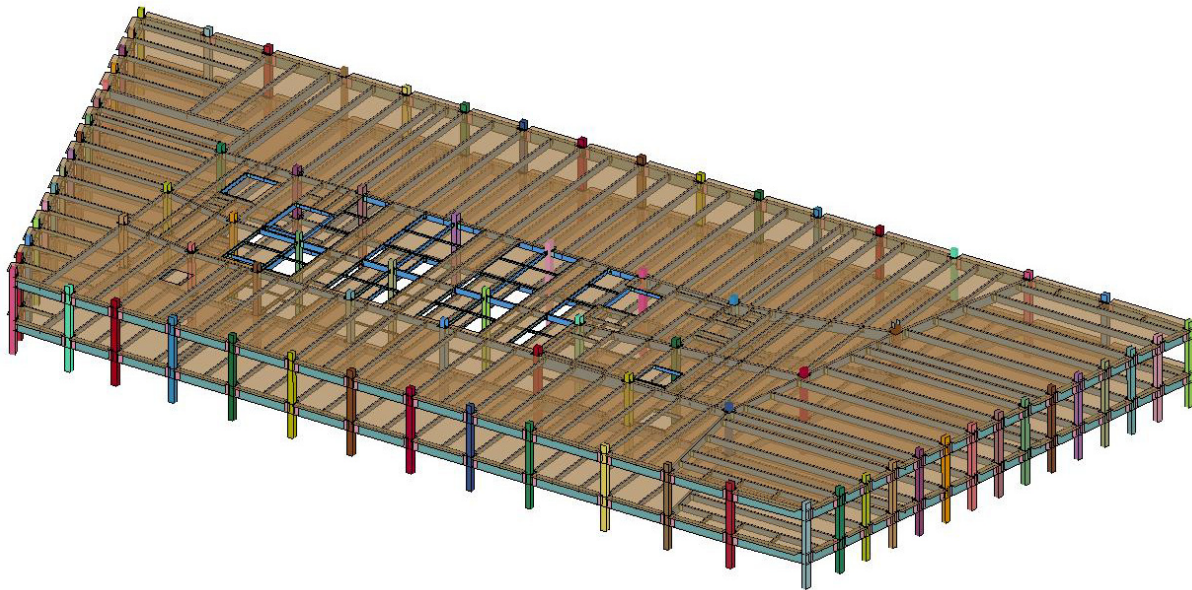
Figure 3-64. Two-floor subassembly model (slabs shown as transparent).

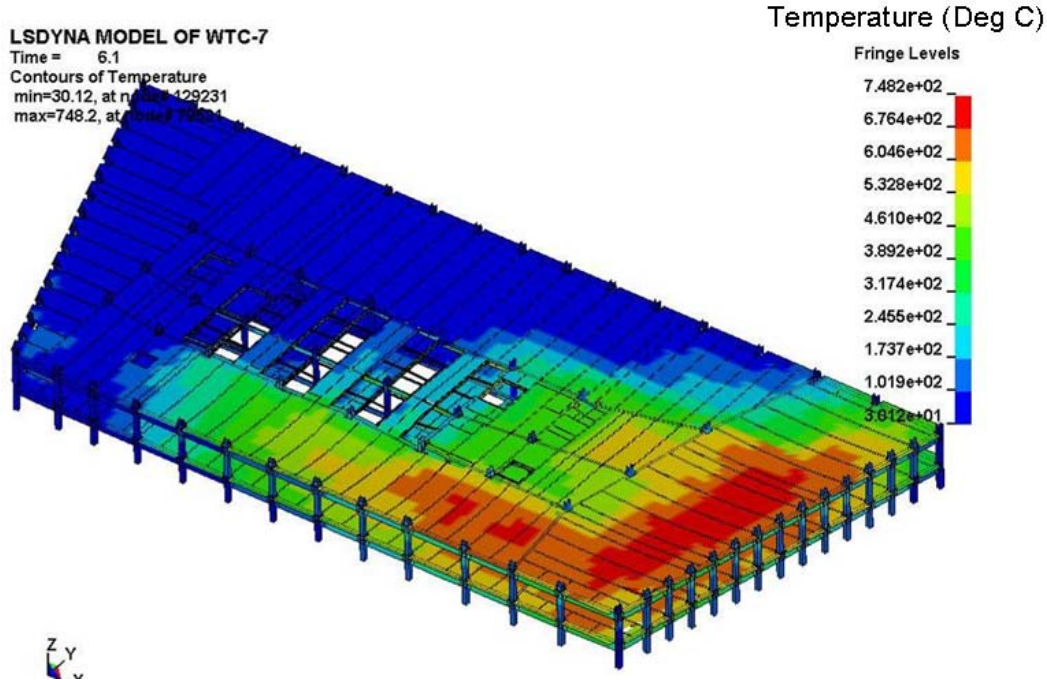
Figure 4-3. Two-Floor model for Case B, 5 h temperatures.

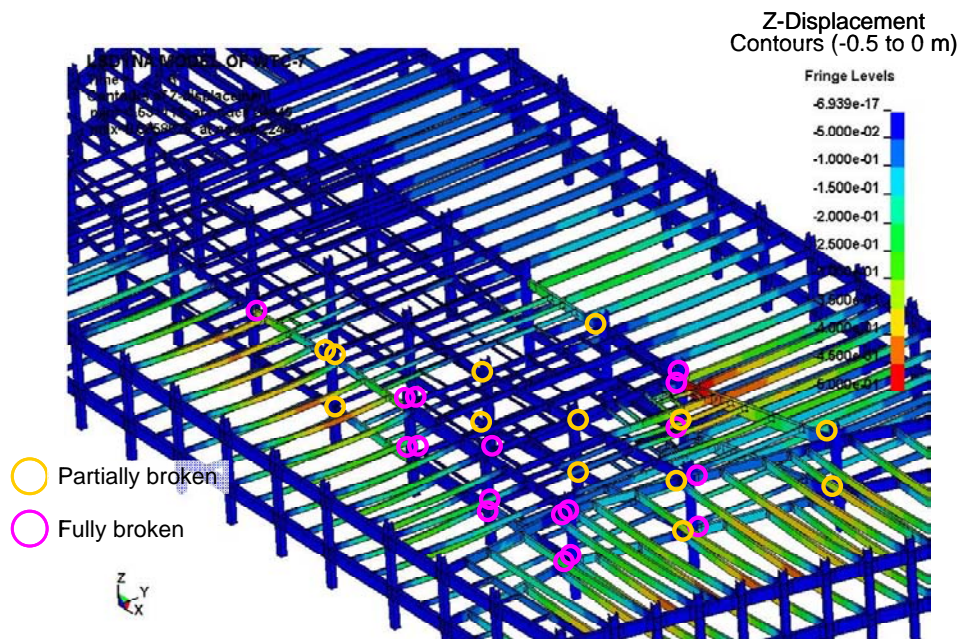
Figure 4-4. Connection damage in the two floor model for Case A, 5 h temperatures.

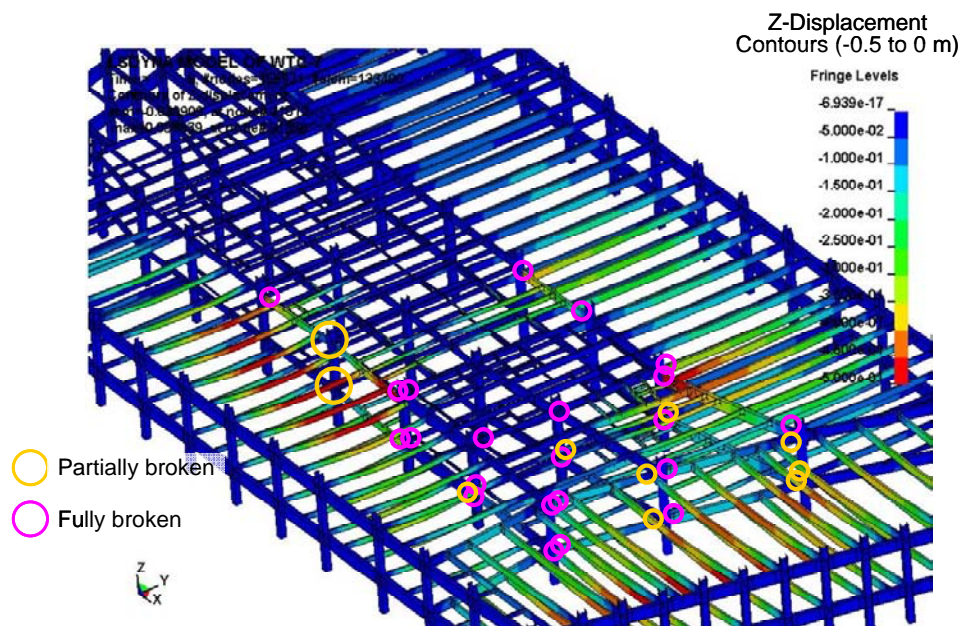
Figure 4-5. Connection damage in the two floor model for Case B, 5 h temperatures.

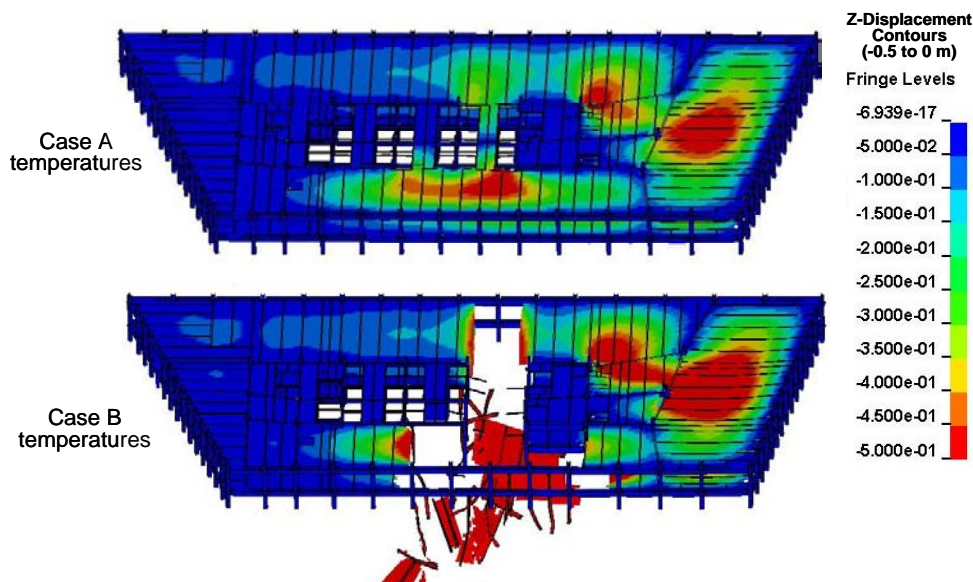
Figure 4-6. Load Case 1 results, 9 s after applying 5 h temperatures.

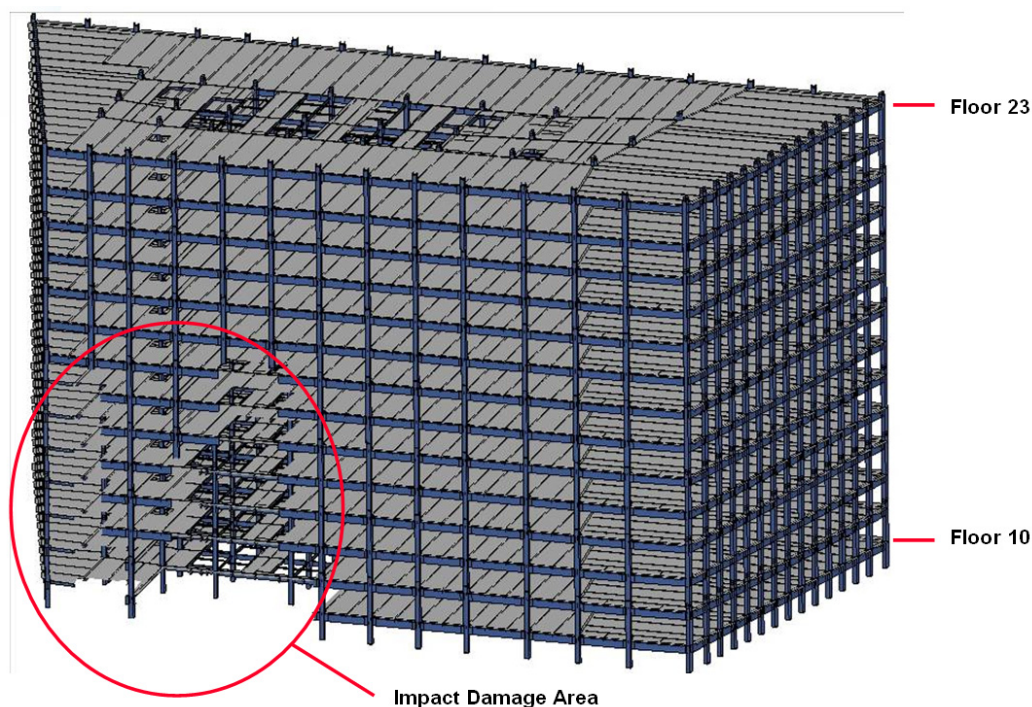
Figure 4-10. Assessment of impact damage on the 14-floor subassembly model.

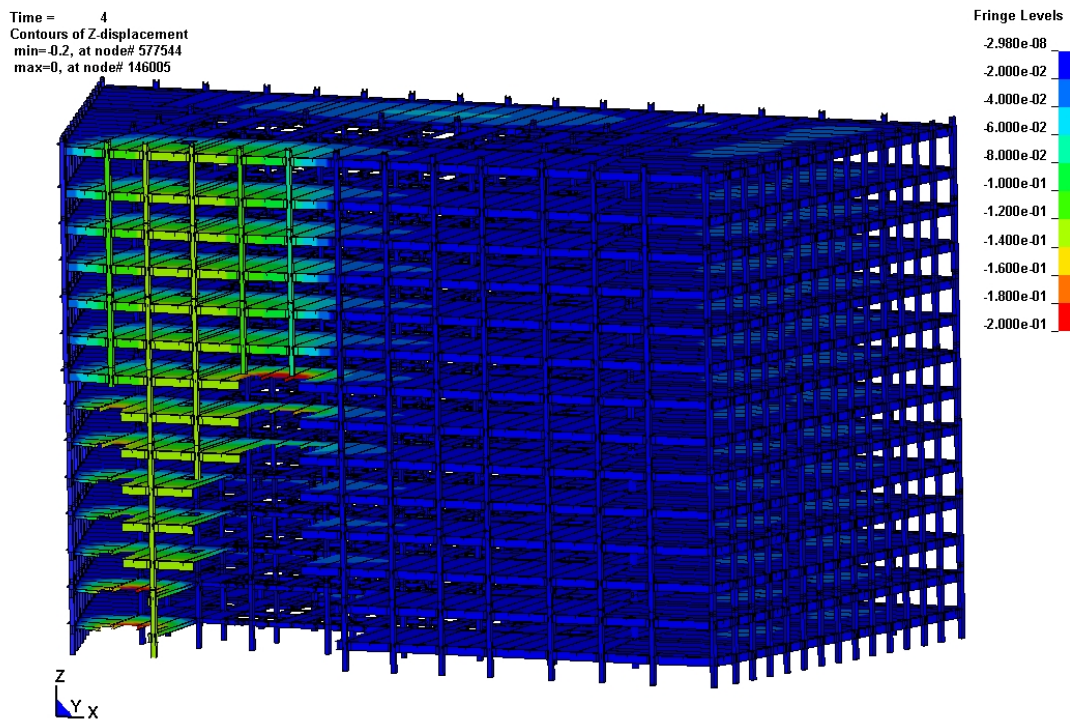
Figure 4-11. Calculated impact damage displacements on the 14-floor model. Vertical displacement contours shown: -0.2 to 0 m (-8 to 0 in).

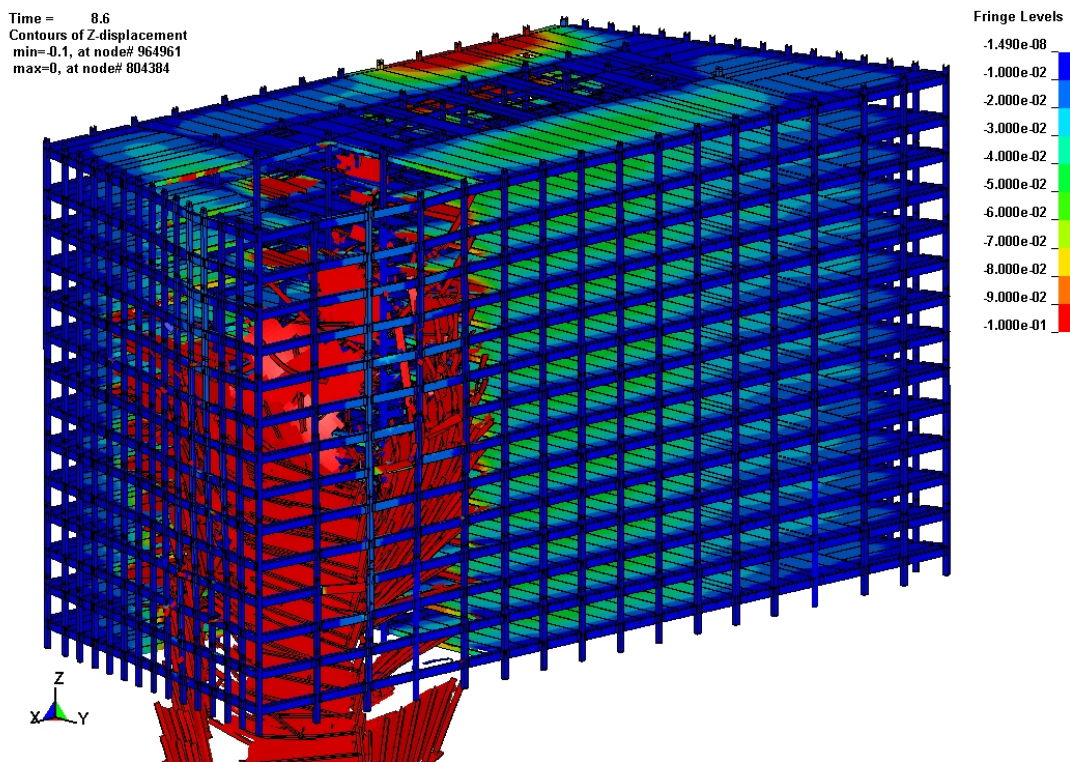
Figure 4-12. Calculated collapse behavior for Column 79 support removal (14-floor Model). Vertical displacement contours shown: -0.1 to 0 m (-4 to 0 in).

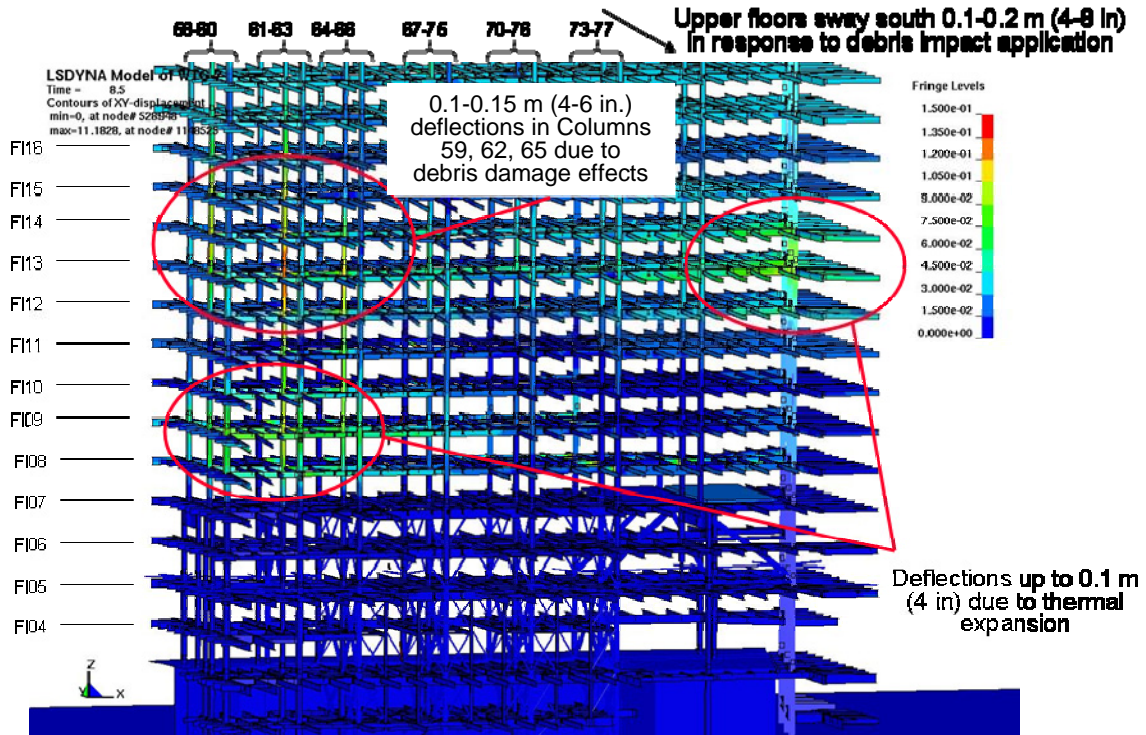
Figure 4-18. Core lateral displacement at -7.5 (8.5) s; end of temperature application.

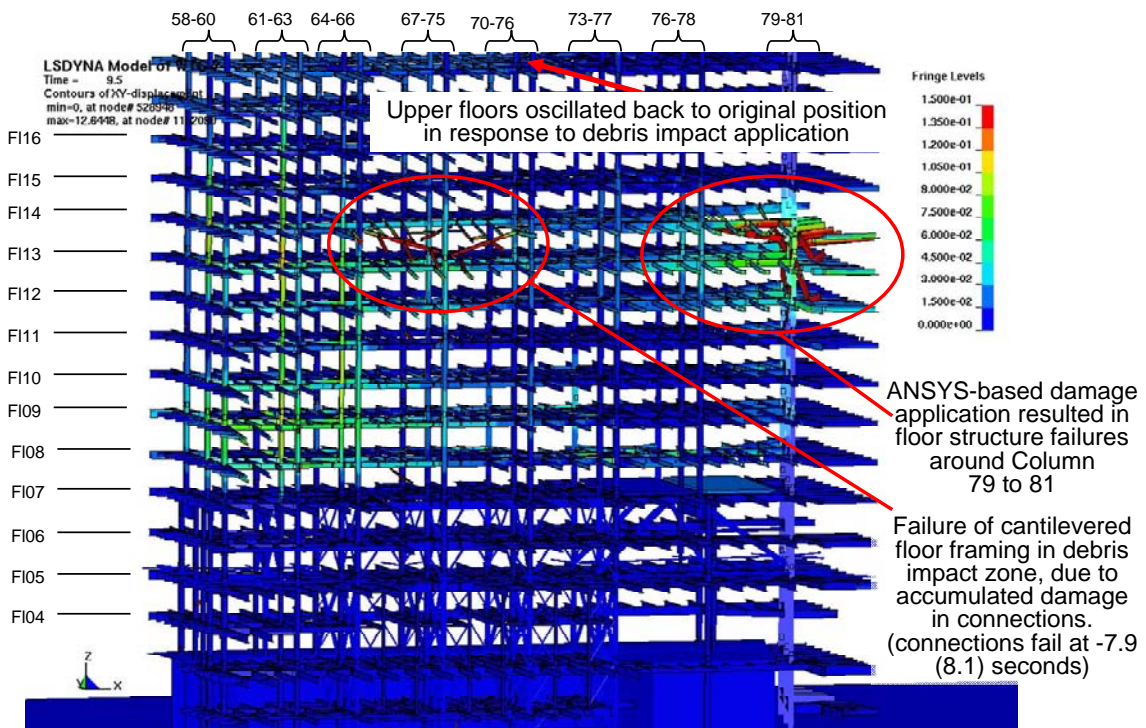
Figure 4-19. Core lateral displacement at -6.5 (9.5) s; start of failure of Floors 13 and 14 start around Column 79.

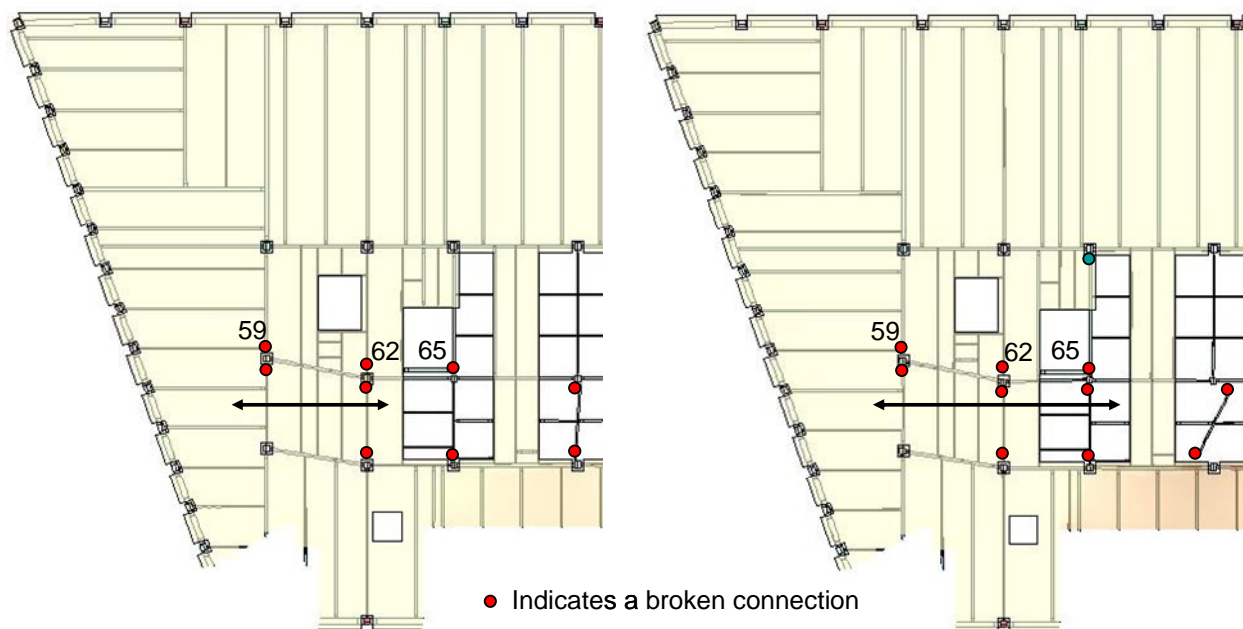
Figure 4-20. Columns 59, 62 and 65 connection damage at the 13th floor.
Slab is transparent

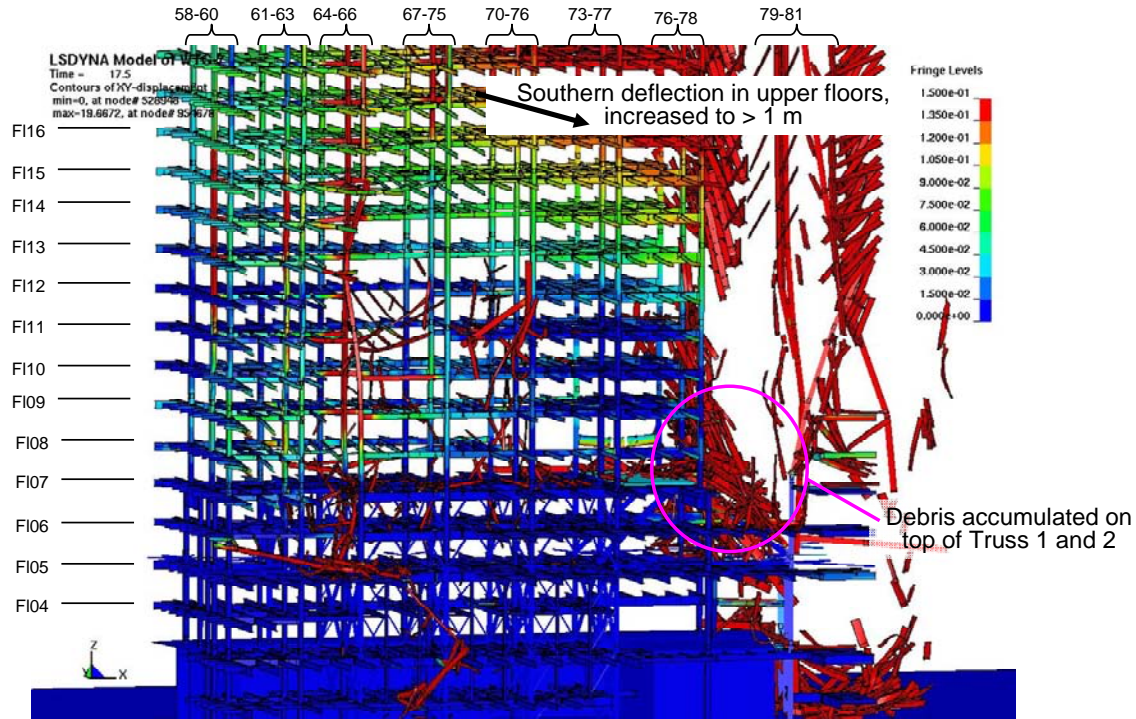
Figure 4-26. Core lateral displacement at 1.5 (17.5) s; falling of debris from the collapsing floors onto the lower floors, including Trusses 1 and 2, impacting Columns 76, 77, and 78.

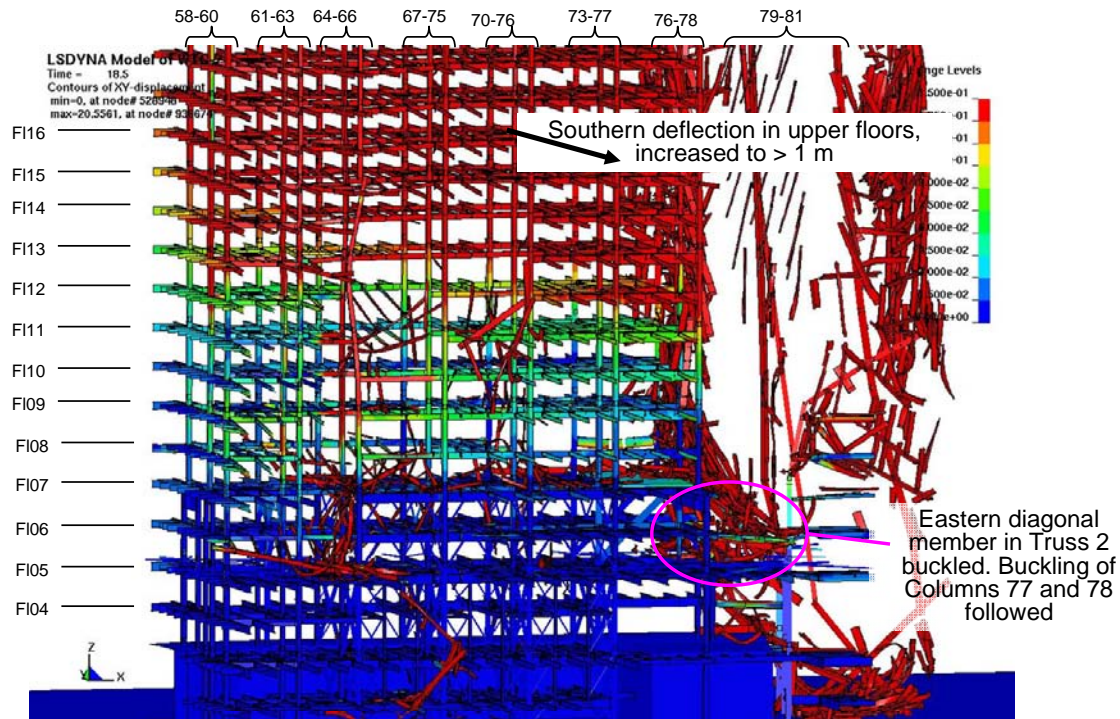
Figure 4-29. Core lateral displacement at 2.5 (18.5) s; buckling of Columns 77 and 78 buckled when Truss 2 failed from debris loads.

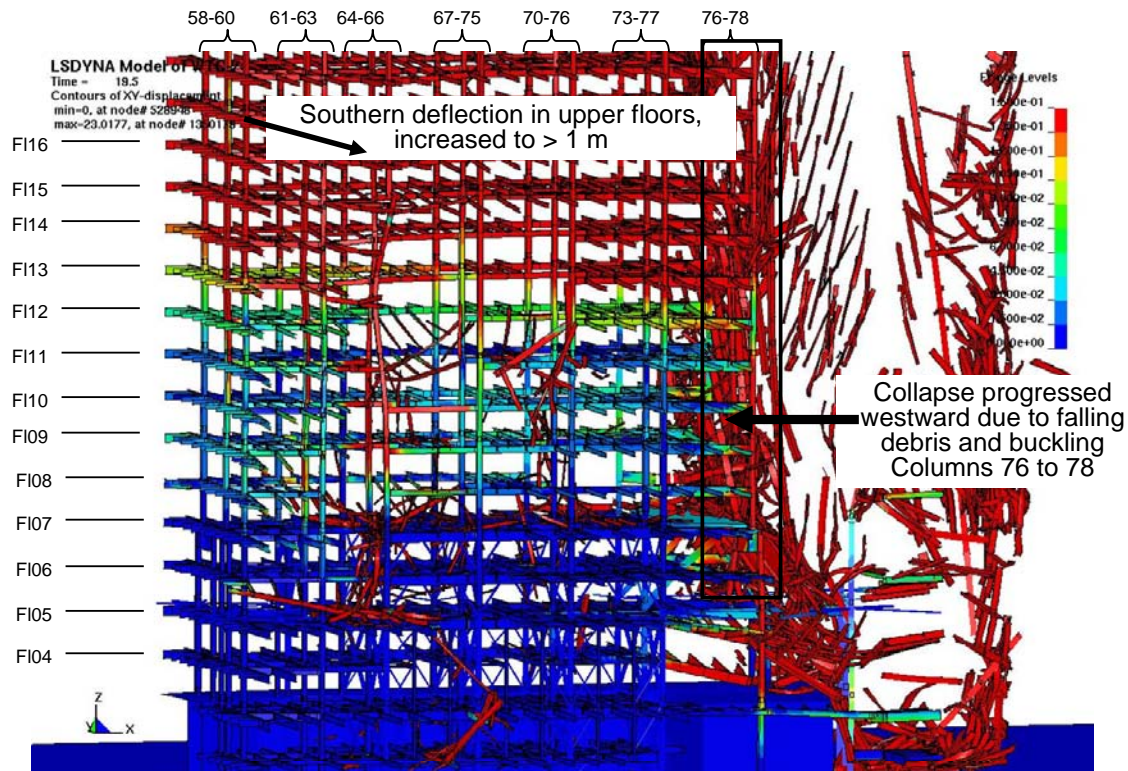
Figure 4-30. Core lateral displacement at 3.5 (19.5) s; buckling Column 76 buckled and start of horizontal progression of the failure.

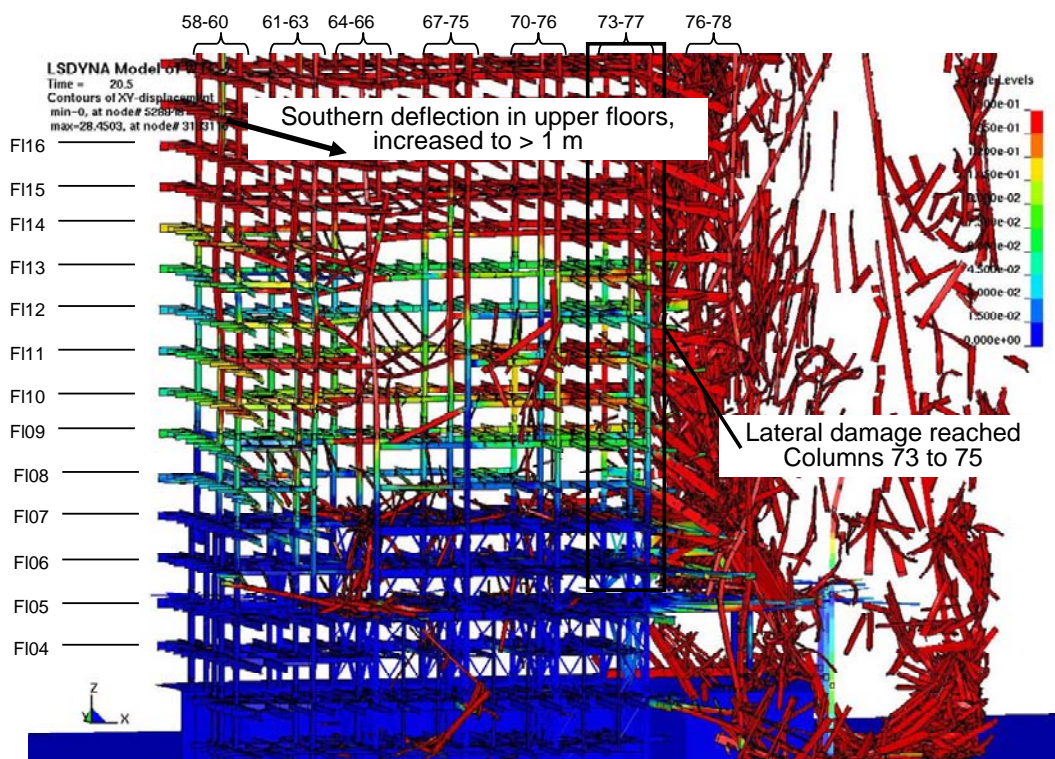
Figure 4-31. Core lateral displacement at 4.5 (20.5) s; failure of Columns 73 to 75.

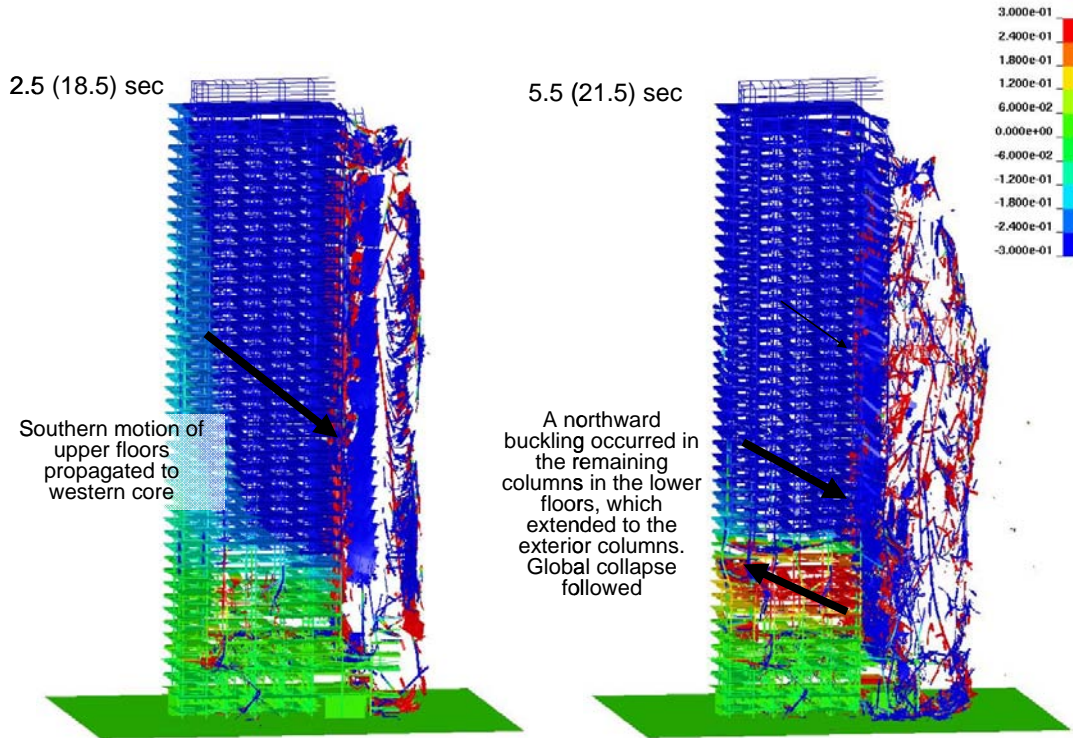
Figure 4-35. Core north-south displacement history, viewed from the south.

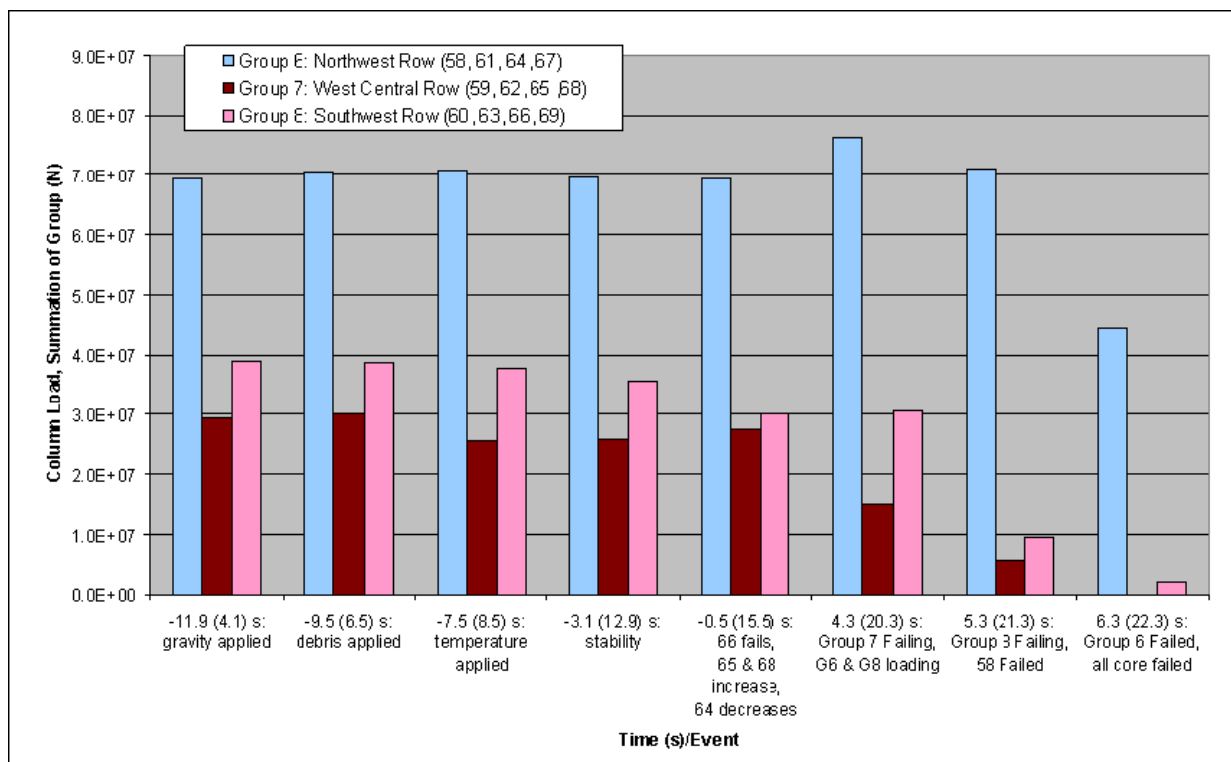
Figure 4-38. West interior column loads, illustrating progression of failure.

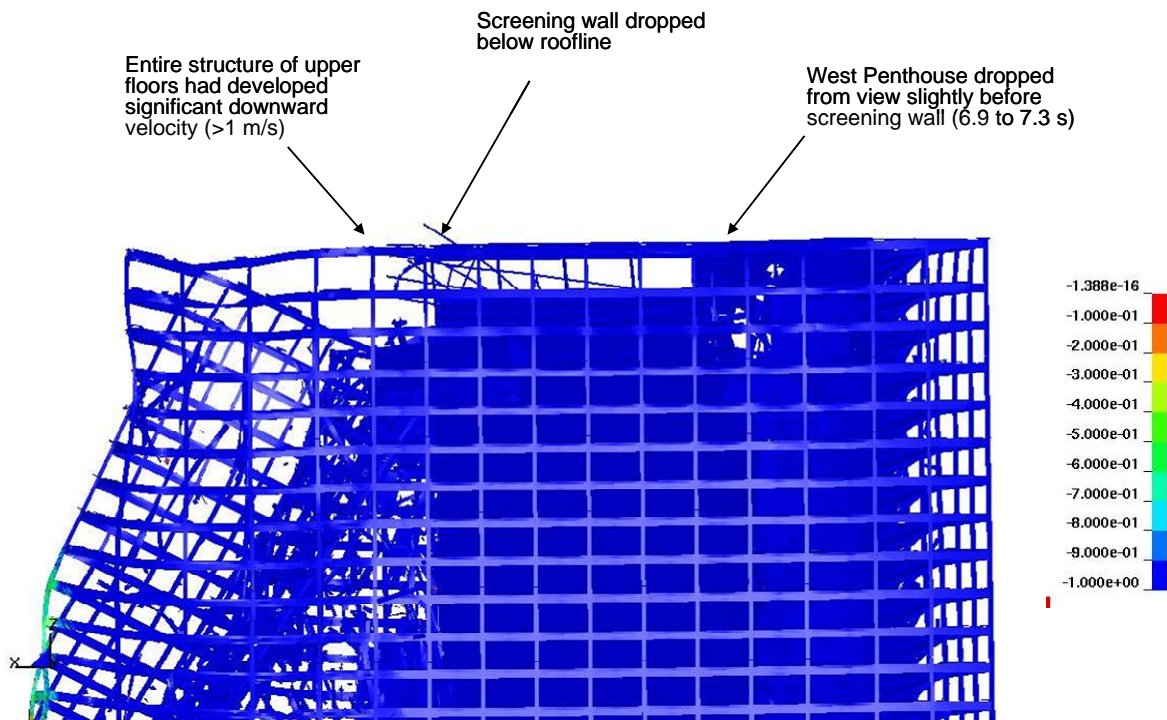
Figure 4-55. Collapse sequence at roofline: 7.7 (23.7) s, viewed from the north.
Fringes of vertical velocity: -1 m/s to 0 m/s

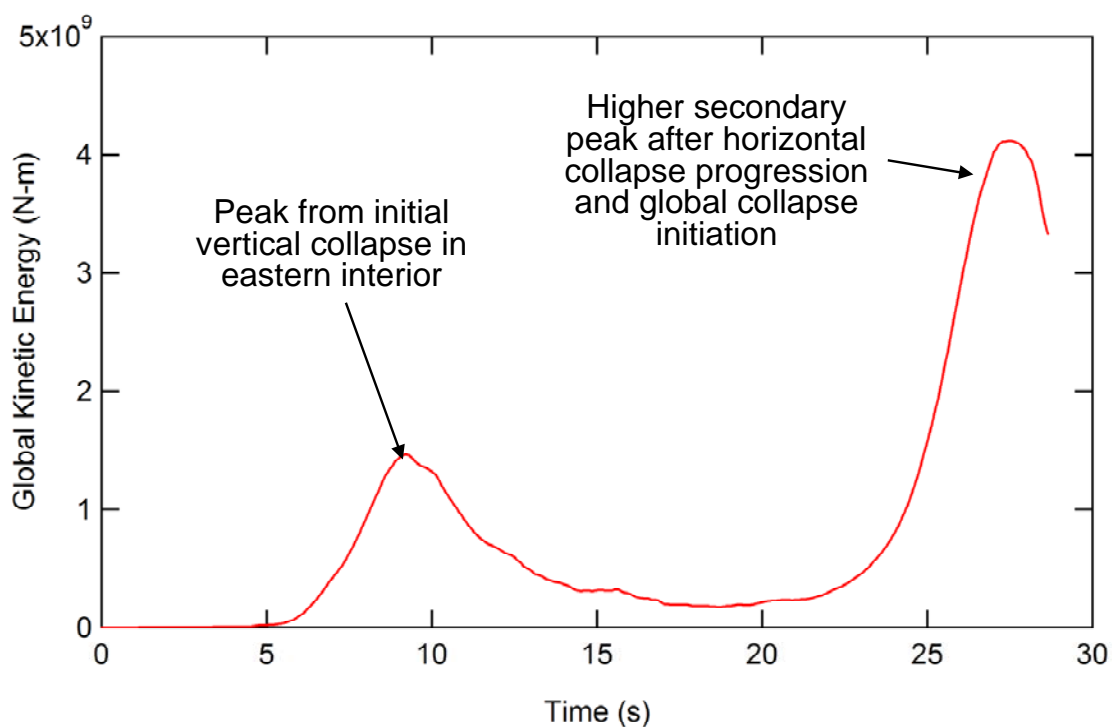
Figure 4–67. Global kinetic energy during the analysis without fire or debris impact damage.
