A STUDY OF THE PROPERTIES OF THE
U.S. CAPITOL SANDSTONE

Report to the
Architect of the Capitol

January 8, 1957

4998

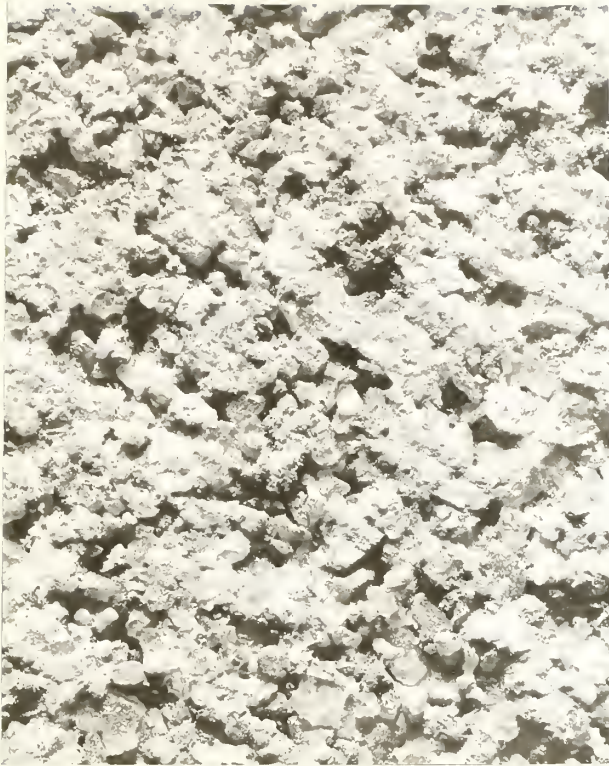
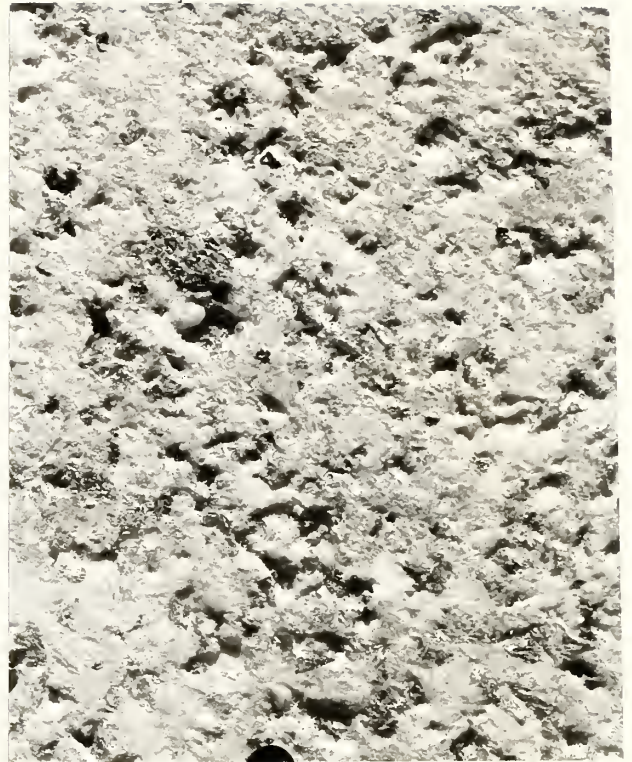
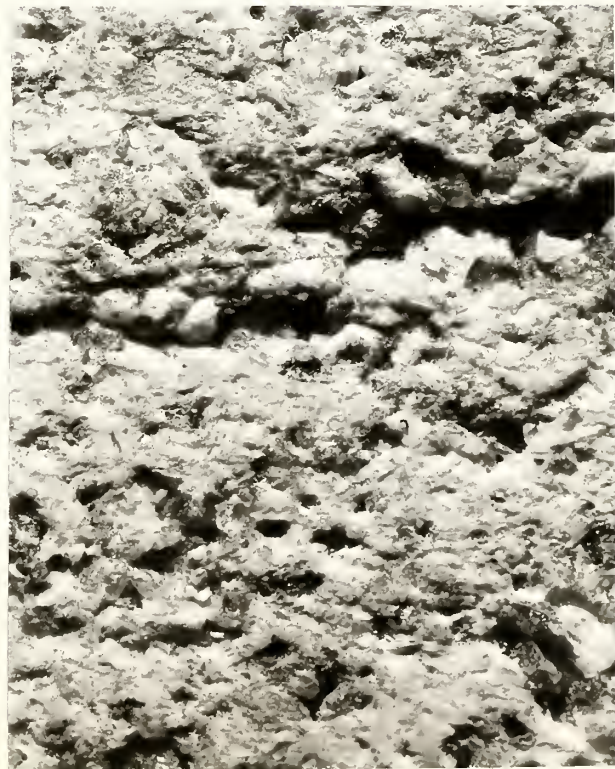
Fig. 4-A. Photographs of sections of samples C-1, C-2, and C-3, showing the variation in texture of the U. S. Capitol sandstone. (magnification, 10 X)

The nine samples submitted show considerable variations, both in composition and in texture. In general, the color of the specimens when observed on a fresh surface is light gray with occasional stains of brownish yellow. These stains were produced by the alteration of minerals containing iron, forming hydrous iron compounds. The variation in textures of the samples can be readily observed from the photographs of the nine specimens, magnified 10 times, representing each of the nine samples (figures 4-A, B and C). The difference in the textures of the specimens is due primarily to a difference in specimen porosity. In some specimens it appears that large voids were formed at the time of lithification of the deposit, as exemplified in figure 4-B (C-5). In other specimens many of the voids may be there as a result of leaching of soluble constituents after the sandstone had lithified as shown in figure 4-A (C-2).

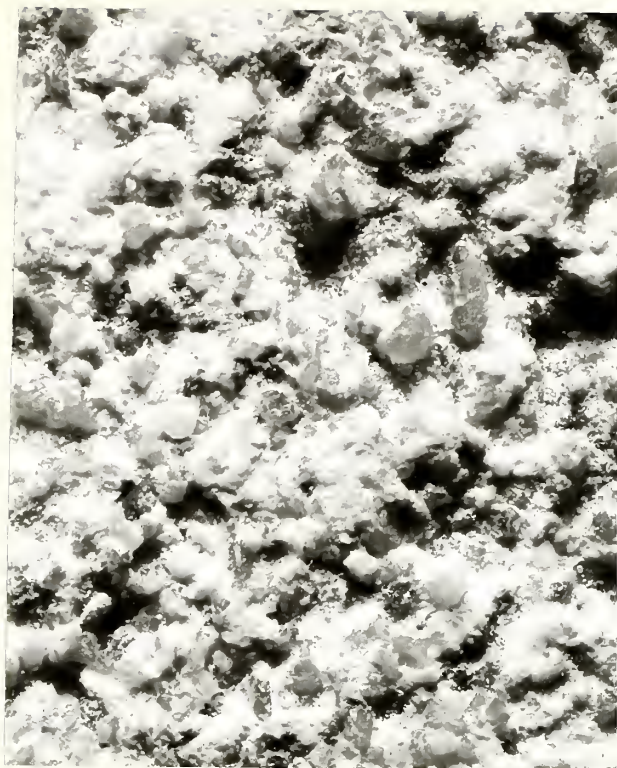
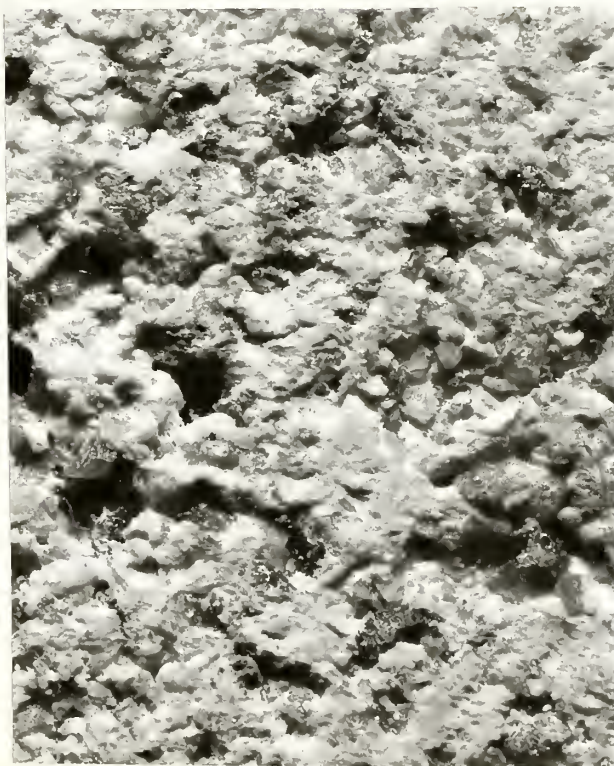
Fig. 4-B. Photographs of sections of samples C-4, C-5, and C-6, showing the variation in texture of the U. S. Capitol sandstone. (magnification, 10X)

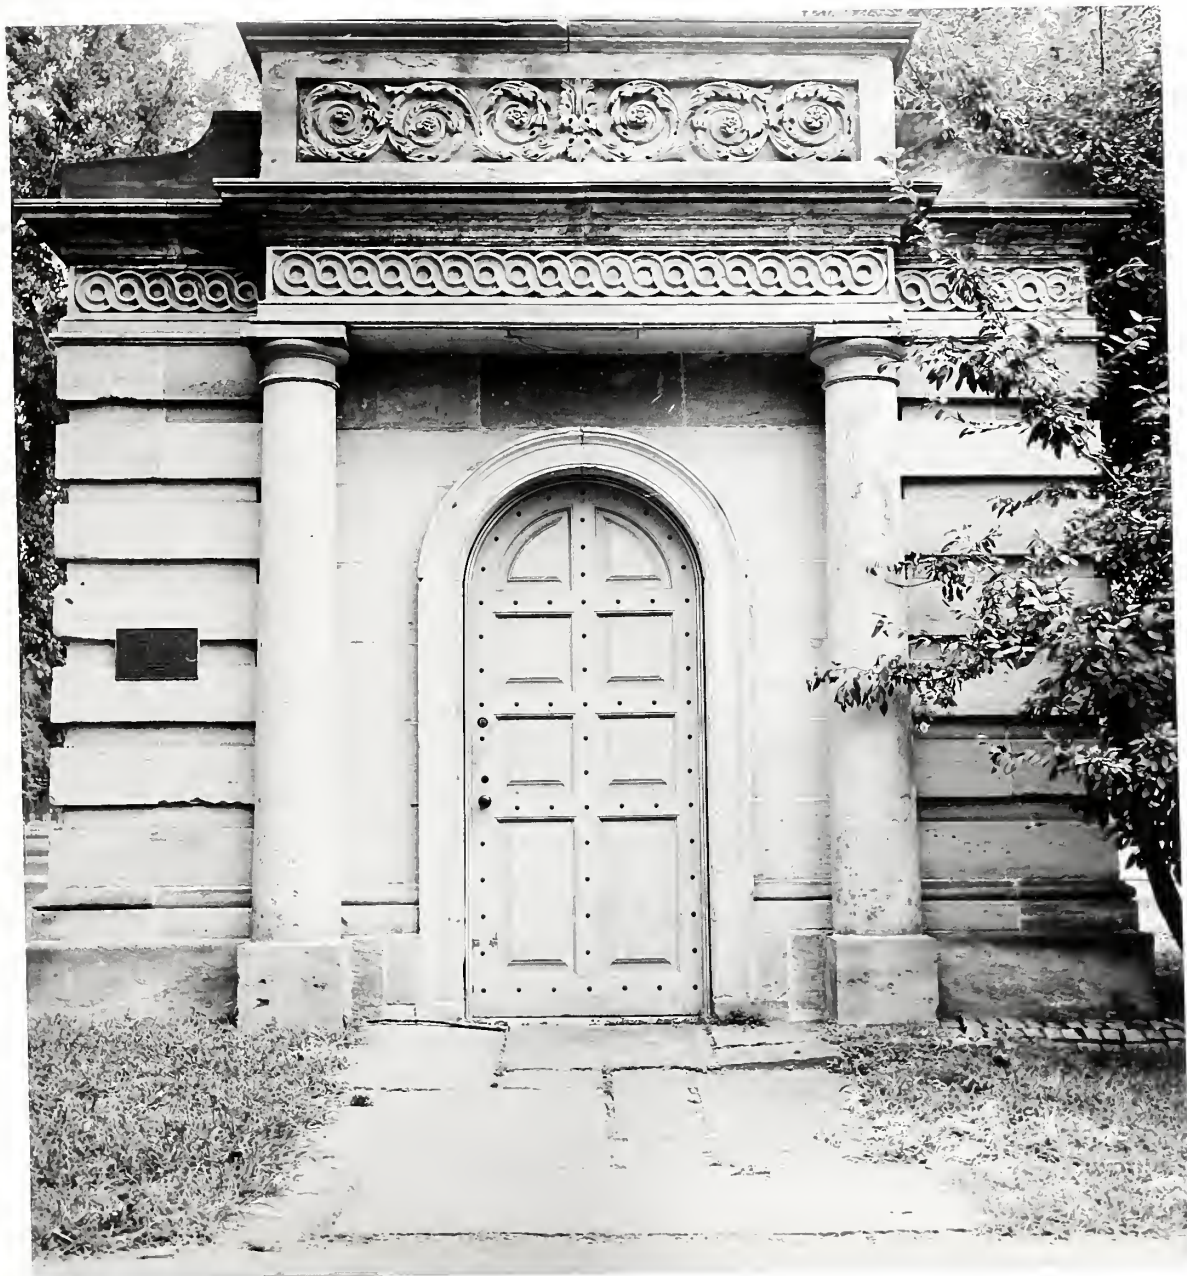
Fig. 7. View of Bulfinch gate house at Constitution Avenue and 17th Street, Washington, D. C. Photograph shows the excellent state of preservation of the unpainted Aquia Creek sandstone after about 125 years of exposure.

The Bulfinch gatehouses, formerly on the Capitol grounds and presently located on Constitution Avenue at 15th and at 17th Streets, are constructed of Aquia Creek sandstone. It is probable that these two buildings were never painted. Photographs were taken of them and reproduced here to illustrate the good condition of the stone (figures 7, 8 and 9). There is not much evidence of weathering except near the ground and at occasional small pits or vugs which may have been filled originally with friable, clayey material which was later removed by weathering.

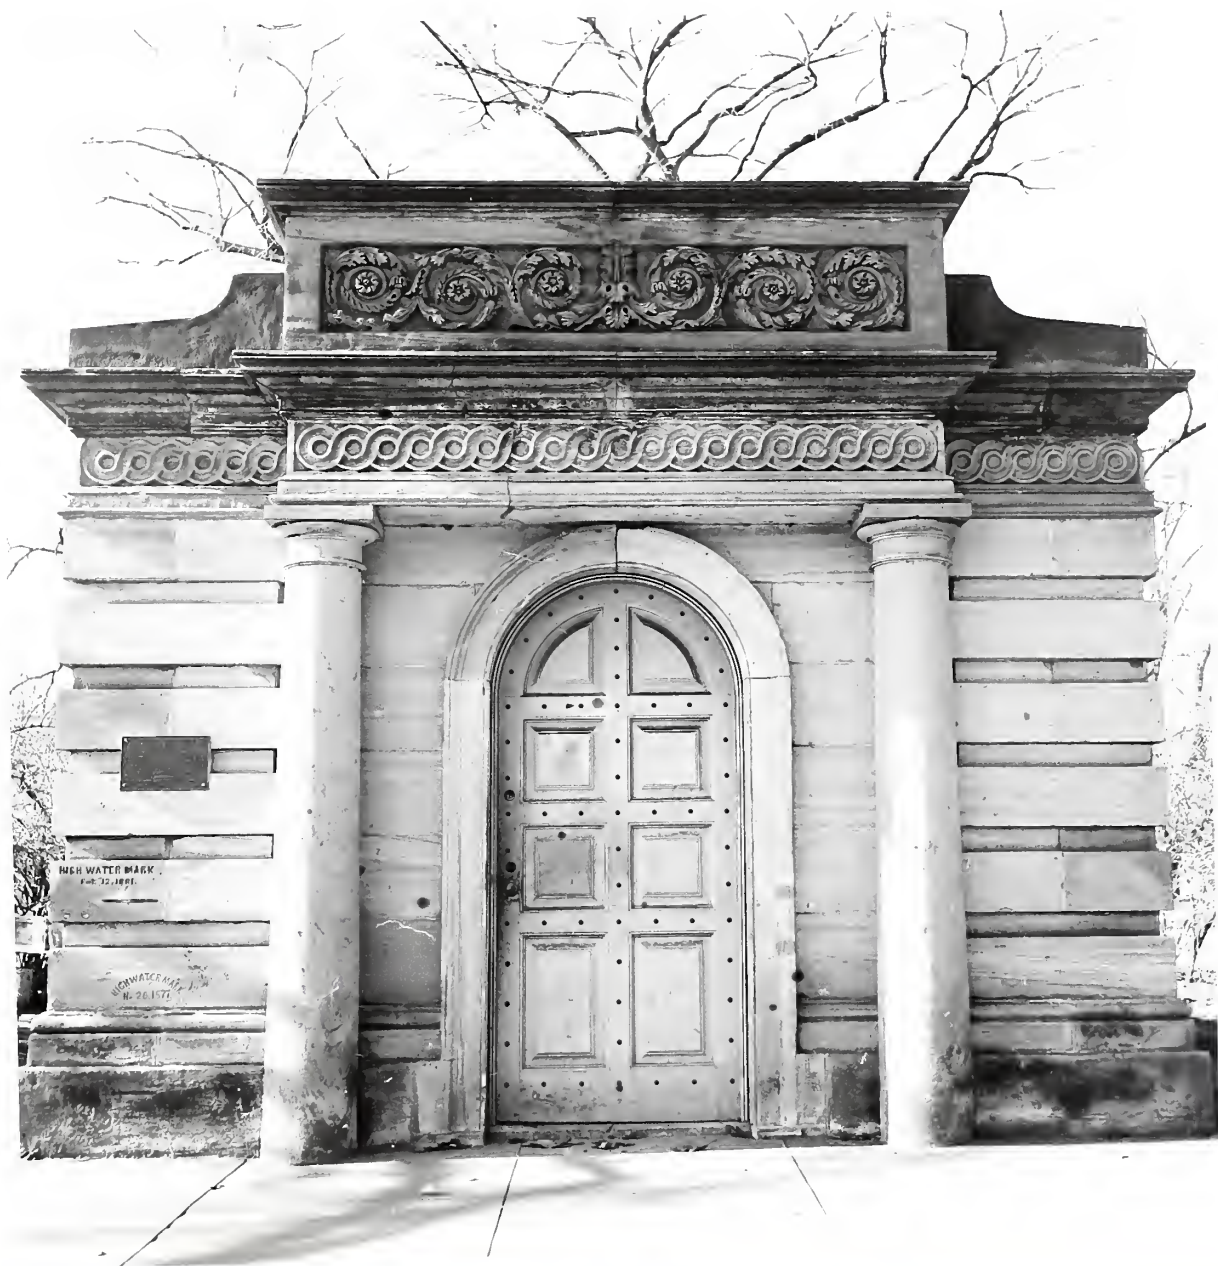
Fig. 8. View of Bulfinch gate house at Constitution Avenue and 15th Street, Washington, D. C. Photograph shows the excellent state of preservation of the unpainted Aquia Creek sandstone after about 125 years of exposure.

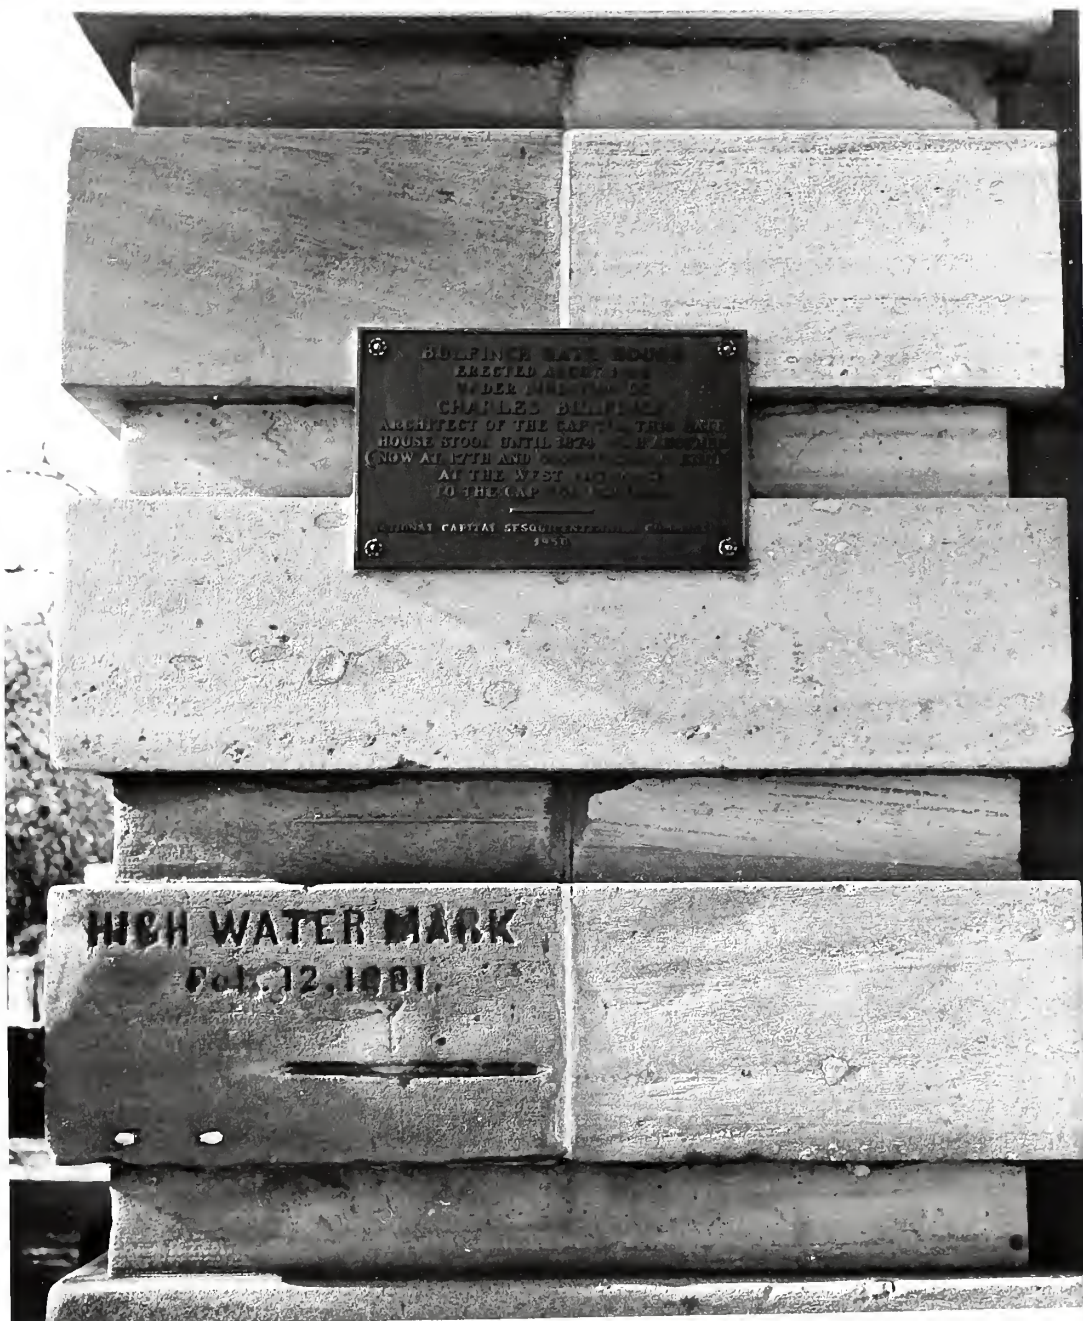
Fig. 9. Close-up view of a section of the east side of the gate house described in Fig. 8.

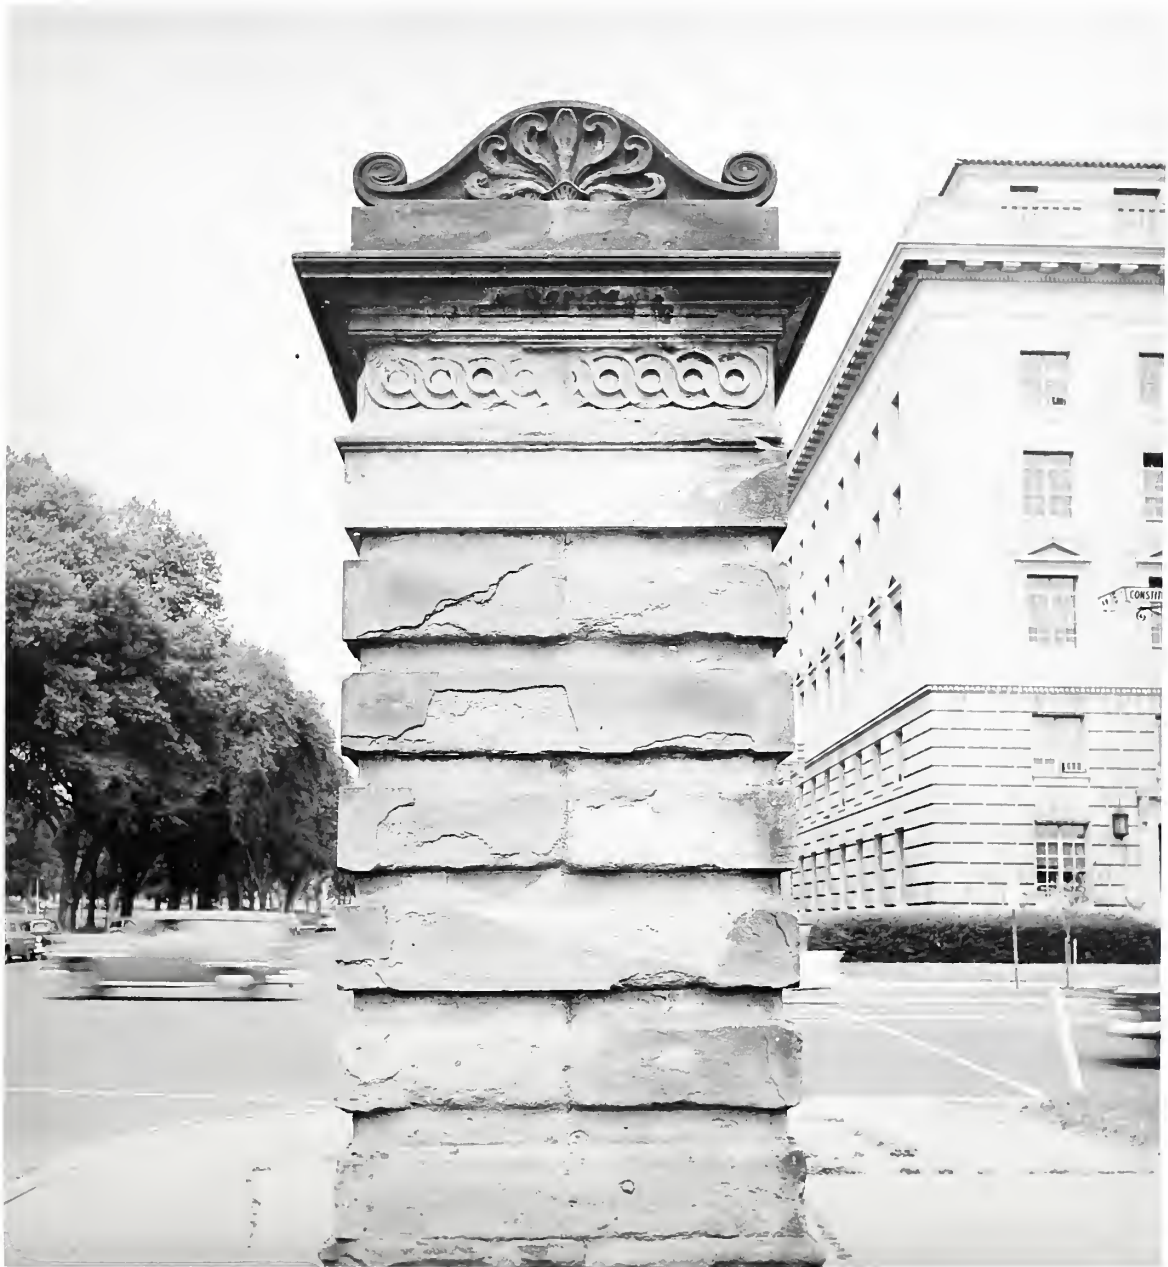
Fig. 10. View of gatepost at the southeast corner of Constitution Avenue and 15th Street, Washington, D. C. illustrating the advanced state of disintegration of unpainted Aquia Creek sandstone after about 125 years of exposure.

The gateposts once situated on the Capitol grounds and now located on 15th and Constitution, are examples of badly deteriorated Aquia Creek sandstone. Figures 10 and 11 illustrate this condition in two of the gateposts. Since some of the blocks in the Capitol have been shown by tests to be of inferior quality, it is likely that such blocks would have eroded very much like the gateposts if no painting had been done on the Capitol stone.

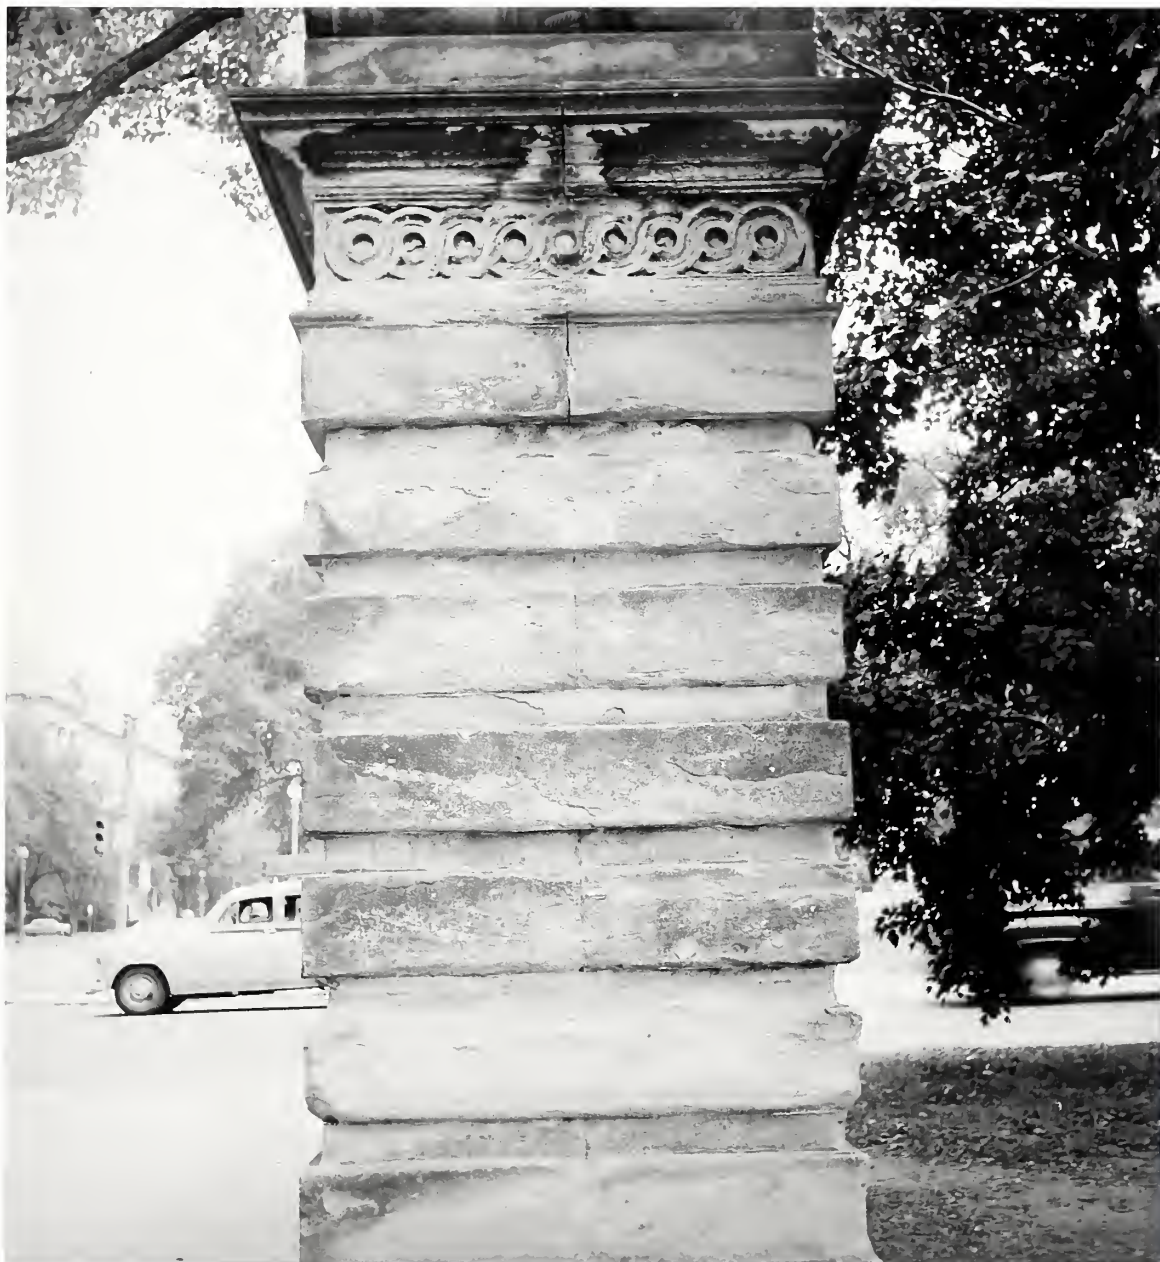
Fig. 11. View of gatepost at the southwest corner of Constitution Avenue and 15th Street, Washington, D. C. illustrating the advanced state of disintegration of unpainted Aquia Creek sandstone after about 125 years of exposure.
