**NBSIR 73-240**

# **Effects of Electroless Nickel Process Variables on Quality Requirements**

Corrosion and Electrodeposition Section  
Metallurgy Division  
Institute for Materials Research  
National Bureau of Standards  
Washington, D. C. 20234

Annual Progress Report  
March 1972–June 1973

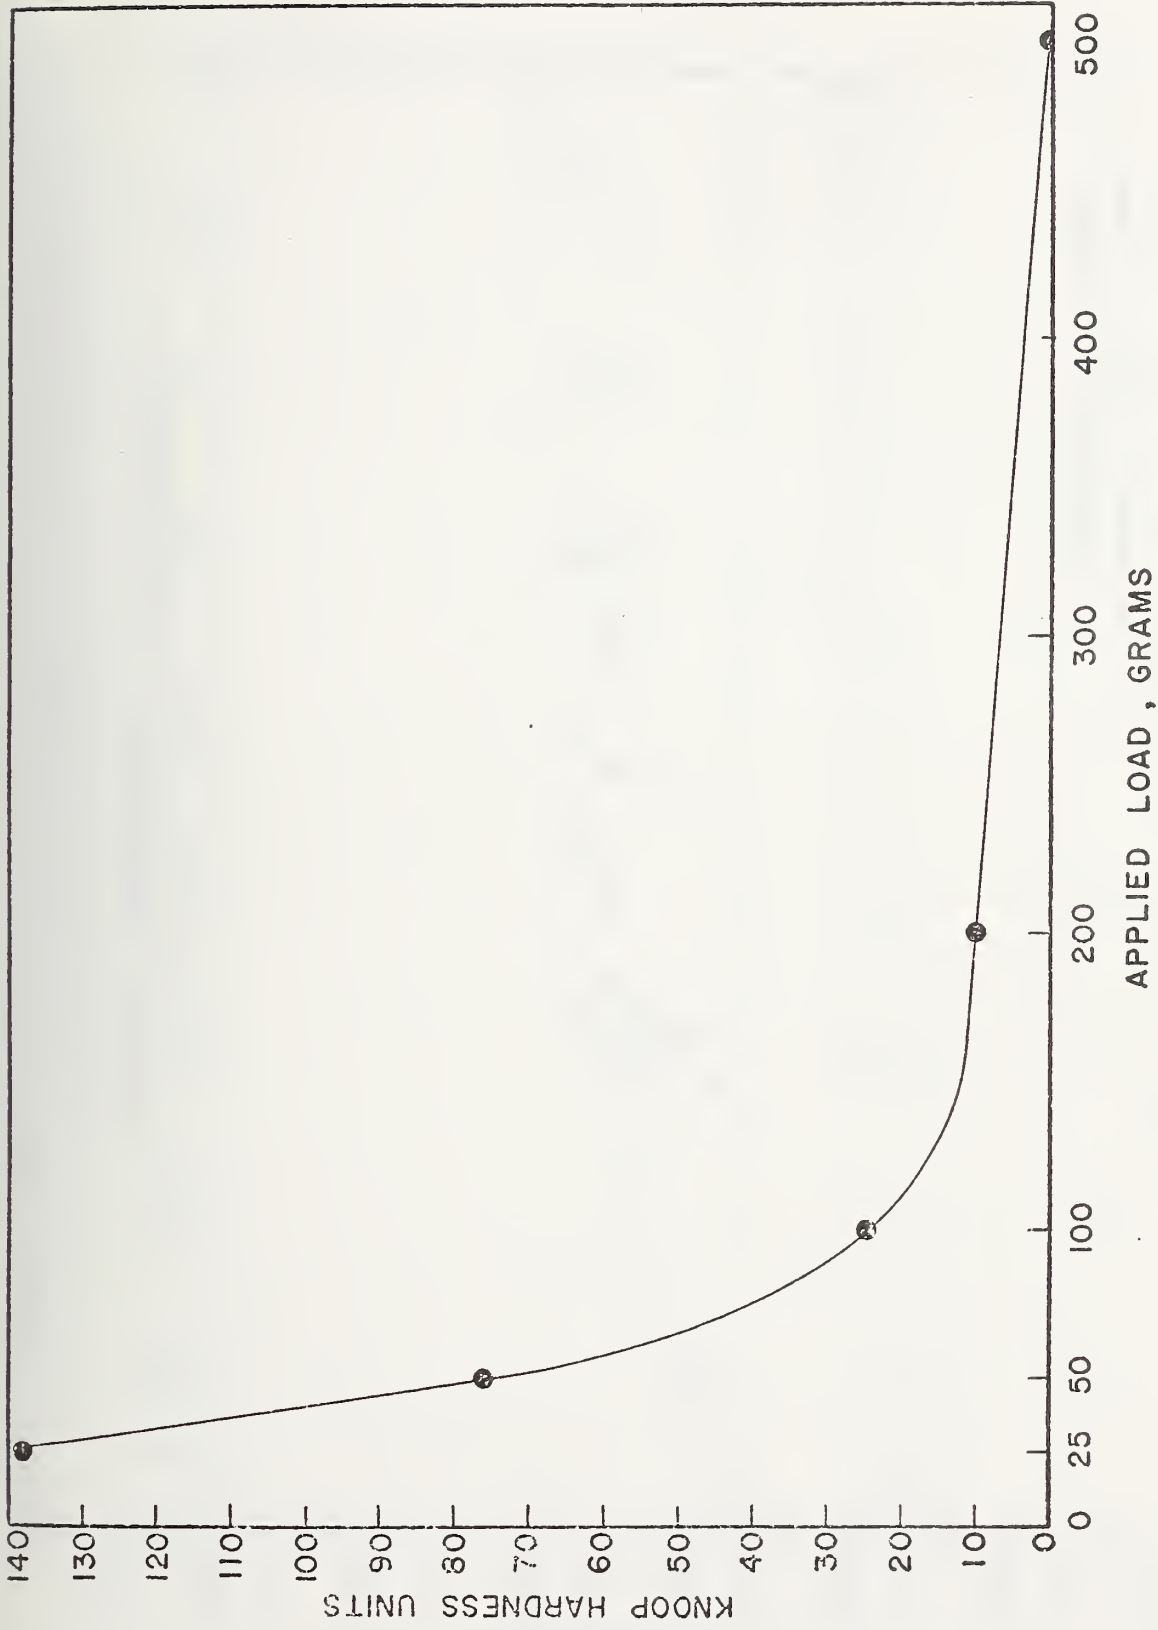
Figure 1 - HARDNESS CONVERSION CURVE.  
Used For Correcting Hardness Values When Changing From One Applied Load To Another  
Without Making An Actual Measurement. Such As, Changing The Load From 500 g To  
100 g; 25 Hardness Units Must Be Added To The Hardness Value Obtained at 500 g.

In order to convert our own data from one load to another, a number of specimens in several different hardness ranges were measured with 25, 50, 100, 200, and 500 g loads. This data was combined to produce a graph (Figure 1) which could be used to convert data for one load to values approximating what would have been obtained at another load. Such a conversion graph has been helpful, but its use, even by the same operator using the same equipment, introduces some error. The use of this specific graph by another laboratory would be questionable. Too much depends on the surface preparation of the specimen, on the operator's technique, and on the hardness measuring equipment. The hardness data of Table 2 is all for a load of 100 g. Most of the data was obtained using a load of 100 g, but some of it as indicated in the table was obtained at a greater load and converted to that for the 100 g load.

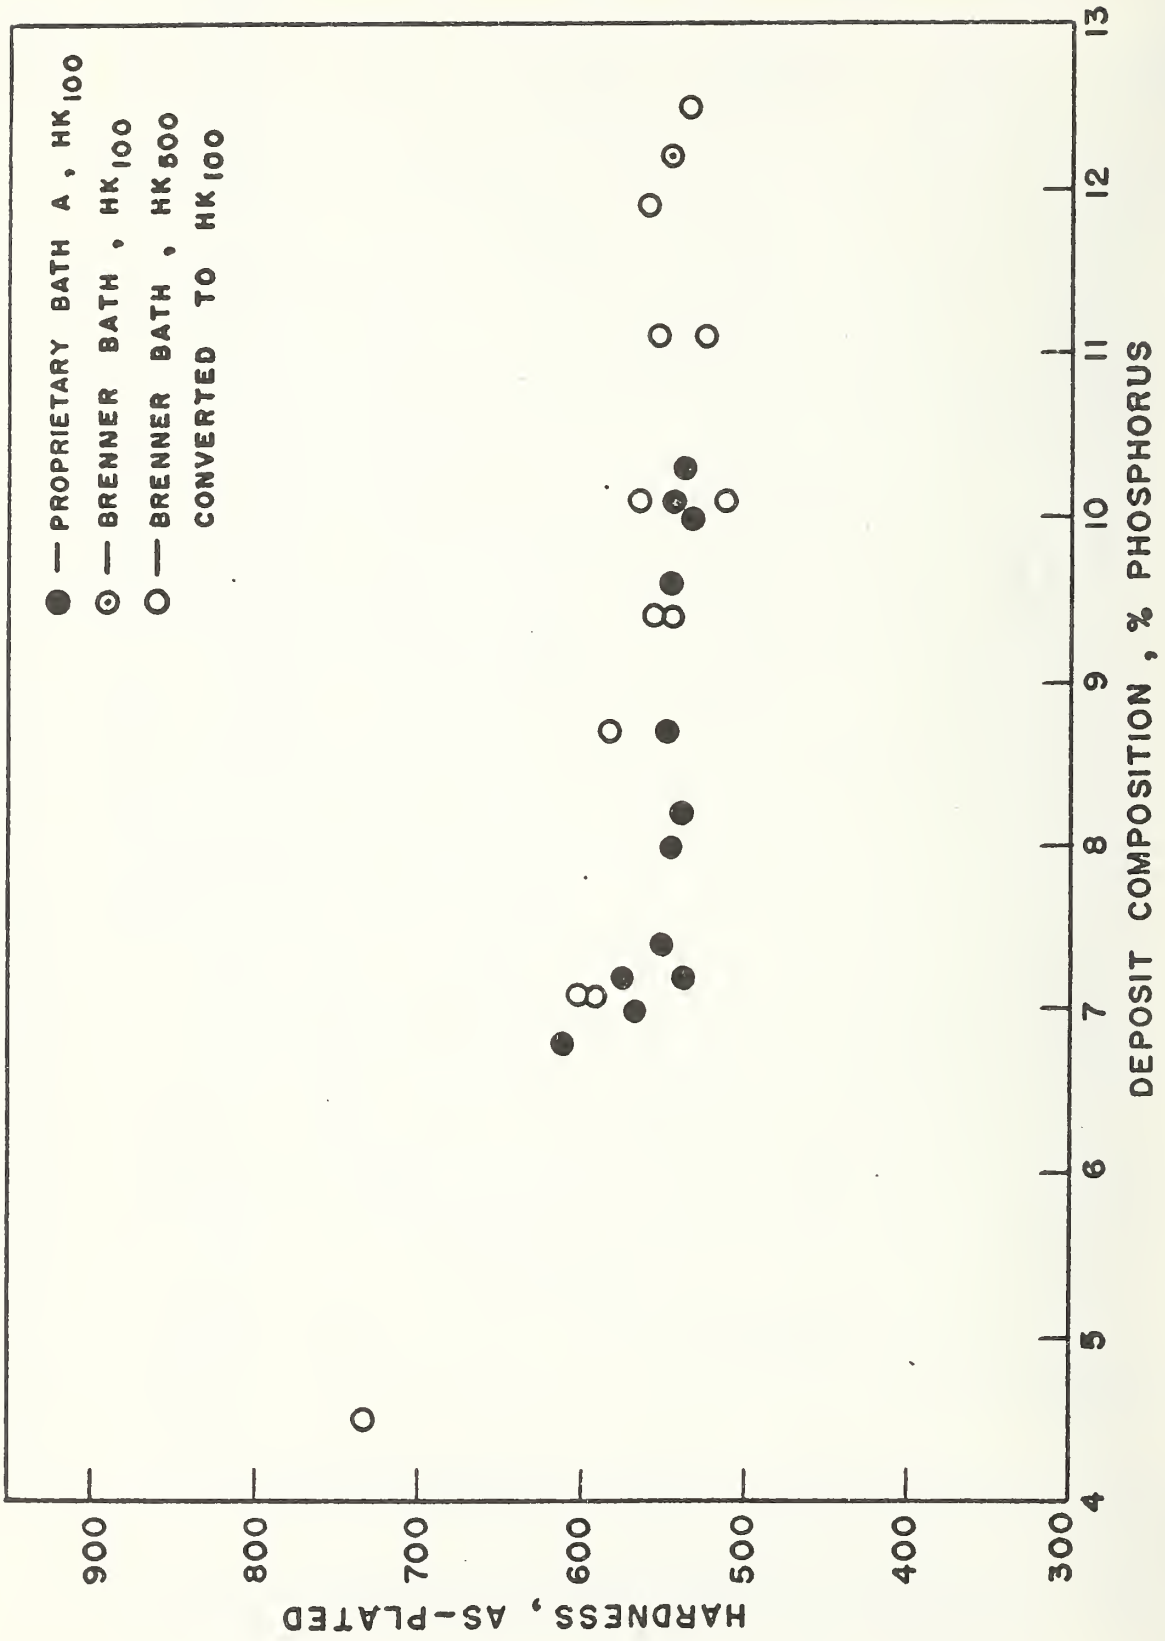
Figure 2 - AS-PLATED HARDNESS AS A FUNCTION OF PHOSPHORUS CONTENT IN THE DEPOSIT.

The data for as-plated deposits given in Table 2 is summarized in Figure 2 where the hardness is plotted against the phosphorus content. These data include deposits from bath A and the Brenner bath, all of which were operated at more than one composition and several different operating conditions. Thus these data represent a variety of electroless nickel deposits. The scatter of the data is, in part, due to the nonuniformity of each deposit and to imprecision of measurement. Another very likely cause of the scatter is that some feature or features of electroless nickel other than phosphorus content, influences the hardness.

It appears that for phosphorus concentrations above 7%, variations of phosphorus are of little practical consequence to hardness. Below 7%, the indication is that the phosphorus has much more to do with the hardness. More data, however, is needed for this phosphorus range.

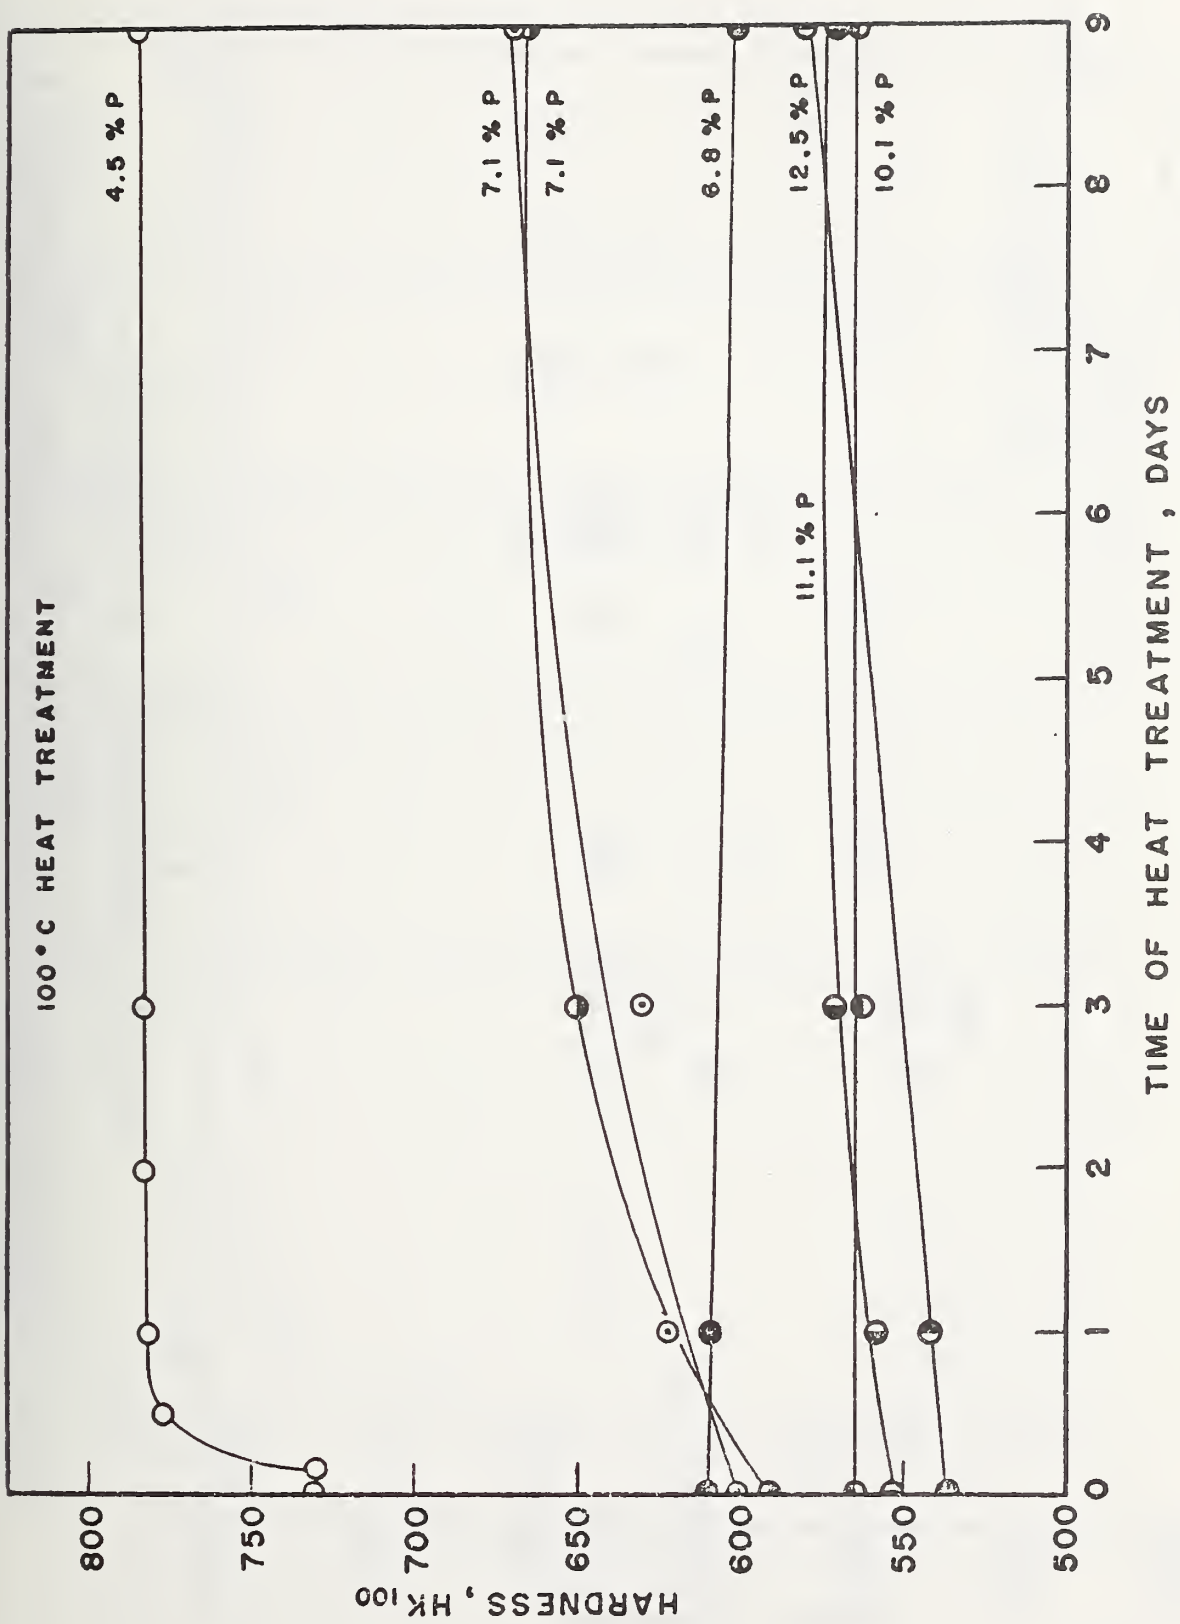
Figure 3 - HARDNESS AS A FUNCTION OF TIME AT 100°C HEAT TREATMENT FOR VARIOUS PHOSPHORUS CONTENT DEPOSITS.

Heat treatment at  $100^{\circ}\text{C}$  has some effect on hardness as shown by Figure 3, but this is probably of no practical significance. The changes are small and slow. It is possible that changes would be significantly greater over periods of months or years. It is interesting to note that the initial rate of change of hardness with time is related to the phosphorus content.

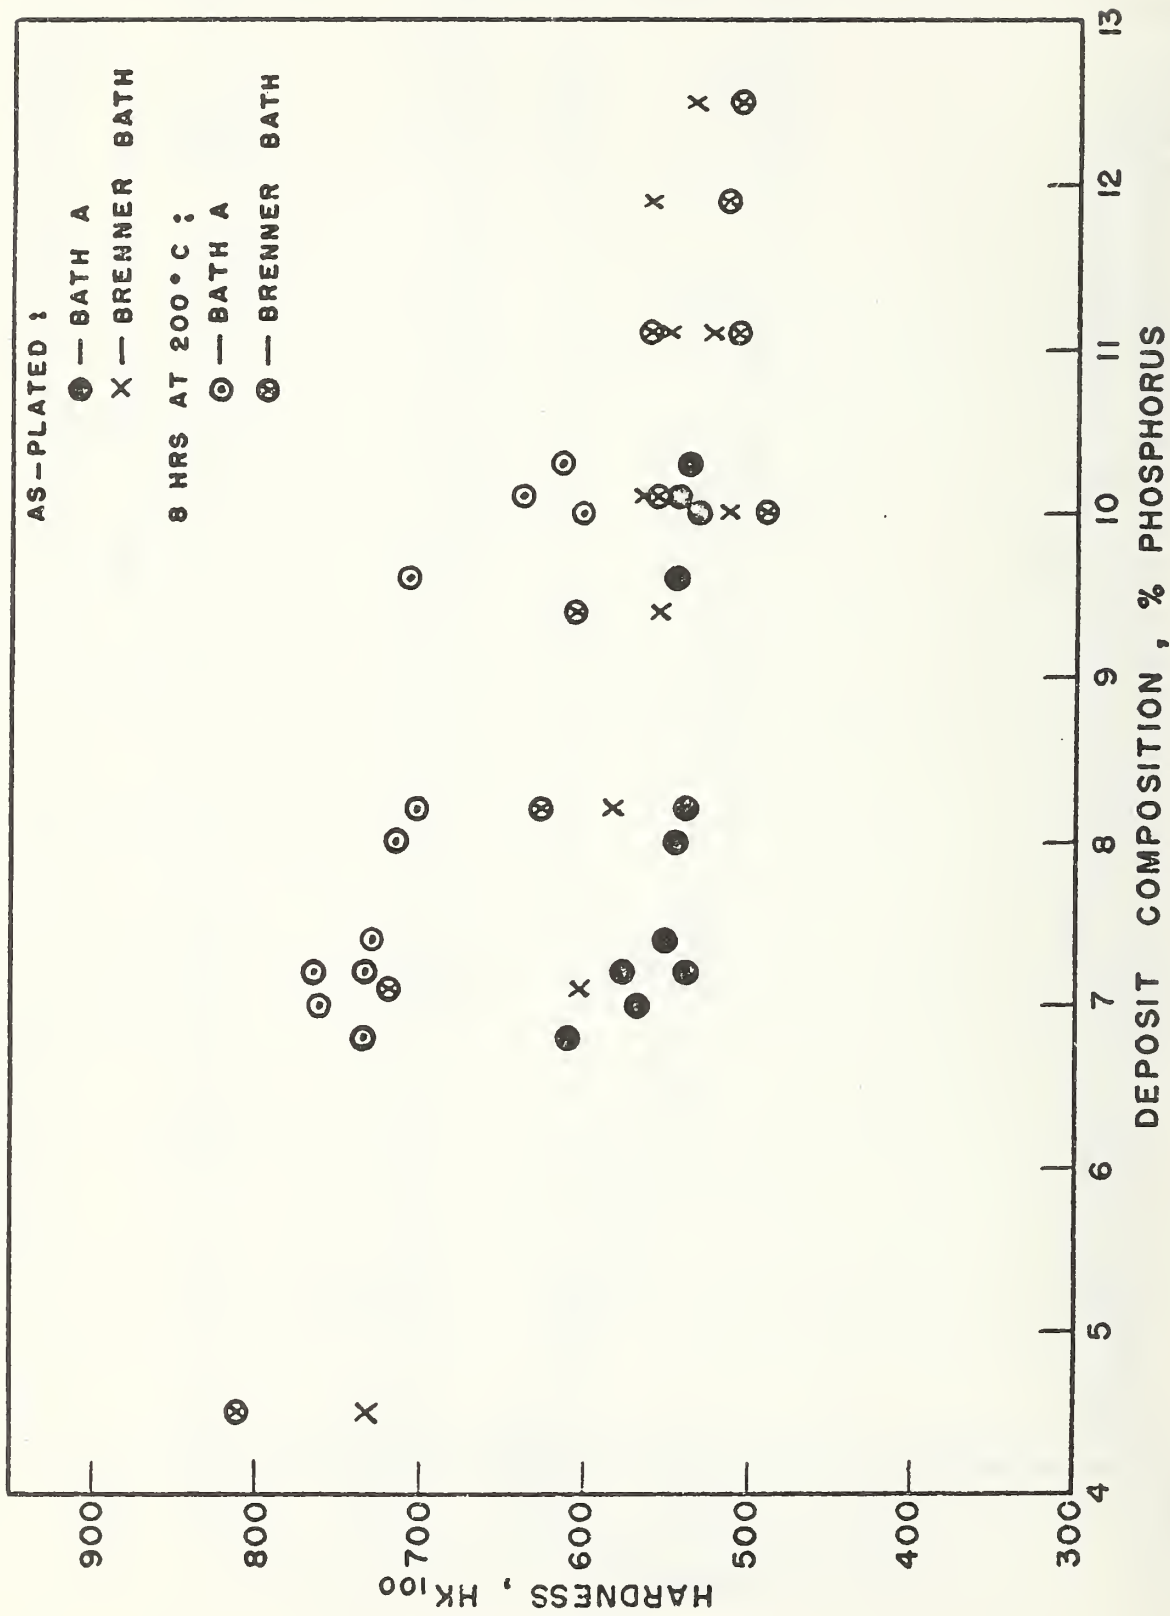
Figure 4 - HARDNESS AS A FUNCTION OF PHOSPHORUS CONTENT IN THE DEPOSIT AFTER 8 HOURS OF 200°C HEAT TREATMENT.

A number of specimens were heat treated at  $200^{\circ}\text{C}$  because such a treatment is often used for embrittlement relief. The hardness effects of heating at  $200^{\circ}\text{C}$  are summarized in Figure 4, which indicates that the hardness may either increase or decrease. In general, the deposits get harder, but those deposits from the Brenner bath with more than 9.8% P become a little bit softer. Figure 4 is for an 8 hour treatment. Figure 5 shows how the hardness varies with time. For low phosphorus content, 4 - 7% P, the heat treatment is essentially complete within four hours. At 8.7% P it was complete within eight hours. For high phosphorus deposits from the Brenner bath, the hardness drops during approximately the first four hours and then returns to approximately its original hardness during the balance of the first 24 hours.

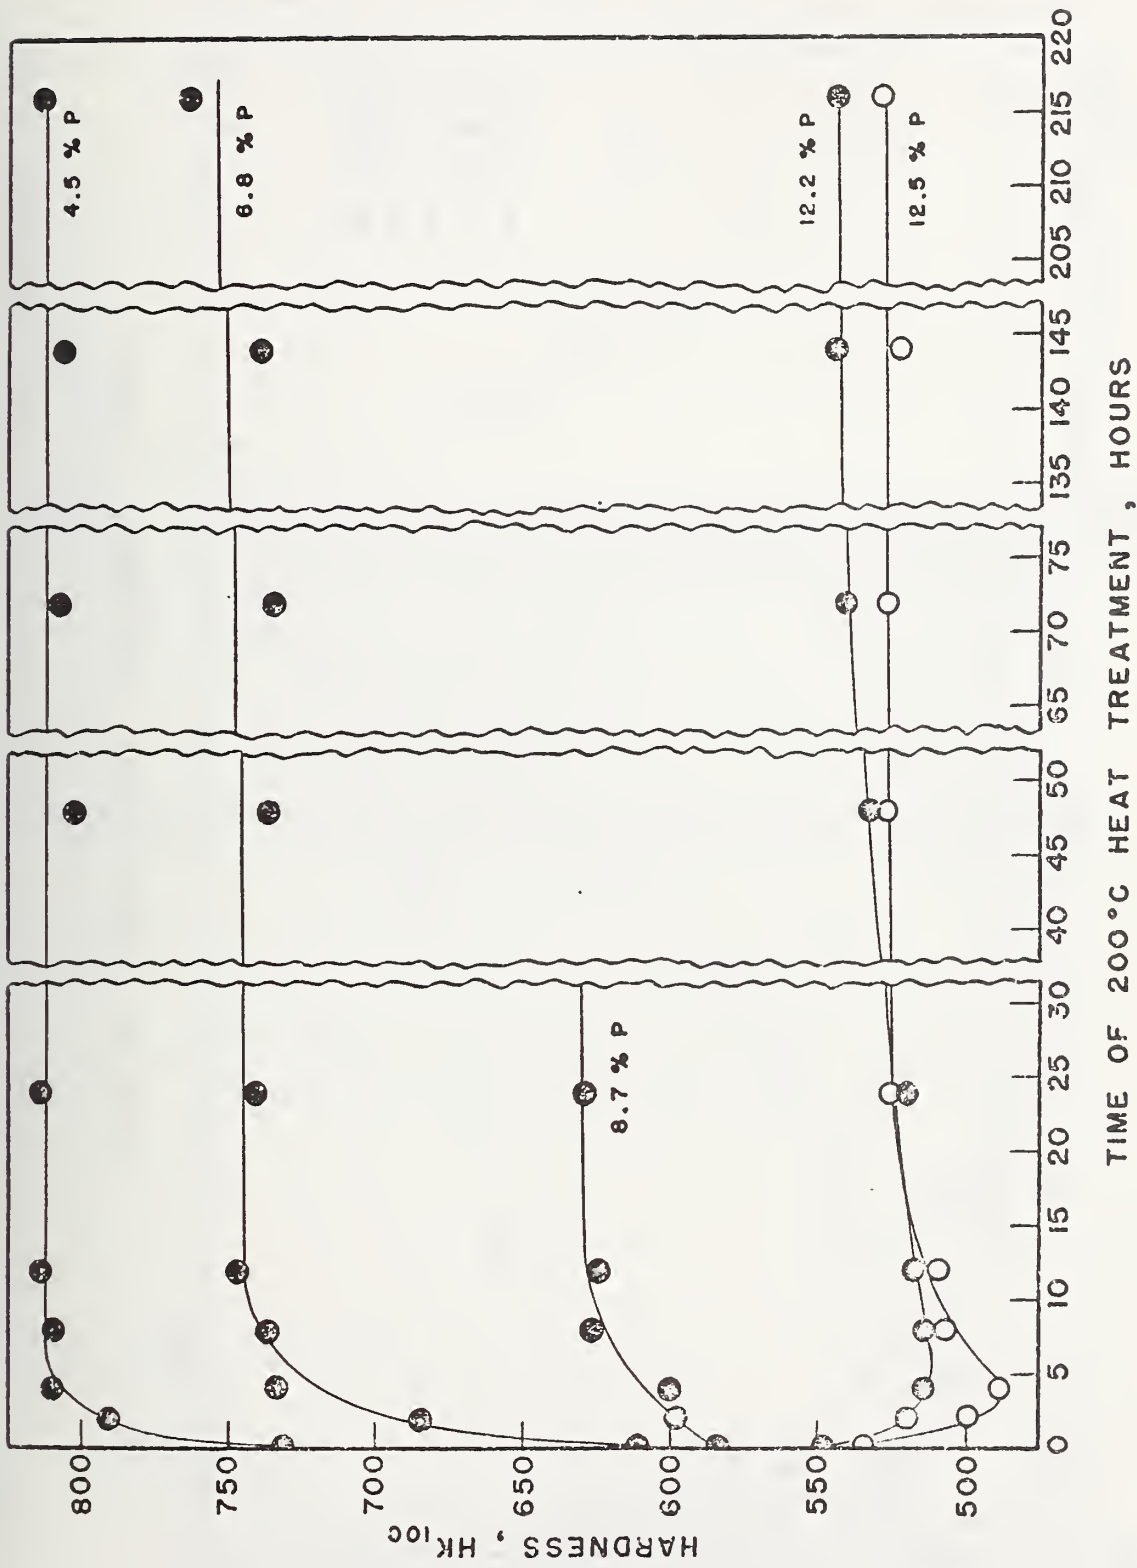
Figure 5 - HARDNESS AS A FUNCTION OF TIME AT 200°C HEAT TREATMENT FOR VARIOUS PHOSPHORUS CONTENT DEPOSITS.

The deposits from the proprietary solution increased in hardness more than those from the Brenner solution.

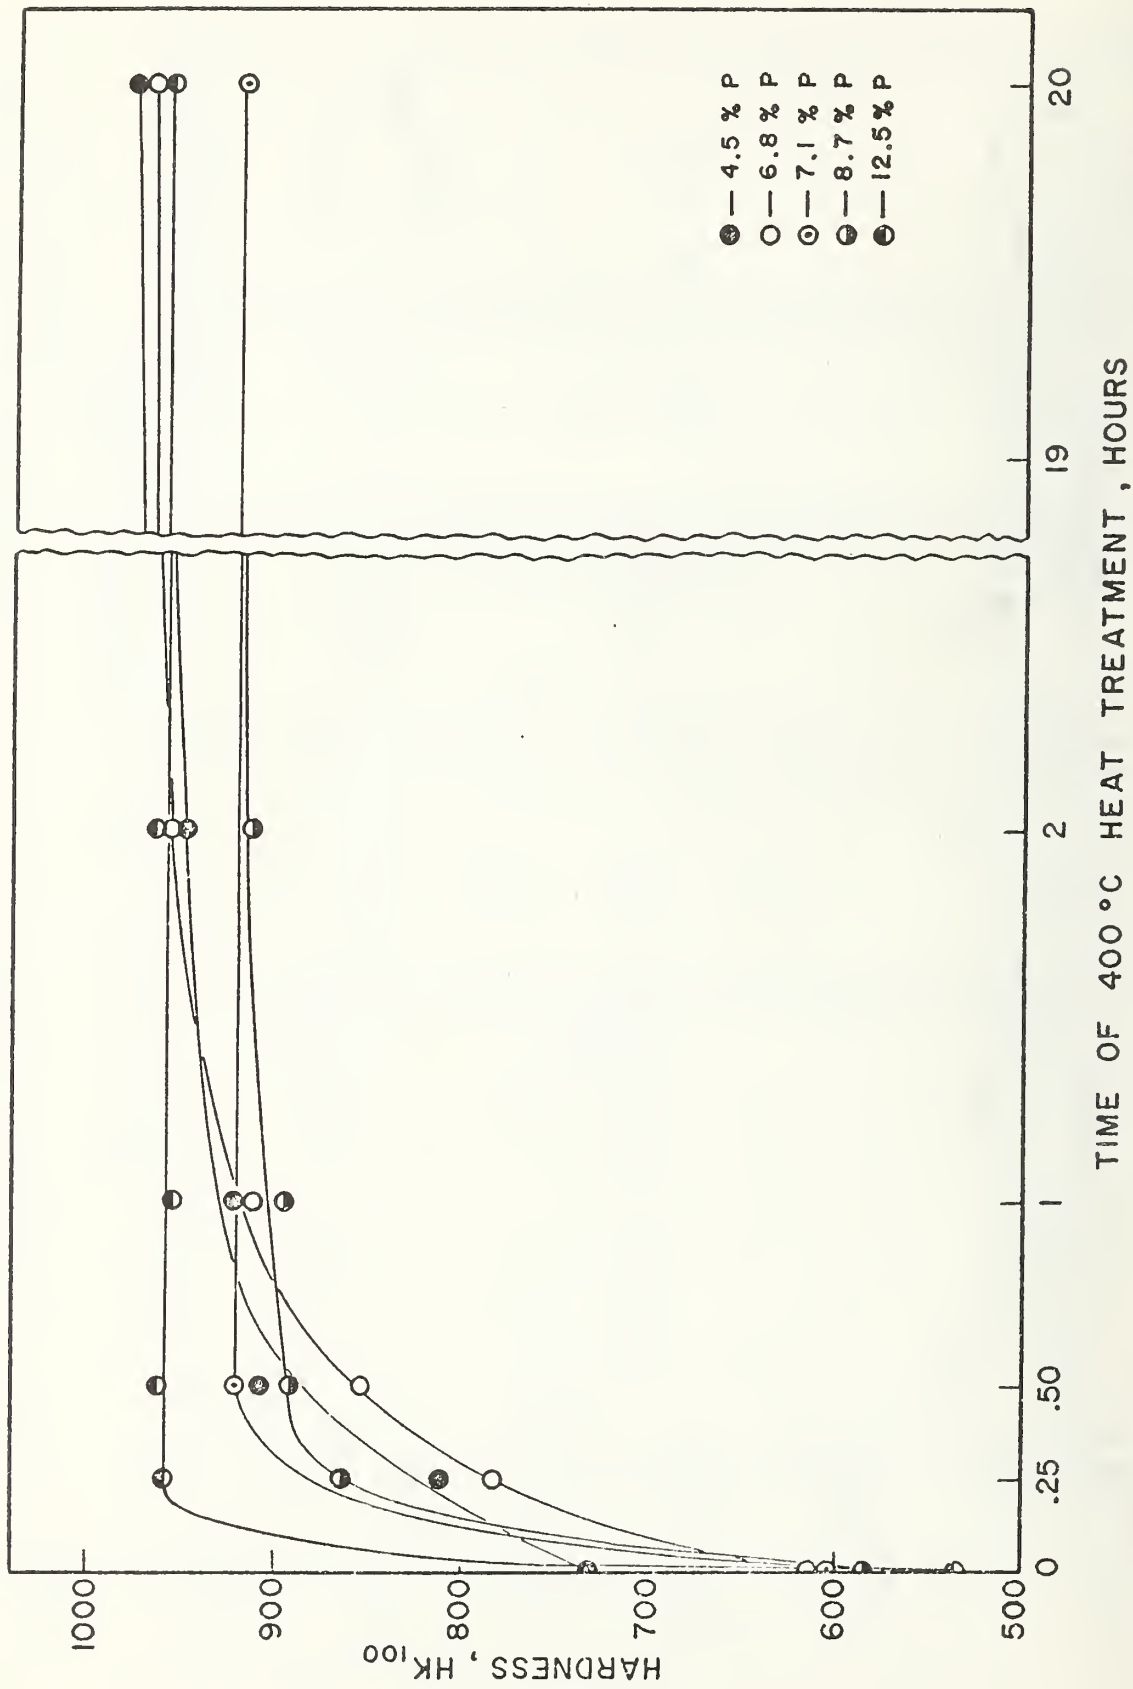
Figure 6 - HARDNESS AS A FUNCTION OF TIME AT 400°C HEAT TREATMENT FOR VARIOUS PHOSPHORUS CONTENT DEPOSITS.

It is generally recognized that maximum hardness of electroless nickel is obtained by heat treatment at  $400^{\circ}\text{C}$ . Figure 6 shows how the hardness changes with the time at  $400^{\circ}\text{C}$ . The rate of increase of hardness is quite rapid at first and then tapers off so that after 1 or 2 hours there is not much change. The hardness range for deposits heated to

400°C for 1/2 hour is 852 to 969 KH<sub>100</sub>. The time needed to obtain the maximum hardness was not determined, but the data for 20 hours indicates that 2 hours is not enough, and the rate of change after 2 hours is quite small.

The final hardness does not appear to be closely related to phosphorus content, but the phosphorus appears to have an effect on the initial rate of hardness change.

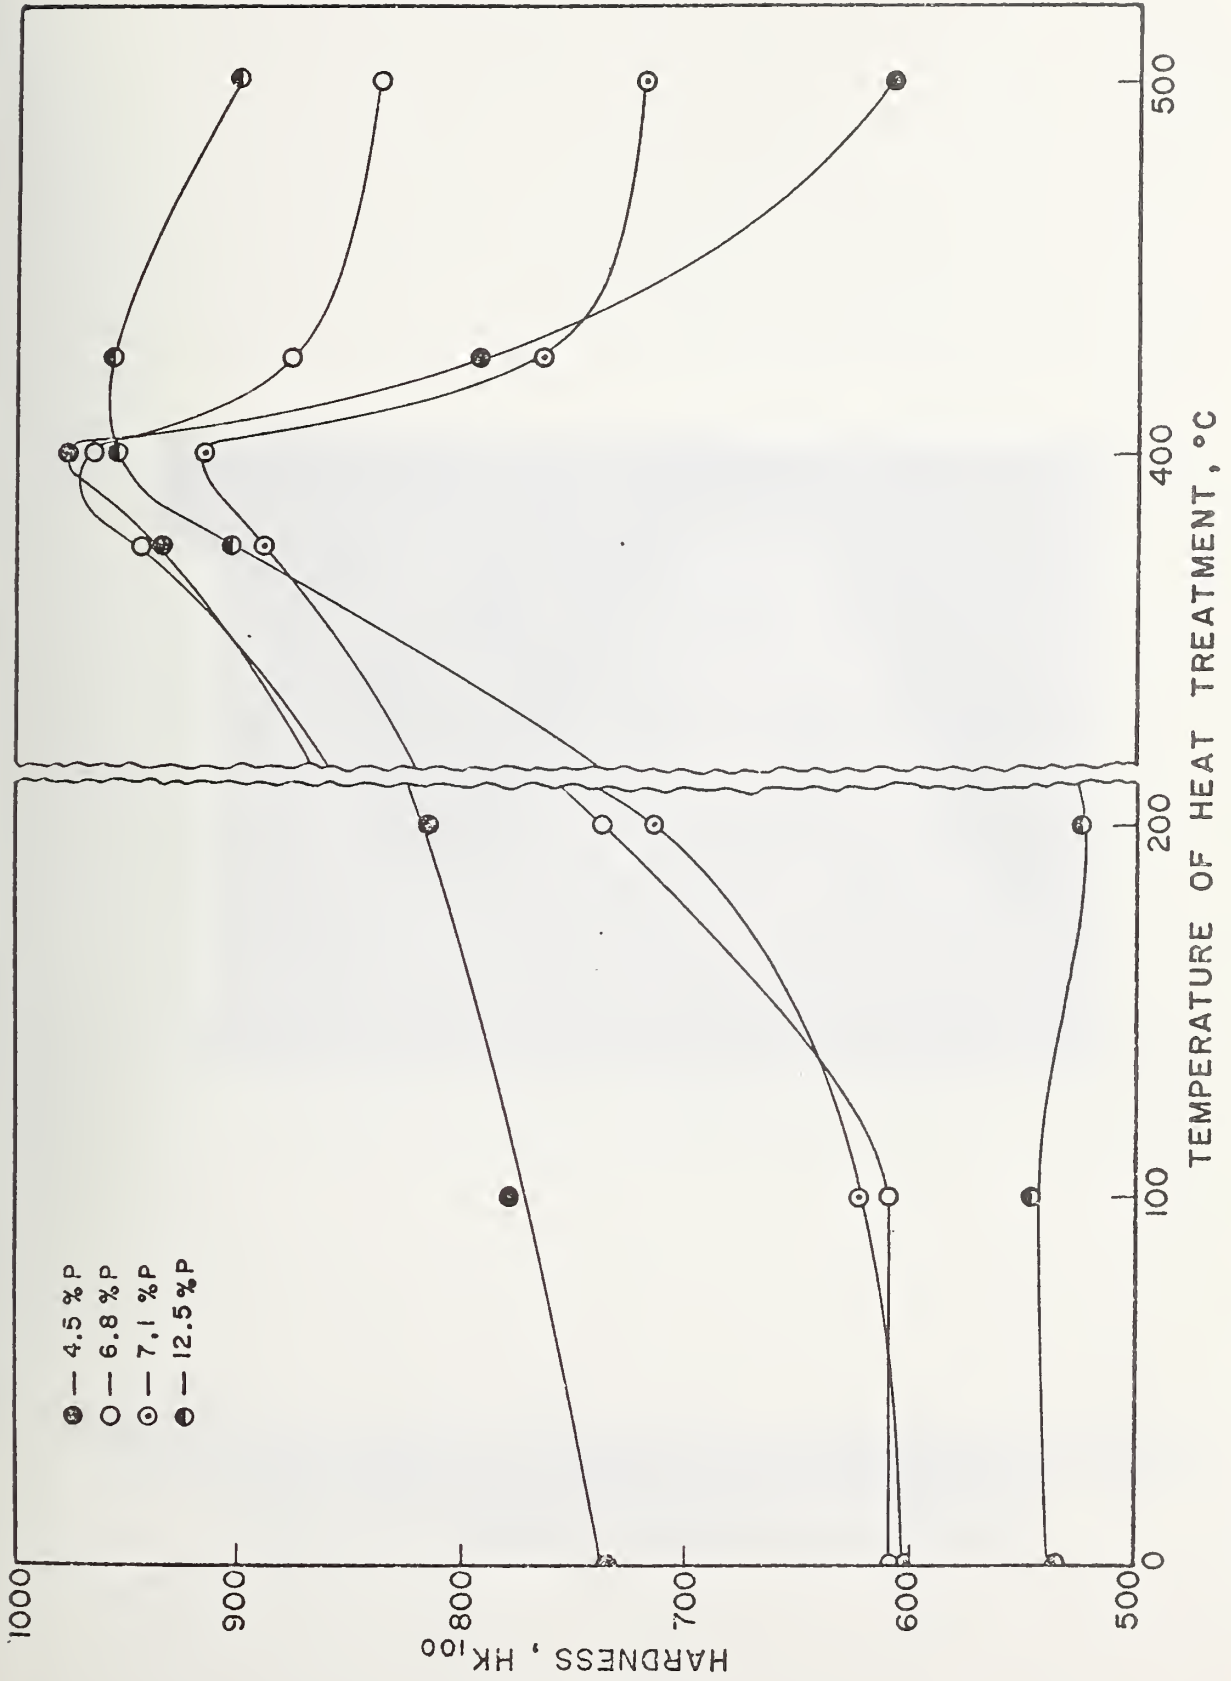
Figure 7 - HARDNESS AS A FUNCTION OF 20 TO 24 HOURS OF HEAT TREATMENT AT DIFFERENT TEMPERATURES FOR VARIOUS PHOSPHORUS CONTENT DEPOSITS.

A few specimens were heat treated at 375, 425, and 500°C in order to determine how critical the temperature is for maximum hardness. These data are plotted in Figure 7. They indicate that after 20 hours at 375°C, the hardness is not far below the maximum. At 425°C, the low phosphorus samples showed a markedly lower hardness and the high phosphorus deposit showed virtually no difference compared to the maximum.

These data are quite similar to those of Randin and Hinterman [5].

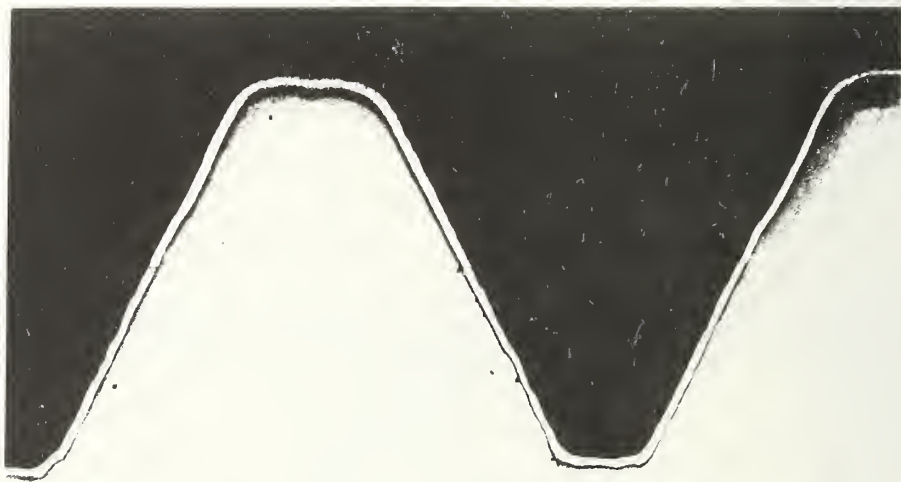
Figure 8 - Photomicrograph of cross section of brass bolt plated with electroless nickel in Brenner bath without agitation at 0.6 mil/hr. Overplated with nickel. 90X  
Peak to valley thickness ratio is 2.

Figure 8 is a photomicrograph of a section of one of two brass bolts plated for 2 hours in the Brenner bath without agitation and while suspended by a wire. The plating rate was about 0.6 mil/hr. The electroless nickel deposit is the layer between the brass substrate and an overplate of electroplated nickel. The deposit thickness was measured

at the top and bottom of the thread at six different "threads" (12 locations). There was a 6% variation between peaks compared to a 71% variation between valleys. The average peak to valley thickness ratio was 2.1. Obviously solution replenishment in the valleys was not as good nor as uniform as at the peaks.

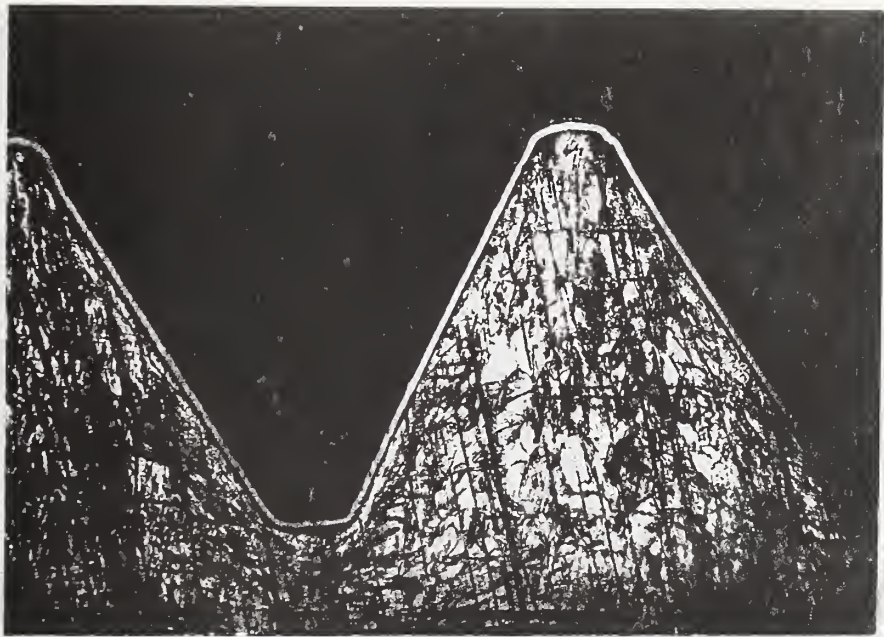
Figure 9 - Photomicrograph of cross section of brass bolt plated with electroless nickel in Bath A without agitation at 0.2 mil/hr. Overplated with nickel. 90X  
Peak to valley thickness ratio is 1.2.

Figure 9 is a section of another bolt plated 2 hours in bath A at a slower rate, about 1/3 that of the bolt in Figure 8, 0.2 mil/hr. Six valleys varied from 0.38 to 0.40 mil. Six peaks varied from 0.44 to 0.50 mil. The ratio of the two averages was 1.2. The improved throwing power may have been influenced by the bath composition, but it may also be due to the slower rate of deposition which permitted faster solution replacement relative to deposition of nickel.

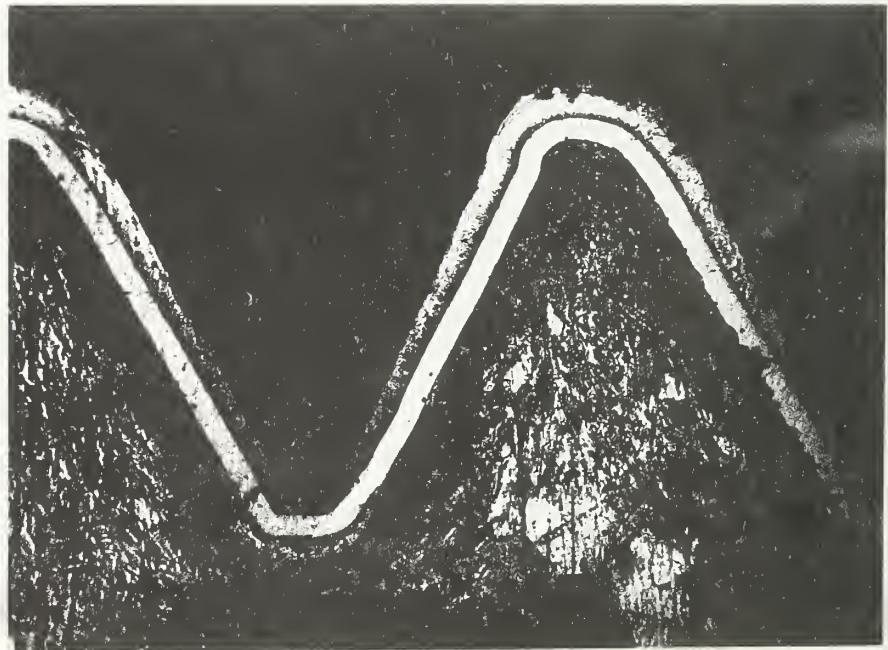
Figure 10 - Photomicrograph of cross section of brass bolt plated with electroless nickel in Bath A with agitation at 0.6 mil/hr. Overplated with nickel. 90X  
Peak to valley thickness ratio is 1.01.

Figure 10 is of a bolt plated near the faster rate in bath A with agitation from a magnetic stirrer and from solution pumped in and out of the tank. The thickness ratio of peak to valley is 1.013, hardly significant. This good throwing power is attributable to appropriate agitation.

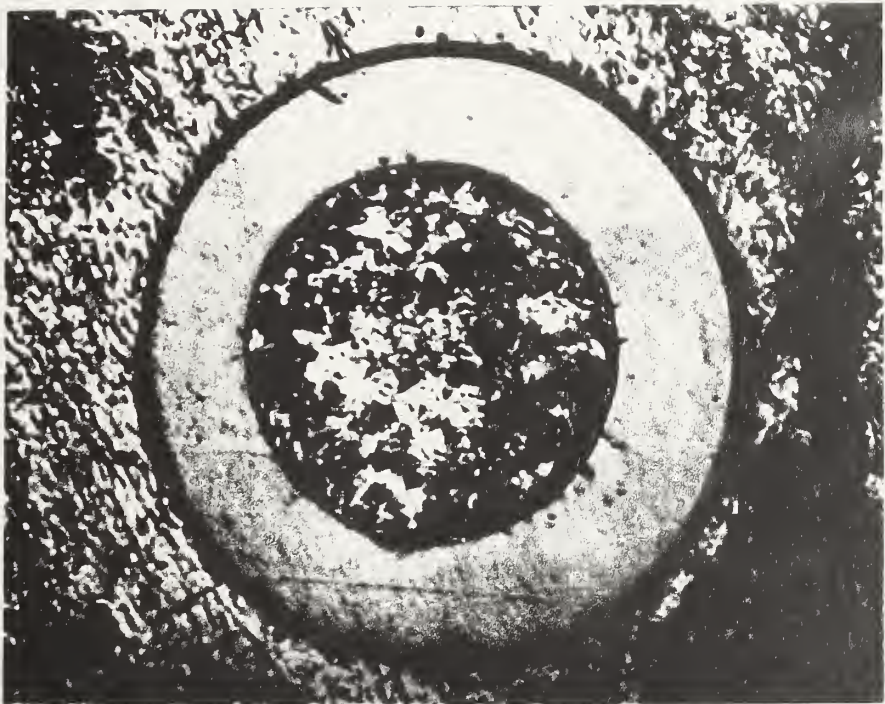
Figure 11 - Photomicrograph of cross section of 4 mil copper wire plated with electroless nickel in Bath A with agitation at 0.6 mil/hr. Overplated with nickel. 470X  
Maximum thickness ratio is 1.25.

The deposit shown in Figure 11 was on a 4 mil diameter wire plated in bath A at the same time as the bolt with uniform metal distribution. It is obvious that the metal distribution is not uniform. The maximum thickness ratio is 1.25. Apparently the agitation did not even out the metal distribution on the wire as it did for the bolt. The wire was suspended in the bath in a manner which permitted it to move with the solution within a revolving agitation pattern. The metal distribution probably reflects a net motion between the wire and solution resulting in unequal solution replenishment.
