NBSIR 77-1314

Solar Energy Systems - Survey of Materials Performance

Final Report

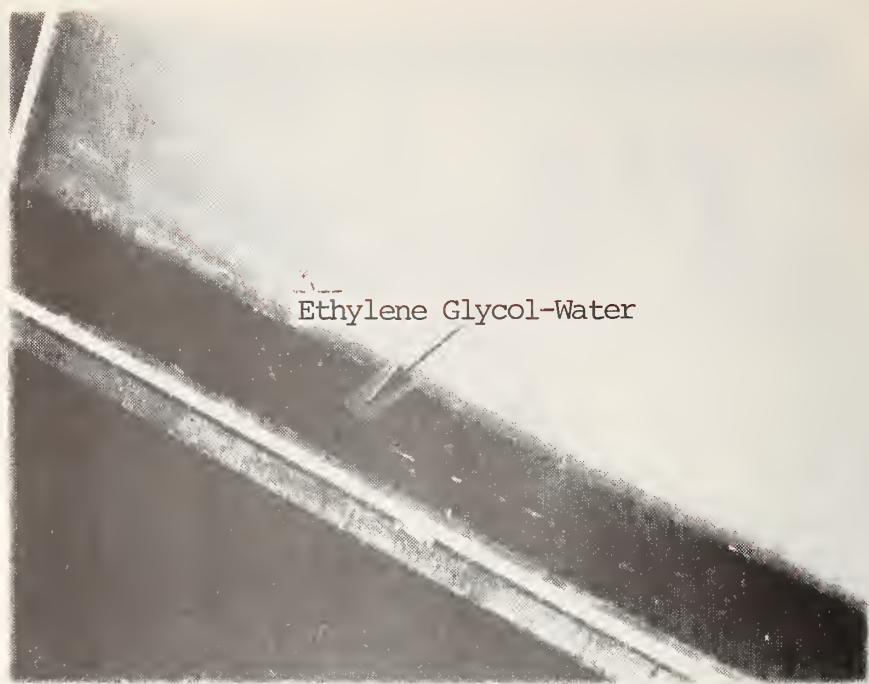
1. Leakage resulting from corrosion has been observed in several systems utilizing aluminum absorber plates with integral fluid flow passages. These observed leakages may not be the fault of the absorber plate itself and the cause of the corrosive action may well originate in some other component of the system (see fig. 2-19).

Figure 2-19. Leaking Aluminum Absorber Plate

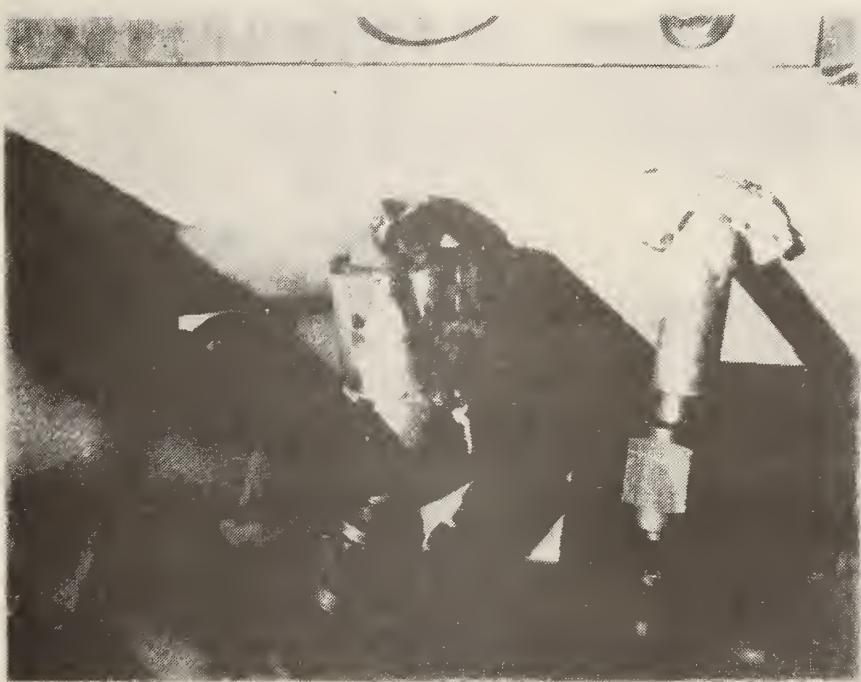
4. Extensive weld failures were observed in one system. The system was of aluminum construction with the inlet and outlet tubing being welded to the absorber plate. Threaded connections were then used to connect the inlet to the transport piping. Overstressing of the weldments during the tightening of the threaded tubing to the transport system was a possible cause for the failures (see fig. 2-22).

Figure 2-22. Aluminum Weld Failures

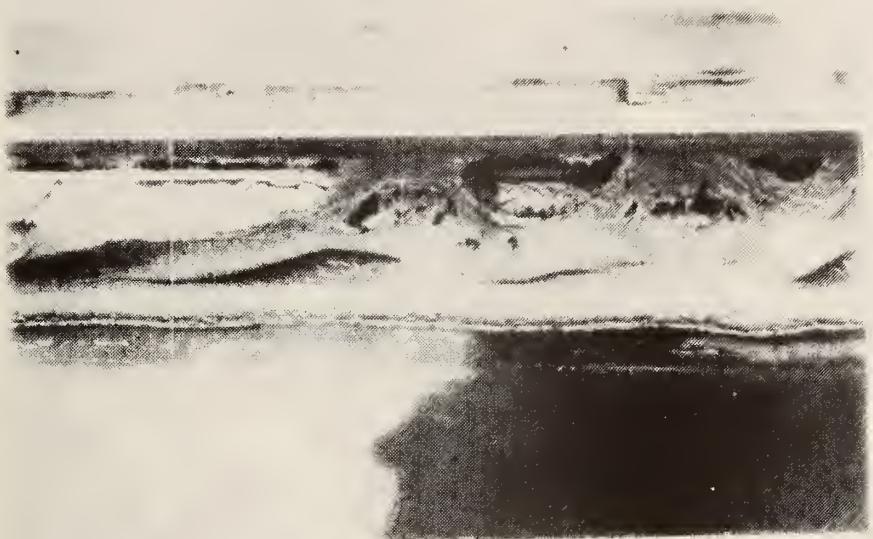
1. At one installation visited, the sealant used between the glass covers and the wood and aluminum collector enclosure was a major problem. The gray-colored (probably butyl) sealants used originally did not permanently seal the joints. The sealant between the inner cover and the wood enclosure was very brittle and lacked adhesion to the substrate. The sealant between the outer cover and either the wood enclosure or the aluminum cross tee was very brittle and had cracked and shrunk due to weather exposure. A number of the glass covers were undersized which meant that a joint of 3/4" to 1 1/2" had to be sealed. Thus not only was an inadequate sealant used but the joints were often impossible to seal with any sealant. The unsealed joints permitted water to penetrate into the collector interior (see figs. 2-9 and 2-25).

Figure 2-25. Failure of Sealant Between Tempered Glass Covers and Aluminum Extrusion

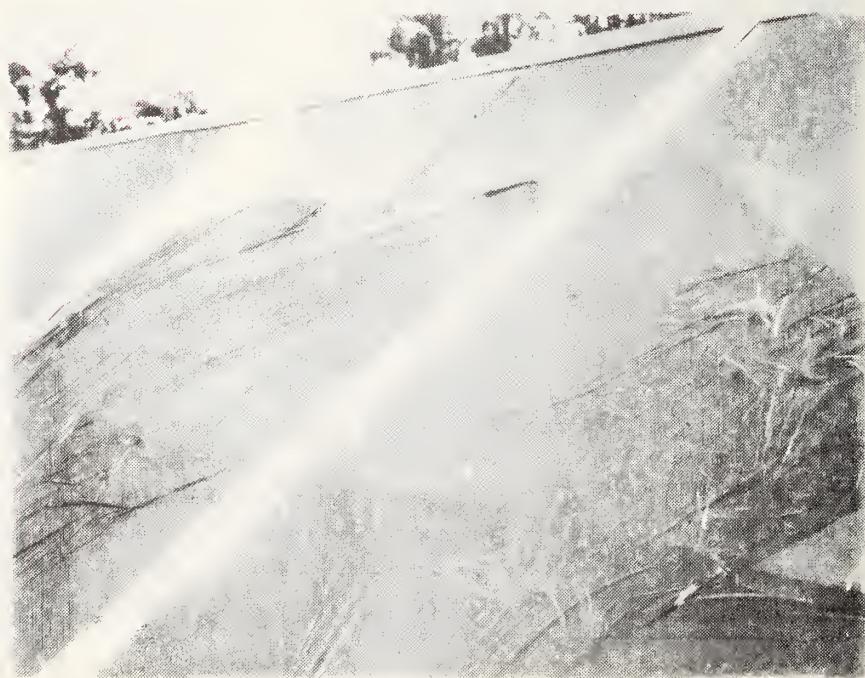
Two flat plate collector systems were inspected which used reflective surfaces. Figure 2-28 shows problems observed on one of the reflective systems. The surface irregularity resulted from difficulties in applying self-adhering aluminized film. Subsequent loss of adhesion required the addition of batten strips.

Figure 2-28. Reflective Surfaces

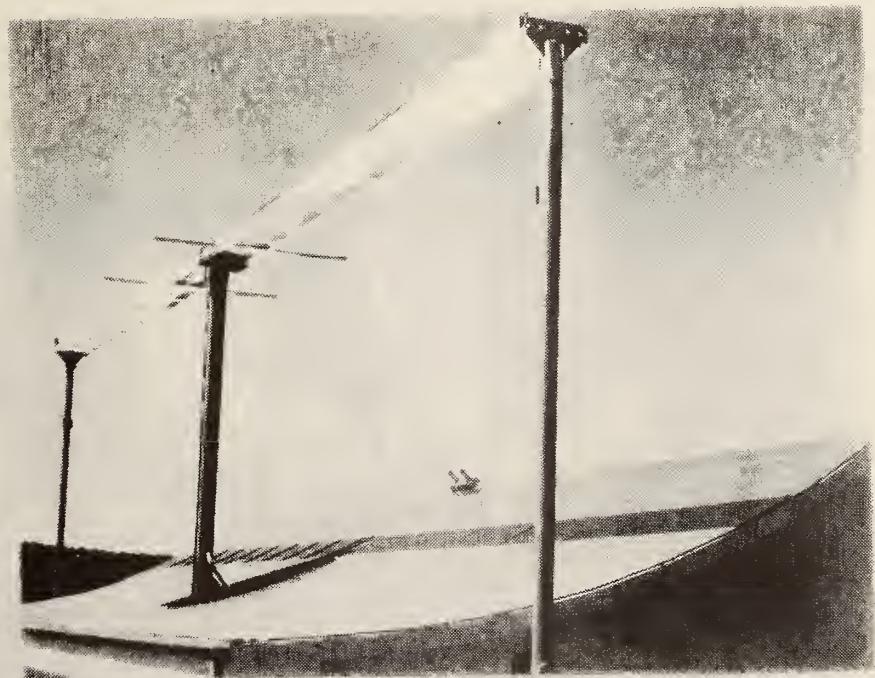
Figure 2-30. Concentrating Collector
with Roof Mounted Reflective
Surfaces

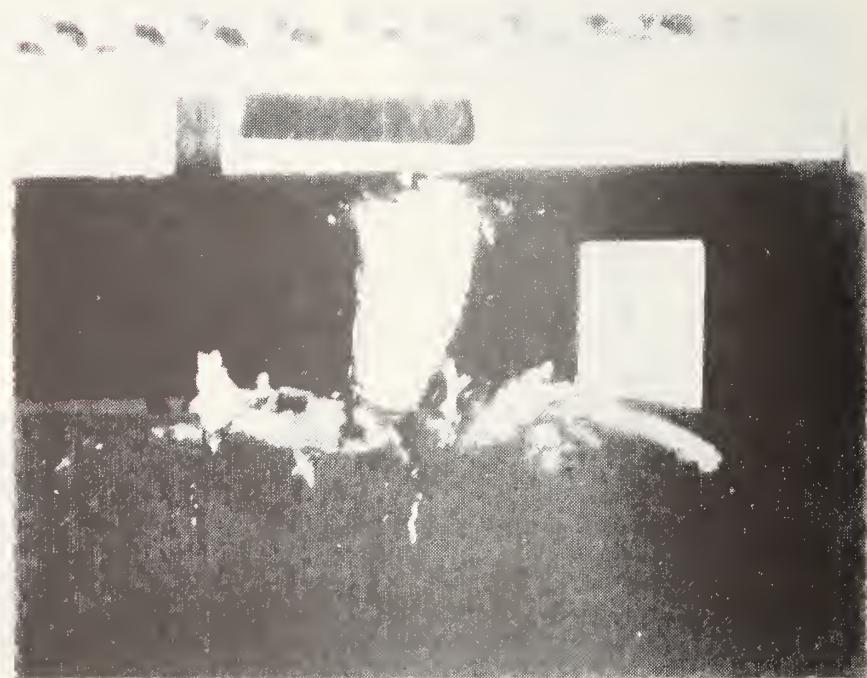
The greatest single problem encountered in regards to transport piping was the flexible hoses at inlet and outlet couplings of flat plate liquid collectors. At every site visited where flexible coupling hoses were used, leakage problems have occurred to a greater or lesser degree. Causes for leakage have been attributed to age hardening and loss of elasticity, plastic flow of hose materials through slotted holes of gear-type clamps resulting in reduced clamping forces, cumulative slippage of hoses due to thermal movements of collectors and ozone or ultraviolet attack of hoses exposed to weathering. Also, it was reported that it is sometimes difficult to replace collectors that are attached with rubber hoses because of the tightness of the hose/metal bond. Attempts to solve these problems ranged from application of sealants and adhesives to the exterior of leaking hoses to the complete replacement of organic hoses with metallic couplers (see figs. 2-32 and 2-33). Figure 2-34 illustrates a design problem. The hose to collector connection was placed inside the collector enclosure making it difficult to tighten the hose connection or replace the hose.

Figure 2-32. Field Expedient Repair of Flexible Coupling Hose

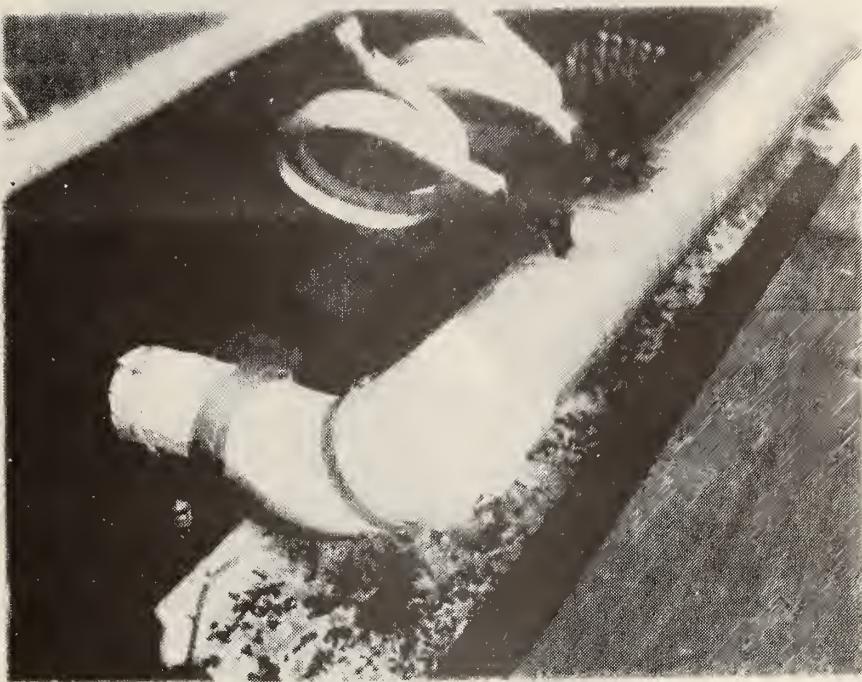
Figure 2-33. Copper Coil Replacement of Flexible Hoses

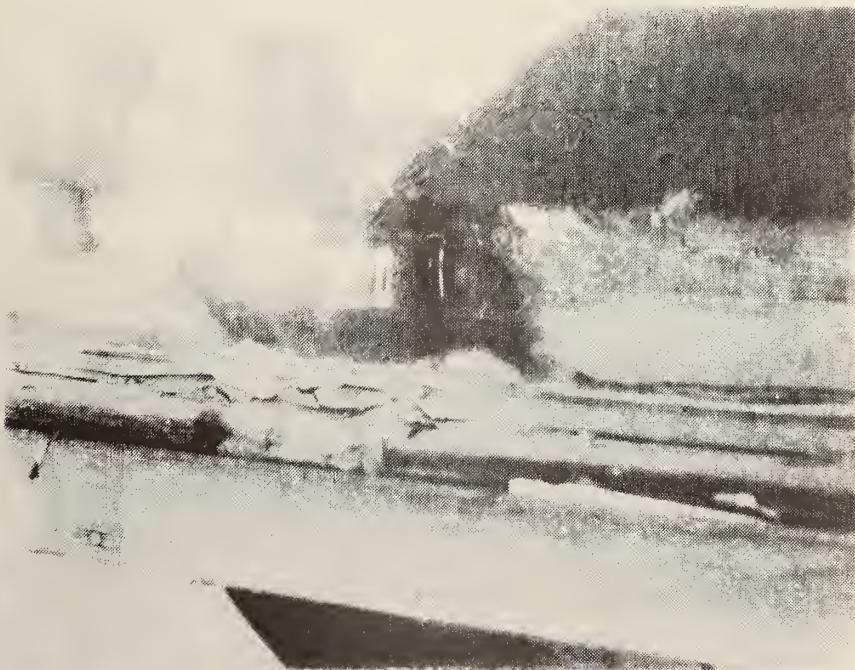
Figure 2-34. Inaccessible Hose Connection

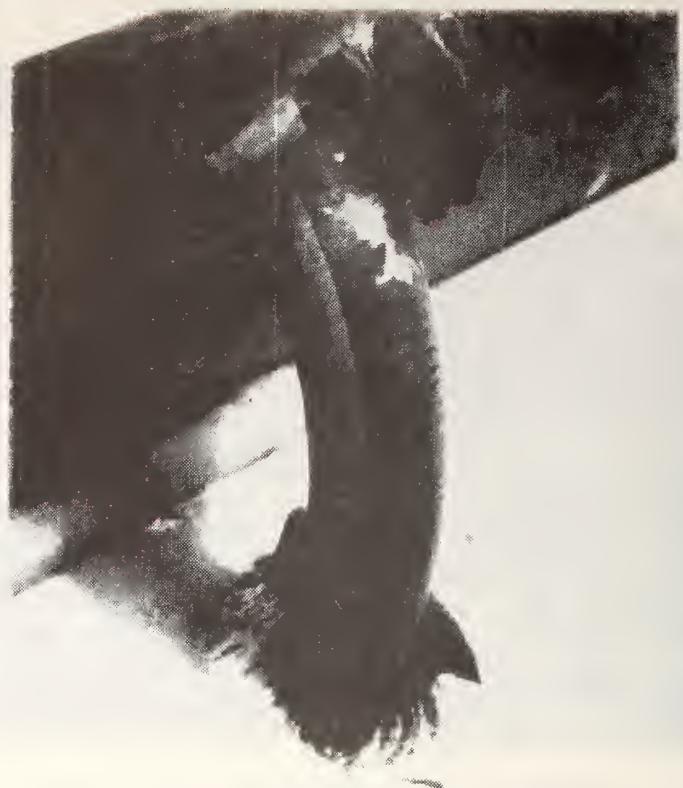
Several other problems were apparent as regards flexible hose couplings. In many cases the hoses were not insulated resulting in heat losses and weathering deterioration (see fig. 2-35). In one case, where coiled copper connections were used to replace flexible hoses, the insulation at the transport piping was not sealed allowing water to enter the insulation resulting in additional heat losses (see fig. 2-33). At another side, different paint coating systems were used to protect the cellular insulation surrounding the hose connections. In one case, the insulation became embrittled and cracked while the same insulation coated with a different material remained flexible with no damage to the insulation (see figs. 2-36 and 2-37).

Figure 2-35. Uninsulated Flexible Coupling

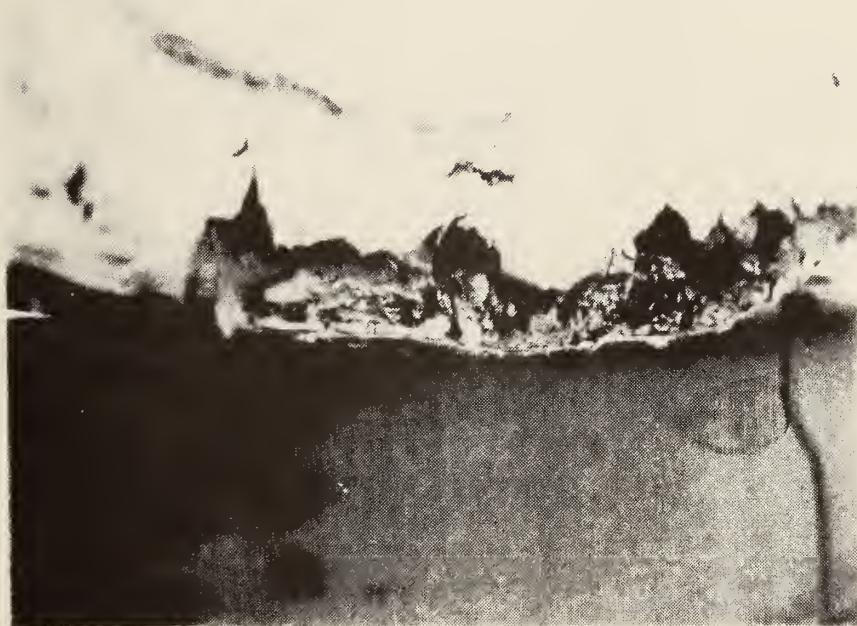
The other two storage problems had to do with the tank insulation. In one case a liquid leak from a tank connection resulted in the deterioration of vermiculite plaster insulation used on the ends of the cylindrical roof mounted tank (see fig. 2-38). In the other case, an insufficient amount of insulation was used on three buried tanks resulting in excessive heat losses. This was evidenced by the fact that the earth cover did not support the growth of vegetation. This heat loss was also substantiated by the rapid drying of the area above the buried tanks after a rain storm when compared to adjacent areas.

Figure 2-38. Deterioration of Vermiculite Plaster Storage Tank Insulation
